IDENTIFICATION: COMMON HISTORICAL NAME: CUMMINS RESIDENCE ADDRESS: 25720 S. Beavercreek Road AREA: BEAVERCRI CUMMERST CUMMINS TOURIER: ROY HENRICI CUME: Farm Compound Comments of the Common Comments of the Common C	PHOTO INFORMATION:	STUDY AREA: COLTON/HIGHLAND
IDENTIFICATION: COMMONU/ HISTORICAL NAME: COMMONU/ HISTORICAL NAME: COMMONU/ HISTORICAL NAME: COMMINS RESIDENCE AMREA: BEAVERCRI COUNTERS: COUMTINS RESIDENCE AMREA: BEAVERCRI COUNTER'S ADDRESS: Same Beavercreek 97004 CORIS IN A COUNTER'S TOWN: COUNTY: X CITY: THEME: Architecture - 19th Century DATE: 1908 DESCRIPTION: ARCHITECTURAL IMPERENT: STYLE: Vernacular DATE: 1908 ARCHITECTURAL IMPERENT: STYLE: Vernacular DATE: 1908 CONDITION: Good ARCHITECT: STORIES: MOOS: Steeply-pitched intersecting gables with boxed eaves. DOORS: WINDOWS: Narrow 1/1 double-hung sash with architrave molding. MAIN ENTRANCE: Wrap-around porch-rounded corners. Sides are enclose Porch posts replaced with wrought iron. HOTES:	ROLL: LX	LEGAL! T. 4 R. 3E SEC. 8

SUBJECT PROPERTY

Address: 25720 S. Beavercreek Road Historic Name: CUMINS, EUGENE AND OLIVE, FARM

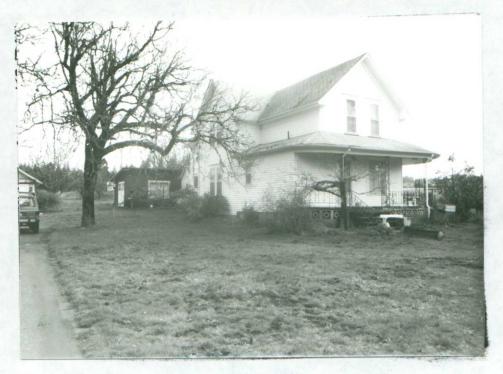
HOUSE

EXTERIOR SURFACING MATERIALS: Vinyl siding; bevel w/ rake boards

OTHER: Enclosed wraparound porch wrought iron posts; paneled

and glazed door CONDITION: Good

EXTERIOR ALTERATIONS (DATE): Re-sided (n.d.); porch partially enclosed and posts replaced (n.d.); chimney added (n.d.); deck added, s. elev. (n.d.); porch deck under reconstruction (1991);

Since the historic period the house has had some alterations. These changes include the replacement of the porch posts with wrought iron and the re-siding of the building with vinyl.

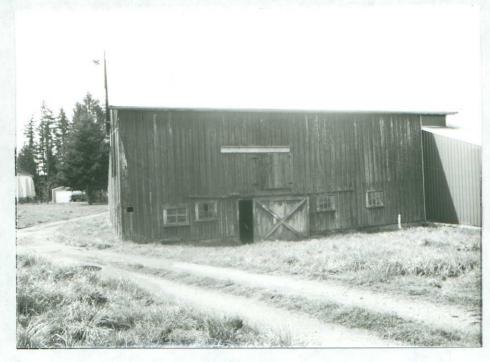
BARN

CONDITION: Good

EXTERIOR ALTERATIONS (DATE): Sheds added (n.d.)

In addition to the house there are several outbuildings, including a barn, chicken coop, garage and granary. The barn is an very good example of the Western barn type. Characteristic features include the tall profile, gable roof and board-and-batten siding. The barn has had wings added to either side, however, the original portion of the barn is clearly evident.

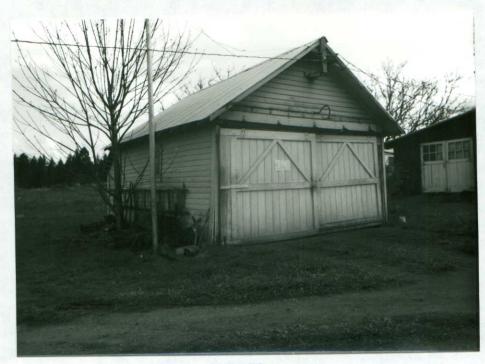
GARAGE

CONDITION: Good

EXTERIOR ALTERATIONS (DATE): Unknown

The garage is believed to have been constructed later than the house. Garages became a common element in the farm ensemble after the 1920s, when automobiles began to replace the wagon as the form of personal transportation.

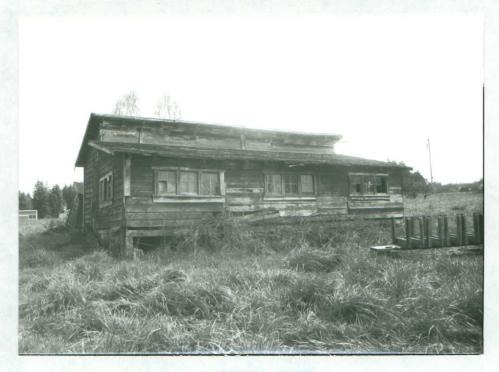
CHICKEN COOP

CONDITION: Poor

EXTERIOR ALTERATIONS (DATE): Clerestory window covered (n.d.)

The chicken coop is not in good condition. It is identified by its distinctive shape. Clerestory windows were often used for poultry buildings in western Oregon. It is not known of this design feature promoted egg laying.

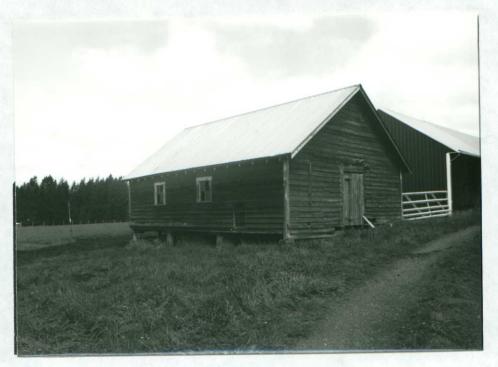
GRANARY

CONDITION: Fair

EXTERIOR ALTERATIONS (DATE): Door altered (n.d.)

The granary is also not in good condition. Characteristic features include the raised floor, designed to keep the grain dry.
