**LINN COUNTY INVENTORY OF HISTORIC PROPERTIES  
HISTORIC BARN SURVEY FORM**

Hist. Name: David Aegerter Barn

Address: 41915 Ridge Dr. T/R/S: 9/1W/36 Tax map no./Tax lot: 9 01W 36/400

Recorded by: Gallagher, Dasch and Nelson, June 19, 1996

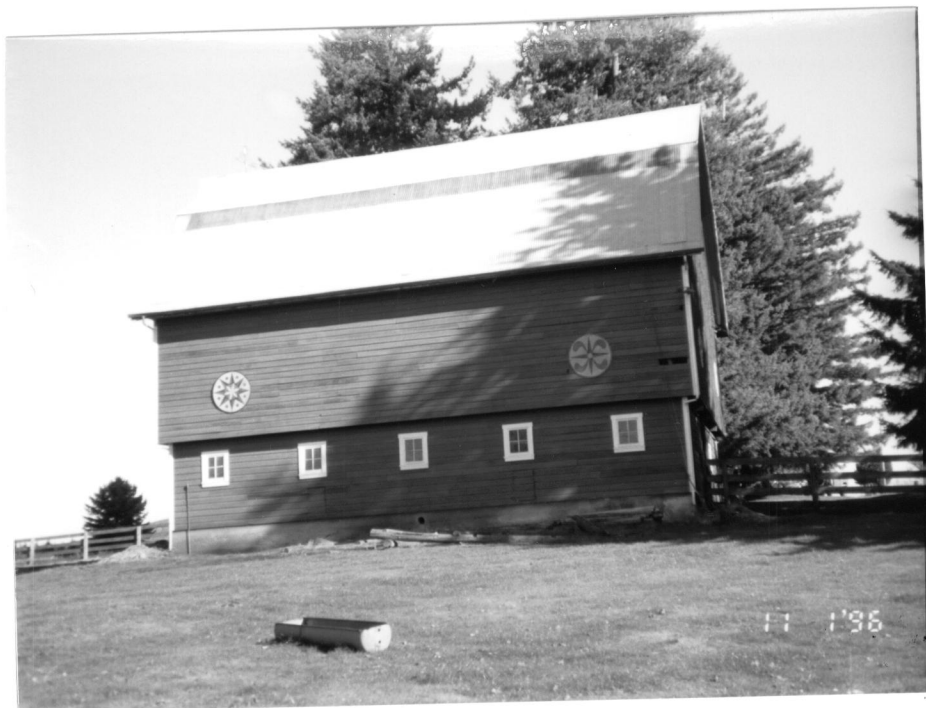
B-61, West elevation. (Photograph: roll 25, frame 16)

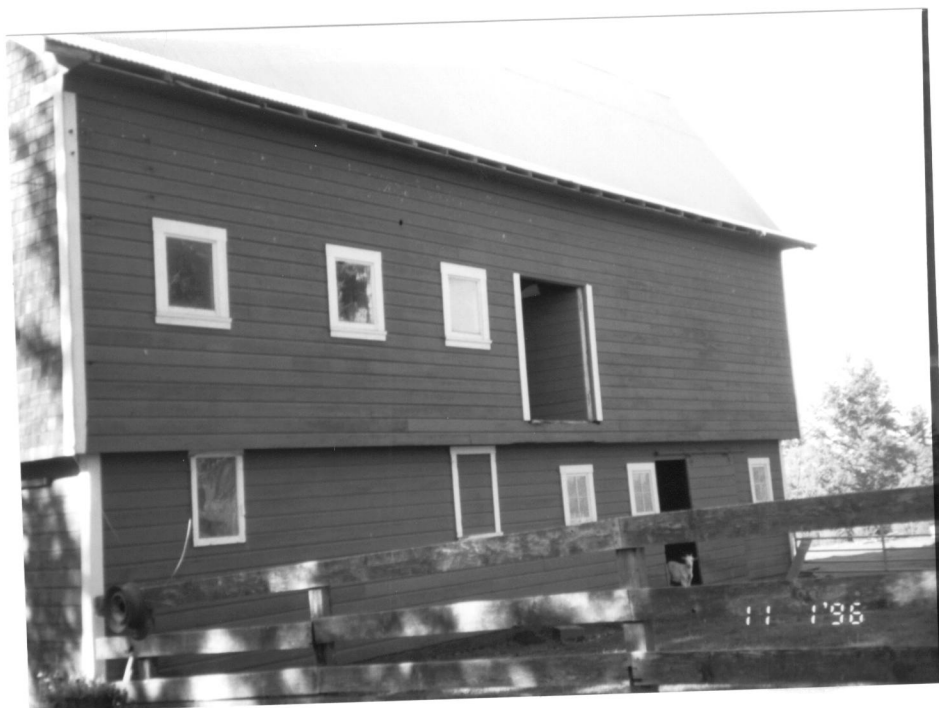
**27. Unglazed Openings:** 1 shuttered opening on the lower wall of the east elevation and 1 shuttered opening on the upper wall to the second level on the east elevation. This shuttered opening to the loft is large and centrally placed reminiscent of the upper level opening located on the forebay side of Pennsylvania barns.

B-61, East elevation. Note the loft level door. (Photograph: roll 25, frame 17)

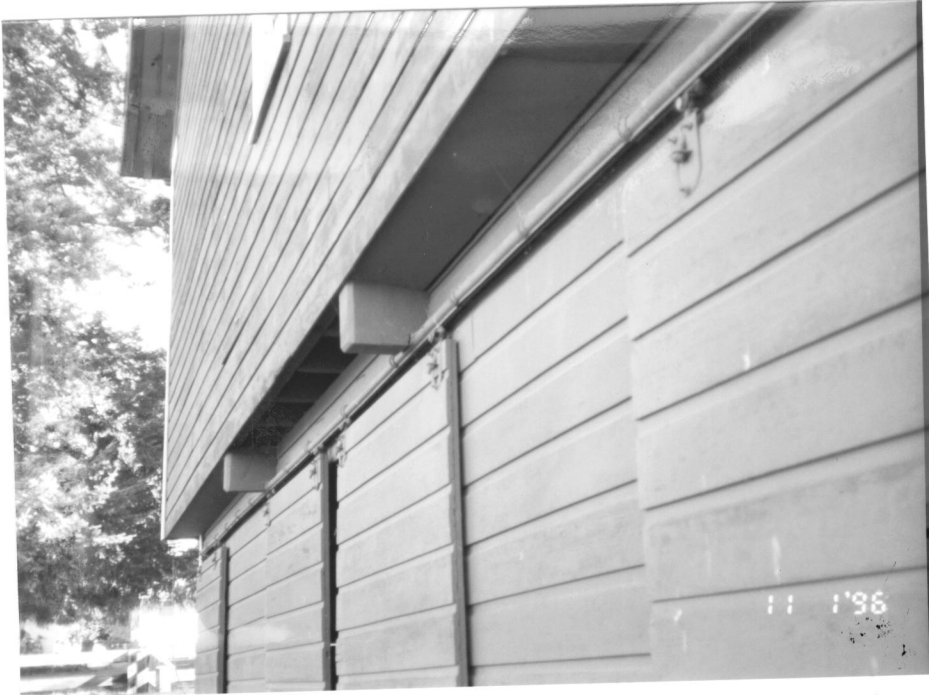
B-61, Detail of overhang on the north elevation. (Photograph: roll 25, frame 15)
