### Exterior Masonry Assessment:

#### **Fenton Hall University of Oregon**

### **Condition Assessment**

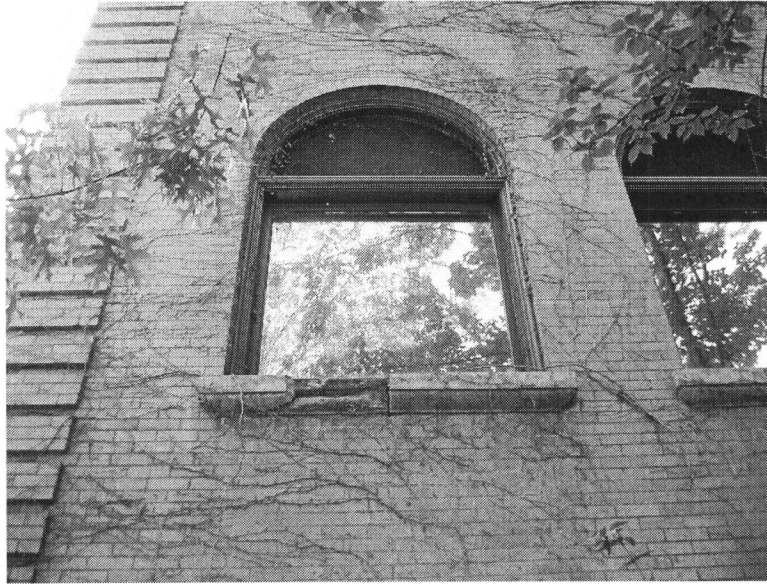
**E1. Intrusive Vegetation:** While most of the vegetation has been treated (likely with an herbicide) and the leaves have dropped off, the remaining vines that cover the structure still need to be removed. *Suggested Maintenance – Remove remains of vegetation.*

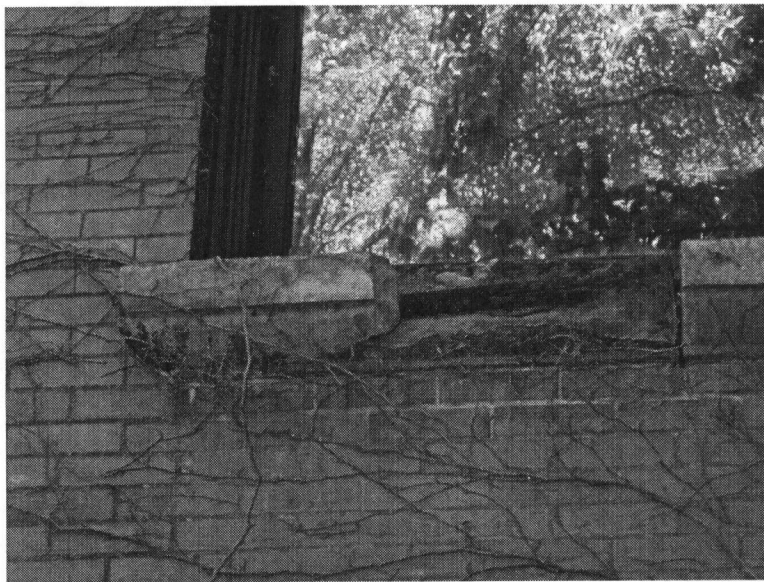
**E2. Lintels:** The lintels beneath the windows on the east elevation are in various stages of disrepair, from minor cracks requiring maintenance and caulking to major damage and missing pieces. *Suggested Maintenance – Repair and replace lintels as needed. Maintain a regular maintenance plan for caulking and sealing.*

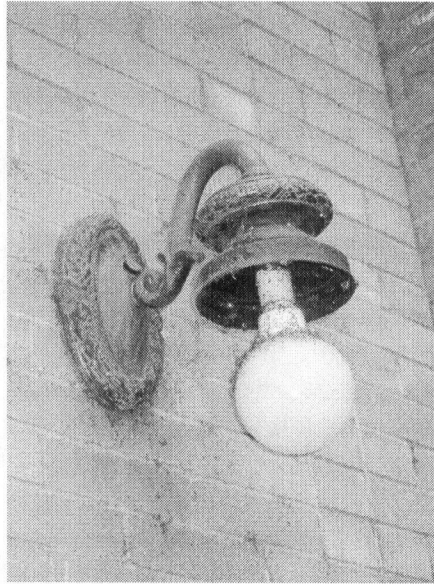
**E3. Light Fixtures:** The globes from the main entry light fixtures are missing, and the fixtures need to be cleaned and repaired. *Suggested Maintenance – Research the original fixtures and replace the globes in kind. Clean and seal the fixtures to prevent further decay and rust.*

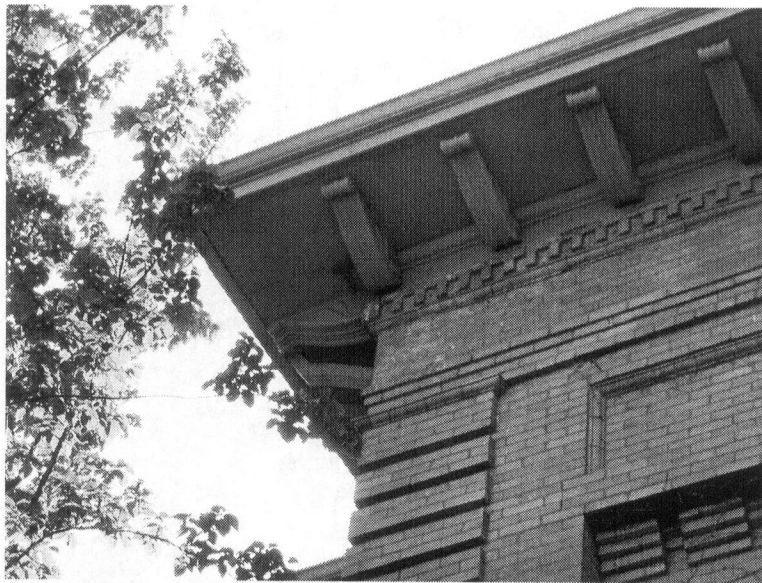
**E4. Efflorescence:** Leaching of salts from within the masonry is causing staining. *Suggested Maintenance – Determine where water is coming and mitigate if possible. Clean to remove salt deposits.*

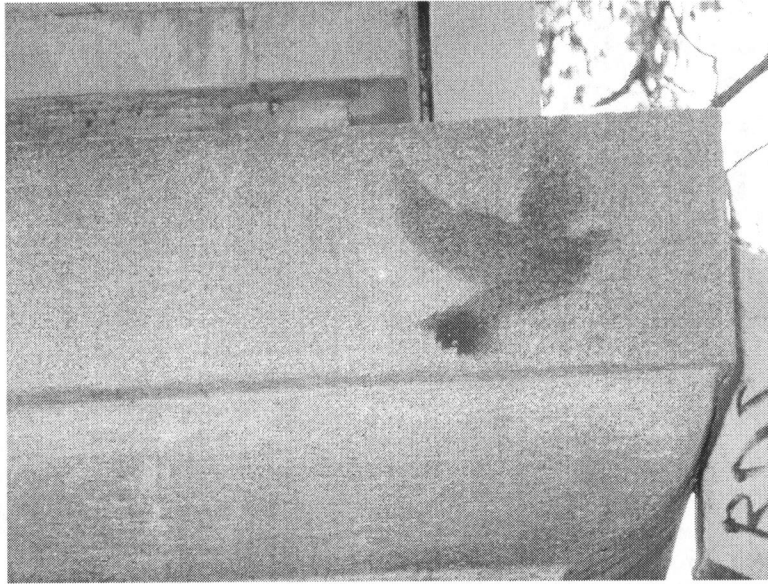
**E5. Graffiti:** A small bird has been spray painted onto the northern side of the water table on the east elevation. *Suggested Maintenance – If possible, remove with low abrasive cleaners.*

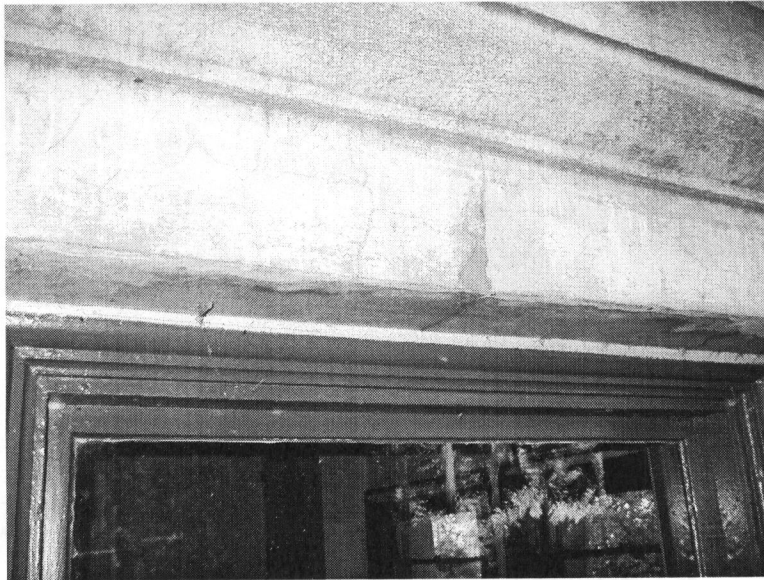
**E6. Cracked Lintels:** The lintels above the basement windows are all in vary states of disrepair, including the northern most which is cracked through and sagging in the middle. *Suggested Maintenance – Repair and caulk the lintels that are able to be salvaged. For the most severely damaged ones, hire a professional and licensed team to repair or replace the lintels.*

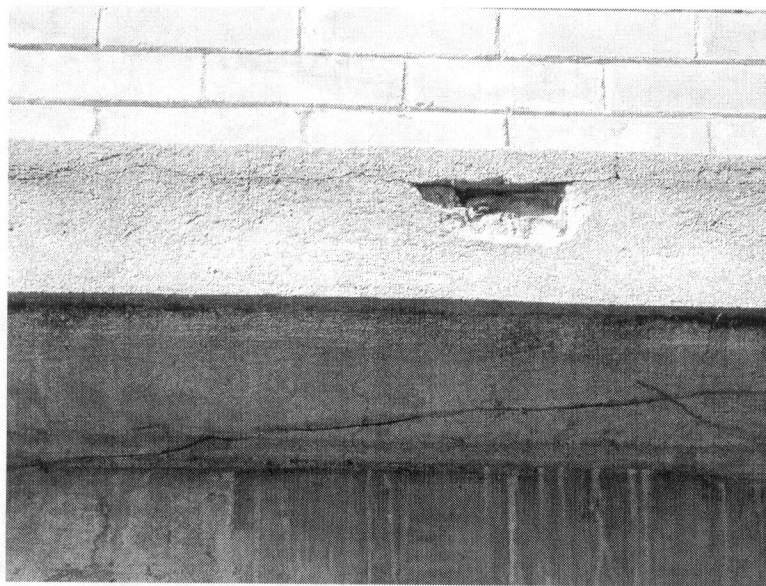
**S1. Water Table Damage:** The concrete water table on the eastern side of the south elevation has a large chunk missing. The rebar inside is beginning to rust. *Suggested Maintenance – Repair the damage to prevent further moisture issues.*

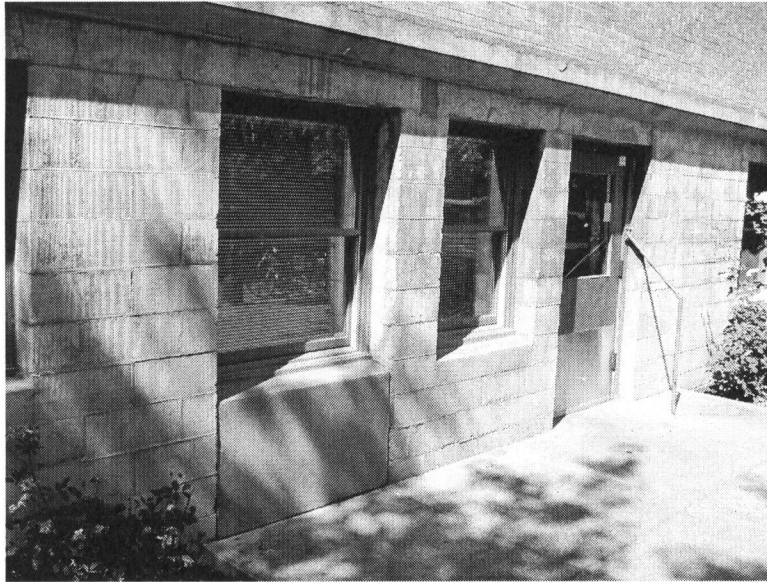
**S2. Insensitive Window and Door Enclosure:** This side entrance on the south elevation was added sometime after 1989. The two windows and door are all different sizes, and the western-most window appears to have been altered from a door. The alterations have forced patches to the raked concrete block, which were apparently done hastily and are not aesthetically appealing. *Suggested Maintenance – Clean and repair raked concrete with an appropriate sealant. Create a more sensitive solution for the doorway enclosure beneath the window.*

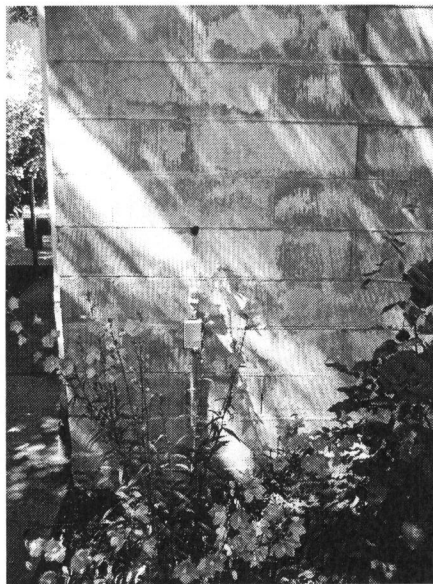
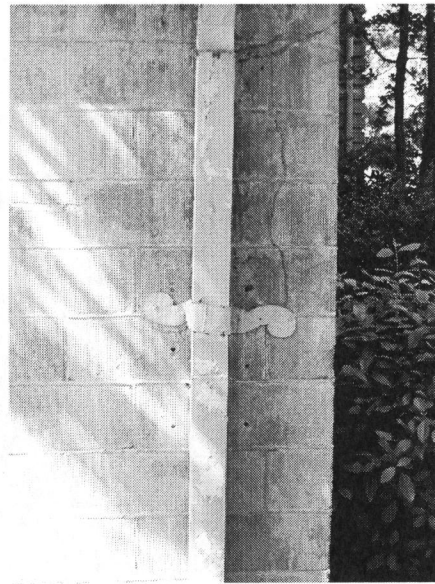
**S3. Holes:** Large holes in the masonry from gutter attachments and electrical intervention have been left unfilled and exposed. *Suggested Maintenance – Fill holes and seal to prevent water and insect infiltration.*

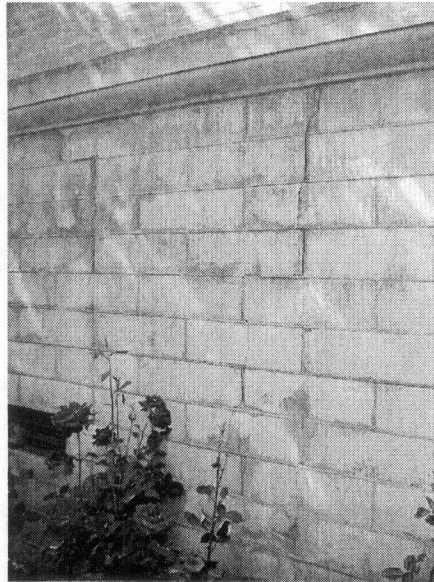
**S4. Cracks in the wall:** Large cracks have developed, mostly in the mortar joints but in some cases through the concrete blocks. *Suggested Maintenance – Consult a structural engineer to ensure that these cracks are not indicative of greater structural or seismic concerns.*

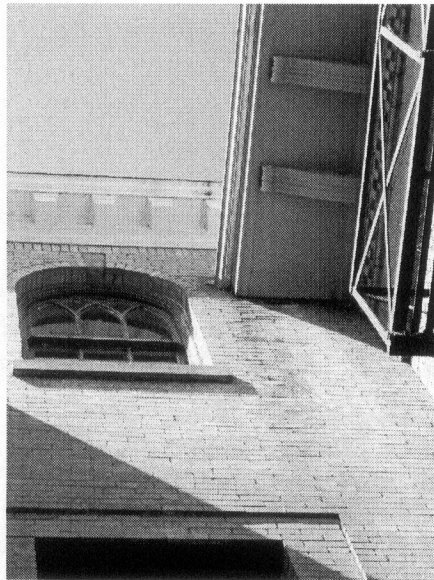
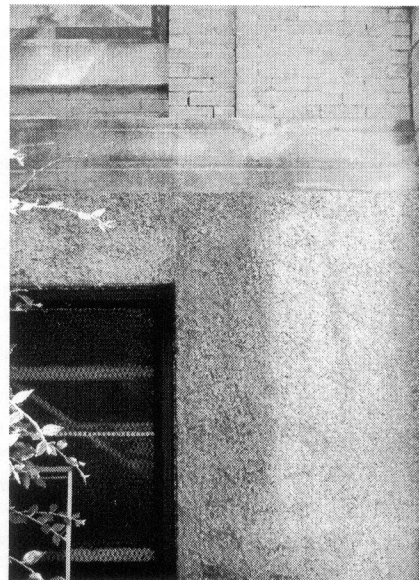
**S5. Gutter Leaks:** The gutter at the joint of the original structure and the tower overflows and is causing water damage and mold growth on both the brick of the tower and the stucco at the base. *Suggested Maintenance – Clean out the gutters. A downspout may be required to divert the water flow away from the masonry.*

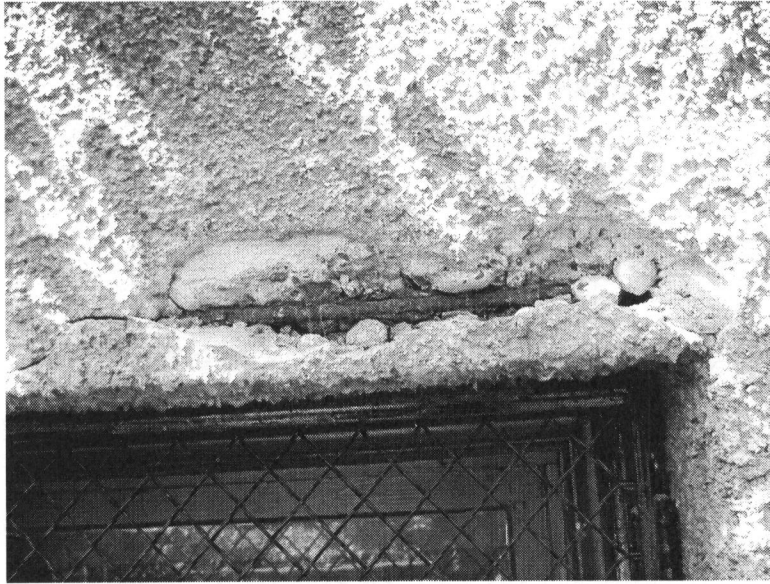
**S6. Stucco Damage:** Steel rebar and insulating foam are exposed where the stucco has been damaged and not repaired. The rebar is beginning to scale where the rust has eaten through several layers. *Suggested Maintenance – Remove existing rust and repair stucco to prevent further water and possible structural damage.*

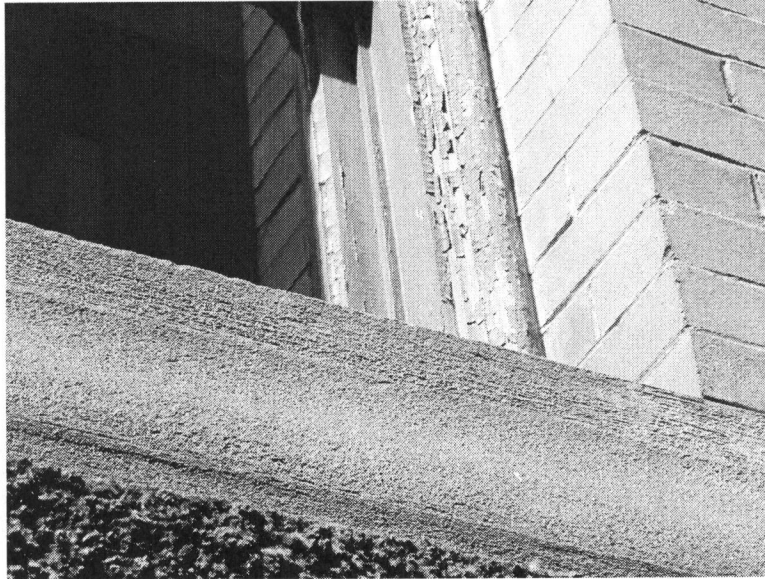
**S7. Peeling Paint on Windows:** Though overall the windows appear to be in good condition, the wooden sills and sashes need to be repainted. *Suggested Maintenance – repair and repaint windows as needed.*

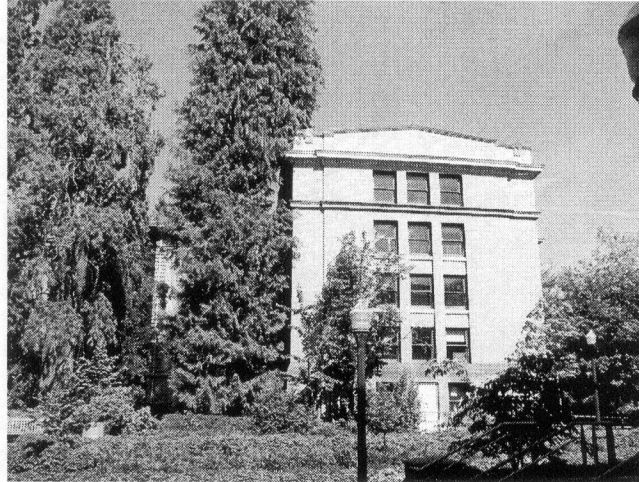
**W1. Intrusive vegetation:** A large evergreen tree looms over the stacks, and is too close to the structure. *Suggested Maintenance – cut tree back so that it does not hang over the roof. Remove all vegetation within four feet of the building.*

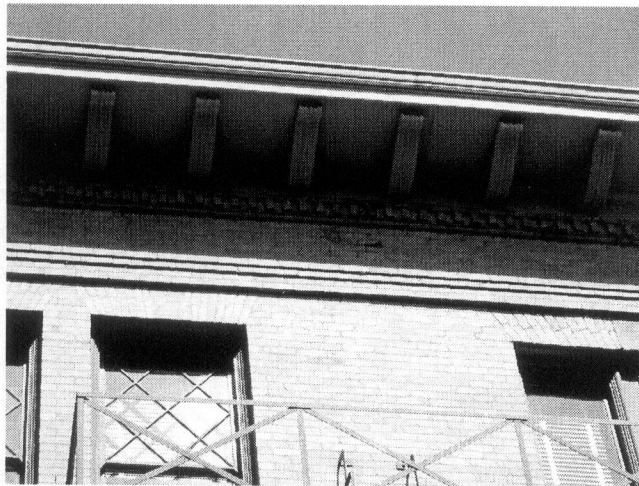
**W2. Damaged Brick:** A small portion of brick is damaged just beneath the cornice on the original portion of the structure. *Suggested Maintenance – Repair and replace brick as needed to prevent further damage to the masonry and mortar joints.*

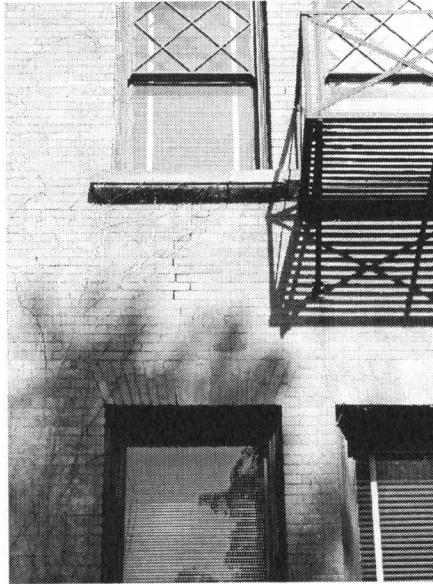
**W3. Mortar Joints:** Cracks in the window lintels that have not been properly sealed and caulked have caused water to run down between the bricks, wearing away at the mortar. *Suggested Maintenance – Caulk and seal lintels, and repair damage to mortar joints.*

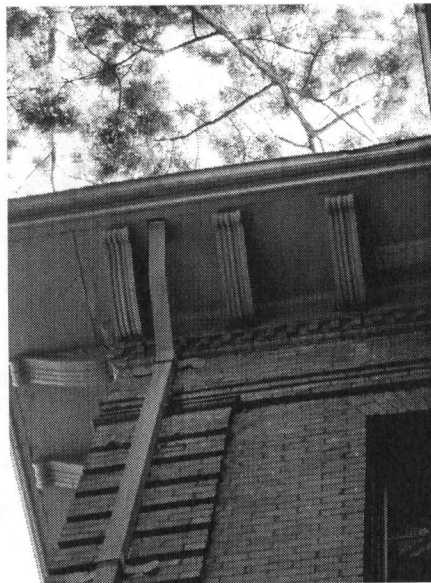
**N1. Modillion Rot:** Visible under the cornice, the modillion brackets are in good condition with a few notable exceptions. *Suggested Maintenance – Determine where water is coming from and repair as needed to prevent future damage. Repair modillions.*

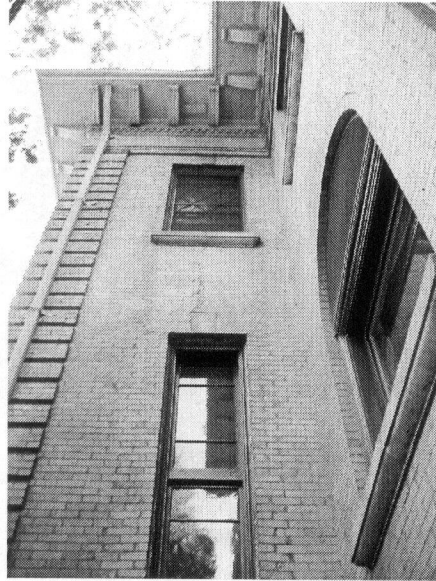
**N2. Mortar Joints:** Cracks in the window lintels that have not been properly sealed and caulked have caused water to run down between the bricks, wearing away at the mortar. *Suggested Maintenance – Caulk and seal lintels, and repair damage to mortar joints.*

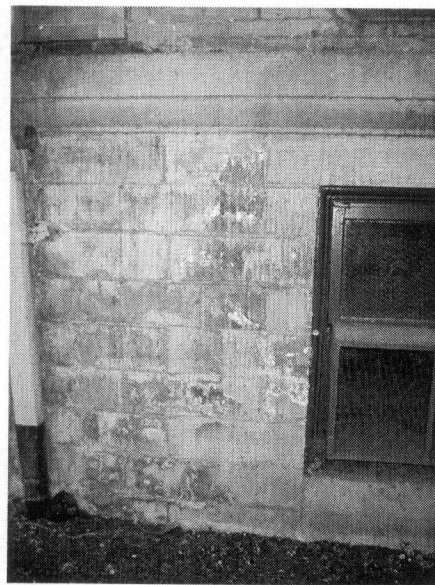
**N3. Efflorescence:** Leaching of salts from within the masonry is causing staining. *Suggested Maintenance – Determine where water is coming from (most likely splash back from the ground) and mitigate if possible. Clean to remove salt deposits.*

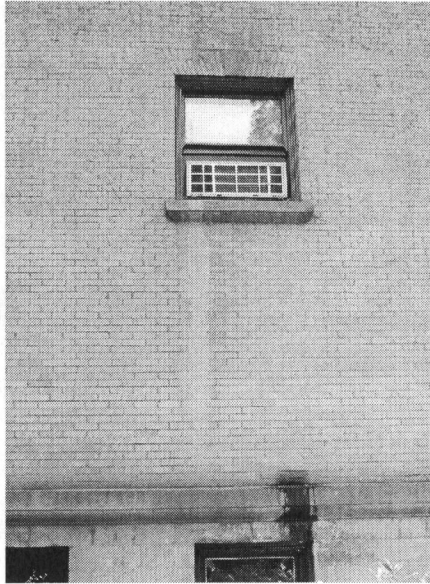
N4. **Water Damage:** Draining moisture from the window air conditioning unit is causing damage to both the brick and the cast stone water table. In addition, the excessive moisture is causing mold to grow on the water table. *Suggested Maintenance – Clean and remove mold buildup. Create an alternative solution for moisture drainage from A/C unit.*

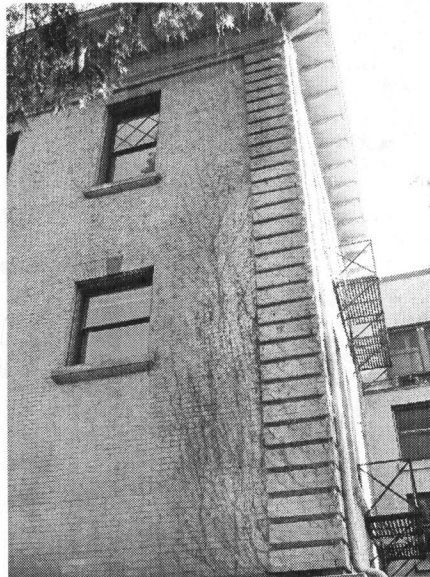
N5. **Intrusive Vegetation:** While most of the vegetation has been treated (likely with an herbicide) and the leaves have dropped off, the remaining vines that cover the structure still need to be removed. *Suggested Maintenance – Remove remains of vegetation.*

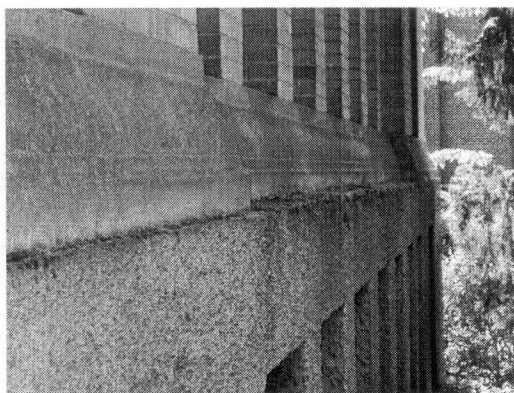
**N6. Moss:** Moss is growing along the water table on the north elevation.  
*Suggested Maintenance – Remove moss and treat surface with a non-acidic herbicide.*

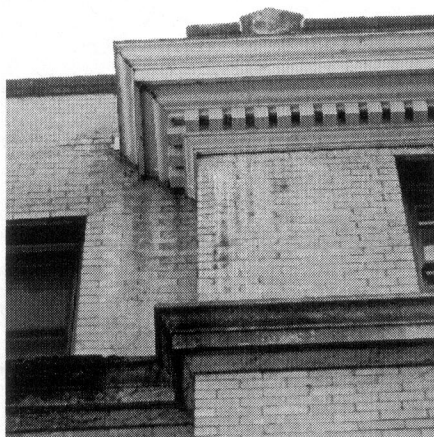
**N7. Insects:** A large colony of bees has taken up residence in the wood work at the cornice of the stacks addition parapet. Though not clearly visible in the photo, the staining on the brick is likely caused by insect excretions, including honey and a red substance (indefinable without closer inspection), that is leaching out at the joint between the wood and brick. This is causing damage to both the wood and masonry, as well as posing a serious safety concern for pedestrians and building inhabitants. *Suggested Maintenance – Hire a licensed insect abatement team to remove the colony. Repair damage as needed.*
