Cultural Resource Survey Form:

CLACKAMAS COUNTY

COMMON/HISTORICAL NAME: Schatz Residence
ADDRESS: 4875 Schatz Road AREA: Stafford
CURRENT OWNER: DONALD H. McBRIDGE USE: Farm Complex
OWNER'S ADDRESS: _____
ORIGINAL OWNER: ROBBINS USE: Farm Complex
AREA OF SIGNIFICANCE: TOWN: _____ COUNTY: X CITY: _____ NATION: _____

HISTORIC NAME: ROBBINS-MELCHER-SCHATZ, FARM
COMMON NAME:
PROPERTY ADDRESS: 4875 S.W. Schatz Road
OWNER: C/O O'Connor, Glenda J. and Donal L.
OWNER ADDRESS: 2520 S.W. Gregory Drive, West Linn OR 97068
RESOURCE TYPE: Buildings
PRESENT USE: Farm complex
ORIGINAL USE: Farm complex
THEME: Culture; Agriculture
ARCHITECT/BUILDER: Unknown
COUNTY: Clackamas
QUAD: Canby
T/R/S: 2S 1E 31A
TAX LOT: 105 and 110
ADDITION: N/A
BLOCK: N/A
LOT: N/A
LOT SIZE: 1.60 and 4.82 Acres, respectively
ZONE: RRF-5

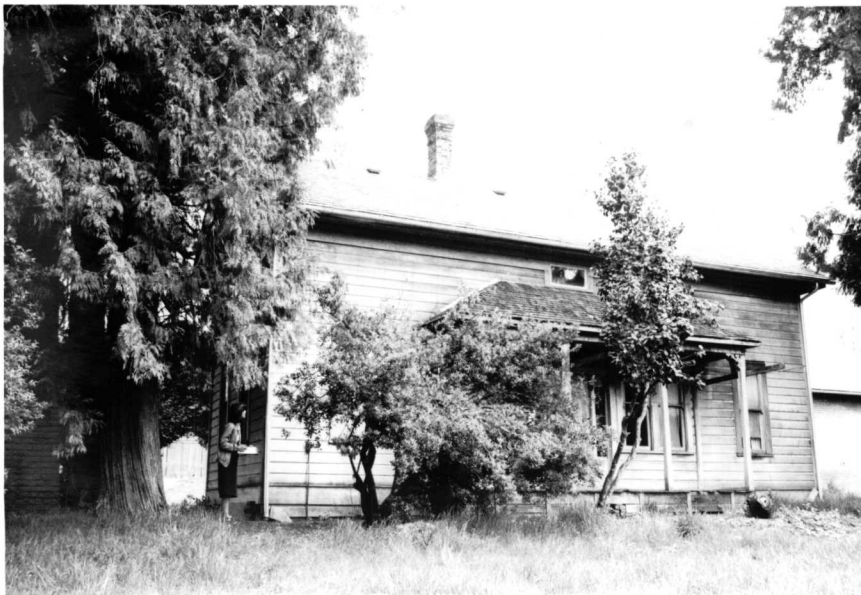
ROLL: XLII
FRAME: 4,5

STYLE: Vernacular (over)
DATE: 1860 CONDITION: Poor ARCHITECT: _____
SIDING: Wide shiplap corner rake STORIES: 1½
ROOF: Gable, partial return, boxed eaves.
DOORS: 4 panel - porcelain knob; 5 light-sided flank.
WINDOWS: 1/1 double-hung long with plain molding.

MAIN ENTRANCE: Hip roof front porch. Chamfered posts; decorative brackets.

NOTES: Watertable. Watertower - shingles hewn - narrow shiplap above, milkhouse. Brick bui is being incorporated into house. Outbuildings
Chicken house

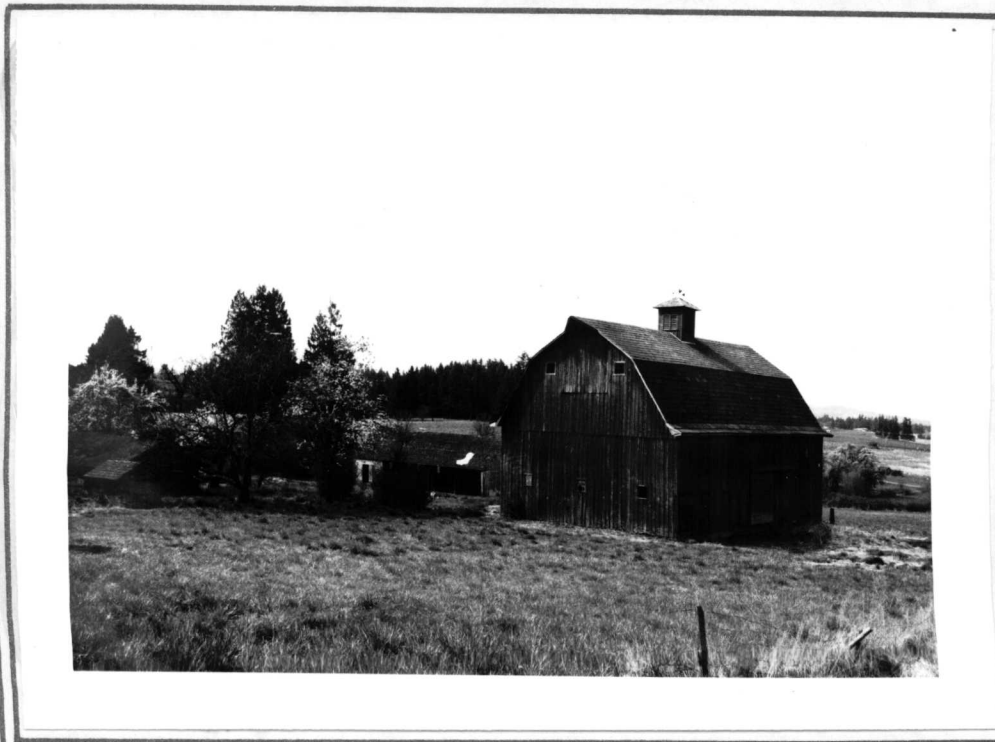
ROLL: XLII
FRAME: 1,2

STYLE: _____ DATE: 1909 CONDITION: Good ARCHITECT: _____ STORIES: _____
SIDING: Board and batten.
ROOF: Gambrel with projection over hay boom.
DOORS: Sliding
WINDOWS: 4 light.

NOTES: Cupola. One continuous beam at ridge.

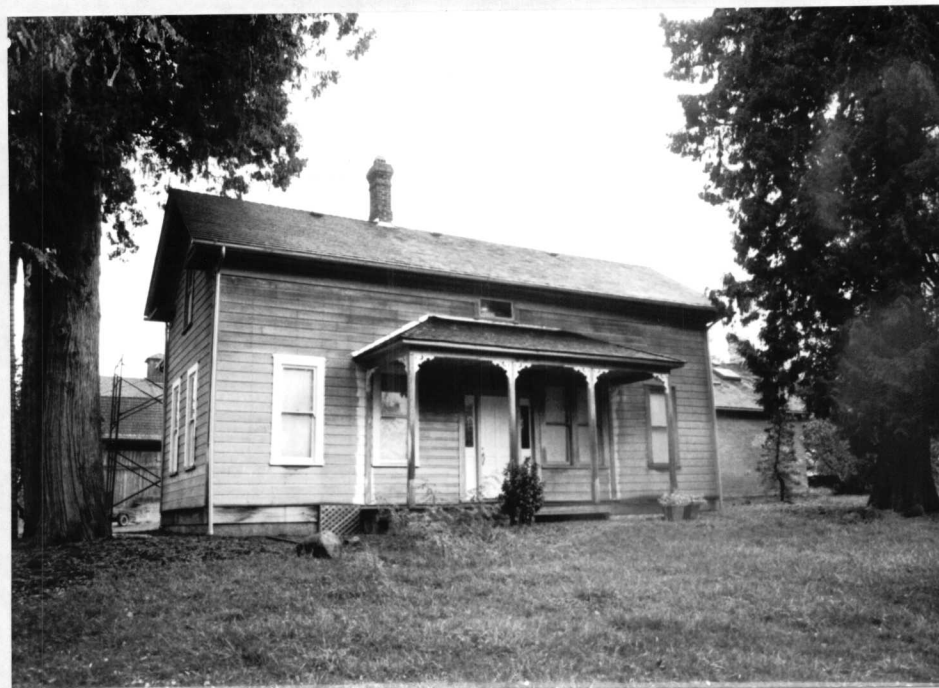
DATE BUILT: 1860
STYLE: Classical Revival
PLAN TYPE/SHAPE: T-plan
NO. OF STORIES: 1 1/2
FOUNDATION MATERIAL: Concrete
BASEMENT: No
ROOF FORM AND MATERIALS: Low-pitched gable w/ heavy, partial returns; wood shingles
WALL CONSTRUCTION/STRUCTURAL FRAME: Wood/unknown
PRIMARY WINDOW TYPE: Double-hung sash w/ plain surrounds
EXTERIOR SURFACING MATERIALS: Wide, drop siding w/ corner, rake and frieze boards
DECORATIVE FEATURES: Porch brackets
OTHER: Central hip roof porch w/ chamfered posts and jigsawn brackets, paneled door w/ paneled sidelights, multi-light transom; interior brick chimney w/ corbelled cap; one-story gabled volume between house and gabled brick volume; gabled two-story wing w/ lap siding and multi-light windows; deck off n.e. corner of house; brick end-wall exterior chimney, e. elev.
CONDITION: Good
EXTERIOR ALTERATIONS (DATE): Front porch rebuilt (n.d.); brick shed attached to house by altered ell (n.d.); gabled wing added (n.d.)

The Robbins House is significant because it is one of the oldest dwellings in the Stafford area and one of a few buildings in the county which display an influence of the Classic Revival style. It is one of two dwellings in the area that date from the second period of development in Clackamas County (1866-1883).

The Robbins House has undergone some minor and some major changes. The original board-and-batten siding was covered with dropped siding, probably prior to the turn-of-the-century. This change may coincide with the Schatz family occupation. Other alterations which greatly effect the physical integrity of the building have been made more recently. Since 1984 a second floor was added to the kitchen wing; a deck has been added to the rear elevation; and a gabled ell added to connect the cool room with dwelling.

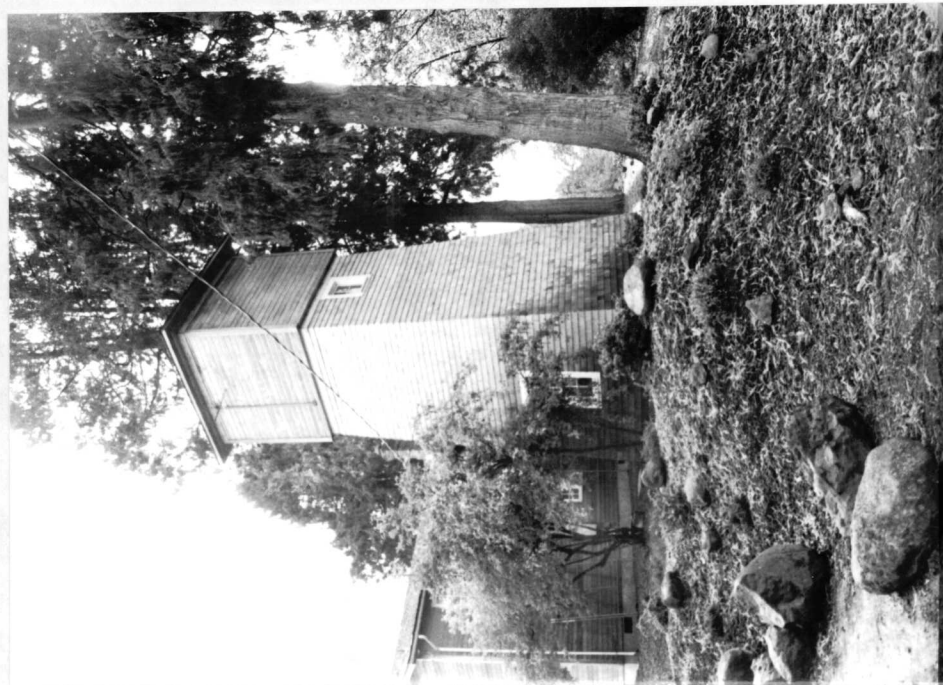
WATERTOWER

DATE BUILT: Unknown
STYLE: Vernacular
PLAN TYPE/SHAPE: Rectangular
NO. OF STORIES: 2
FOUNDATION MATERIAL: Unknown
BASEMENT: No
ROOF FORM AND MATERIALS: Hip w/ wood shingles
WALL CONSTRUCTION/STRUCTURAL FRAME: Wood/stud
PRIMARY WINDOW TYPE: Four-over-four double-hung sash windows
EXTERIOR SURFACING MATERIALS: Drop siding w/ wood shingles
DECORATIVE FEATURES: None
OTHER: Four-vertical paneled door
CONDITION: Good
EXTERIOR ALTERATIONS (DATE): Unknown

The Robbins Farm is nonetheless significant because it is part of a multi-building farm complex; several buildings in the ensemble appear to date from the historic period. The cool room is constructed of brick and is believed to be the largest example of this type of buildings in the county. The water tower, located adjacent to the house, is the one of two listed on the Inventory in the study area. It is one of few buildings of this type in the county and appears to have been recently restored.

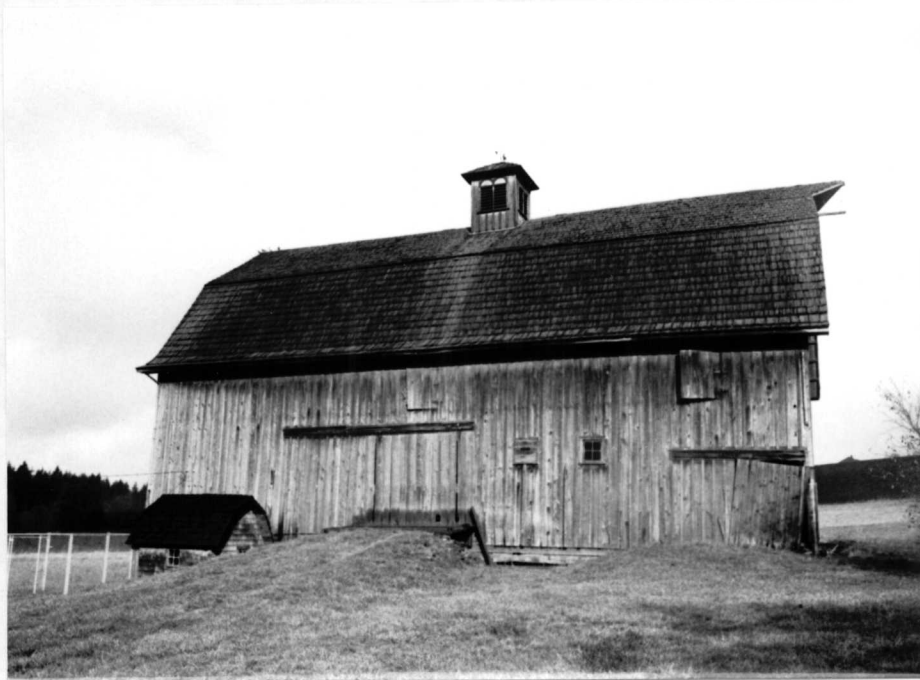
BARN SHPO 479

DATE BUILT: c. 1909
STYLE: Gambrel
PLAN TYPE/SHAPE: Rectangular
NO. OF STORIES: 2
FOUNDATION MATERIAL: Unknown
BASEMENT: No
ROOF FORM AND MATERIALS: Gothic gambrel w/ wood shingles
WALL CONSTRUCTION/STRUCTURAL FRAME: Wood/stud
PRIMARY WINDOW TYPE: Multi-light
EXTERIOR SURFACING MATERIALS: Board-and-batten siding
DECORATIVE FEATURES: None
OTHER: Small hay hood; hipped cupola w/ weather vane; side-wall overhead door
CONDITION: Good
EXTERIOR ALTERATIONS (DATE): Unknown

The Gambrel barn is noteworthy because of its size. It is further distinguished by its handsome cupola and weather vane.

It is one of the best preserved examples of this type of barn in the study area. It is believed to have been built circa 1910. Its distinctive gambrel roof-shape indicates a European influence, frequently associated with German immigrants. Many German and Russian families emigrated to the area around the turn-of-the-century, having paused for a generation in South Dakota or other parts of the Midwest.
