# Cultural Resource Survey Form:

COMMON/HISTORICAL NAME: W. Koellermeier Farm  
ADDRESS: Route 1, Box 818, Wilsonville AREA: Advance  
CURRENT OWNER: Leonard Deboff USE: Residence  
OWNER'S ADDRESS: 12440 S.W. Iron Mountain Blvd, Lake Oswego  
ORIGINAL OWNER: \_\_\_\_\_ USE: Residence  
AREA OF SIGNIFICANCE: TOWN: \_\_\_\_\_ COUNTY: X CITY: \_\_\_\_\_ NATION: \_\_\_\_\_

HISTORIC RESOURCES INVENTORY 1989-90

HISTORIC NAME: KOELLERMEIER, WILLIAM, FARM  
COMMON NAME:  
PROPERTY ADDRESS: 3030 S.W. Advance Road, Wilsonville  
OWNER: Prochnau, James W.  
OWNER ADDRESS: 3000 Hurleywood Dr. NW, Albany OR 97321  
RESOURCE TYPE: Buildings  
PRESENT USE: Farm complex  
ORIGINAL USE: Farm complex  
THEME: Culture; agriculture  
ARCHITECT/BUILDER: Unknown  
COUNTY: Clackamas  
QUAD: Canby  
T/R/S: 3S 1E 17  
TAX LOT: 102  
ADDITION: N/A  
BLOCK: N/A  
LOT: N/A  
LOT SIZE: 3.78 Acres  
ZONE: GAD

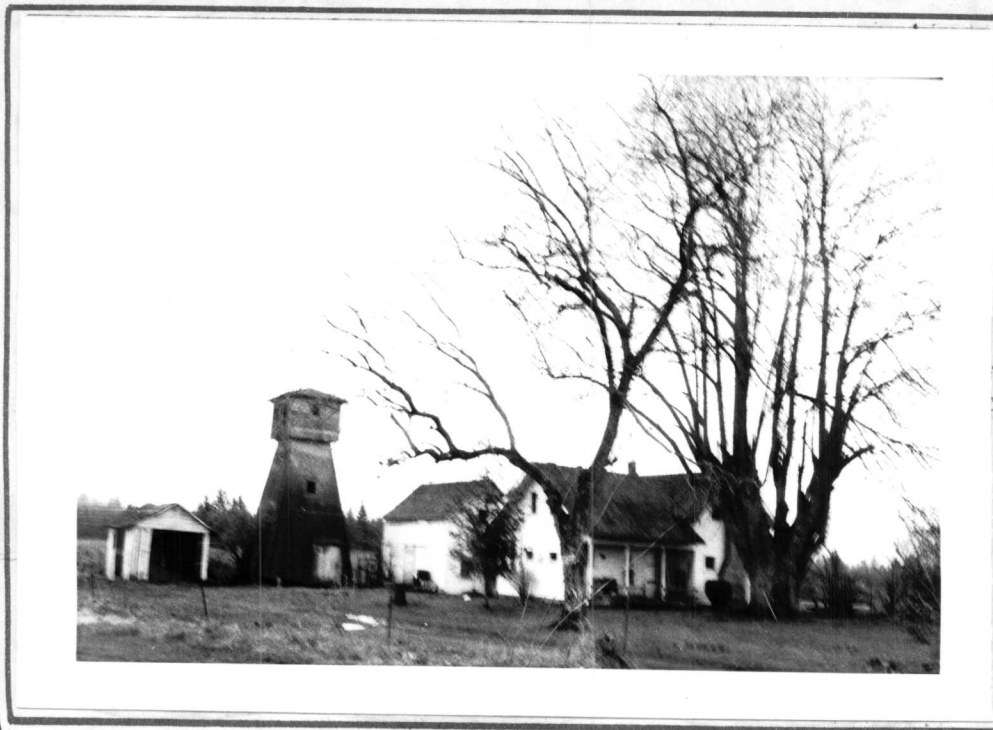
ROLL: \_\_\_\_\_ XL  
FRAME: \_\_\_\_\_ 6

STYLE: Vernacular/Bungalow STORIES: 2  
DATE: 1910 CONDITION: Good ARCHITECT: \_\_\_\_\_  
SIDING: Shiplap  
ROOF: Cross gable with wide overhanging eaves and exposed rafters. Diagonal  
DOORS: Decorative muntins  
WINDOWS: Fixed sash and 1/1 double-hung.

MAIN ENTRANCE: Roof extends over porch supported by plain posts.

NOTES: Water tower, Outbuildings

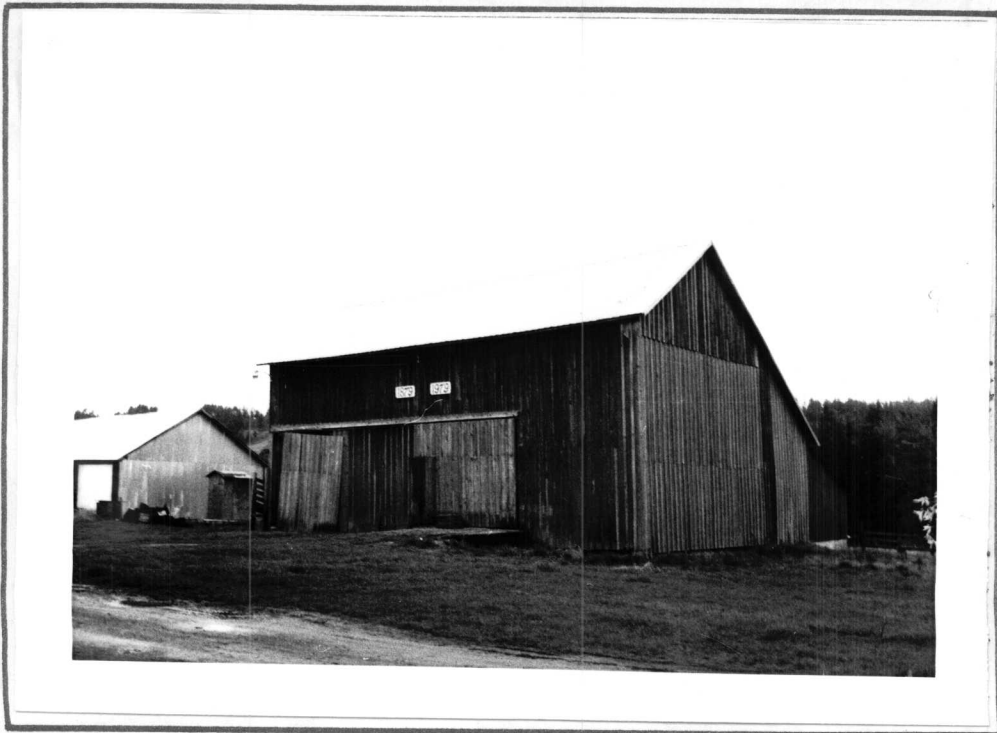
ROLL: XL  
FRAME: 5

STYLE: \_\_\_\_\_ DATE: 1879 CONDITION: Good ARCHITECT: \_\_\_\_\_ STORIES: \_\_\_\_\_  
SIDING: Board and batten  
ROOF: Low pitched gable roof  
DOORS: \_\_\_\_\_  
WINDOWS: Square windows with 4 lights set on angle

NOTES: The barn was moved from across the street to its present location.

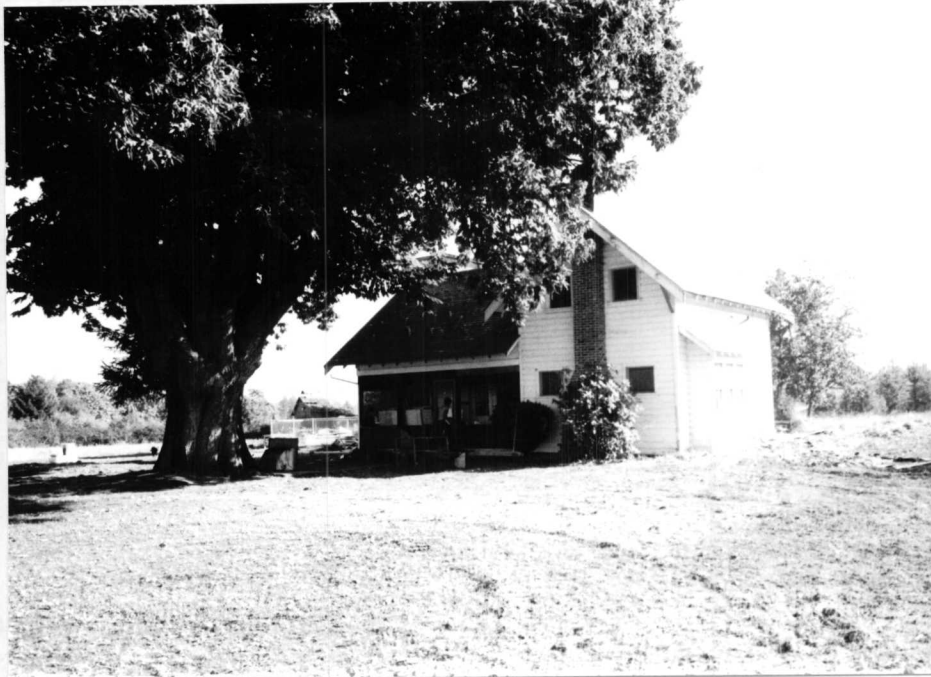
#### HOUSE

DATE BUILT: c. 1890/1910; 1879  
STYLE: Vernacular/Craftsman  
PLAN TYPE/SHAPE: Asymmetrical  
NO. OF STORIES: 1 1/2  
FOUNDATION MATERIAL: Tile  
BASEMENT: None  
ROOF FORM AND MATERIALS: Intersecting gable w/ composition shingles  
WALL CONSTRUCTION/STRUCTURAL FRAME: Wood/stud  
PRIMARY WINDOW TYPE: Double-hung sash and single-fixed sash  
EXTERIOR SURFACING MATERIALS: Unknown  
DECORATIVE FEATURES: None  
OTHER: Recessed front porch w/ wood deck, partially enclosed; door w/ vertical muntins; exposed rafters, purlins and braces; rectangular bay w/ shed roof, w. elev.; exterior chimney  
CONDITION: Good (house); Fair-Poor (outbuildings)  
EXTERIOR ALTERATIONS (DATE): Porch enclosed (n.d.)

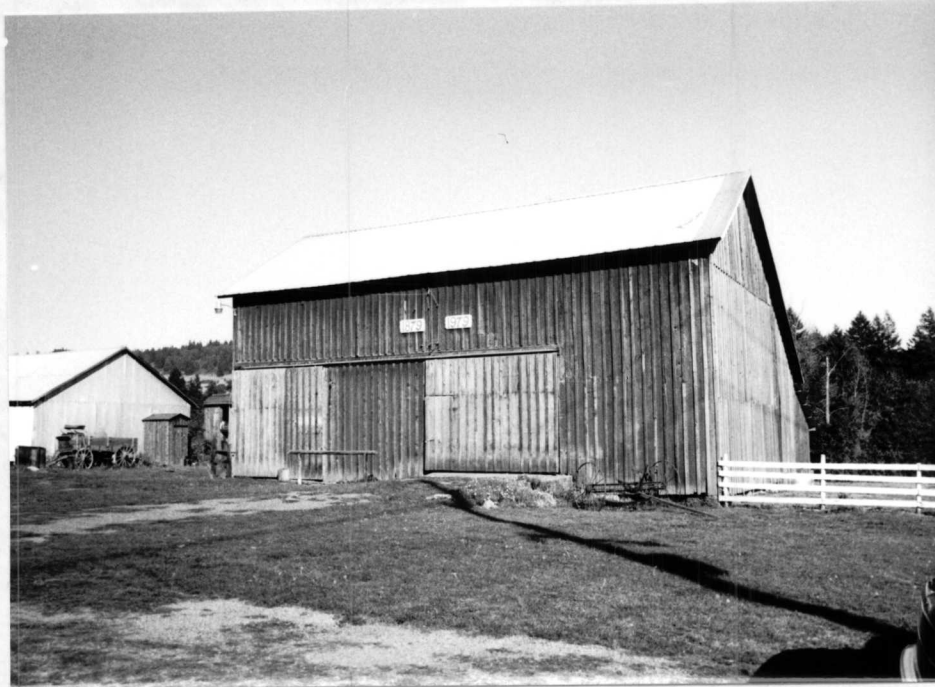
BARN SHPO 503

DATE BUILT: 1879  
STYLE: Western  
PLAN TYPE/SHAPE: Rectangular  
NO. OF STORIES: 2  
FOUNDATION MATERIAL: Unknown  
BASEMENT: None  
ROOF FORM AND MATERIALS: Gable on hip w/ sheet metal  
WALL CONSTRUCTION/STRUCTURAL FRAME: Wood/Unknown  
PRIMARY WINDOW TYPE: None  
EXTERIOR SURFACING MATERIALS: Board-and-batten  
DECORATIVE FEATURES: Diamond gable-end window opening, s. elev.  
OTHER: Side-wall overhead sliding door  
CONDITION: Good  
EXTERIOR ALTERATIONS (DATE): None apparent

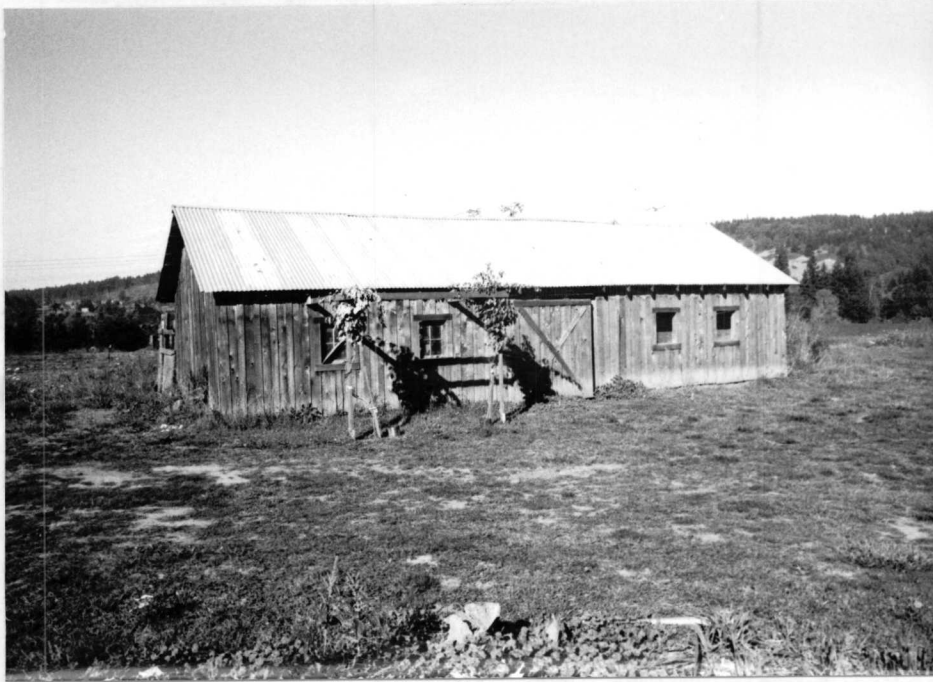
DATE BUILT: Unknown  
STYLE: Vernacular  
PLAN TYPE/SHAPE: Rectangular  
NO. OF STORIES: 2  
FOUNDATION MATERIAL: Unknown  
BASEMENT: None  
ROOF FORM AND MATERIALS: Hip w/ composition shingles  
WALL CONSTRUCTION/STRUCTURAL FRAME: Wood/Unknown  
PRIMARY WINDOW TYPE: None  
EXTERIOR SURFACING MATERIALS: Dropped horizontal siding and  
shingles  
DECORATIVE FEATURES: None  
OTHER: Plank door  
CONDITION: Fair  
EXTERIOR ALTERATIONS (DATE): None apparent

DATE BUILT: Unknown  
STYLE: Vernacular  
PLAN TYPE/SHAPE: Rectangular  
NO. OF STORIES: 1  
FOUNDATION MATERIAL: Log  
BASEMENT: None  
ROOF FORM AND MATERIALS: Gable w/ sheet metal over wood shingles  
WALL CONSTRUCTION/STRUCTURAL FRAME: Wood/Unknown  
PRIMARY WINDOW TYPE: None  
EXTERIOR SURFACING MATERIALS: Dropped horizontal siding, corner  
and rake boards  
DECORATIVE FEATURES: None  
OTHER: Side-wall overhead sliding door  
CONDITION: Fair  
EXTERIOR ALTERATIONS (DATE): Unknown

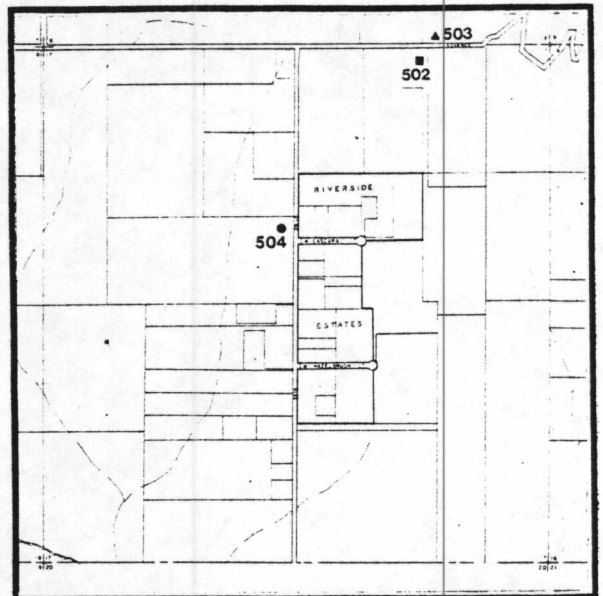
SITE PLAN AND VICINITY MAP

The William Koellermeier Farm is composed of a six buildings, which include a dwelling, water tower, wood shed, a large barn and two smaller sheds, one for storing potatoes, another for drying nuts. As noted above, the house appears to have been constructed in two major phases. The first, the eastern volume, is Vernacular in style. The western volume shows the influence of the Craftsman style, which was popular during the teens and twenties. The barn is believed to have been constructed in the late 19th century, perhaps as early as 1879. The most significant landscape feature is the chestnut tree in front of the house; it is believed to be the largest tree of its type in the state.
