Cultural Resource Survey Form:

CLACKAMAS COUNTY
HISTORIC RESOURCES INVENTORY 1989-92

HISTORIC NAME: MILLER, ^{EDWARD B.} JACOB G., FARM
COMMON NAME:
PROPERTY ADDRESS: 8962 S. Heinz Road, Canby, OR 97013
OWNER: Nelson, Lester P.
OWNER ADDRESS: 8962 S. Heinz Road, Canby, OR 97013
RESOURCE TYPE: Buildings
PRESENT USE: Farm Complex
ORIGINAL USE: Farm Complex
THEME: Culture: Architecture; Agriculture: Farming
ARCHITECT/BUILDER: Unknown
COUNTY: Clackamas
QUAD: Yoder
T/R/S: 4 1E 28
TAX LOT: 1000
ADDITION: N/A
BLOCK: N/A
LOT: N/A
LOT SIZE: 11.22 Acres
ZONE: EFU-20

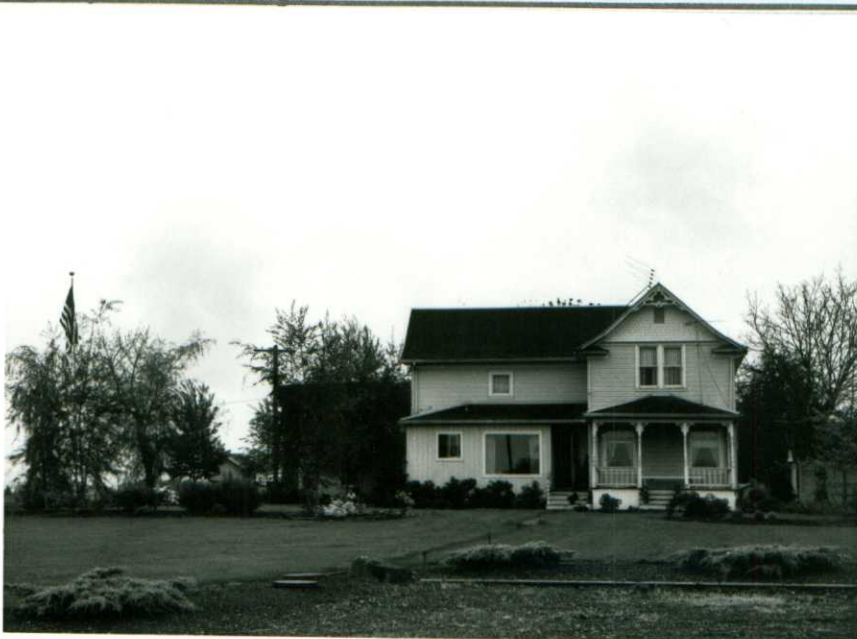
ROLL: XLIV
FRAME: 15

STYLE: Queen Anne Vernacular STORIES: 2
DATE: 1911 CONDITION: Good ARCHITECT: _____
SIDING: Tongue and groove with decorative shingles above second floor
ROOF: Cross gable with flared eaves and partial return
DOORS: Replaced
WINDOWS: 1/1 double-hung windows with architrave molding

MAIN ENTRANCE: Hip roof front porch. Two large windows flank former front door.

NOTES: Square window set on angle in gable peak. Gable permanent. Small house with tongue and groove siding; paneled doors; and 1/1 double hung window; rake and corner boards; outbuildings

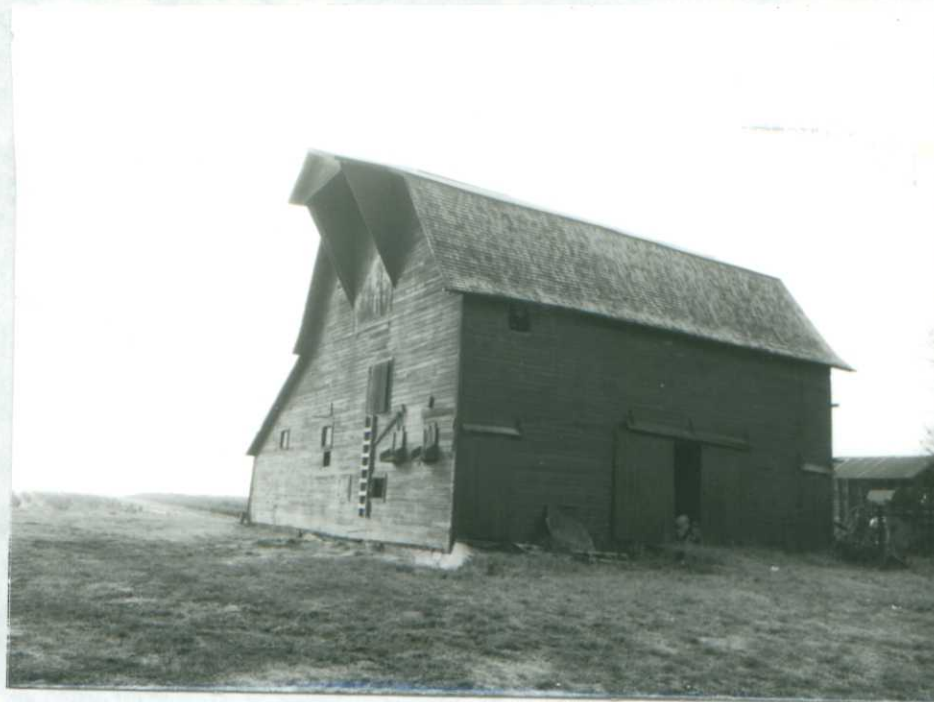
BARN

ESTIMATED DATE BUILT: 1930
STYLE: Western
PLAN/TYPE/SHAPE: Rectangular
NO. OF STORIES: 2
FOUNDATION MATERIAL: Concrete; post-and-beam
BASEMENT: No
ROOF FORM AND MATERIALS: Gable w/ composition shingles
WALL CONSTRUCTION/STRUCTURAL FRAME: Wood/stud
PRIMARY WINDOW TYPE: Multi-light fixed w/ plain surrounds
EXTERIOR SURFACING MATERIALS: Wide drop siding w/ cornerboards
DECORATIVE FEATURES: None
OTHER: Three side-wall overhead sliding doors; three hinged doors; lean-to, s. elev.; hay hood; shed attached w/ board-and-batten and wide drop siding
CONDITION: Fair
EXTERIOR ALTERATIONS (DATE): Unknown

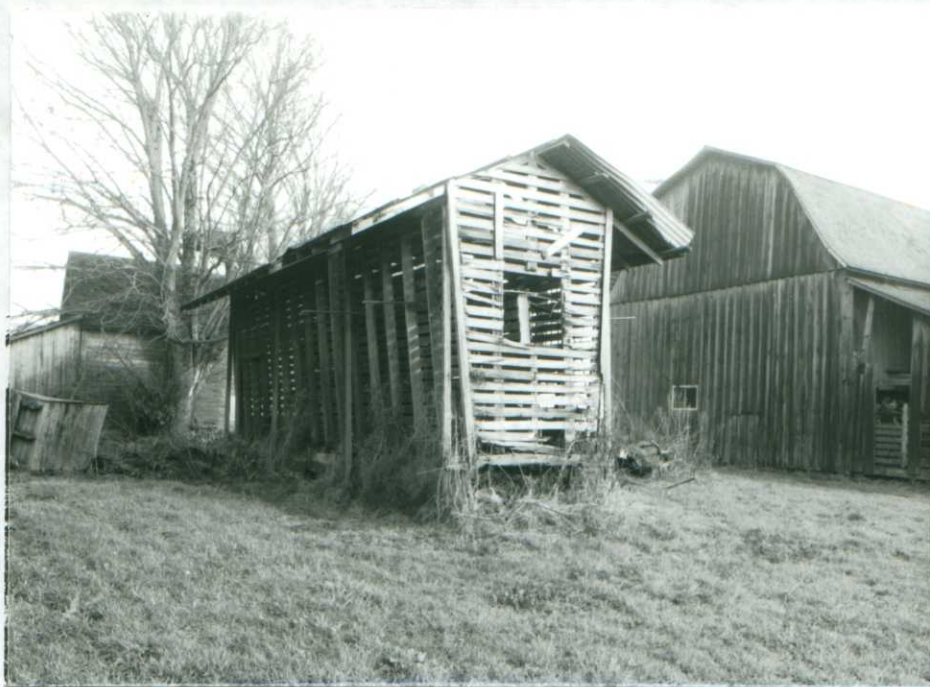
CORN BIN

ESTIMATED DATE BUILT: c. 1930
STYLE: Vernacular
PLAN/TYPE/SHAPE: Rectangular
NO. OF STORIES: 1
FOUNDATION MATERIAL: Post-and-beam
BASEMENT: No
ROOF FORM AND MATERIALS: Gable w/ sheet metal
WALL CONSTRUCTION/STRUCTURAL FRAME: Wood/stud
PRIMARY WINDOW TYPE: None
EXTERIOR SURFACING MATERIALS: Widely-spaced horizontal boards
DECORATIVE FEATURES: None
OTHER: None
CONDITION: Poor
EXTERIOR ALTERATIONS (DATE): Unknown

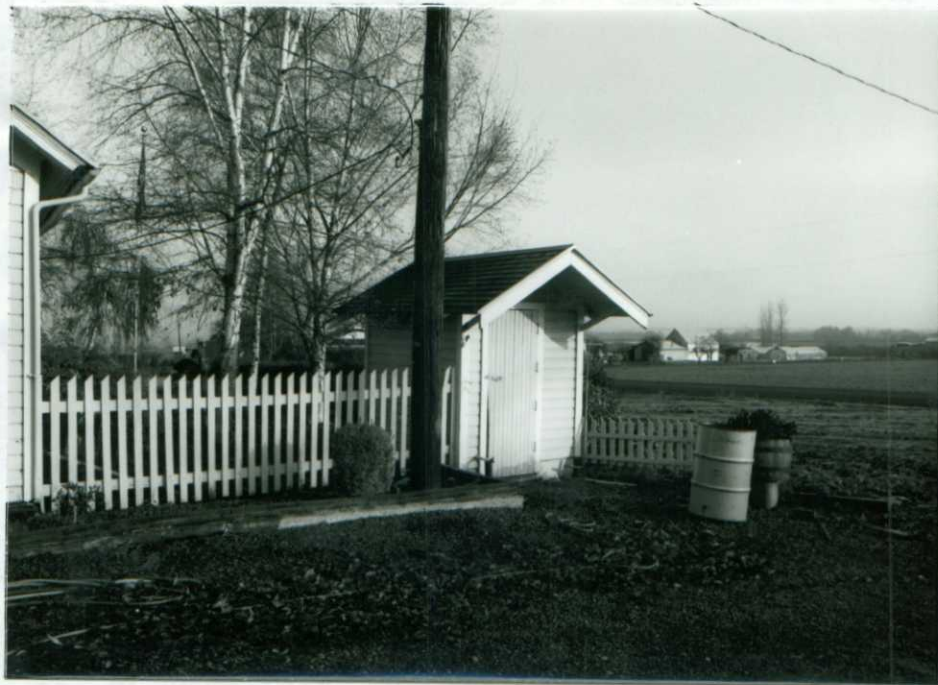
PUMPHOUSE

ESTIMATED DATE BUILT: c. 1911
STYLE: Vernacular
PLAN/TYPE/SHAPE: Rectangular
NO. OF STORIES: 1
FOUNDATION MATERIAL: Post-and-beam
BASEMENT: No
ROOF FORM AND MATERIALS: Gable w/ composition shingles
WALL CONSTRUCTION/STRUCTURAL FRAME: Wood/stud
PRIMARY WINDOW TYPE: None
EXTERIOR SURFACING MATERIALS: Wide drop siding w/ cornerboards
and rake boards
DECORATIVE FEATURES: None
OTHER: None
CONDITION: Good
EXTERIOR ALTERATIONS (DATE): Unknown

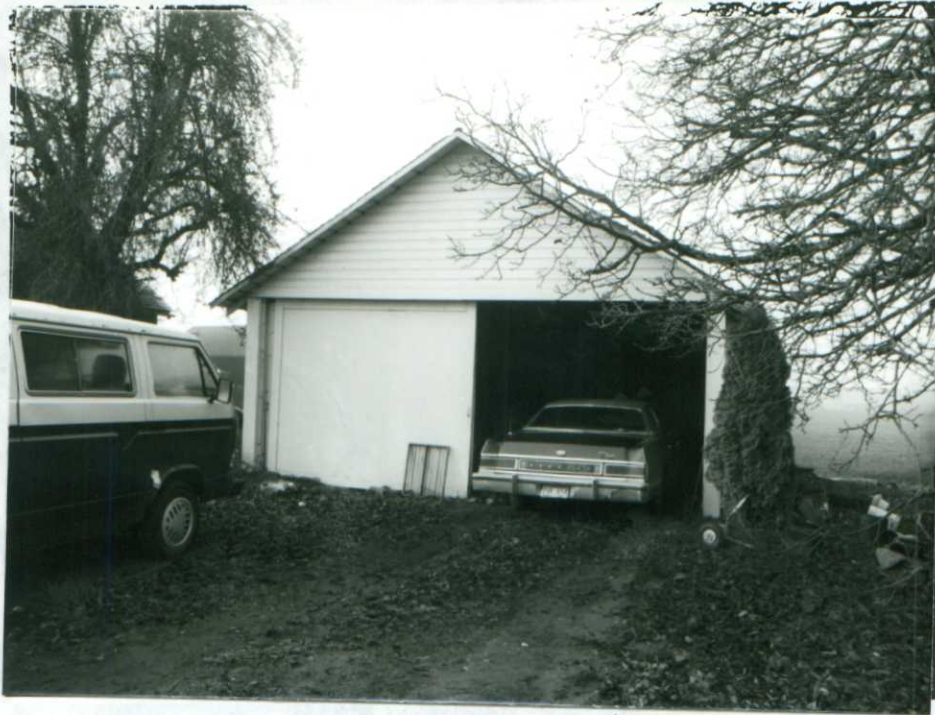
GARAGE

ESTIMATED DATE BUILT: c. 1930
STYLE: Vernacular
PLAN/TYPE/SHAPE: Rectangular
NO. OF STORIES: 1
FOUNDATION MATERIAL: Post-and-beam
BASEMENT: No
ROOF FORM AND MATERIALS: Gable w/ composition shingles
WALL CONSTRUCTION/STRUCTURAL FRAME: Wood/stud
PRIMARY WINDOW TYPE: None
EXTERIOR SURFACING MATERIALS: Wide drop siding
DECORATIVE FEATURES: None
OTHER: None
CONDITION: Good
EXTERIOR ALTERATIONS (DATE): Unknown

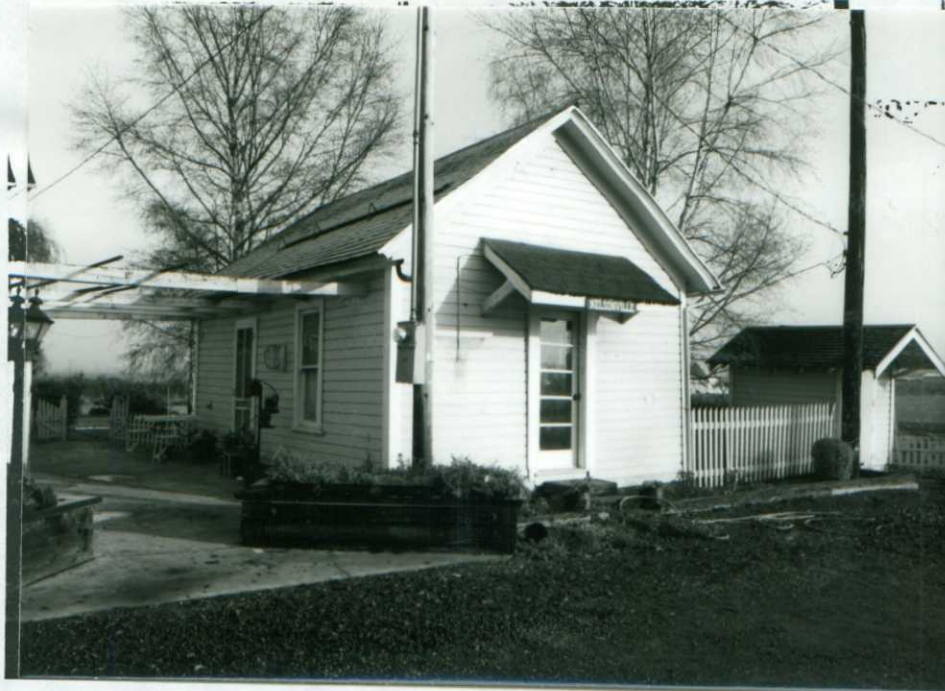
WASH HOUSE/KITCHEN

ESTIMATED DATE BUILT: c. 1911
STYLE: Vernacular
PLAN/TYPE/SHAPE: Rectangular
NO. OF STORIES: 1
FOUNDATION MATERIAL: Post-and-beam
BASEMENT: No
ROOF FORM AND MATERIALS: Gable w/ composition shingles
WALL CONSTRUCTION/STRUCTURAL FRAME: Wood/stud
PRIMARY WINDOW TYPE: One-over-one double-hung sash w/ plain surrounds
EXTERIOR SURFACING MATERIALS: Wide drop siding w/ cornerboards and rake boards
DECORATIVE FEATURES: None
OTHER: Paneled door; paneled-and-glazed door; screen door; shed roof overhang, s. elev.
CONDITION: Good
EXTERIOR ALTERATIONS (DATE): Unknown
