Address: 156 North Main Street

ASHLAND CULTURAL RESOURCE INVENTORY

Irwin, A.L., House

C. 1914  
Bungalow

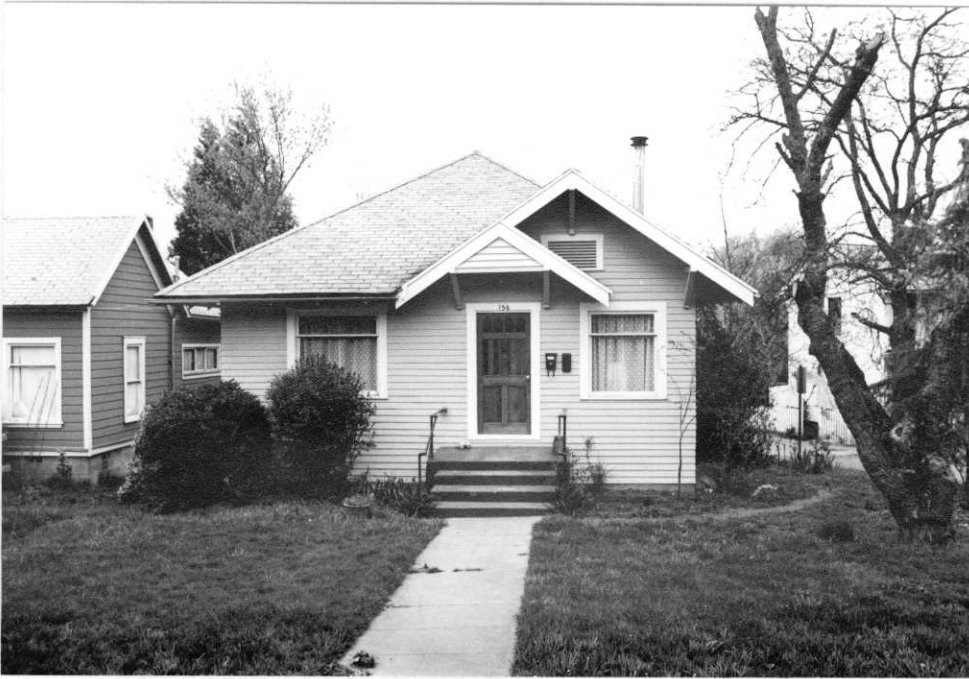
Shape - rectangular  
Roof - Hip with intersecting gable on front elevation; gable over entryway;  
composition shingle  
Sheathing - beveled shiplap  
Openings - one-over-one double hung sash; plain trim  
Foundation - concrete  
Siting - 45' set back  
Condition - good  
Note - Assessment Records list 1914 construction date; Ashland Telephone Directory, 1915 list A.L. Irwin at this address.

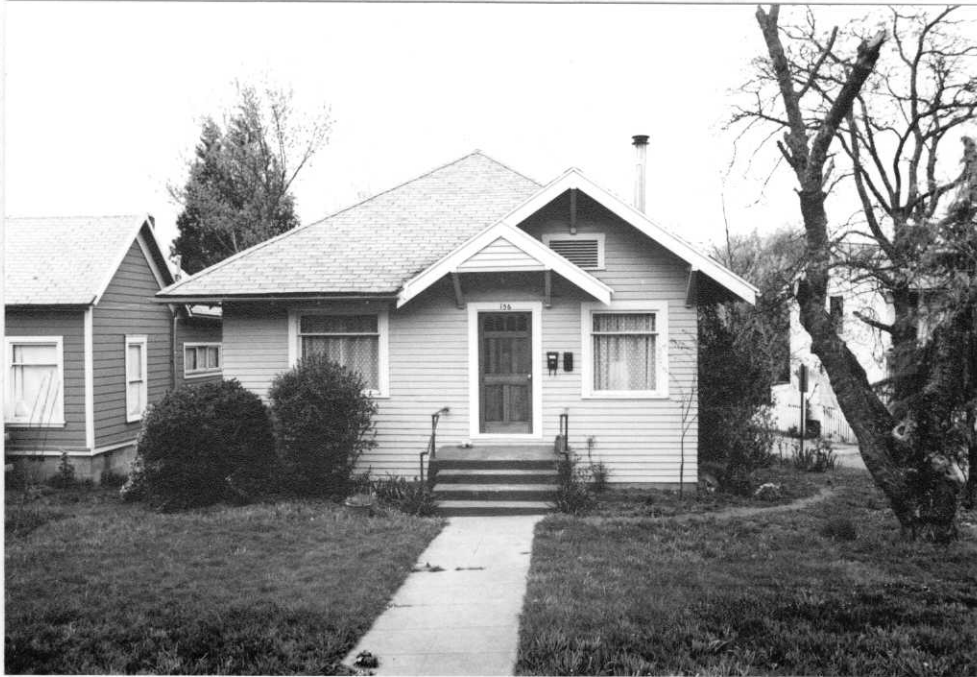
Shape: Rectangular  
Roof: Hip with intersecting gable on front; gable over  
Sheathing: Beveled shiplap /entry  
Openings: One-over-one double hung sash; plain trim  
Foundation: Concrete  
Siting: 45' setback  
Condition: Good
