**NATIONAL REGISTER OF HISTORIC PLACES
INVENTORY -- NOMINATION FORM**

DEPRESSION-ERA BUILDINGS

Unity Ranger Station

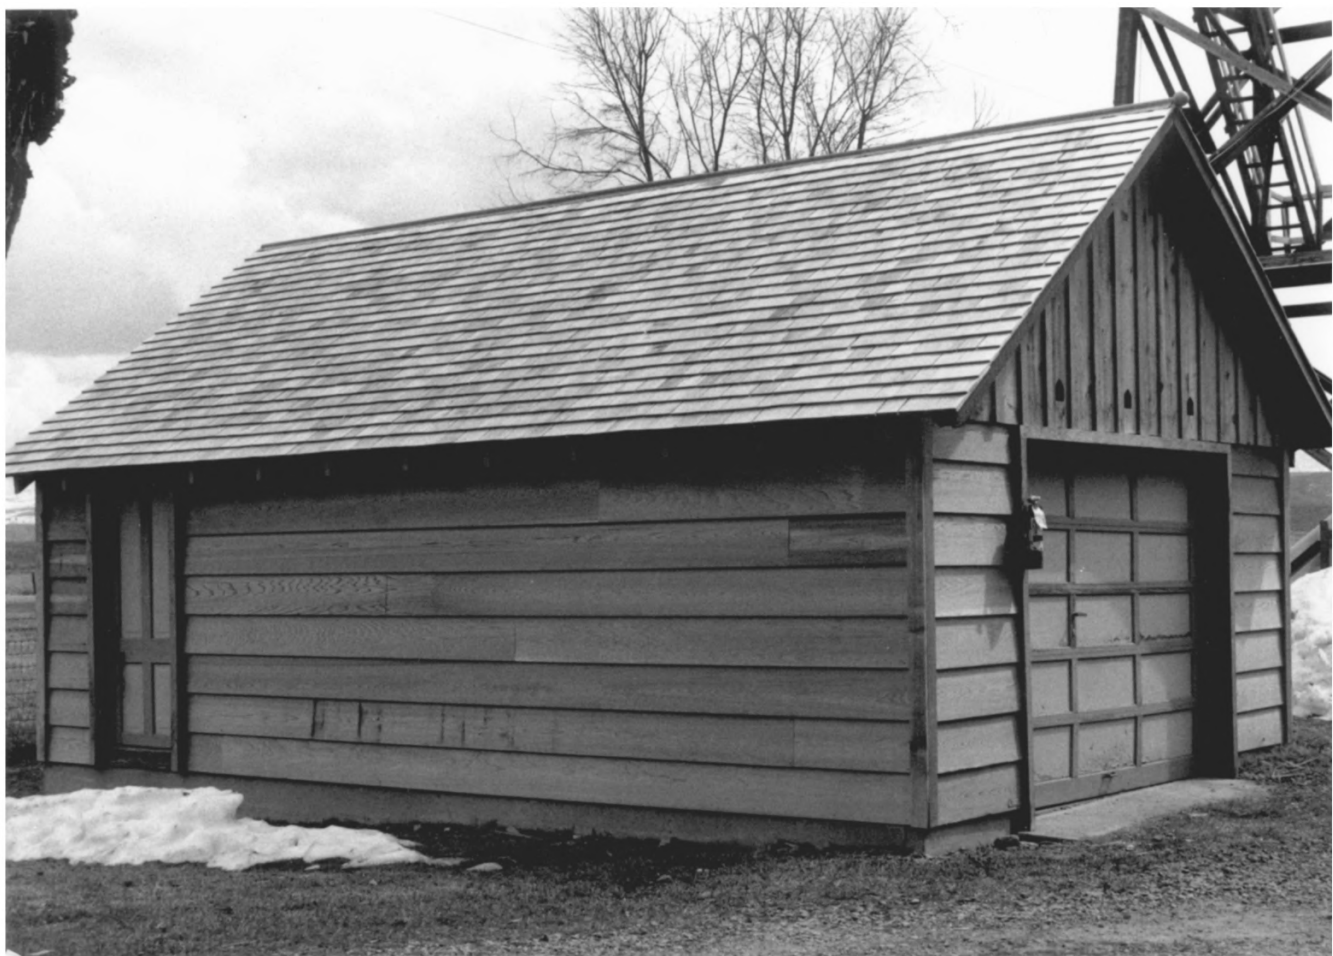
- 1) Name of Property: Unity Ranger Station--Garage
#1051
- 2) City and State: Unity, Oregon
- 3) Photographer: Jan Alexander
- 4) Date: 4/17/84
- 5) Negative Location: USDA Forest Service, Regional Office, Recreation Unit, CRM files.
- 6) Description: Looking southeast at north elevation,
west gable end
- 7) Photograph Number: 16-09-1051G

Garage: Rectangular, 1 story, wood-frame, poured concrete foundation, wood-shingled medium gable roof. Horizontal lapped siding, vertical board and batten on gable ends. Overhead lift vehicle door replaces original slide-opening door on west gable end; single left four panel door offset to left on north elevation. Exterior wall materials replaced strictly in kind 1983.

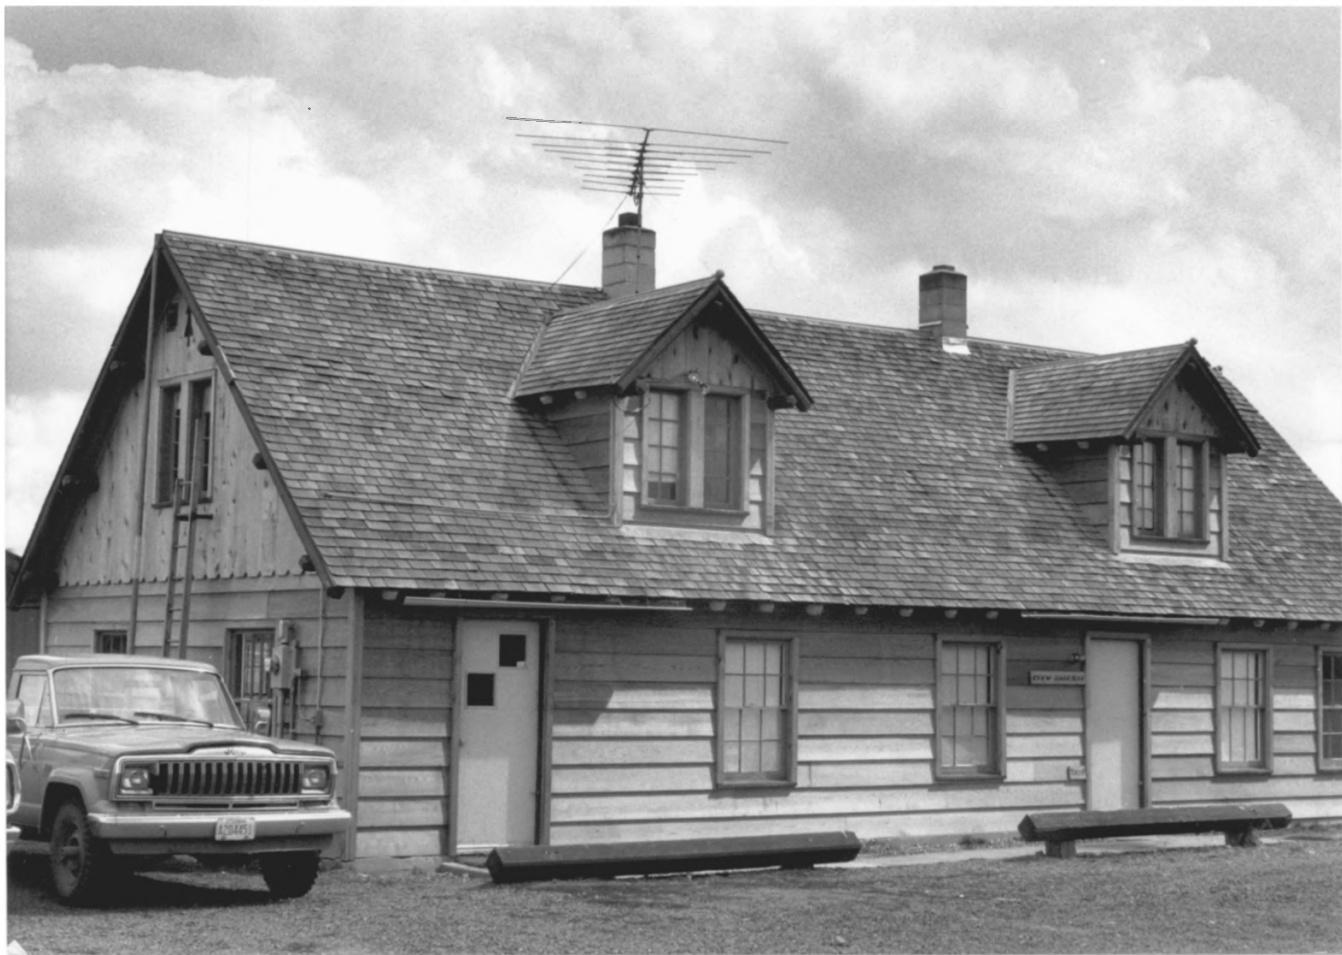
- 1) Name of Property: Unity Ranger Station--Bunkhouse #1306
- 2) City and State: Unity, Oregon
- 3) Photographer: Jan Alexander
- 4) Date: 4/17/84
- 5) Negative Location: USDA Forest Service, Regional Office, Recreation Unit, CRM files.
- 6) Description: Looking southeast at north gable end; main west-facing facade.
- 7) Photograph Number: 16-09-1306

Unity Ranger Station, Bunkhouse #1306: Rectangular, 1 1/2 story, wood frame, concrete foundation, wood-shingled high gable roof with two large gable roofed dormers on front slope; two cement chimneys straddle ridgeline. Horizontal clapboard exterior with rounded vertical boards on gable ends. Six-over-six double-hung sash windows. Single graceful pine tree logos cut out just below peak on east and west gable ends. Six peeled pole purlins and ridge pole project at gable ends with peeled pole end joist as fascia. Effect repeated on dormers.

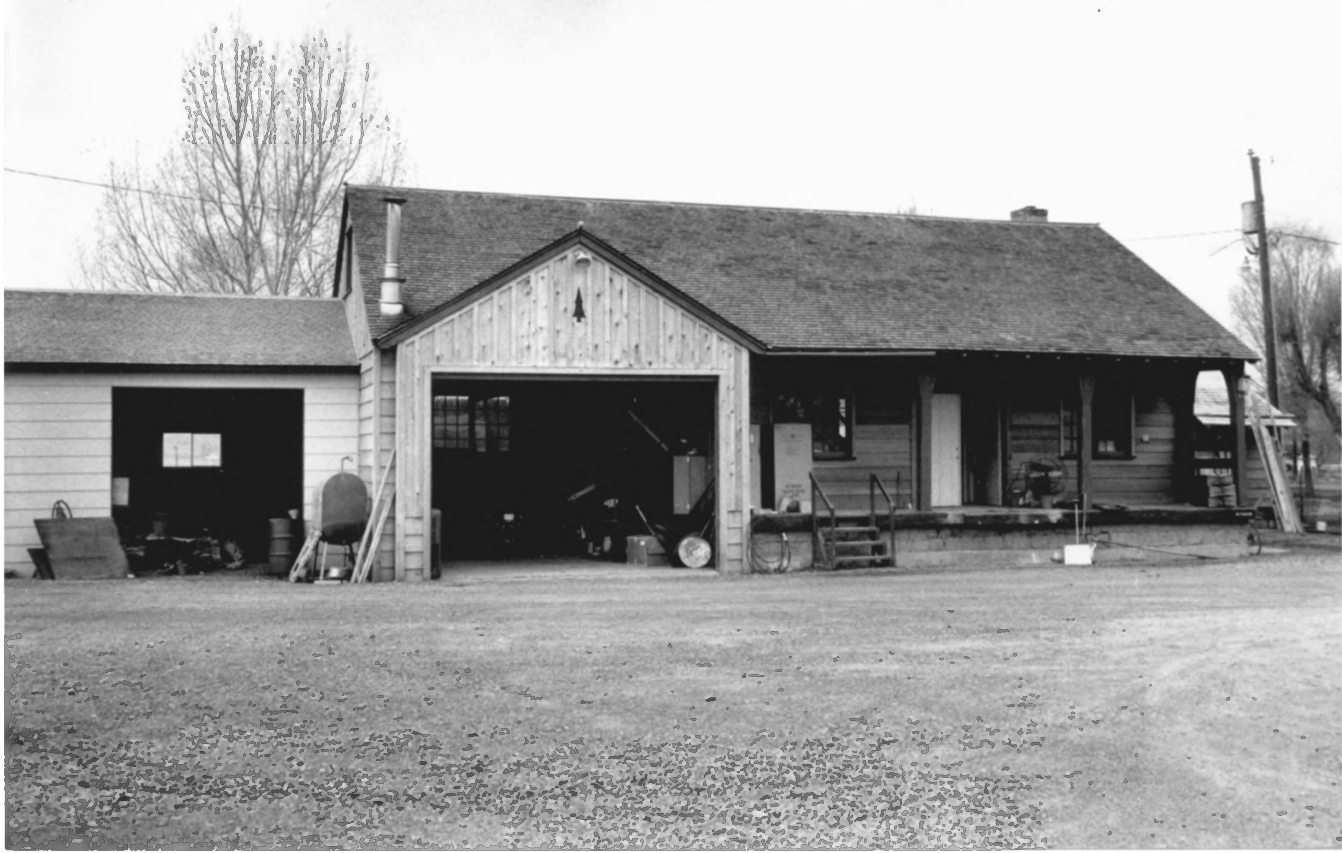
- 1) Name of Property: Unity Ranger Station--Warehouse #2207
- 2) City and State: Unity, Oregon
- 3) Photographer: Jan Alexander
- 4) Date: 4/17/84
- 5) Negative Location: USDA Forest Service, Regional Office, Recreation Unit, CRM files.
- 6) Description: Looking west at east facing main facade
- 7) Photograph Number: 16-09-2207

Unity Ranger Station, Warehouse #2207: T-shaped, wood frame, concrete foundation, stone veneered, wood-shingled medium gable roof with projecting major gable off center (N.E.); red lava stone chimney off center on south roof slope; raised, rock faced porch extends along north facade to offset gable, building front recessed, main roof slope extends to form porch roof which is supported by squared-timber posts. Horizontal clapboard exterior with vertical board and batten on gable ends. Windows are eight and twelve-light single sashes with mullions. Single pine tree logo cutout on offset gable end. Gable roofed storage area on east end is an addition, structurally and materially well matched. Very good condition.

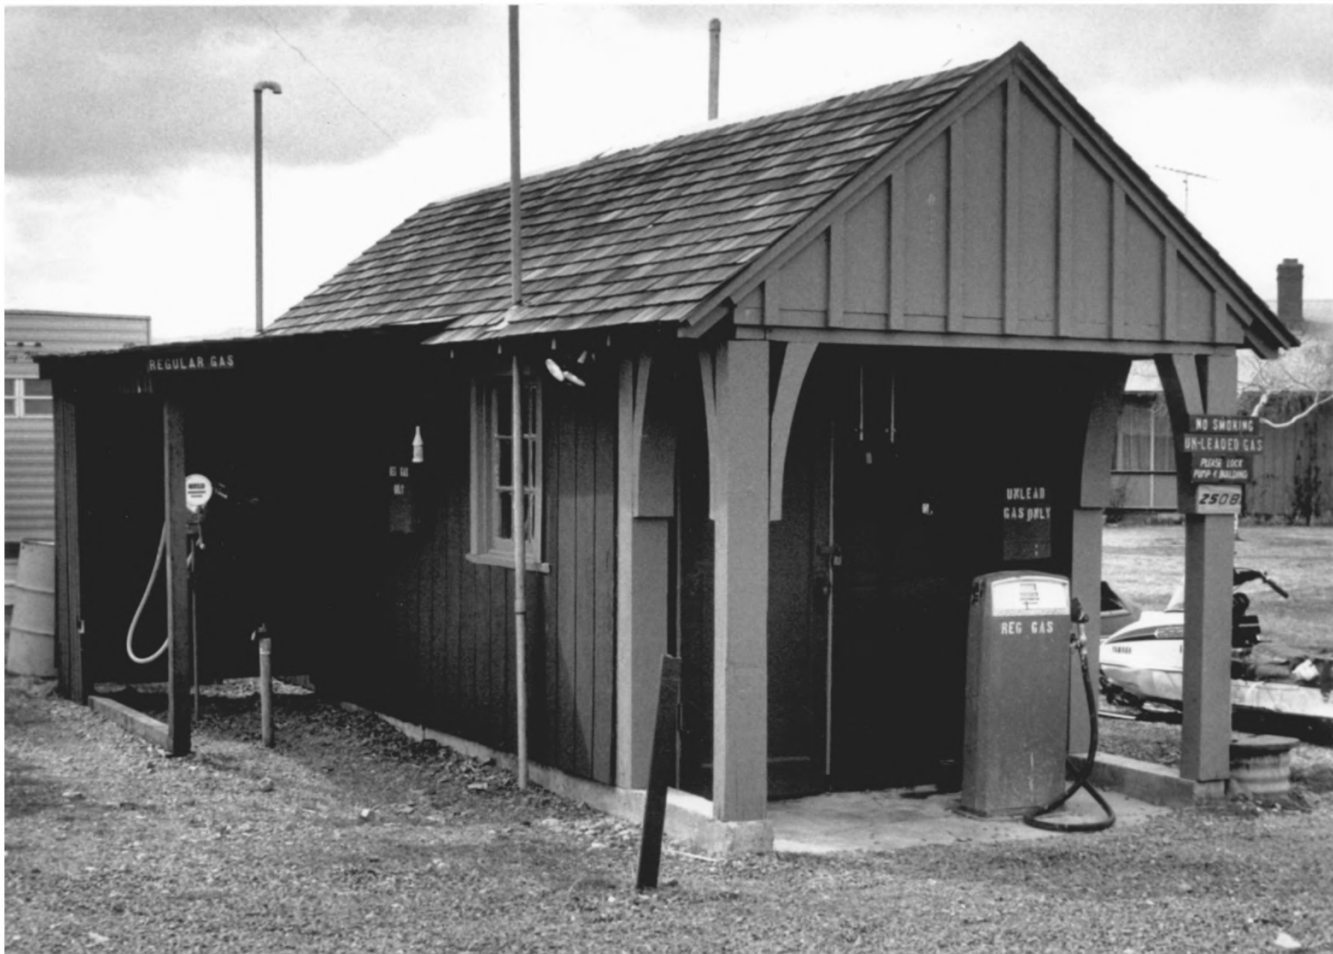
- 1) Name of Property: Unity Ranger Station--Gas House #2508
- 2) City and State: Unity, Oregon
- 3) Photographer: Jan Alexander
- 4) Date: 4/17/84
- 5) Negative Location: USDA Forest Service, Regional Office, Recreation Unit, CRM files.
- 6) Description: Looking southwest at east elevation, north gable end
- 7) Photograph Number: 16-09-2508

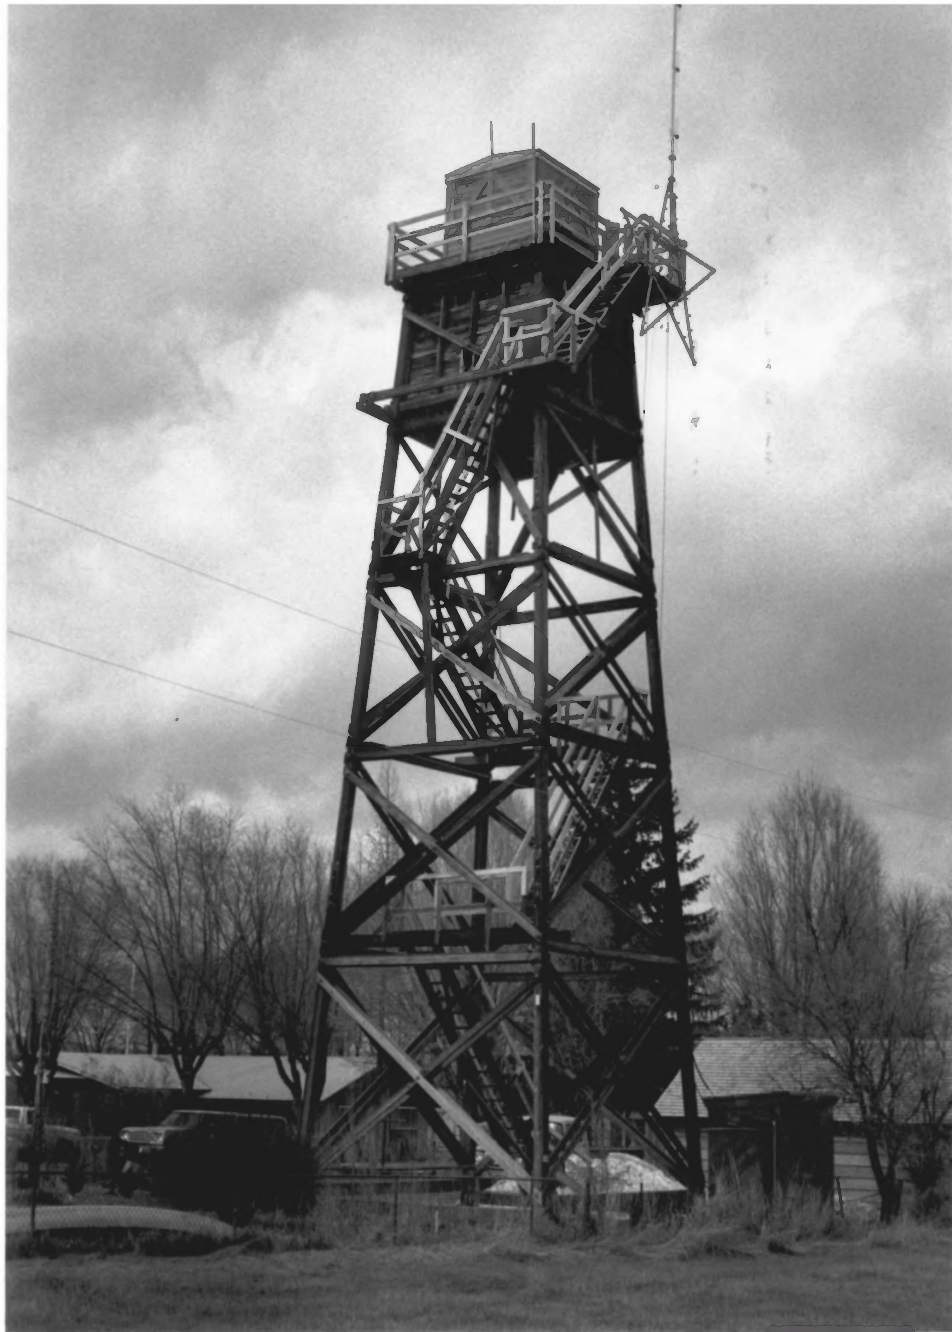
- 1) Name of Property: Unity Ranger Station--Fire Lookout #4220
- 2) City and State: Unity, Oregon
- 3) Photographer: Jan Alexander
- 4) Date: 4/17/84
- 5) Negative Location: USDA Forest Service, Regional Office, Recreation Unit, CRM files.
- 6) Description: Looking southwest at fire lookout; water tank is held in top bent of tower.
- 7) Photograph Number: 16-09-4220

Fire Lookout-Water Tower #4220: 1938; Square; 1 story cabin on 60 feet tower; canvas-covered low gable roof; type CT1 Lookout: 7' X 7' wood frame cabin on 12'8" square deck, catwalk enclosed by simple railing; exterior walls are flush siding; windows are six-light fixed sash on all elevations. Top-hinged board shutters append to plate above windows. Tower is of prefabricated ring-connected timber construction, of creosoted Douglas-fir, with five bents; cab accessed through trap door from wooden stairway. Top bent of tower holds wood stave water tank. No apparent structural additions or alterations; no obvious materials modifications.

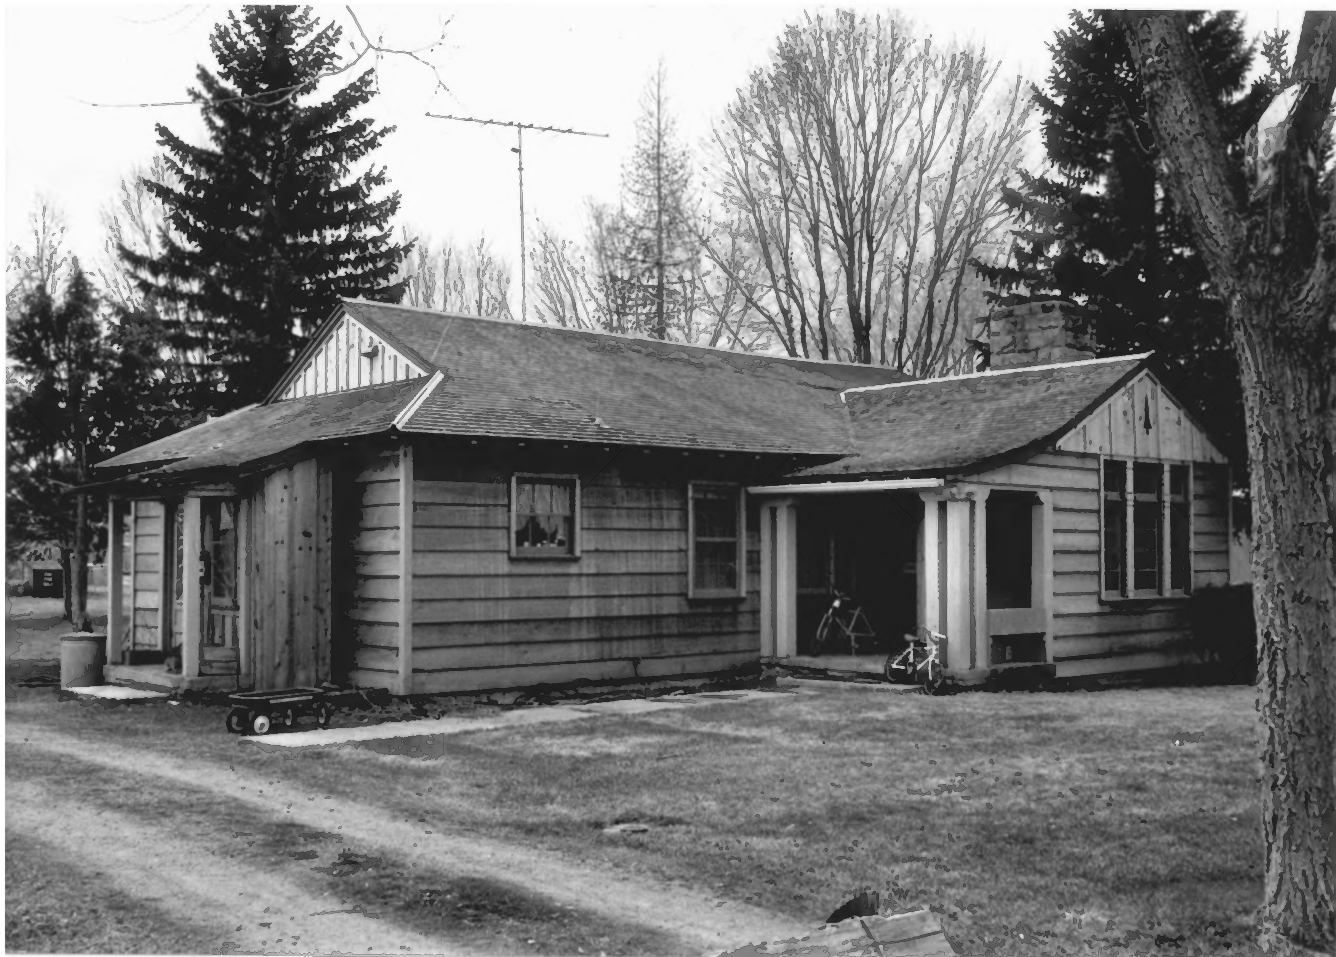
- 1) Name of Property: Unity Ranger Station--Residence #1051
- 2) City and State: Unity, Oregon
- 3) Photographer: Jan Alexander
- 4) Date: 4/17/84
- 5) Negative Location: USDA Forest Service, Regional Office, Recreation Unit, CRM files.
- 6) Description: Looking southwest of east gable end and main north-facing facade
- 7) Photograph Number: 16-09-1051

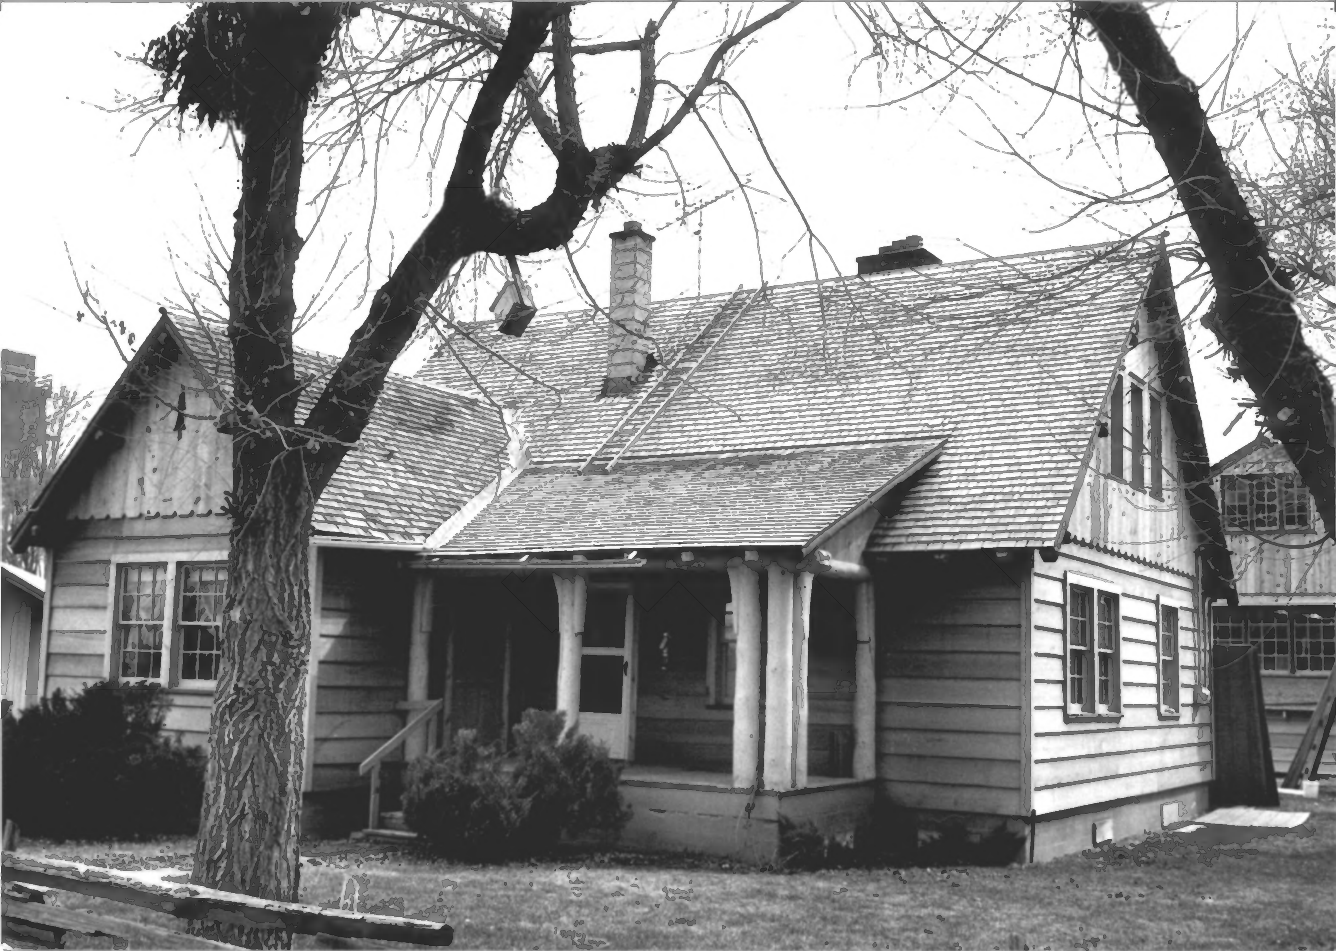
- 1) Name of Property: Unity Ranger Station--Residence #1052
- 2) City and State: Unity, Oregon
- 3) Photographer: Jan Alexander
- 4) Date: 4/17/84
- 5) Negative Location: USDA Forest Service, Regional Office, Recreation Unit, CRM files.
- 6) Description: Looking southeast at west gable end and main north-facing facade.
- 7) Photograph Number: 16-09-1052

Unity Ranger Station, Residence #1052: L-shaped, 1 1/2 story, wood frame, concrete foundation wood-shingle high gable roof with large gable roofed dormer on south (rear) slope, major offset gable on N.E. corner, with shed roofed porch adjacent on north (main) elevation. Porch roof supported by round peeled log posts. Cement chimney off center, north slope, brick chimney off center, south slope. Horizontal clapboard exterior with wood corner trim, vertical boards ends rounded, on all gable ends. Six-over-six double-hung sash windows singly and in combinations with mullions. Particularly graceful single pine tree logos cut out of two vertical boards centered just below peak on north, east and west gable ends. No apparent exterior alterations. In very good condition.
