# National Register of Historic Places Registration Form

historic name Sheffield, John and Sarah, House  
other names/site number Paraside Springs Farm

street & number 4272 SE Washington Street  not for publication  
city, town Portland  vicinity  
state Oregon code OR county Multnomah code 051 zip code 97215

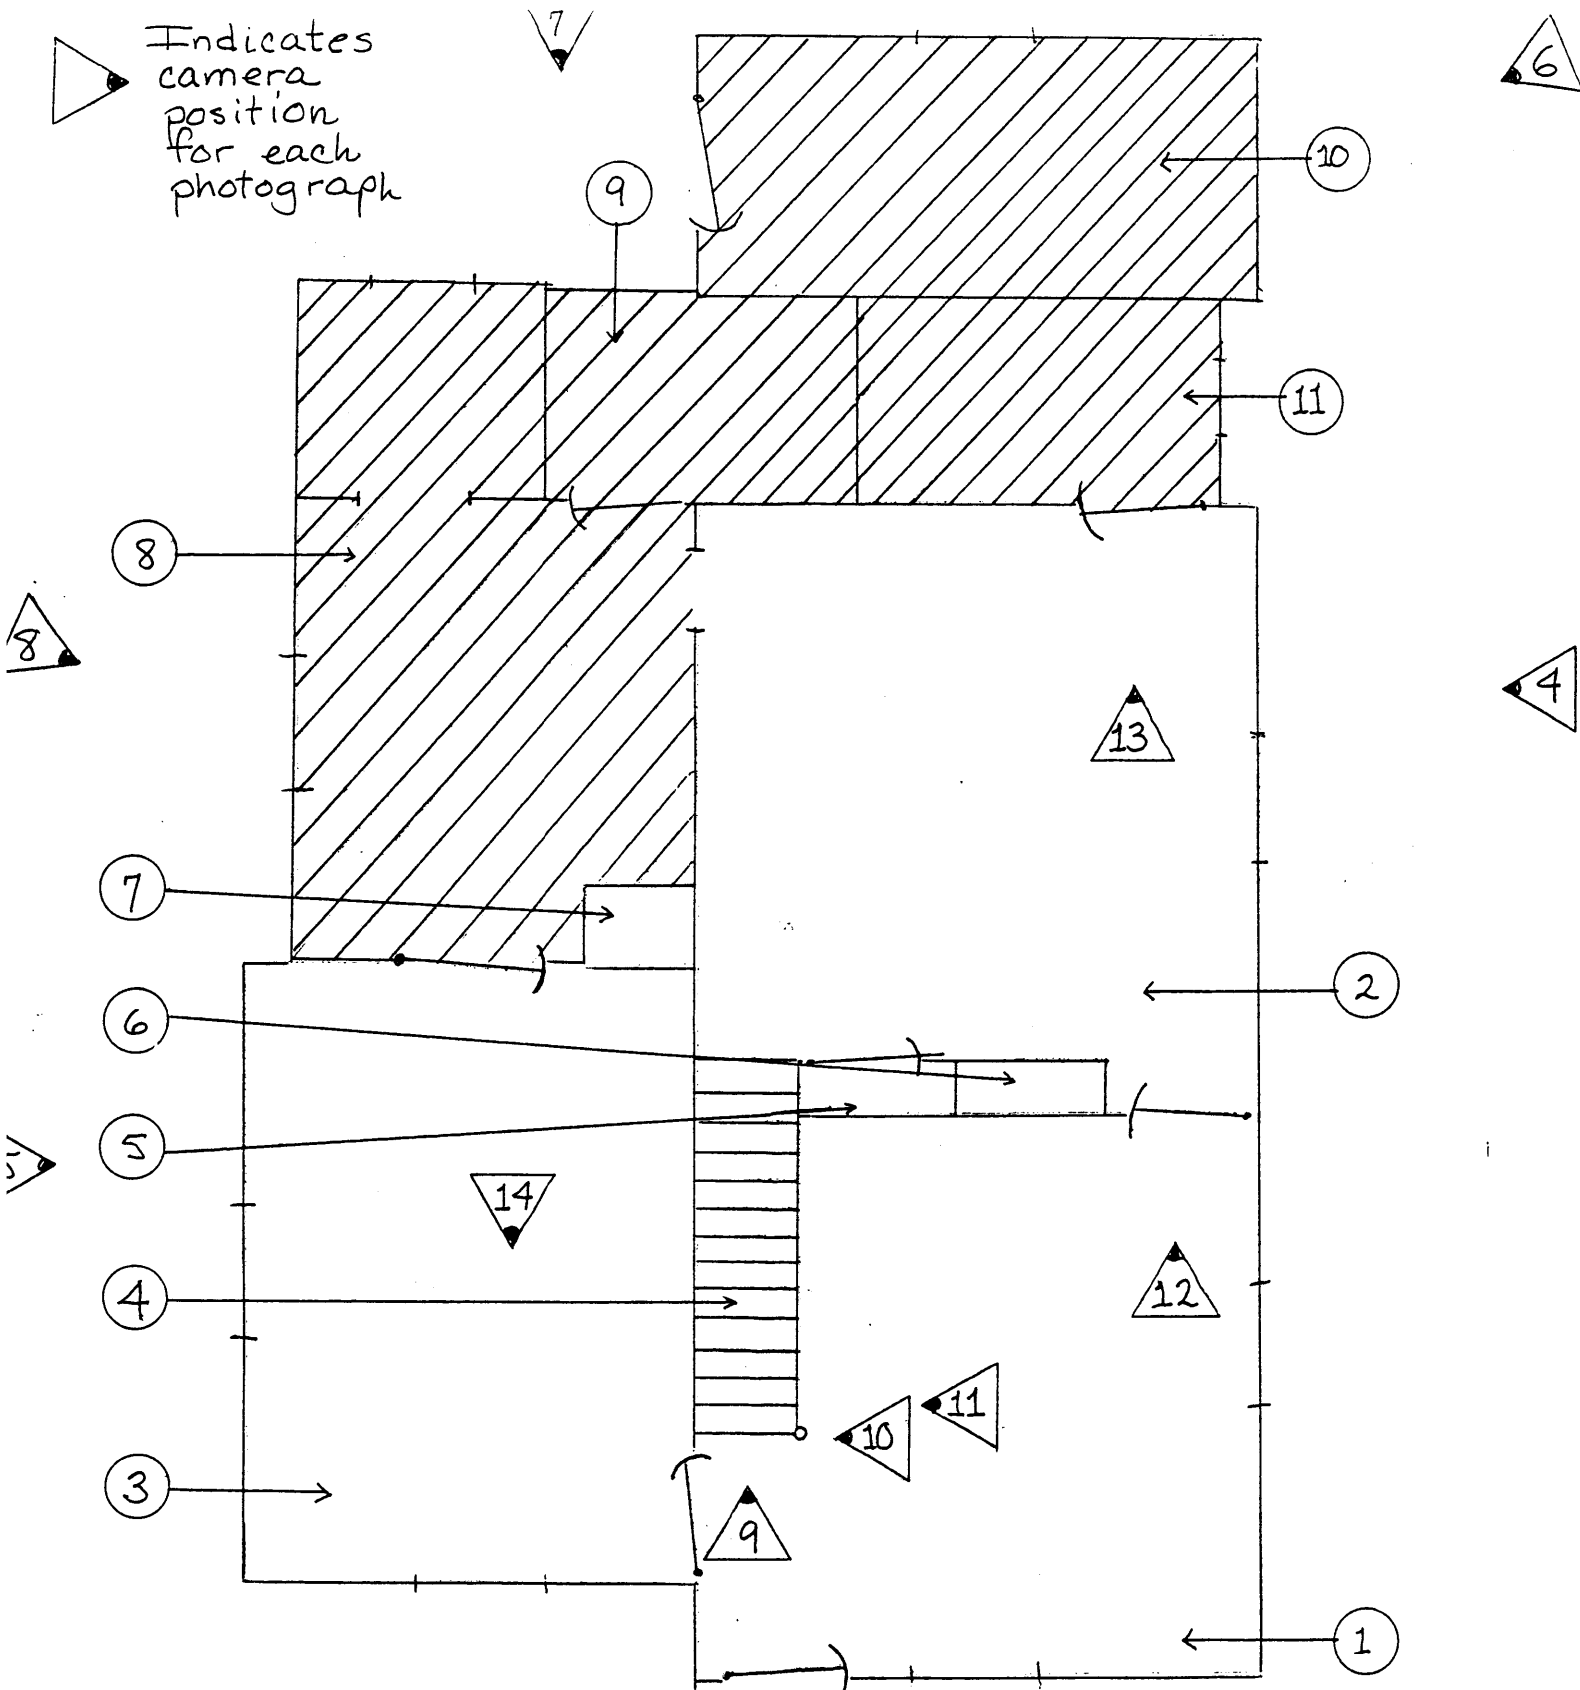
Paradise Springs Farm House  
First floor

- 1. Living Room 12'7" x 15'0"
- 2. Dining Room 15'0" x 16'0"
- 3. Parlor 11'4" x 15'10"
- 4. Stair 2'8" x 10'0"
- 5. Closet
- 6. Chimney in chase
- 7. Chimney

- 8. Kitchen addition 10'2" x 17'4"
- 9. Porch addition 4'0" x 8'4"
- 10. Shed addition 7'0" x 15'0"
- 11. Bathroom addition 5'9" x 9'2"

The Paradise Springs Farm House is a two-story structure with two single-story additions, which date from the 1900 era, to the rear. The plan of the house is two gables: the larger is 16' by 31' and is oriented north-south; the smaller is 12' by 16' and is oriented east-west. The east-west gable is set back at the north elevation from the west gable end about 2 1/2'.

In approximately 1900, an addition was made to the south of the east-west gable. This one-story structure was fit directly against the existing walls and the original doorways were retained as access. It does not cover any earlier windows, and contains one window to the east and one to the south, a kitchen sink, and a stove. There is a rear door leading

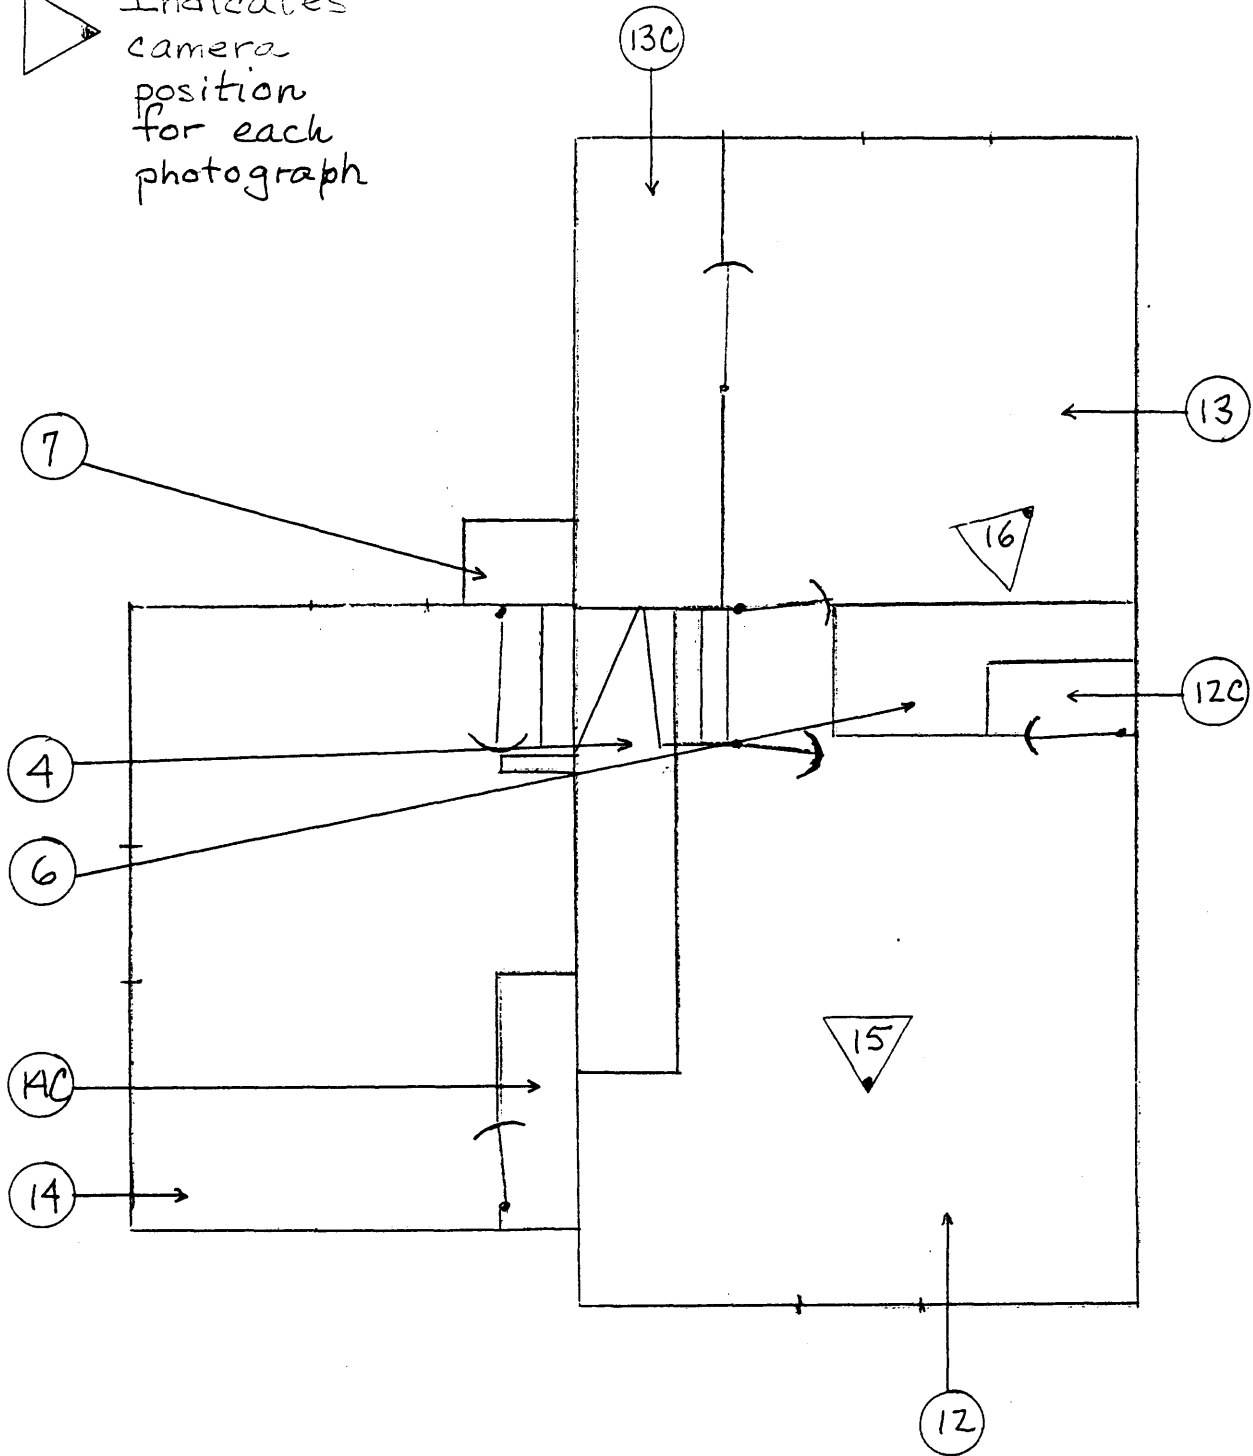
Paradise Springs Farm House  
 Second floor

- 12. North bedroom 12'4" x 15'4"
- 12C. Closet
- 13. South bedroom 9'10" x 15'0"
- 13C. Closet
- 14 East bedroom 11'8" x 11'8"
- 14C Closet

- 4. Stair
- 6. Chimney in chase
- 7. Chimney

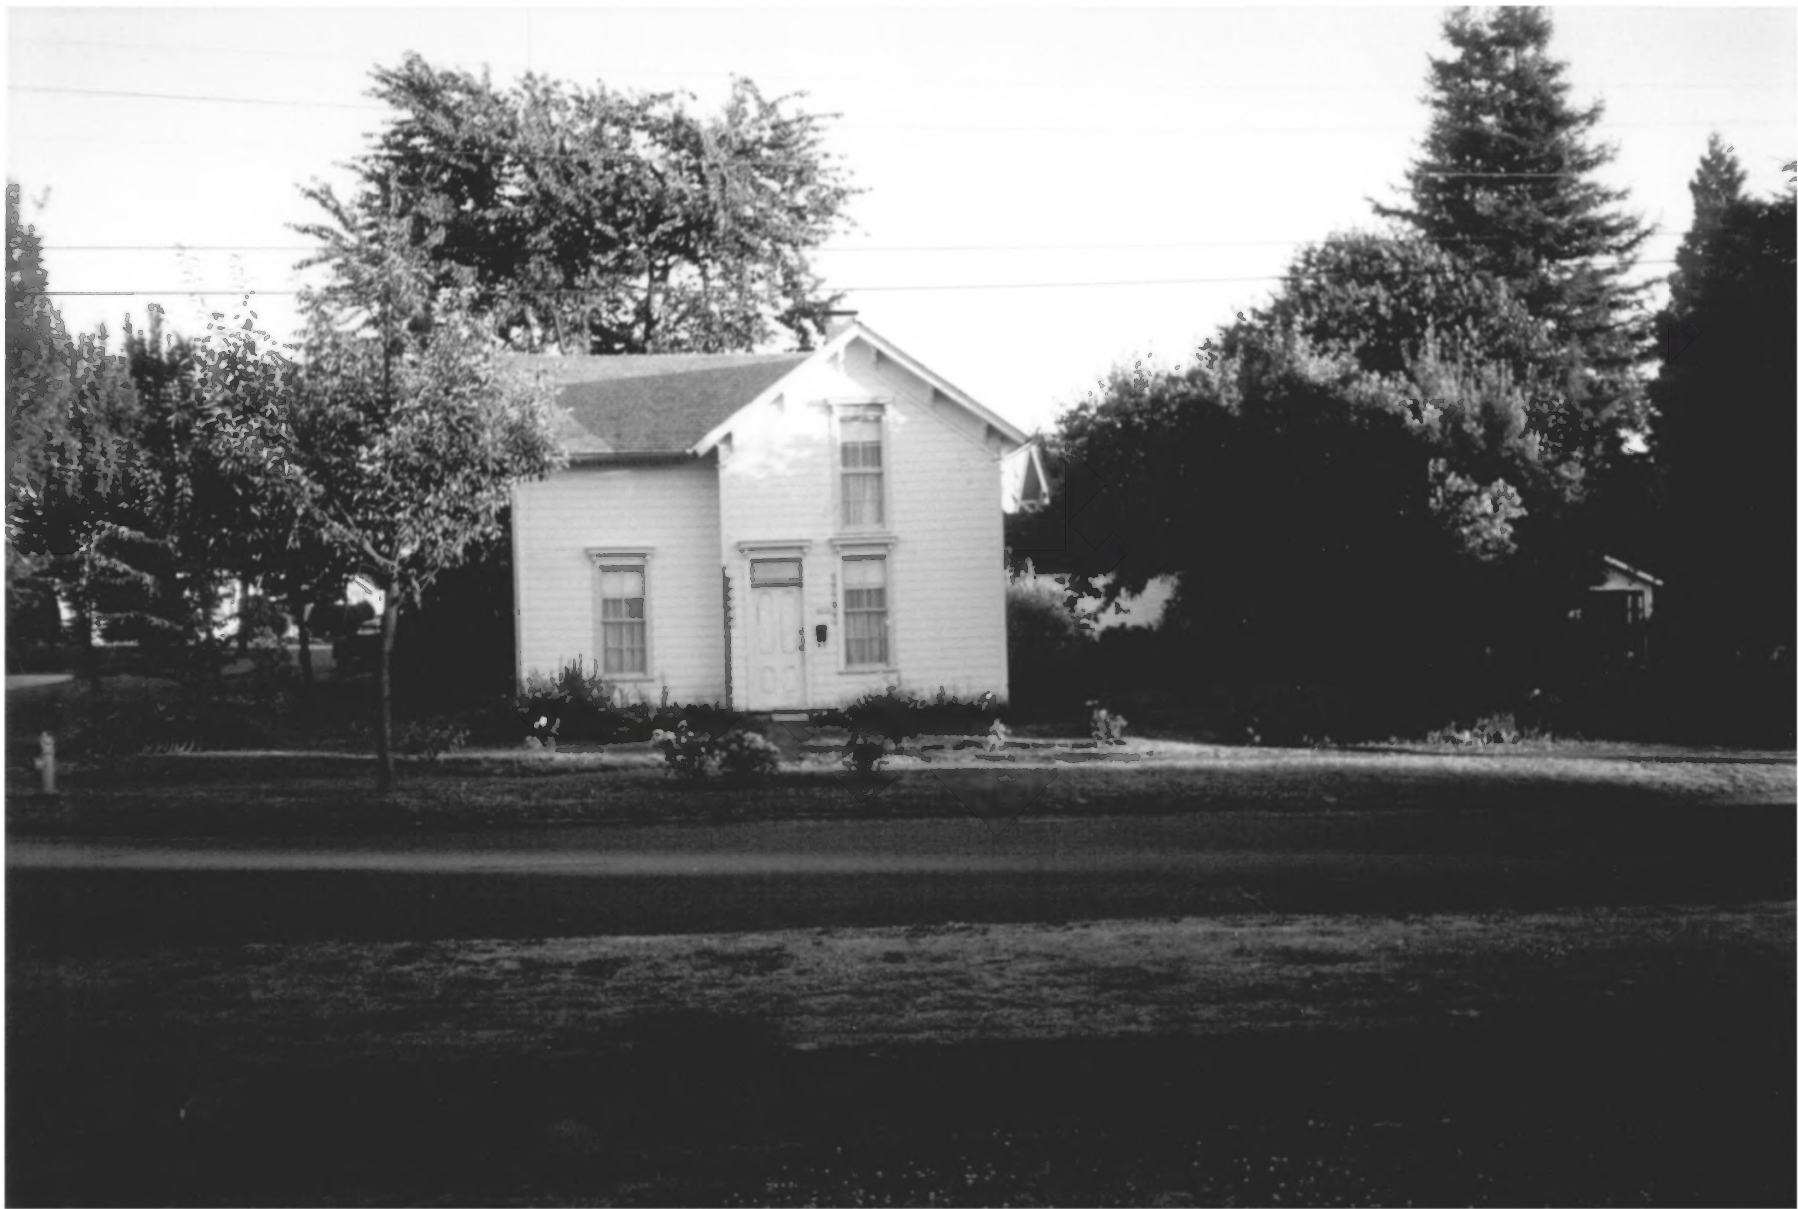
1 of 18

North elevation from N. of S.E. Washington St.

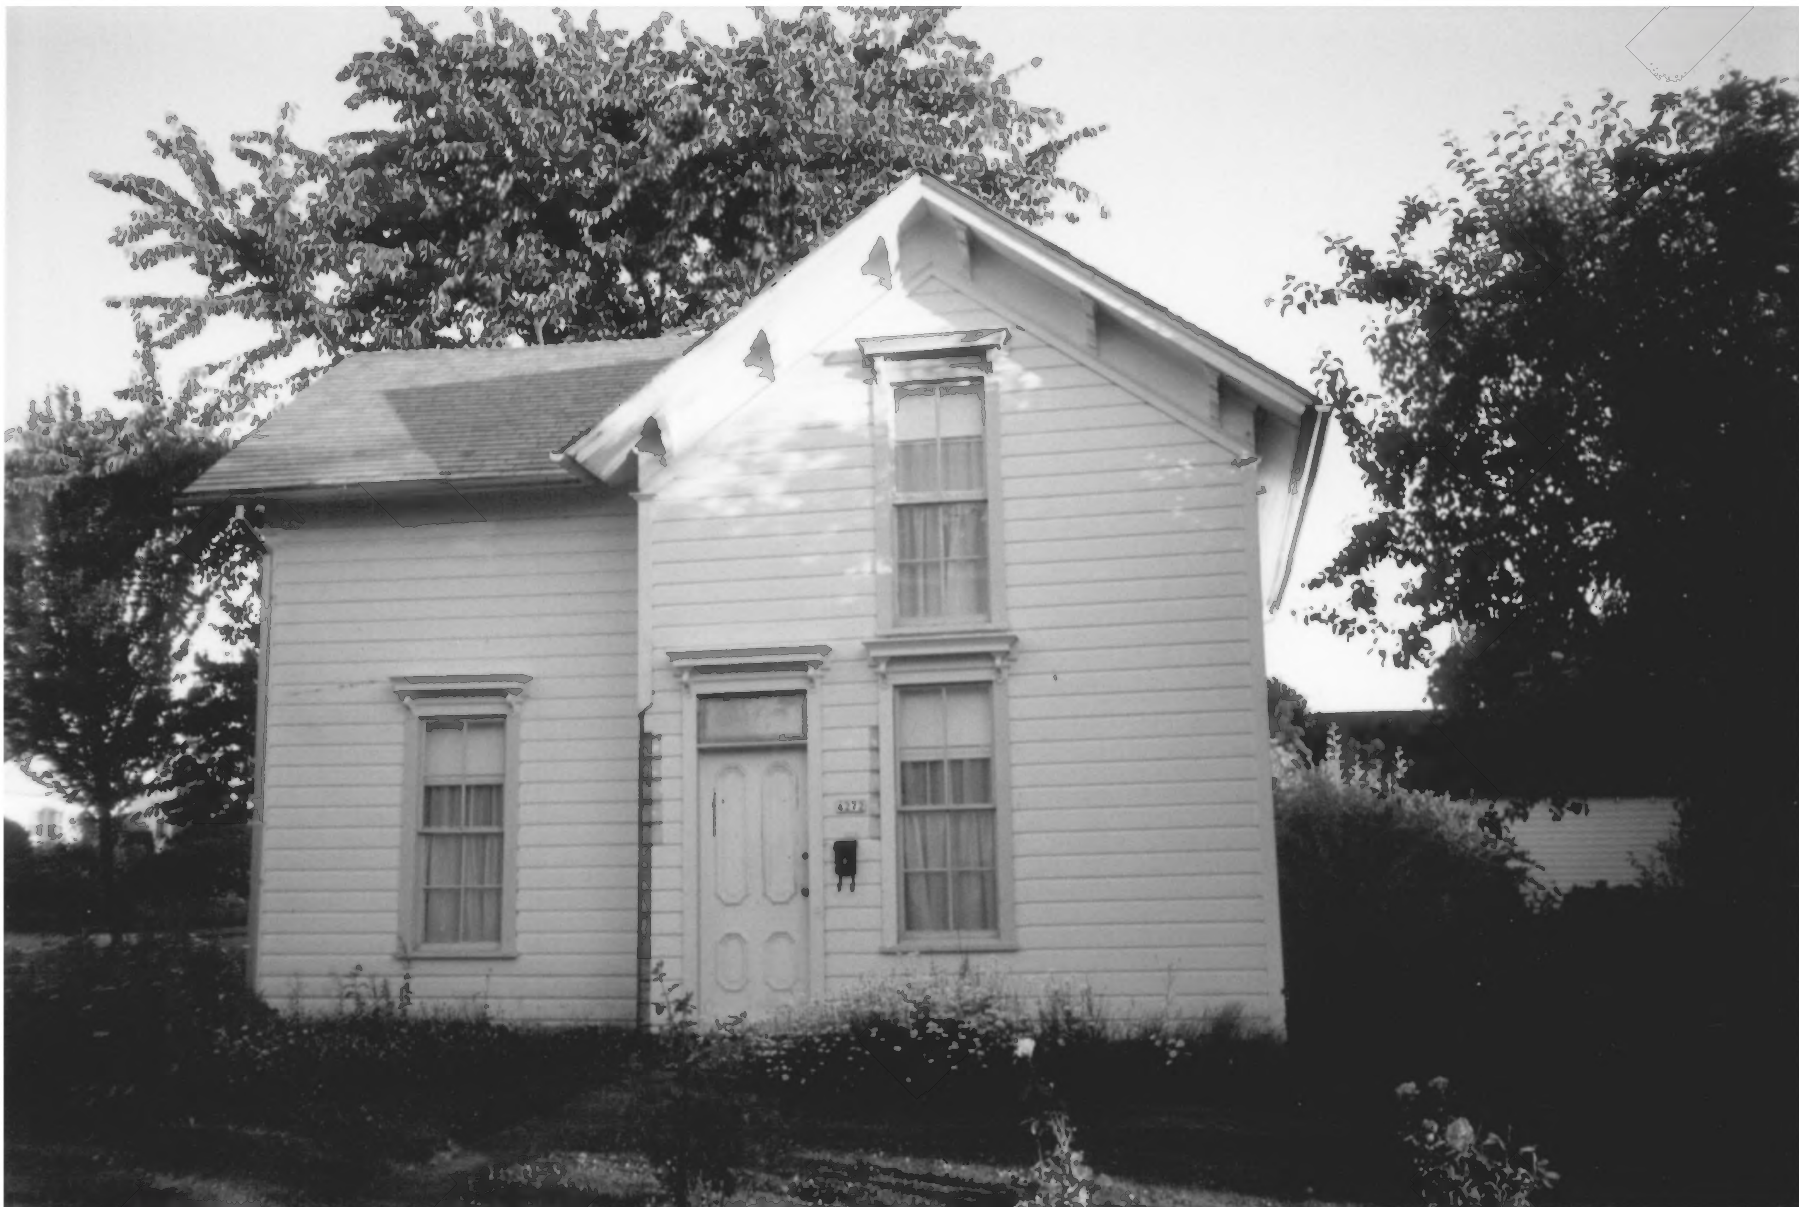
2 of 18

North elevation from S.E. Washington St.

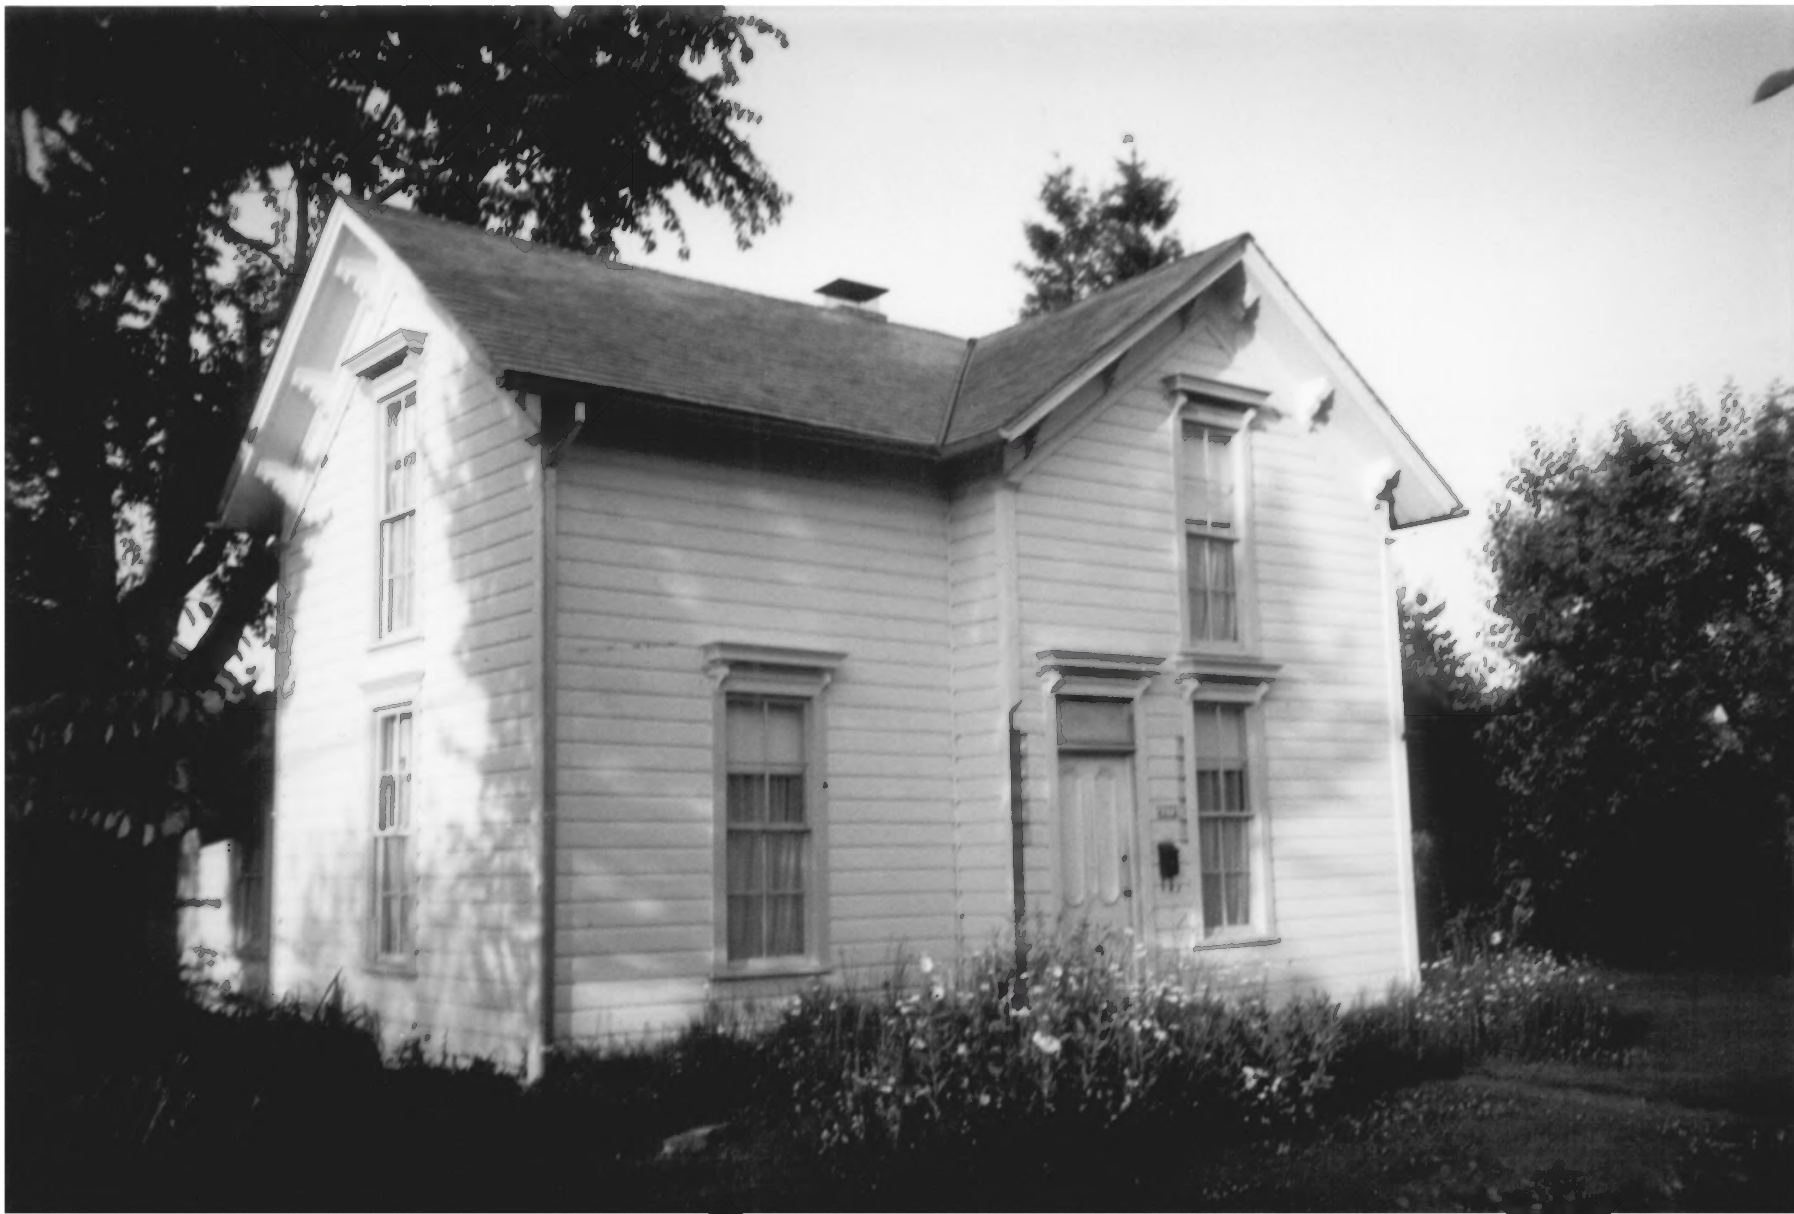
3 of 18

North and east elevations from the intersection of S.E. Washington St.  
and 43<sup>rd</sup> Ave.

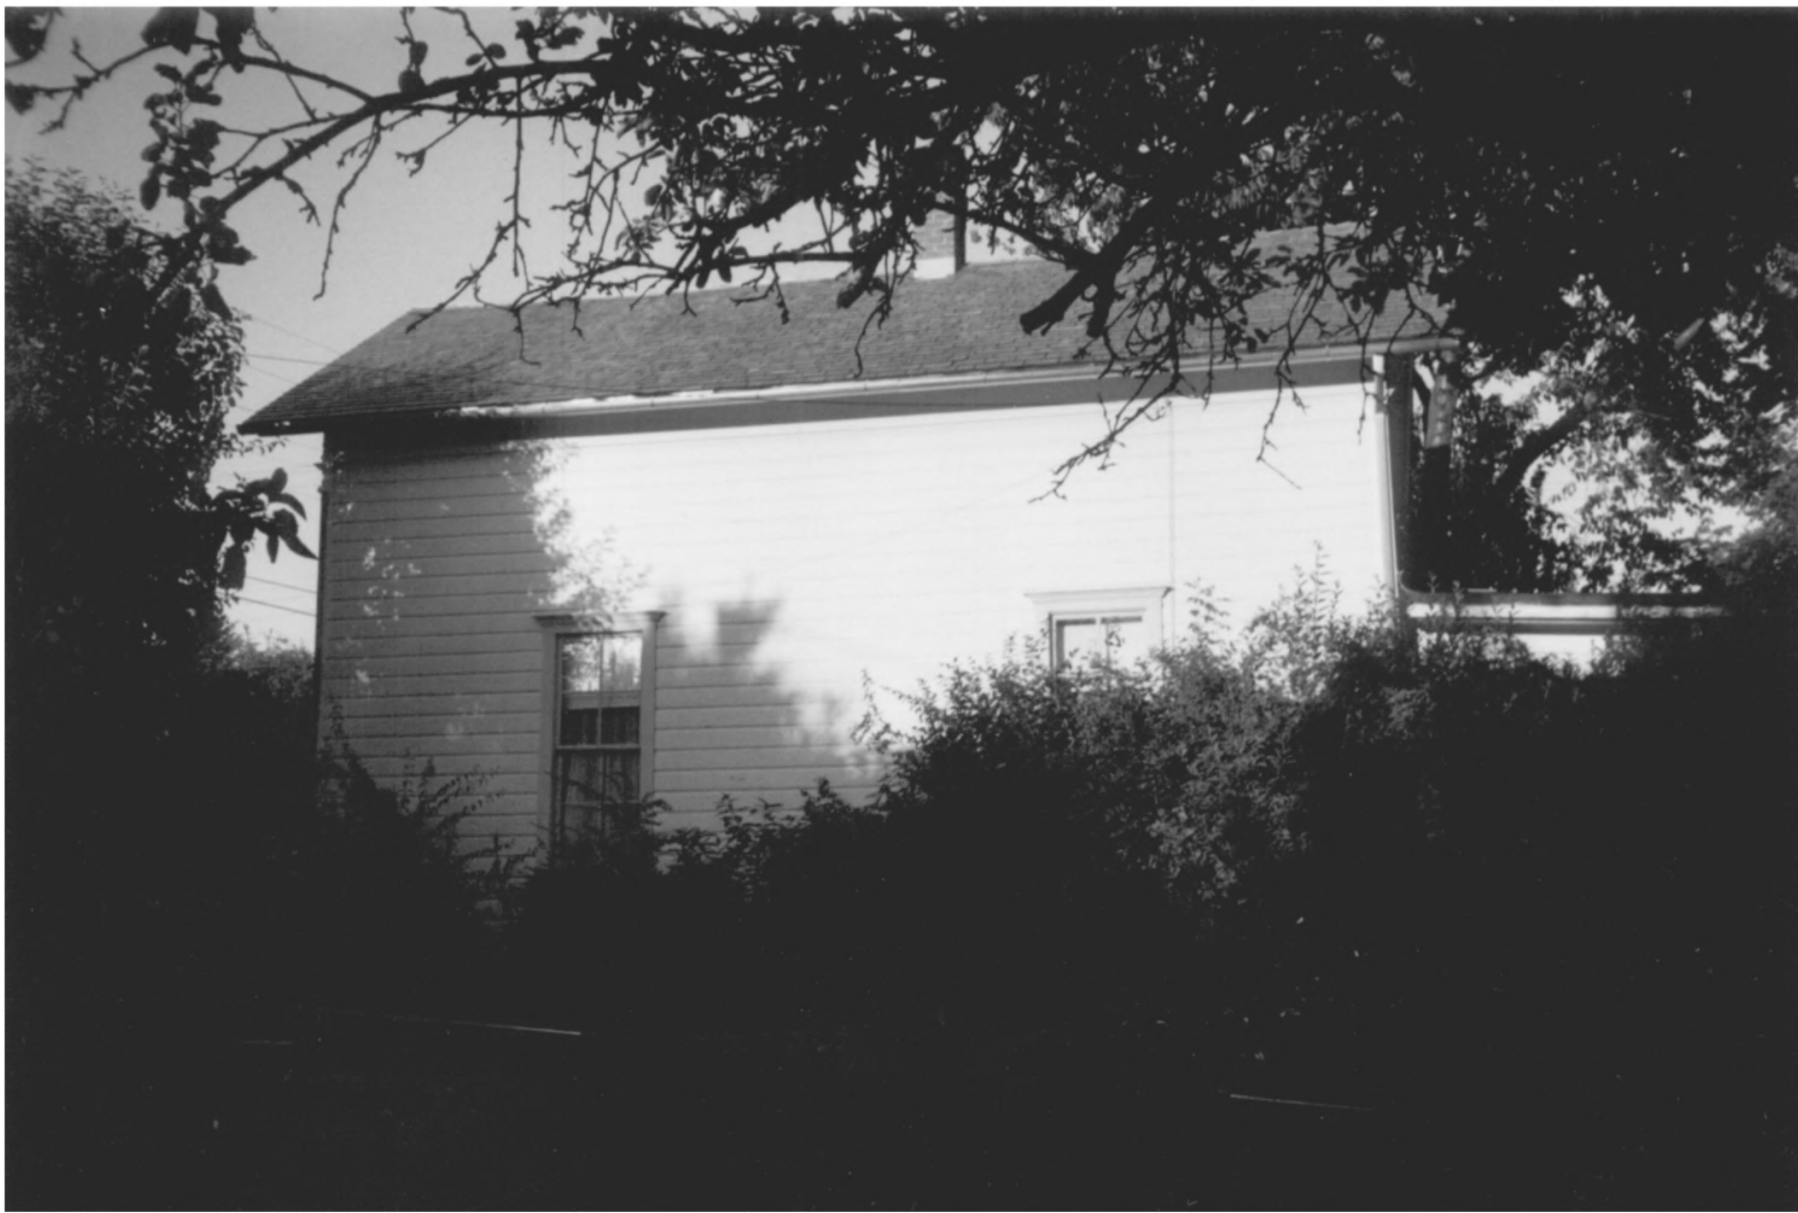
4 of 18

West elevation from west property line

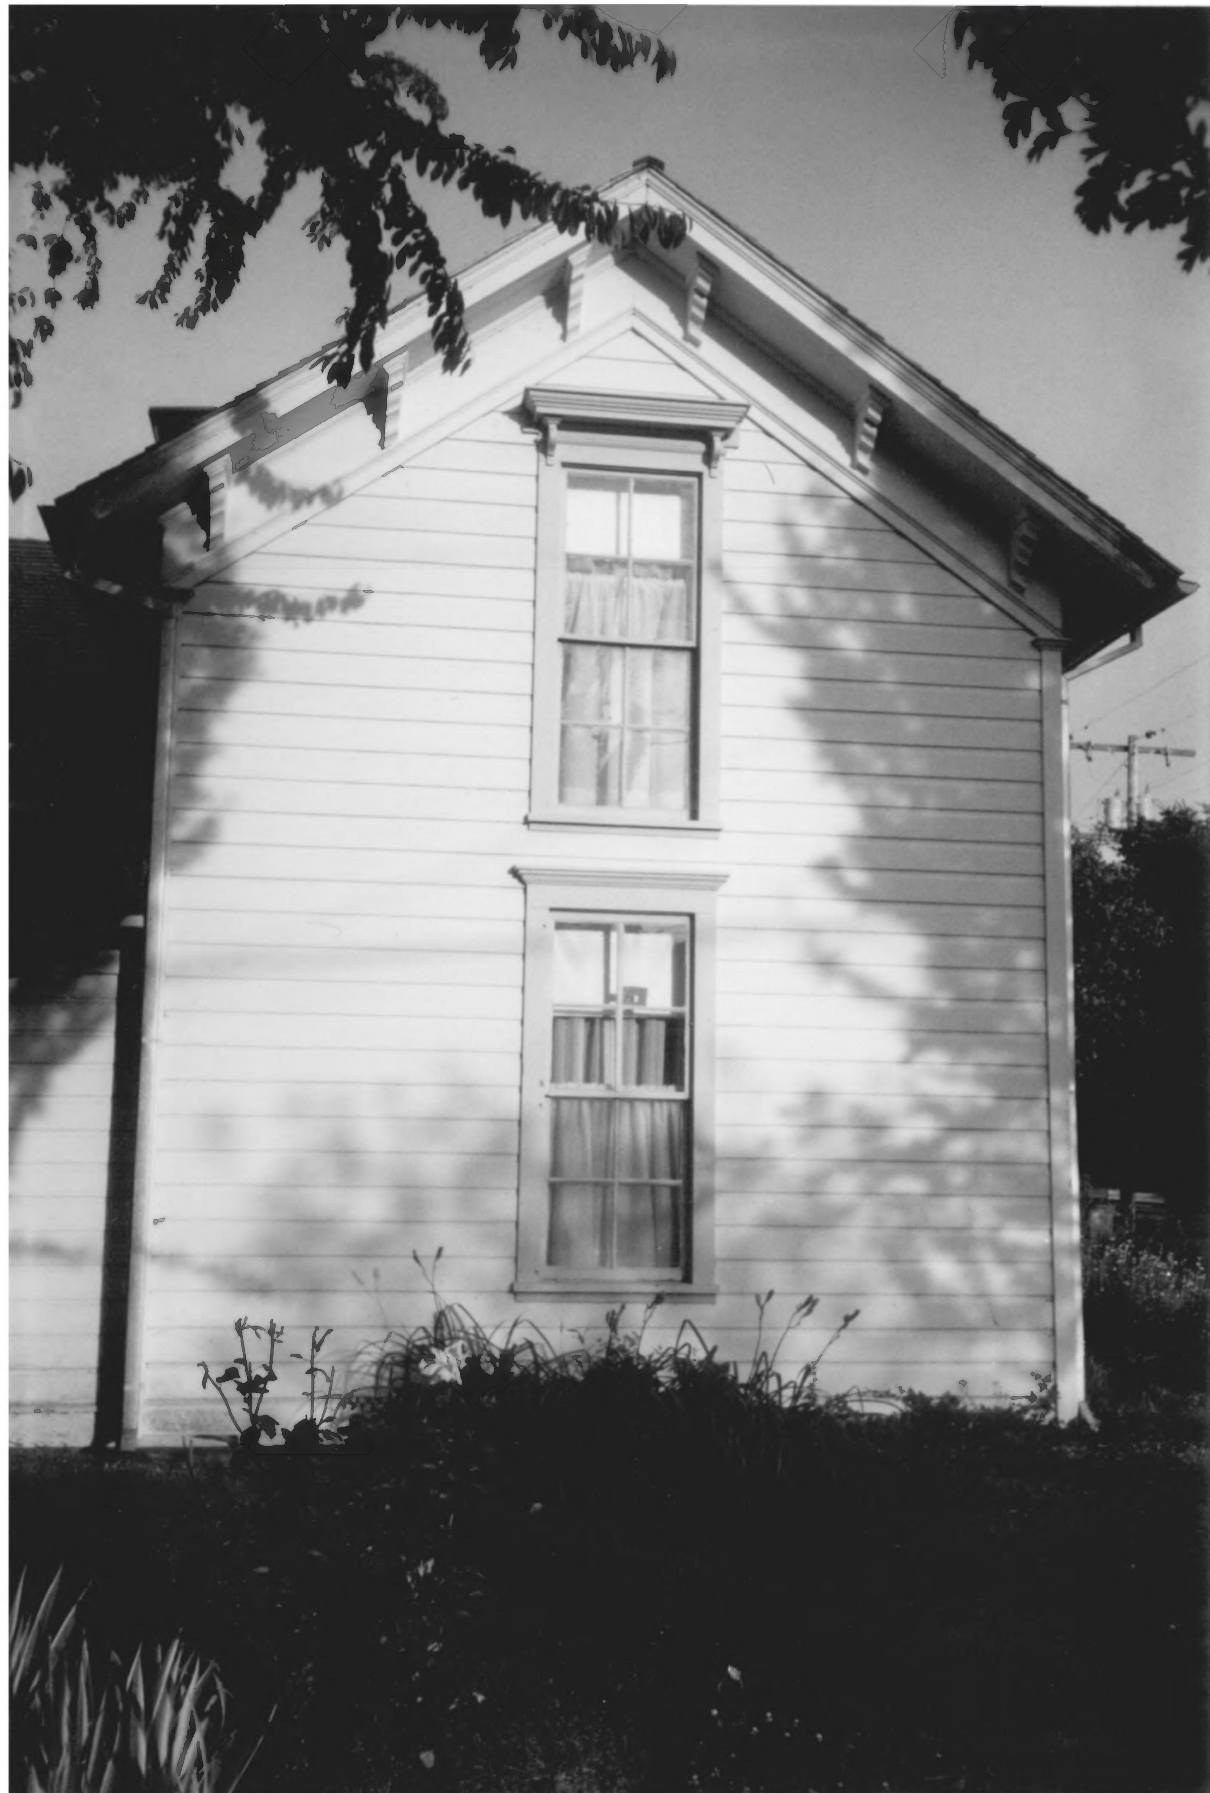
East elevation from east property line  
5 of 18

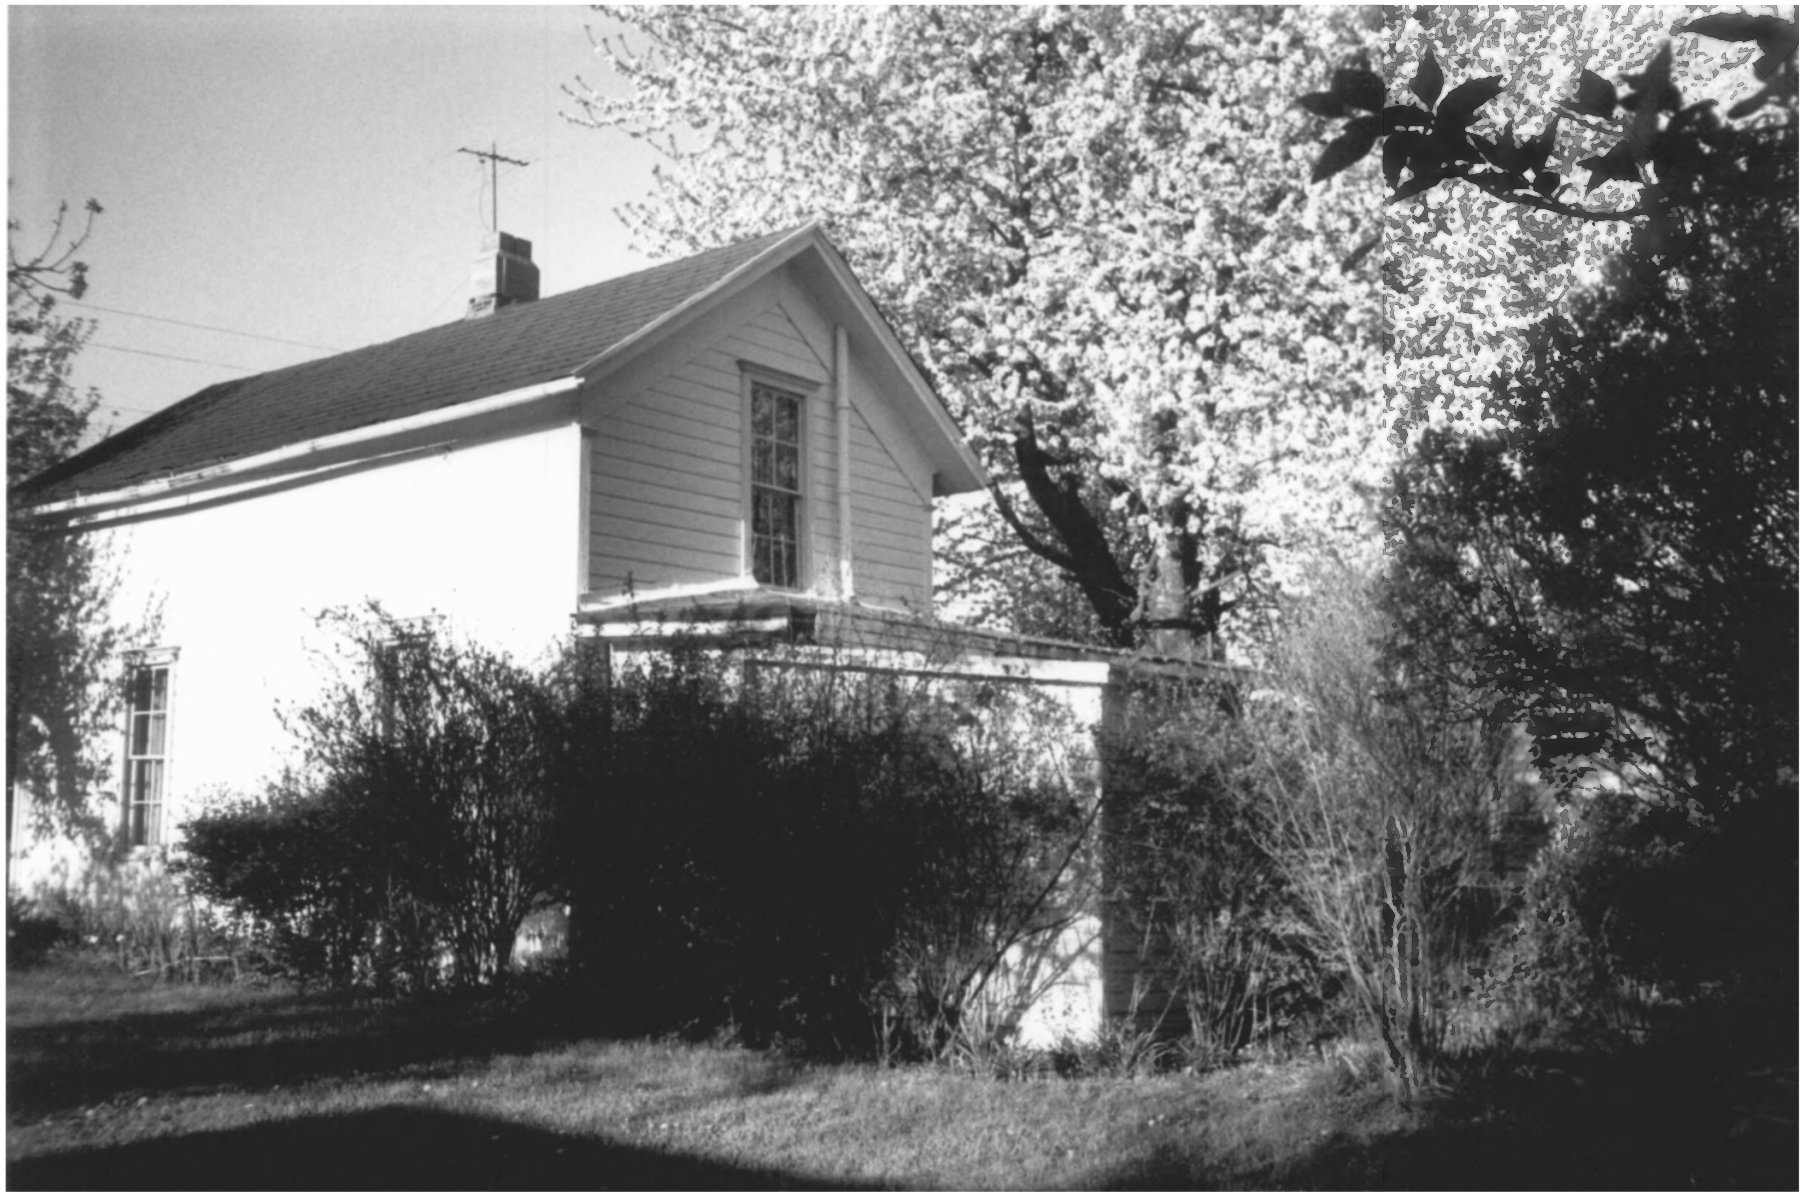
6 of 18

South elevation from southwest corner of property line

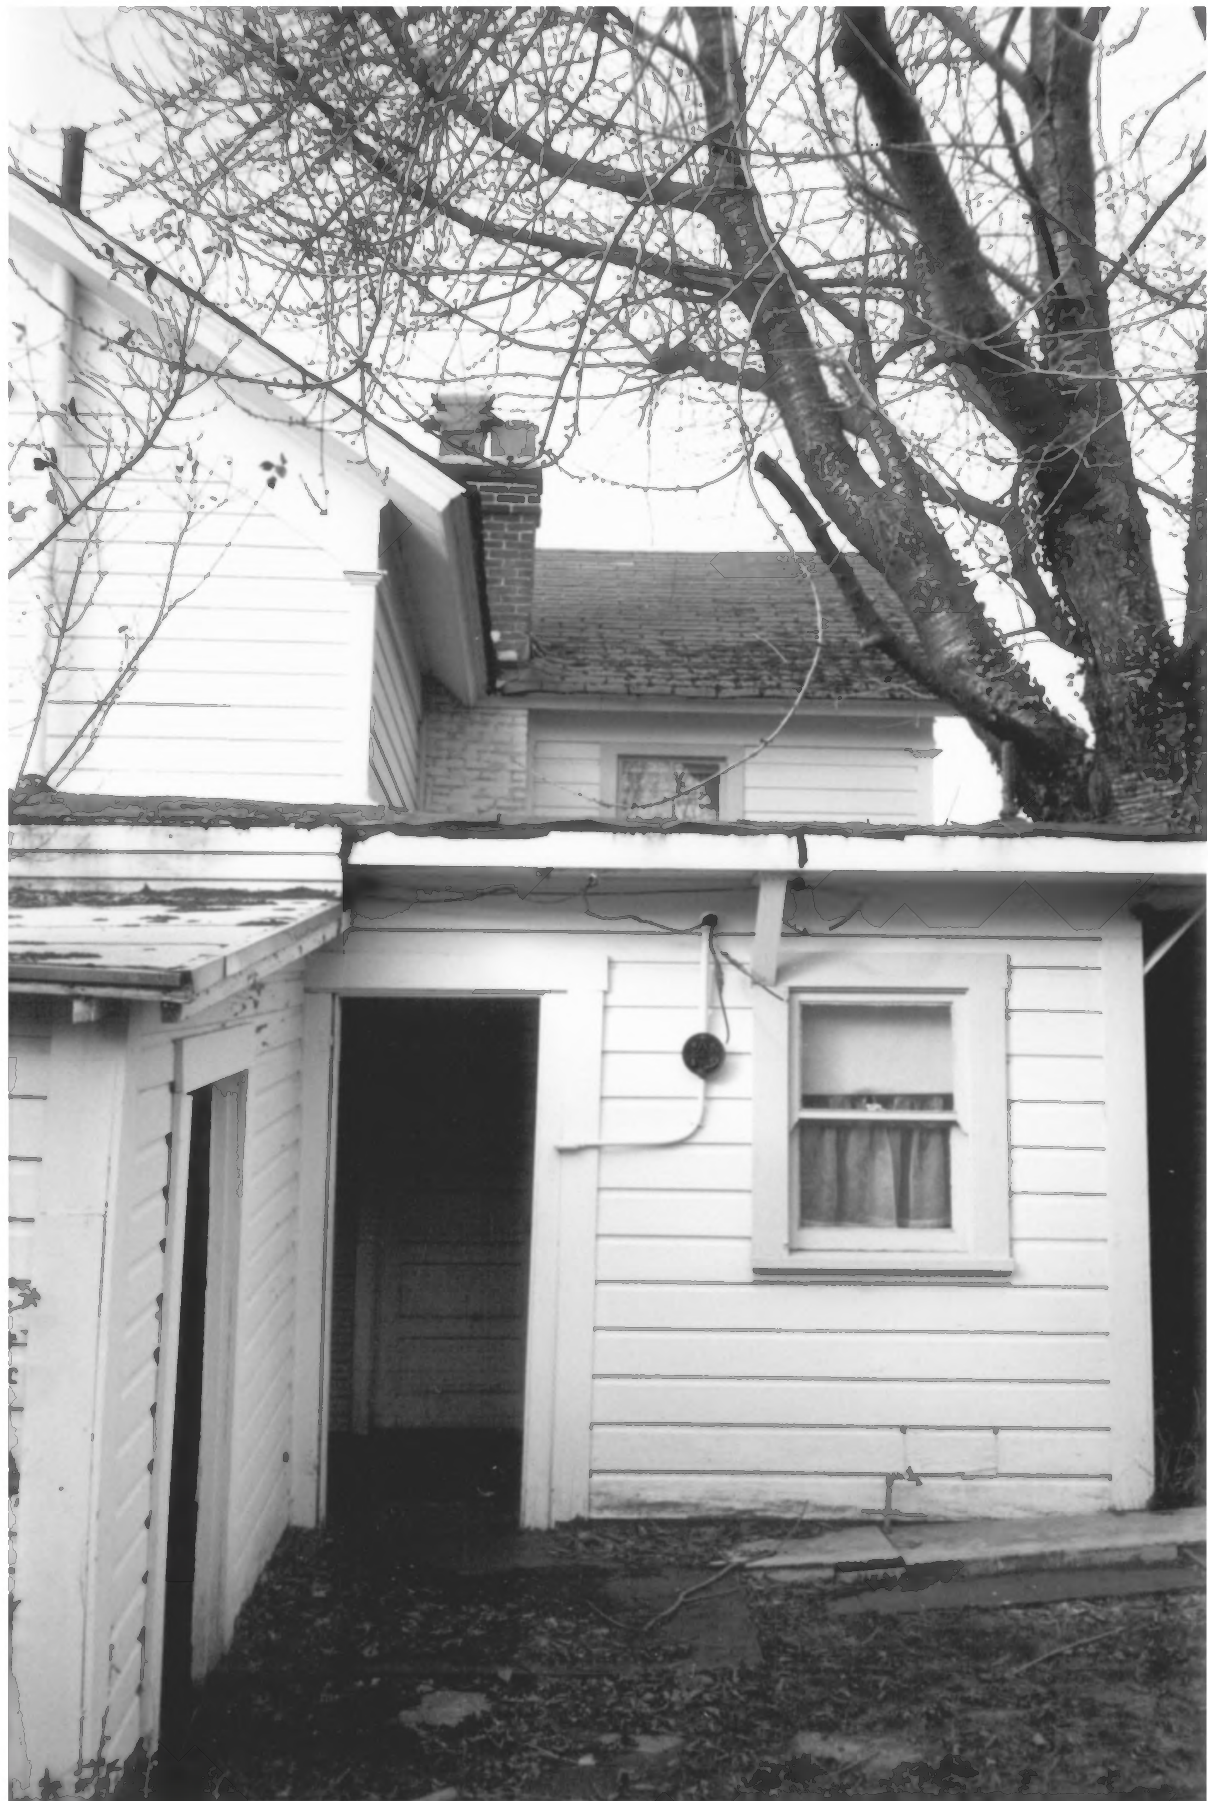
7 of 18

South elevation from south property line

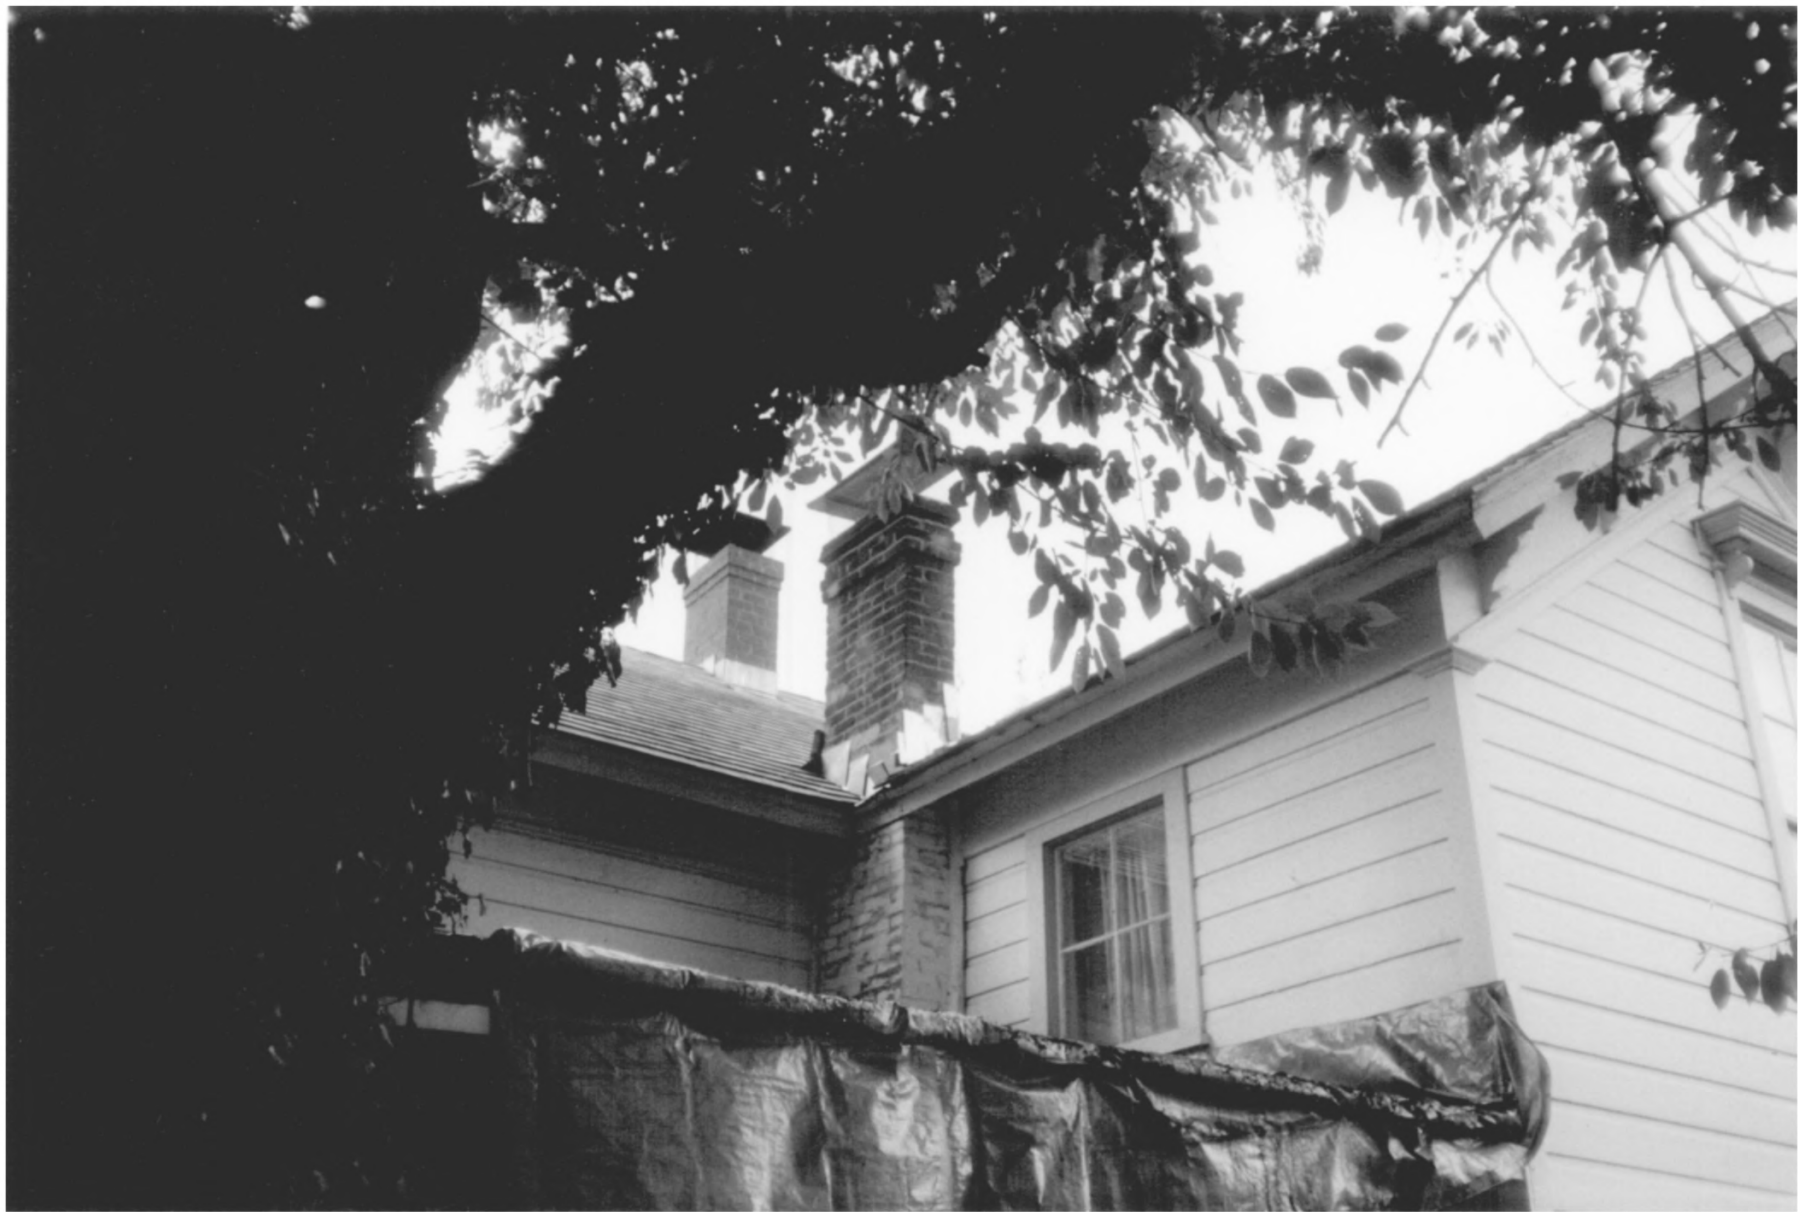
East and south elevation from east property line  
8 of 18
