# National Register of Historic Places Registration Form

historic name Sheffield, John and Sarah, House  
other names/site number Paraside Springs Farm

street & number 4272 SE Washington Street  not for publication  
city, town Portland  vicinity  
state Oregon code OR county Multnomah code 051 zip code 97215

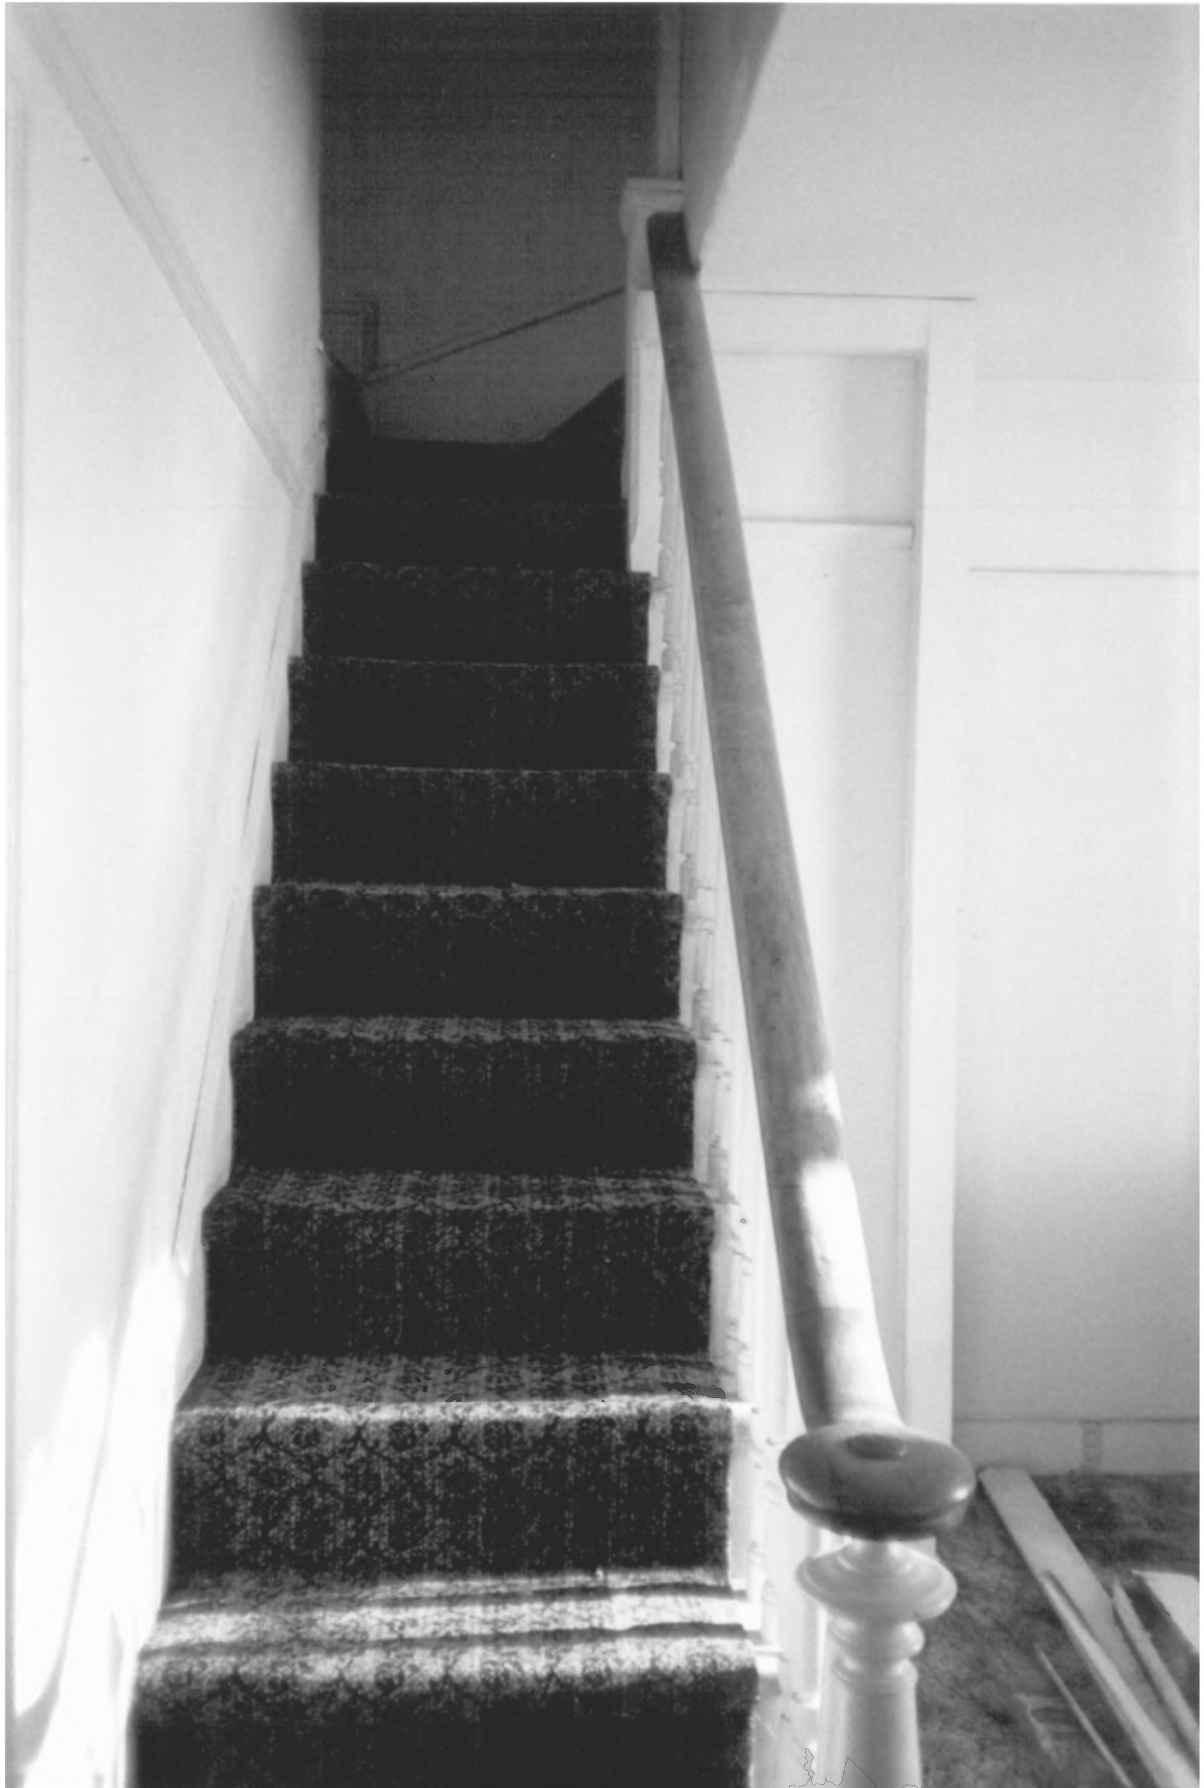
9 of 18

Staircase from just inside entry door

The staircase is directly in line with the front door, and 6' from it. It ascends in a straight line 12 steps to a very small landing from which two sets of steps lead to the bedrooms, which have doors directly opening from them. The handrail has been painted and then stripped. It is maple. The balusters and newel post were also painted, and most of this remains, except at the top of the newel post. Chips in this paint reveal that

the balusters and newel post are also maple. The condition of the entire staircase is excellent.

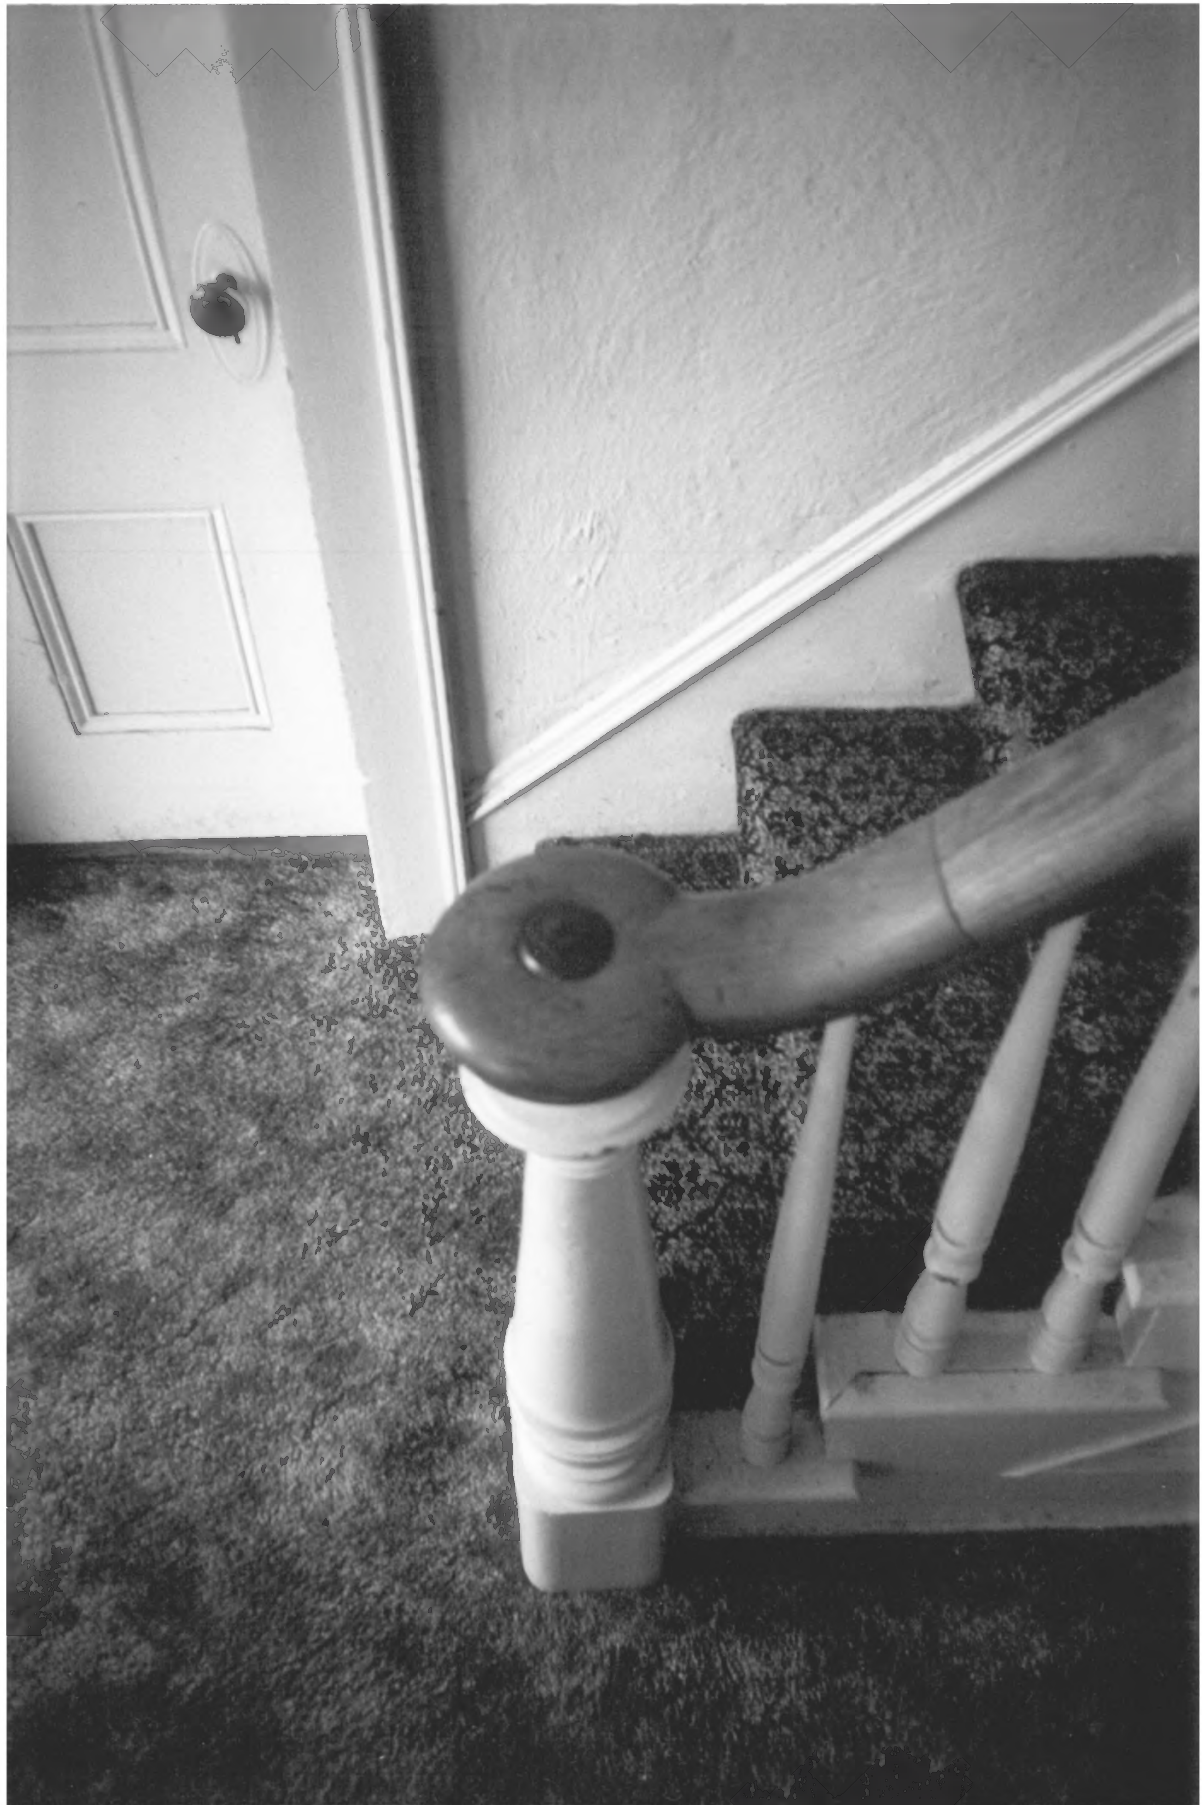
10 of 18

From 5' to east of staircase

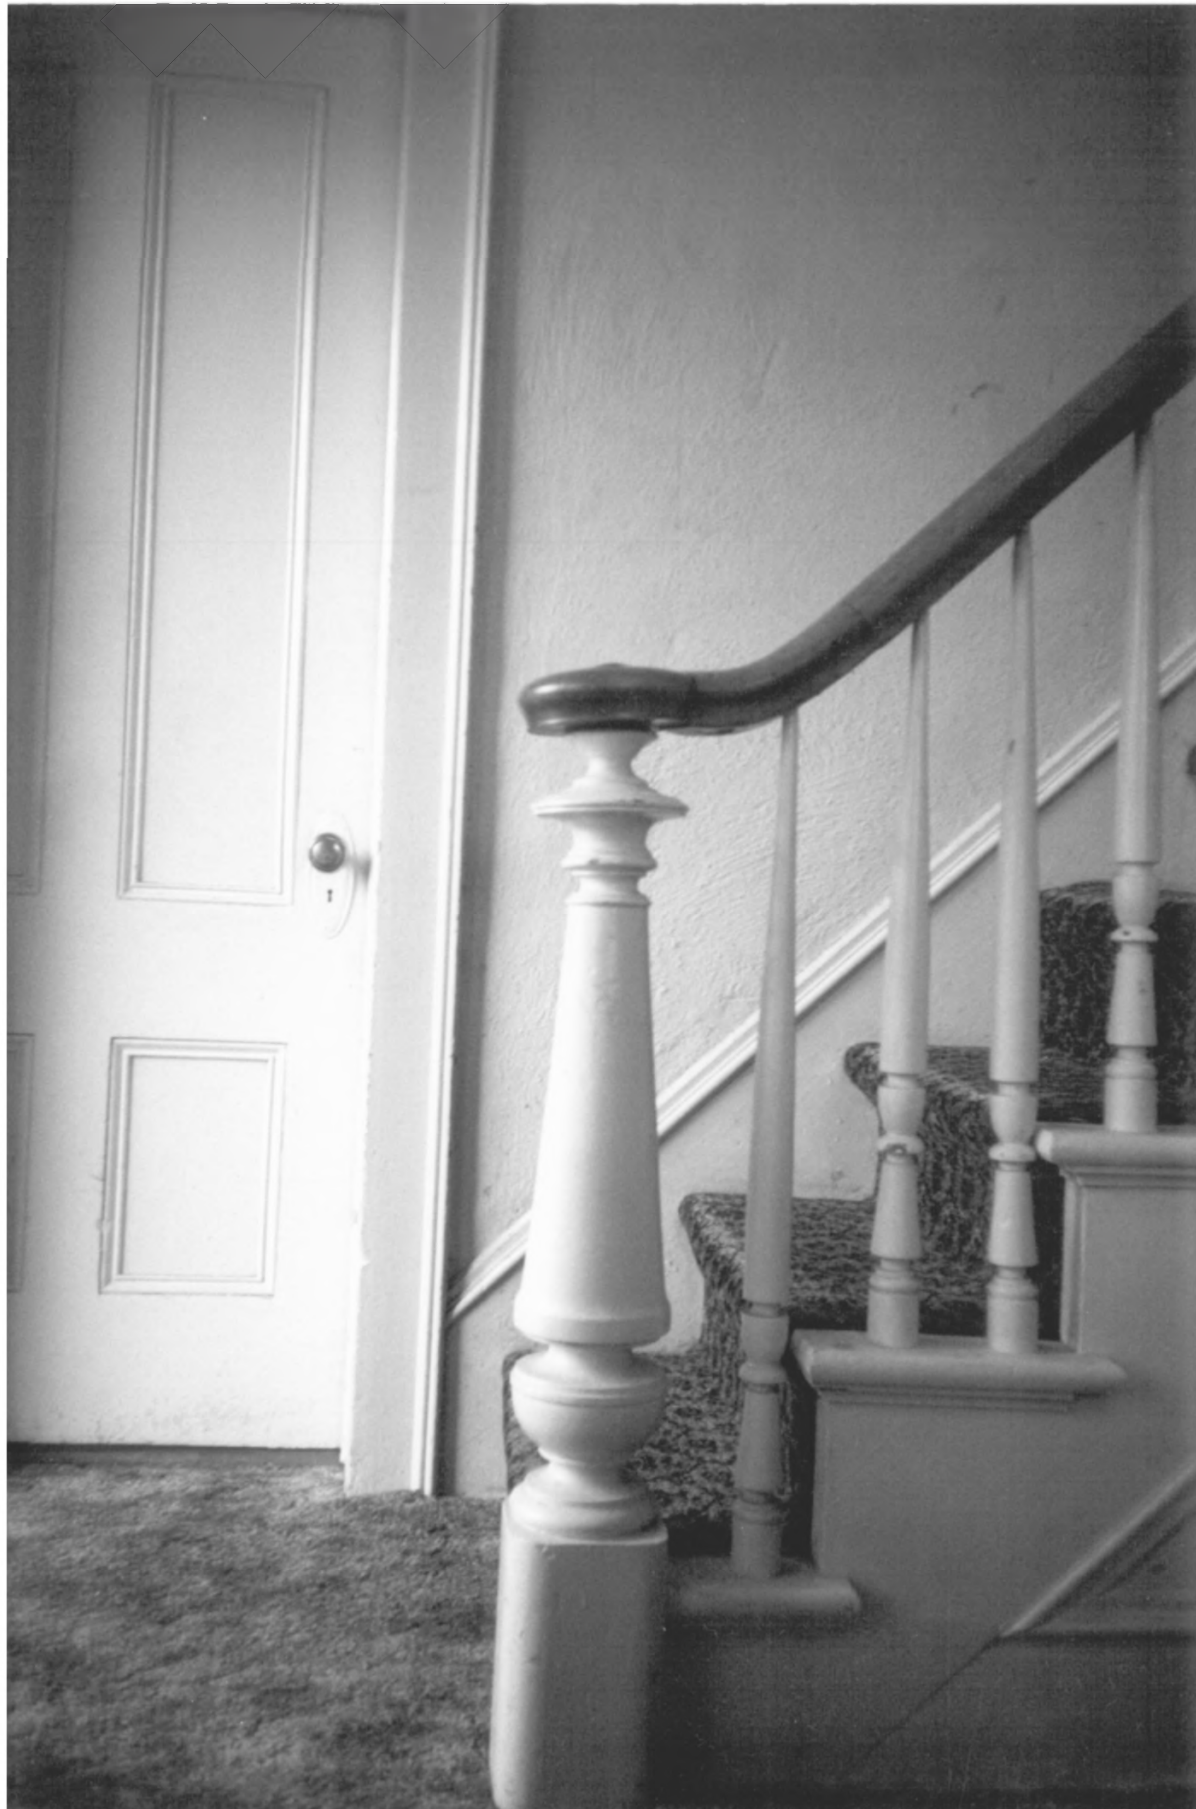
11 of 18

Staircase from 7' to east.

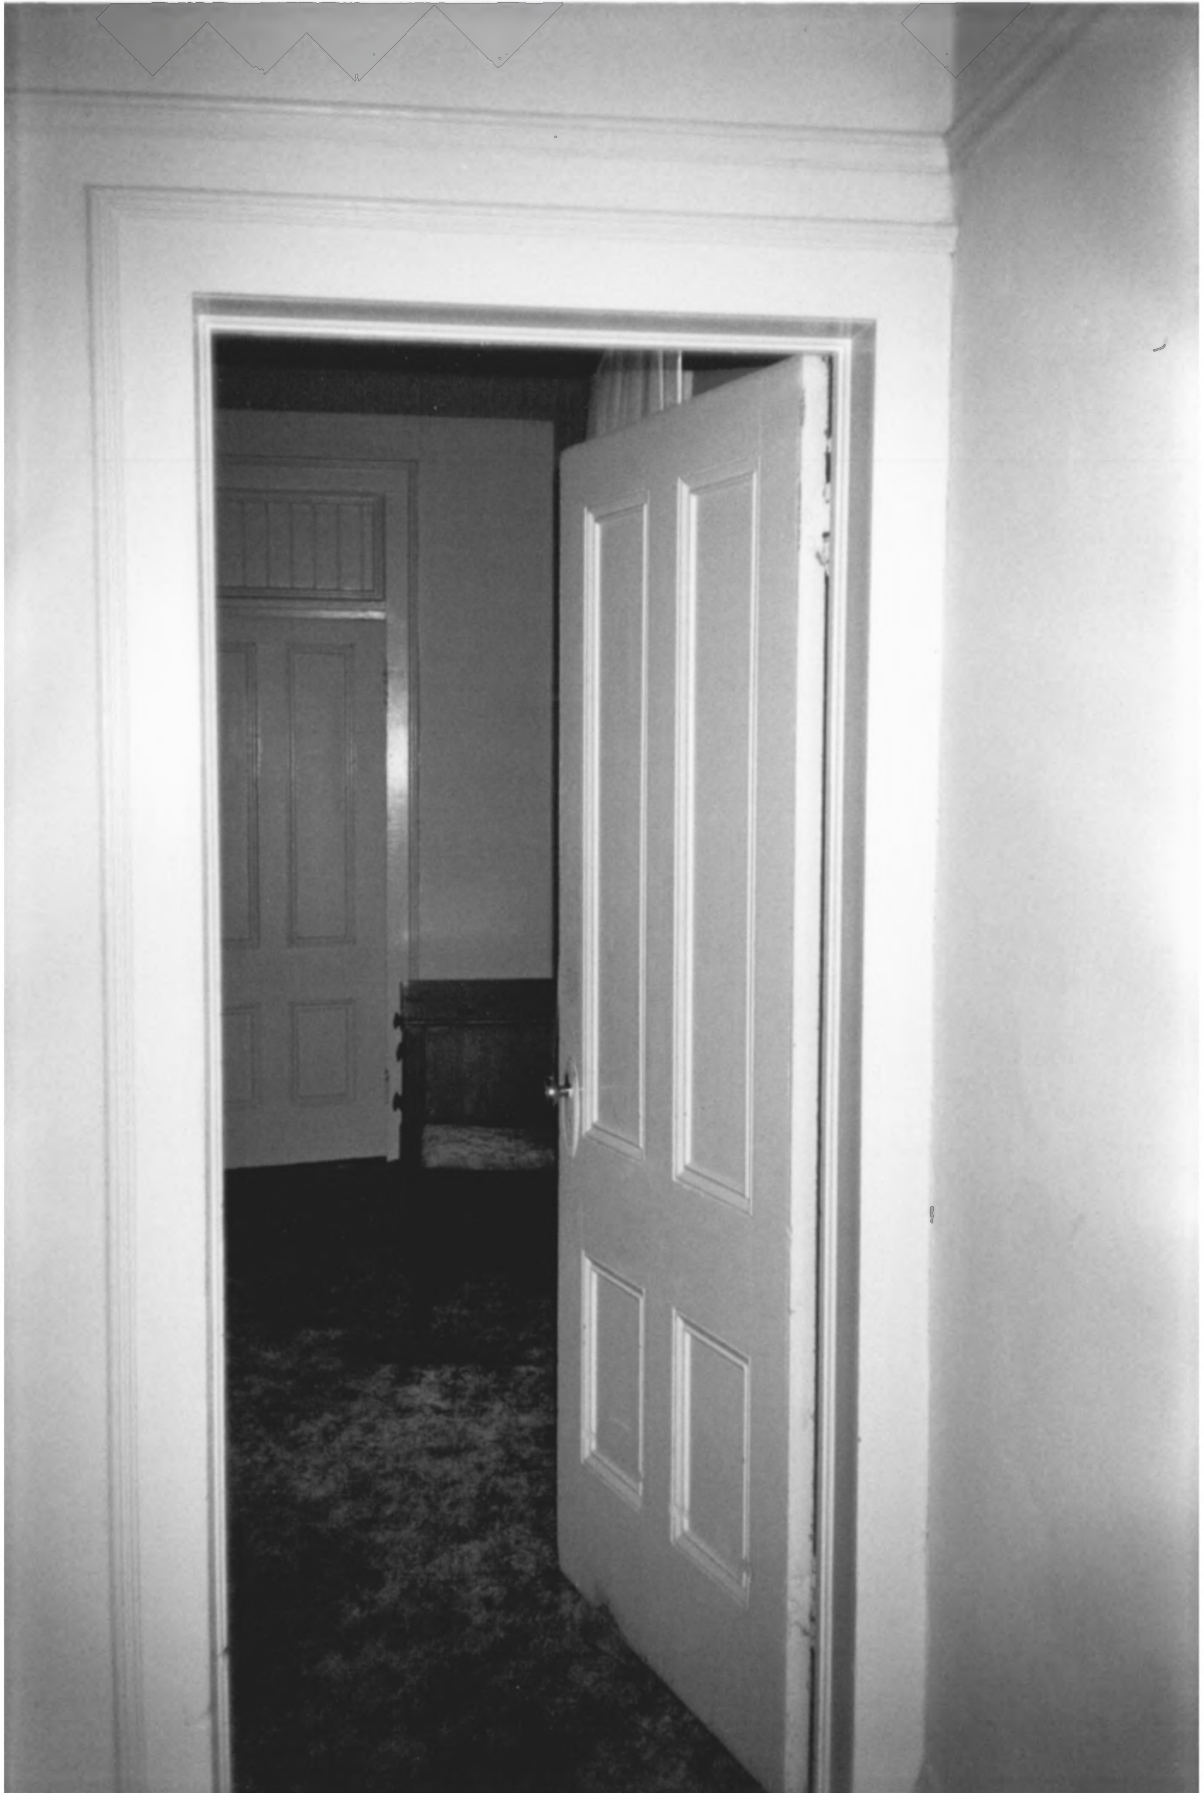
12 of 18

From Livingroom south through dining room

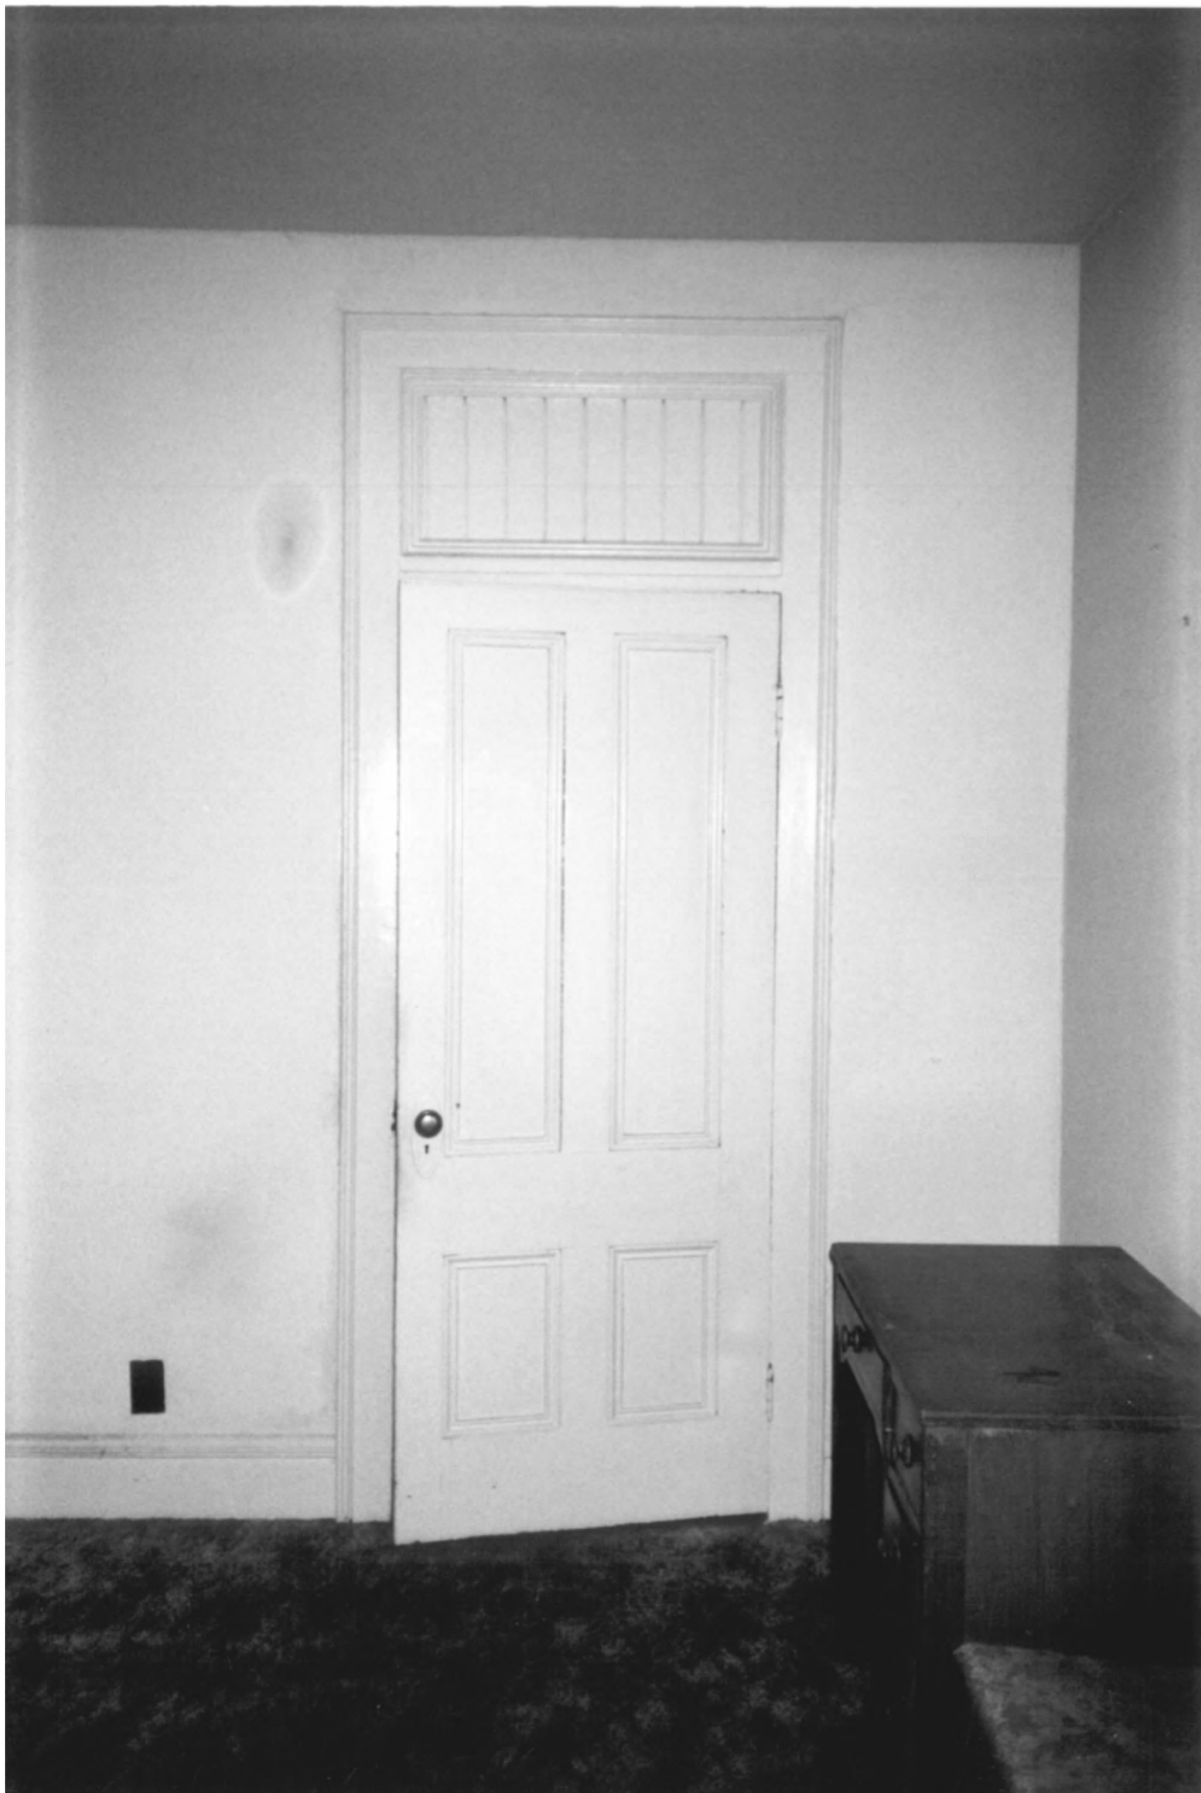
13 of 18

Original rear door with transom

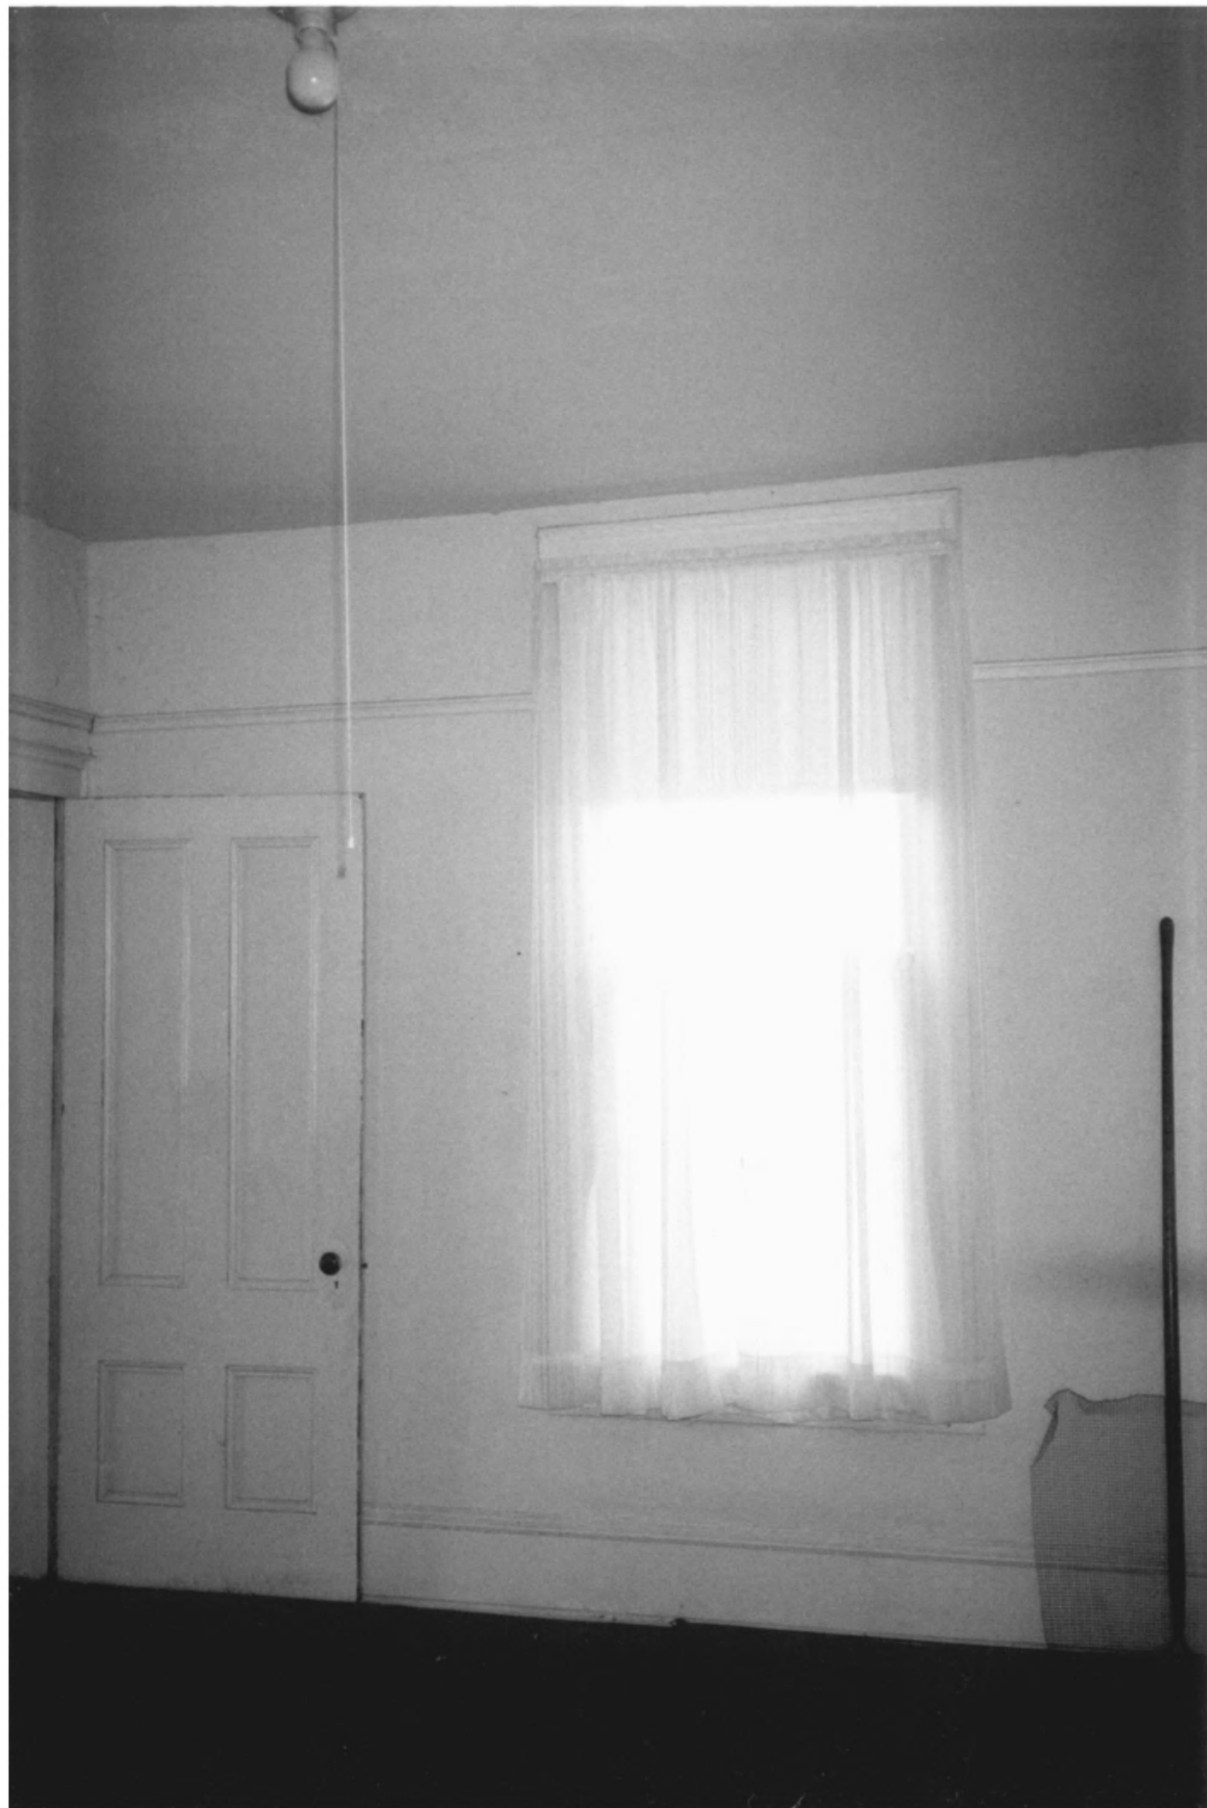
14 of 18

Window and door on first floor of east-west gable  
facing north.

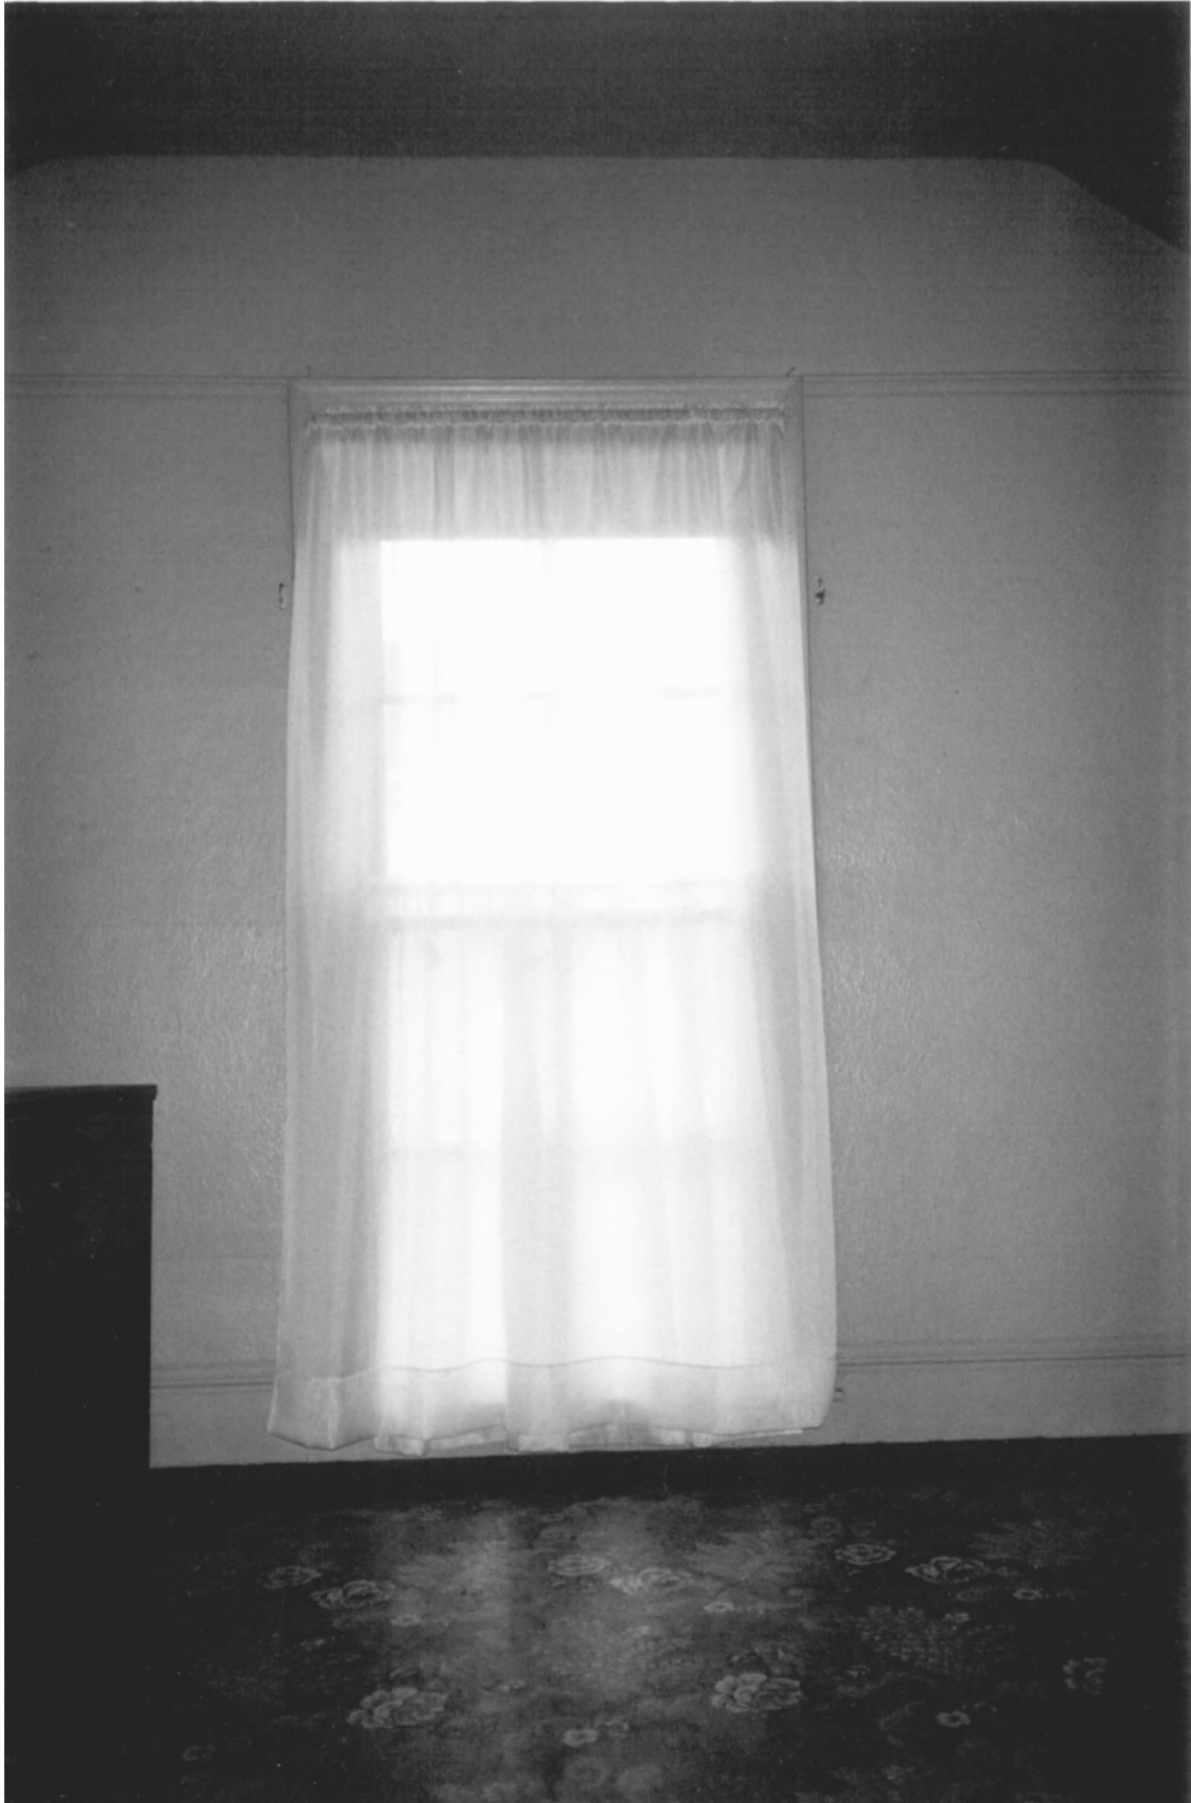
15 of 18

Window in second floor room of north-south gable.  
Facing north

The original windows are sliding sash, four over four, with narrow muntins and, in nearly every instance, old wavy glass with many air bubbles.

All windows and windowframes are original and are in good condition although painted shut. All were constructed without ropes or props, and are held in several open positions by means of a spring pin which fits into the frame through the stile, holes having been drilled into each part. The downstairs windows are 81" and the frame is directly below the ceiling. The sills are 26" above the floor. The upstairs windows are, in the east-west gable, actually floor to ceiling, and in the north-south gable reach from the floor to within 8" of the ceiling. They are very important in contributing to the overall effect of the rooms.

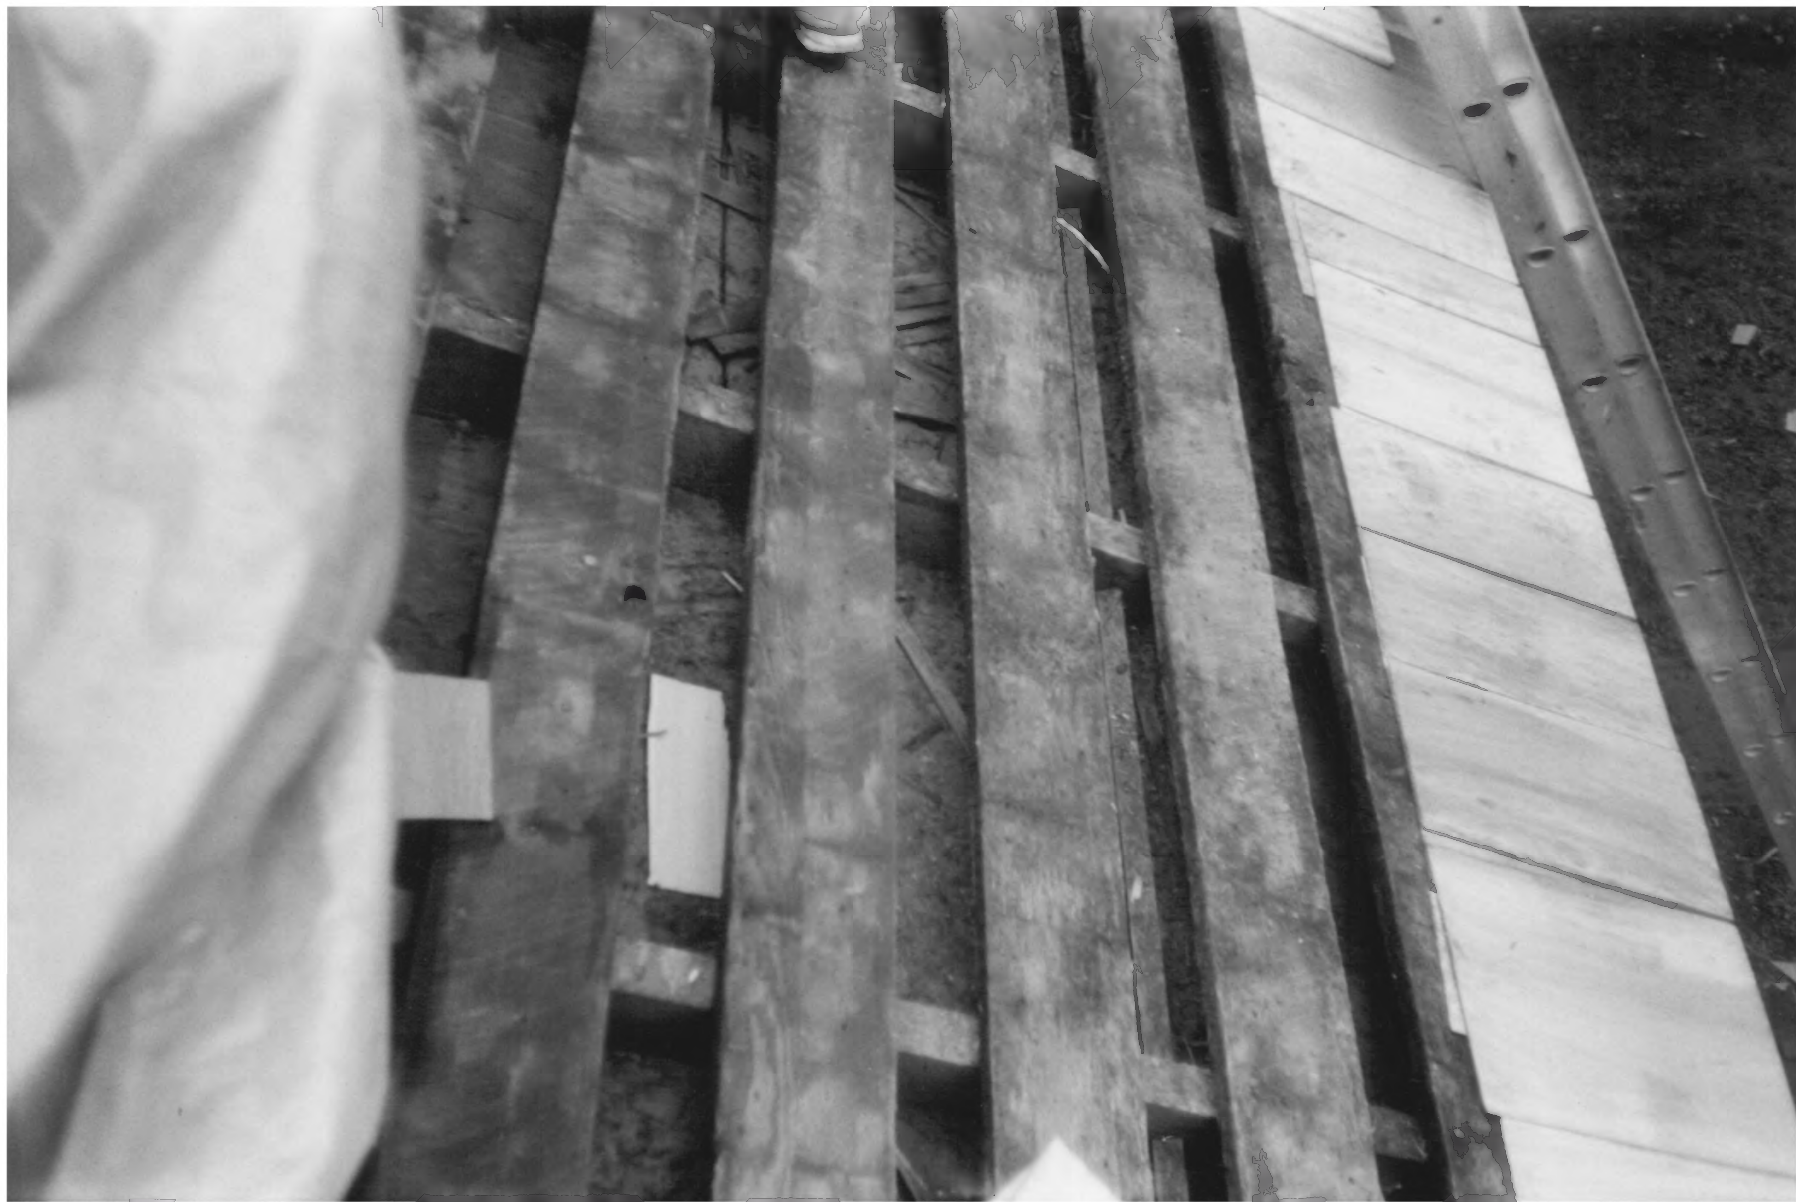
16 of 18

Rafters exposed during reroofing, north-south gable. From west

When it was acquired by the present owners in 1989, the house had a worn-out roof consisting of 5-7 layers of asphalt shingles. After the chimney repairs were made, it was apparent that the original roof had been cedar shingle. A professional roofer specializing in these roofs was found to instal a replacement. When all the roofing had been removed, photographs were taken. The rough original lumber was approximately 5" wide, 1 3/4" thick, and spaced nearly 3" apart. There

was no filler of any kind between the roof and the lath of the ceiling below. The attic space was at the maximum 18".

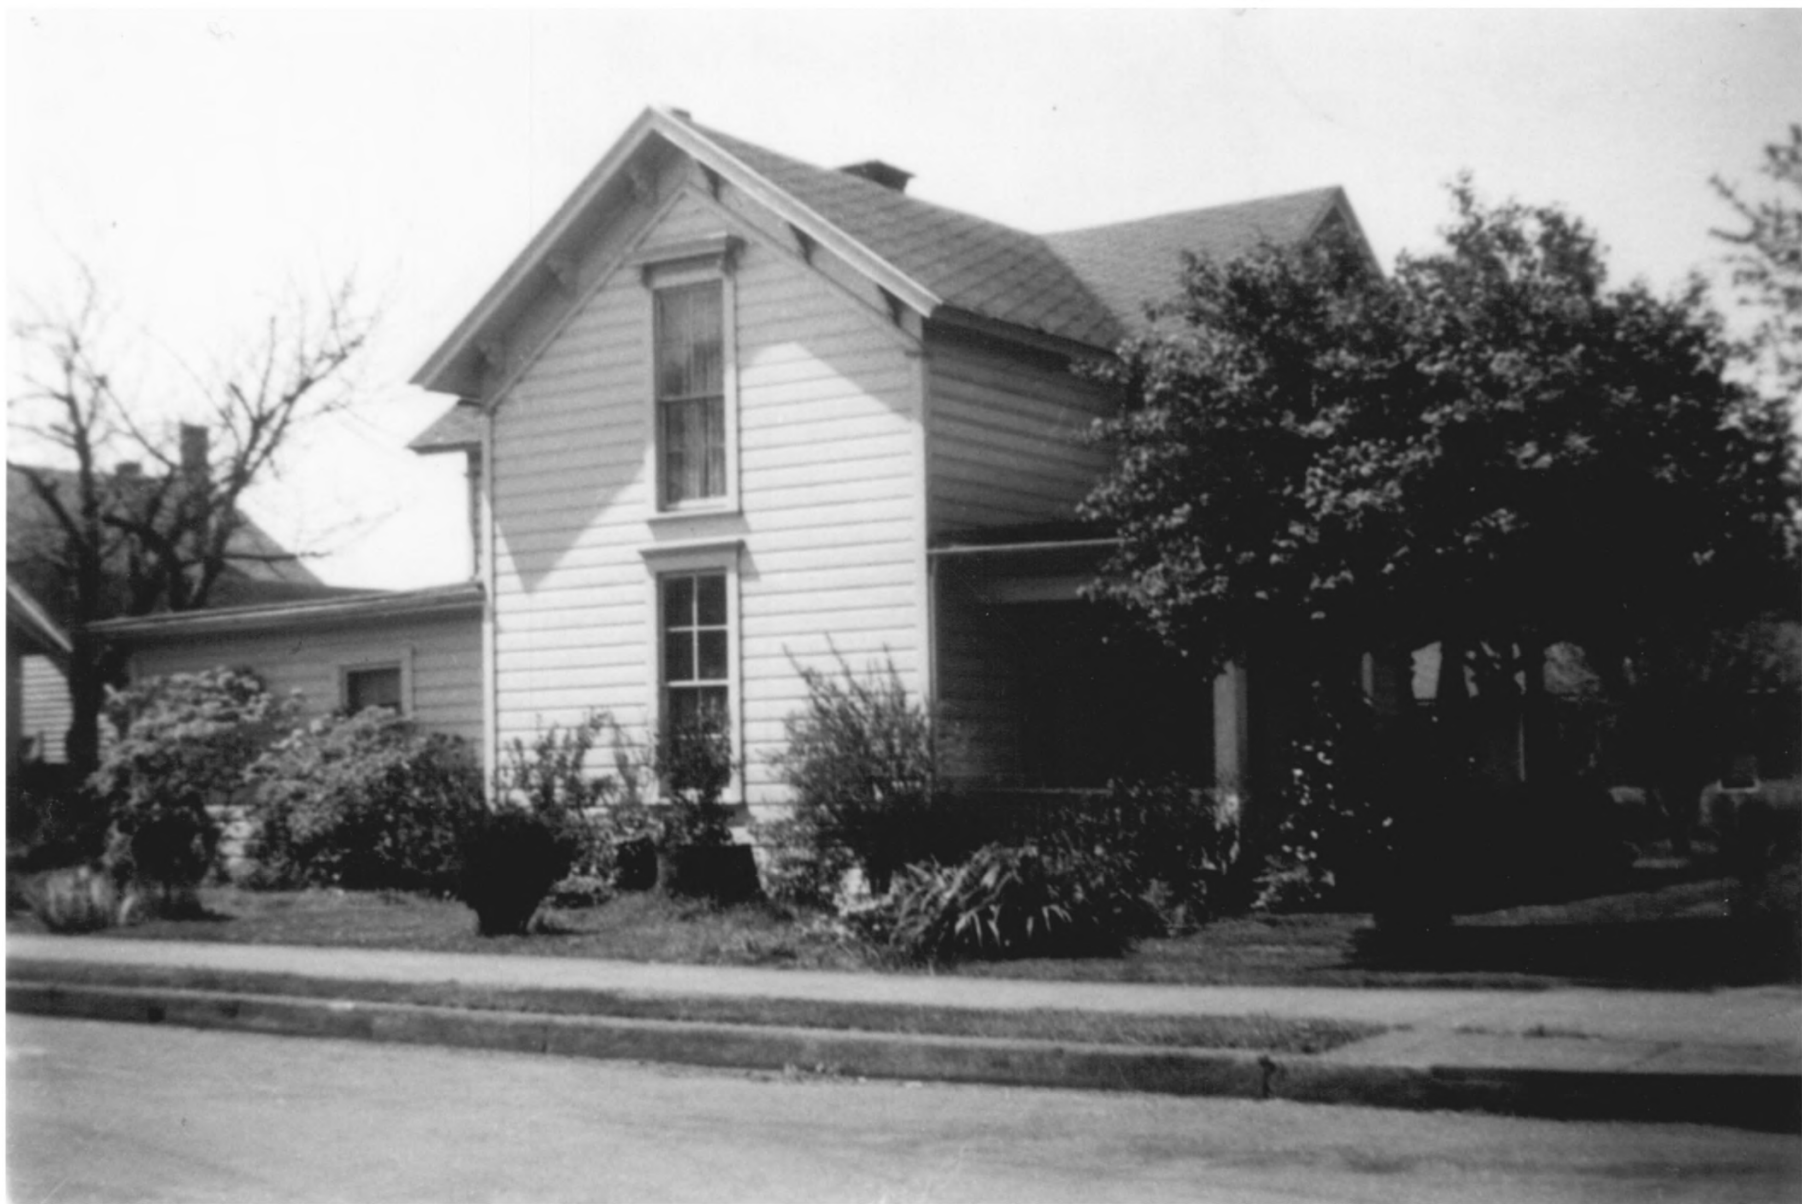
17 of 18

North and east elevations from S.E. 43<sup>rd</sup> Ave.
