**National Register of Historic Places
Registration Form**

historic name Johnston, Andrew J. and Anna B., Farmstead

JOHNSTON, ANDREW J. AND ANNA B., FARMSTEAD (1898-1920)

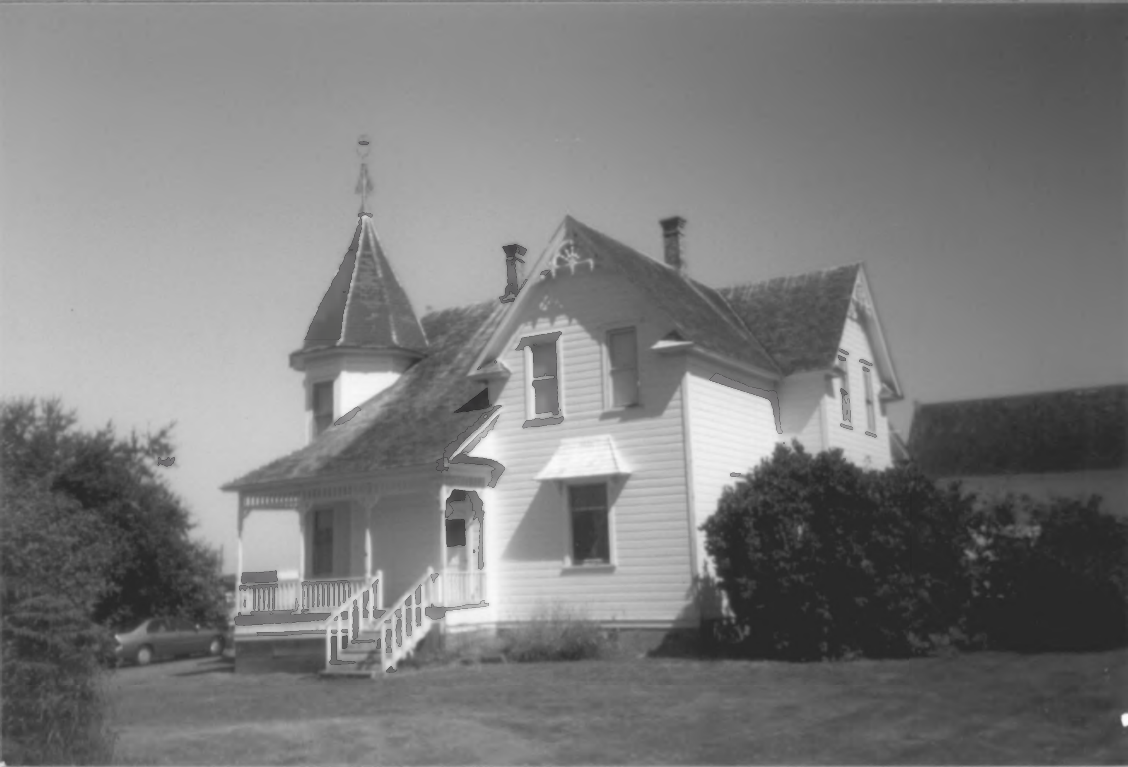
#2 OF 19

South view of house

The primary dwelling is a two-story Queen Anne in good condition. It has the characteristic asymmetrical floor plan, approximately 36' wide by 43' long. It rests on a post and beam foundation, which has been recently supplemented with concrete block and rebar around the perimeter. This alteration replaces the original wood apron scored to mimic stone block. The only basement is a root cellar under the kitchen.

The main entrance is a hip roof front porch supported by chamfered posts. There are Eastlake brackets and a spindlework fascia and balustrade. This leads to a chip glazed, single light, horizontal decorative raised panel front door with a single pane clear transom light. Opposite the east end of the porch on the first story bay is a one over one window covered with a cedar shingle mansard-shaped hood supported by brackets and detailed with cutwork trim. The clipped cross gable roof is cedar shingle with partial return on frontal gable with a frieze. There are three finely detailed chimneys recently repointed. On the west end of the front porch is a two story polygonal bay window. This develops in the second story as a polygonal full-height turret with tent onion-shaped roof with composition shingles and metal trim. The turret is detailed with a wooden scroll finial at the peak.

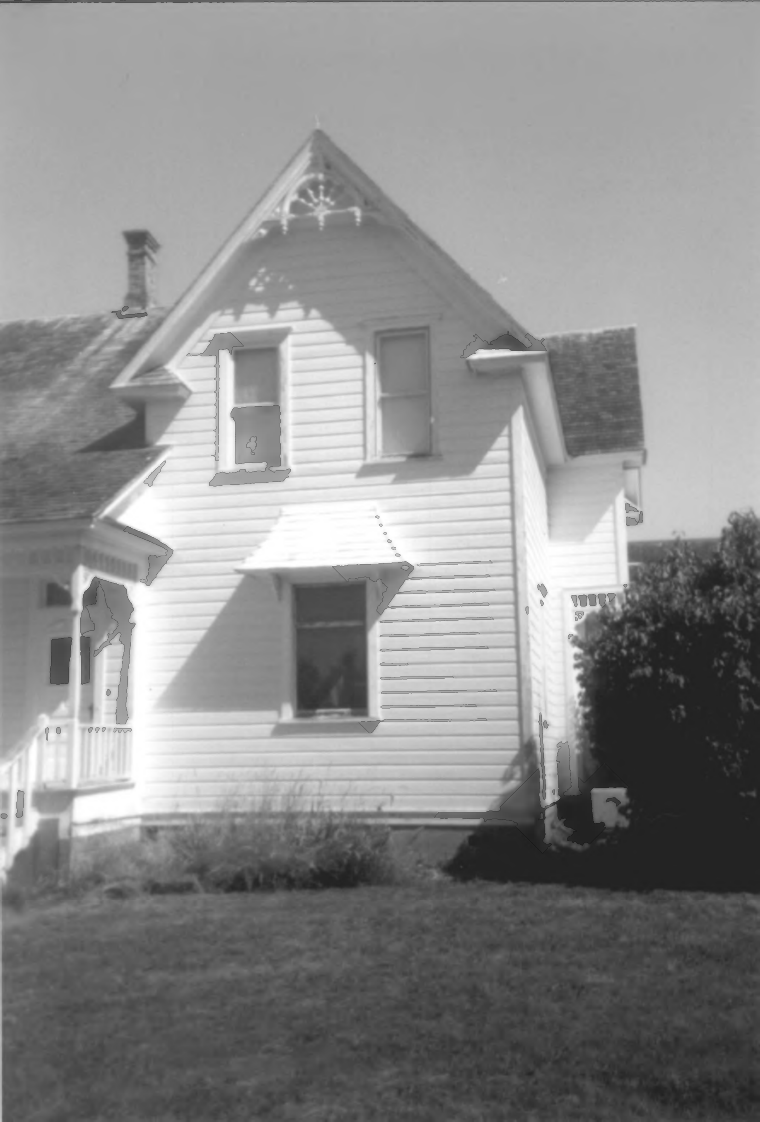
#3 of 19

bay on south facade

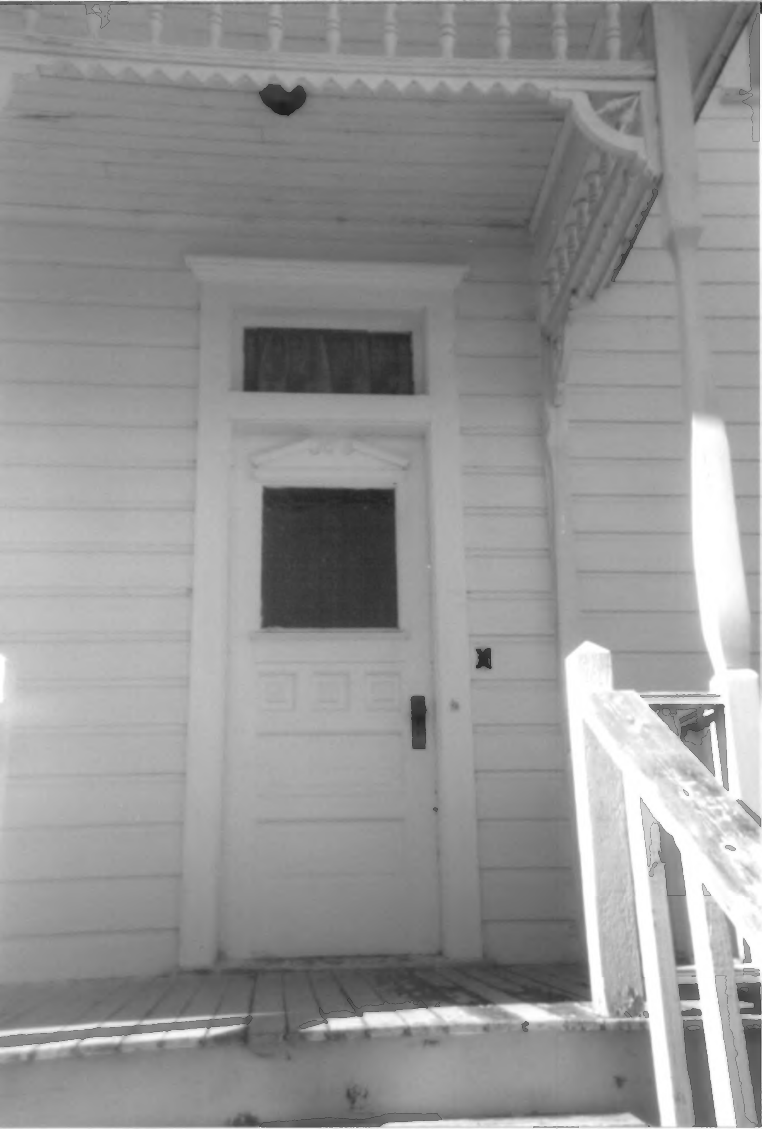
4 of 19

detail of front door on
south facade

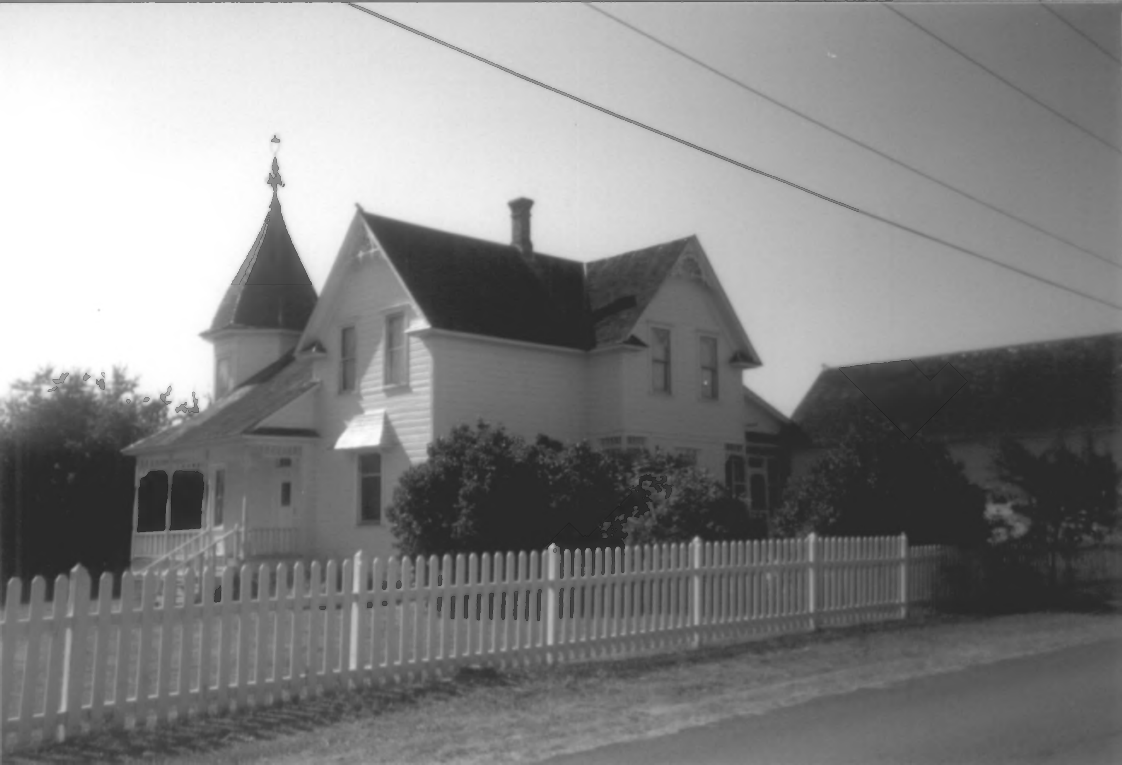
#5 of 19

east facade of house

The east side of the house is detailed by a projecting bay. The first floor has canted walls, sandwich bracket window hoods. Other bay details include eave returns, corner boards, and gable eave collar beam with "half wagon wheel" shaped beaded spindlework. Additional gable spindlework is located on other three bays on north, south, and west facades. On the east side of the kitchen is an enclosed porch, which connects to the woodshed, or by pocket door to the back yard. The cream separator room is located on the porch but is accessed by a four panel door from the kitchen. A one-over-one window is opposite the cream separator door.

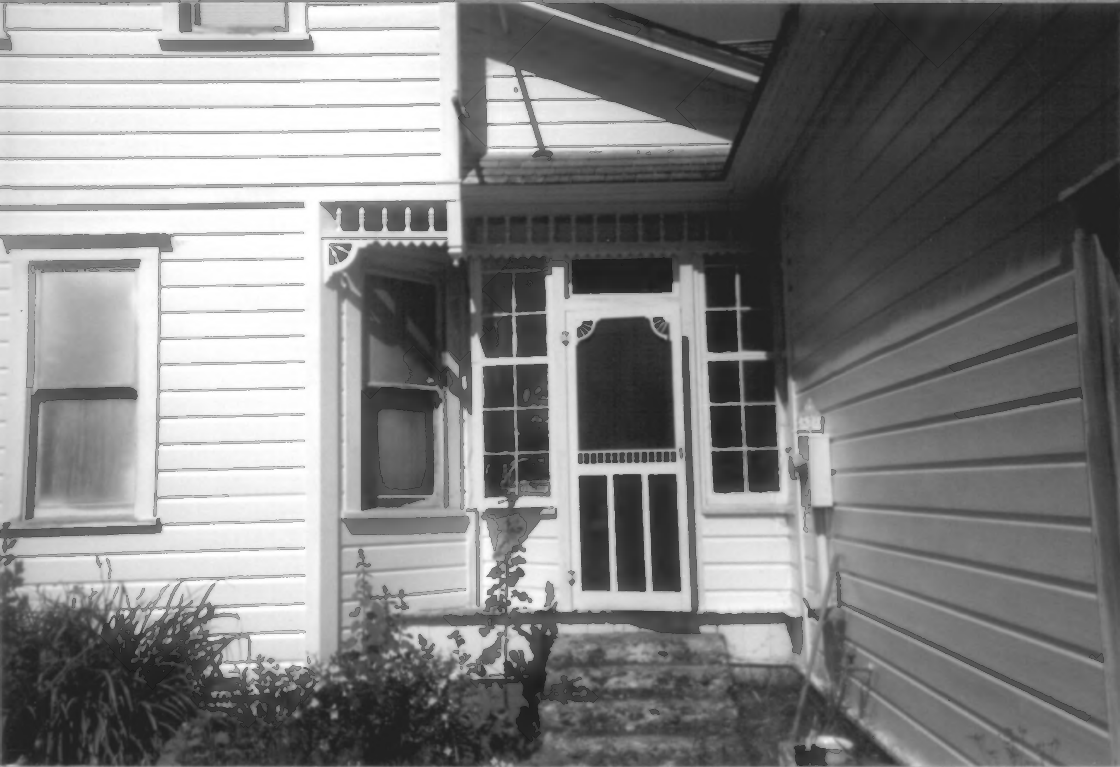
#6 of 19

detail east kitchen porch

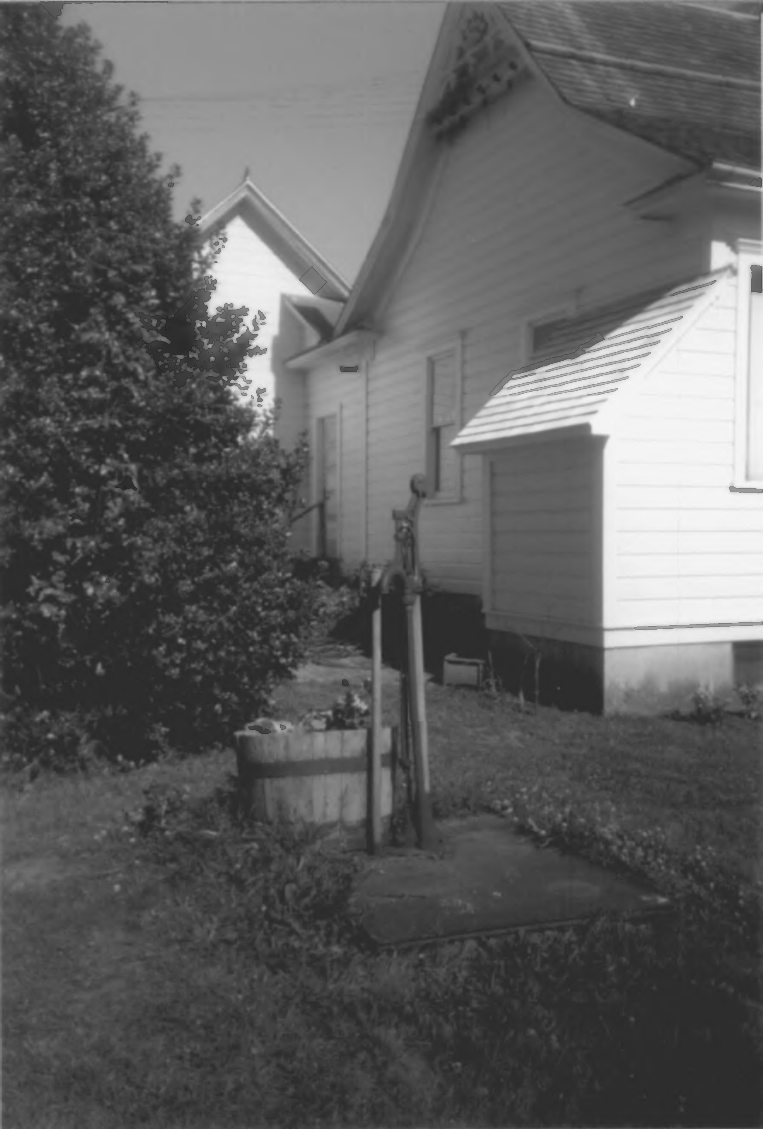
8 of 19

well + pump

This complex encircles a small group of six fruit trees planted in 1907, as part of the kitchen garden area. There is a hand-dug, brick-lined well just outside the west kitchen door that provided water for the home. In historic photographs, a wooden rail fence surrounded the immediate home and yard, with a picket fence in the back yard. A new wooden rail fence has been put up on the same fence lines, restoring use of a wooden fence, but adding lattice work to create privacy and security to the back yard. A picket fence has been added to the front yard in line with the original configuration of fencing.

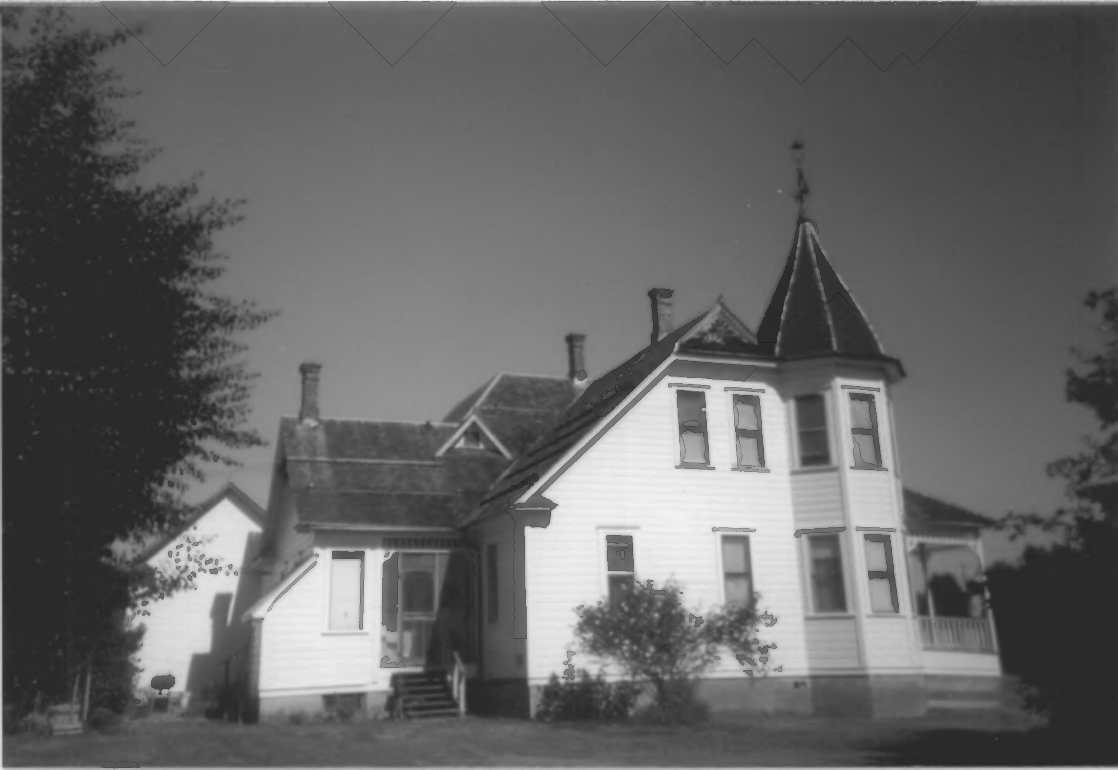
#9 of 19

West view of house

On the west end of the house, off the kitchen there is a small single bay, hipped porch.

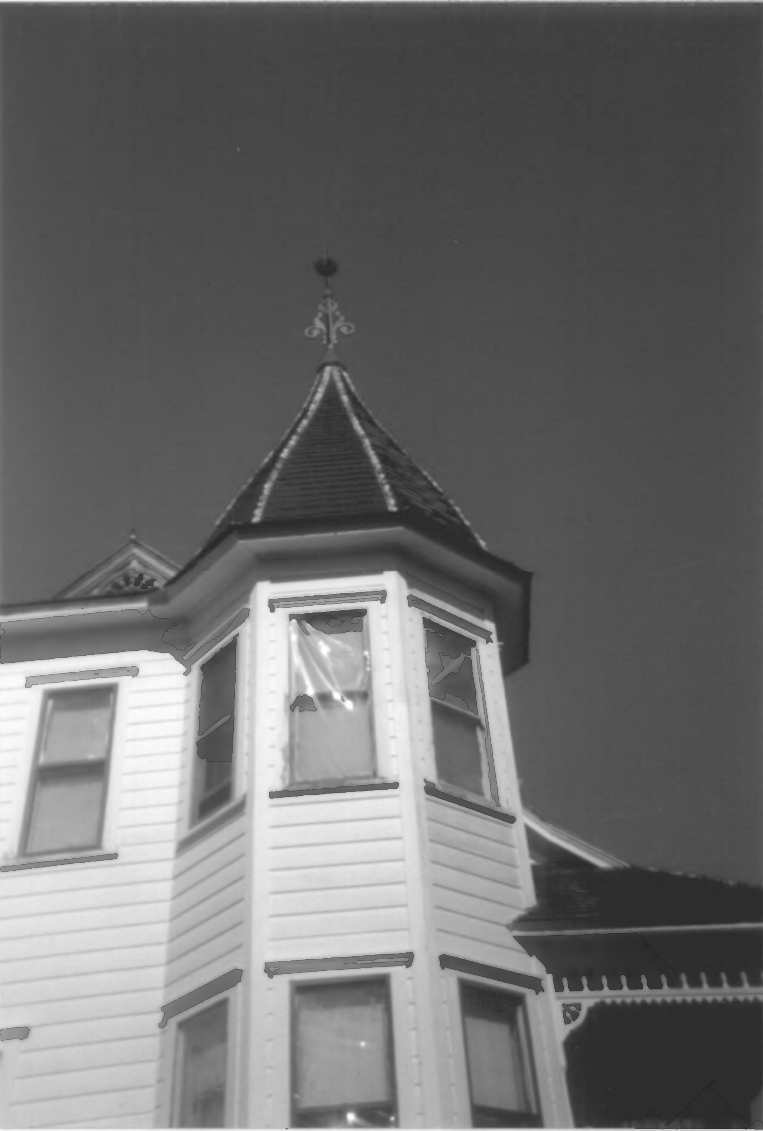
#12 4-12

turret

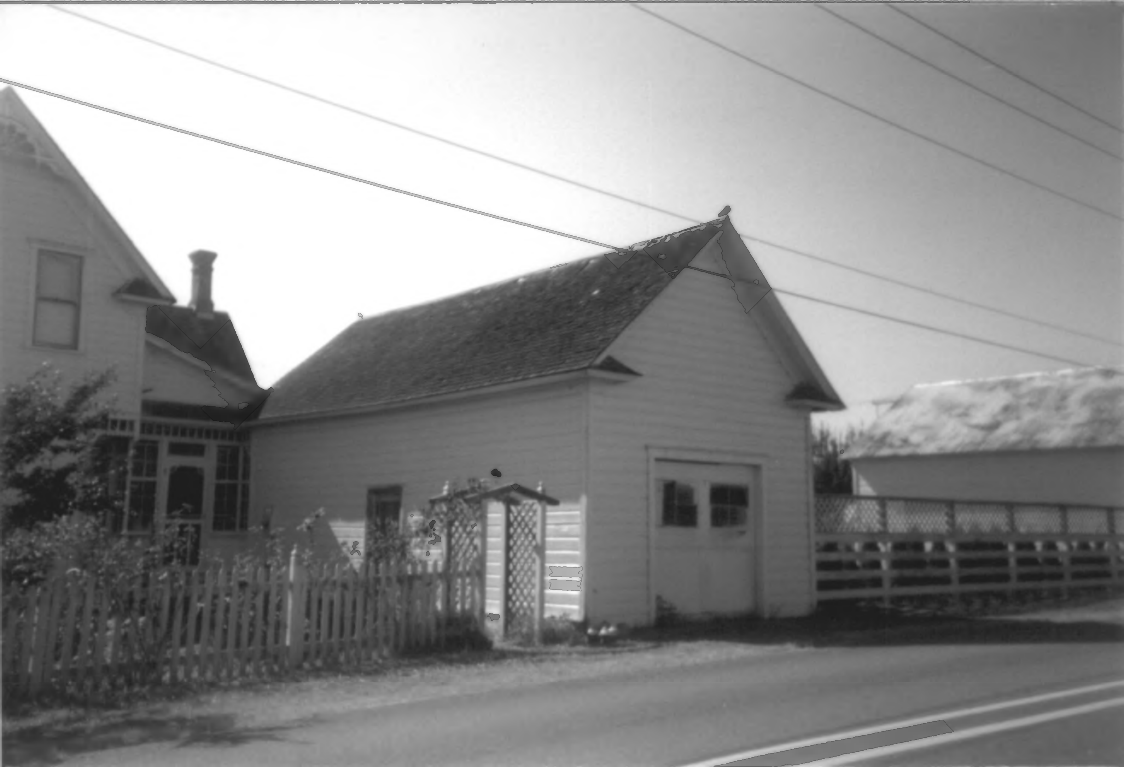
#11 of 19

South + east walls of wood shed

The woodshed (c. 1914) is approximately 16 x 32 with a shingled gable roof. The original garage door is on the east facade and is counter-weighted to lift overhead. It has two vertical panels below and obscure glass panel above. It faces east/west and is attached to the NE corner of the house with the shared porch area.

Restoration includes a new shingle roof, restoration of the foundation, adding a cement floor, and repairing weathering of the rafters. The building will be painted to match the house and have gutters replaced or repaired if possible.

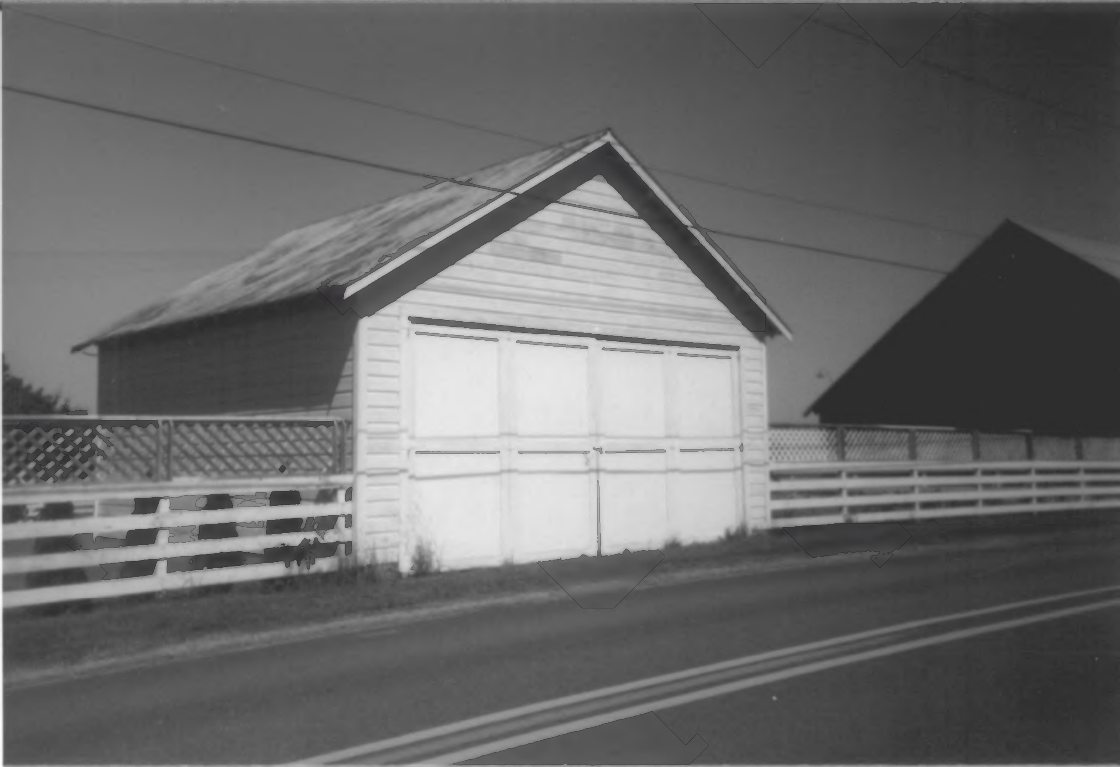
#12 OF 19

South + east walls of
machine shed

The machine shed (c.1920) is single story that faces east/west and is approximately 24 x 26. It has a gable roof covered with galvanized roofing. It has house drop siding and double doors that hinge (bi-fold) on the east side.

This building will be painted to match the house, and gutters added.

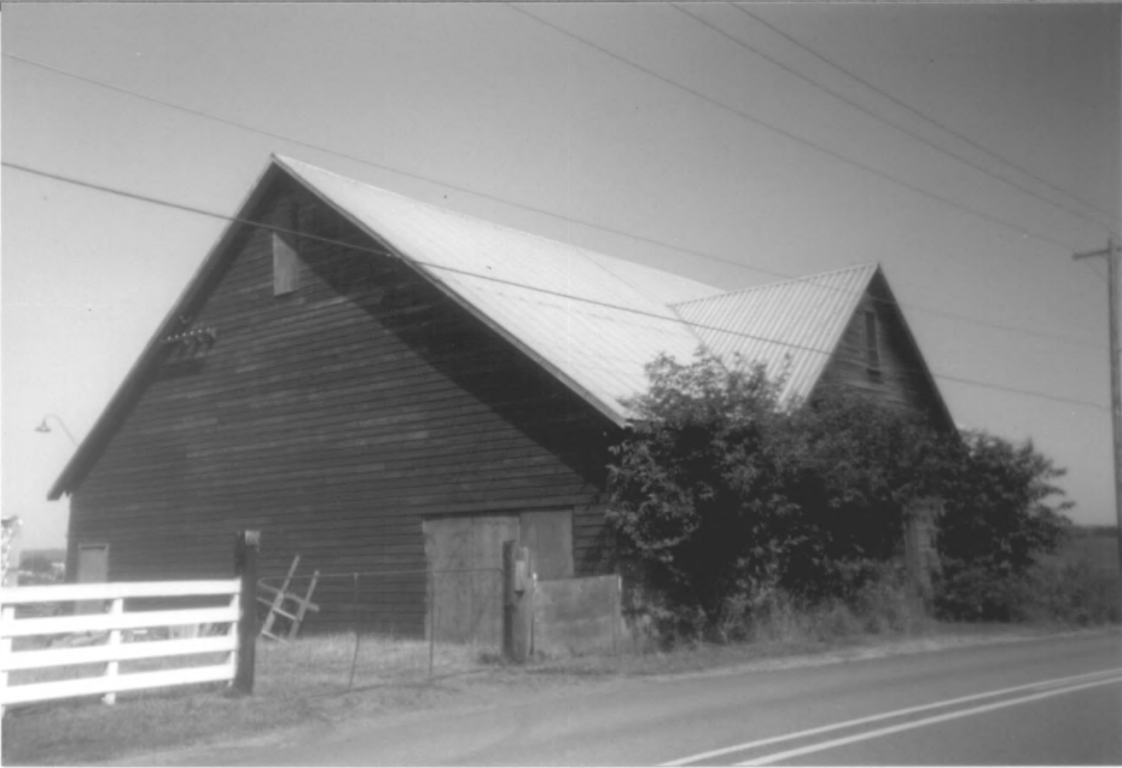
13 OF 19

South + east facade of barn

The cross gable Western barn was built in 1898 and is approximately 40' x 60'. The barn has a cross gable roof with central gablet and double 12' sliding doors on the east and west walls for central side entry drive through. The east and west walls also have four double hung sash windows each. The main gable facades, north and south, have the hay lofts, with the hay fork track full length of the barn. There are small 5 x 8 access doors at each corner: NW corner for cattle, NE for horse stalls, and southern corners for work areas. It has house drop siding and the original hand

split shingles were replaced by galvanized roofing. The wood was milled at a local Redland mill except for the hand-hewn 8' x 8' purlins which are 60 feet in length and all one piece. The beams are 8' x 8' with mortise and tenon joints. These are held secure with two one-inch hardwood dowels (oak?) approximately eight inches long. The missing element is the central roof ridge cupola, square in plan, louvered, and pyramidal capped.

Because the roof was deteriorating, the beam work was exposed to the elements and rot was developing. Restoration is in progress to replace rotted areas. Galvanized roofing has replaced original shingles. The 8 x 8 was reset onto the foundation stones and the barn was straightened and secured in place by new siding on the south side. The windows and cupola will be replaced in kind, with the help of original photographs. Though it was originally painted green, the owner and builder wanted it red, according to the son. It will be painted red, to match an original tinted photograph in the home. Horse stalls, loft, and cattle stantions will also be restored.

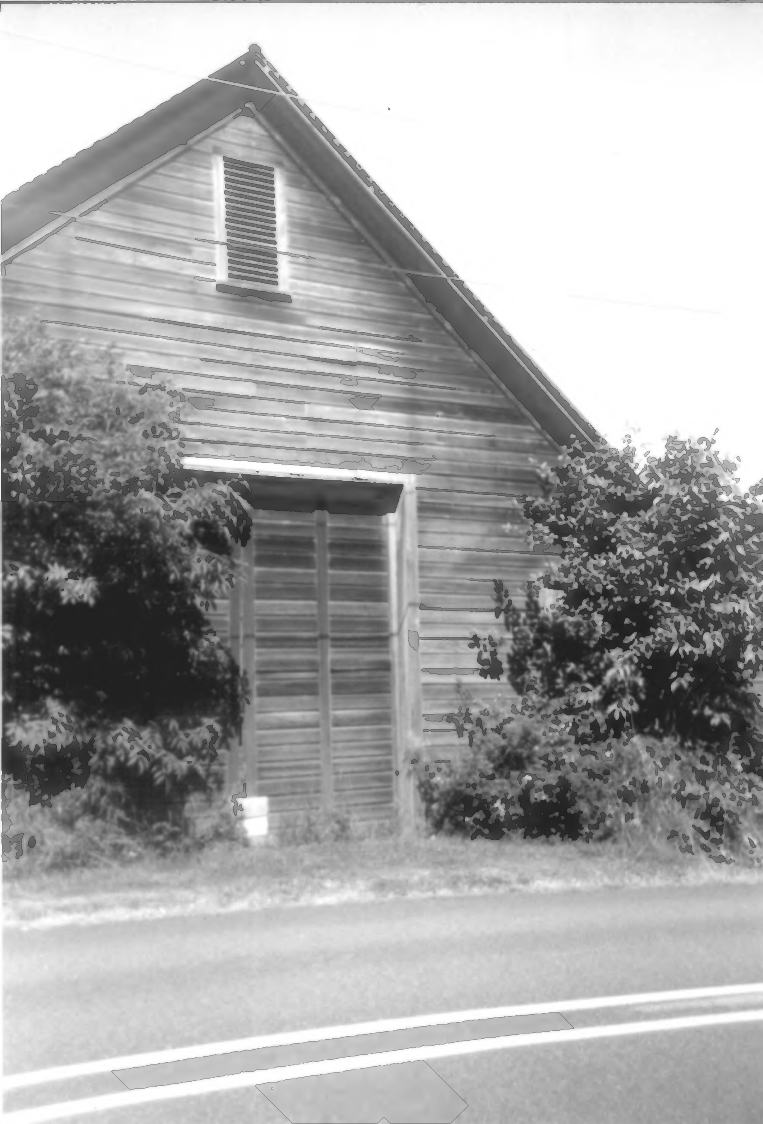
#14 of 19

detail of door
detail of door on barn
east wall

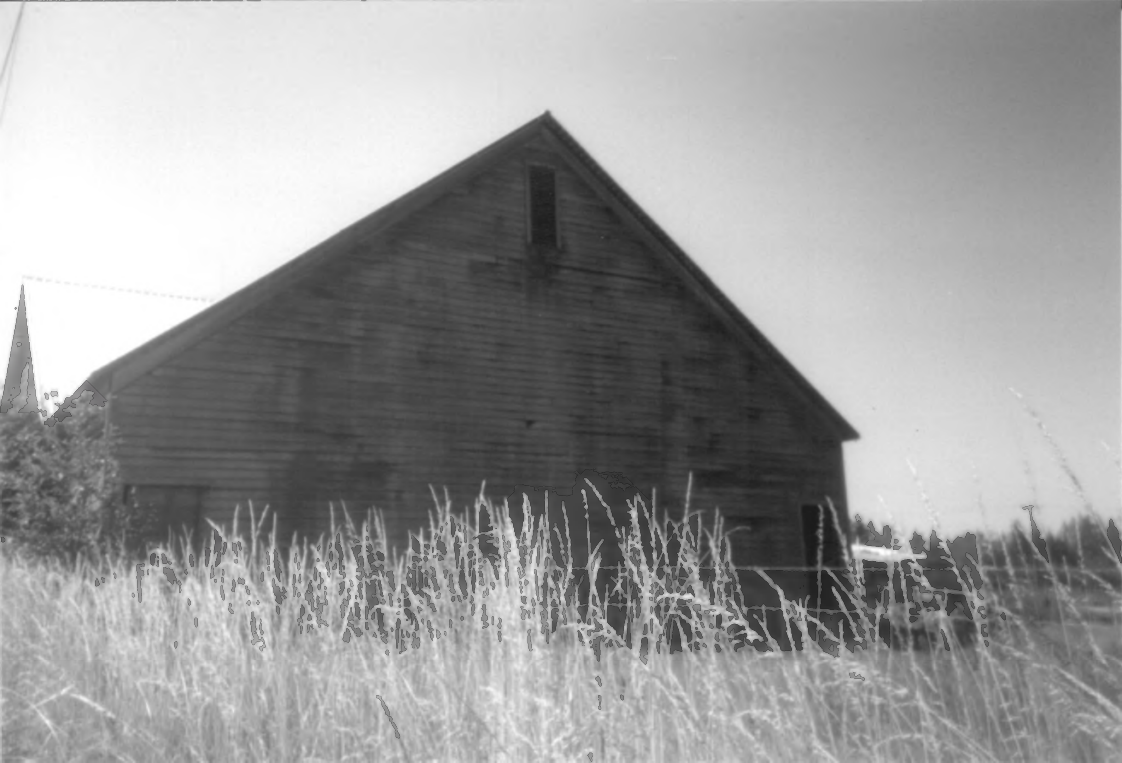
15 of 19

north facade of barn

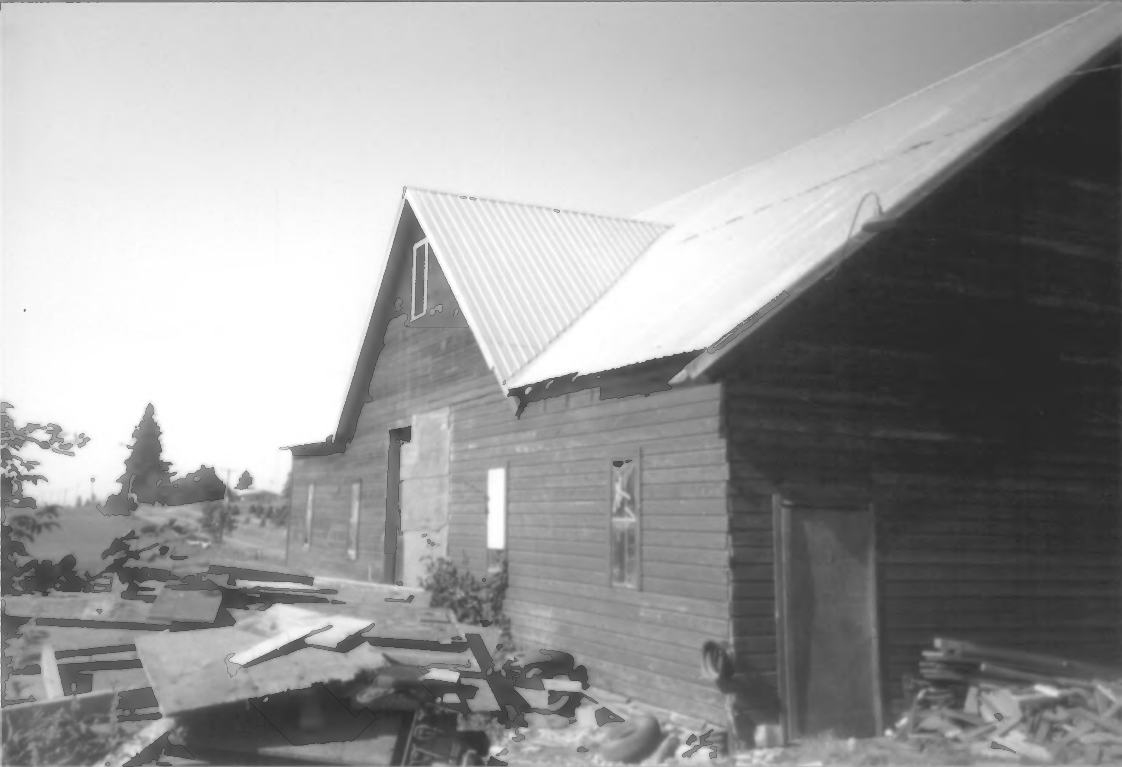
#16 of 19

South + west facade of barn

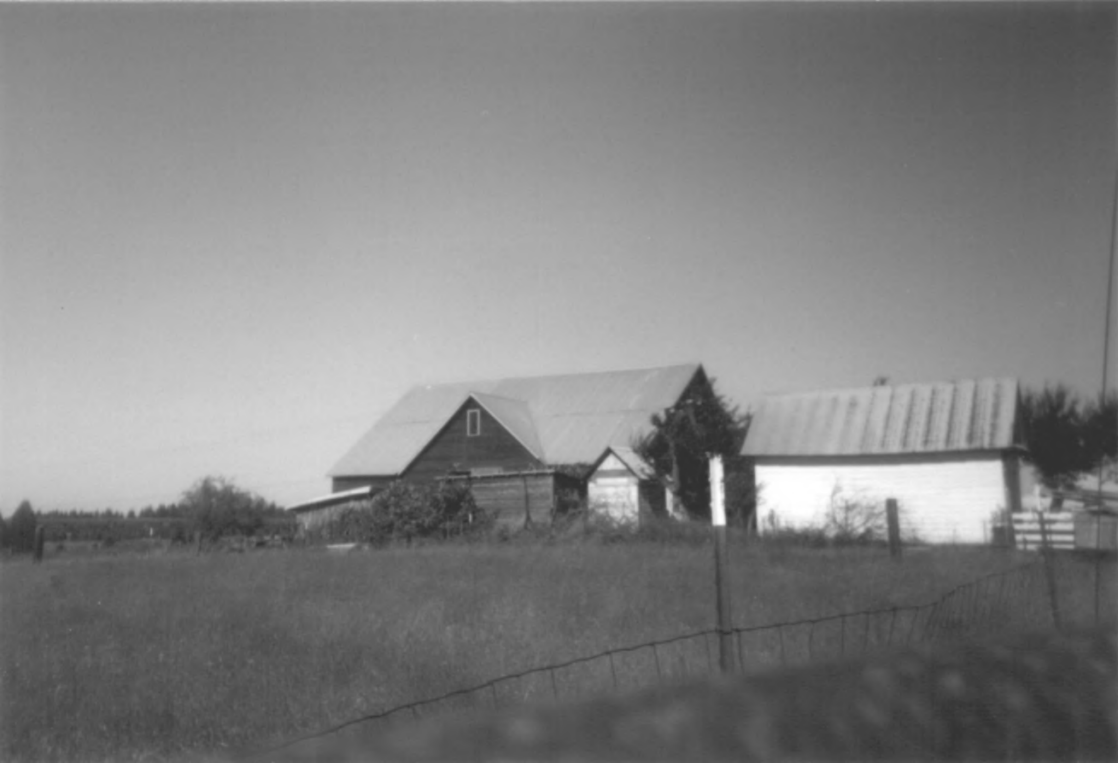
17 of 19

West face of barn, outhouse, garage

The outhouse (c.1898) is approximately 6 x 8 in size. The gable roof has hand split shingles and partial return. There is partial sunburst shingle work above the door. The door has two vertical panels below, and two vertical obscure glass panes above. It has house drop siding and was built with three seats inside, one for a small child.

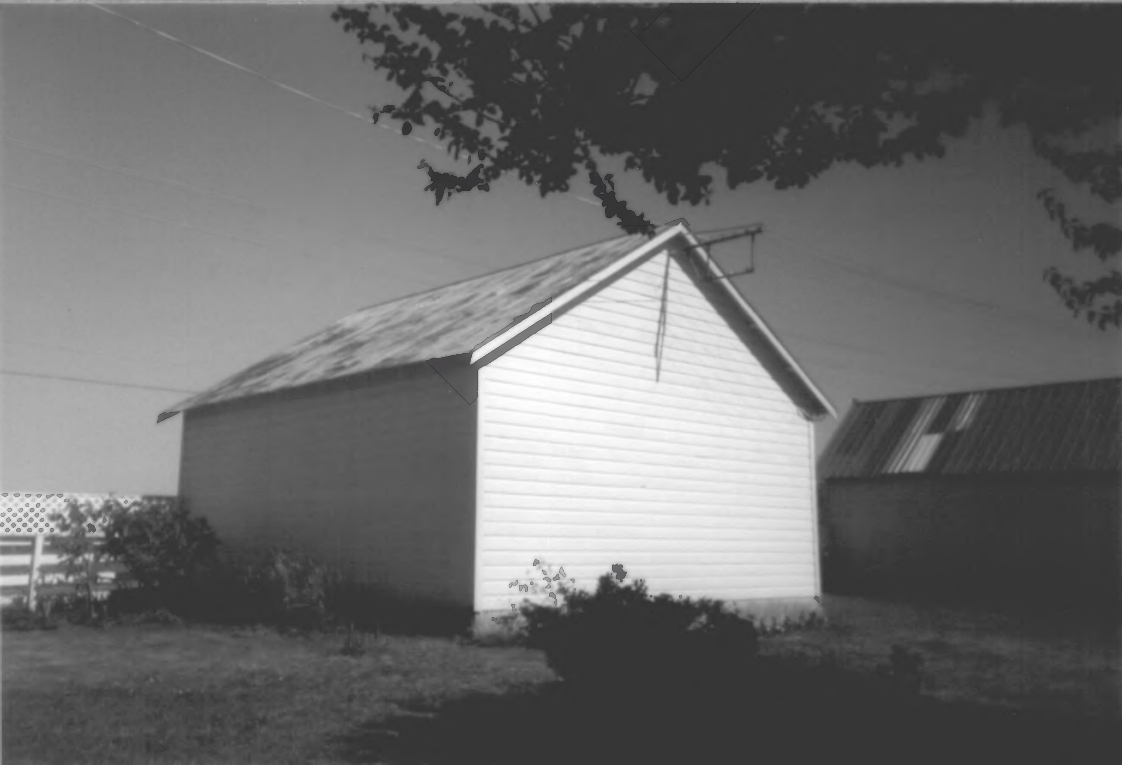
#18 OF 19

north & west walls of machine shed

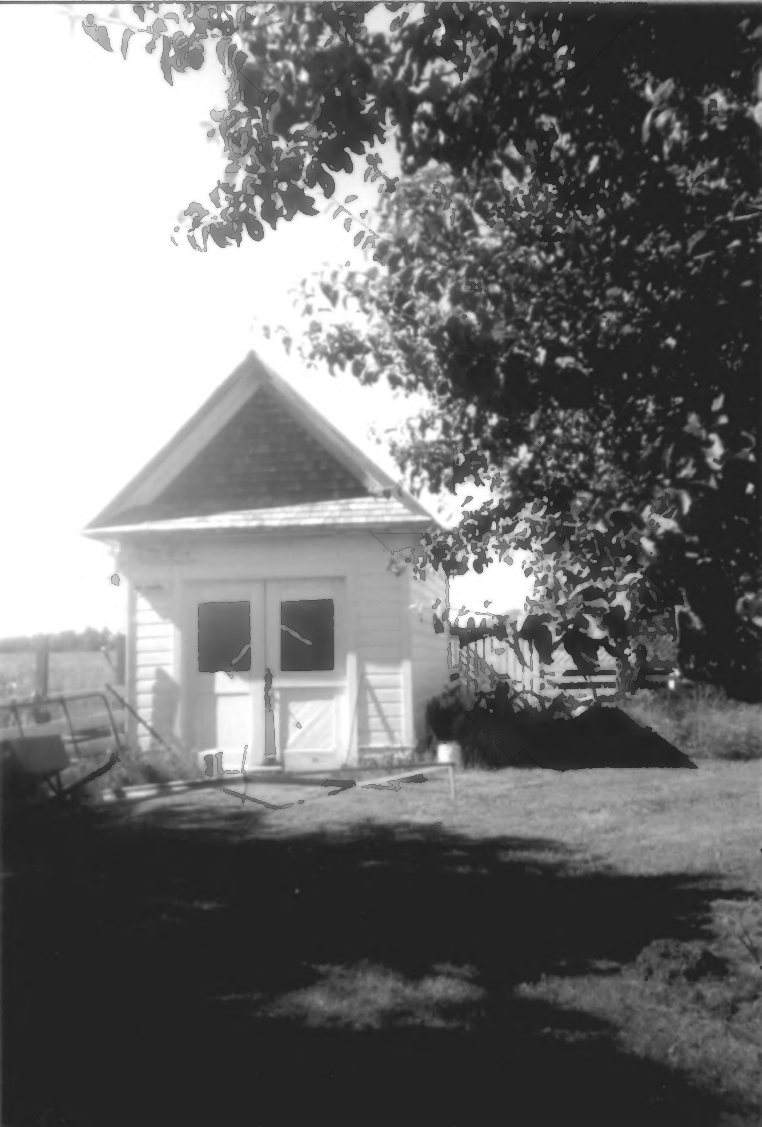
South + east walls of
garage

The garage (c.1910) is a single story and approximately 12 x 24 that faces north/south. It has a shingle pent roof and shingled gable face. It has house drop siding and double doors on south facade with 1/4" obscure glass. Inside is 1 x 4 v-grooved wainscot and workbench.

This building will be painted to match the house, and gutters added.
