National Register of Historic Places Registration Form

historic name The Roba Ranch
other names/site number _____

street & number 66953 Roba Ranch Road not for publication
city or town Paulina vicinity
state Oregon code OR county Crook code 013 zip code 97751

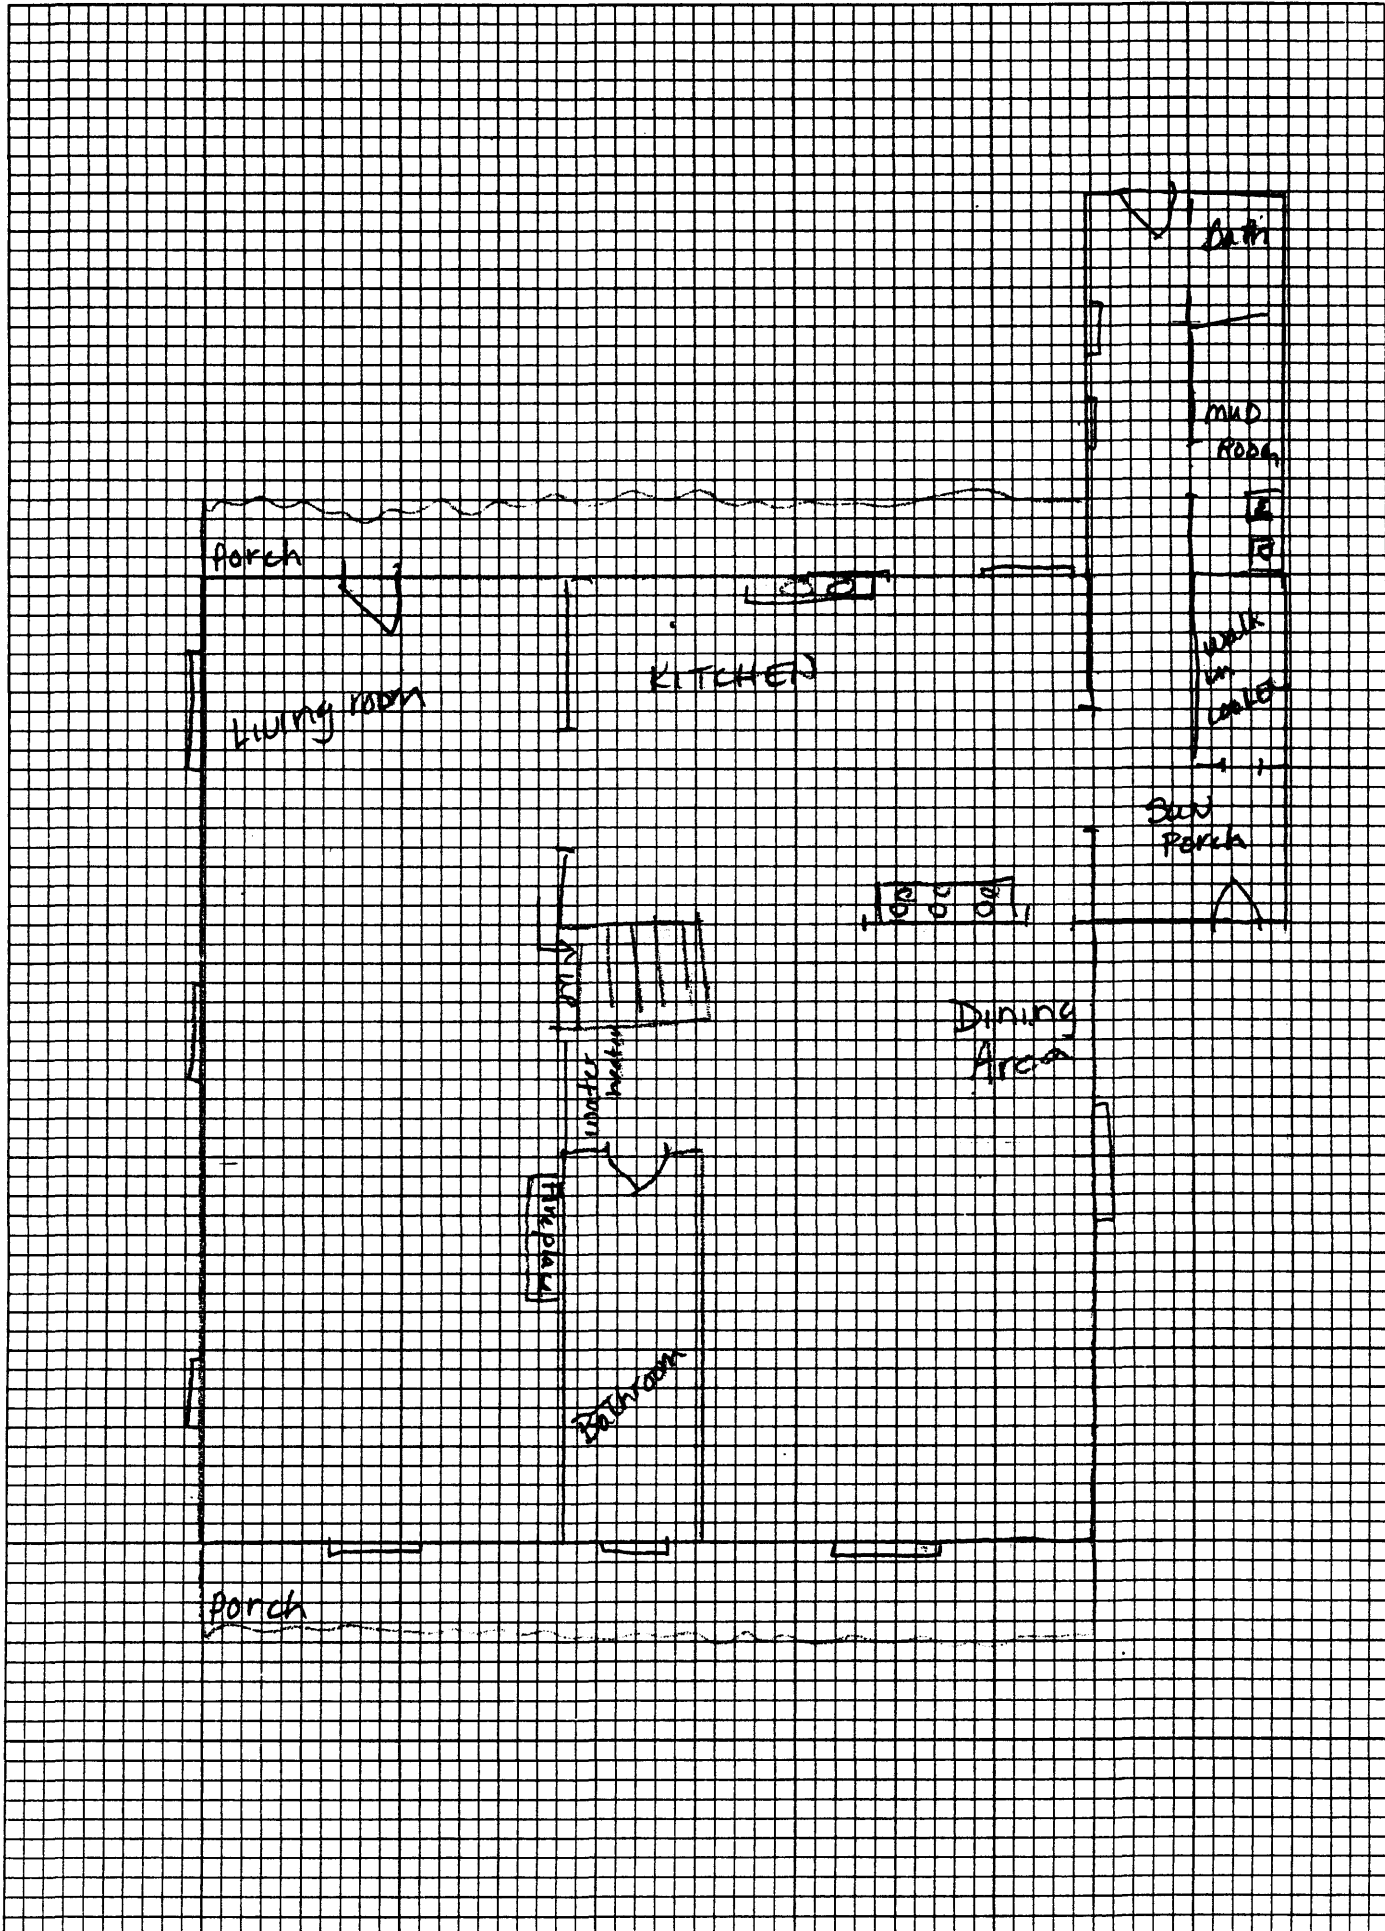
Main floor
Rata Ranch

The main entrance to the house is through the north end of the house addition. A long hallway runs north and south with eight, 4-light fixed windows on the west wall. A bathroom, utility room, and meat storage/cooling room are located in the east part of the addition. The full-bathroom is located in the northeast corner of the addition and includes two, 4-light windows on the north wall, with simple 1 by 2-inch trim. The utility room consists of a laundry area with washer, dryer, and a utility sink, with 1 by 4-inch baseboards. The meat storage/cooling room is south of the laundry room and has a large metal and wood-insulated door. The front part of the addition consists of an enclosed dining/sunroom and single-pane windows with 1 by 2-inch trim face out to the south and east. A 2-panel, 4-light wood door is centered on the south wall. The main floor of the ranch house is accessed through a single-panel, 10-light door placed in the original exterior of the house, originally a window space. The painted tuff stone exterior of the original building makes up this wall of the addition. The addition has linoleum floors throughout with simple trim around doors, and plasterboard walls.

From the addition, the kitchen leads to the dining room, bathroom, and living room. Laminate wood flooring is throughout the main floor of the house. The modest kitchen is situated in the northeast corner of the house with the dining room to the south and the living room to the west. Two equally spaced, one-over-one windows with glass blocks underneath are located on the north wall of the kitchen. Centered on the south wall is a

range backed with brick veneer and a stainless steel range hood. The dining room includes two, one-over-one, double-hung wood sash windows on the south and east facades with deep windowsills. A single-panel wood door with bulls-eye corner mouldings is on the west side of the room and leads into a small hallway with the bathroom to the south. From the hallway, access to the living room is back through the kitchen. The living room faces out to the north, west, and south. On the north wall is a single-panel, 15-light wood door, with a plain wood surround. The west wall contains three, evenly-spaced windows. The outer two windows are one-over-one, double-hung wood sash, while the center window is a fixed one-light pane. A window on the south wall is also a single fixed pane. All windows have a simple wood surround with bulls-eye corner mouldings. A fireplace with running bond and soldier bond brick with a wood mantel and wood surround painted green is located on the east wall of the living-room.

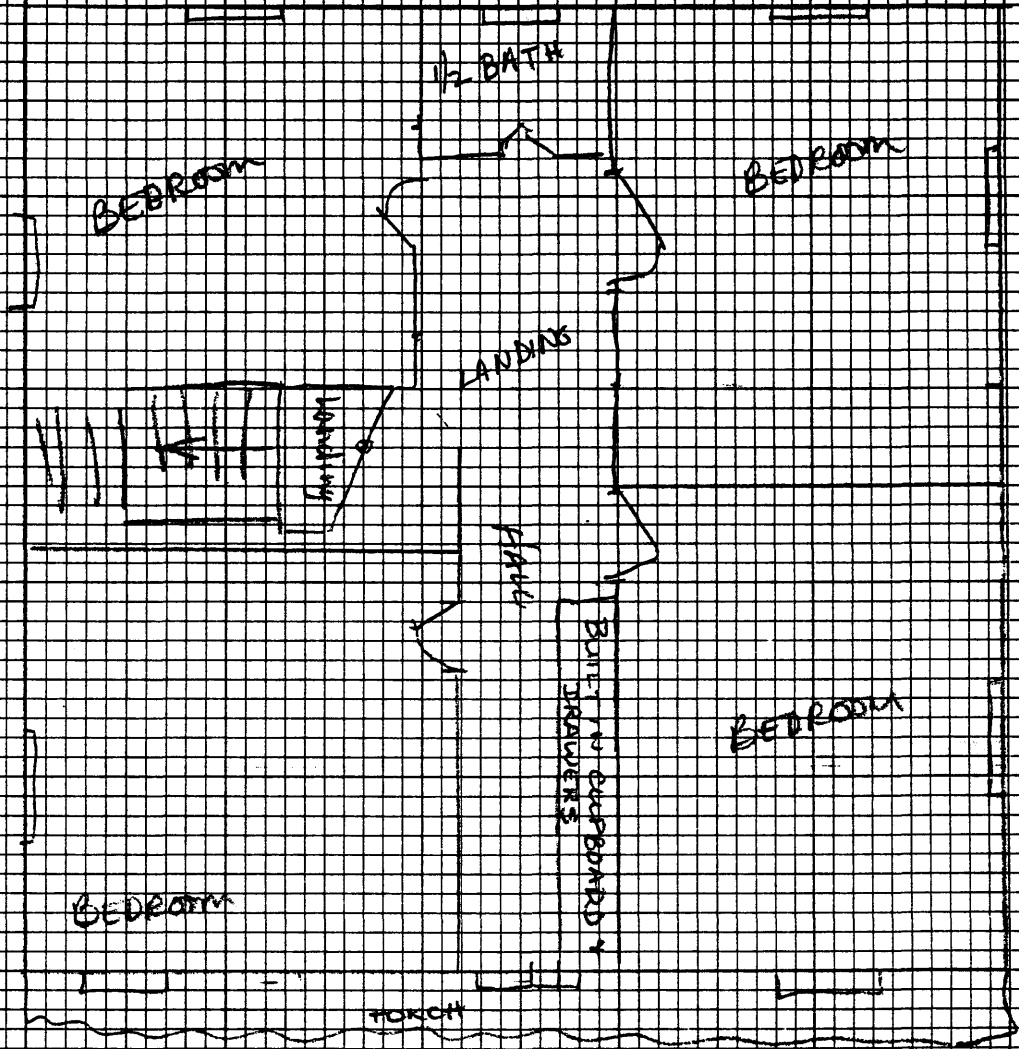
2nd floor
Riba Ranch

A steep and narrow-step staircase is located in the middle of the east wall of the living room with a single 4 by 4-inch baluster in the southwest corner supporting ½-inch round railing. The stair steps are rounded with trim. There is also ¼-inch round trim on the ceiling of the stairwell. A single-panel wood door and a doorjamb are located approximately half-way up the staircase. There is a single wood, 4 by 4-inch baluster topped with decorative moulding and railing on either side at the top of the staircase. The staircase leads to the upper level of the house that contains four bedrooms, a half-bathroom, and hallway leading to the balcony to the south. Floor to ceiling built-in drawers and cupboards line the entire east side of the hallway. The bedrooms are located in each corner of the upper-level of the house, with the bathroom centered on the north side, and the staircase and hallway taking up the center space.

All of the upper-level bedrooms have one slanted wall on the gable sides of the building, and recessed single-light casement windows on the gable ends. Each bedroom also has built-in closets, with one-panel wood doors, carpet, and ceiling tile. The southeast and southwest corner bedrooms both have one, two-over-two, double-hung wood sash window with a deep windowsill and beveling located on the south wall. The northeast and northwest corner bedrooms both have one single-light casement window located on the north wall. A small, half-bath is located in the middle of the north side, with one, single-light casement window on the north wall. A small closet with a single-panel door is located just to the west of the bathroom. The hallway leads to a single-panel, 10-light wood door, which leads through to the balcony. Access to the attic is also located at the end of the hallway by the balcony access door. Wood trim throughout the upper floor is varied, including ½-inch and ¼-inch.
