**NATIONAL REGISTER OF HISTORIC PLACES
INVENTORY -- NOMINATION FORM**

United States Post Office, Roseburg, Oregon

Federal Office Building, Roseburg, Oregon

704 S.E. Cass Ave.

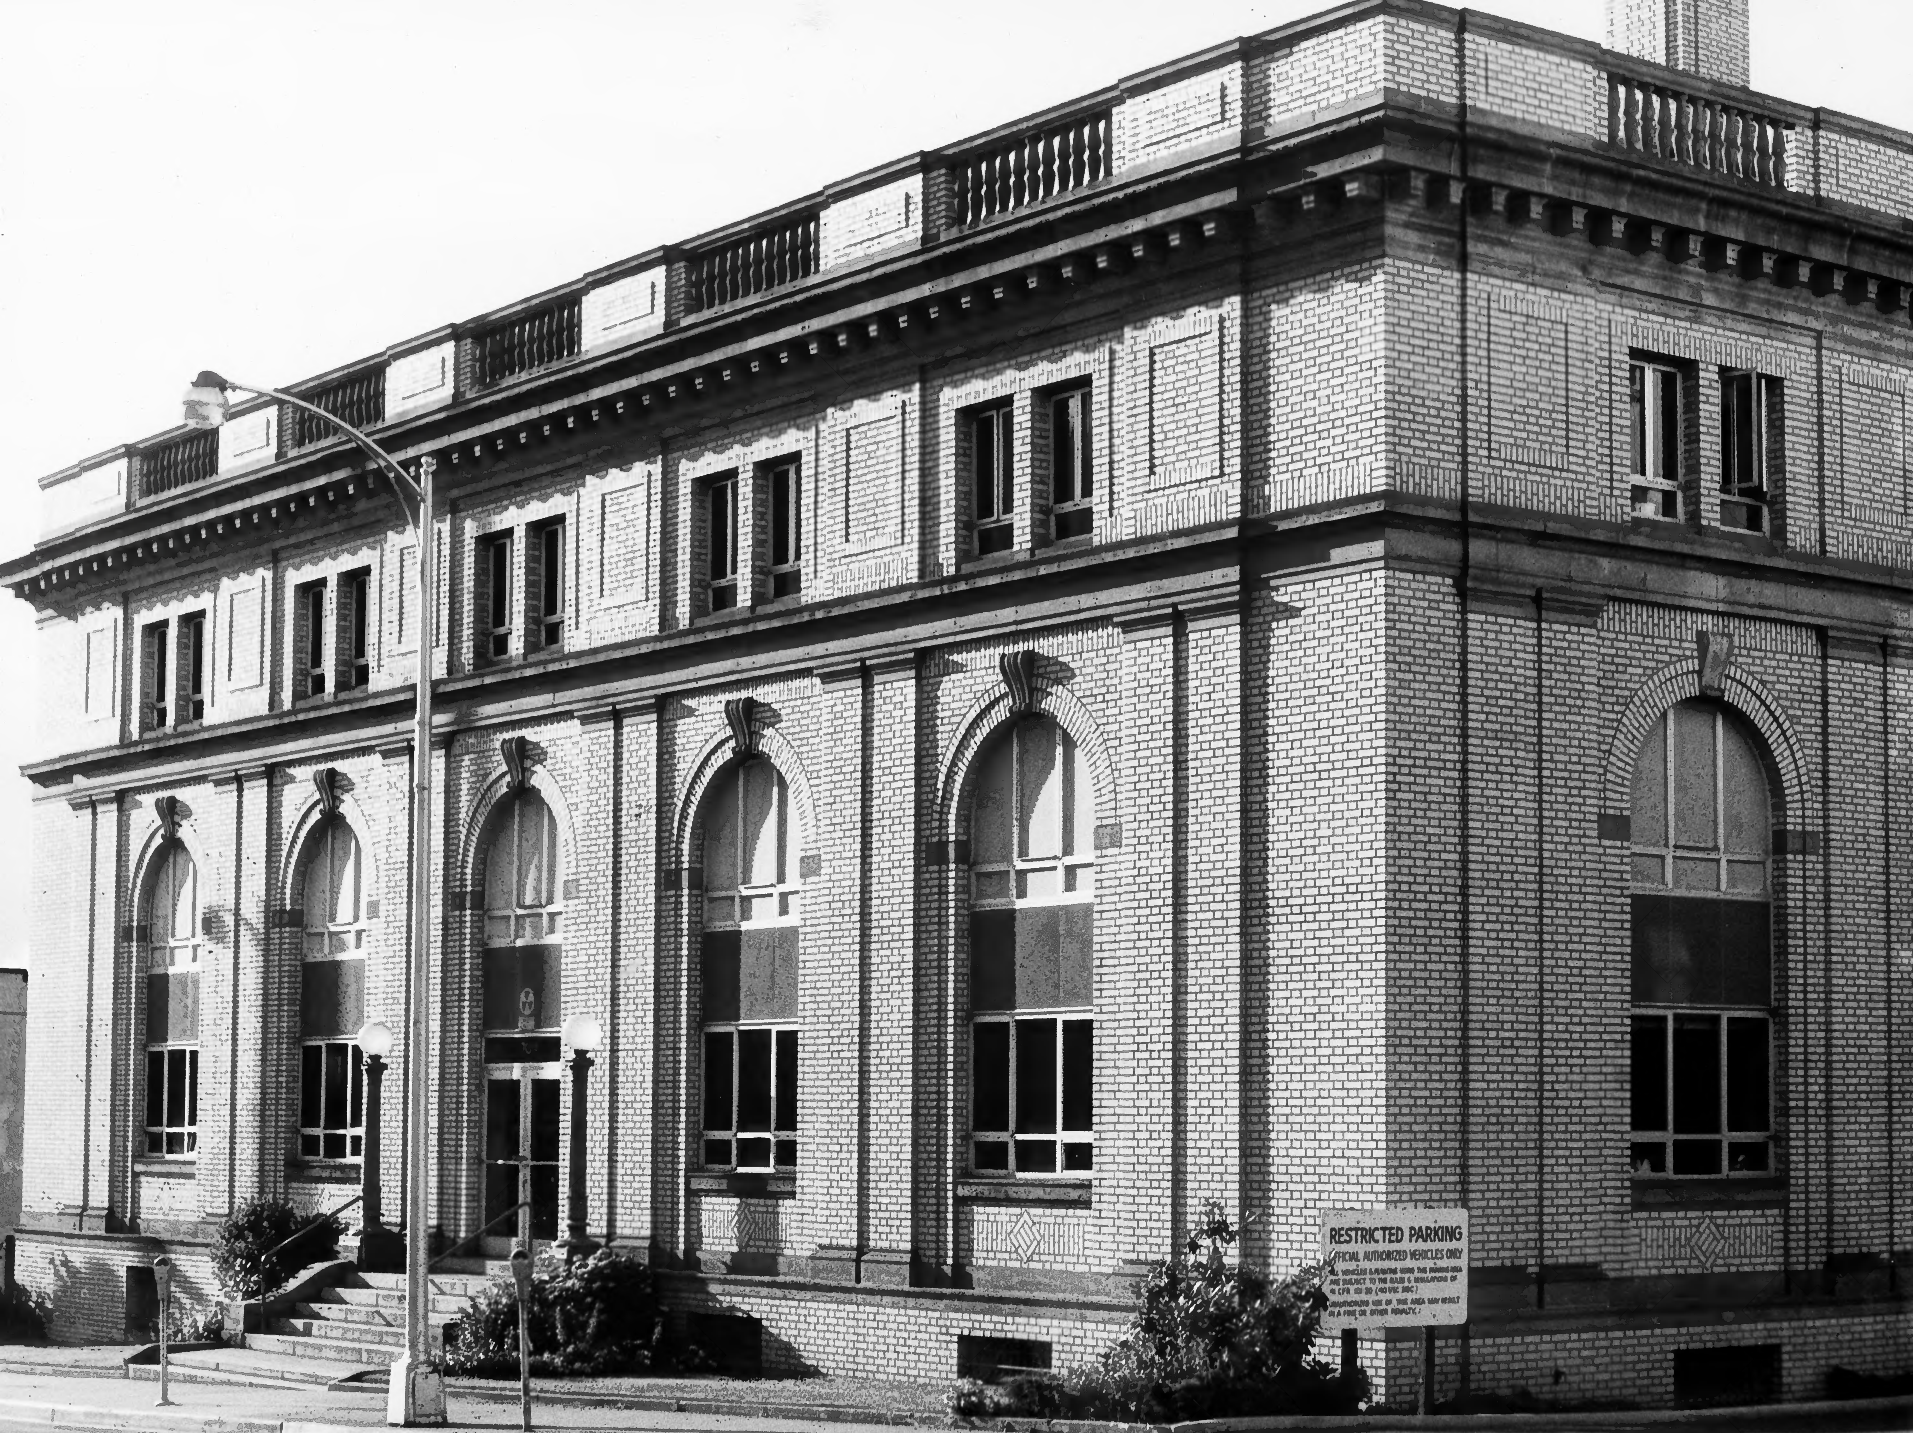
PHOTOGRAPH # 1 OF 9

MAIN (SOUTH) FACADE LOOKING NORTH

Five window bays are symmetrically distributed across the south-facing main (Cass Avenue) facade. In the first storey are four tall 14' X 6 1/2' windows with stilted arches, sandstone sills and sandstone keystones and imposts. Beneath each window is a diamond-shaped brick pattern and a grilled basement window. In the center bay is a similar arched opening over the main entrance. Double sets of brick pilasters frame the windows and extend vertically between a sandstone string course at the first floor level and another at the level of the second floor. The pilasters have sandstone bases and sandstone Roman Doric capitals.

In the second storey are five sets of two 4 1/2' X 2 1/2' rectangular windows separated by square brick panels in low relief. A denticulated sandstone cornice interrupts the panels which continue on the brick parapet above to the sandstone coping. The parapet is broken by a stone balustrade above each window bay.

Five granite steps with sandstone cheek blocks lead up to the entrance. On either side of the landing are lamps 8' tall. White glass globes are supported by cast iron stands with a Corinthian column theme.

The original Palladianesque windows had 30 lights and a radiating fanlight with mullions painted a little darker than the building's face brick. These were destroyed by an explosion in downtown Roseburg on August 7, 1959. They were subsequently replaced by silver colored aluminum windows with porcelain enameled steel panels.

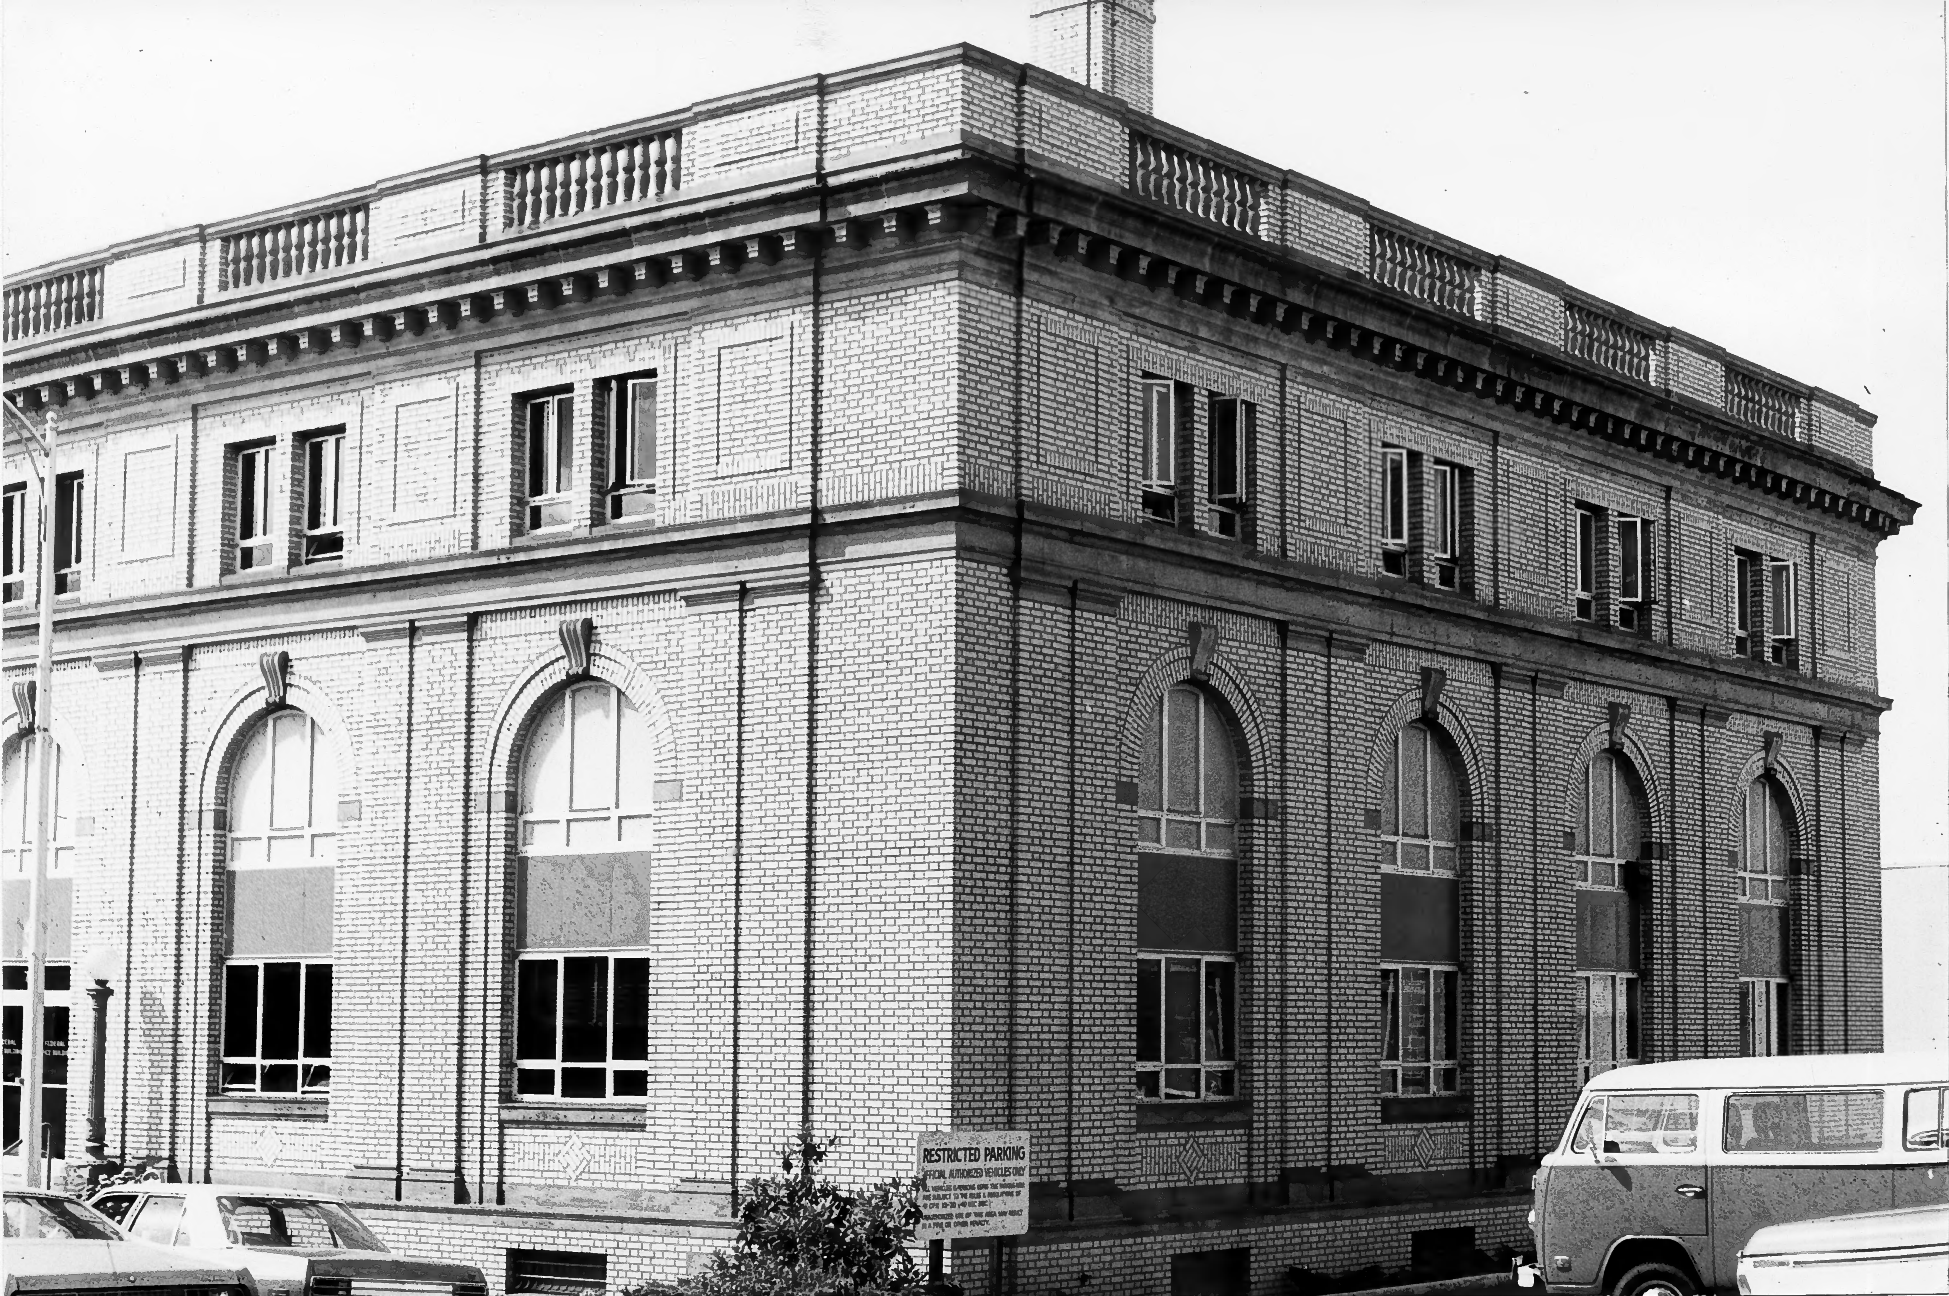
PHOTOGRAPH # 2 OF 9

EAST FACADE LOOKING NORTHWEST JUN 18 1979

The east and west facades are similar to the main facade but narrower and with only four window bays.

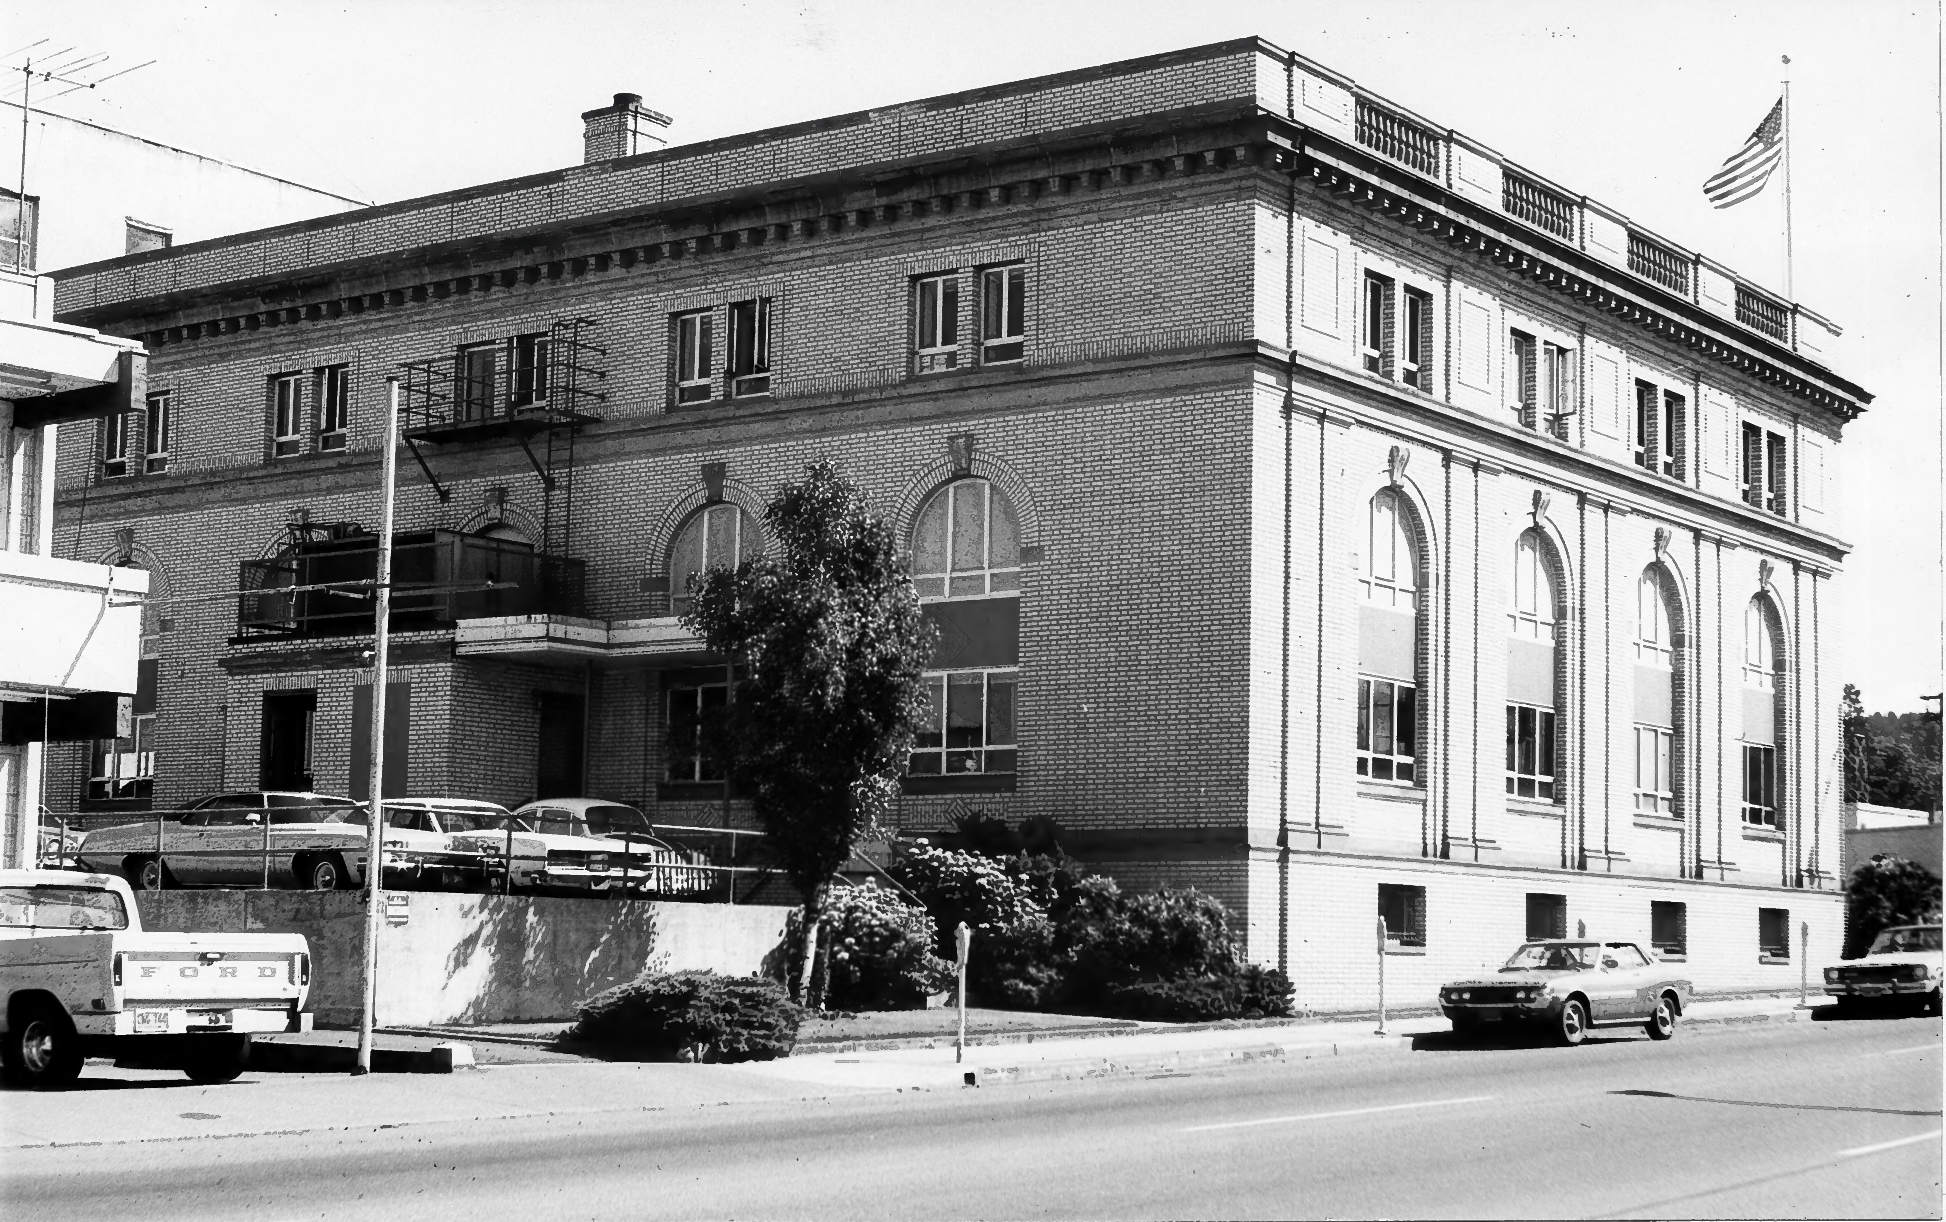
PHOTOGRAPH # 3 OF 9
JUN 18 1979 MAY 23 1979

NORTH (REAR) & WEST FACADES LOOKING SOUTH

The rear facade is similar also, with five window bays, but a small mailing vestibule covers the lower half of the central bay. The vestibule is brick with a flat roof, two doors on the north side, one door on the west side and a single small window on the east. A small canopy cutting across the second window from the western corner of the rear facade was added about 1968.

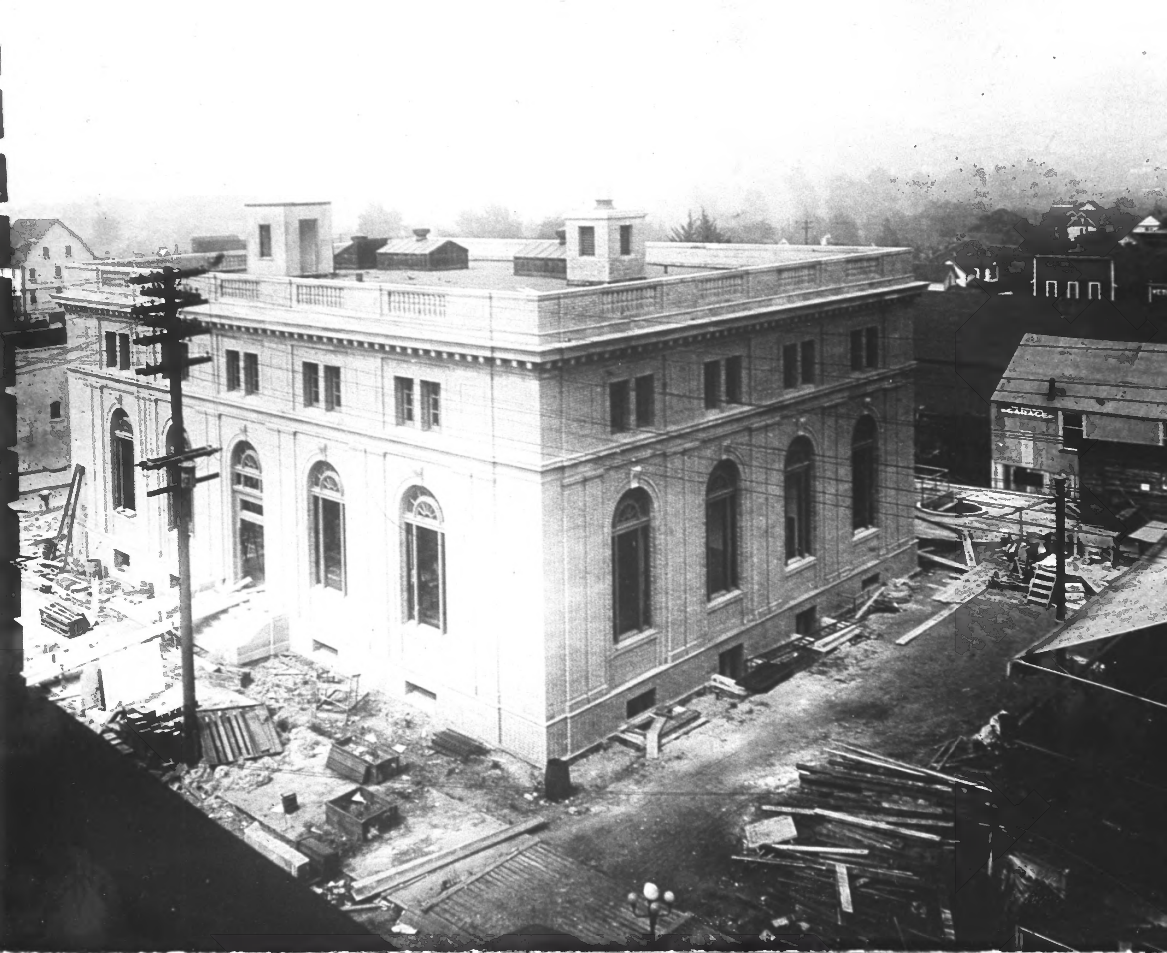
PHOTOGRAPH # 4 OF 9

UNDER CONSTRUCTION 9/13/17 LOOKING NORTH

The original specifications called for structural steel and reinforced concrete floor slabs, wood studs and furring, and metal lath. On May 10, 1916 the contractors requested permission to use reinforced concrete construction and terra cotta partitions and furring. Permission was granted.

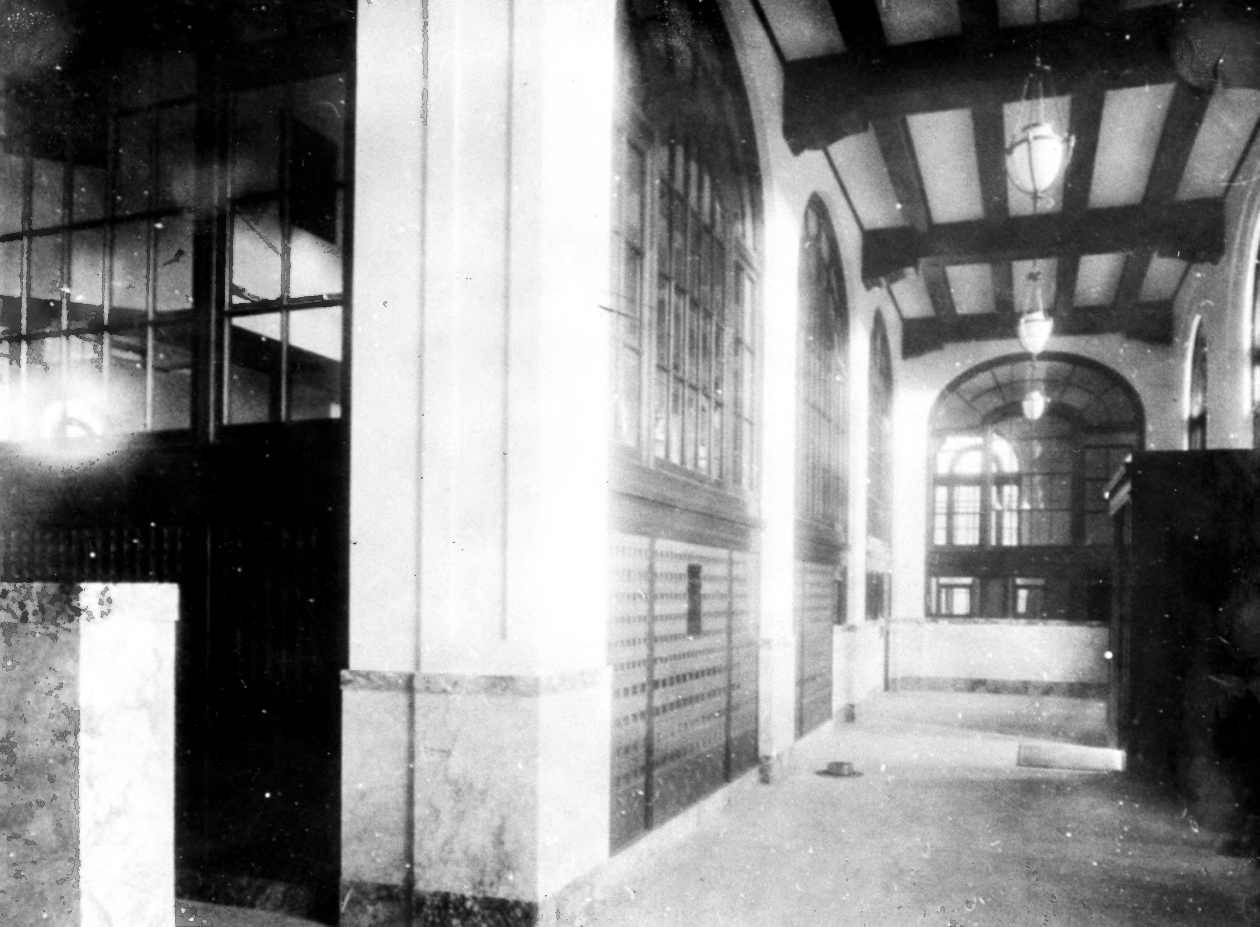
PHOTOGRAPH # 6 OF 9

1917 POST OFFICE LOBBY LOOKING EAST

The 910 postal lock boxes were contained in an oak screen with five arched window bays reaching almost to the full 20' height of the lobby. The entrance vestibule, bulletin boards, and desks were also of oak. The floor was white terrazzo, the wainscot of Tokeen marble and the base and borders of Gravina marble. (The specifications had originally called for the use of red quarry tile and pink Tennessee marble.) The walls and ceiling were light colored plaster with dark wood beams and trim. White glass lamps were suspended by brass chains and trim. Round arrises, 6" from the windows, were framed by elliptical head arrises. Kick and push plates and window screens were brass. A simple marble stairway led up to the second floor from the west end of the lobby.

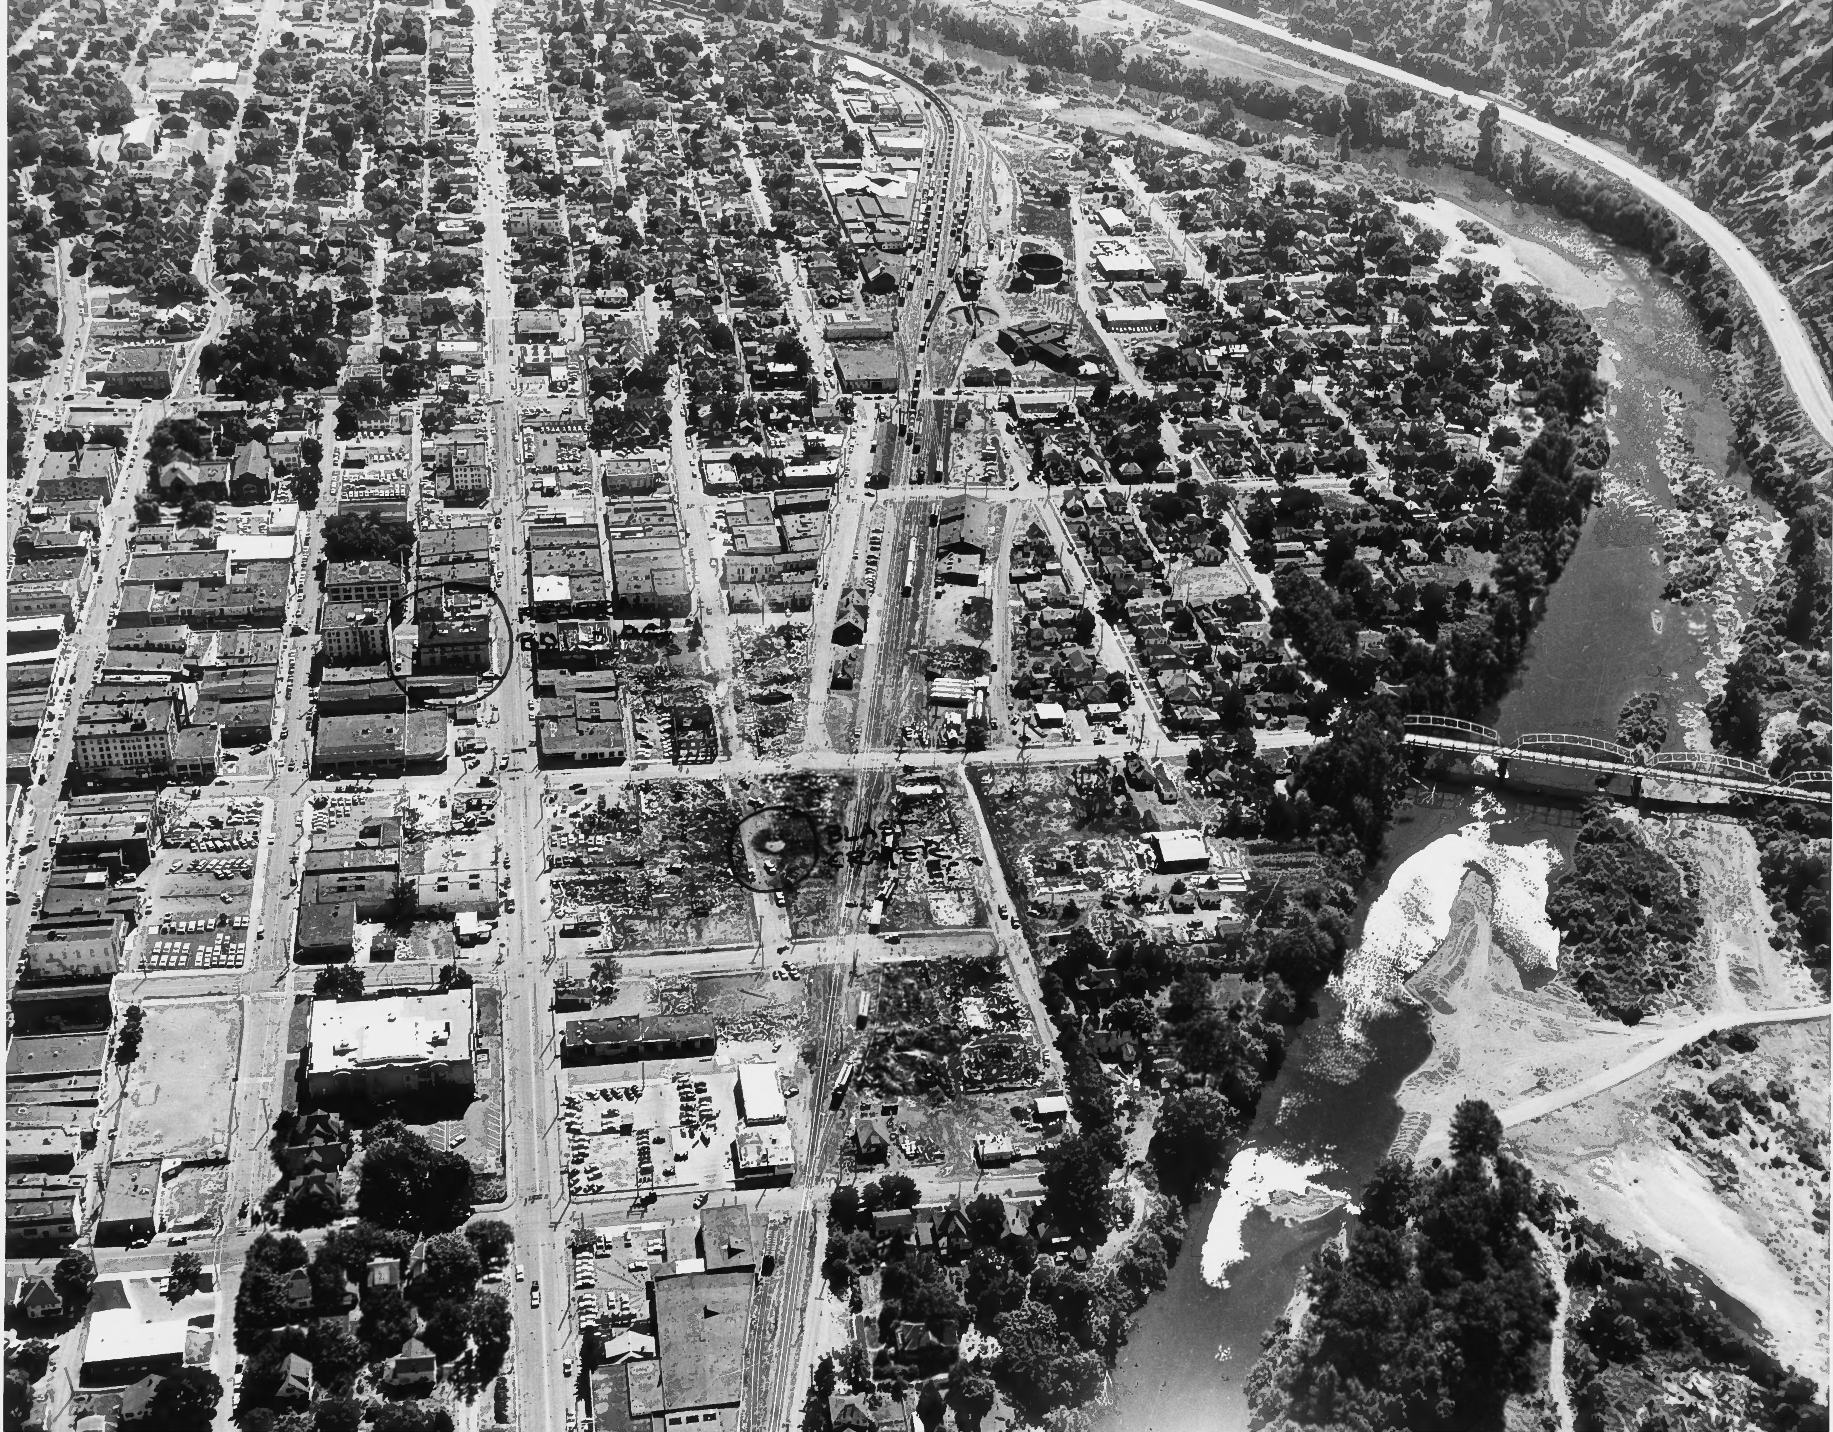
PHOTOGRAPH # 7 OF 9

8/8/59 AERIAL VIEW SHOWING BLAST CRATER

Then, before dawn on August 7, 1959, the biggest event since the founding of Roseburg shook the town. A truck from Tenino, Washington, carrying an explosive fertilizer mix exploded only two blocks from the Federal Building. The explosion created a crater 25' deep and 55' across. Thirteen people were killed and many others injured. Eight blocks of Roseburg were leveled completely and all glass was broken in a 40 block area.

"The only thing wrong with the Post Office lobby after the blast was the front windows being blown out into the street and the ornate screen line of sash and glass above the box sections being dumped into the workroom in a tangled mess of broken sash, glass and twisted metal rods. . . All the doors and windows were blown out both outside and inside. . . There was no apparent structural damage. . . which attests to the excellent quality of construction. . . In spite of the mess, mail delivery was only one-hour late the next day."⁵

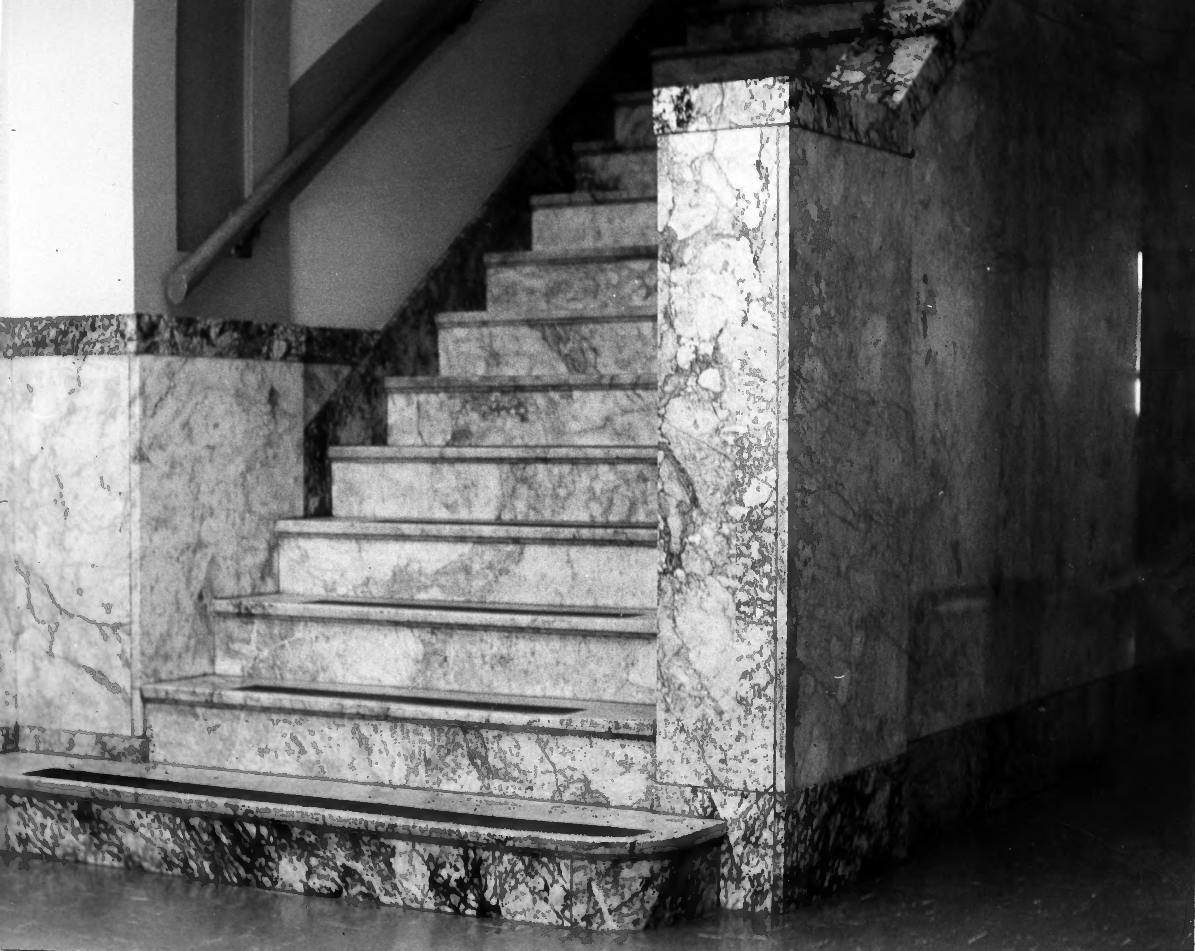
PHOTOGRAPH # 8 OF 9

MARBLE STAIRCASE IN LOBBY LOOKING WEST

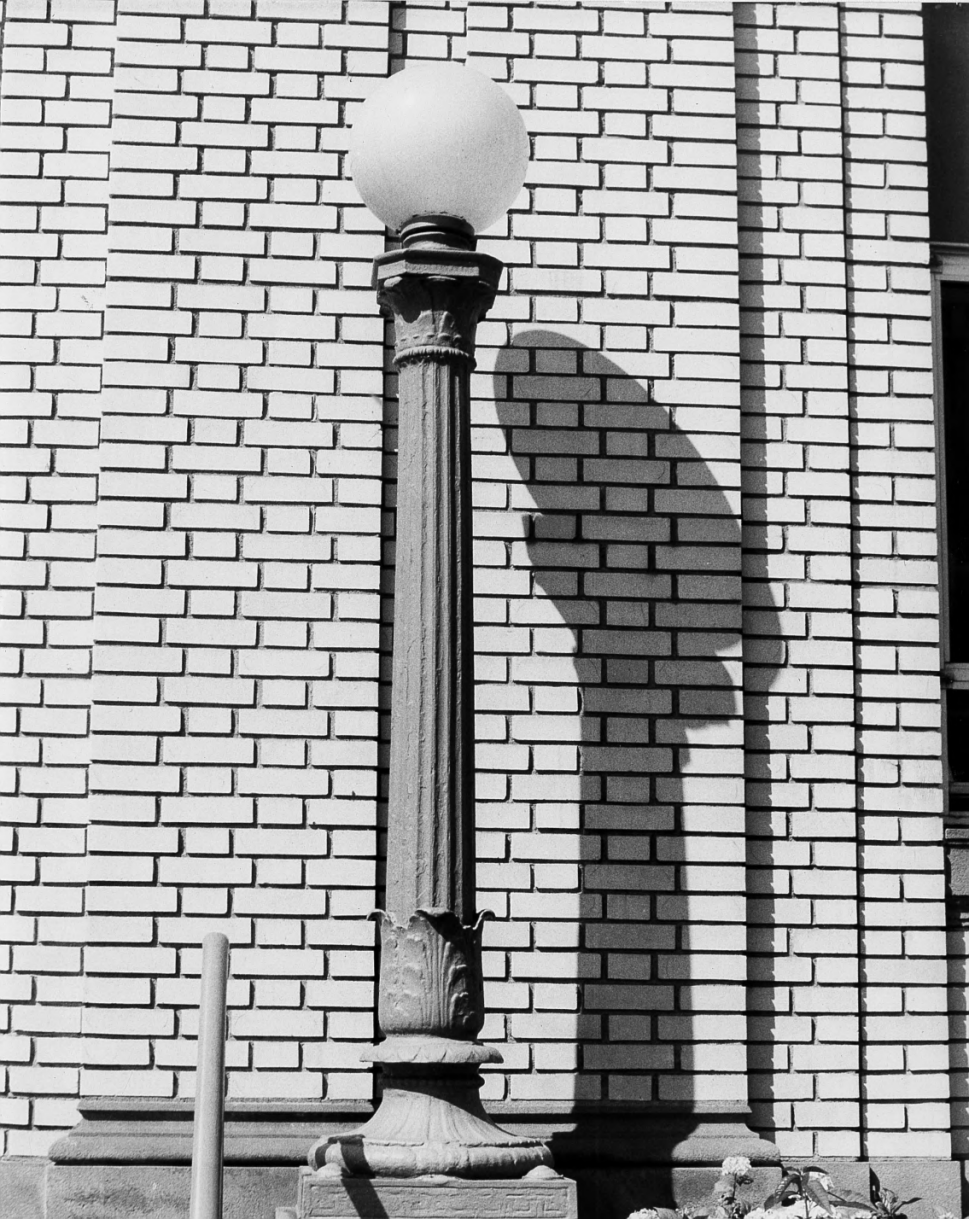
PHOTOGRAPH # 9 OF 9

LAMP STAND ON CHEEK BLOCK AT MAIN ENTRANCE
