**NATIONAL REGISTER OF HISTORIC PLACES
INVENTORY -- NOMINATION FORM**

HISTORIC
Bly Ranger Station
AND/OR COMMON
Bly Ranger Station

7 DESCRIPTION

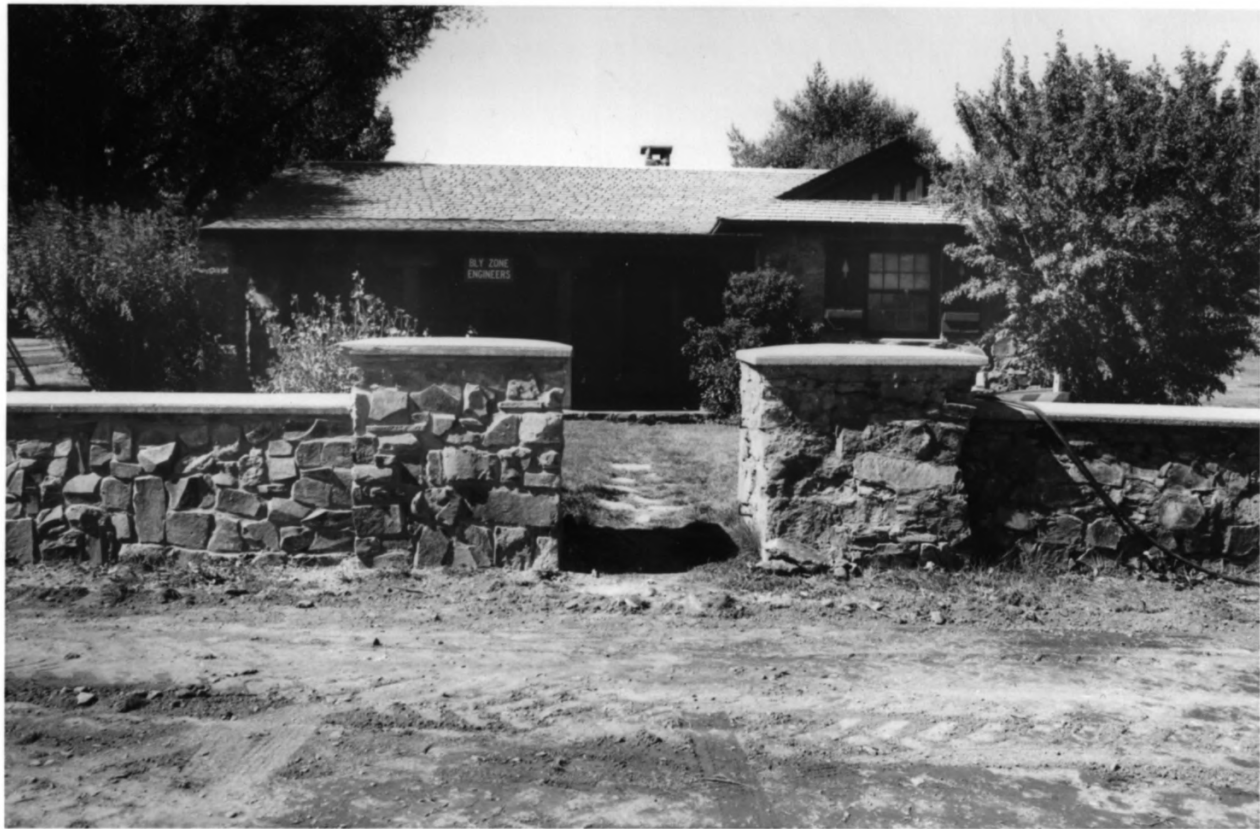
1. Office #2000, Bly Ranger Station Historic District
2. Bly, Oregon
3. Photographer: E.G. Throop **SEP 3 0 1980**
4. Date: August 1979 *Klamath Co.*
5. Negative Location: Fremont National Forest
Supervisor's Office, Lakeview, Oregon.
6. Looking west from parking area toward the east
(main) facade of the old office, with pedestrian
entry in foreground. Hinges for gate, now
removed, are discernible on right hand post.
7. Photograph Number: #1A

1. Old Office #2000: 1936; 962 sq. ft.; L-shaped, 3-room office, 1 story wood frame, medium gable roof, intersecting gable off-set with gabled hip, wood shingled. North roof slope, extends bell cast to form porch roof, supported by two squared timber posts, round flush brackets and a stone post with buttress; south roof slope extends, straight, to cover rear entry. Stone chimney, off-set on south (rear) slope of roof. Stone exterior, coursed rubble of varying sizes and shapes, natural surface; red and green rhyolite and gray basalt; horizontal clapboard on north wall beneath porch roof. Vertical boards, angular cut, and battens on gable ends and on gablet. Six-over-six double hung sash windows, flanked by decorative shutters exhibiting a simple pine tree cut out. Curving rock buttress at each corner and on north face of porch post. Single simple pine tree cut out centered on each gable end. Doors exhibit a "rough plank" exterior with hand forged latches and latch plates. Interior somewhat modified--ceiling material replaced, fluorescent lighting fixtures added, entry hall altered. Knotty pine wall materials, knotty pine surface on interior doors. Hand forged latches and plates. Well maintained, in excellent condition; slightly altered materially on interior but does not greatly detract from integrity.

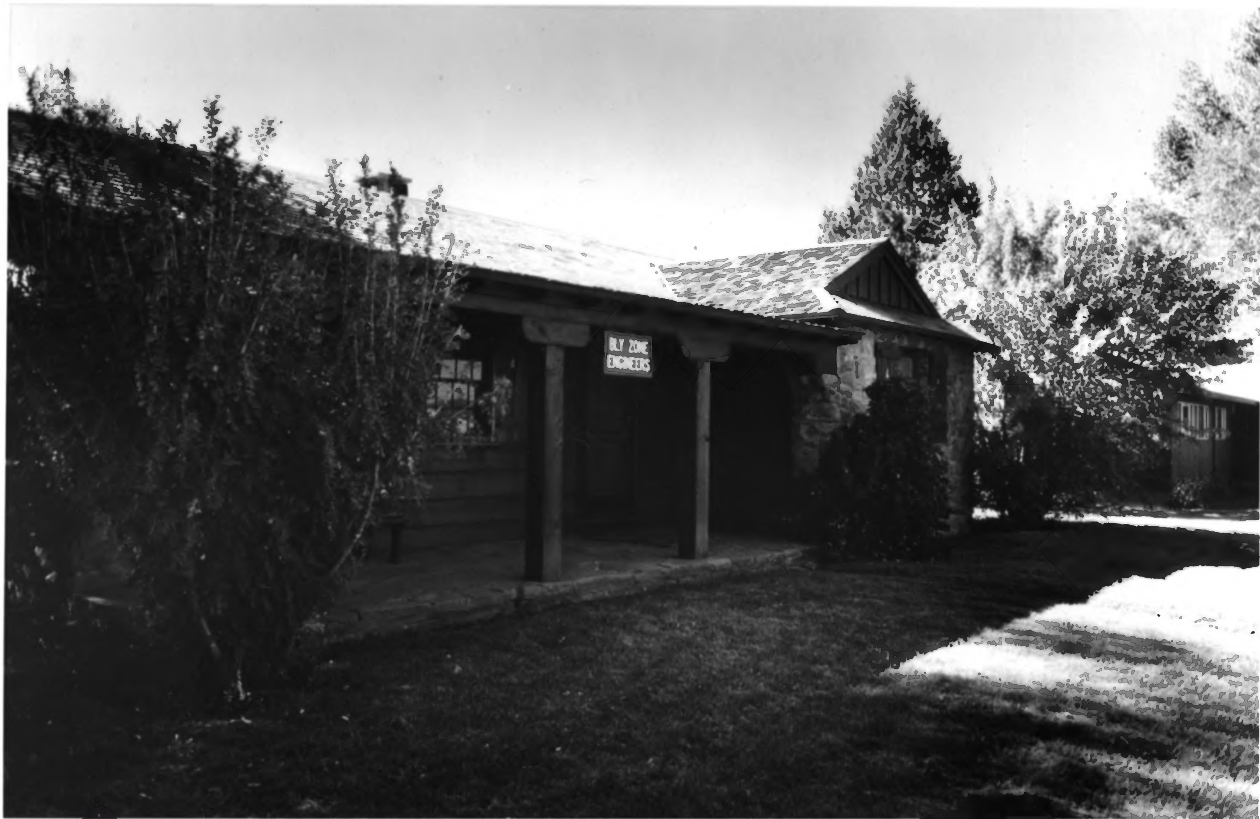
1. Office #2000, Bly Ranger Station Historic District
2. Bly, Oregon
3. Photographer: E.G. Throop
4. Date: August 1979
5. Negative Location: Fremont National Forest, Supervisor's Office, Lakeview, Oregon.
6. From southeast, detail of porch, entry, Office #2000.
7. Photograph Number: 1B

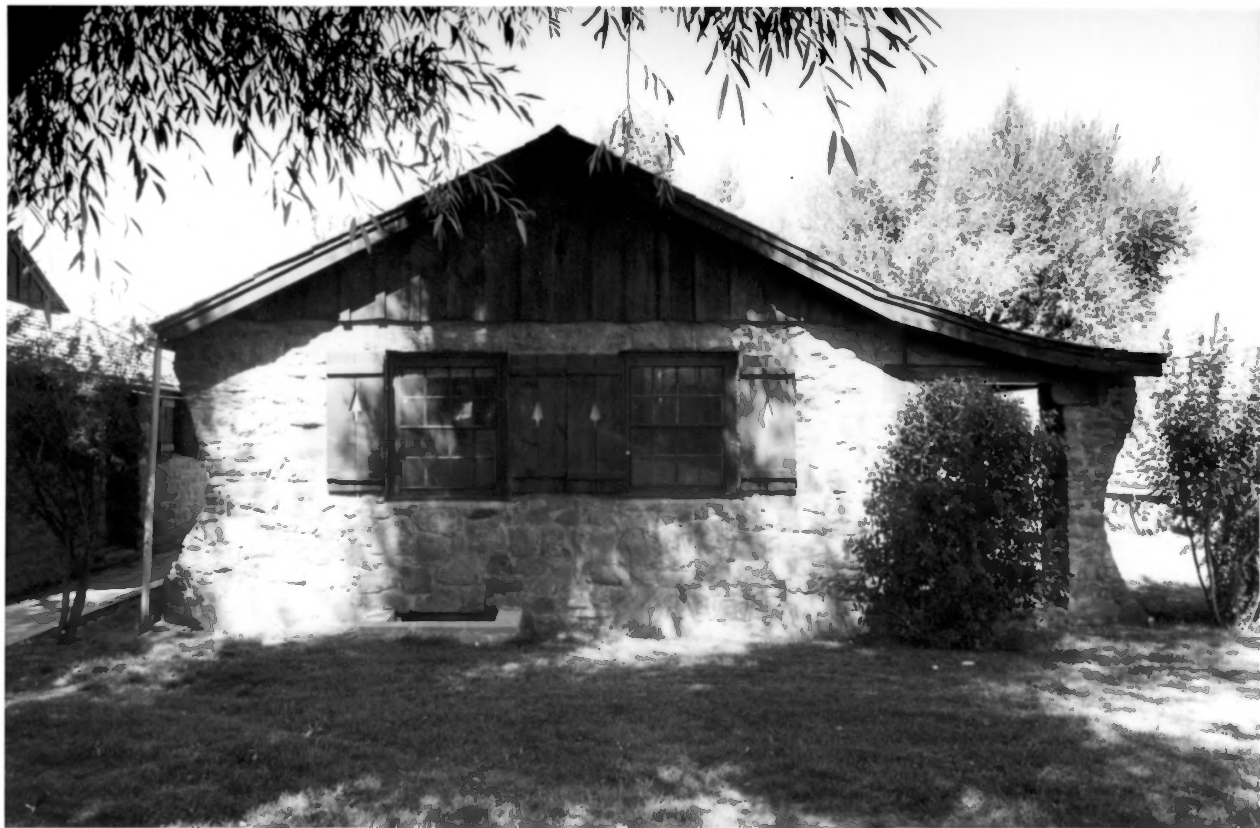
1. Office #2000, Bly Ranger Station Historic District
2. Bly, Oregon
3. Photographer: E.G. Throop
4. Date: August 1979 *Klamath co.*
5. Negative location: Fremont National Forest Supervisor's Office, Lakeview, Oregon.
6. Looking north toward the south gable end of Office #2000, corner buttress, decorative shutters, typical window treatment, and buttressed porch pillar visible.
7. Photograph Number: #1C

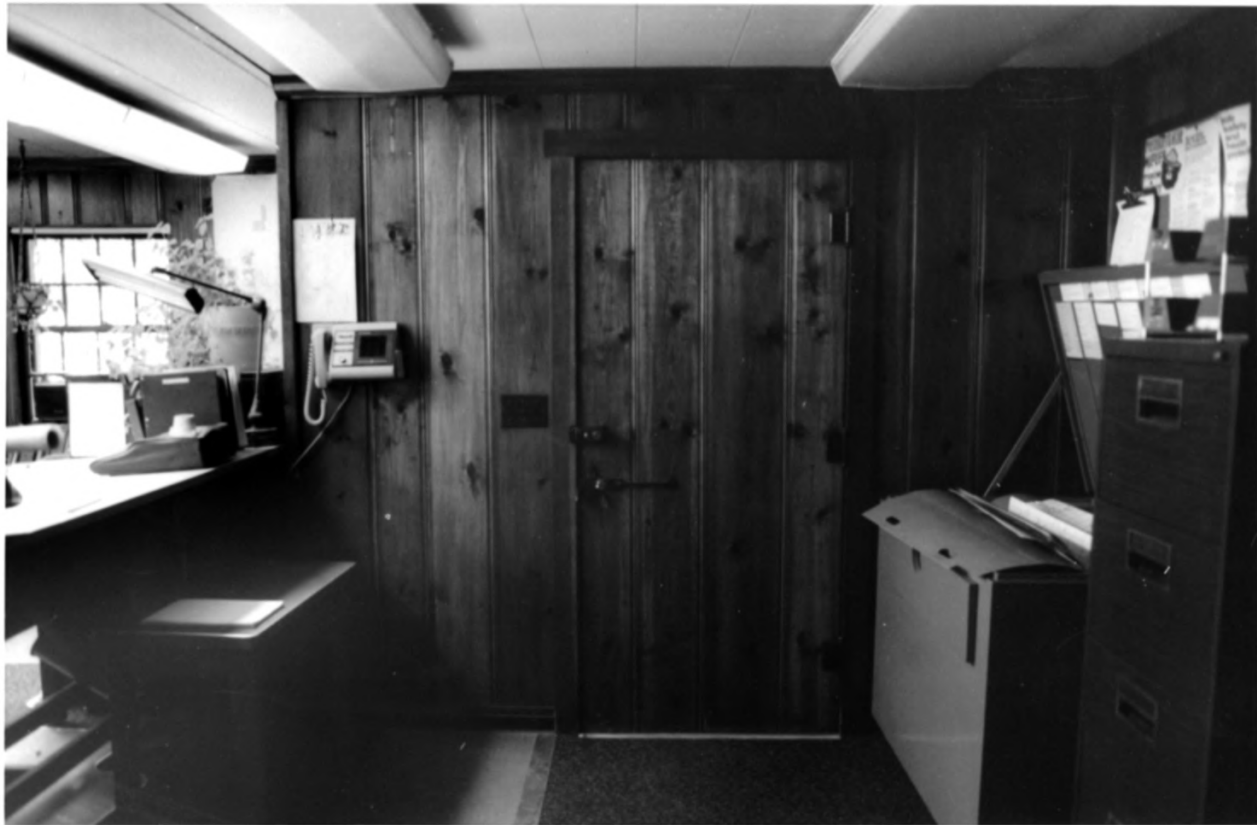
1. Office #2000, Bly Ranger Station Historic District
2. Bly, Oregon
3. Photographer: E. G. Throop
4. Date: August 1979 *Klamath co.*
5. Negative Location: Fremont National Forest Supervisor's Office, Lakeview, Oregon
6. Interior looking at main entry: original knotty pine paneling, paneled plank door, hand-forged hardware visible. Alterations including accoustical tile ceiling materials, fluorescent light fixtures also visible.
7. Photograph Number: 1D

The Bly Ranger Station compound appears much as it did when built, retaining its strong ensemble character. The exteriors of the original buildings remain unaltered, and few interior alterations have occurred. The interior of the Old Office #2000 has undergone the most significant alterations: The entry has been modified by removal of wall partitions, and by the replacement of original ceiling materials and light fixtures with acoustical tiles and fluorescent lights.

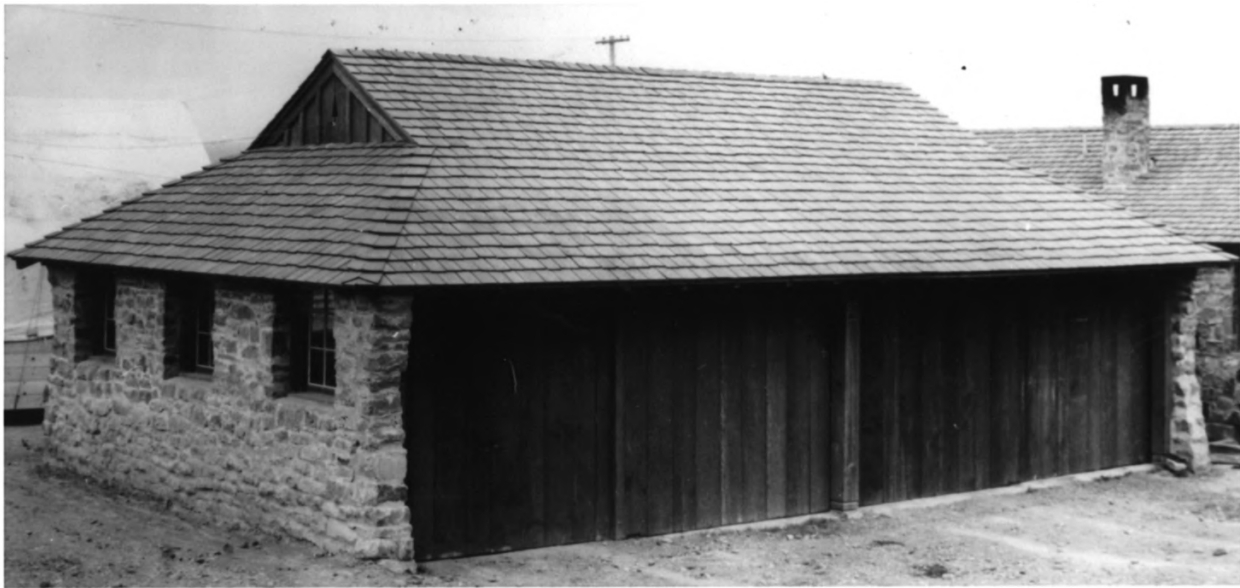
1. Garage #1501, Bly Ranger Station Historic District
2. Bly, Oregon
3. Photographer: Unknown
4. Date: ca. 1938 *Klamath Co-*
5. Negative Location: Fremont National Forest Supervisor's Office, Lakeview, Oregon Historic Photograph Collection.
6. From southwest looking toward south elevation and west gable end of Garage # 1501. Corner buttresses visible.
7. Photograph Number: #2Hst..

2. Garage #1501: 1936; Rectangular 4 bay structure, 1 story wood frame, dirt floor. Gabled hip roof, wood shingled. Stone exterior wall material gray basalt cut in narrow irregular shapes, coursed, to eave line, buttressed corners; vertical board and batten on gablets. Six-vertical-light sashes flanked by decorative shutters, each having a single simple pine tree symbol, similar simple pine tree centered on each gablet. South facade has four large vertical--"rough sawn" plank doors, slide opening; three hand-routed squared-timber supports. No apparent alterations, excellent condition.

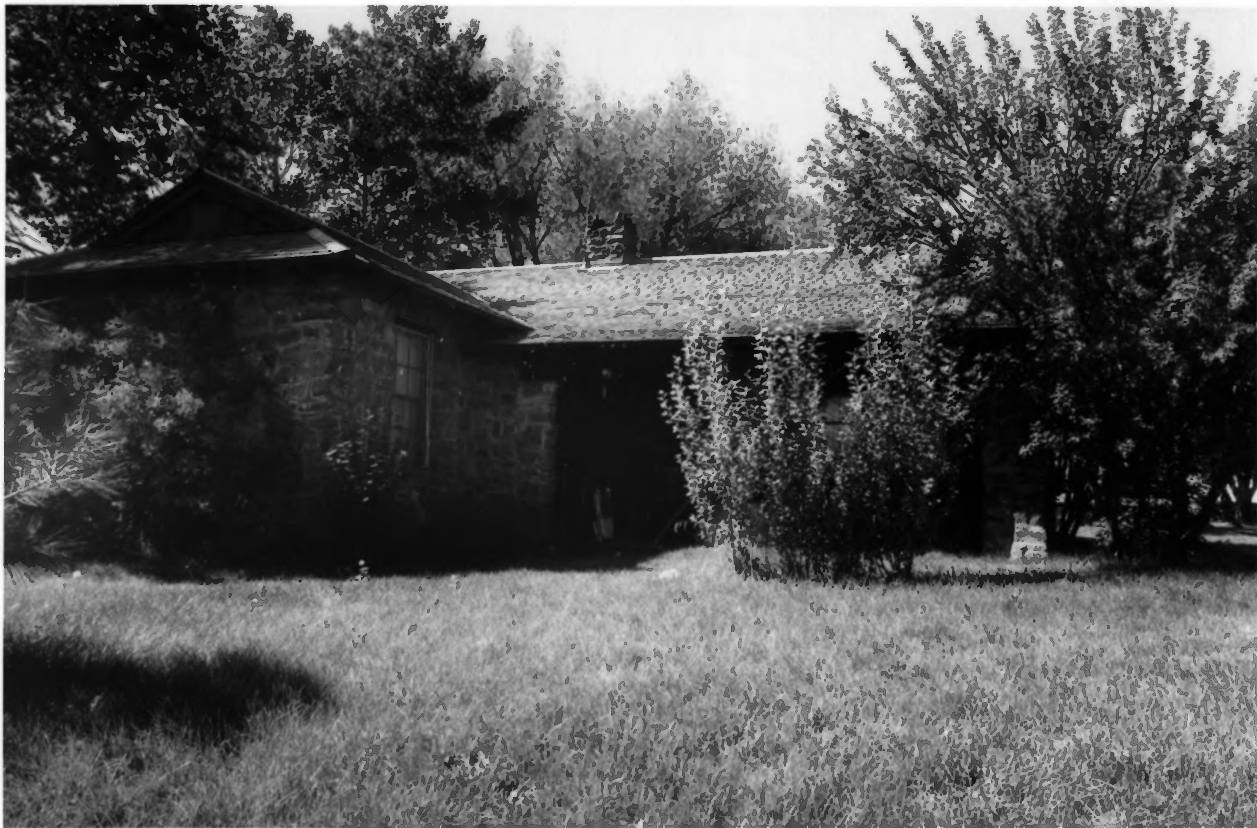
1. Assistant Ranger's Residence #1003 / Bly Ranger Station Historic District
2. Bly, Oregon
3. Photographer: E.G. Throop *Klamath Co.*
4. Date: August 1979
5. Negative Location: Fremont National Forest Supervisor's Office, Lakeview, Oregon
6. From northeast, the east elevation and main entry of Assistant Ranger's Residence #1003.
7. Photograph Number: #3A

3. T.M.A. Residence #1003: (formerly designated Assistant Ranger's Residence) 1937; 1140 sq. ft.; T-shaped, 5-room dwelling, 1 story wood-frame, poured concrete foundation, basement, wood-shingled medium gable roof, intersecting cross gable, off-set with gabled hips; east (front) wall recessed to form porch, roof supported by buttressed stone pillar, squared-timber posts with short, rounded flush brackets. Stone interior chimney offset on west slope of main gable. Stone exterior wall material to eave line, coursed rubble, varying dimensions, red and green rhyolite and gray basalt; vertical boards, angular cut, battens on gable ends and gablets, enclosed rear entry, exterior board and batten. Decorated mullion window with six-over-six double-hung sash, flanked by four-over-four sashes and surmounted by transom lights,

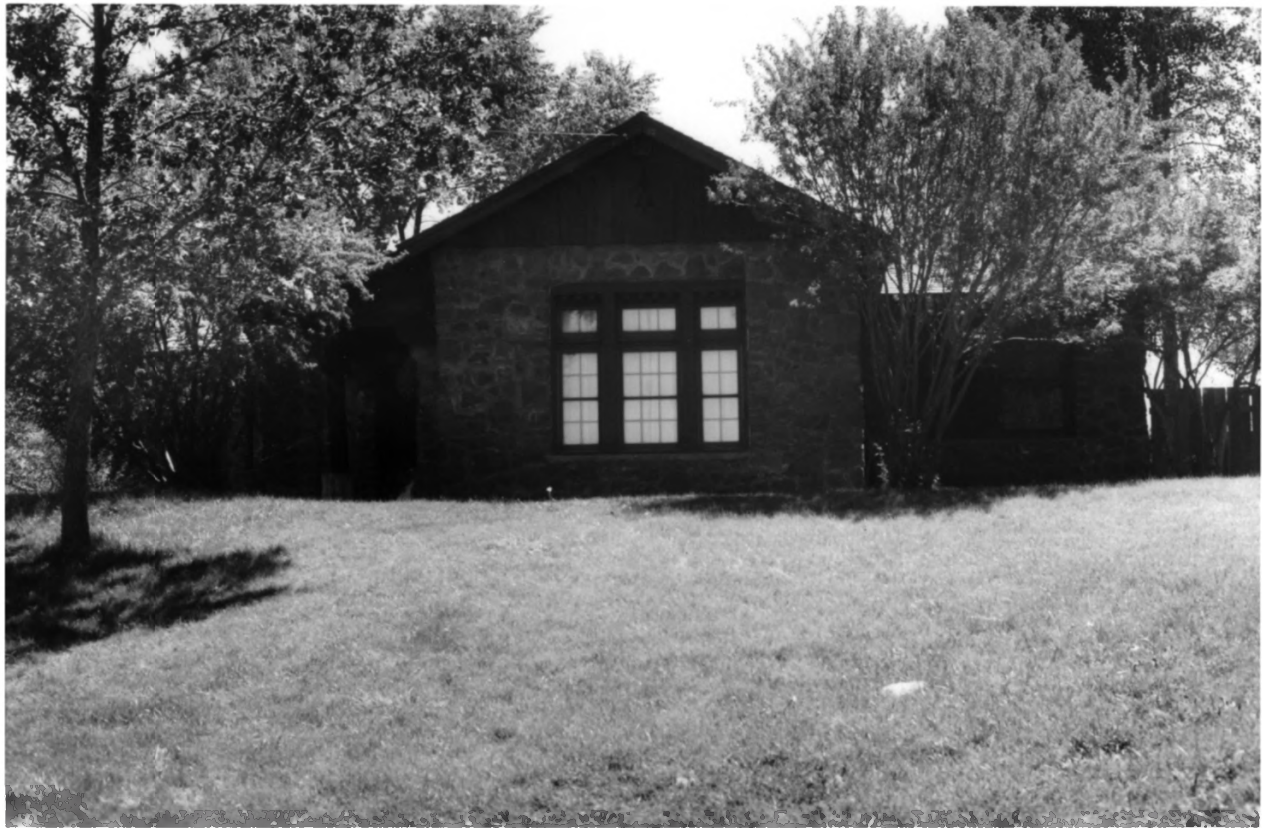
1. Assistant Ranger's Residence #1003, Bly Ranger Station Historic District.
2. Bly, Oregon
3. Photographer: E.G. Throop *Klamath Co.*
4. Date: August 1979
5. Negative Location: Fremont National Forest Supervisor's Office, Lakeview, Oregon.
6. From north, the north elevation of Assistant Ranger's Residence #1003 showing distinctive mullion window, pine tree symbol incised on gable end.
7. Photograph Number: #3B

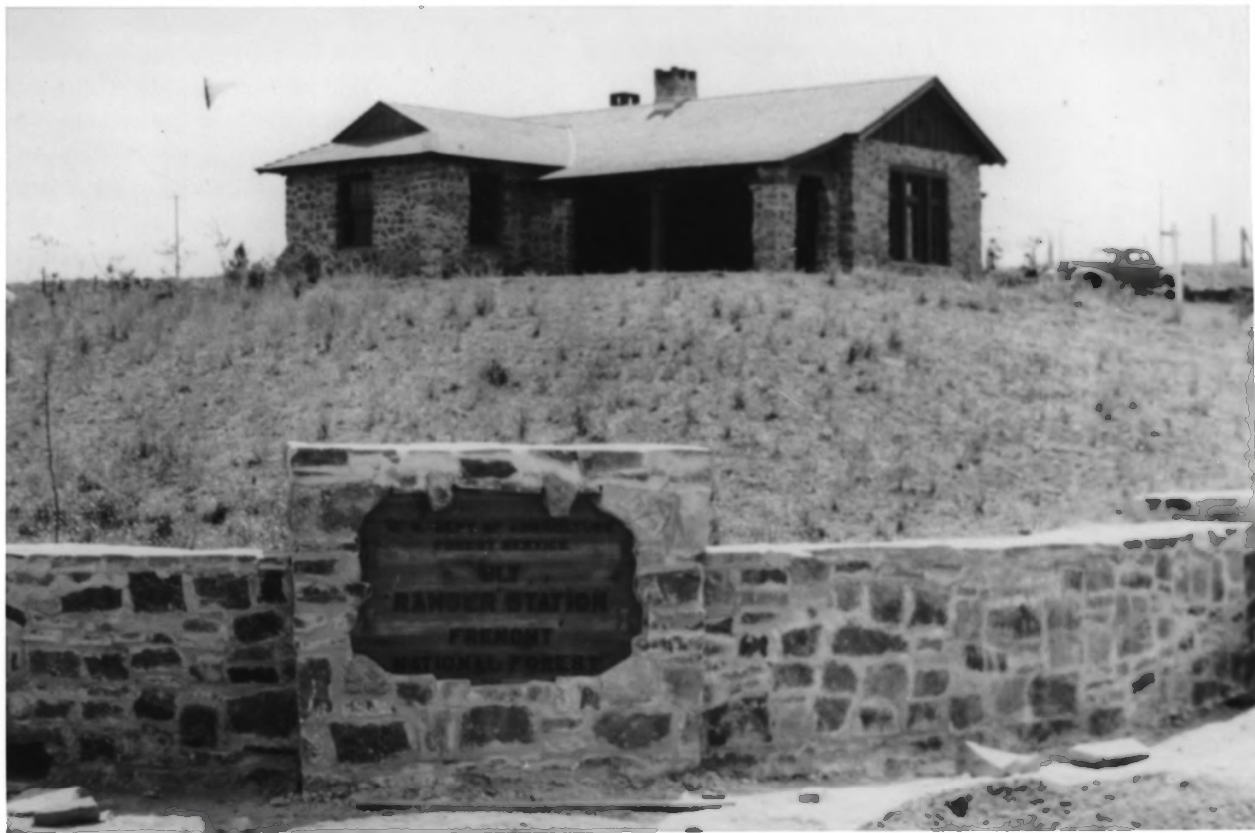
1. Assistant Ranger's Residence #1003, Bly Ranger Station/Historic District.
2. Bly, Oregon
3. Photographer: Unknown *Klamath co.*
4. Date: ca. 1938
5. Negative Location: Fremont National Forest Supervisor's Office, Lakeview, Oregon. Historic Photograph Collection.
6. From northeast, looking toward the north and east elevations of the Assistant Ranger's dwelling. Photograph shows architectural design, details clearly. Routed wood slab station sign, implanted in stone fence post, in immediate foreground.
7. Photograph Number: #3Hst.

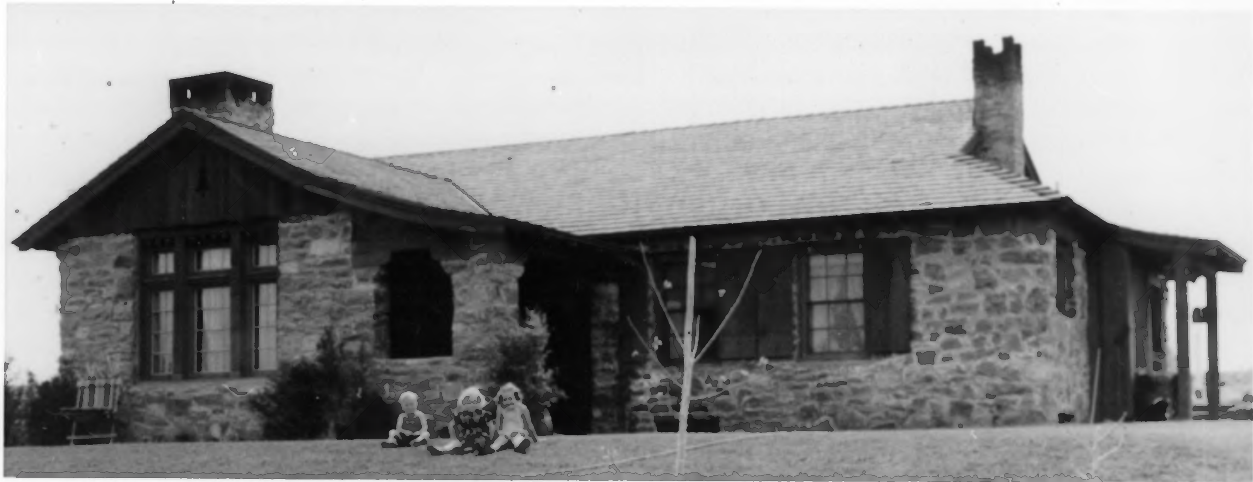
1. Ranger's Residence #1002, Bly Ranger Station
Historic District
2. Bly, Oregon
3. Photographer: Unknown
4. Date: ca. 1938
5. Negative Location: Fremont National Forest Supervisor's Office, Lakeview, Oregon, Historic Photograph Collection.
6. From northeast, the east (main) facade of the Ranger's Residence #1002. Photograph shows architectural design, details clearly
7. Photograph Number: #4 Hst.

4. Ranger's Residence #1002: 1936; 1505 sq. ft.; T-shaped, six room dwelling, 1 story wood frame, poured concrete foundation, basement, wood-shingled medium gable roof, gabled hip on north gable end, off-set gable projects from east facade with bellcast eave forming roof over semi-enclosed entry supported by buttressed stone pillars, squared-timber lintels distressed by adze to appear hand-hewn, short, rounded flush brackets, semi-circular arch window opening in stone porch wall, north hip extends to cover rear enclosed entry, exterior vertical board and batten. Exterior end chimney coarsed rubble, varying, on south gable end; stone interior chimney off-set on west roof slope. Stone exterior wall material to eave line, vertical board, angular cut, battens on gable ends, gablet, and rear enclosed entry, also on projecting bay on west facade. Decorated mullion window with six-over-six double-hung sash flanked by four-over-four sashes, surmounted by transom lights center, off-set east gable; six-over-six double-hung sash windows flanked by decorative shutters each with single simple pine tree cut out. Single large, well formed pine tree cut out centered south and east gable ends. Knotty pine interior, unaltered high ceiling with squared-timber beams and two trusses, hand-routed, and distressed with adze in living room, window seat flanked by built-in bookcases. Stone fireplace, pine-tree cut and fitted in center as cartouche; hand-forged wrought-iron chandelier, two small hand-made wall-mounted light fixtures. Wood-pegged wood cornice trim, knotty pine wall material; open structural door opening, squared-timber lintel adze-distressed, scrolled, short, rounded inset flush brackets. Dry masonry wall, cement steps, retain short natural slope and access house. Shorter, less extensive dry masonry wall retains a second slope rise and stone steps access a lawn area above house on west. No significant structural or material alteration. Excellent condition.

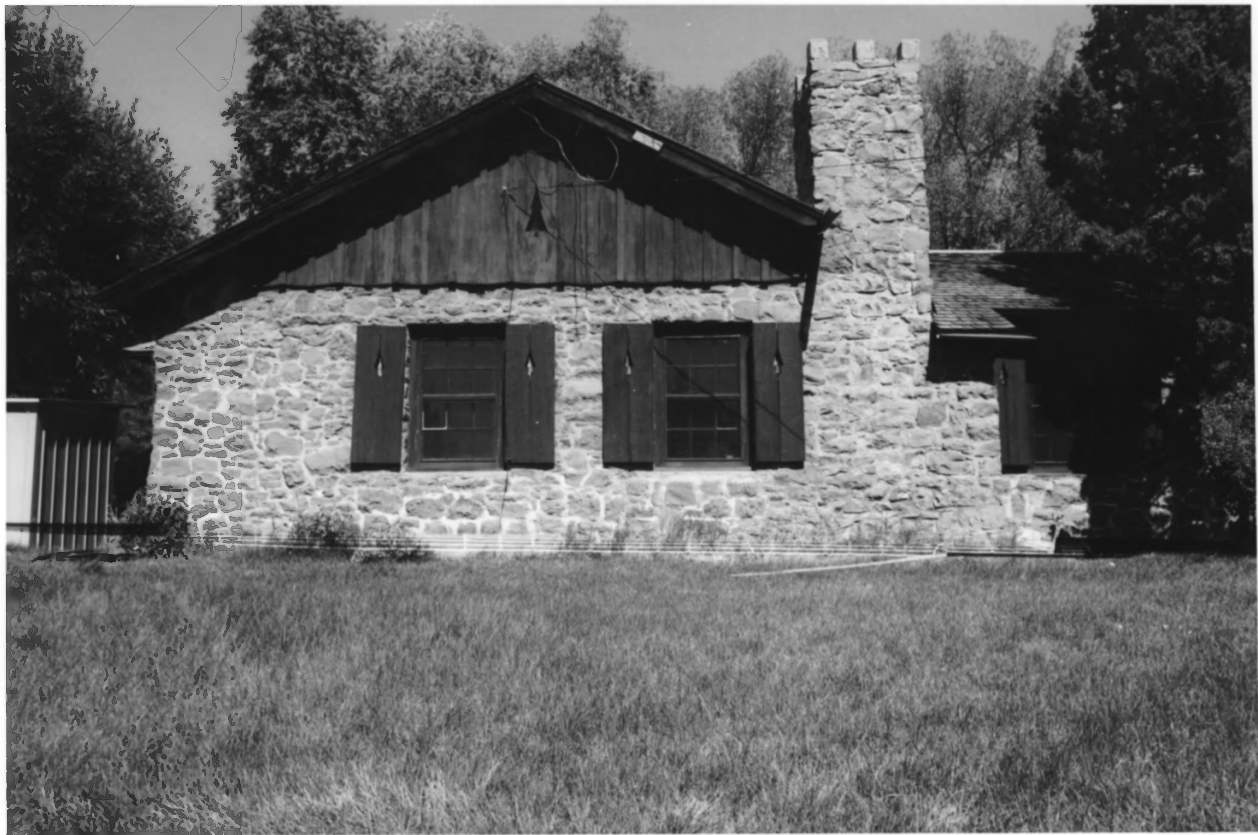
1. Ranger's Residence #1002, Bly Ranger Station
Historic District
2. Bly, Oregon
3. Photographer: E.G. Throop *Klamath Co -*
4. Date: August 1979
5. Negative Location: Fremont National Forest Supervisor's Office Lakeview, Oregon
6. From south, the south gable end of Ranger's Residence #1002, showing the high quality of stone masonry in exterior walls, typical windows treatment with decorative shutters, pine tree symbol incised in gable end.
7. Photograph Number: #4B

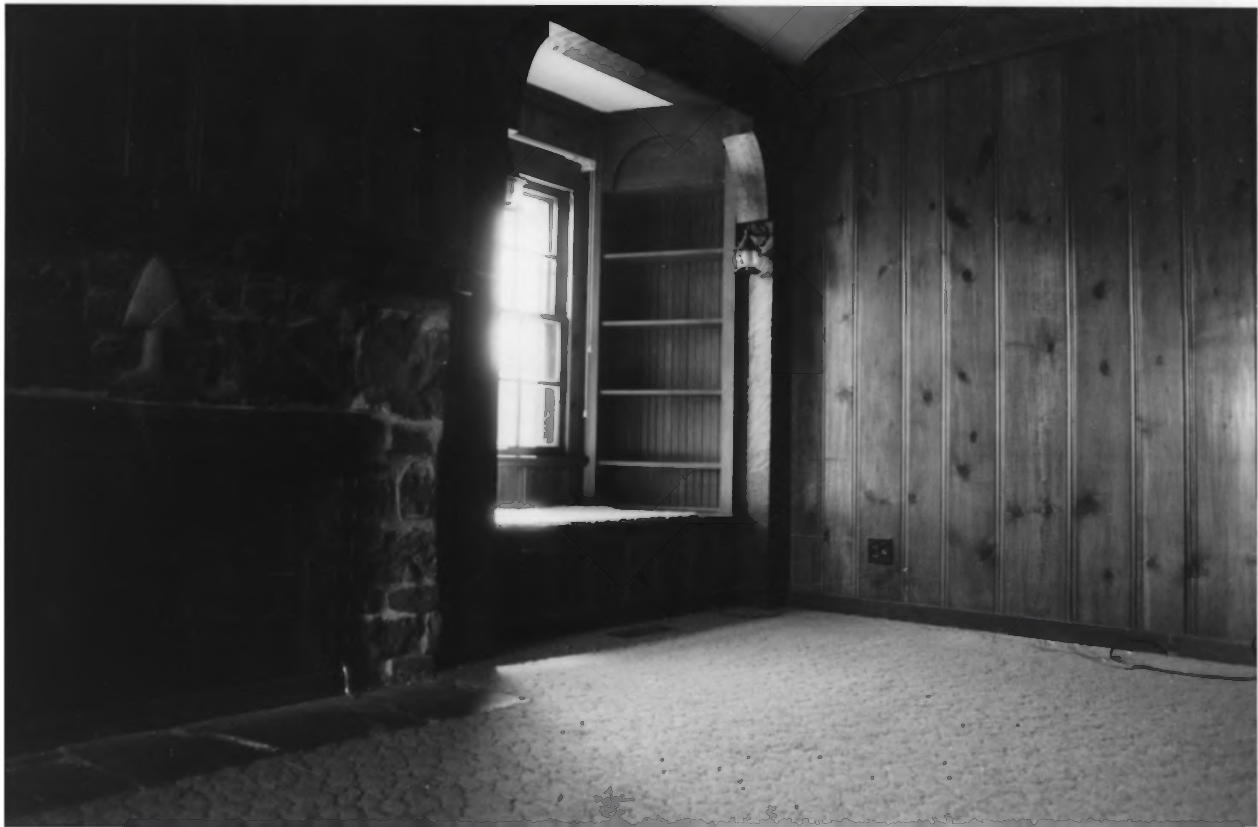
1. Ranger's Residence #1002, Bly Ranger Station
Historic District
2. Bly, Oregon
3. Photographer: E.G. Throop
4. Date: August 1979
5. Negative Location: Fremont National Forest Supervisor's Office, Lakeview, Oregon
6. Interior, living room, looking southwest: photograph shows knotty pine paneling, window seat with built-in bookshelves, hand-forged light fixtures, stone fireplace with pine tree cartouche.
7. Photograph Number: #4C

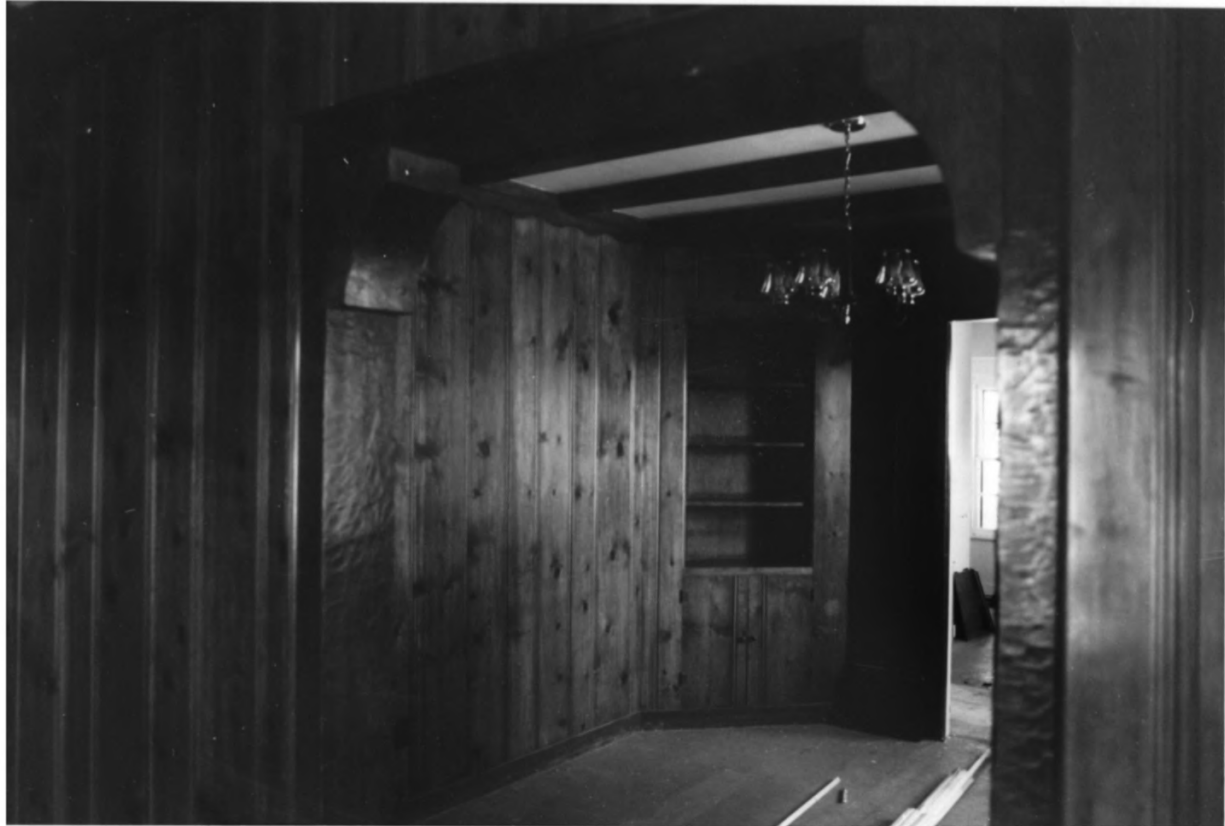
1. Ranger's Residence #1002, Bly Ranger Station
Historic District
2. Bly, Oregon
3. Photographer: E.G. Throop
4. Date: August 1979
5. Negative Location: Fremont National Forest
Supervisor's Office, Lakeview, Oregon
6. Interior, looking northwest from living room
toward dining room, photograph shows separating
arch with adzed uprights, and sorolled cross
member, curved flush brackets, knotty pine
paneling and built-in corner china closet.
7. Photograph Number: #4D

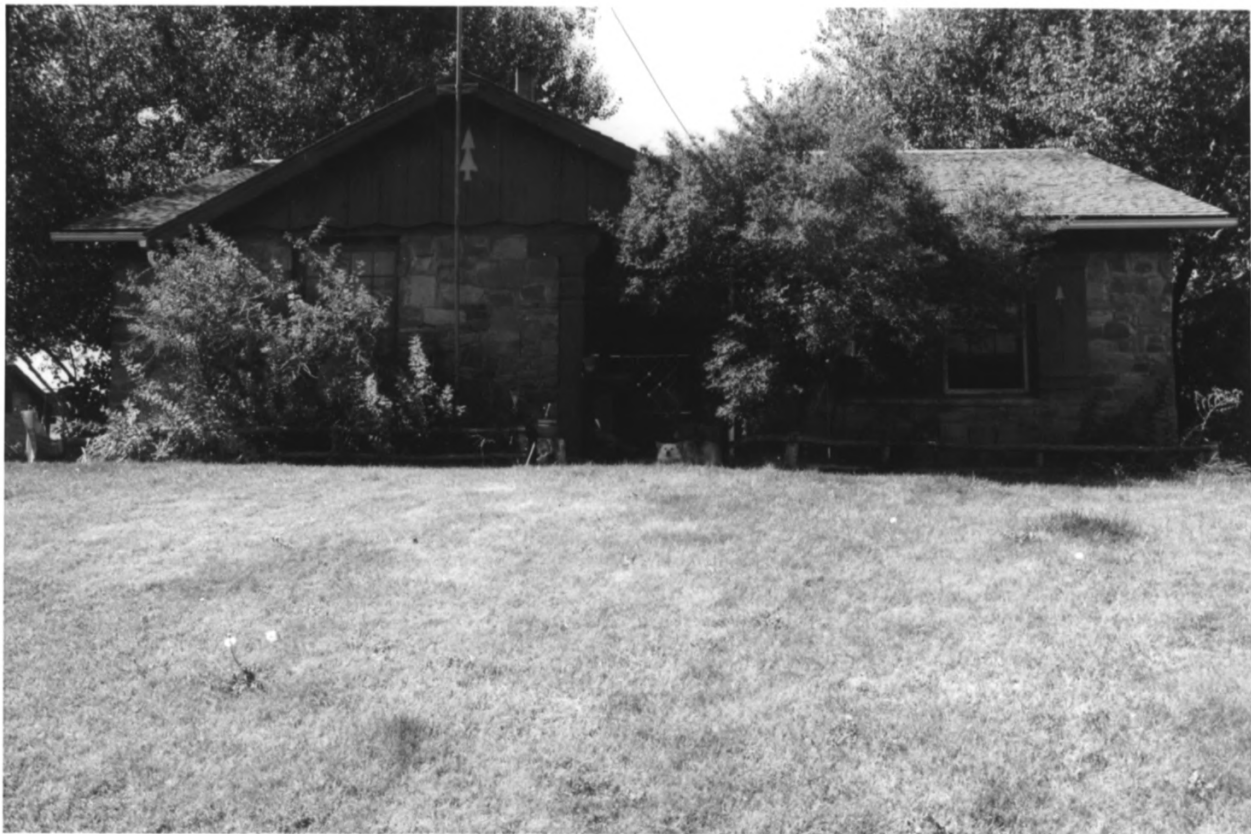
1. Guard's (P.A.'s) Residence #1004, Bly Ranger Station Ranger District
2. Bly, Oregon
3. Photographer: E.G. Throop *Klamath Co.*
4. Date: August 1979
5. Negative Location: Fremont National Forest Supervisor's Office, Lakeview, Oregon
6. Looking west at east (main) facade of Guard's Residence, photograph shows a differing application of stone in exterior walls, details of main entry.
7. Photograph Number: #15

5. D.E.A. Residence #1004: (formerly designated guard's or D.A. Residence) 1941; 936 sq. ft.; T-shaped, 4-room dwelling, 1 story wood frame, poured concrete foundation, basement. Wood-shingled medium gable, projecting center gable, north facade. Stone exterior, coursed rubble of dissimilar shapes and sizes incorporating red and green rhyolite gray basalt, occasional brick, corners not buttressed; vertical boards, angular cut and battens on all gable ends. Six-over-six double-hung sash windows flanked by decorative shutters, single well-shaped complex pine tree cut out. Single, large well-shaped pine tree cut out centered on each gable end. Uncovered entrance centered on south gable end; main entry recessed, off-set on center gable, porch roof supported by two large squared-timber posts, with short, rounded flush inset brackets, posts are hand-routed with chisel. Knotty pine interior, little alteration.

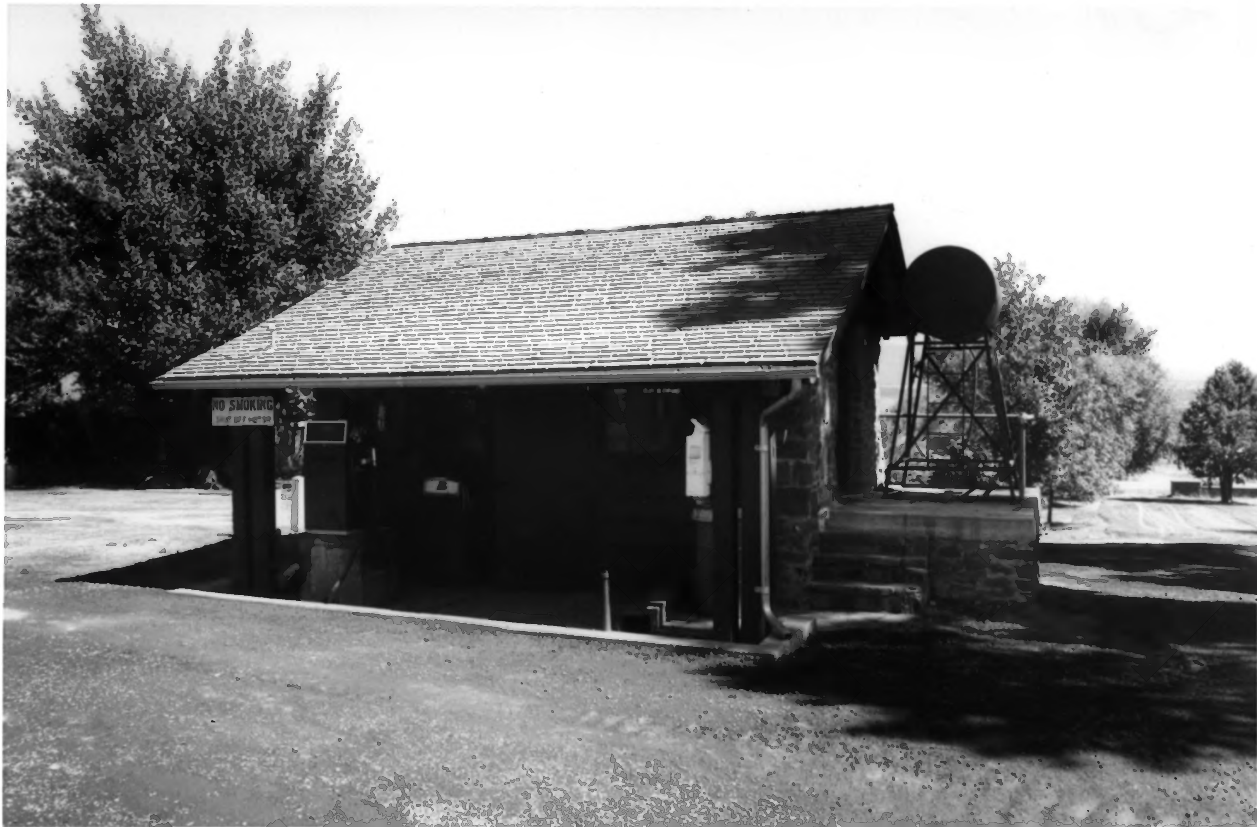
1. Gas and Oil House #2500, Bly Ranger Station
Historic District.
2. Bly, Oregon
3. Photographer: E. G. Throop
4. Date: August 1979
5. Negative Location: Fremont National Forest
Supervisor's Office, Lakeview, Oregon
6. From southwest, photograph shows west (main)
facade of Gas House, loading dock on south
gable end.
7. Photograph Number: #6

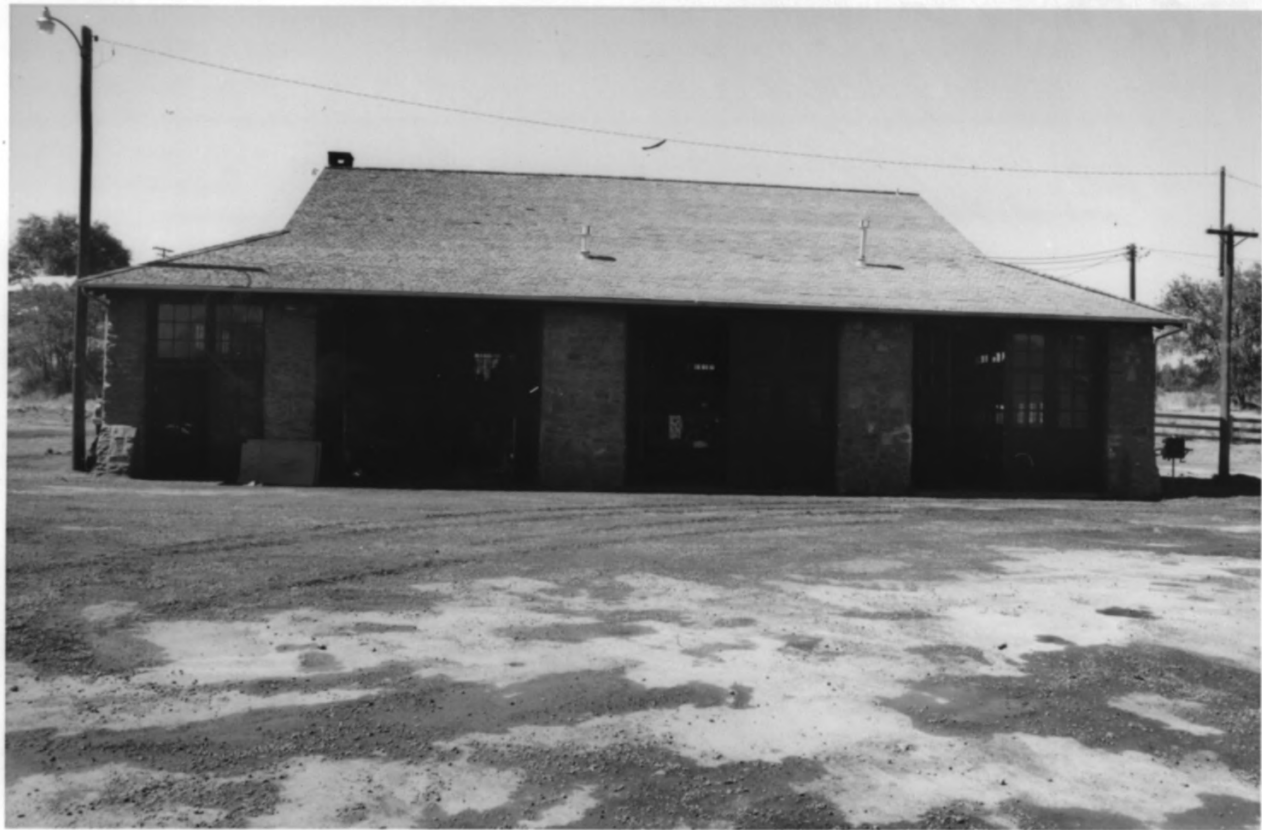
1. Warehouse#2201, Bly Ranger Station Historic District
2. Bly, Oregon
3. Photographer: E.G. Throop *Klamath Co.*
4. Date: August 1979
5. Negative Location: Fremont National Forest Supervisor's Office
6. From east, the main facade of Warehouse #2201. Photograph shows the corner buttresses, the folding double-leaf doors, and the pine tree symbol, set in green rhyolite, in the upper third of right hand pillar.
7. Photograph Number: #7A

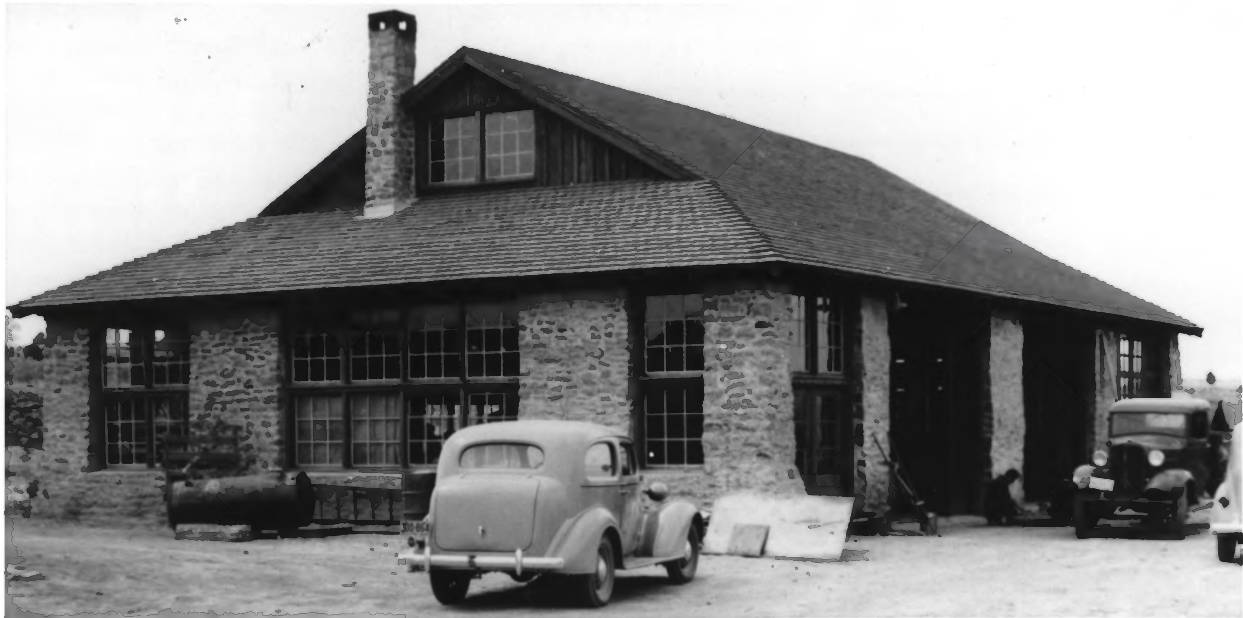
1. Warehouse #2201, Bly Ranger Station Historic District
2. Bly, Oregon
3. Photographer: Unknown
4. Date: ca. 1938
5. Negative Location: Fremont National Forest, Supervisor's Office, Lakeview, Oregon. Historic Photograph Collection.
6. From southeast, photograph shows the south gable end and east (main) facade of Warehouse #2201
7. Photograph Number: #7Hst.

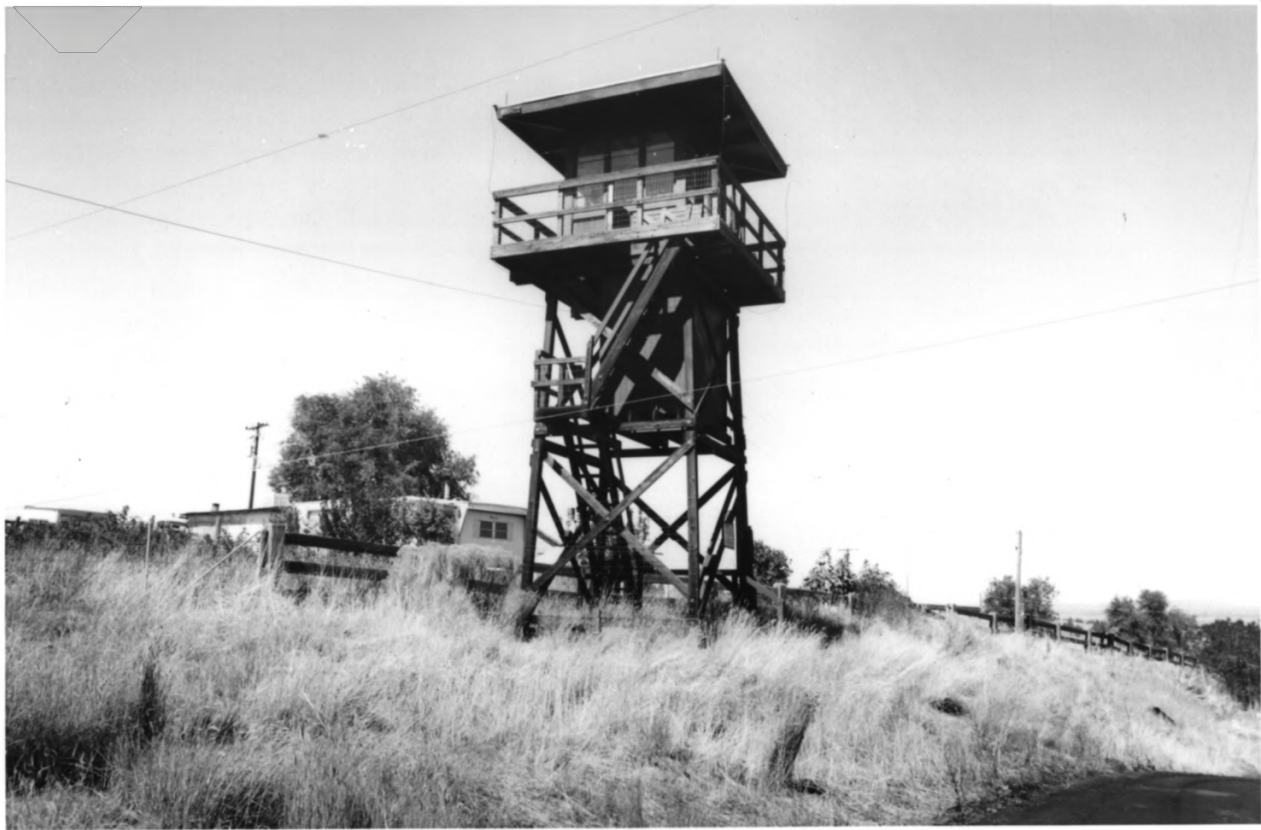
1. Fire Lookout #4214, Bly Ranger Station
Historic District
2. Bly, Oregon
3. Photographer: E.G. Throop
4. Date: August 1979
5. Negative Location: Fremont National Forest
Supervisor's Office, Lakeview, Oregon
6. From southeast, photograph shows the south
elevation of the tower, cabin and catwalk
of Fire Lookout #4214
7. Photograph Number: #8

A standard design fire lookout is located in the extreme southwest corner of the compound proper on the fourth terrace level above the Service Court. Contemporary with the construction of the Ranger Station, it was "maintained for the discovery of forest fires." It remains operational.

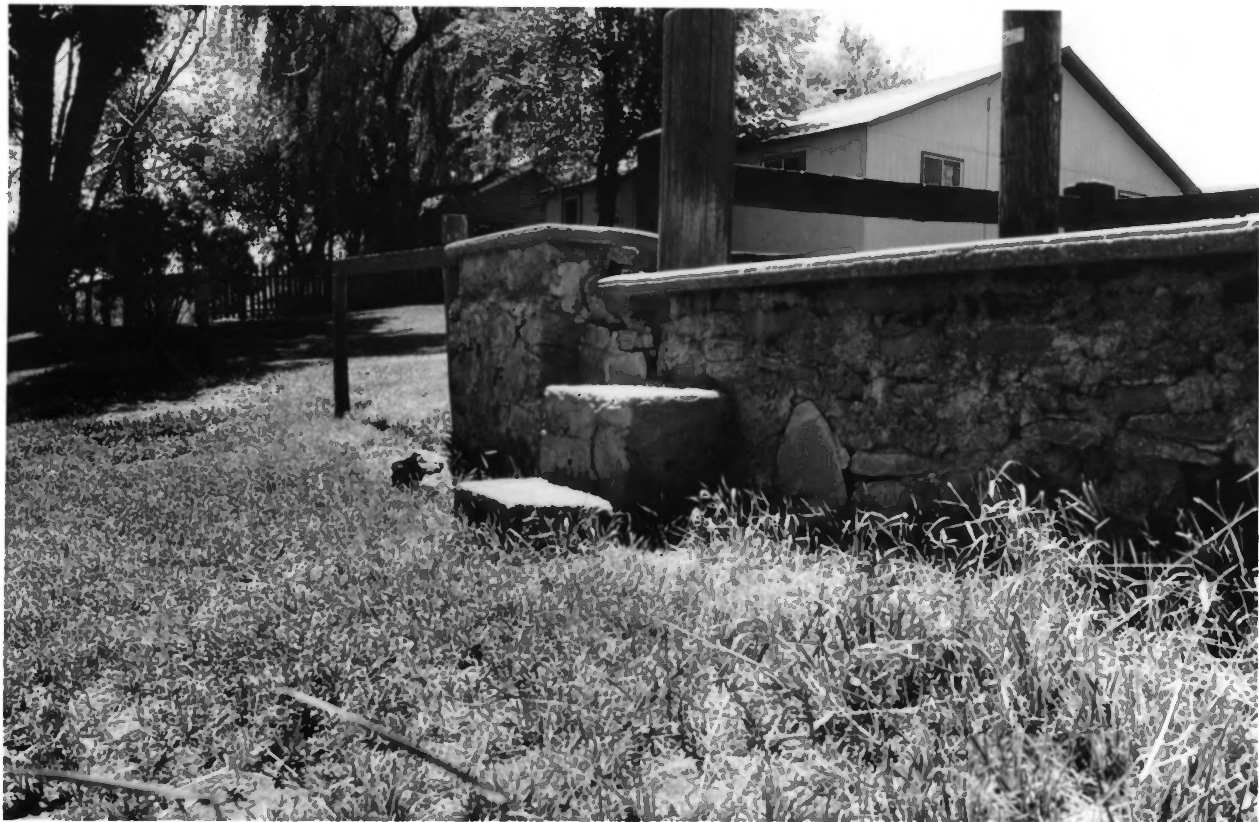
1. Stone Wall, Bly Ranger Station Historic District
2. Bly, Oregon
3. Photographer: E.G. Throop *Klamath Co.*
4. Date: August 1979
5. Negative Location: Fremont National Forest
Supervisor's Office, Lakeview, Oregon
6. From northeast, the southernmost corner of stone wall. Photograph shows varying quality of stone masonry; details of corner post and stile. Photograph also shows concrete capstone placed to protect wall from further weathering of stone and mortar.
7. Photograph Number: #9A

9. Stone Wall: 1936-37; Extends across the length of Forest Service property fronting on State Highway 140. Solid stone railing interspersed with stone posts, red and green rhyolite, gray basalt in irregular shapes and sizes, coursed. Quality of stonemasonry is less than that of compound structures. Deterioration of softer stones used, separation and washing of mortar resulted in protective cement capstone as a recent addition. Some repairs and replacement of materials, but not obvious or incompatible.
