**NATIONAL REGISTER OF HISTORIC PLACES
INVENTORY -- NOMINATION FORM**

HISTORIC
Bly Ranger Station
AND/OR COMMON
Bly Ranger Station

7 DESCRIPTION

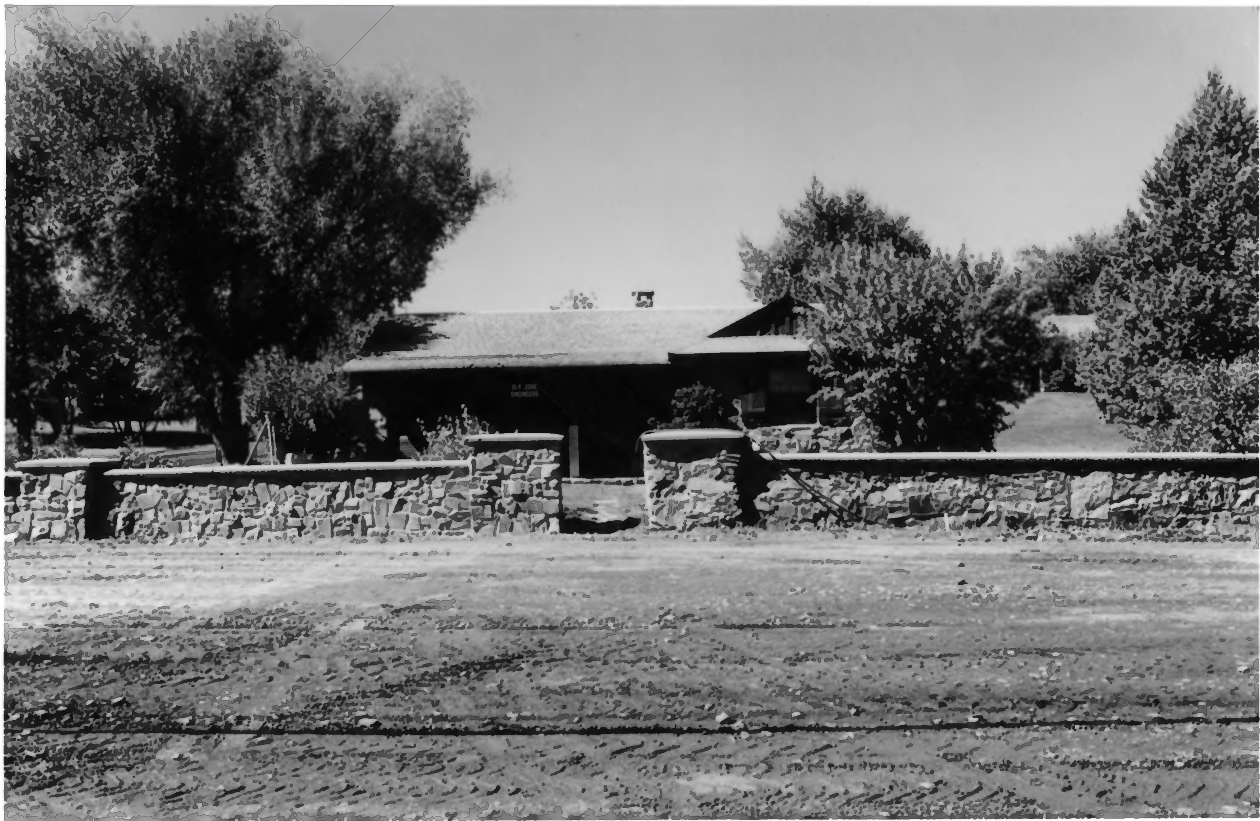
1. Stone Wall, Bly Ranger Station Historic District
2. Bly, Oregon
3. Photographer: E.G. Throop *Klamath Co.*
4. Date: August 1979
5. Negative Location: Fremont National Forest Supervisor's Office, Lakeview, Oregon
6. From east, portion of stone fence delineating eastern boundary of Bly Ranger Station Historic District. Photograph shows stone posts, solid railing, and quality of stone masonry.
7. Photograph Number: #9B

9. Stone Wall: 1936-37; Extends across the length of Forest Service property fronting on State Highway 140. Solid stone railing interspersed with stone posts, red and green rhyolite, gray basalt in irregular shapes and sizes, coursed. Quality of stonemasonry is less than that of compound structures. Deterioration of softer stones used, separation and washing of mortar resulted in protective cement capstone as a recent addition. Some repairs and replacement of materials, but not obvious or incompatible.

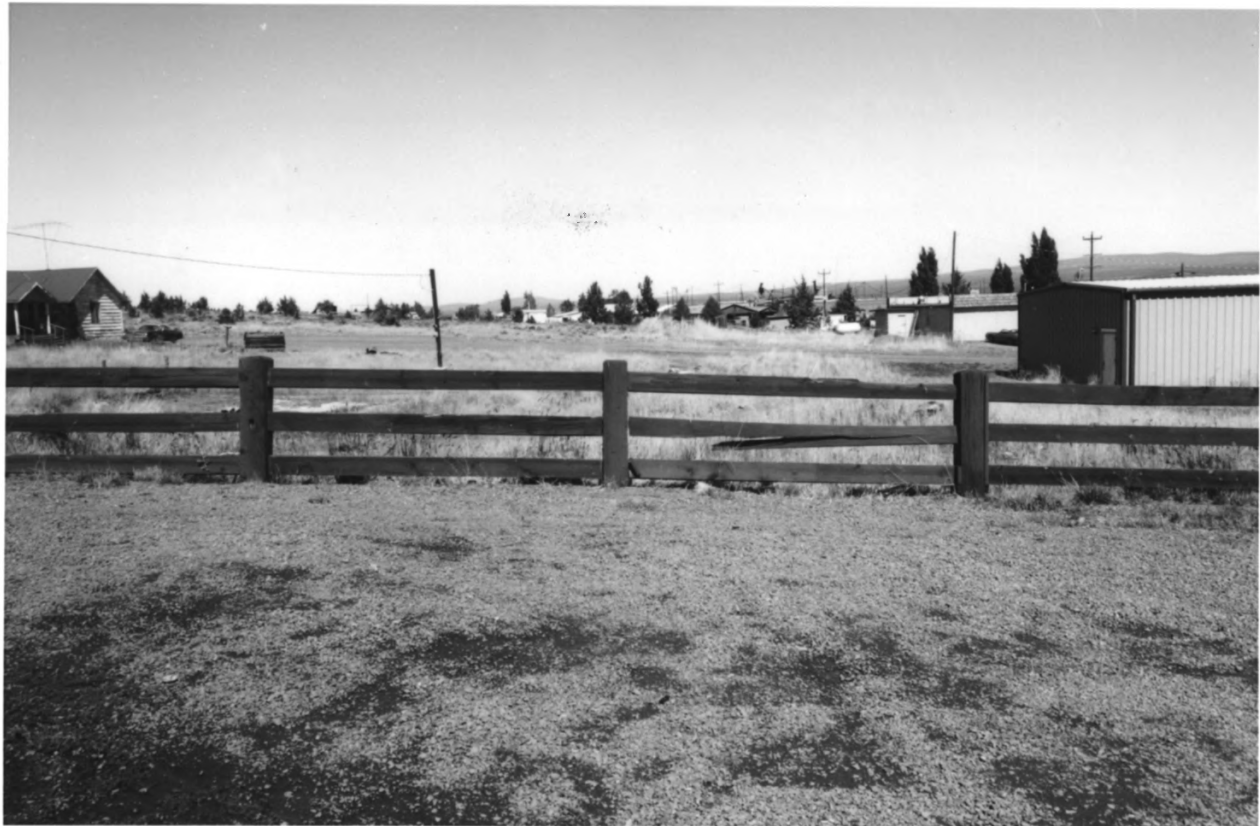
1. Post and Rail Fence, Bly Ranger Station Historic District
2. Bly, Oregon
3. Photographer: E.G. Throop *Klamath Co.*
4. Date: August 1979
5. Negative Location: Fremont National Forest Supervisor's Office, Lakeview, Oregon
6. From south, portion of post and rail fence delineating northern perimeter of Bly Ranger Station Historic District. Photograph shows rails notched into posts; damaged rail.
7. Photograph Number: #10

10. Post and Rail Fence: 1936-37; defines northern, southern and western limits of Forest Service property. Squared-timber posts, 3 feet, three horizontal 1 x 4 board rails notched into posts. Some repairs, rails reaffixed.

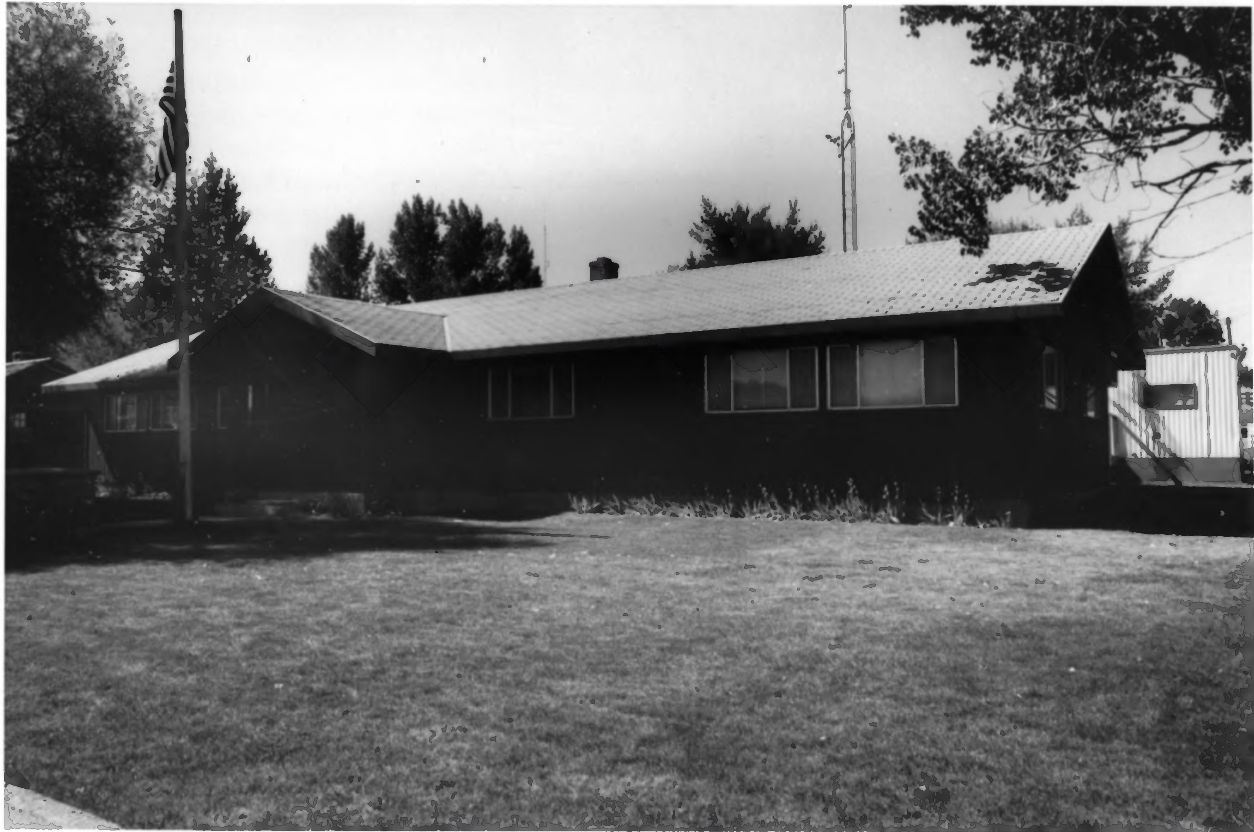
1. Office #2006, Bly Ranger Station Historic District
2. Bly, Oregon
3. Photographer: E.G. Throop
4. Date: August 1979
5. Negative Location: Fremont National Forest Supervisor's Office, Lakeview, Oregon
6. From northeast, the east (main) facade and north gable end of Office #2006. Building exhibits nonconforming architectural design and exterior materials.
7. Photograph Number: #11

11. New Office #2006: ca 1963; rectangular, 1 story, wood-frame, poured concrete foundation, low gable roof with center porch gable, east (main) facade, brick interior chimney, center, west slope of roof. Vertical board exterior walls. Aluminum casement windows. Main entry, single leaf laminated door, center east facade, accessed by two-straight cement steps, open cement platform covered by low center porch gable. Rear entry, center, west facade, enclosed by added shed-roof vestibule, open on north elevation. No decoration. Composition shingles.

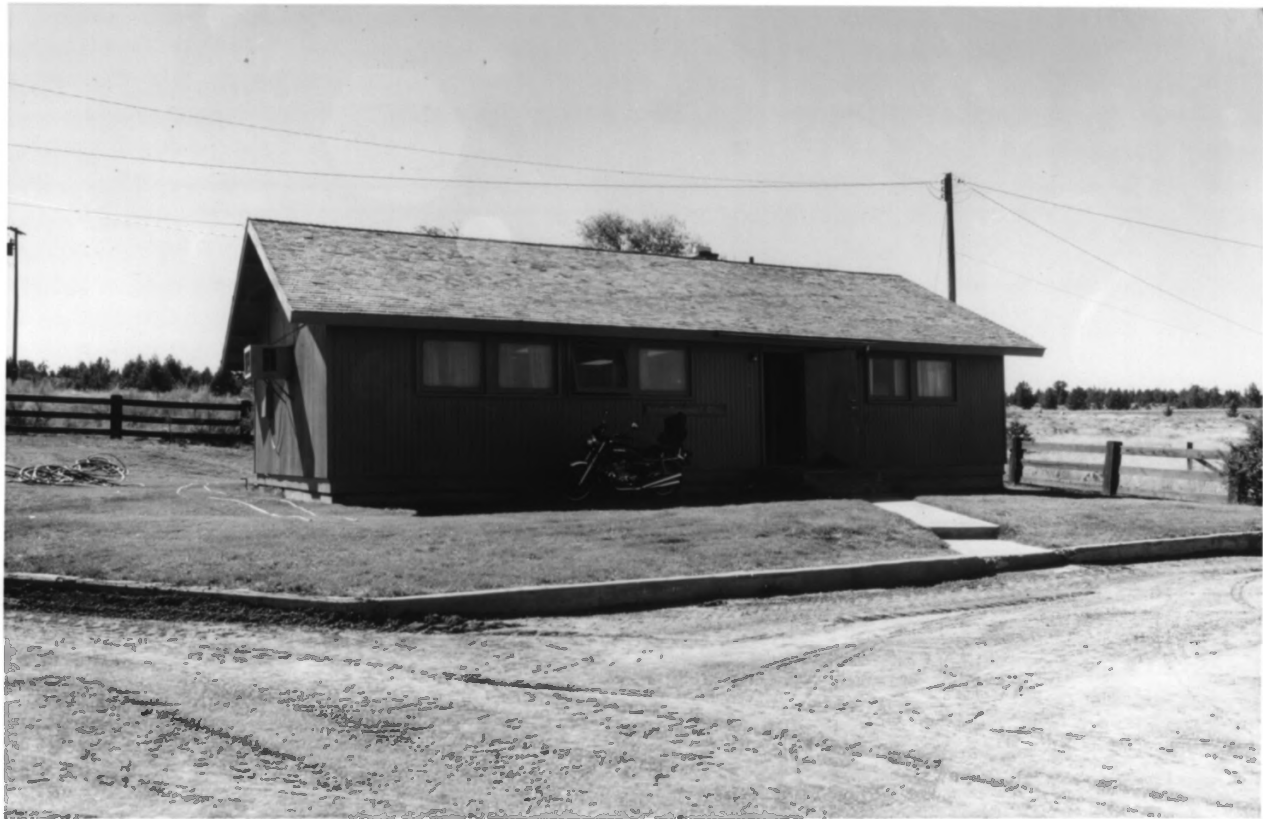
1. Timber Management Office #1305, Bly Ranger Station Historic District
2. Bly, Oregon
3. Photographer: E.G. Throop *Klamath Co.*
4. Date: August 1979
5. Negative Location: Fremont National Forest Supervisor's Office, Lakeview, Oregon
6. From southeast, the east (main) facade and south gable end of Timber Management office #1305. Building exhibits nonconforming architectural design and exterior materials
7. Photograph Number: #12

12. Timber Management Office #1305: ca 1963; rectangular, 1 story, wood-frame, poured concrete foundation, wood-shingled low gable roof. Exterior walls covered with vertical commercial siding. Aluminum casement windows. Main entry, single-leaf laminated door, off-center on east (main) facade, accessed by two straight cement steps, small open platform, uncovered. No decoration.

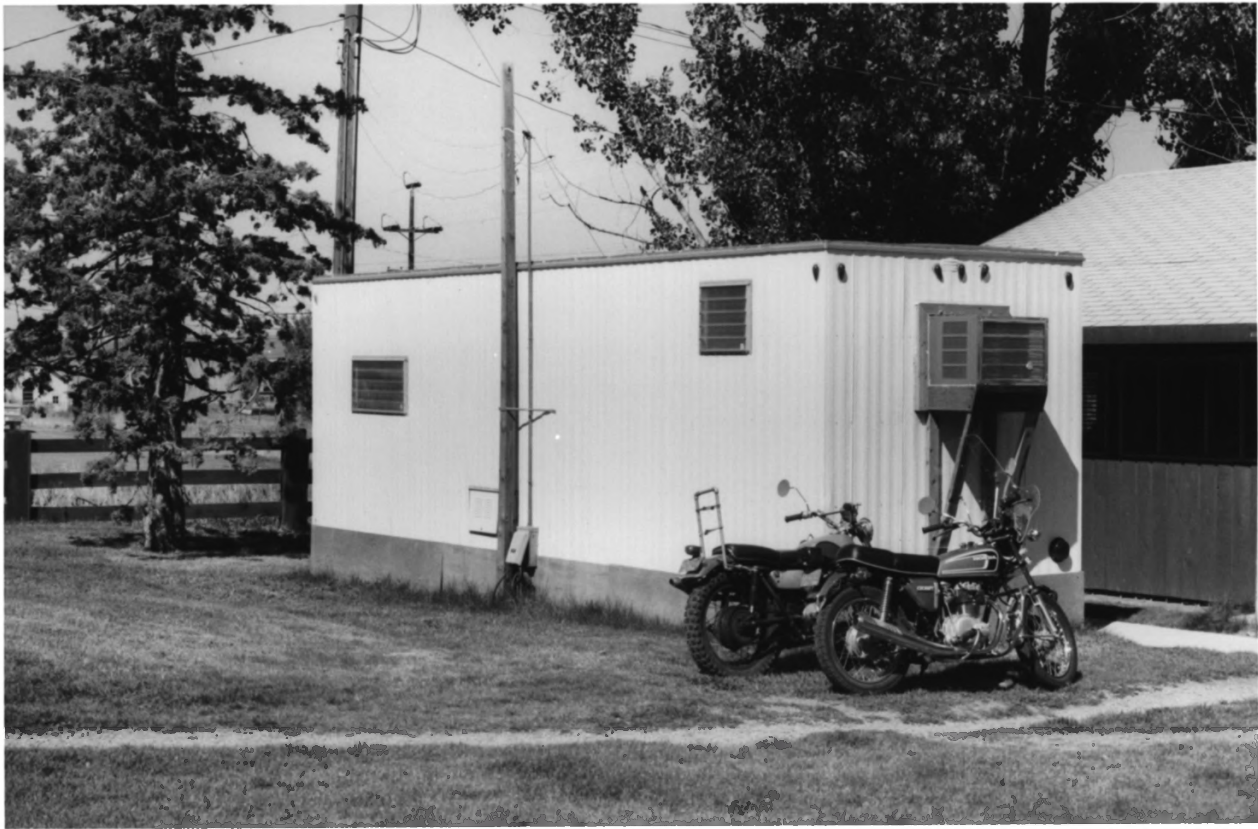
1. Office Annex, Bly Ranger Station Historic District
2. Bly, Oregon
3. Photographer: E.G. Throop *Klamath Co.*
4. Date: August 1979
5. Negative Location: Fremont National Forest Supervisor's Office, Lakeview, Oregon
6. From southwest, the west and south elevations of office annex. Structure represents a nonconforming intrusion within the boundaries of the Bly Ranger Station Historic District.
7. Photograph Number: #13
