# National Register of Historic Places Inventory—Nomination Form

Type an entire	· complete applicas.	J. 0000.00.10		
1. Nam	le .			
historic	Zimmerman, Jacob	, House Nu	mber of contributing	resources 2
and/or common	Same	Nu	mber of non-contribu	ting resources 1

The Jacob Zimmerman House is a two-story farmhouse with one story kitchen wing, originally constructed in 1878 in the Classic Revival style. Altered substantially in 1899, the house today primarily reflects its Queen Anne/Eastlake-style modifications. Apart from the 1899 alterations, the house retains its original integrity and finishes. The nominated parcel includes a woodshed, "brick dairy" and garage, of which the former two are contributing buildings. The garage does not relate to the historic period of significance, but is nonetheless compatible with the ensemble.

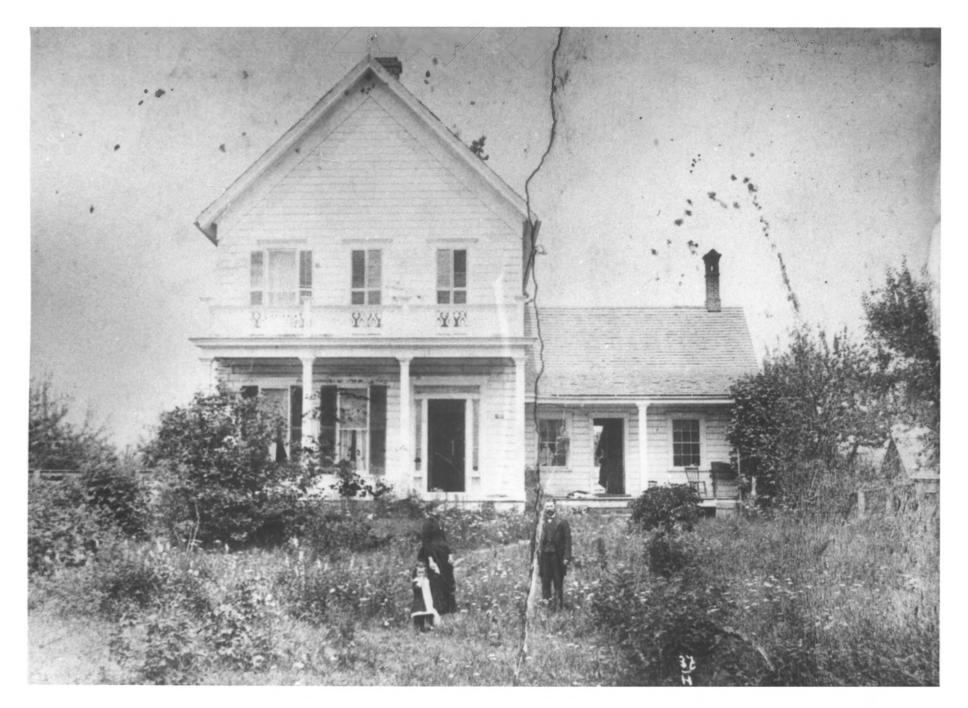
1 of 16 Historic view, South (front) elevation, c. 1890, prior to remodeling

The house is essentially L-shaped in plan with a single-story kitchen wing on the east side. The main two-story volume presents gable ends to the south (front) and west elevations. As originally constructed, the building consisted only of a two-story rectangular volume (north/south orientation) with an attached one-story wing to the east. Cornice moldings over windows, beveled wooden "quoins," classicized square porch columns, wide raking cornice and boxed eaves are typical Classic Revival features present on the 1878 building.

The Eastlake-style ornament on the Zimmerman House is particularly notable. The elaborate foliated sawn balustrade on the upper porch shown in a c. 1890 photograph, appears to have been the inspiration for the 1899 upper balustrade, although changes in supports and spacing suggest that the existing balustrade may have been copied from the one seen in the photograph. Parenthetically, there is also reason to suspect that the sawn balustrade in the 1890 photo was not original, as its design was not in character with the house's original Classical Revival decorative motifs.

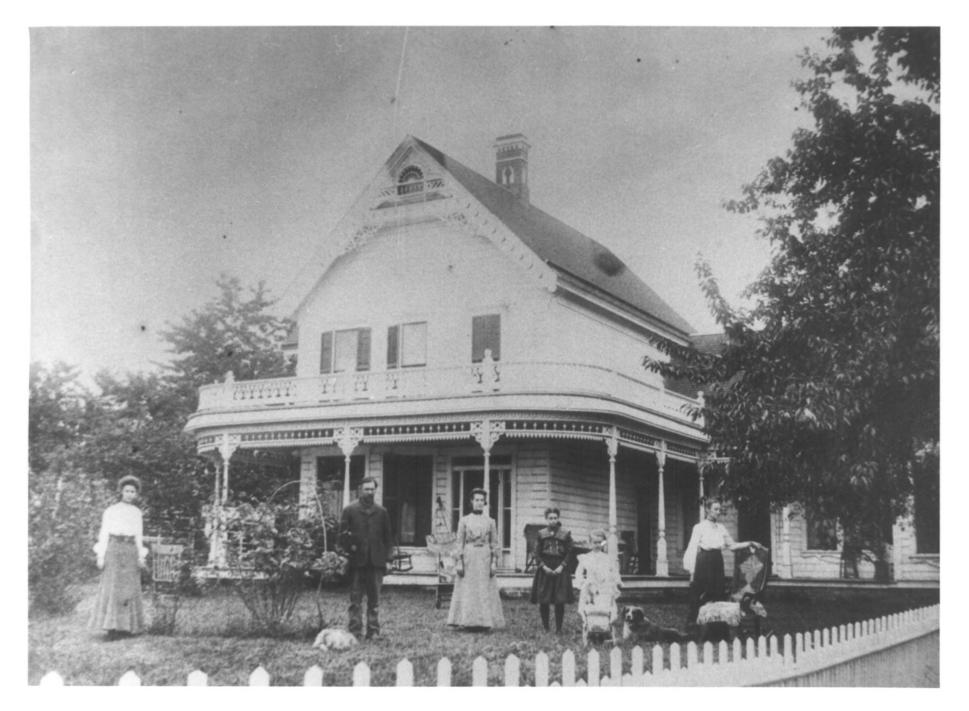
2 of 16 Historic view, South (front) elevation, c. 1905, showing remodelling of 1899.

In 1899, the house was enlarged by a local carpenter, Jack Brown, to reflect a Queen Anne/Eastlake profile. Changes included the substantial expansion of the exterior porches, in the Eastlake style, an extension of the east wing, the addition of a west wing, the addition of a slanted bay projection on the south elevation, the addition of a cedar shingle covering on the upper south elevation gable end, the alteration of east wing windows, the addition of a "flower house" on the east wing extension, plus the addition of jigsawn, scroll-cut boards beneath selected window sills.

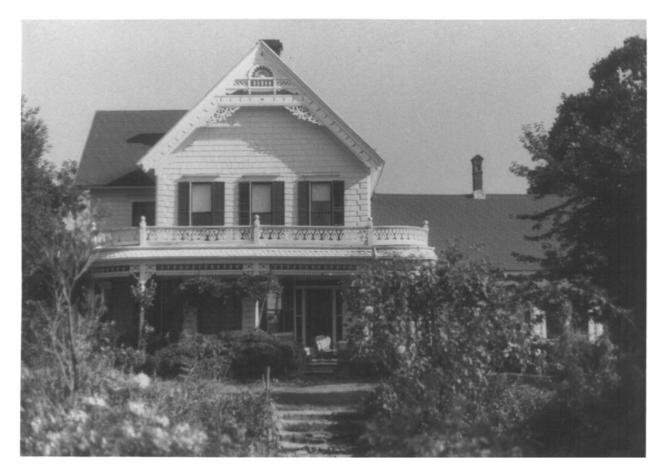
4 of 16 South (front) elevation

A slightly flared shingled skirt appears below the upper balustrade, and shelters the frieze below, which consists of an applied band of scallop-edged boards over identical bays consisting of opposing rectangular panels with a pierced, stylized foliate design, between which appears a succession of reel ornaments. These features are supported by a plain horizontal board, below which appears a sawtooth frieze. Porch supports are 6-inch turned posts embellished with sawn scroll brackets and a circular applied ornament. There is no lower porch balustrade.

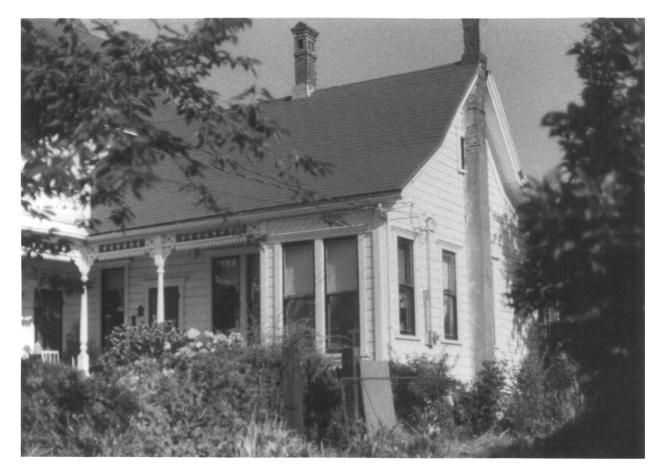
5 of 16 South (front) and East end of east wing (kitchen)

The new kitchen was added in 1899 directly east of the dining room. The kitchen remains unchanged except for a more recent electric stove. To the north of the kitchen is the pantry, which now serves as a utility room. The kitchen addition sets on brick piers, which appear to be sturdy.

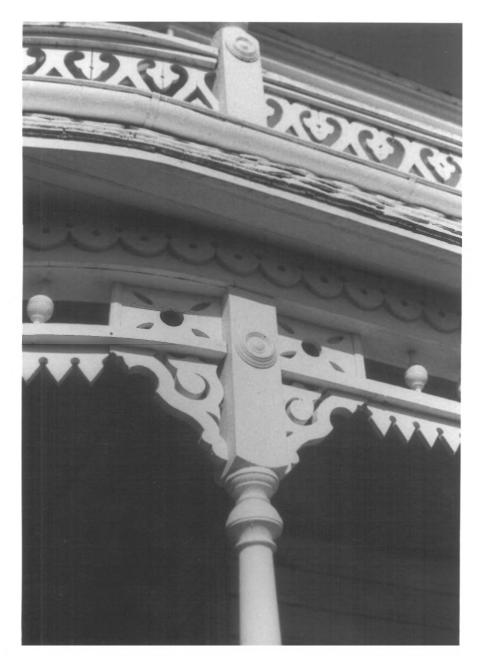
7 of 16 Detail of stylized Eastlake ornament, front porch

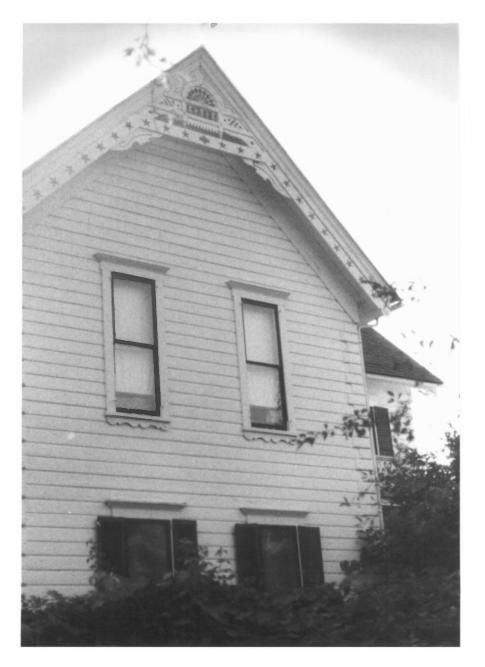
8 of 16 Gable, west wing

Bargeboards on the south and west elevations are equally elaborate, consisting of various applied and pierced boards, with sunburst bead and reel patterns. Notable are the star cutouts on the west, and quarter moon cutouts on the south elevation.

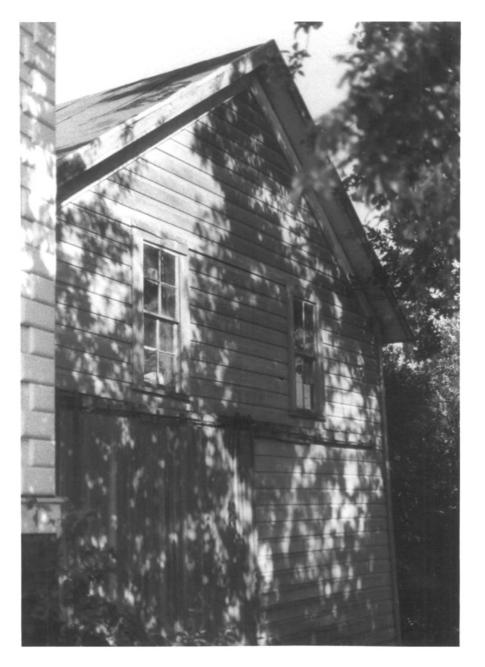
10 of 16 East elevation of woodshed attached to north side

The attached woodshed was constructed c. 1899, measures 25' x 30', and lies directly north of the kitchen and dining room. It is 1-1/2 stories and is sided with 6" drop siding and now has composition roofing. Cedar shingles were most likely the original roofing material. Windows are four-over-four, double-hung sash. This building had quarters for the hired hands above, and drive through doors for wood delivery. Between the west drive-through door below and the basement double doors is a brick paved area. The owner recalls her uncle exchanging room and board for labor. He laid the brick paving where the wagon wheels always made ruts behind the house. Overgrowth makes this area inaccessible.

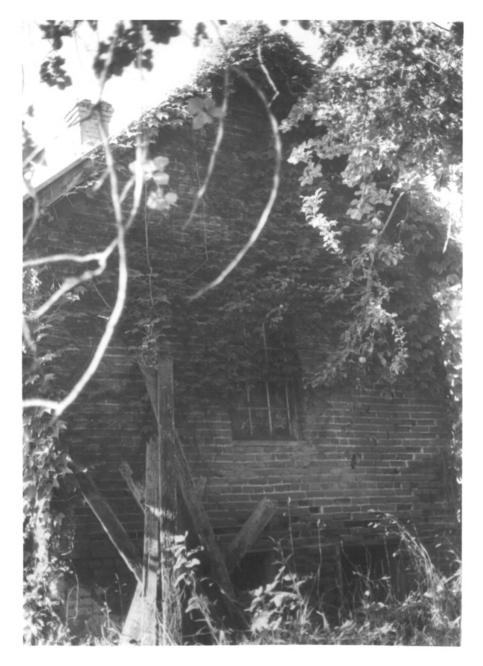
11 of 16 Brick dairy building, North (rear) eleavation

The "brick dairy" (c. 1890s) measures 14' x 25', and is of frame construction with brick veneer. It has two windows with six-over-six, double-hung sash. George Zimmerman made cheese and butter in this building. There is one interior chimney with corbel cap. Boston ivy has overtaken the building and has damaged the brick veneer facing.

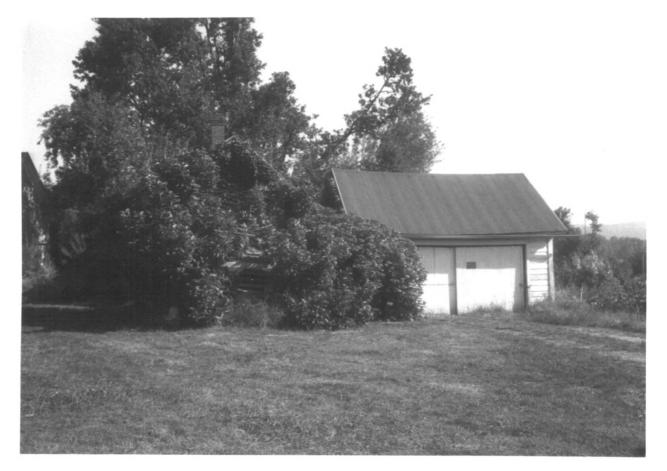
12 of 16
South elevations, vine-covered brick dairy building and 1920s garage. The garage is non-contributing but compatible

The double garage which was built c. 1920 from salvaged drop siding and other available materials may or may not be significant on its own, but blends in with the cluster of outbuildings that remain of the Zimmerman farm.

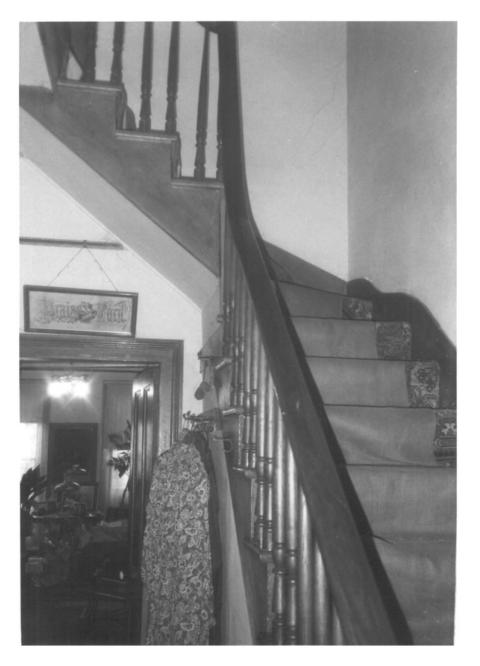
13 of 16 Entry stairhall, looking North

The main entrance hall is plastered with a blue and gold picture molding. The open staircase is oak and leads to the three bedrooms upstairs. Two of these bedrooms were enlarged during the extension of the west gable approximately five feet. The three bedrooms are also finished in plaster. The hallway upstairs contains one floor-to-ceiling attached cabinet, which probably served as a clothes closet, and a cedar woolen storage bin.

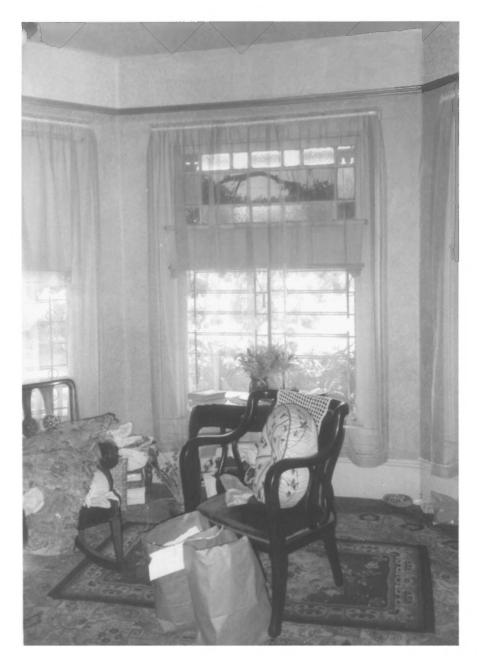
14 of 16 Front parlor, looking South

The parlor is plastered and wallpapered and features gilt picture molding and painted baseboards. It is illuminated with a c. 1920s light fixture. The property owner recalls electricity coming to the area at that time. During the 1899 remodeling, the two front windows were eliminated in favor of a projecting bay with three windows, the central one containing colored glass.

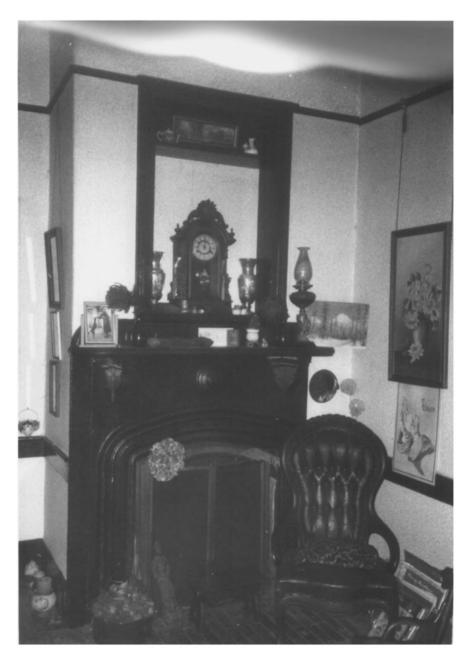
15 of 16 Chimneypiece, rear parlor

Beyond the main hall and to the north lies the sitting room which contains the only interior fireplace. The mantel is wood and dark-stained plaster. The room is wallpapered and has a dark chair rail stained to match the fireplace and 4-panel doors. The wood in this room has been stained so heavily that it appears not to be wood at all. This room contains the entrances to the two main floor bedrooms. The rooms are also plaster finished, and you can see the scar caused by enlarging these bedrooms approximately 5 feet to the west. The sitting room has an elaborate colored glass door for it's own separate entrance. Beside this door there is a coat closet which contains a trapdoor to the 1/2 basement.

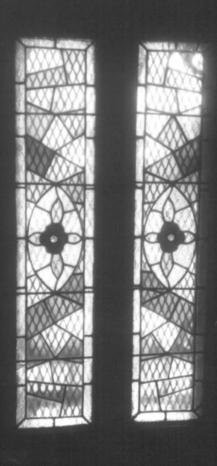
16 of 16 Stained glass panels, door to sittingroom

The four exterior doors have colored and frosted glass panes. Three have ornamental screen doors painted black. The main entrance door is oak and has a large ornate brass door bell. Colored glass side lights and transom frame the doorway.
