United States Department of the Interior
National Park ServiceNational Register of Historic Places
Registration Form

historic name Eugenia Apartments
other names/site number N/A

street & number 1314 S.E. Salmon ☐ not for publication
city, town Portland ☐ vicinity
state Oregon code OR county Multnomah code 051 zip code 97214

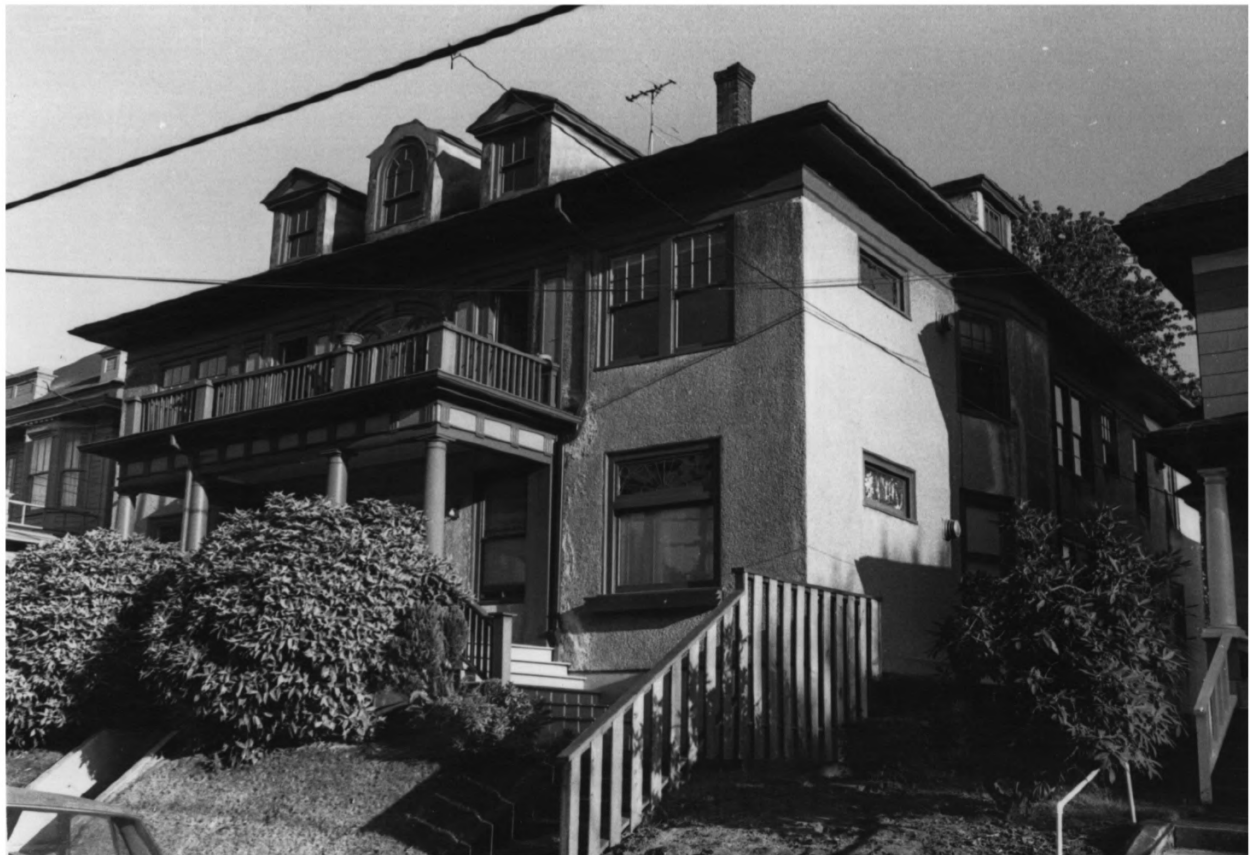
- 1 1314 S.E. Salmon RUBENIA ARANTMANIS
- 2 Portland, Oregon, Multnomah County
- 3 Smith, Patrick
- 4 August 1988
- 5 Roll S-21 # 24
- 6 Looking southeast at north and west elevations.
- 7 #1 OF 3

This two-story house is rectangular in plan with a two-story porch in the center toward the street. A shallow pitched hip roof of composition shingles crowns the structure with overhanging eaves below which runs a one-foot wide dentilated cornice. Two hip dormers with single three-over-three double-hung sash windows face the east and west. Three dormers are grouped at the front (north) edge of the roof. A central dormer has a round-headed window with radiating muntins in the upper sash and is flanked by pedimented dormers. These also have single three-over-three double-hung windows. Four red brick chimneys rise from the roof.

The front elevation of the house is symmetrical except for the recessed entry which is slightly off center. The attached porch has four regularly spaced Doric columns with a plain balustrade. A classical entablature surrounds the top of the porch with a frieze of triglyphs and guttae. Above the porch on the second level there is a balustrade between four square piers. The majority of

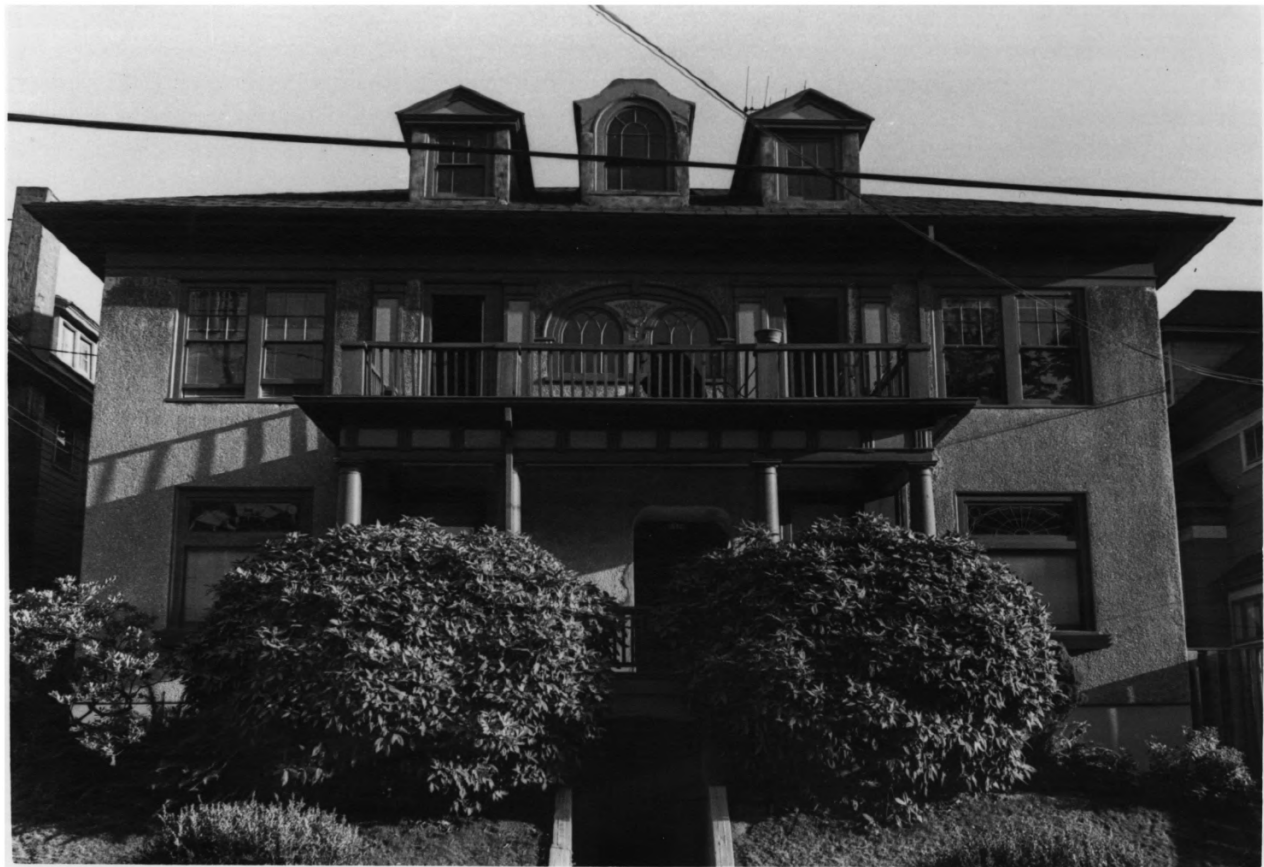
1 1314 S.E. Salmon ~~EUGENIA~~ APARTMENTS
2 Portland, Oregon, Multnomah County
3 Smith, Patrick
4 August 1988
5 Roll 5-21 #22
6 Looking south at north elevation
7 #2 of 3

the surface decoration appears on the second level. At the center, there is a segmented wood arch within which are two round-arch windows divided by curved muntins. Between these windows a floral design executed in plaster ornaments the spandrel. Two multi-paned doors on either side of this segmented arch are themselves flanked by wood pilasters with recessed panels and simple capitals. A pair of six-over-one double-hung windows are found on opposite sides of this second-floor decorative facade.

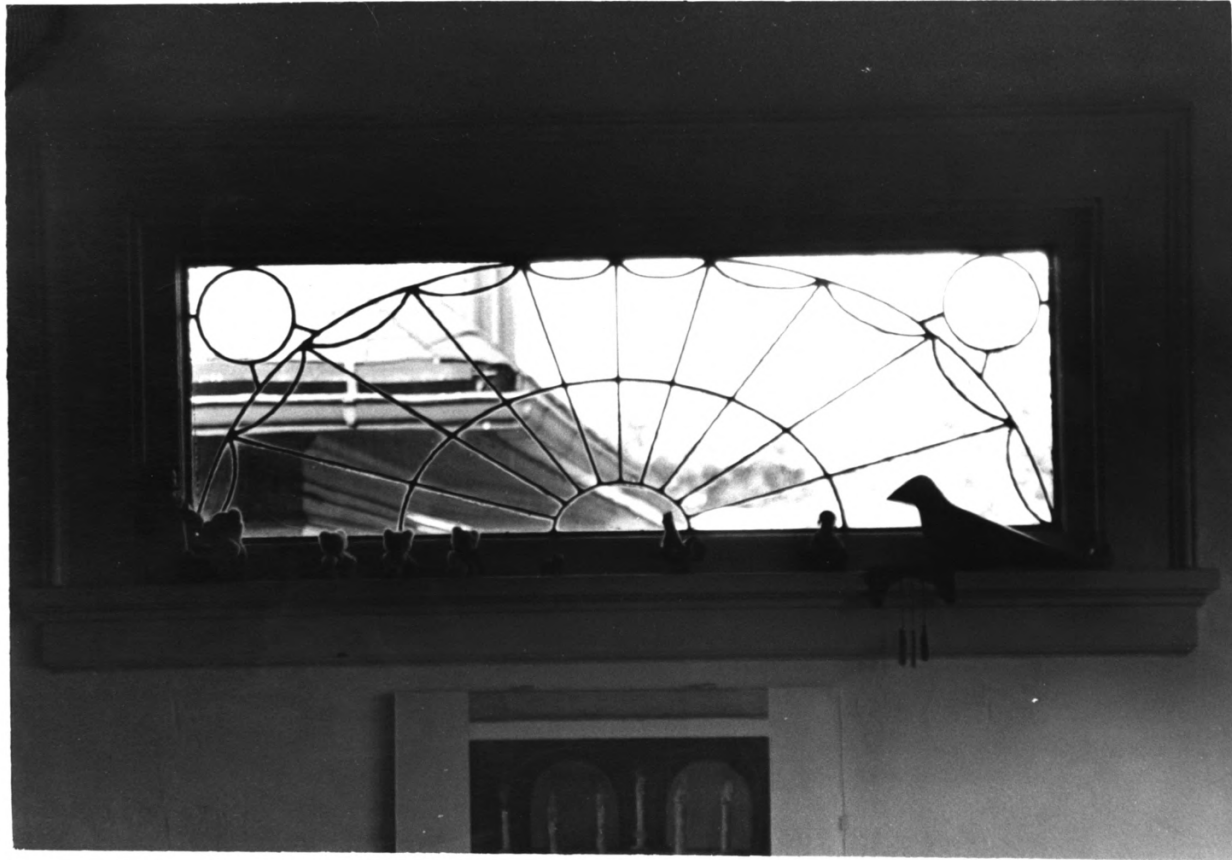
7 #3 OF 3

6 Interior detail of leaded glass casement

The front units are entered from the front stair hall. Finishwork is simple. The living rooms have leaded windows and oak floors. The original dining rooms also have oak floors and shallow polygonal bay windows; these rooms are now generally used as bedrooms. The "bed closets", as originally named, are used as walk-in closets. The cupboards in the kitchen have been retained, although the fixtures and finishes have been updated within the past five years. The bathrooms have concrete floors. Second-floor, front units also have access to the balcony.
