National Register of Historic Places Registration Form

historic name Patton Home

street & number 4619 N. Michigan Avenue not for publication

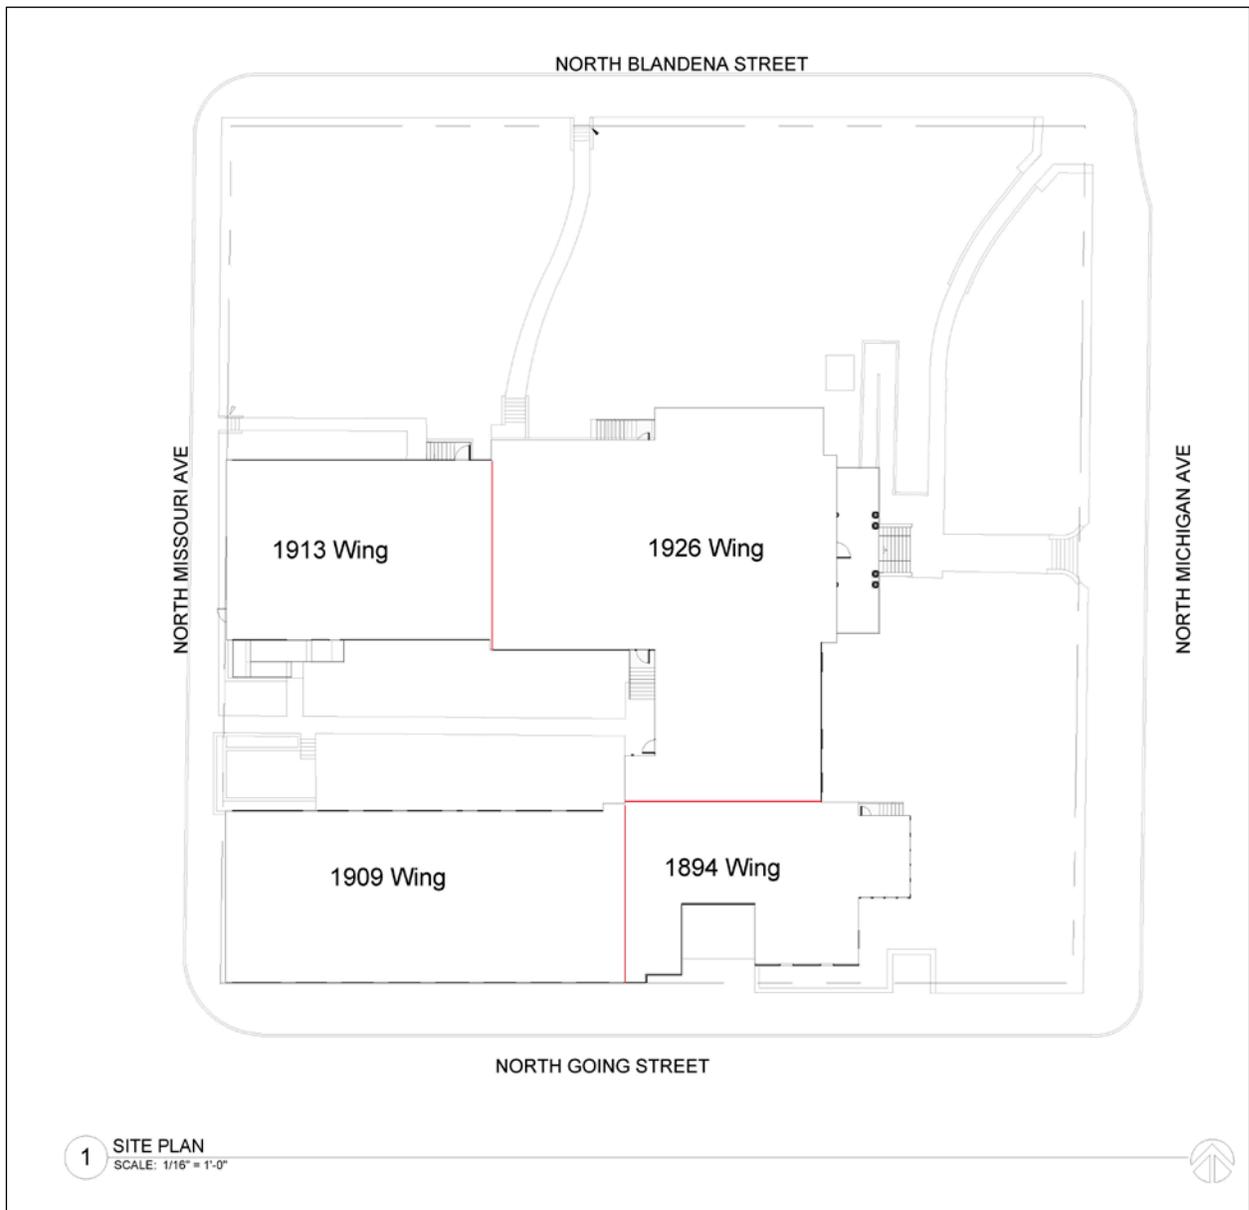
Figure 4: Site Plan

The site plan in Figure 4 shows the relationship of the wings and their dates of construction. The exterior descriptions are broken out by wing and each wing is described in its entirety, even when it has multiple elevations. These wing-by-wing descriptions begin with the 1926 primary façade entry wing even though it is chronologically the youngest. Next, the 1894 wing is described because it also comprises a portion of the primary façade. Continuing clockwise, the 1909 wing is described next, followed by the 1913 wing. Because the interior is homogenous in design, style, and materials, it is described as a whole and not discussed wing by wing. Elevation drawings are provided in Figure 7 in addition to referenced photographs.

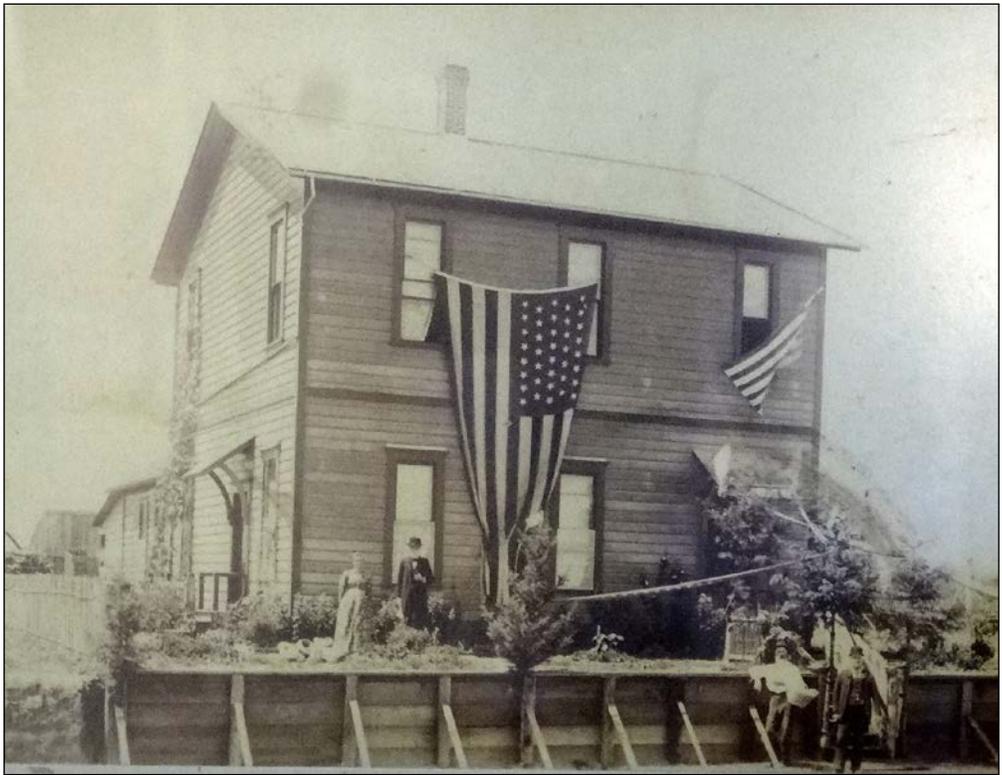
Figure 9: Original building, 1890.⁹³

The Patton Home is a 2.5-story building that was constructed in phases. The home began as a wood-frame building (as seen in Figure 9), but most of the original wood-frame wings were replaced or altered over time. The wing that comprises the masonry portion of the primary façade today was a substantial alteration to one of the wood-framed wings. Constructed in 1926, it provides the main architectural entry point for the building. A wood-frame corner wing at the southeast was constructed in 1894. The southern masonry wing was constructed in 1909. The northwestern masonry wing was constructed in 1913. Each of the wings is described in detail below.

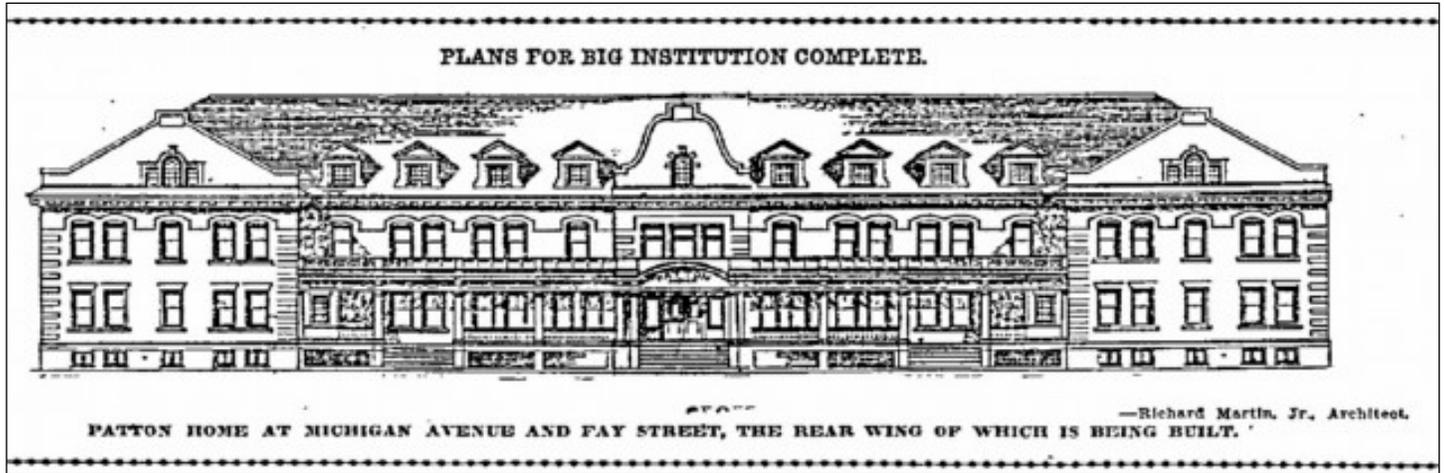
Figure 13: Richard Martin Jr.'s 1909 design for Patton Home.⁹⁶

Connecting to the west side of the wood-frame section is a red brick wing constructed in 1909, shown in Photo 7. This wing was designed by Richard Martin Jr. and was part of a larger design for a masonry building (Figure 13) that would replace the wood-frame buildings, of which only this wing was built as designed. Based on the rendering of the proposed south elevation, the design could be classified as Flemish Revival due to the decorative parapet walls at the gables. However, Colonial Revival details were also incorporated such as the heavy dentilated cornice molding at the eaves, classical columns at the porch, Palladian windows, and attic dormer windows.

In 1909, architect Richard Martin Jr. designed a grand masonry building, shown in Figure 13, to replace the frame buildings.³⁰ It is not known how Martin initially became connected with the home; however, he did architectural work for the Association for nearly two decades and his wife served as president of Patton Home’s board in the 1920s. Construction commenced on the south wing of Martin’s design in 1909, but they did not have the funds to complete the rest of the structure.³¹ This addition increased the facility’s capacity to 40 residents. A photo of this wing shortly after completion is seen in Figure 14.

The final expansion of Patton Home was made in 1926 when the new entry wing was constructed. Martin was again the architect, but completely revised his grand design from 1909. The new design kept some of the foundations and framing of the existing wood building to save on construction costs. The foundation footprint expanded slightly to the north and the entire building was given a new Colonial Revival façade treatment. Martin's design included an architecturally prominent entry, which had been lacking for decades. His plans also contemplated replacing the remaining piece of wood-frame building at the southeast corner in a future phase, but this was never completed.

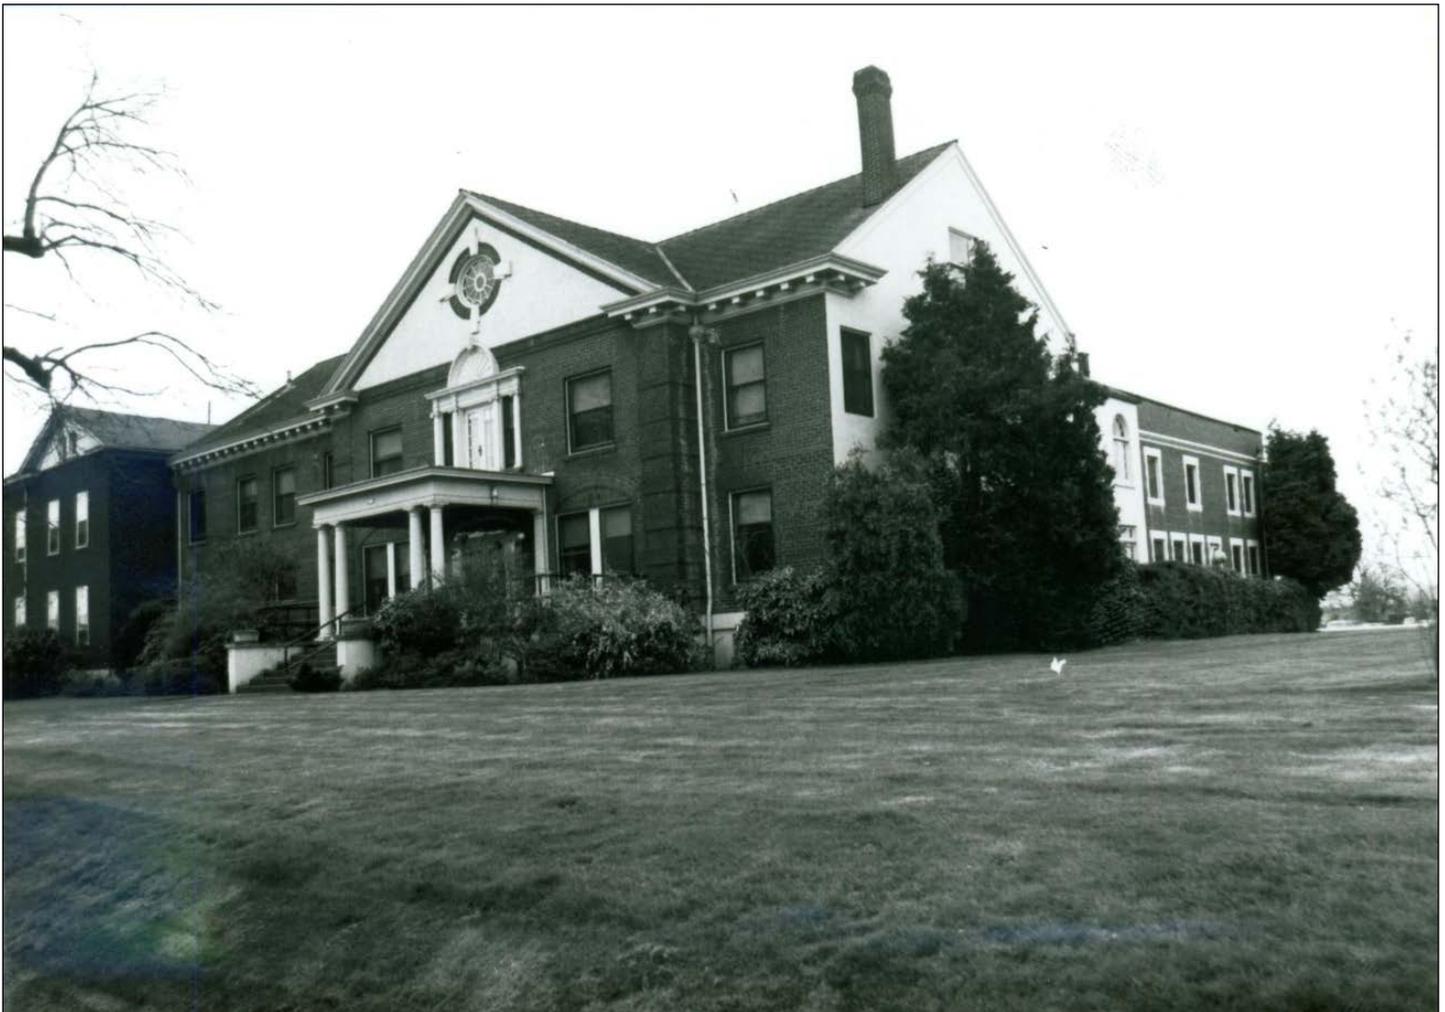
Figure 16: Patton Home, c. 1983.⁹⁹

It is unclear how this wood-frame section of the building changed between 1910 and 1999. However, while not easily visualized, the 1983 photo from the Portland Historic Resources inventory in Figure 16 shows that the windows had been replaced, the window trim removed, and the wood lap siding had been replaced by this date.

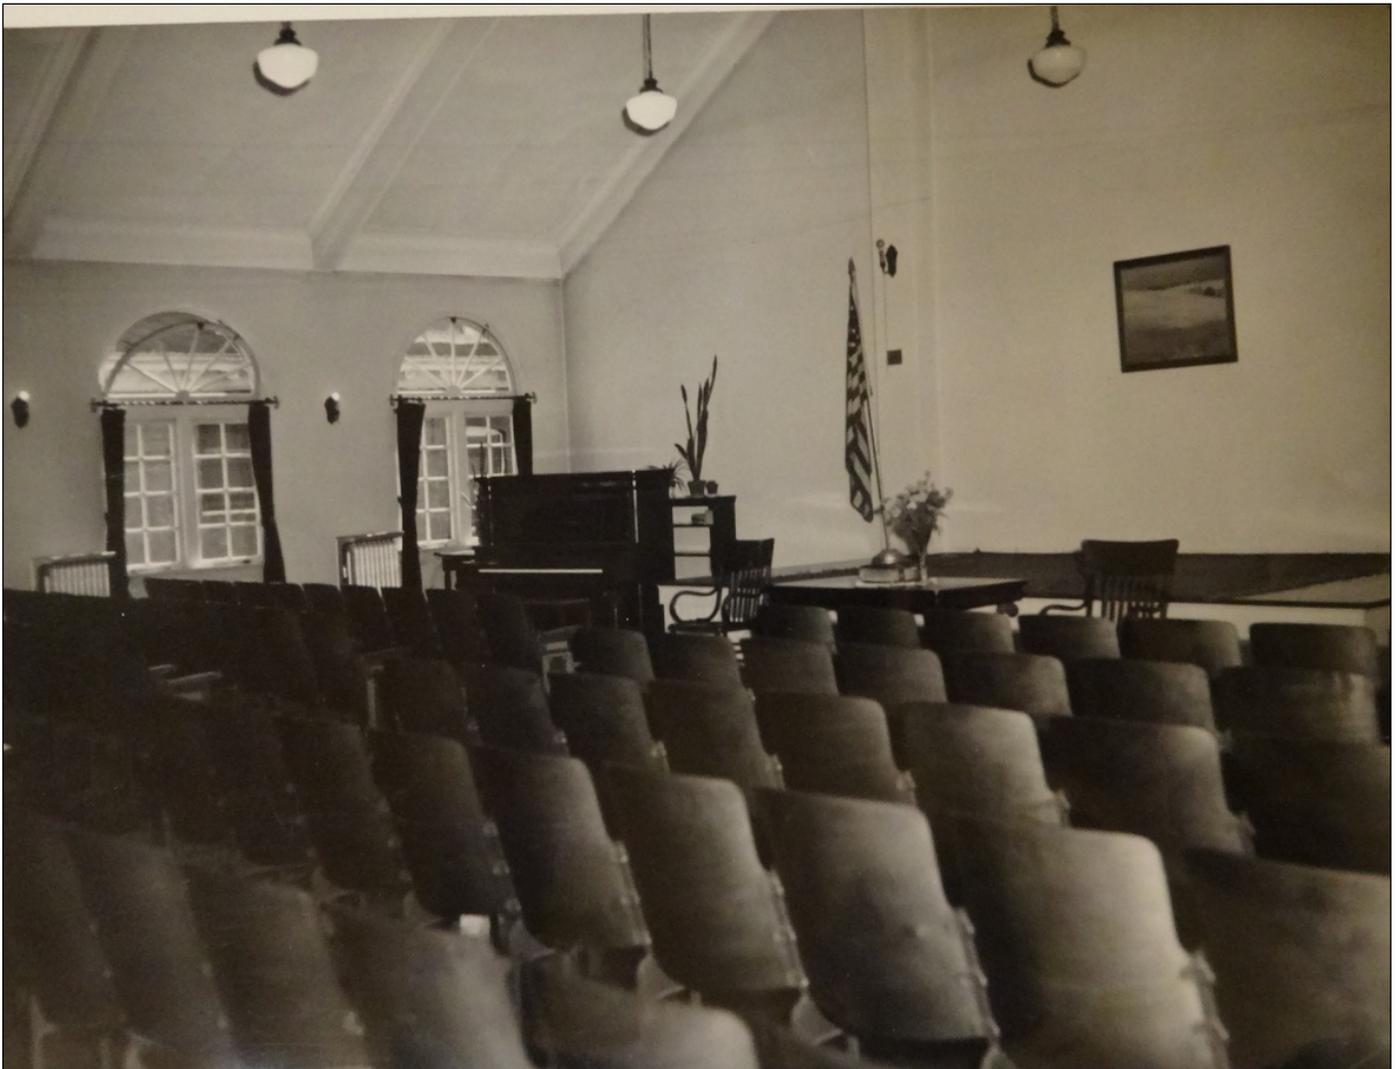
Figure 22: Patton Home auditorium, c. 1950. Converted to additional rooms in 1956.¹⁰⁵

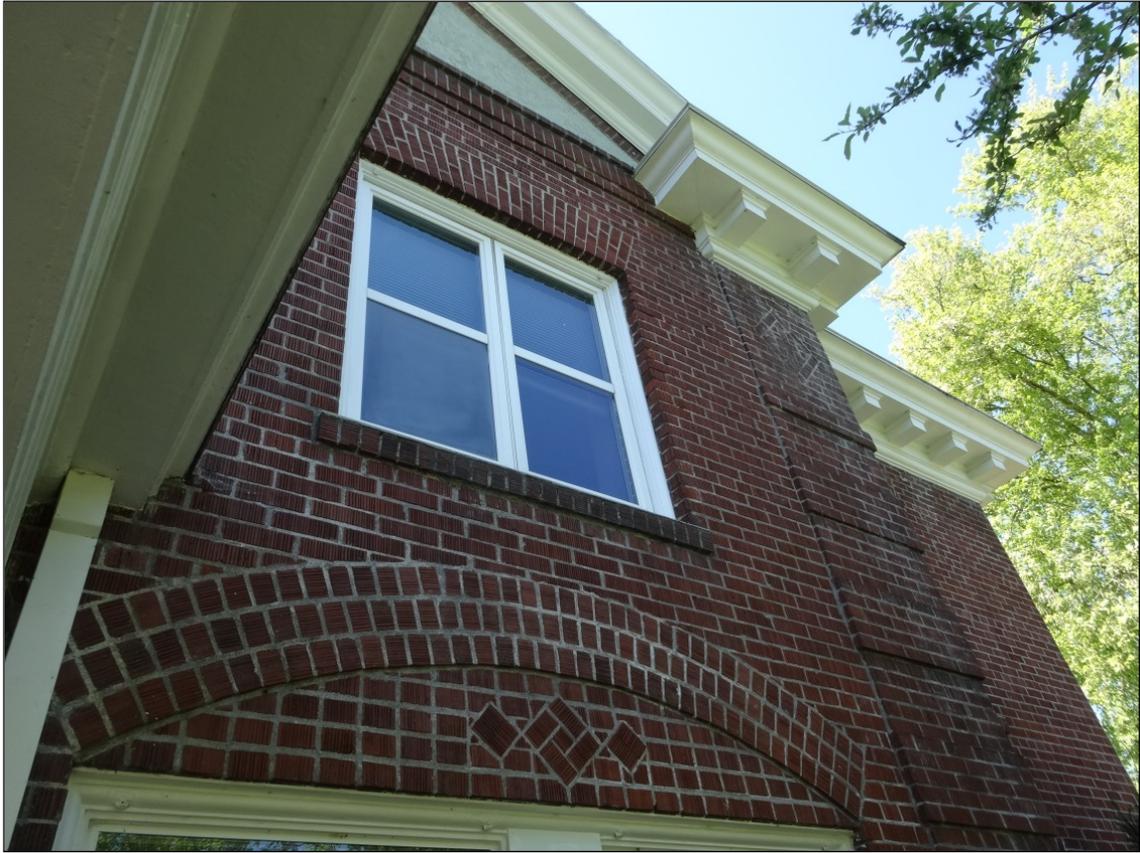
Photo 5 of 21: East elevation brick detailing and cornice.

- Photo 5 of 21:** (OR_MultnomahCounty_PattonHome_0005)
East façade brick detailing, camera facing west.
- Photo 6 of 21:** (OR_MultnomahCounty_PattonHome_0006)
South facade, camera facing north.

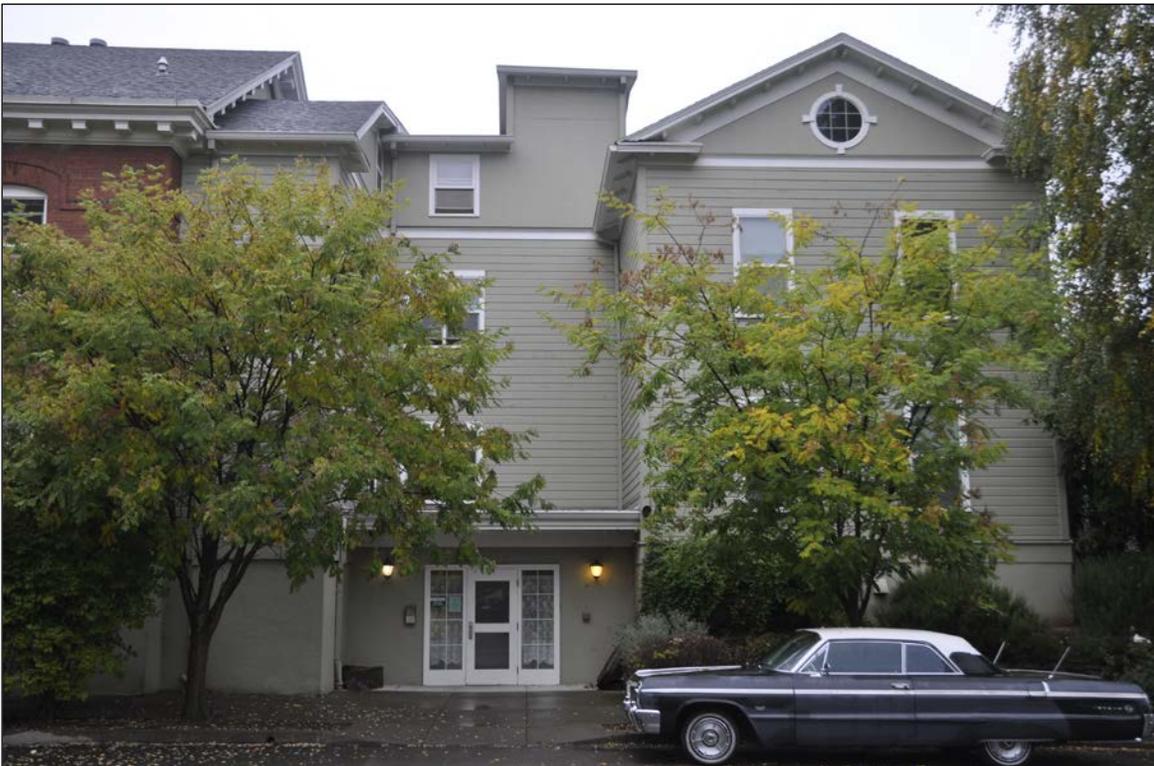
Photo 6 of 21: Wood frame portion of south elevation.

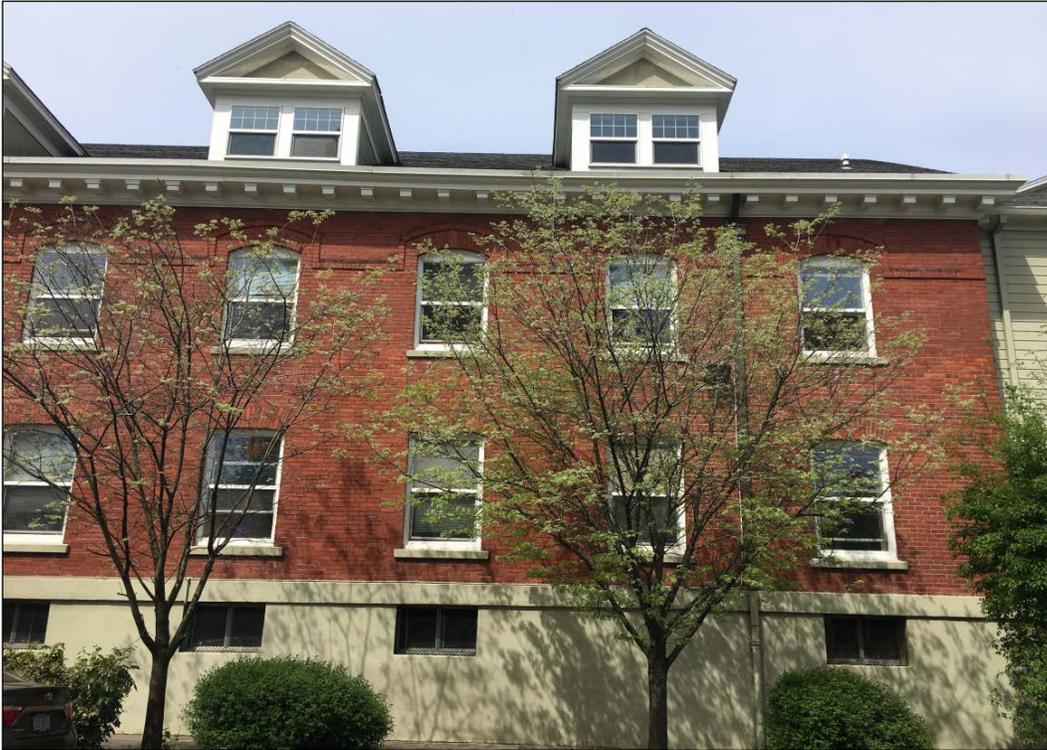
Photo 7 of 21: Masonry wing, south elevation.

The south elevation faces N Going Street and the north elevation faces the courtyard. This 2.5-story wing sits on a tall concrete foundation, punctuated with small basement windows. A concrete belt course separates the foundation wall from the brick exterior wall and runs around the entire wing. The masonry features decorative brick details including quoins at the gable ends, flat arches above all first-floor windows, and segmental arches above all second-floor windows. A brick belt course aligns with the second-floor window heads and runs continuously on all three sides of the wing, arcing above each of the segmental arches. The original window type was a one-over-one wood window and today the first and second-floor windows are one-over-one vinyl windows in the original wood frames. A heavy dentilated wood cornice is featured at the eave line wrapping all three sides of the wing.

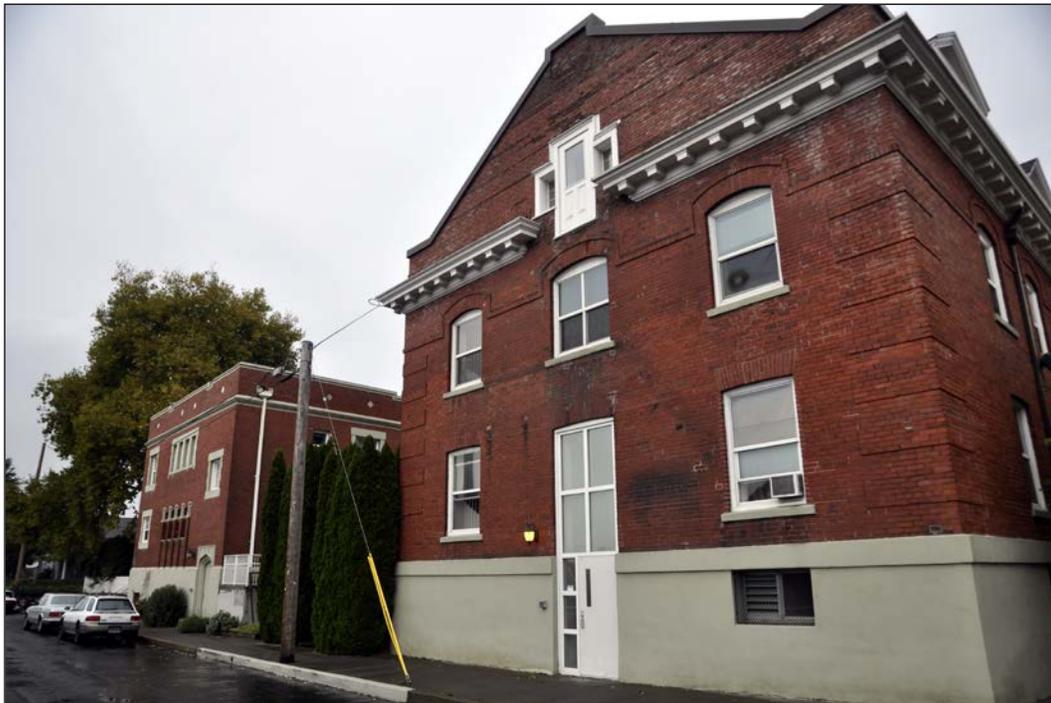
Photo 8 of 21: West elevation

The west elevation, shown in Photo 8, features an end wall with a simplified stepped gable. A door centered at the basement level has been replaced with a modern service door topped with a large transom. The transom was likely inserted into an original first-floor window opening. On either side of the transom is a one-over-one window. The second floor has three window openings that align with those below—a single one-over-one, followed by a pair of one-over-one windows, followed by another single one-over-one. The dentilated cornice breaks above the second-floor window to frame a decorative window/door grouping. Presently there is a non-historic fixed door flanked by two six-light vinyl windows. It is unknown if the historic condition featured a door or a window in the larger opening.

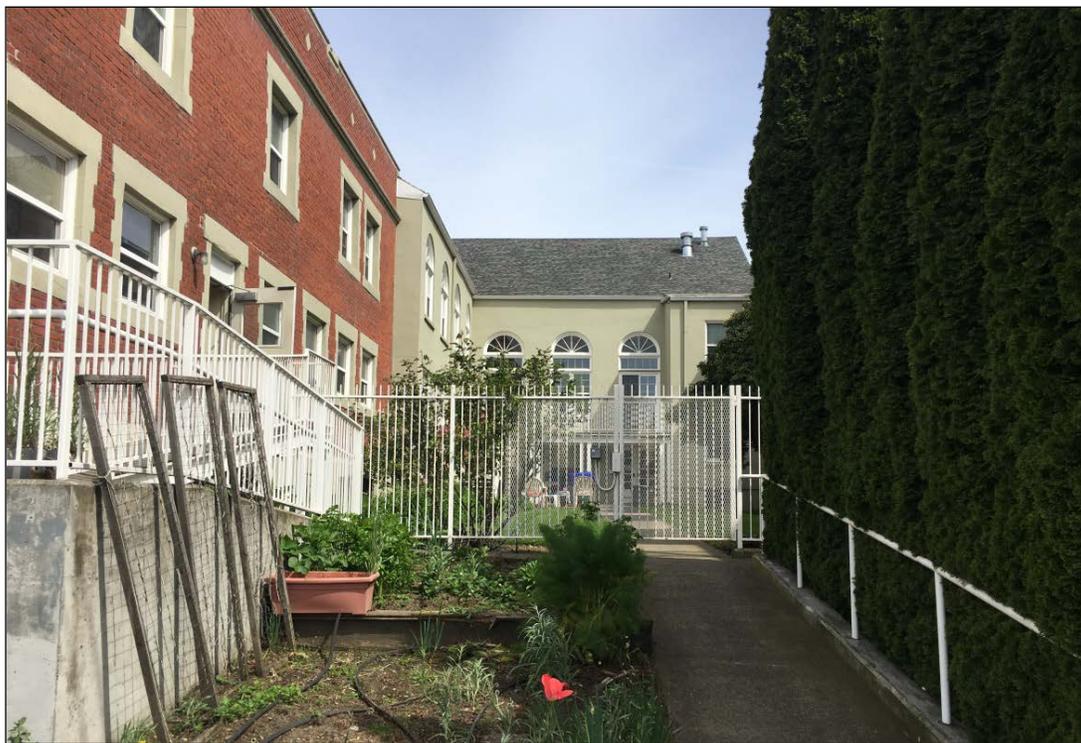
Photo 10 of 21: Courtyard looking east

Shown in Photo 10, the south side of the cross gable extension faces the courtyard, continuing the same painted stucco treatment. The windows were designed in the same style as the afore-described north elevation with four windows per floor. The original fanlight windows exist; however, all other windows have been replaced with one-over-one vinyl windows.

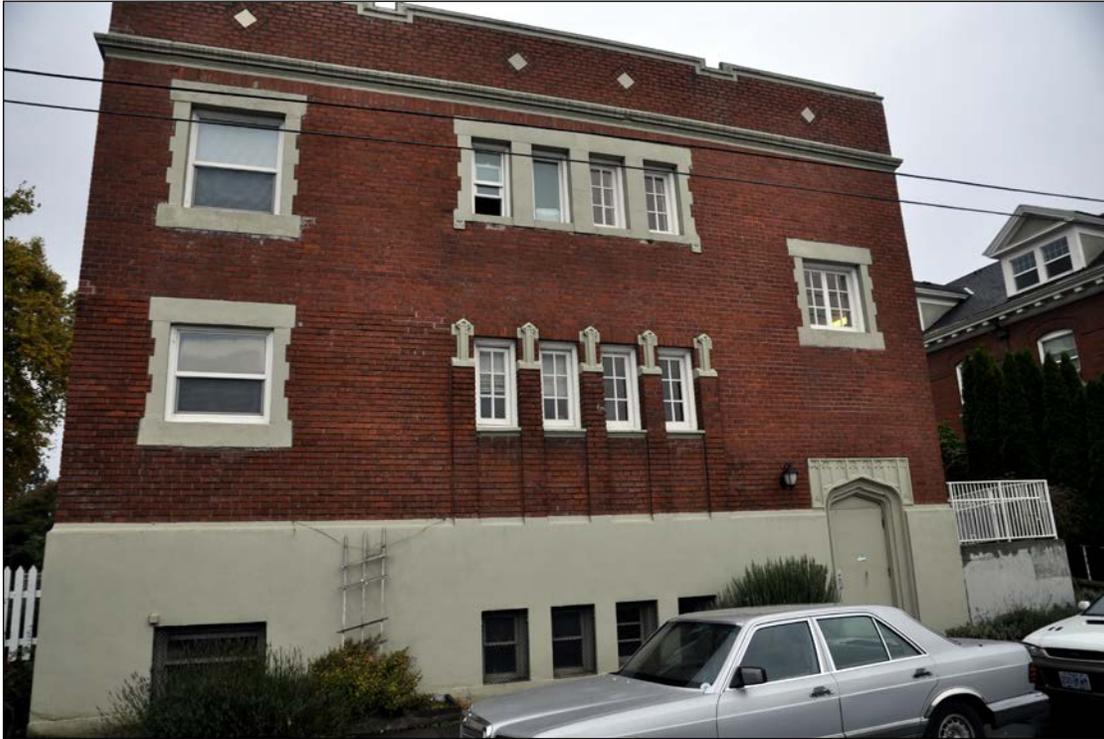
Photo 11 of 21: West elevation

In 1913, a Jacobethan-style structure was erected at the northwest corner of the Patton Home complex. When the 1926 wing was built, its west gable extension connected with the east façade of this wing. Shown in Photo 11, the 1913 wing is two stories and sits on a tall concrete foundation. The building is faced with red brick and has cast stone architectural details, including window surrounds, a cornice, and parapet coping. The parapet coping has a decorative notch that occurs twice on each of the building's three elevations. Cast stone diamonds are further used to add a level of decoration to the parapet on all three sides. The roof is flat.

The main architectural façade of this building faces west. The arrangement of architectural features is broken into three bays on this façade. At the foundation level, the south bay features an entry door with a cast stone Tudor arch surround. The original door has been replaced with a modern metal utility door. To the north is a grouping of five basement windows with another single basement window in the third and final bay. At the second floor, there is a one-over-one window above the door that aligns halfway between the first and second floors. This original wood casement window has six lights in each sash. It is set within a cast stone surround. The center bay features four small single casement windows at the first-floor level. These are original wood windows with six lights in each sash. The windows are separated by narrow brick pilasters topped with a cast stone Jacobethan detail. In the northern bay, there is a single one-over-one window in a cast stone surround. At the second-floor level, there is another grouping of four small casement windows in the center bay. These are set within a cast stone surround and separated by cast stone mullions. The two southern windows are original, while the two northern windows have been replaced—one with a fixed, single-light window and the other with a one-over-one vinyl window. The northernmost bay features a one-over-one wood window in a cast stone surround.

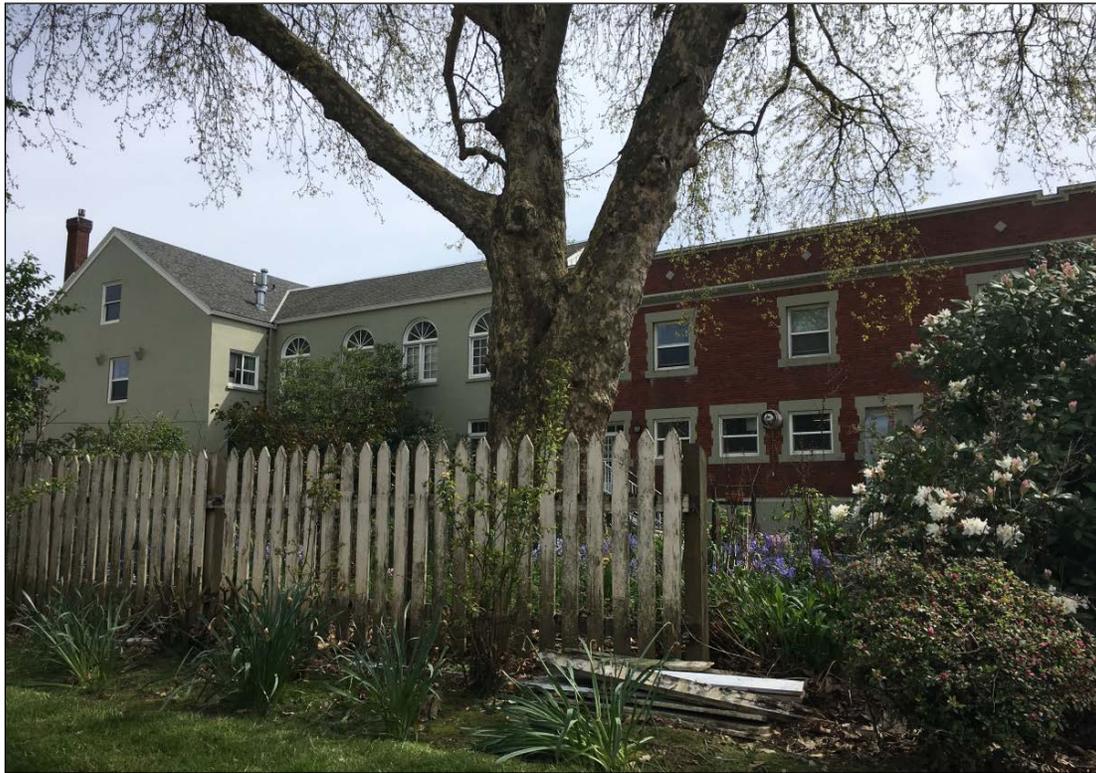
Photo 12 of 21: North elevation and community garden

Shown in Photo 12, the north elevation of the cross gable continues the same painted stucco wall material with decorative detailing or applied ornamentation. Given that this portion of the building originally housed the dining hall on the ground floor and the auditorium on the second floor, the windows are large and architecturally significant to the elevation. On the ground floor north elevation, there is a door and three windows, each topped with a multi-light transom. Historically the lower window type was a casement window with eight lights in each sash. These were replaced with a pair of four-over-four vinyl windows. The ground floor door was originally a pair of French doors. This door pair was replaced with a single leaf door with six lights and a side light with five lights. On the second floor, there is another door and three windows grouped directly over those windows below. The windows are multi-light casement windows topped with an arched fan light. The original windows still exist at this level, except

for one casement leaf that was replaced with a one-over-one vinyl window. The cross gable extends back to meet the 1913 wing, which will be discussed in its own section.

The arrangement of the north elevation, shown in Photo 12, is not symmetrical like the west elevation. It features three basement windows, as well as mechanical equipment that is located against the foundation wall. The first floor features six window openings. One has been infilled with a kitchen vent. There is a second kitchen vent located between two windows. At the east end of the elevation is an exterior door and a non-original metal staircase. The second floor features five one-over-one windows. All windows at the first and second-floor levels are set in the same cast stone surround and all have been replaced with one-over-one vinyl windows.

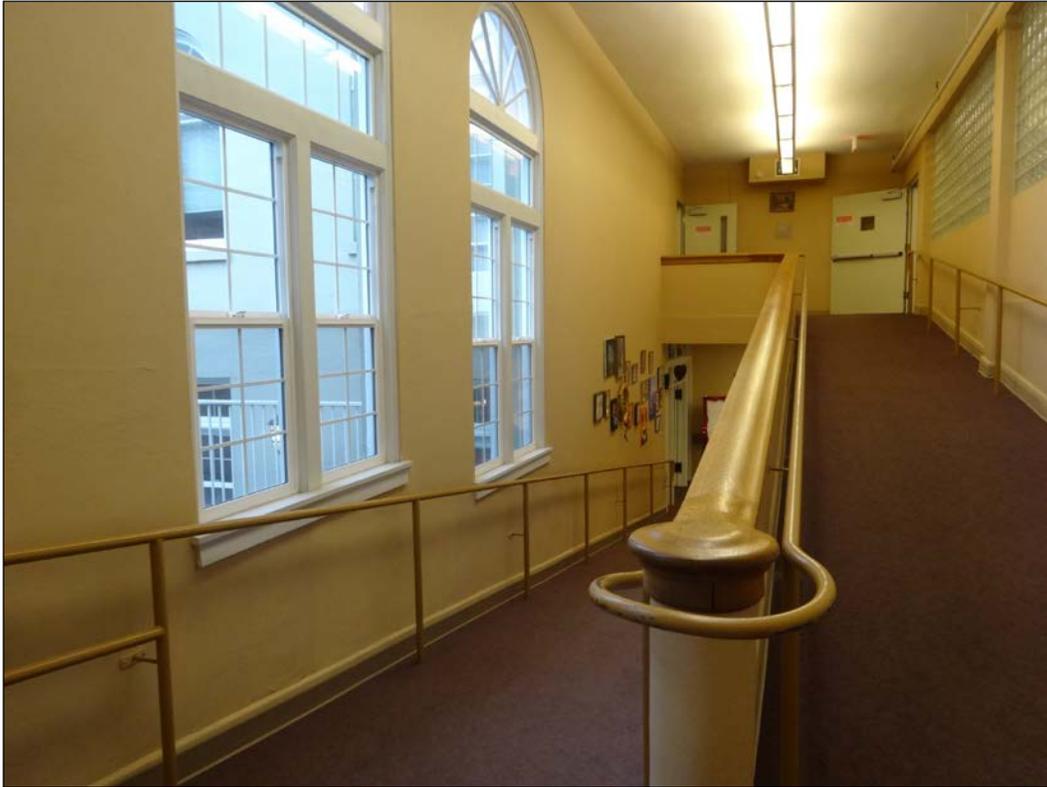
Photo 19 of 21: Ramp to connecting the first and second floors, looking north.

- Photo 18 of 21:** (OR_MultnomahCounty_PattonHome_0018)
Kitchen, camera facing south.
- Photo 19 of 21:** (OR_MultnomahCounty_PattonHome_0018)
Interior ramp, camera facing south.
