Cultural Resource Survey Form:

CLACKAMAS COUNTY
HISTORIC RESOURCES INVENTORY 1989-92

HISTORIC NAME: ALBRIGHT, DANIEL, FARM
COMMON NAME:
PROPERTY ADDRESS: 9912 S. Wildcat Road, Molalla OR 97038
OWNER: Regan Brothers
OWNER ADDRESS: 672 South N Street, Livermore, CA 94550
RESOURCE TYPE: Buildings
PRESENT USE: Farm Complex
ORIGINAL USE: Farm Complex
THEME: Culture: architecture; Agriculture
ARCHITECT/BUILDER: Hendershott, Cyrus, builder of barn
COUNTY: Clackamas
QUAD: Scotts Mill
T/R/S: 6 1E 11
TAX LOT: 400
ADDITION: N/A
BLOCK: N/A
LOT: N/A
LOT SIZE: 177.72 Acres
ZONE: EFU-20/CR

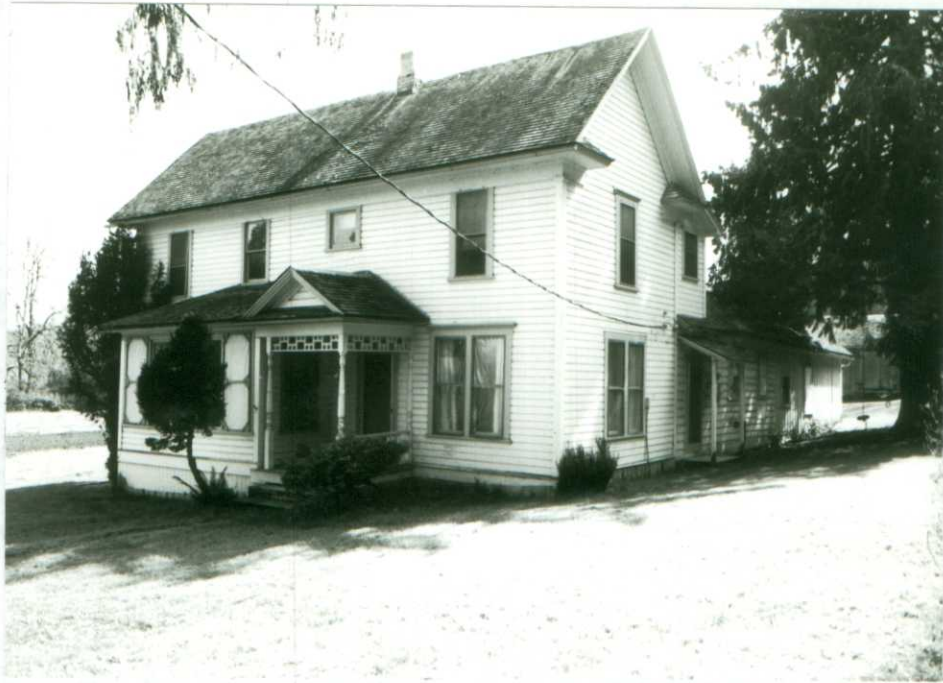
HOUSE

DATE BUILT: 1865

DATE OF MAJOR REMODEL: 1904

STYLE: Greek Revival

PLAN/TYPE/SHAPE: Asymmetrical

NO. OF STORIES: 2

FOUNDATION MATERIAL: Concrete

BASEMENT: Yes

ROOF FORM AND MATERIALS: Intersecting gable w/ partial returns and pedimented arch over door w/ wood shingles

WALL CONSTRUCTION/STRUCTURAL FRAME: Wood/unknown

PRIMARY WINDOW TYPE: Double-hung sash w/ some architrave molding

EXTERIOR SURFACING MATERIALS: Wide drop siding; tongue-and-groove siding; cornerboards w/ caps, rake boards and watertable

DECORATIVE FEATURES: Turned posts; balustrade; ornate door; frieze

OTHER: Single-bay porch w/ gable roof, n. elev.; paneled-and-glazed door; gable roof ell and shed roof ell, s. elev.; shed roof ell, s.e. elev.; interior chimney; interior end-wall chimney

CONDITION: Good

EXTERIOR ALTERATIONS (DATE): Raised to two stories from 1 1/2 (1904); windows replaced w/ one-over-one double-hung sash (1904); bay window enlarged (1904); porch partially enclosed, n. elev. (1904); partially resided (n.d.); window cut and filled at gable, e. elev. (n.d.); porch enclosed in two phases (n.d.); ells added, s. and e. elev. (n.d.)

The earliest remaining building, the Greek Revival house, was built in 1865. It was built as a 1 1/2-story house, which remodeling in 1904 raised to a full two stories. The house faces west and the entrance is flanked by two large oak trees. Several small cedars are situated in close proximity to the house on the south and west sides. The Greek Revival style was brought west with the pioneers and was used extensively in the early farm houses of the Willamette Valley. The house is of box construction of butt-jointed vertical plank walls which were cheese-clothed and papered over on the interiors, with horizontal clapboard siding used on the exterior....

In 1904, the house underwent several changes which provided more room for the expanding family and incorporated the new plumbing and electrical services available at that time...The significant changes made in 1904 were as follows: the roof was raised about four feet to create a full second story, and a new single-pane, double-hung sash windows were added. To be consistent, these new windows were installed throughout the house. The bay window in the west living room wall was doubled in length, and as a result, the double door entrance porch was narrowed to one door. The earth was excavated under the north end of the house to make way for a concrete basement and furnace. ...

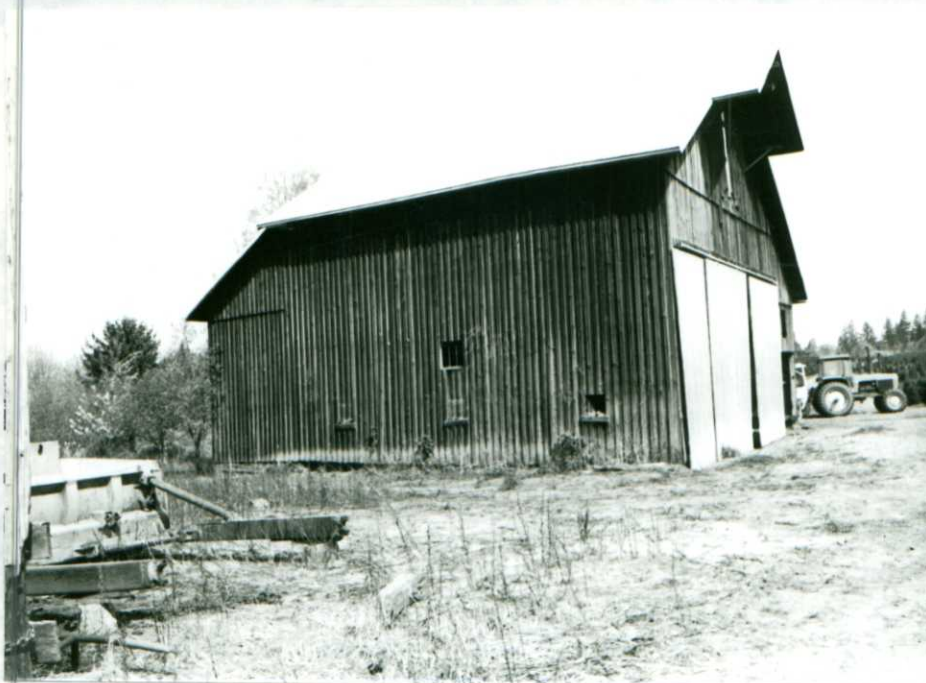
BARN

DATE BUILT: 1901

STYLE: Western

PLAN/TYPE/SHAPE: Rectangular

NO. OF STORIES: 2

FOUNDATION MATERIAL: Hewn frame on stone

BASEMENT: No

ROOF FORM AND MATERIALS: Gable w/ sheet metal

WALL CONSTRUCTION/STRUCTURAL FRAME: Wood/unknown

PRIMARY WINDOW TYPE: Six-light fixed

EXTERIOR SURFACING MATERIALS: Board-and-batten, s. and w. elev.

DECORATIVE FEATURES: None

OTHER: End-wall overhead sliding door; lean-to, n. and e. elev.;
hay hood

CONDITION: Good

EXTERIOR ALTERATIONS (DATE): Sheet metal roof added (1971); hay
door boarded (n.d.); overhead sliding door replaced w/ sheet
metal (n.d.)

Two of the farm buildings are unusually fine examples of their kind. Both appear to be superior to anything like them in western Oregon. The 1901 barn is a very late example of mortis/tenoned, hewn frame construction. Two or three other 20th-century hewn frame barns have been encountered, but the quality of construction was poor and spatial systems of little interest. Heavy sawn frames would have superseded hewn frames as the means of barn frame construction on most Oregon farms by the 1880s. The Albright granary also is in contrast to the unusual [sic] granary building, which was standardized from farm to farm: plain structures with a one-level scheme of a central drive flanked by bins. Among Oregon granaries the Albright granary is unique. Both the barn and the granary are far above ordinary... execution of the frame, in finish detail and in the ingenuity of their spatial arrangement.

The 1871 and the 1901 barn are good examples of how early farmers put strong emphasis on the particular siting needs of their various buildings. The 1871 granary uses a structural system base on the amount of volume needed to store given amounts of grain (four and eight hundred bushels). It also took advantage of the gently sloping hill. The north end floor of the granary was lowered so grain could be removed from the "upper granary" by means of a gravity feed system. The 1901 hewn frame barn, built by Cyrus Hendershott, is a fine example of the type of barn which came into use near the end of the 1880s. The type utilized a hay forklift located under the roof peak hood to lift hay to the second floor storage area, also a new addition to the function of barns. Both of these buildings have survived the ravages of time and remain today in fine condition.

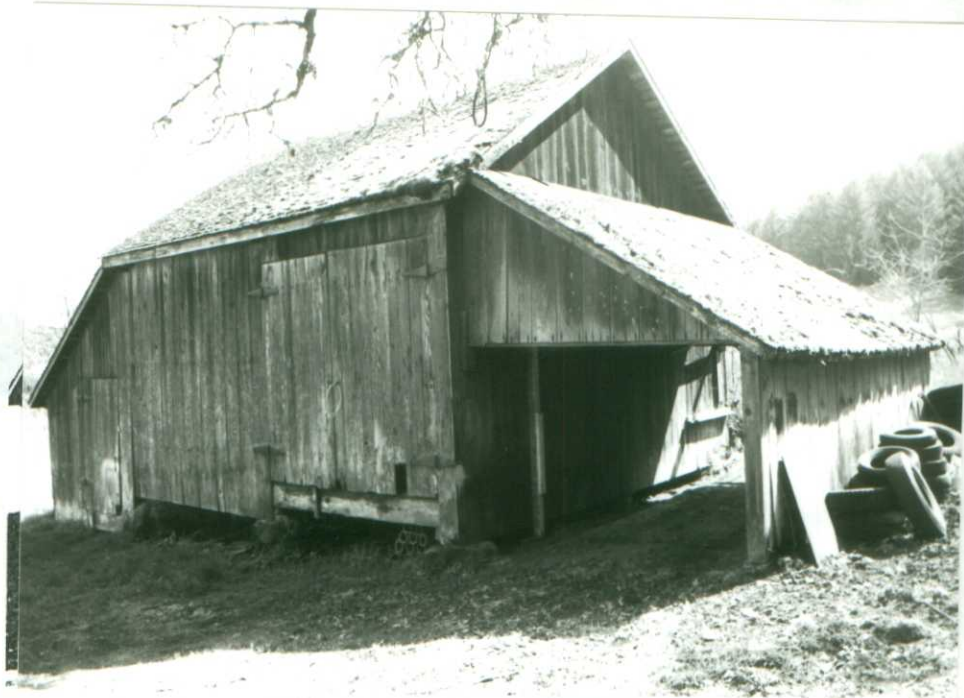
GRANARY

DATE BUILT: 1870
STYLE: Vernacular
PLAN/TYPE/SHAPE: Rectangular
NO. OF STORIES: 2
FOUNDATION MATERIAL: Hewn frame on stone
BASEMENT: No
ROOF FORM AND MATERIALS: Gable w/ wood shingle
WALL CONSTRUCTION/STRUCTURAL FRAME: Wood/unknown
PRIMARY WINDOW TYPE: None
EXTERIOR SURFACING MATERIALS: Vertical boards
DECORATIVE FEATURES: None
OTHER: Hinged doors, some pairs; lean-to, w. and e. elev.
CONDITION: Fair
EXTERIOR ALTERATIONS (DATE): Lean-tos added, w. & e. elev.
(n.d.)

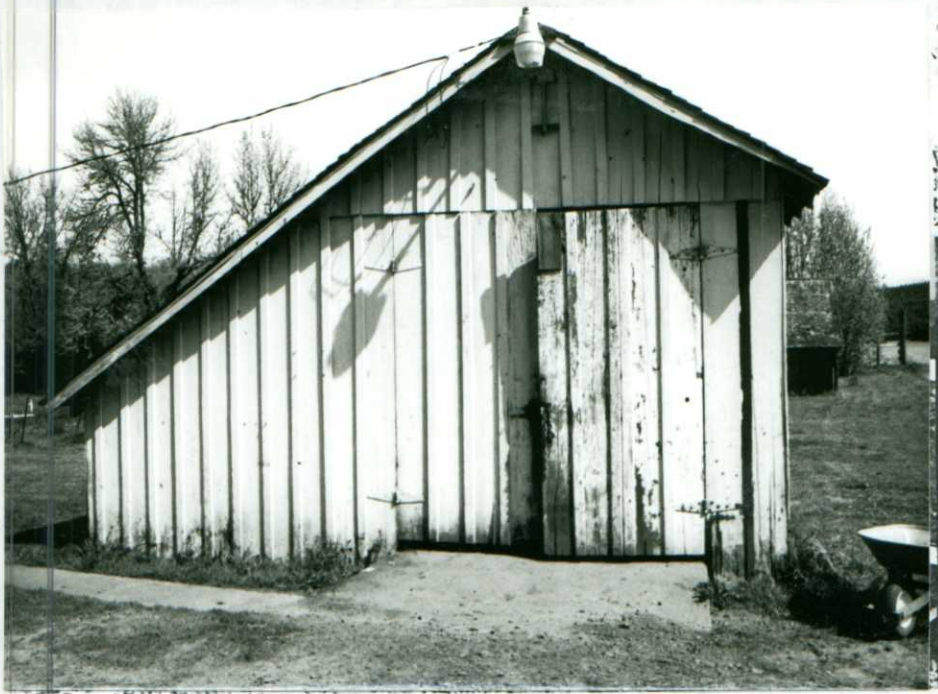
GARAGE

ESTIMATED DATE BUILT: c. 1900
STYLE: Vernacular
PLAN/TYPE/SHAPE: Rectangular
NO. OF STORIES: 1
FOUNDATION MATERIAL: Post-and-beam
BASEMENT: No
ROOF FORM AND MATERIALS: Gable w/ wood shingles
WALL CONSTRUCTION/STRUCTURAL FRAME: Wood/unknown
PRIMARY WINDOW TYPE: None
EXTERIOR SURFACING MATERIALS: Board-and-batten
DECORATIVE FEATURES: None
OTHER: Paned hinged doors; shed roof lean-to, w. elev.
CONDITION: Good
EXTERIOR ALTERATIONS (DATE): Lean-to added, w. elev. (n.d.)

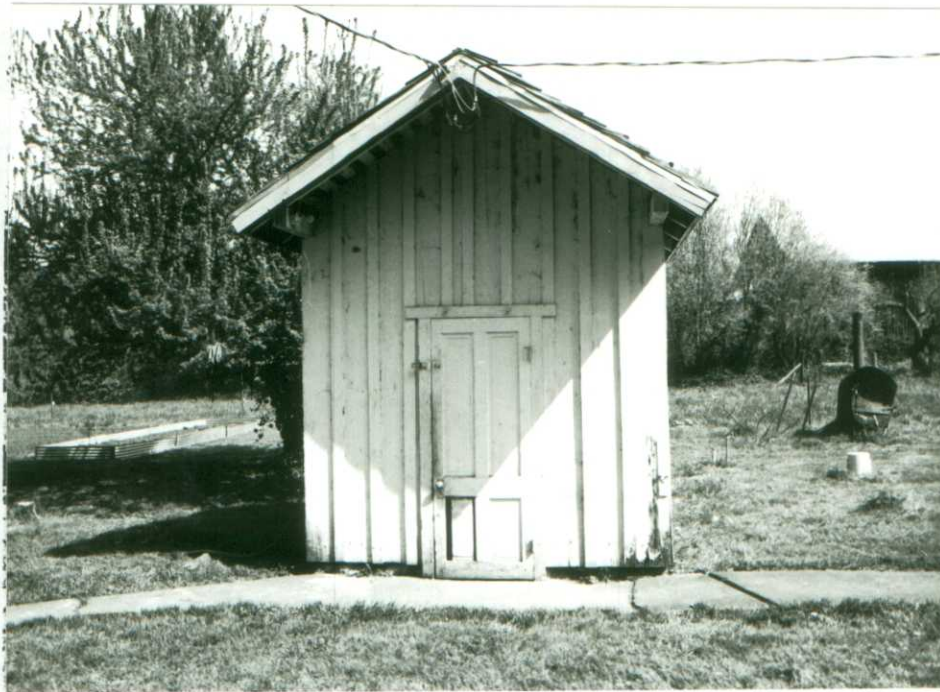
SMOKEHOUSE

ESTIMATED DATE BUILT: c. 1900
STYLE: Vernacular
PLAN/TYPE/SHAPE: Rectangular
NO. OF STORIES: 1
FOUNDATION MATERIAL: Concrete
BASEMENT: No
ROOF FORM AND MATERIALS: Gable w/ wood shingles
WALL CONSTRUCTION/STRUCTURAL FRAME: Wood/unknown
PRIMARY WINDOW TYPE: None
EXTERIOR SURFACING MATERIALS: Board-and-batten
DECORATIVE FEATURES: None
OTHER: Four paneled door
CONDITION: Good
EXTERIOR ALTERATIONS (DATE): Unknown

The other remaining buildings include a typical smokehouse (9x9') of vertical plank construction and a concrete floor,

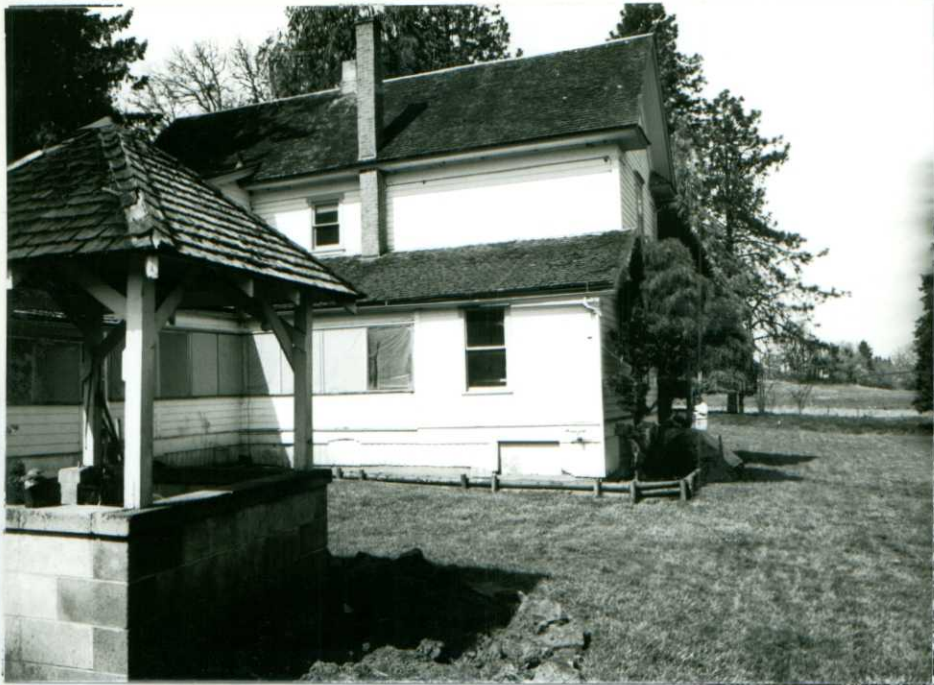
WELL HOUSE

ESTIMATED DATE BUILT: c. 1870
STYLE: Vernacular
PLAN/TYPE/SHAPE: Square
NO. OF STORIES: 1
FOUNDATION MATERIAL: Concrete block
BASEMENT: No
ROOF FORM AND MATERIALS: Hip w/ wood shingles
WALL CONSTRUCTION/STRUCTURAL FRAME: Masonry/posts
PRIMARY WINDOW TYPE: None
EXTERIOR SURFACING MATERIALS: Concrete block
DECORATIVE FEATURES: None
OTHER: None
CONDITION: Good
EXTERIOR ALTERATIONS (DATE): Concrete block added (n.d.)

the well--which is part of the original farmstead, its use discontinued in 1904 with the addition of running water, and the two remaining buildings--the chicken coup and garage--which exemplify turn-of-the-century farm architecture.

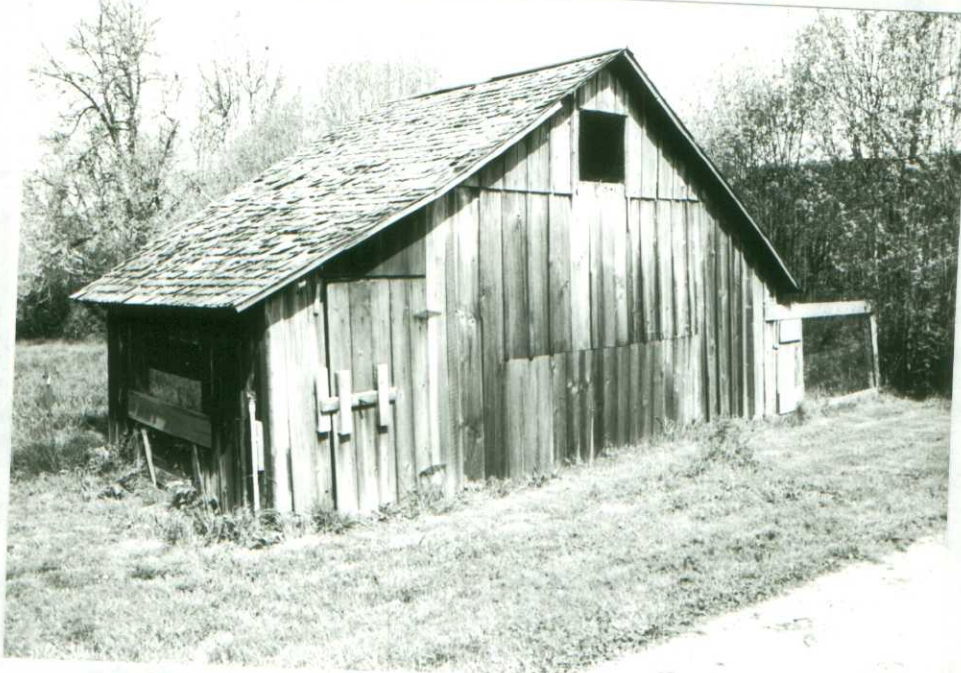
CHICKEN COOP

ESTIMATED DATE BUILT: c. 1900
STYLE: Vernacular
PLAN/TYPE/SHAPE: Rectangular
NO. OF STORIES: 1
FOUNDATION MATERIAL: Post-and-beam
BASEMENT: No
ROOF FORM AND MATERIALS: Gable w/ wood shingles
WALL CONSTRUCTION/STRUCTURAL FRAME: Wood/unknown
PRIMARY WINDOW TYPE: Unglazed
EXTERIOR SURFACING MATERIALS: Board-and-batten
DECORATIVE FEATURES: None
OTHER: Hinged
CONDITION: Fair
EXTERIOR ALTERATIONS (DATE): Unknown
