Historic  
Resource  
Inventory  
CITY OF PORTLAND, OREGON

620 S.W. Fifth Avenue

ORIGINAL NAME: *Failing Building*

HISTORIC NAME: FAILING BUILDING, Alterations

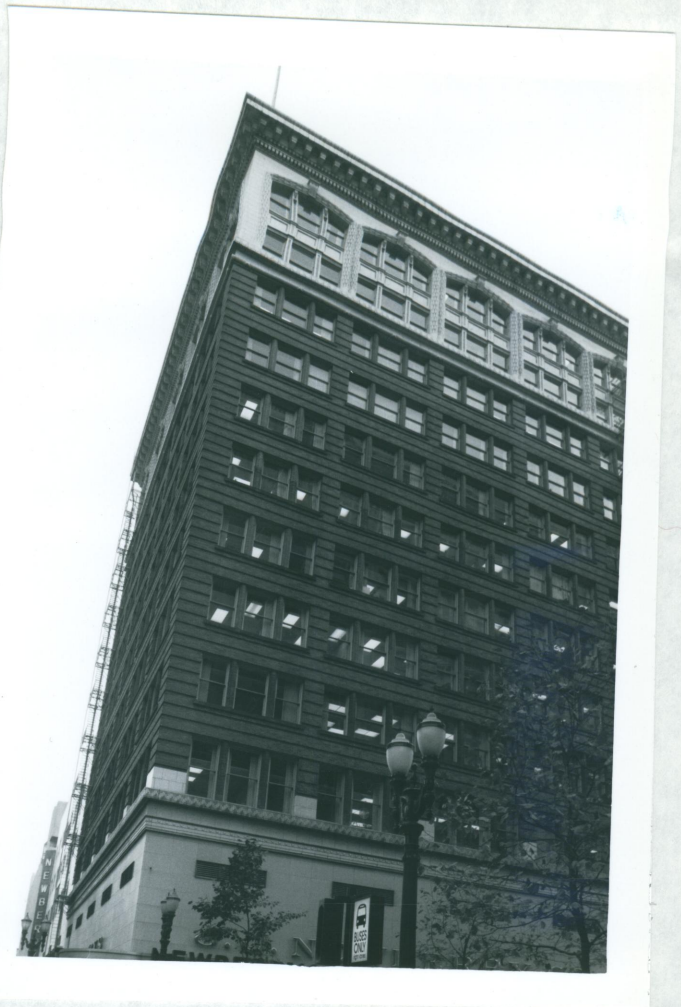
*Lower six stories were constructed in 1907, remaining in 1913. Cream-colored glazed terra cotta on upper two stories may have originally been on fifth and sixth floors. Yellowish pressed-face brick manufactured by Gladding, McBean*

is laid in colored mortar with ruled joints. Sill courses of Tenino stone. Terra cotta decorative motifs include keystone with fish scale design, and window surrounds with laurel leaf design.

Columns and spandrels at lower two floors were faced with glazed terra cotta. A marquise ran the full length of both street facades.

Ceramic veneer (extruded glazed terra cotta tiles) on lower floors dates from 1951 alteration.

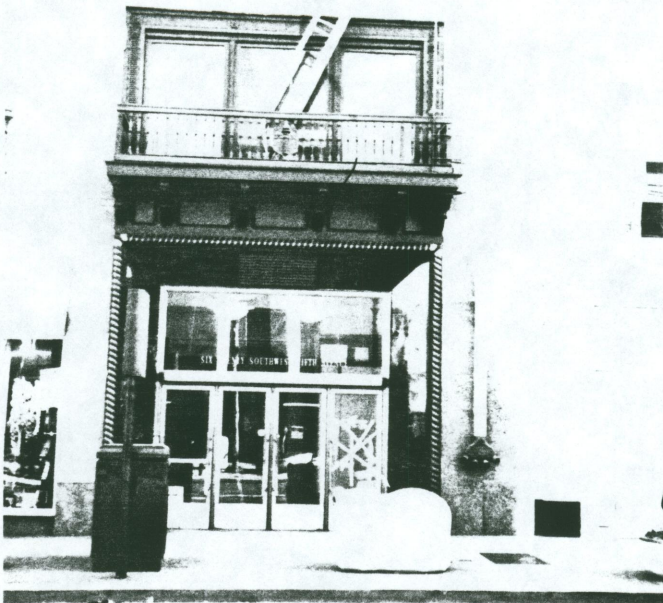
RECENT PHOTO  
NEGATIVE #s:  
SIR2, #17

lobby entrance; four bronze doors with transoms topped by a small balcony,  
marble sheathing, cast stone or terra cotta braiding frames entrance

numerous alts. to bldg; L.H.A. alterations include 10th floor office alt.(1936)  
misc. alts. and lobby alt. (1937), misc. alts (1939), only lobby/entr. extant

Of the four alterations cited in the Master Index, the lobby/entrance alteration is the only extant alteration. This building is referred to as the Failing Bldg in the Index but should not be confused with the Failing/Postal Bldg. located on SW 2nd. The original Failing Bldg. marquee has been removed and the door pulls and transoms have also been altered. The building has been connected internally with the Newberry building, which was constructed in @1977.
