SANTIAM PASS SKI LODGE

AN EVALUATION OF HISTORIC SIGNIFICANCE

McKenzie Ranger District
Willamette National Forest
USDA Forest Service

JULY 1989

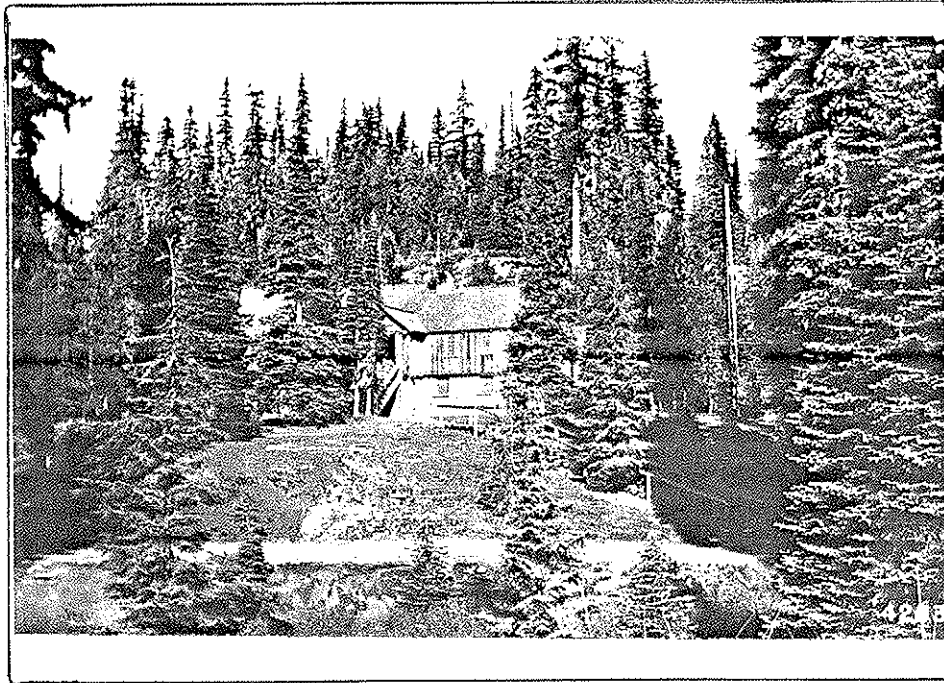
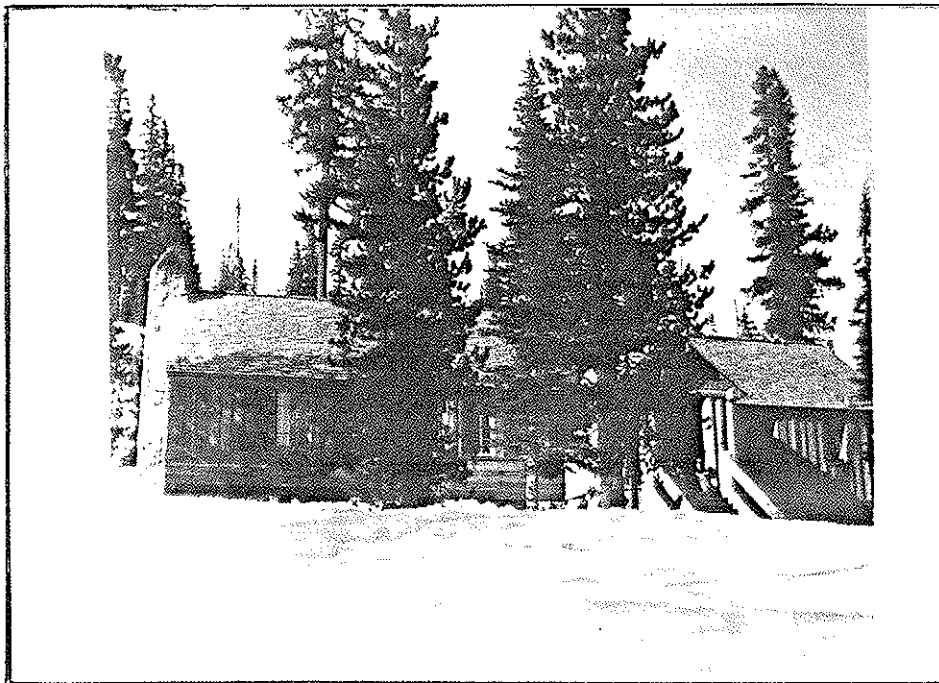
Figure 3. Historic photographs of the Santiam Lodge (ca. 1940). Upper photo shows lodge in its original setting; lower photo is a view of the front elevation with deep snow concealing the foundation of the building.

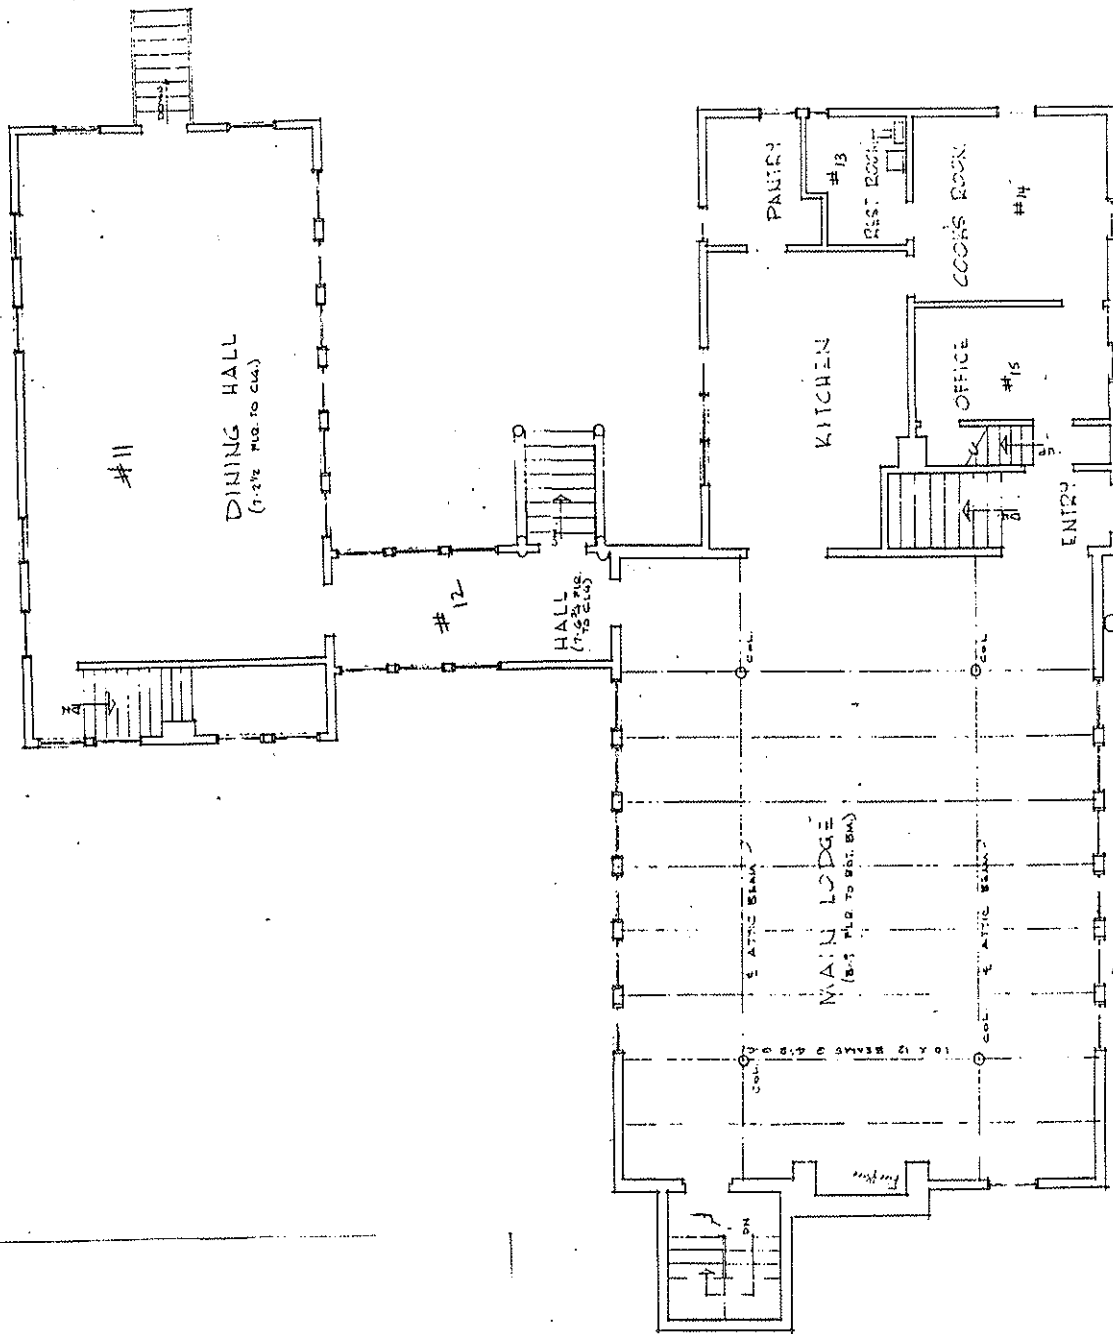
SIXTH FLOOR PLAN 1/4" = 1'-0"
 SANTIAM LODGE

Figure B-8. Santiam Lodge: Second Floor Plan. Existing Building drawn in 1974. Shows the same additions as indicated in previous figure.

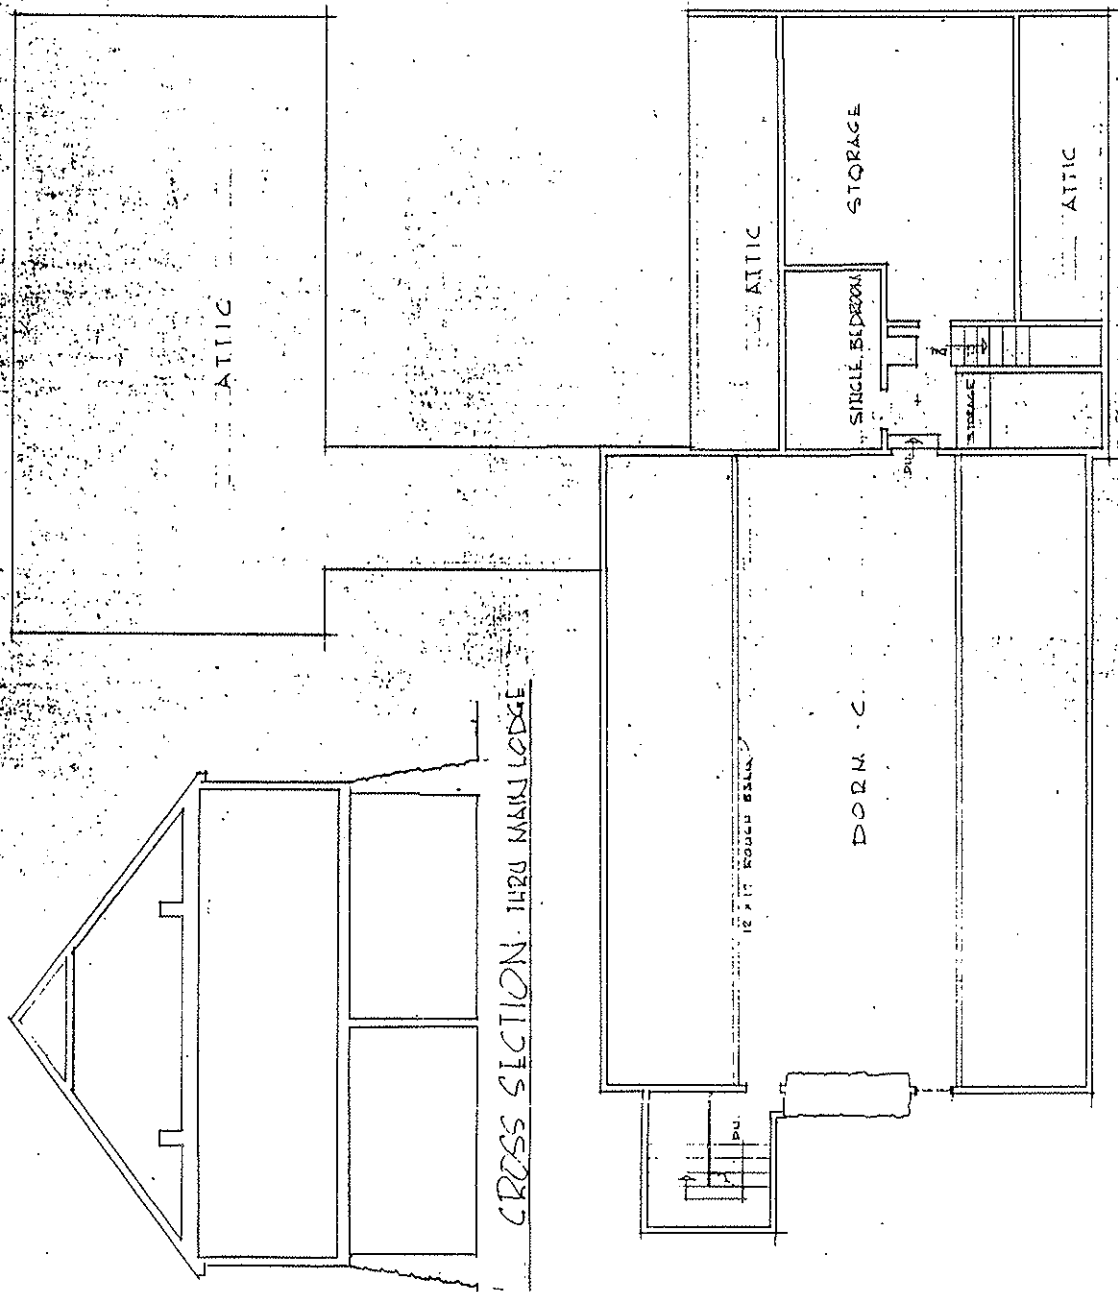
ATTIC FLOOR PLAN
 SANTIAM LODGE
 EXISTING BUILDING
 DRAWN BY - H. J. S. SALLEN, DOR.
 ARCHITECTURAL FIRM
 421 N. W. 5th St., Salem, Ore.

Figure B-9. Santiam Lodge: Attic Floor Plan. Existing Building drawn in 1974. Same additions as shown in previous figures (B-7, B-8).

The attic level floor plan is fairly simple with the west half of the main structure containing another dormitory; the remaining space is primarily storage. The attic of the north wing is not accessible from the main structure on this level.

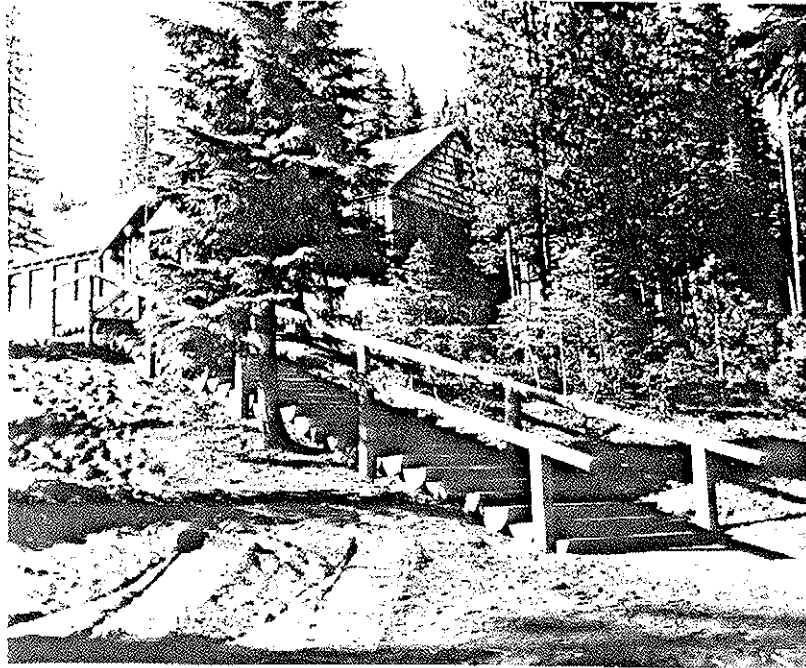
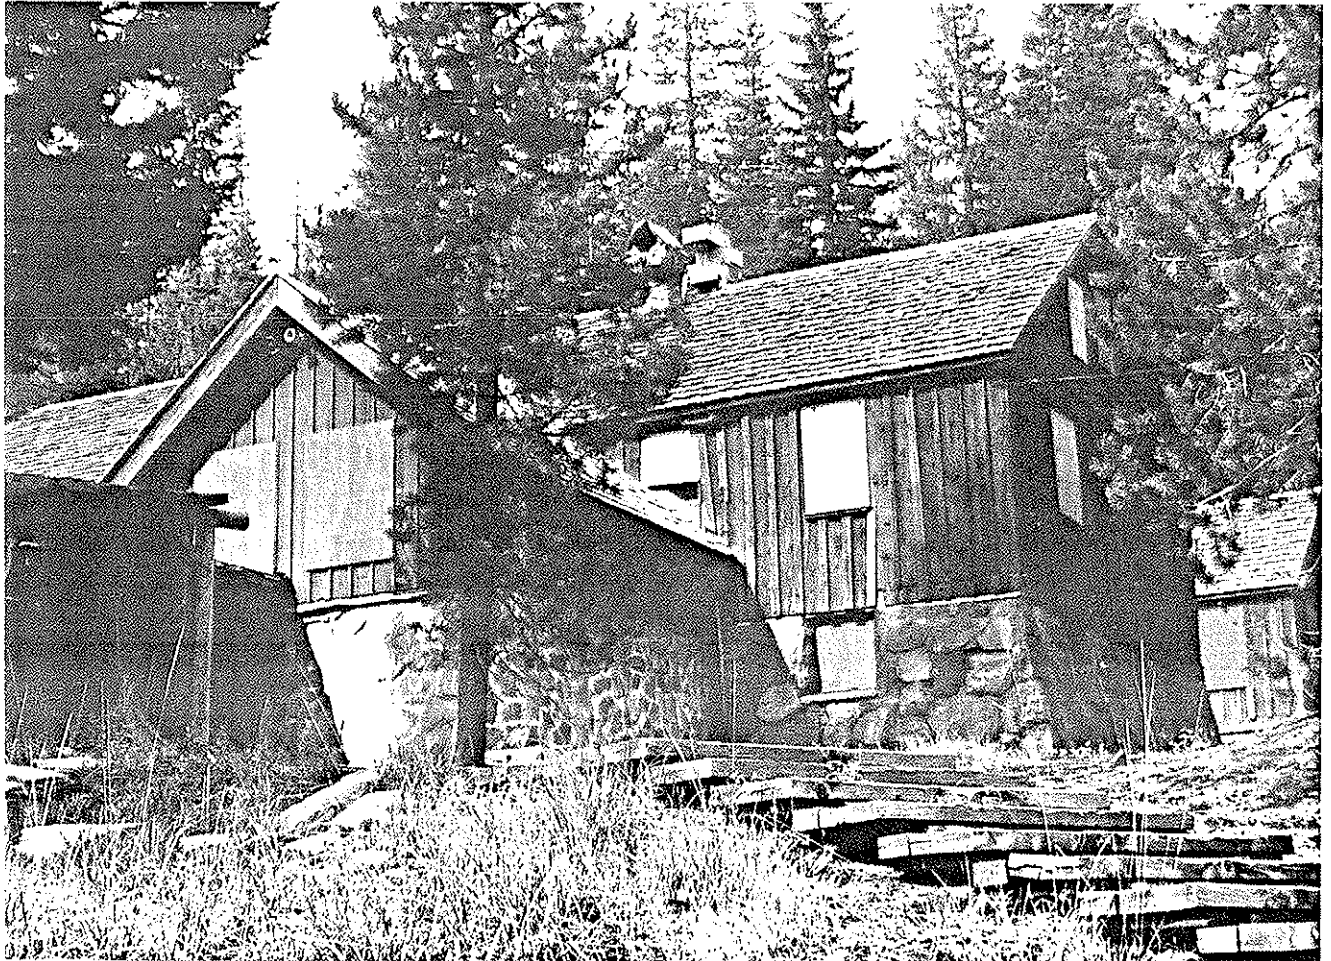
Figure C-1. Santiam Lodge. (Above) Historic photo of approach stairway to the lodge. Compare with stairway shown in current photo. (Below) South elevation, east end, showing alteration of the entrance way, part of the snow tunnel addition, and the replacement stairway to the parking lot and garage below. October 1988.

A primary feature directly associated with the lodge is a long stairway from the garage and parking area to the lodge entrance above. This was originally designed of large, half-logs about 6 feet in length for the individual steps (about 35) with smaller pole railings and supports on either side of the

stairs. The stairs which remain today are apparently in the original location; however, the railings are no longer in place and the steps themselves have been replaced with planks of similar dimension.

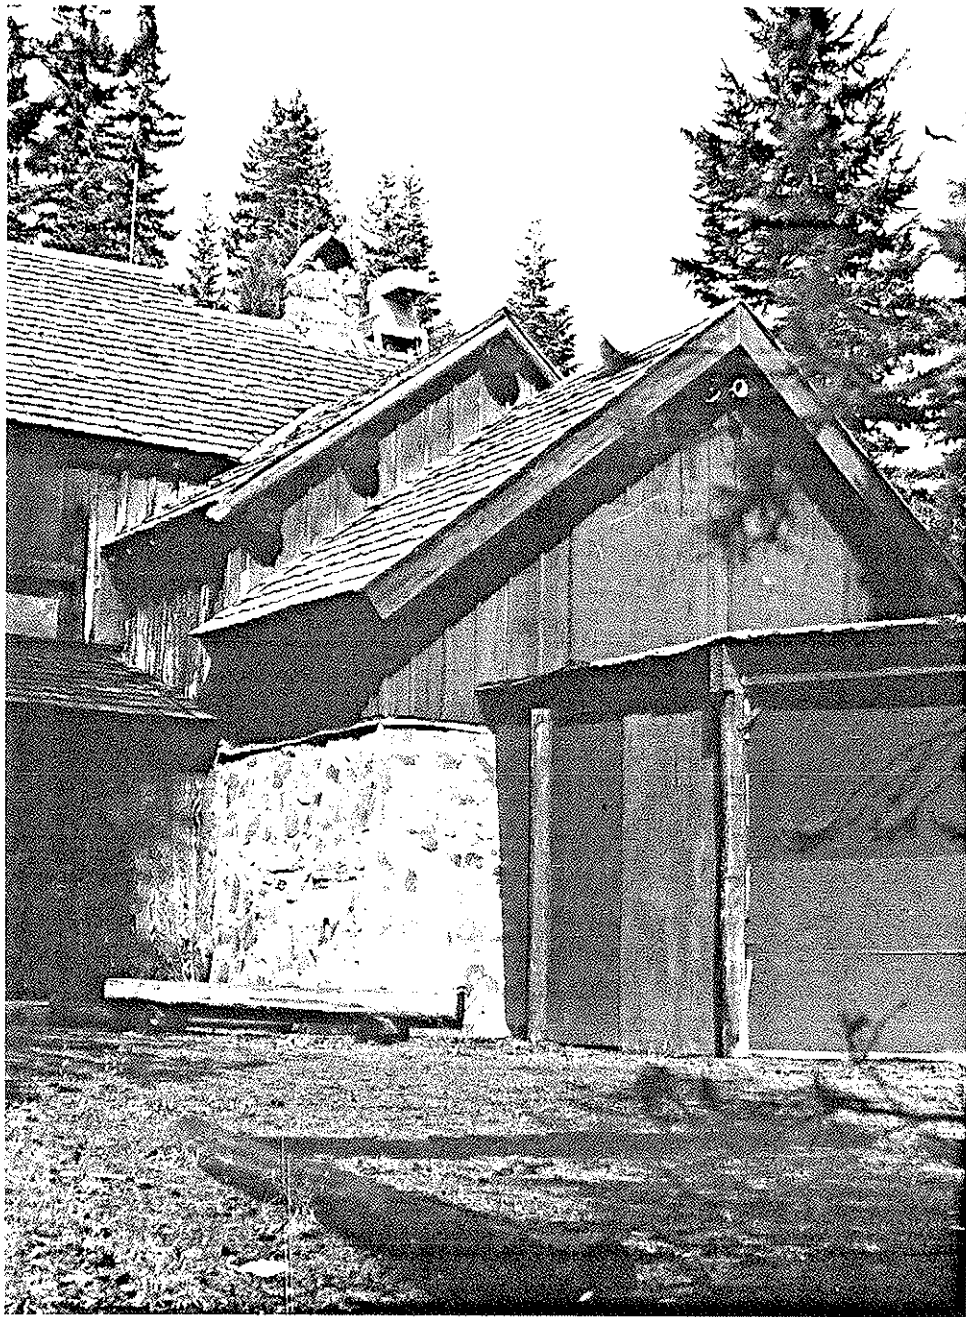
Figure C-2. Santiam Lodge. South elevation, center. Entrance way viewed from southwest shows alteration/addition to entrance vestibule and snow tunnel. October 1988.

Alterations: The exterior of the lodge has been modified through several additions which were executed during the early 1960s, according to special-use permit files. The front entrance has been quite extensively remodeled. A vestibule and a 45-foot long snow tunnel (1968) were constructed from the front entrance down along the stairs to the garage/parking area below. The tunnel has been partially removed and only a portion remains over the entrance way. {See Photos, Appendix C}. The extant addition consists of an enclosure covering the original entrance stairway (i.e., vestibule) which is constructed primarily of wood frame and plywood siding with a gable roof similar to the original entrance. The enclosure extends along the front walk to the head of the stairway which leads to the garage. This too is wood-framed with plywood siding but has a shed roof.

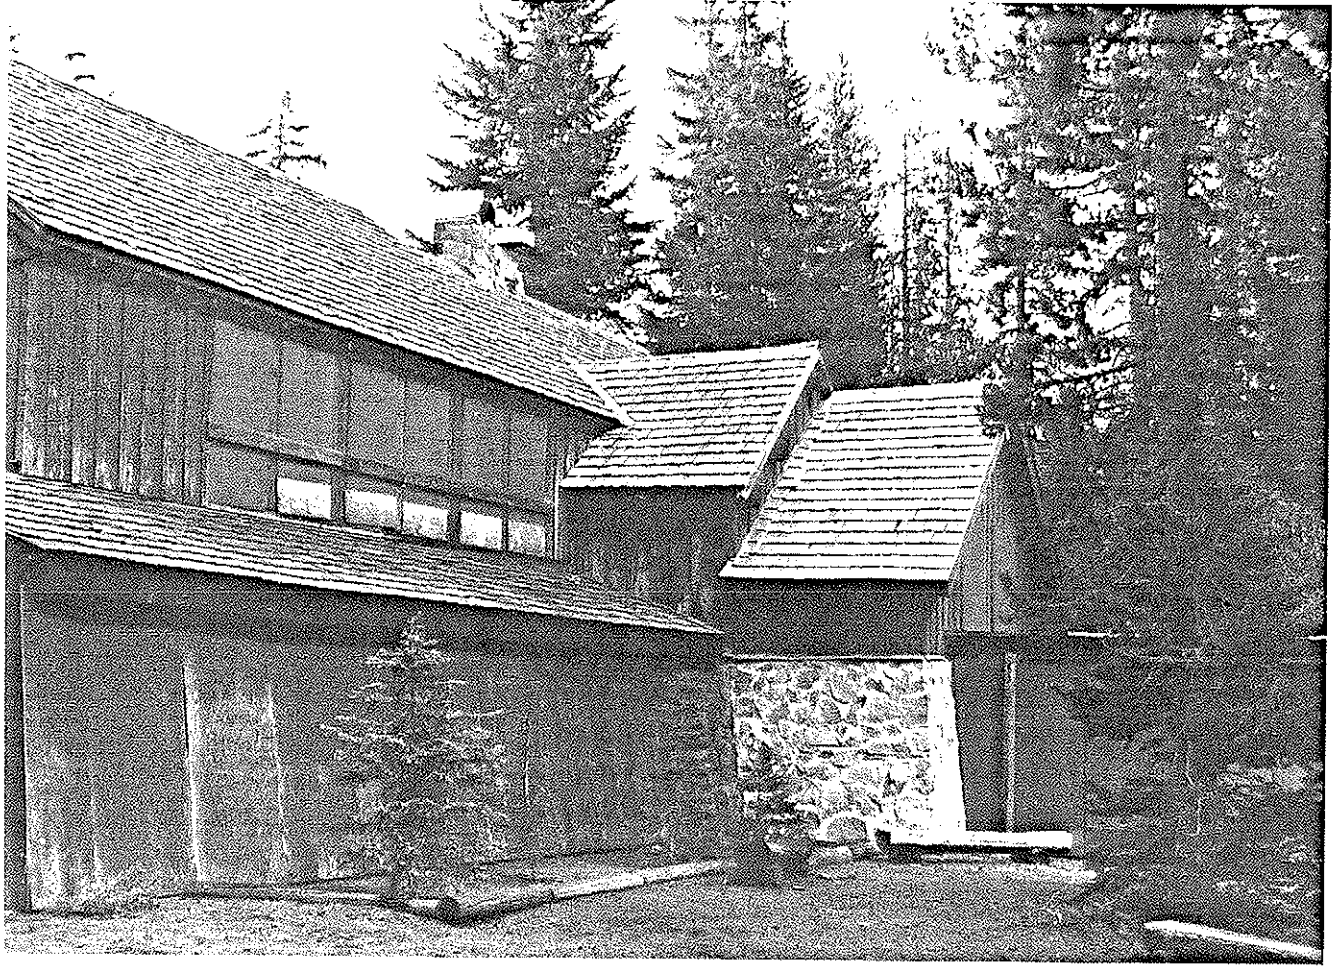
Figure C-3. Santiam Lodge. South elevation, west end. This view shows the covered walkway which connects the entrance and the wood storage area. Plywood along the front is a temporary, protective covering, as is the plywood covering the windows of the lodge. October 1988.

The front elevation of the west side of the main structure has also been enclosed in a similar fashion; that is, wood-framed with plywood siding and a shed roof. This forms an enclosed walkway to the firewood storage area at the southwest corner of the building. The covered walkway then conjoins with an enclosed exterior stairwell/fire escape on the west elevation of the lodge. This was built about 1963 and is also a wood-framed construction with plywood siding.

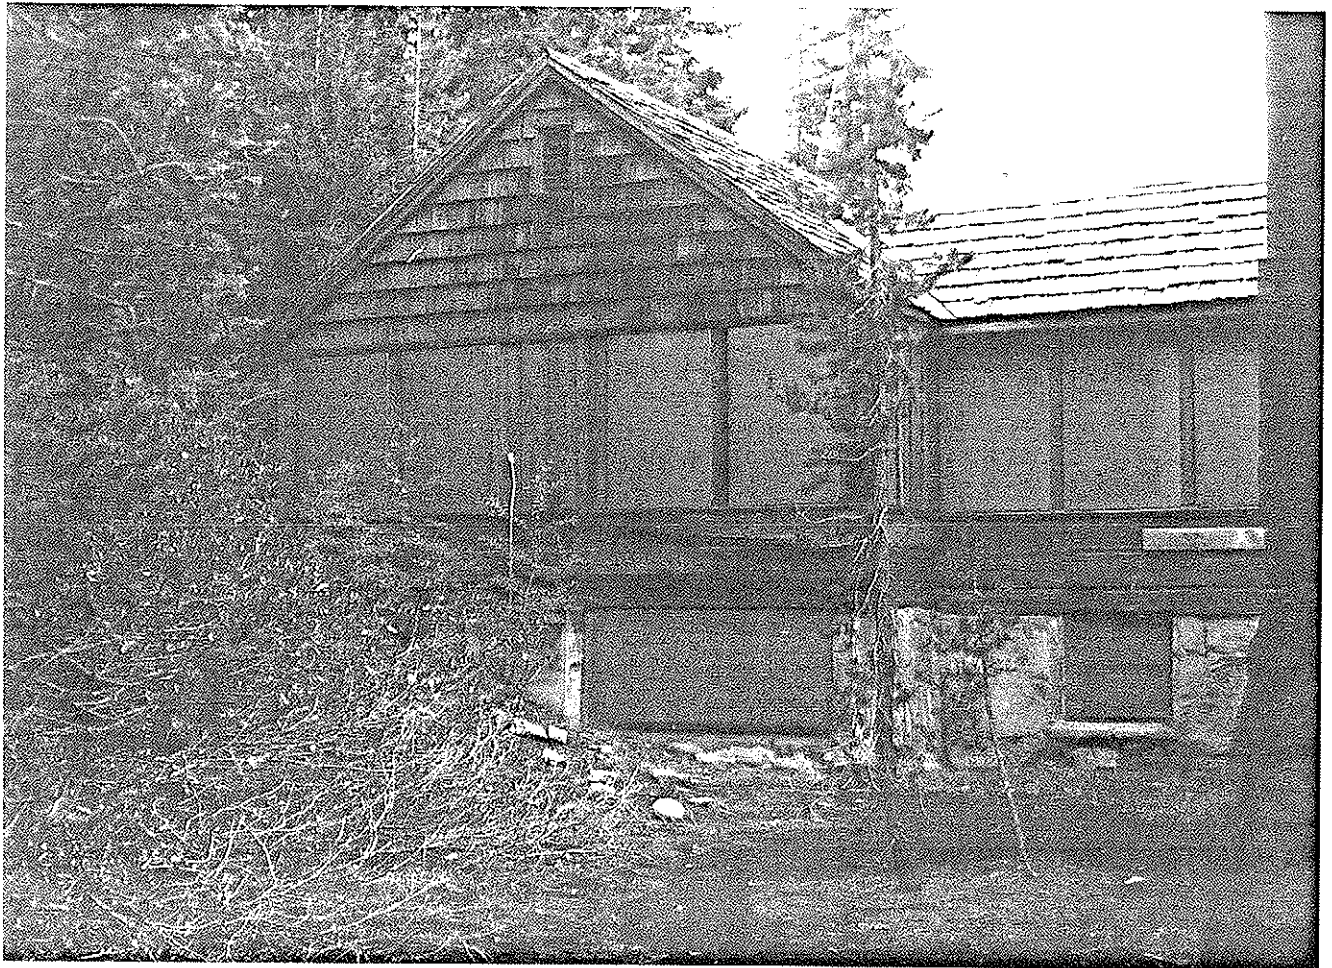
Figure C-4. Santiam Lodge. West elevation of back wing of structure (i.e., Recreation/Dining rooms) and adjoining hallway. Again plywood is covering window openings for protective purposes. October 1988.

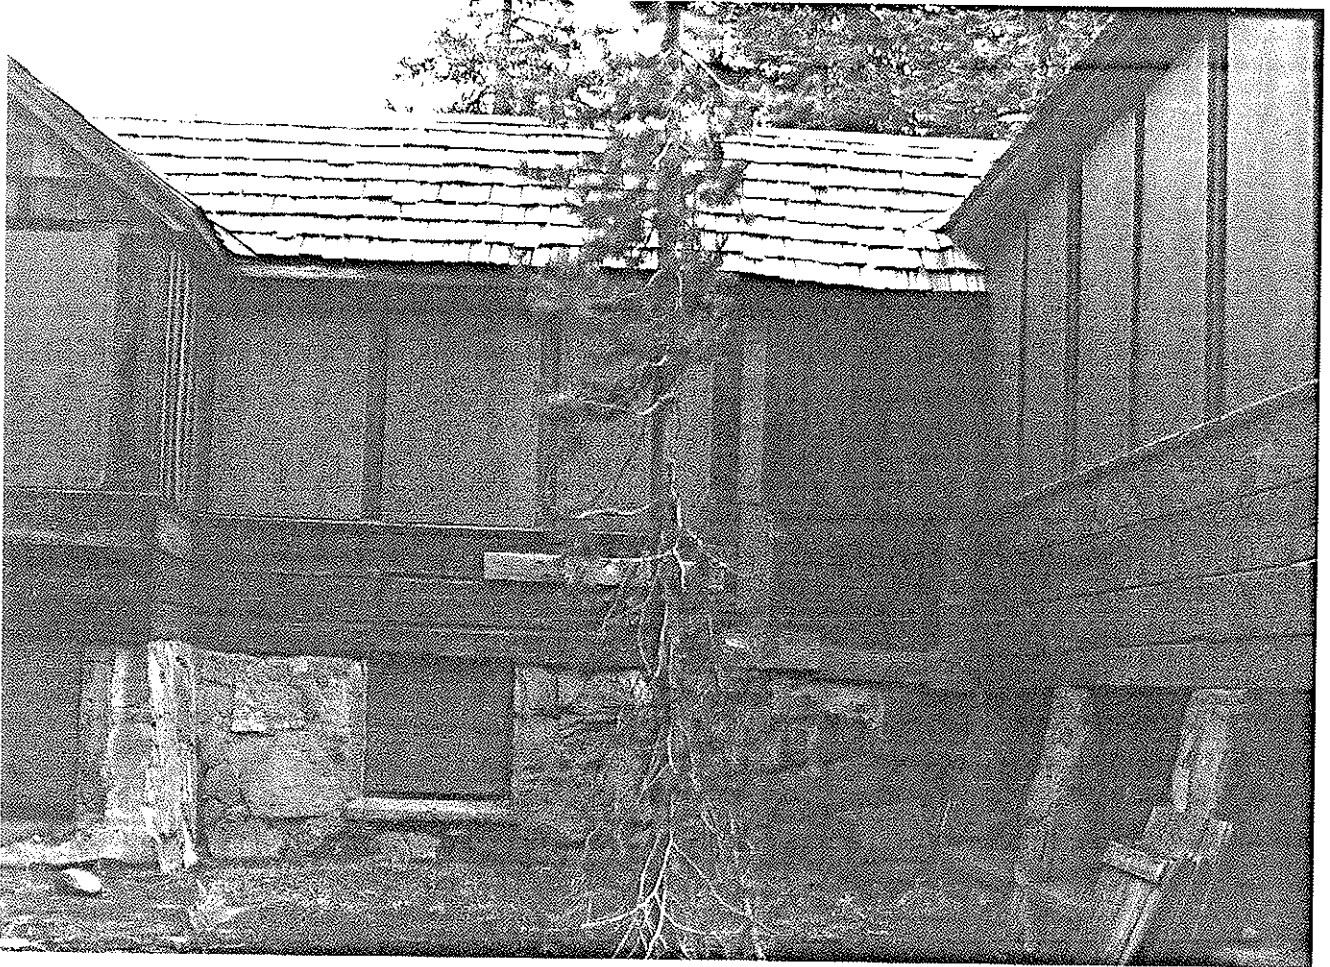
Figure C-5. Santiam Lodge. West Elevation, center, showing hallway which connects the back wing to the main structure. October 1988.

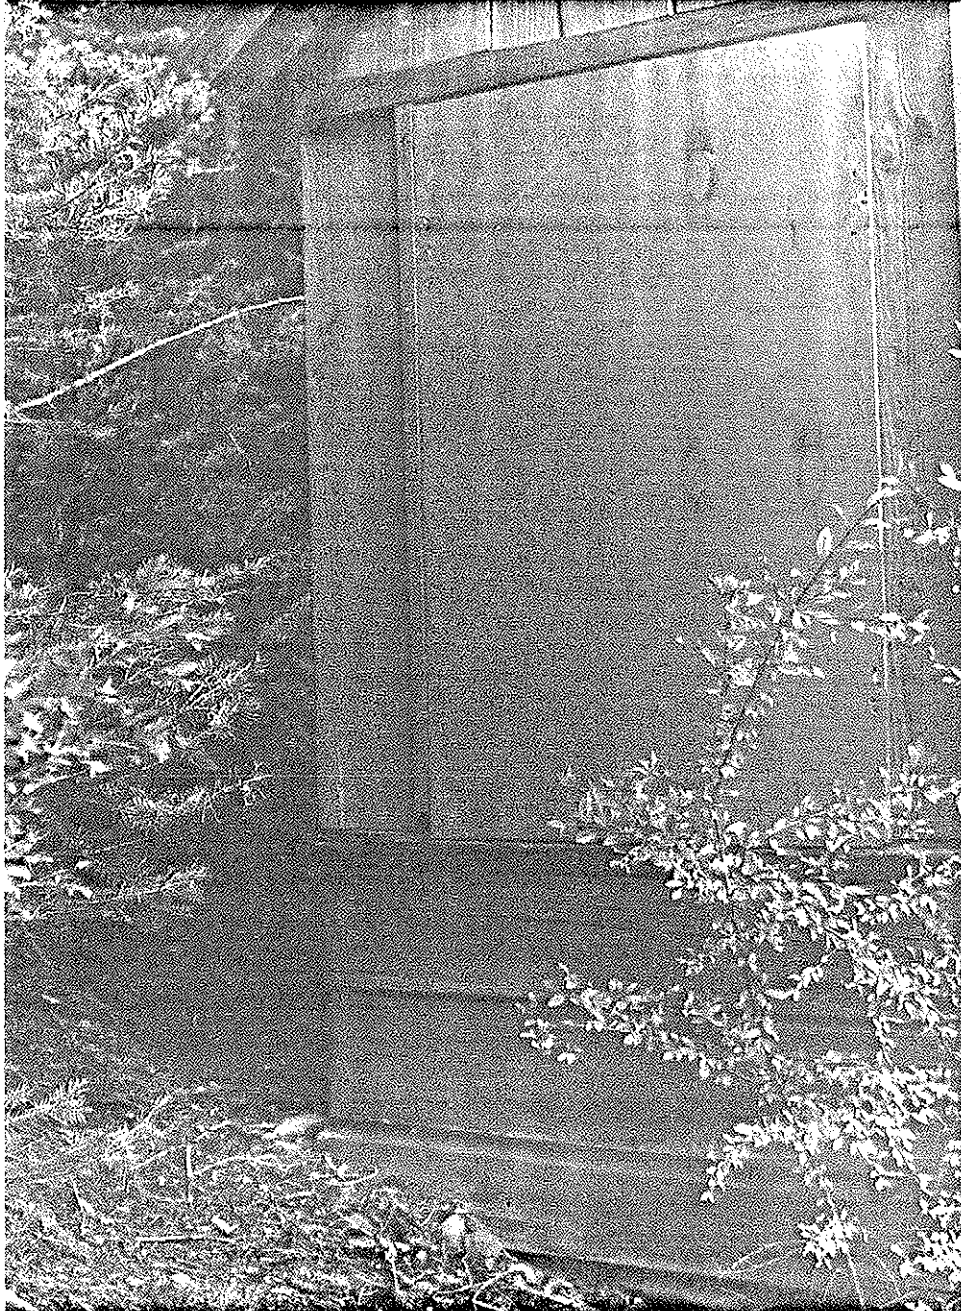
Figure C-6. Santiam Lodge. Northwest corner of the back wing of the structure. View shows back hillside settling into building along north elevation. October 1988.

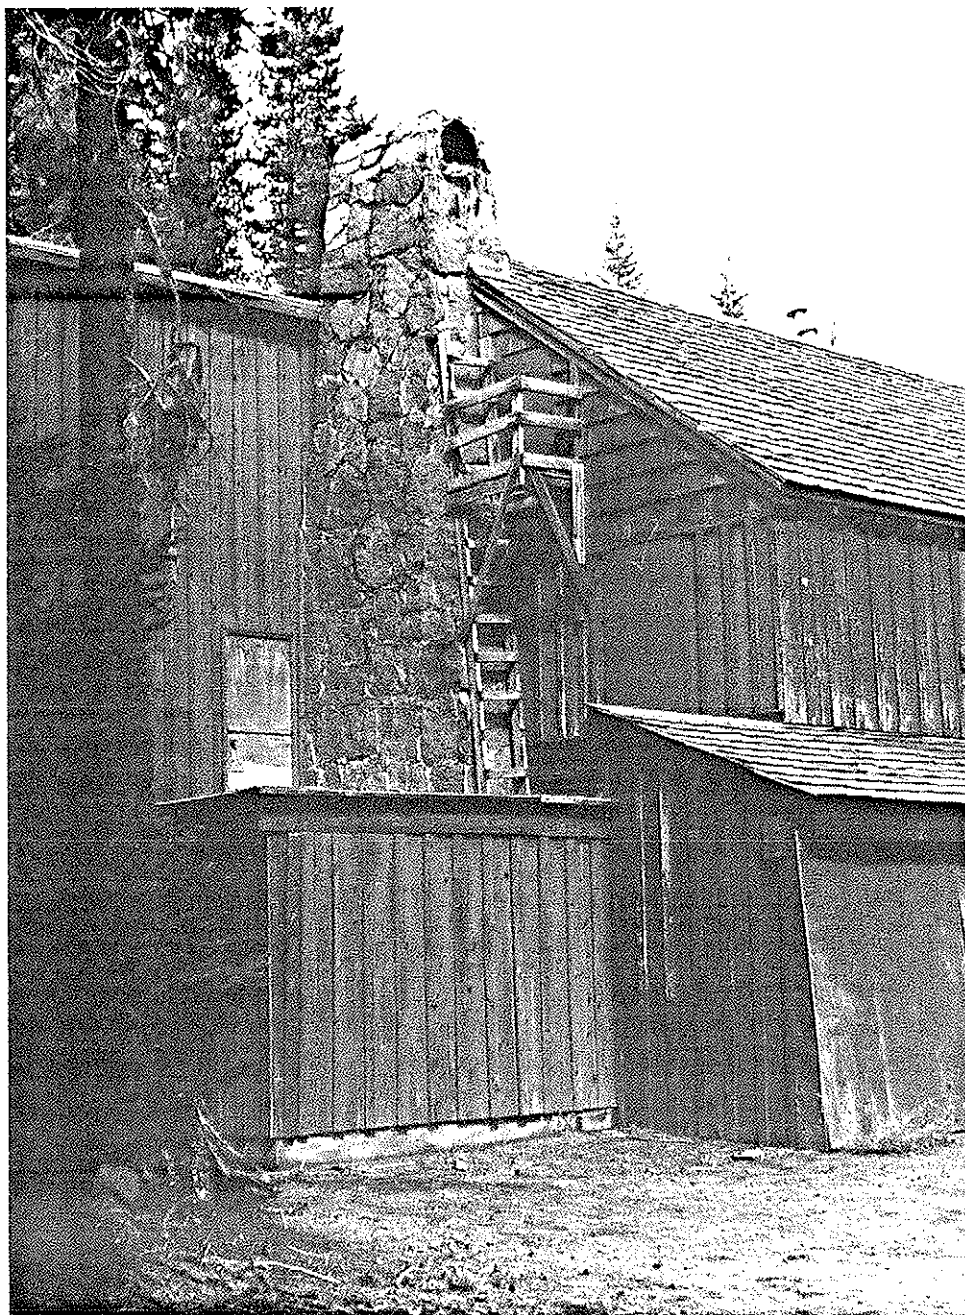
Figure C-7. Santiam Lodge. Southwest corner of main structure showing additions: Covered walkway (right), wood storage area (center), and enclosed exterior stairwell (left-rear). Also shown is one of the lodge's two original vaulted cap chimneys of uncoursed stone construction. October 1988.

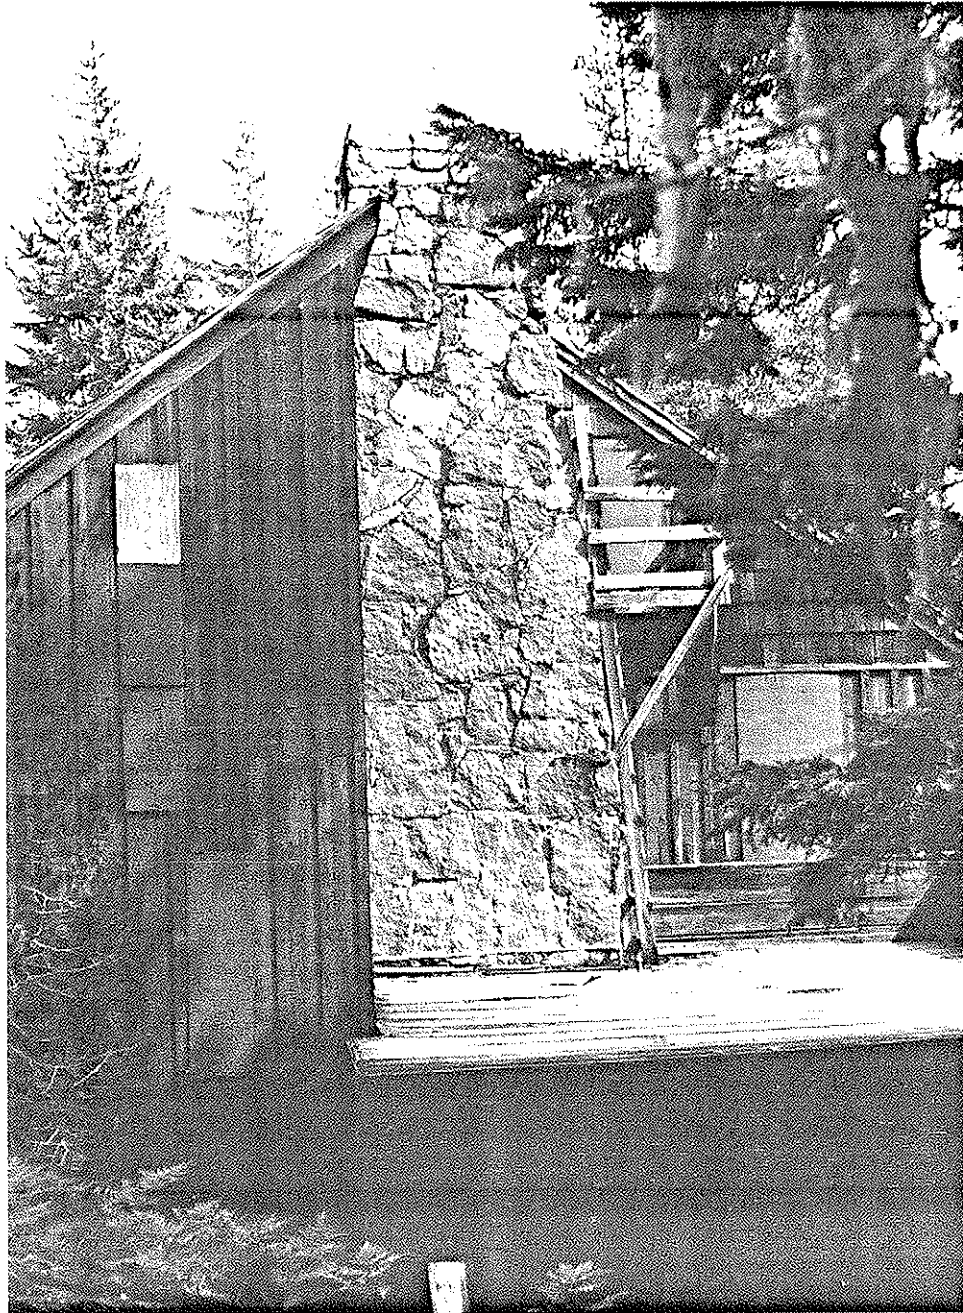
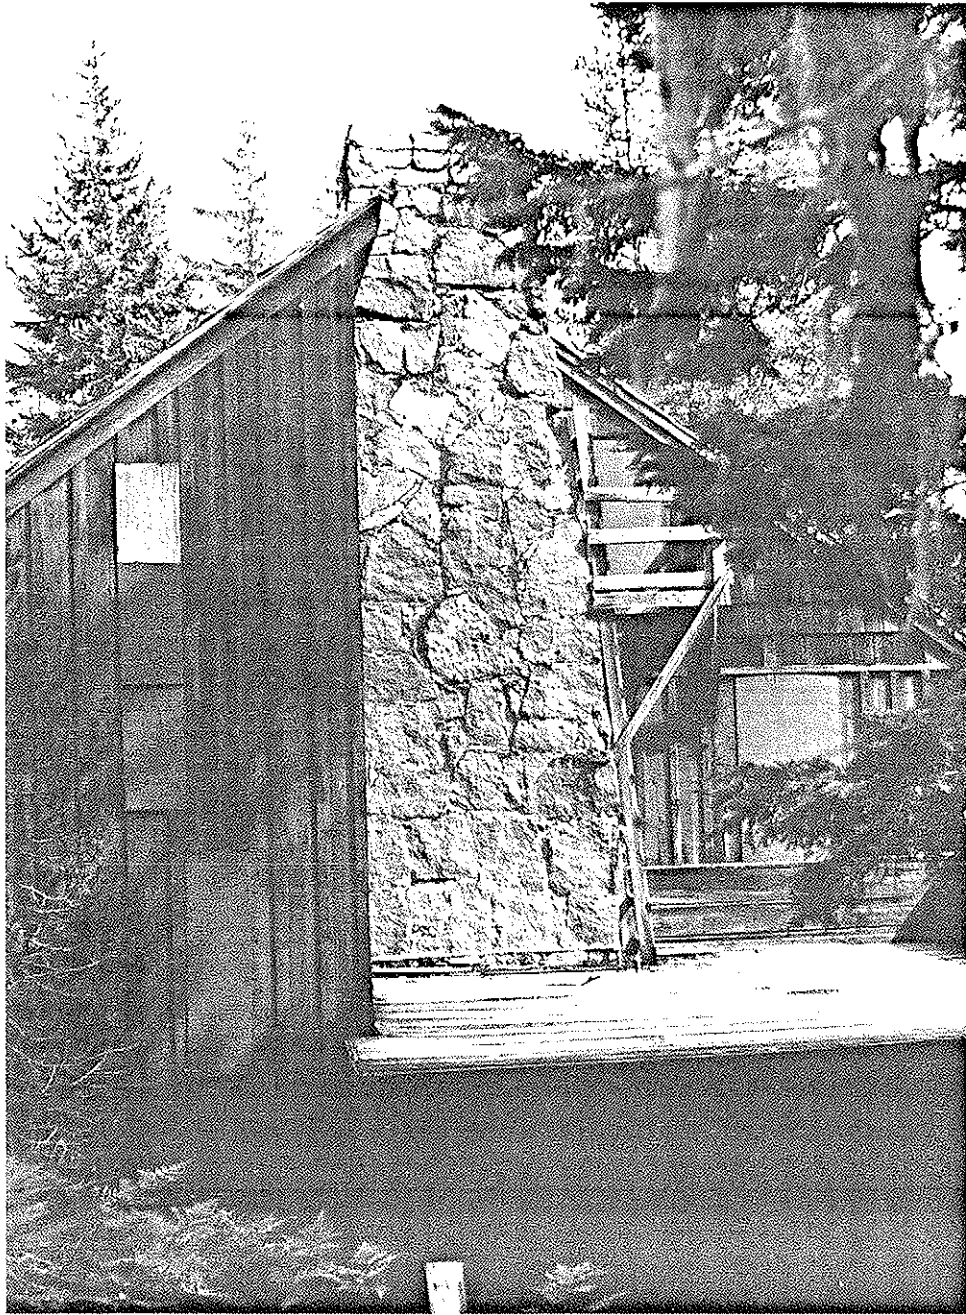
Figure C-8. Santiam Lodge. West elevation of main structure showing chimney, enclosed stairwell (left), and roof of the wood storage area (lower right). October 1988.

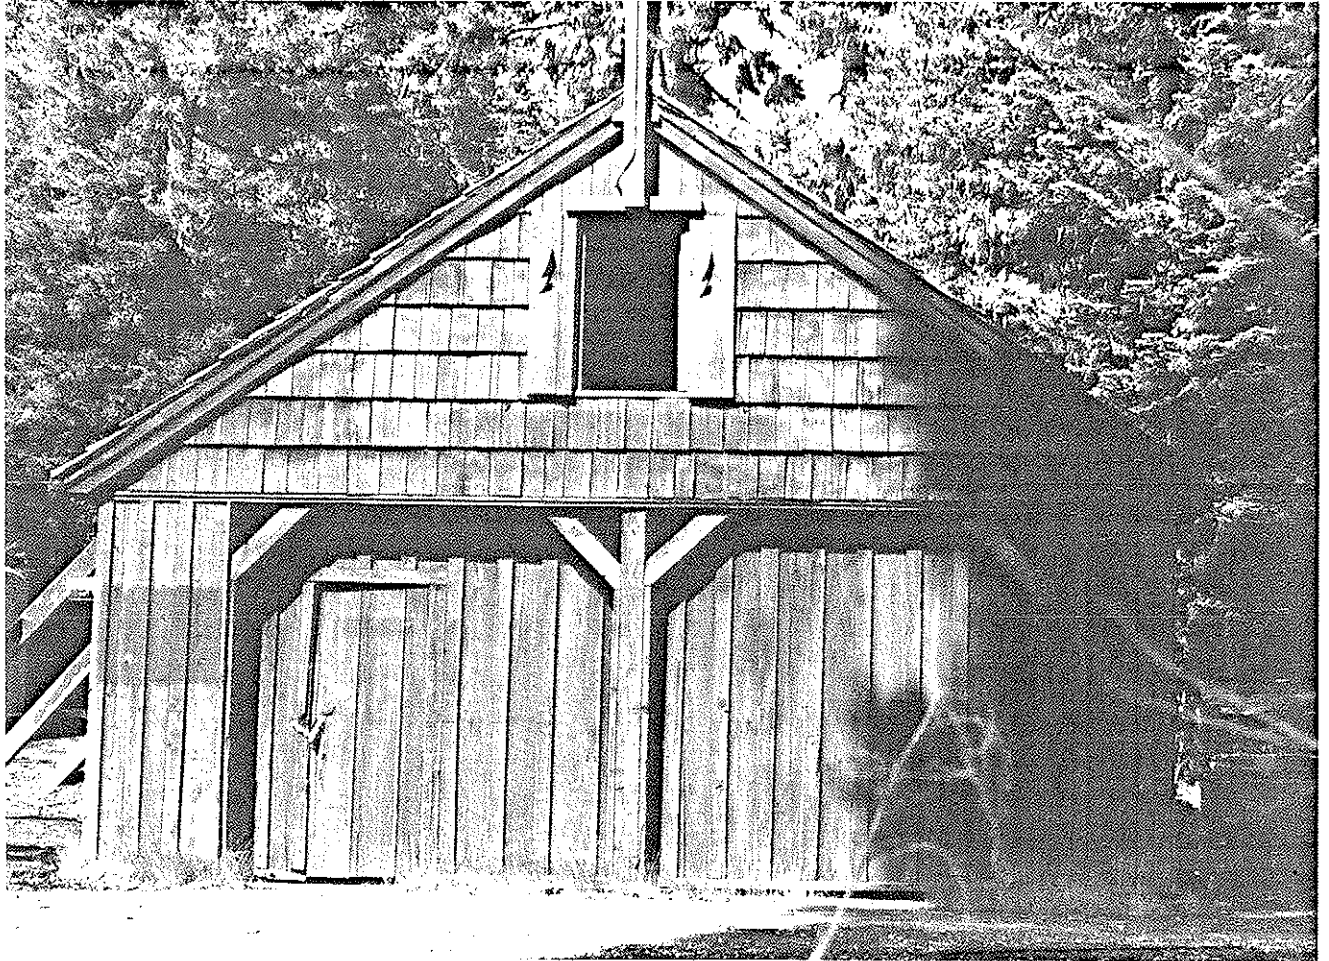
Figure C-9. Garage at Santiam Organization Site. South elevation. Also houses generator and apparatus for the ski lift. Note the pine tree cut-outs, representative of CCC-era buildings, on the window shutters. October 1988.

A double bay garage is located about 125 feet east of the lodge. Constructed in 1940, following completion of the lodge, this structure measures approximately 20 by 25 feet. It is rectangular in plan, wood-framed with vertical board and batten construction and wall shakes on the gable ends. The garage sits on a poured concrete foundation and floor. It has a wood-shingled medium gable roof, close eaves with cornice fascia on close verges. A series of three windows are located on each the east and west elevations; a single window is centered on the south gable end. Two large vertical lift doors are located on the south gable end. A rectangular addition, slightly taller than the building itself, is located on the north gable end and houses the hardware of a rope tow and a generator. Decoration is limited to well-defined pine tree cut outs on the shutters of the gable window and those along the east elevation. No exterior modifications are apparent.

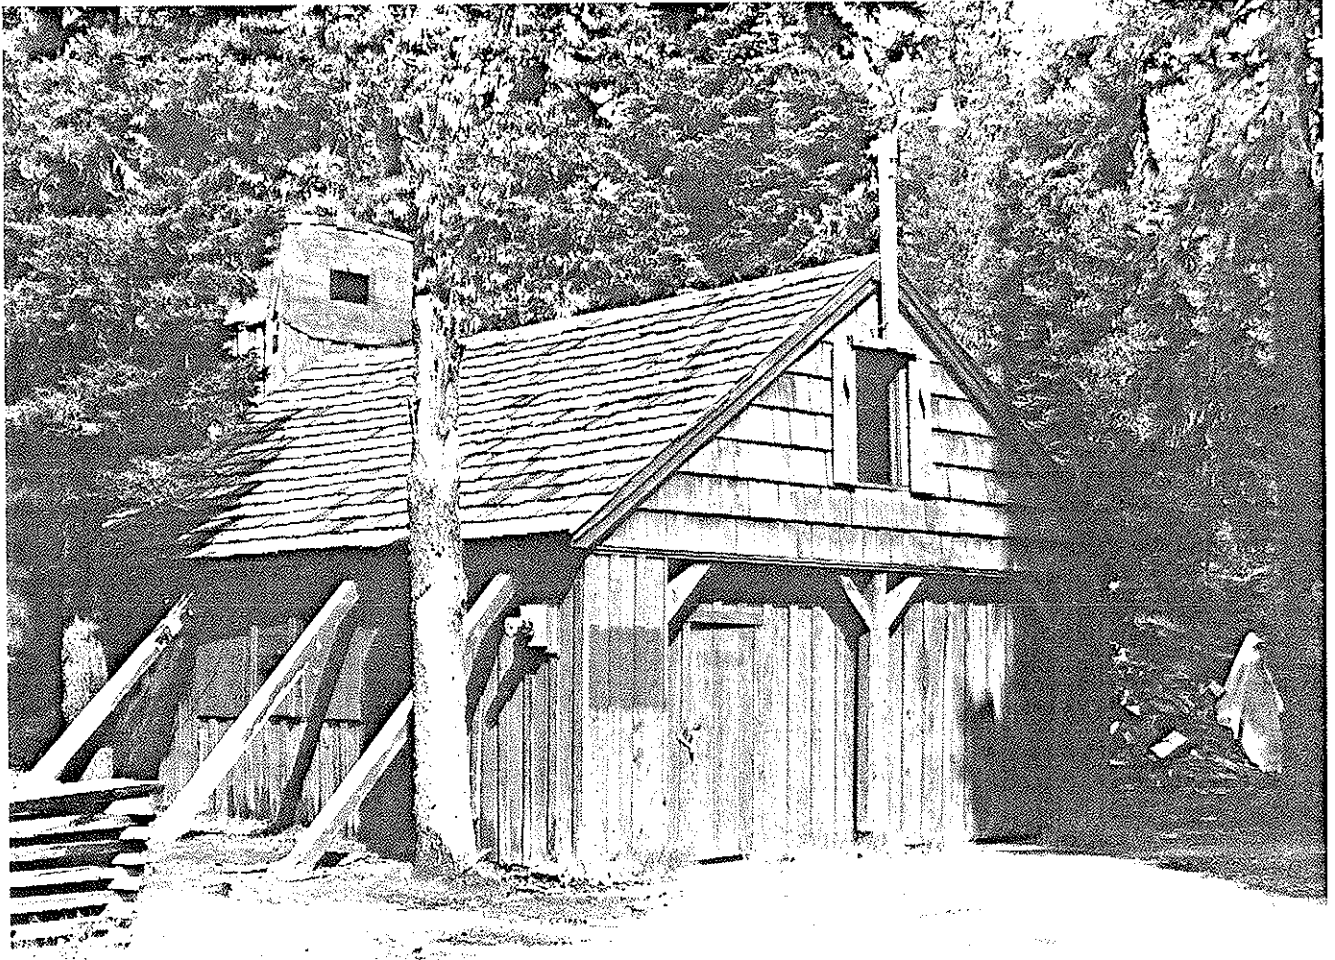
Figure C-10. Garage. Santiam Organization Site. Southwest corner of the building. Note: The tower at the rear of the building is part of the ski tow apparatus. October 1988.

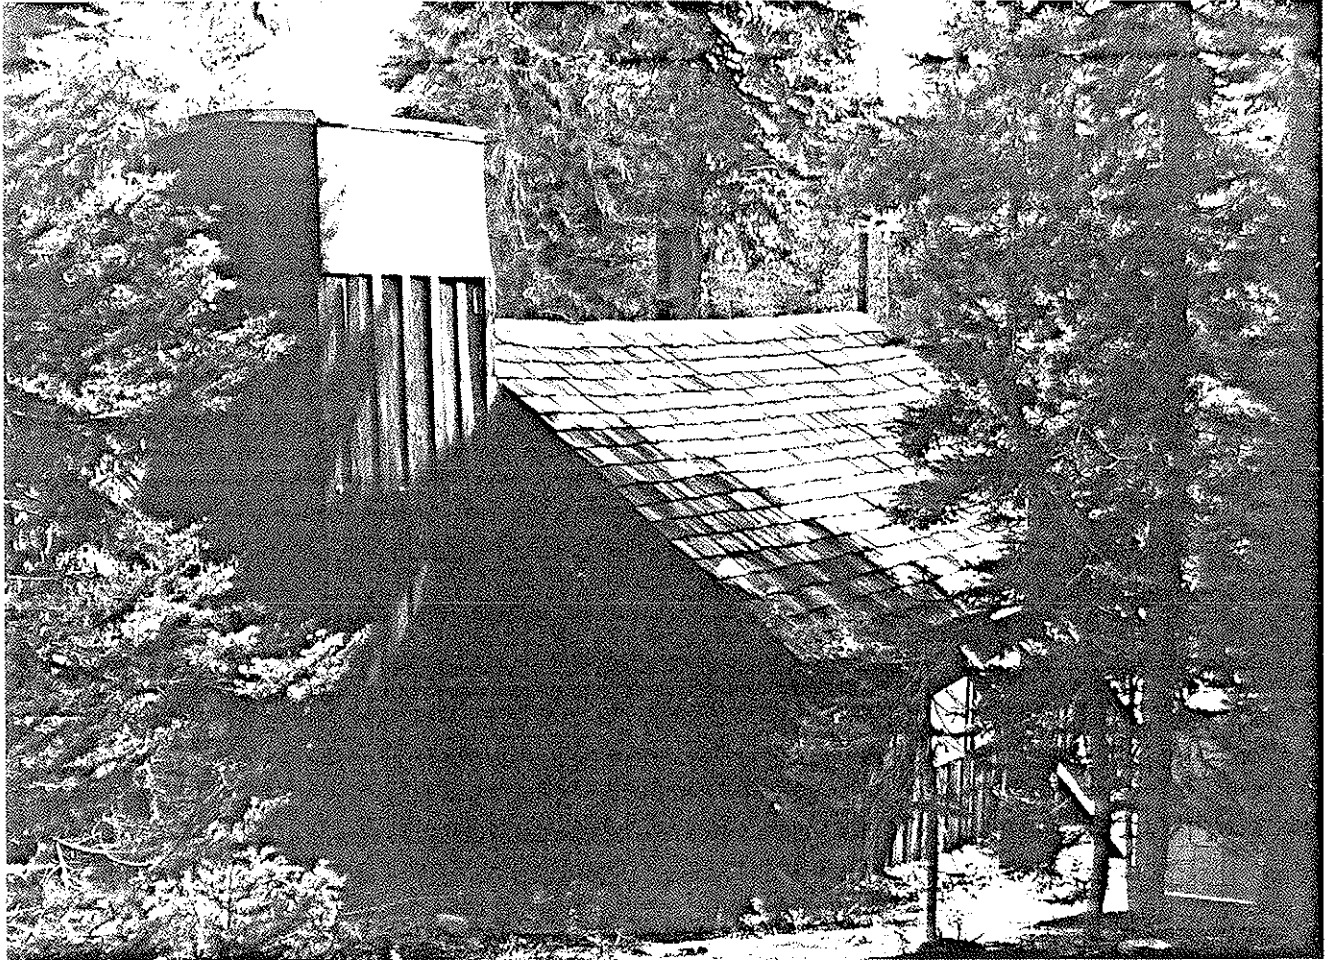
Figure C-12. Garage. North elevation. The rectangular tower/extension is part of the ski tow; a generator is housed inside. October 1988.

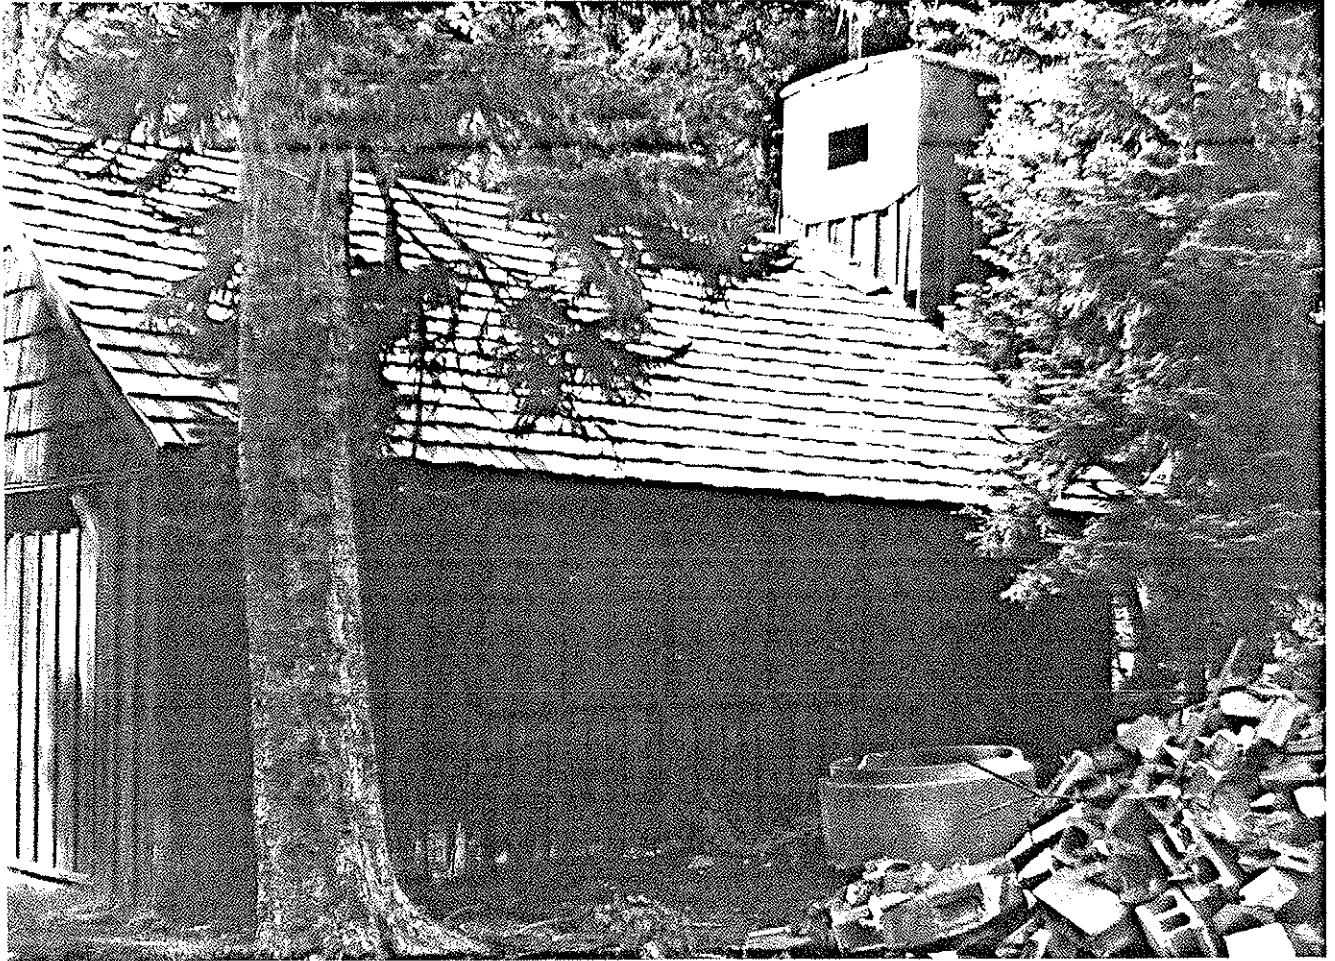
Figure C-14. Garage. East elevation. Note the pine tree cut-outs on the window shutters, a common element of CCC construction. The garbage visible in the right foreground is the remains of improvements removed by the past special-use permit holders; it has since been cleaned up. October 1988.
