SANTIAM PASS SKI LODGE

AN EVALUATION OF HISTORIC SIGNIFICANCE

McKenzie Ranger District
Willamette National Forest
USDA Forest Service

JULY 1989

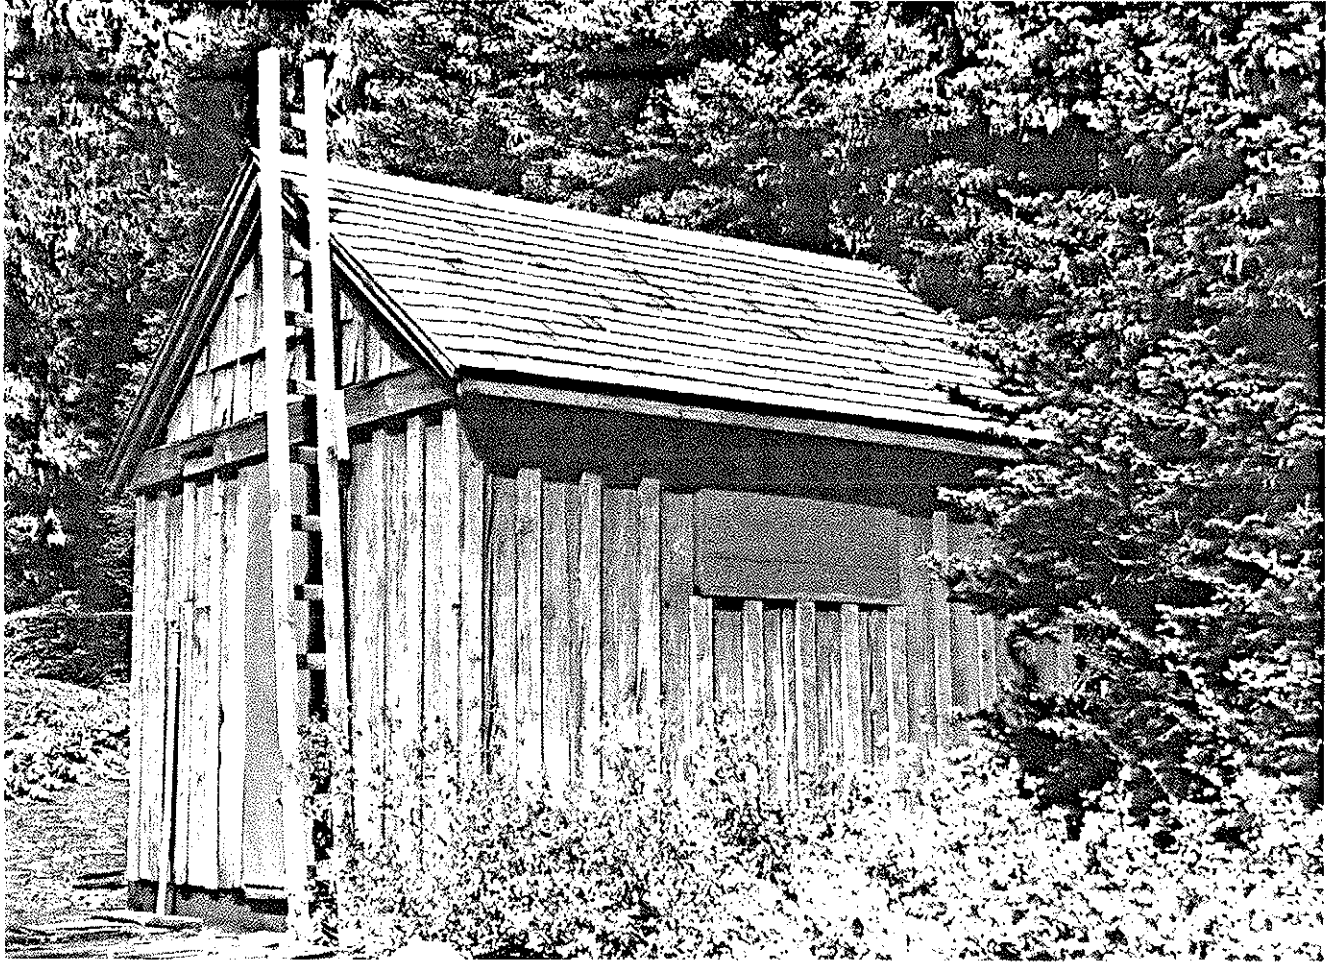
Figure C-16. Pump house. South elevation. October 1988.

The garage and pumphouse are in good condition. They have been maintained in their original design.
