CULTURAL PROPERTY INVENTORY
AND
REQUEST FOR A DETERMINATION OF ELIGIBILITY

HISTORIC: Pechuck Lookout
COMMON :

STREET ADDRESS:	
CITY:	COUNTY: Clackamas
STATE: Oregon

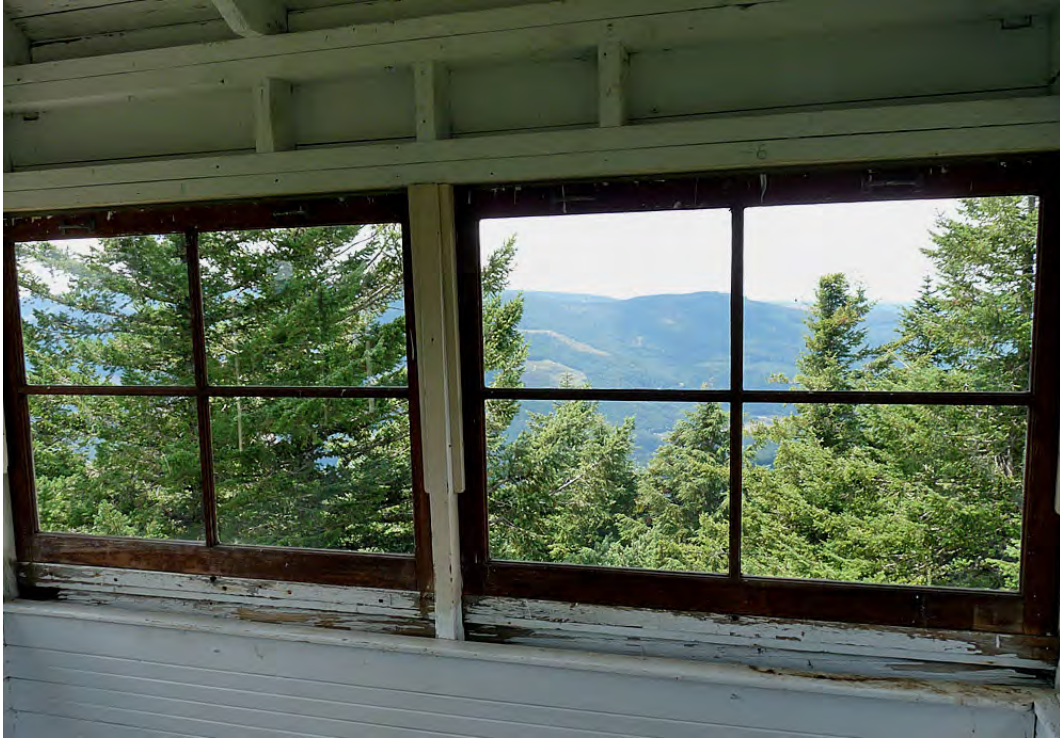
Figure 3. View to the south from the cupola at Pechuck Lookout.

Pechuck Lookout is located in south central Clackamas County, Oregon on land administered by the Salem District, Bureau of Land Management (Figure 1). The lookout sits on Pechuck Mountain, a high promontory situated at the southeastern end of the High Ridge Trail just outside of the Table Rock Wilderness (Figure 2). Pechuck Lookout is positioned at an elevation of 4338 feet above mean sea level on a rocky knoll that, on a clear day, overlooks the surrounding terrain in all directions. Views from the lookout encompass the Molalla River drainage to the south and west, the Camp Creek and Table Rock Fork drainages to the north, and the High Cascades to the east. However, the recent growth of trees on and around the outcrop has blocked the panoramic views from the lookout in most directions (Figures 3 and 4).

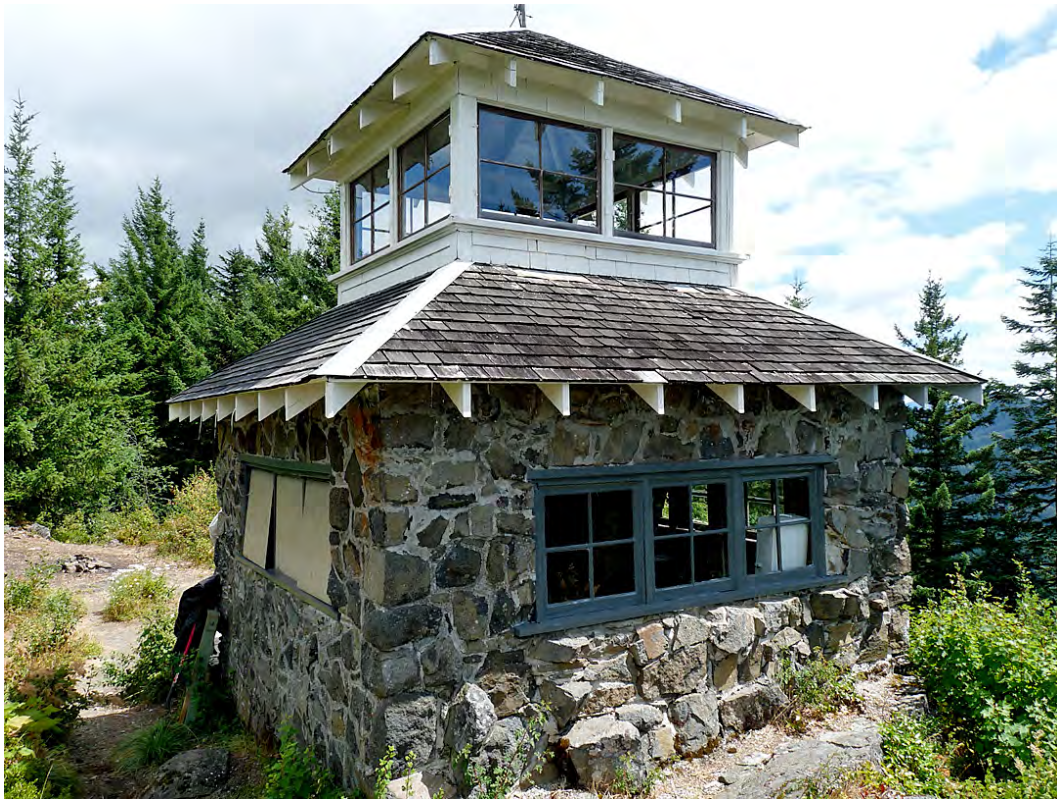
Figure 4. View to the southeast of the west and north walls of Pechuck Lookout.

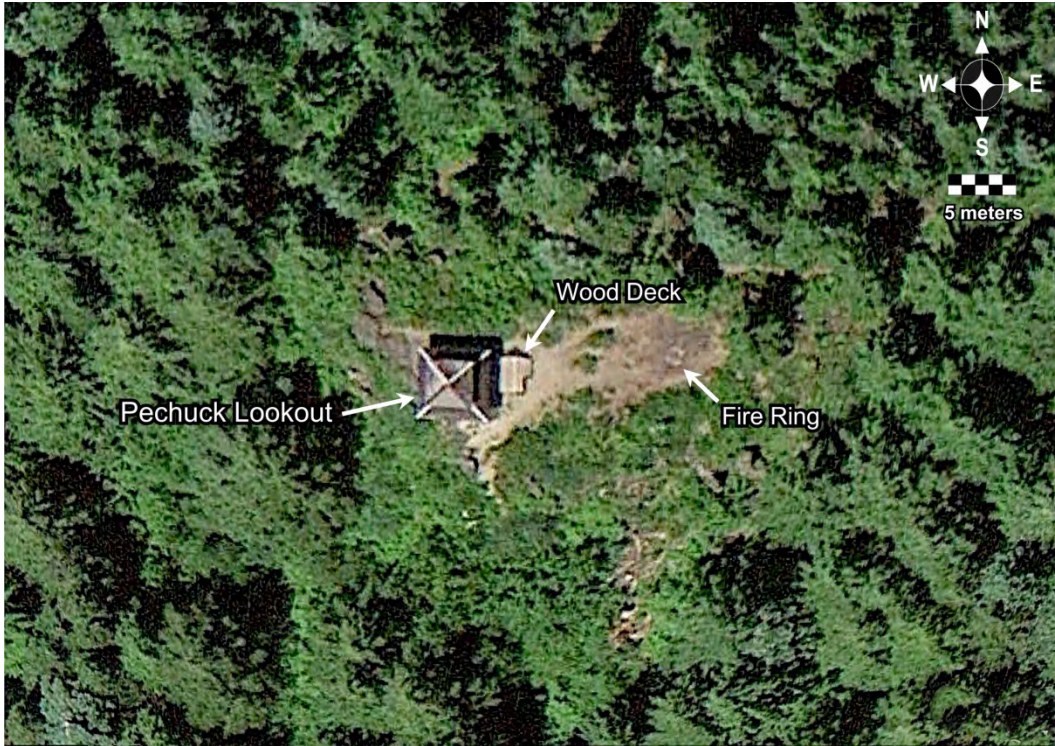
Figure 6. Aerial view of Pechuck Lookout showing the locations of the wood deck and fire ring in relation to the lookout (adapted from a GoogleEarth aerial photograph, July 8, 2013).

The lookout is positioned near the west edge of a small, relatively level ridgetop at the highest point on the ridgetop. This level area is roughly 30 x 15 meters, with a rock outcrop that drops off precipitously situated on the west side of the knoll. The level area to the east of the lookout consists of open dirt-covered ground surrounded by low brush, with a rock fire ring situated at the east end (Figure 6). An abandoned road switchbacks up the north side of the knoll from Road 7-4E-27-2 to the lookout (Figure 5). The area directly surrounding the lookout is open and has been kept relatively free of litter, with most of the refuse items observed on the ground surface within the fire ring.

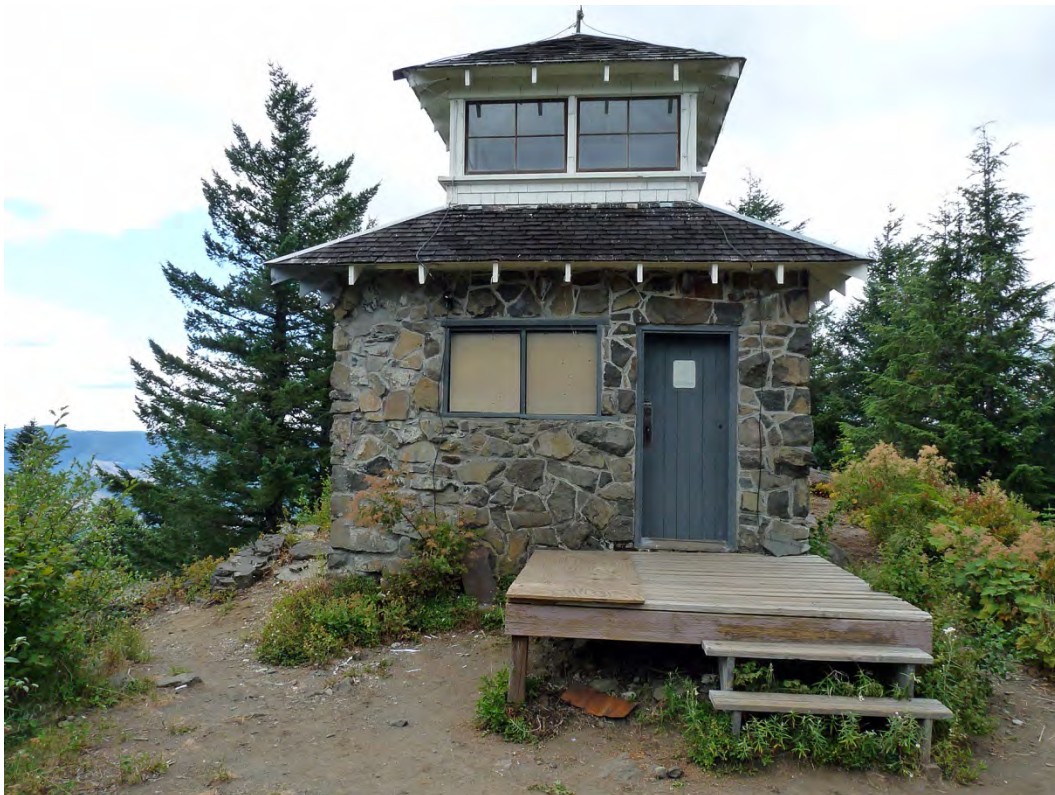
Figure 7. View to the west of the front of Pechuck Lookout showing the deck and stairs.

Pechuck Lookout is a cupola groundhouse design (D-6) with the lower story built of native stone and the upper cupola constructed of wood, with a cedar shake roof (Figure 7). The lower story consisted of the living quarters and upper cupola was the fire lookout.

The outside dimensions of the stone structure are 14 x 14 feet, with the height of the rock wall on the west side of the building at 7.5 feet, on the north and east sides 9.6 feet, and on the south side where the ground slopes sharply at 10.6 feet. The lower story has three sets of three four-pane fixed windows on three sides (Figure 9) and a fixed two-pane window on the east side (Figure 7). These windows have protective steel shutters that fold out and up and are held open by wires that attach to the roof (Figure 9). A heavy duty, windowless wooden entry door is located on the east side of the building where a recently added wood deck and stairs provide access to the door (Figure 7).

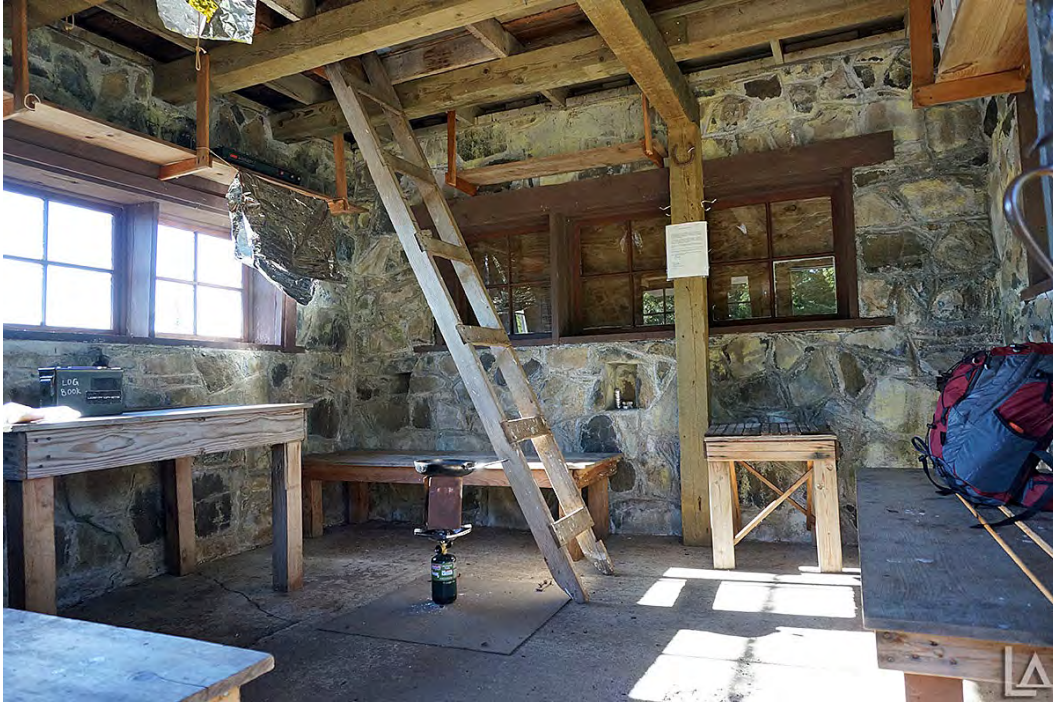
Figure 8. View from the entry door of the inside of the lower story of Pechuck Lookout.

At Pechuck Lookout, the interior dimensions of the lower story are 12 x 12 x 7 feet, with a concrete slab floor. The interior was restored in the early 1990s, and milled 6 x 6 inch beams replaced the original 6 x 6 inch hand-hewn beams that support the upper story (Figure 8). Several wooden shelves, benches, and tables are present in the lower story (USDI Bureau of Land Management 2015).

The interior of the upper cupola measures 7.5 x 7.5 feet. The lower walls of the cupola are of tongue and groove construction. The walls below the windows stand 3 feet tall (Figure 10), with the walls 6 foot in height and the center height of the cupola at 9 feet (Figure 11). The cupola has sets of two four-paned windows on all four sides that slide down into the walls to open (Figure 10). Access to the cupola is by a wooden ladder through a trap door in the ceiling of the lower story (Figure 8).

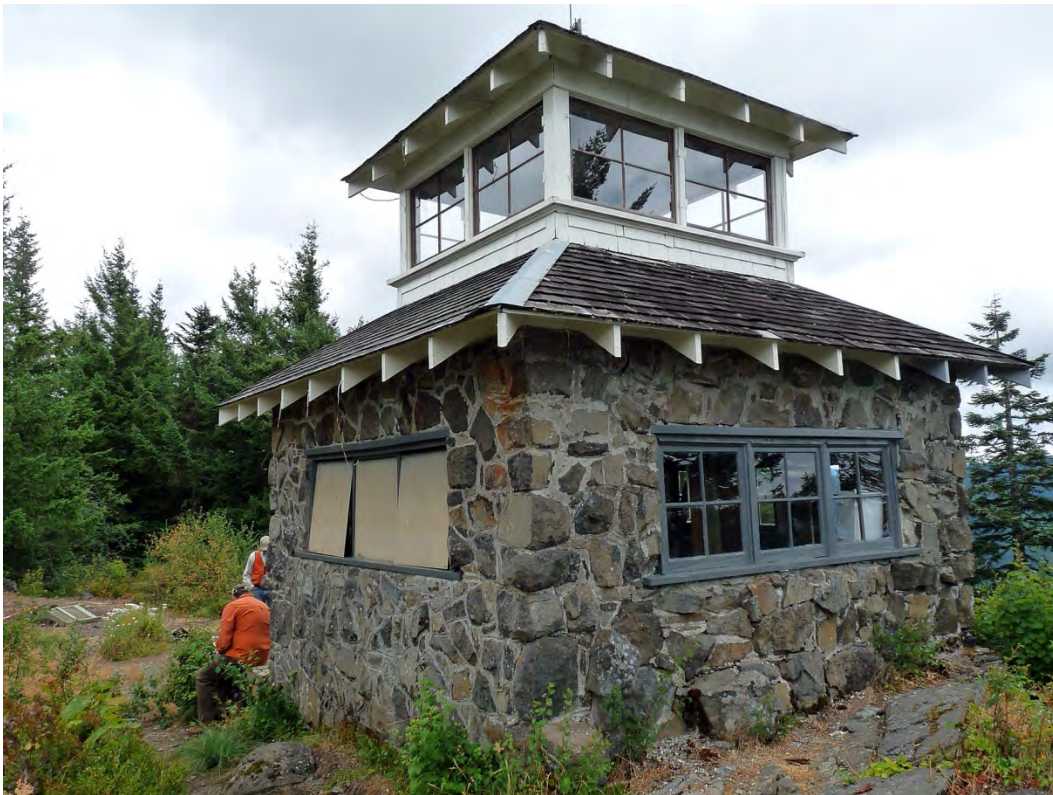
Figure 9. View to the southeast of the back of Pechuck Lookout showing the shutters on the windows on the north wall.

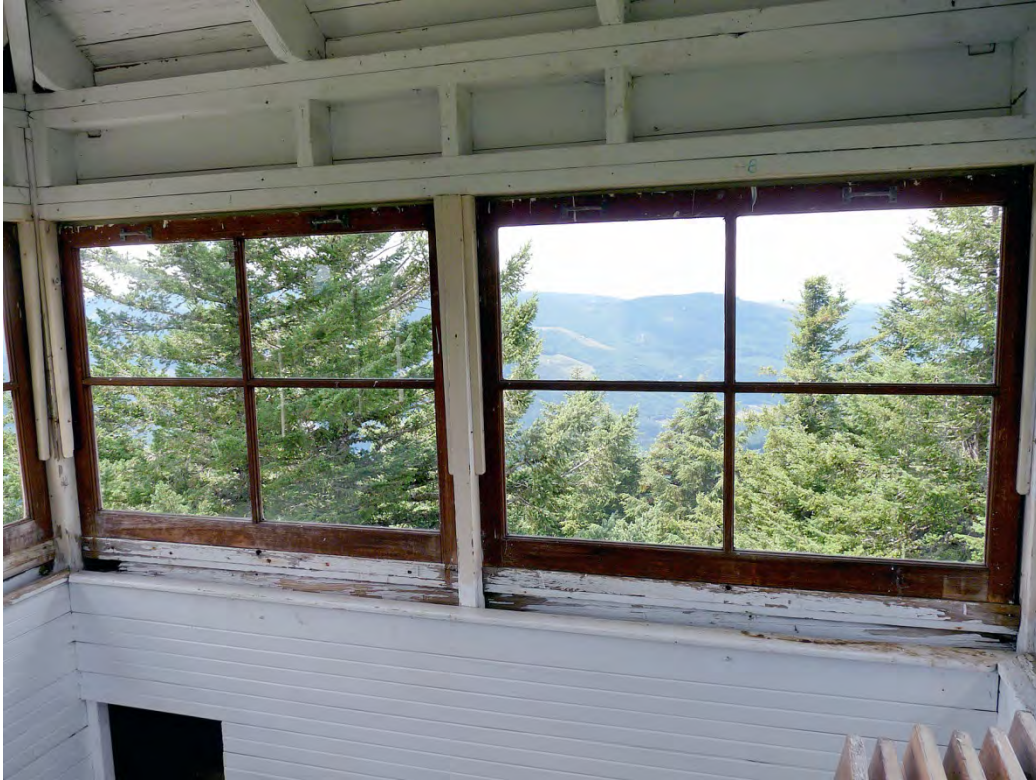
Figure 10. View of the windows in the cupola and the slot in the wall under the sill where the windows are lowered and stored when opened.

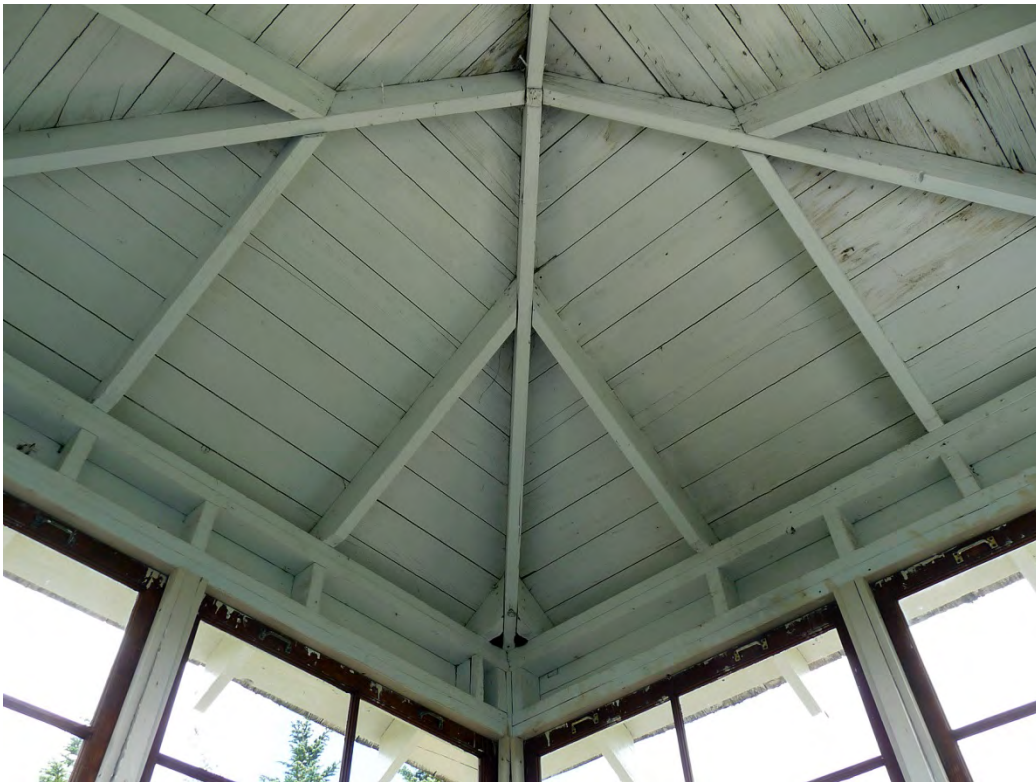
Figure 11. View of the construction of the interior of the roof in the cupola.

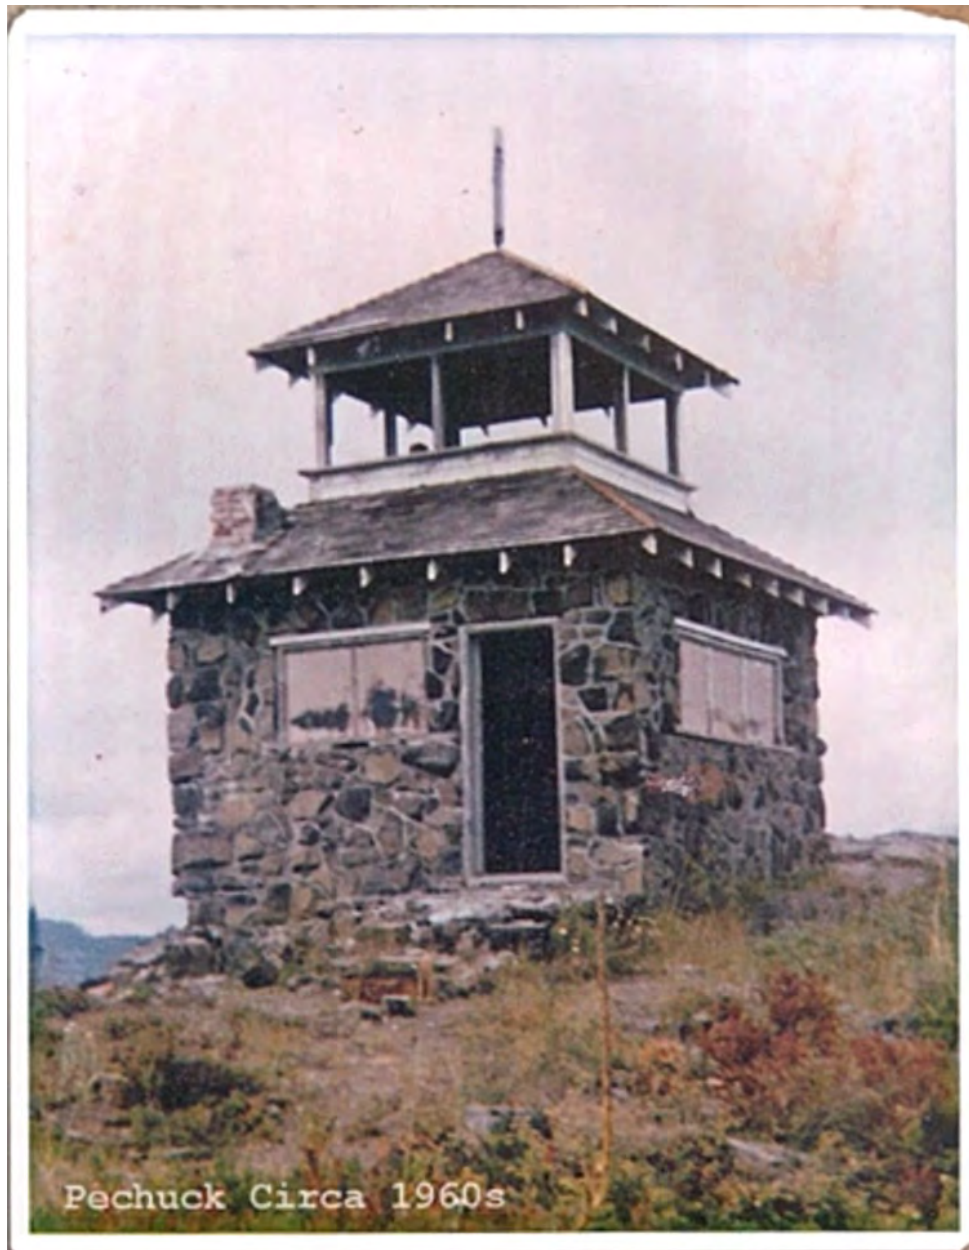
Figure 12. View to the southwest of the front of Pechuck Lookout in the 1960s (Clackamas County Government Channel 2016).

Over the years after its abandonment, the lookout was vandalized and neglected. The condition of the structure began to deteriorate (Figures 12 and 17), with the chimney collapsing, windows broken out, and the mortar between the stones crumbling (Clackamas County Government Channel 2016). In 1991 a group of volunteers began restoration work on the lookout. The restoration work was completed in 1995. The BLM acquired the lookout in a land exchange in 1992. The restored lookout is open to the public for overnight use, and a volunteer organization has partnered with the BLM to assist in the maintenance of the lookout. Pechuck Lookout (US 2, OR 2) was placed on the National Historic Lookout Register in 1992 (National Historic Lookout Register 2016; USDI Bureau of Land Management 2015).

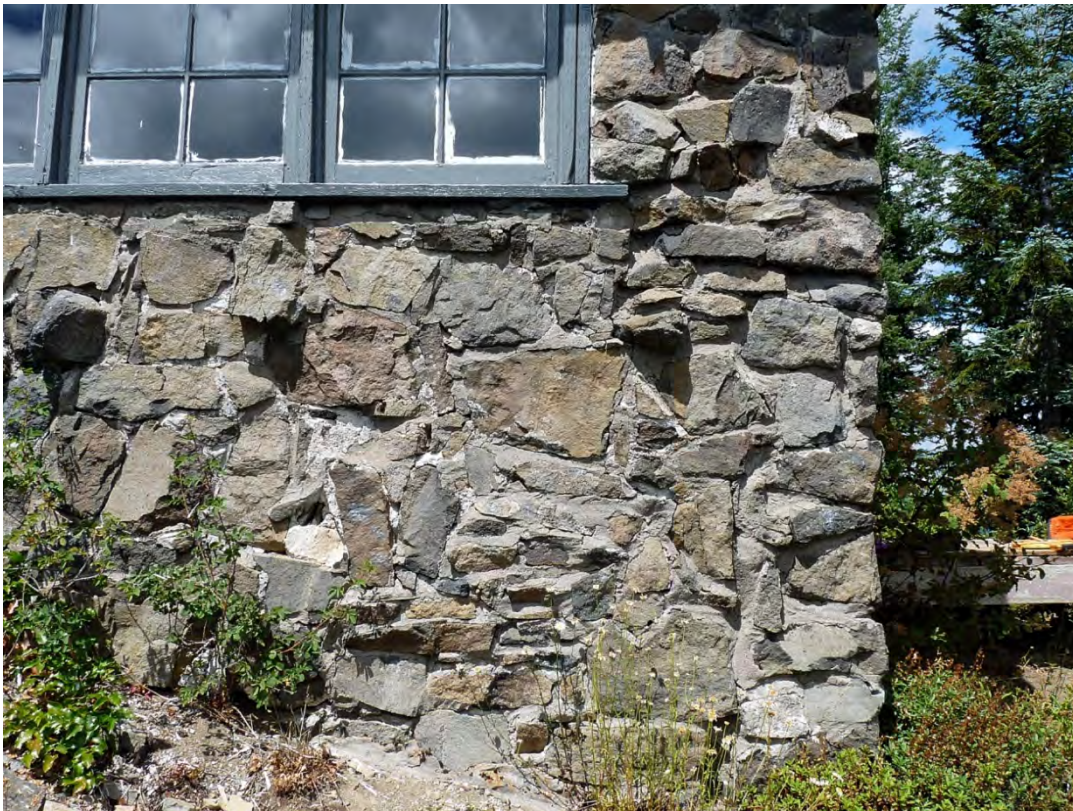
Figure 15. View of the local stone used in the construction of Pechuck Lookout.

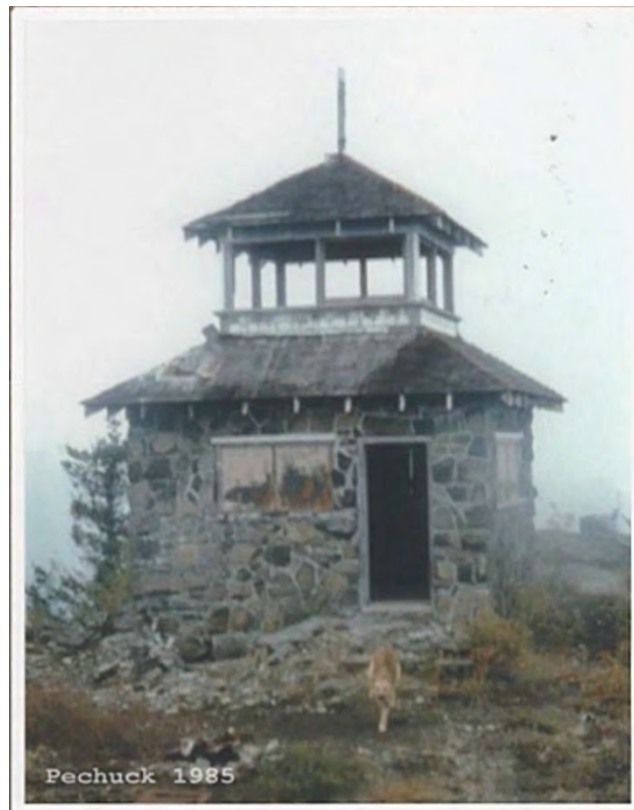
Figure 17. View to the west of the front of Pechuck Lookout in 1985 prior to restoration work (Clackamas County Government Channel 2016).
