**NATIONAL REGISTER OF HISTORIC PLACES
REGISTRATION FORM**

historic name Fairmount Hotel
other names/site number Fairmount Apartments, Evergreen Apartments

FAIRMOUNT HOTEL (1905)
1920 NW 26th Avenue
Portland, Multnomah County, Oregon

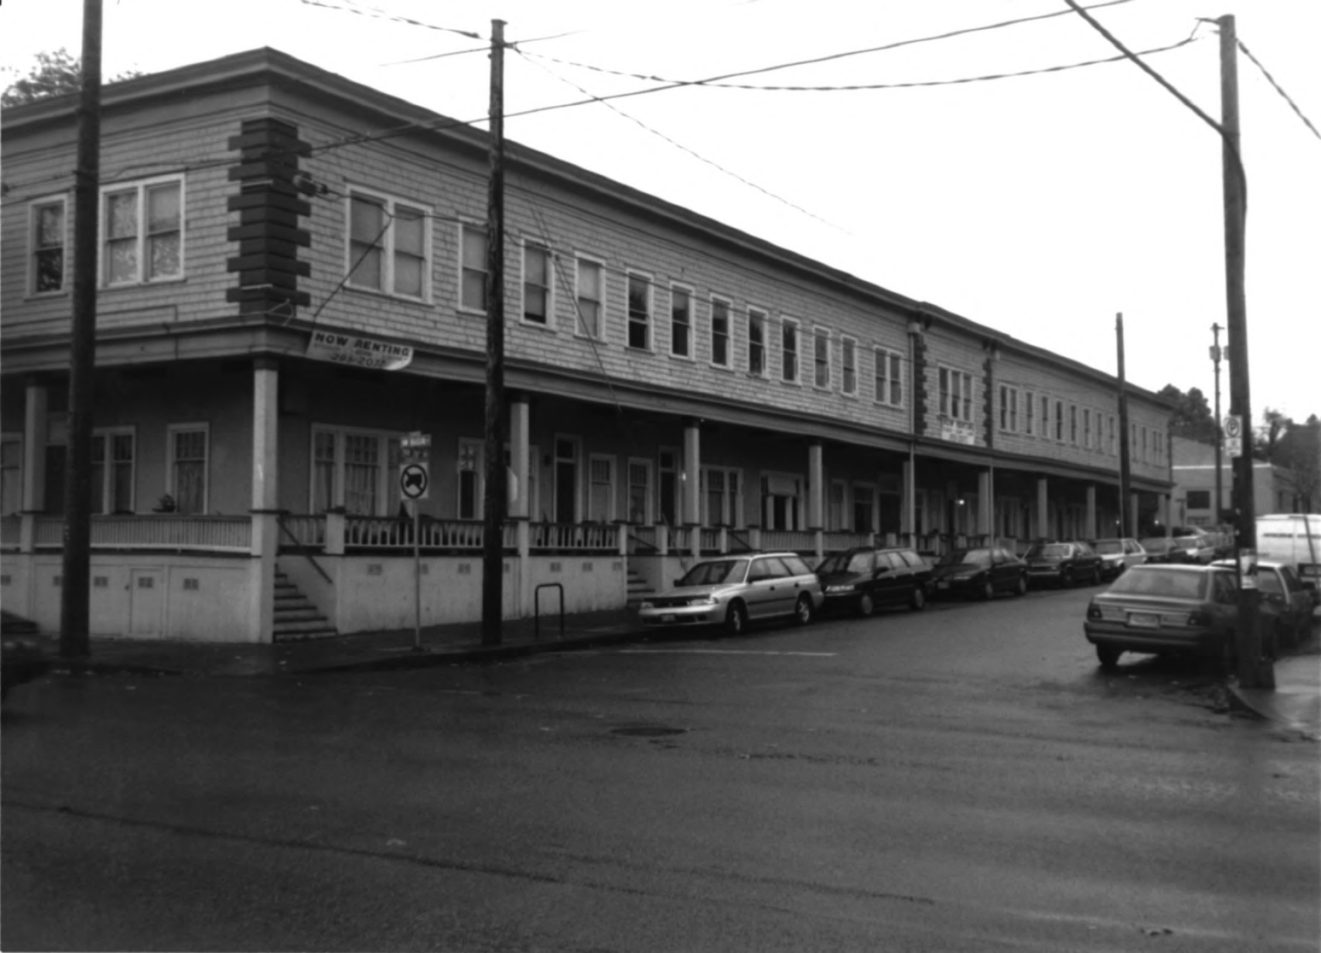
1/16

Main (W) elevation facing SE

The primary elevation on NW 26th is a symmetrical front with slightly projecting portico emphasized by quoins at the second story and decorative eave brackets. The second story of the building projects over the first floor, on the north, west and south elevations. Historical photos from the Exposition show glass doors, in between simple columns, enclosing the first floor creating a solarium. First floor units opened out into the solarium area providing private entrances. Windows throughout the building are a variety of single or double 8/1 double-hung windows are single or triple windows of 8/1 flanked by 4/1 double hung windows. Exterior doors to the building are eight-light three-panel wooden doors.

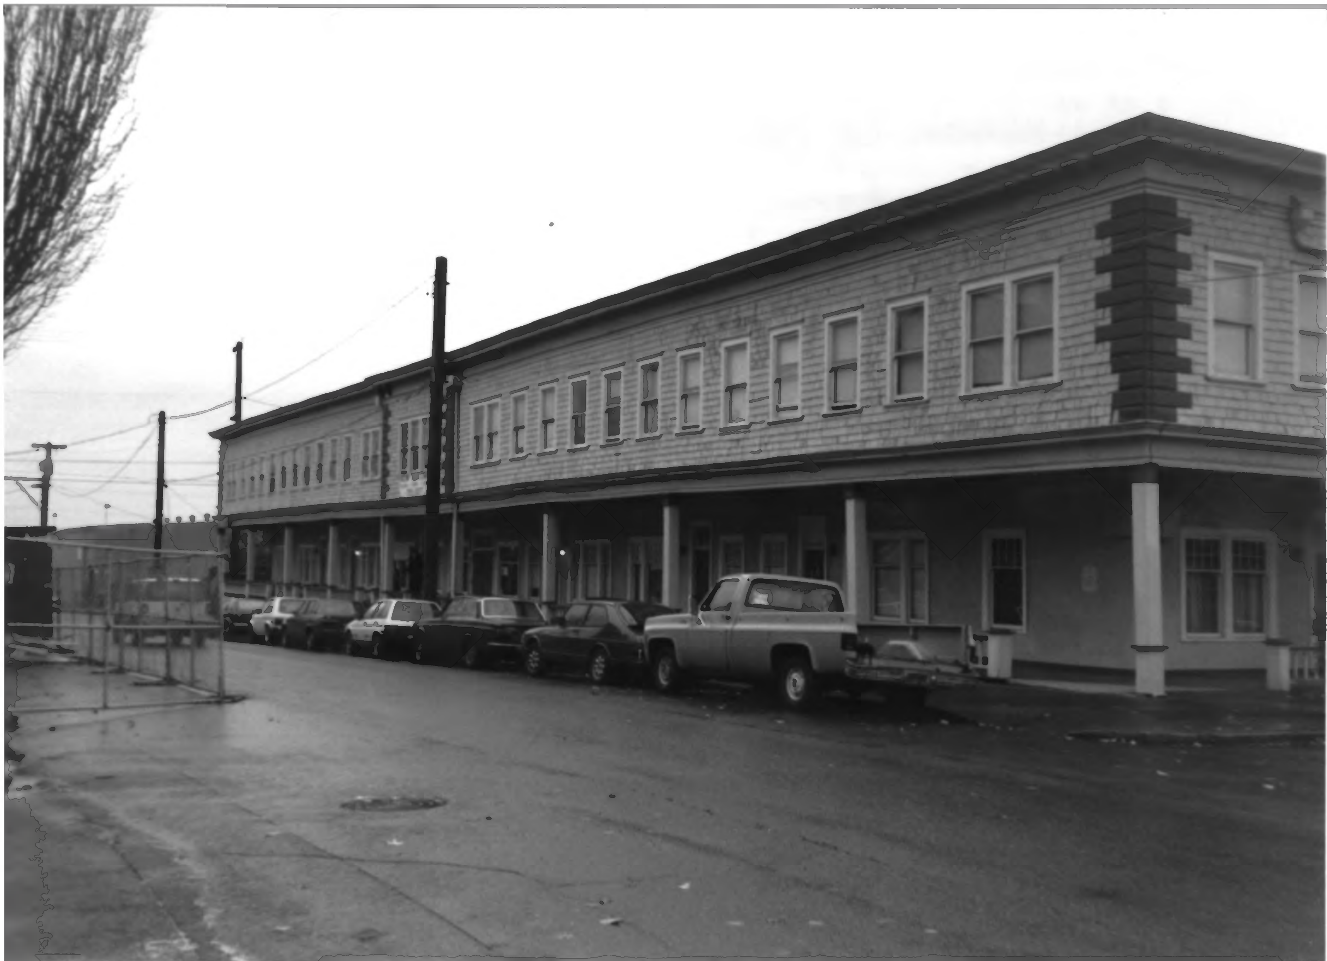
2/16

main (w) elevation, facing NE

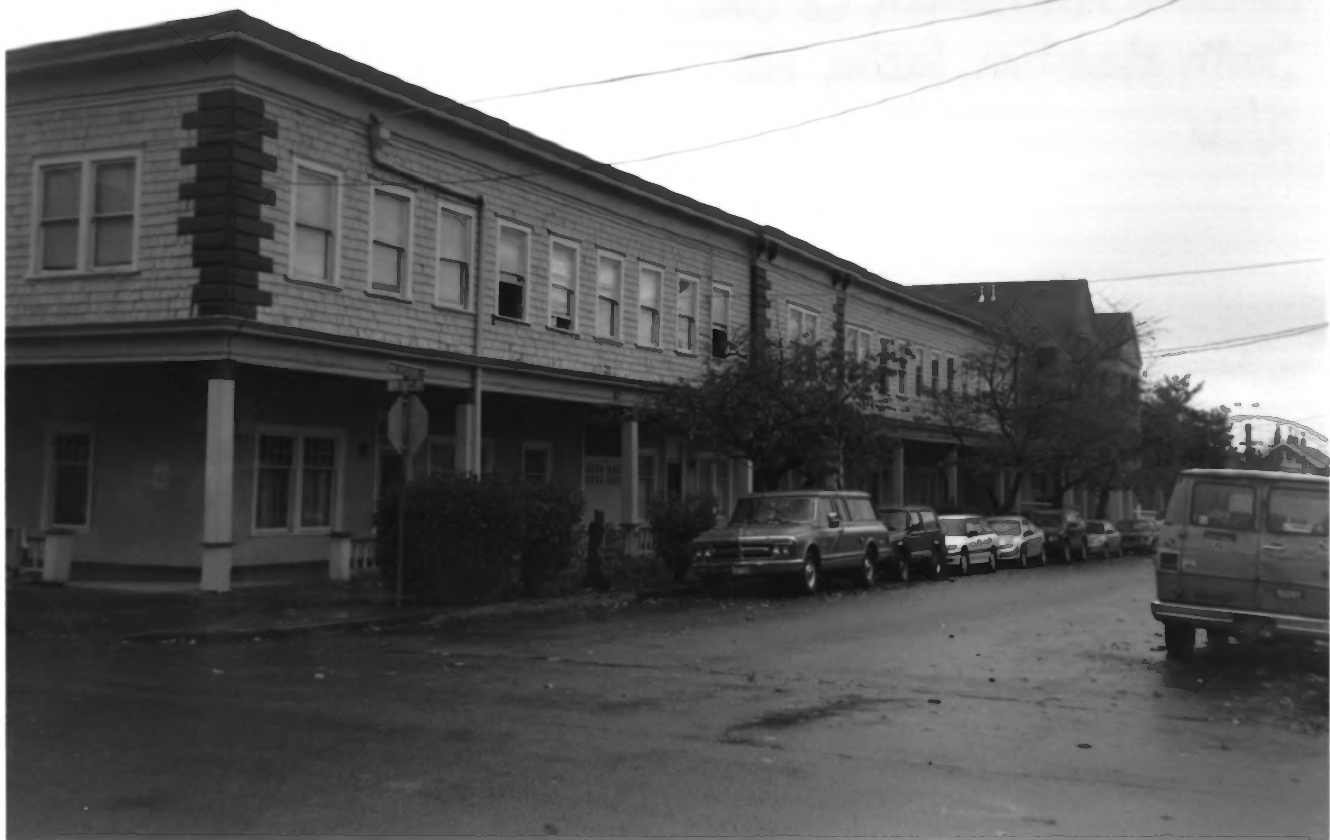
3/16

South elevation, facing NE

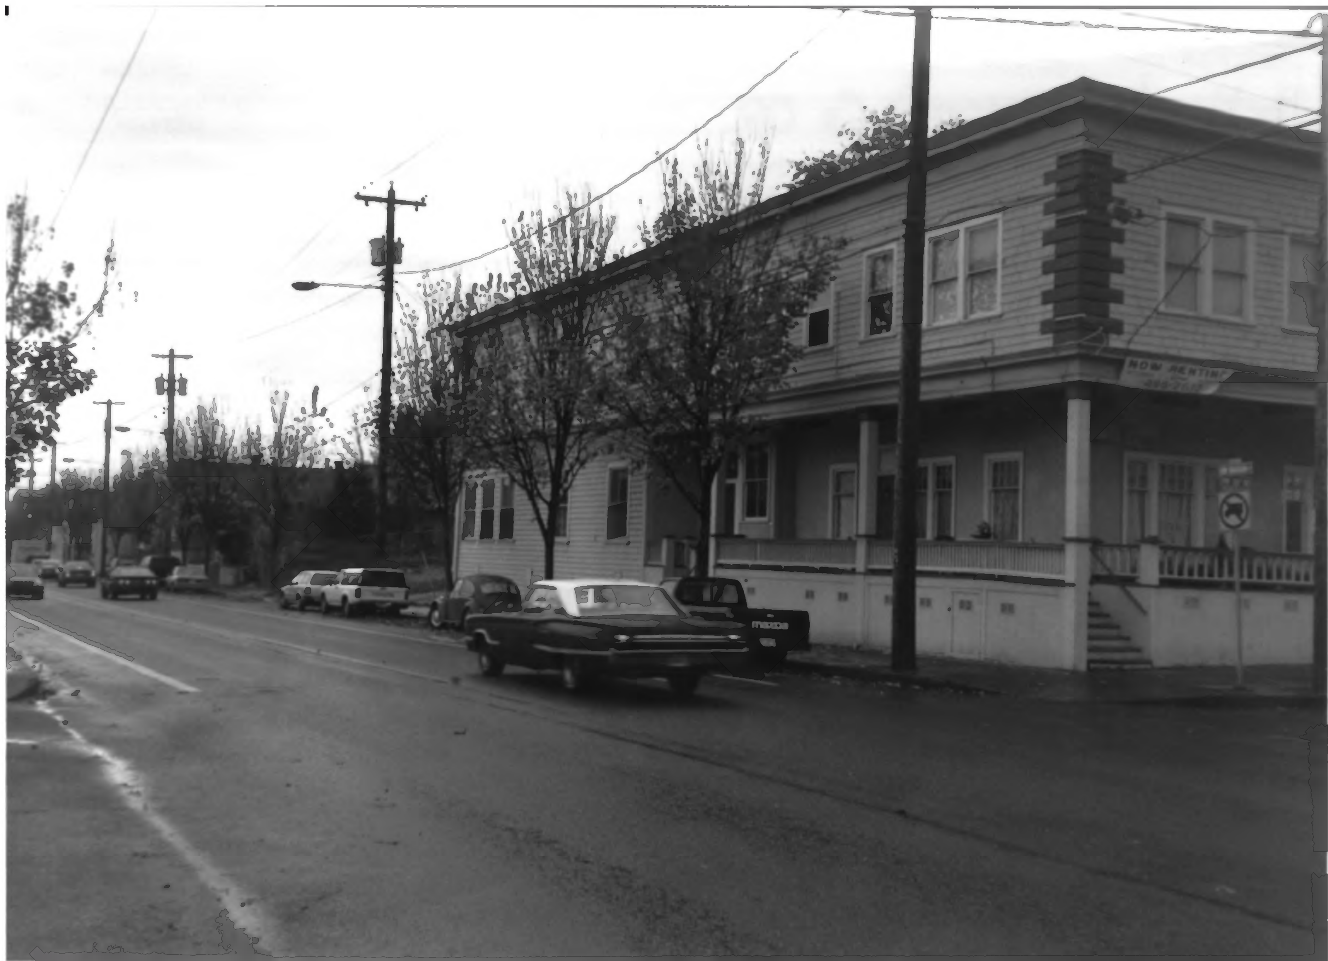
4/16

north elevation facing SE

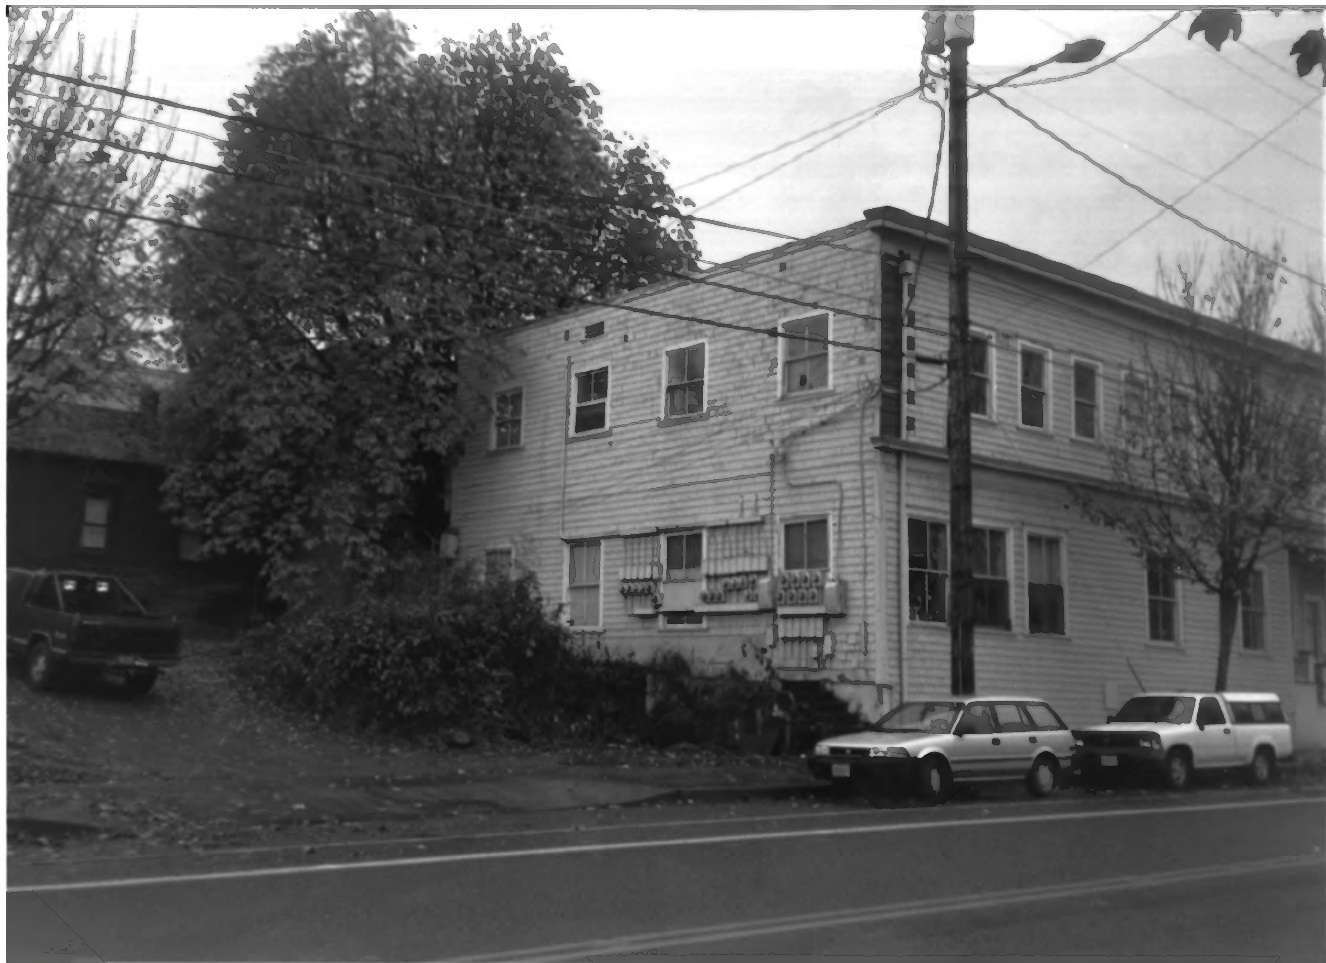
5/16

East elevation of wing facing SW

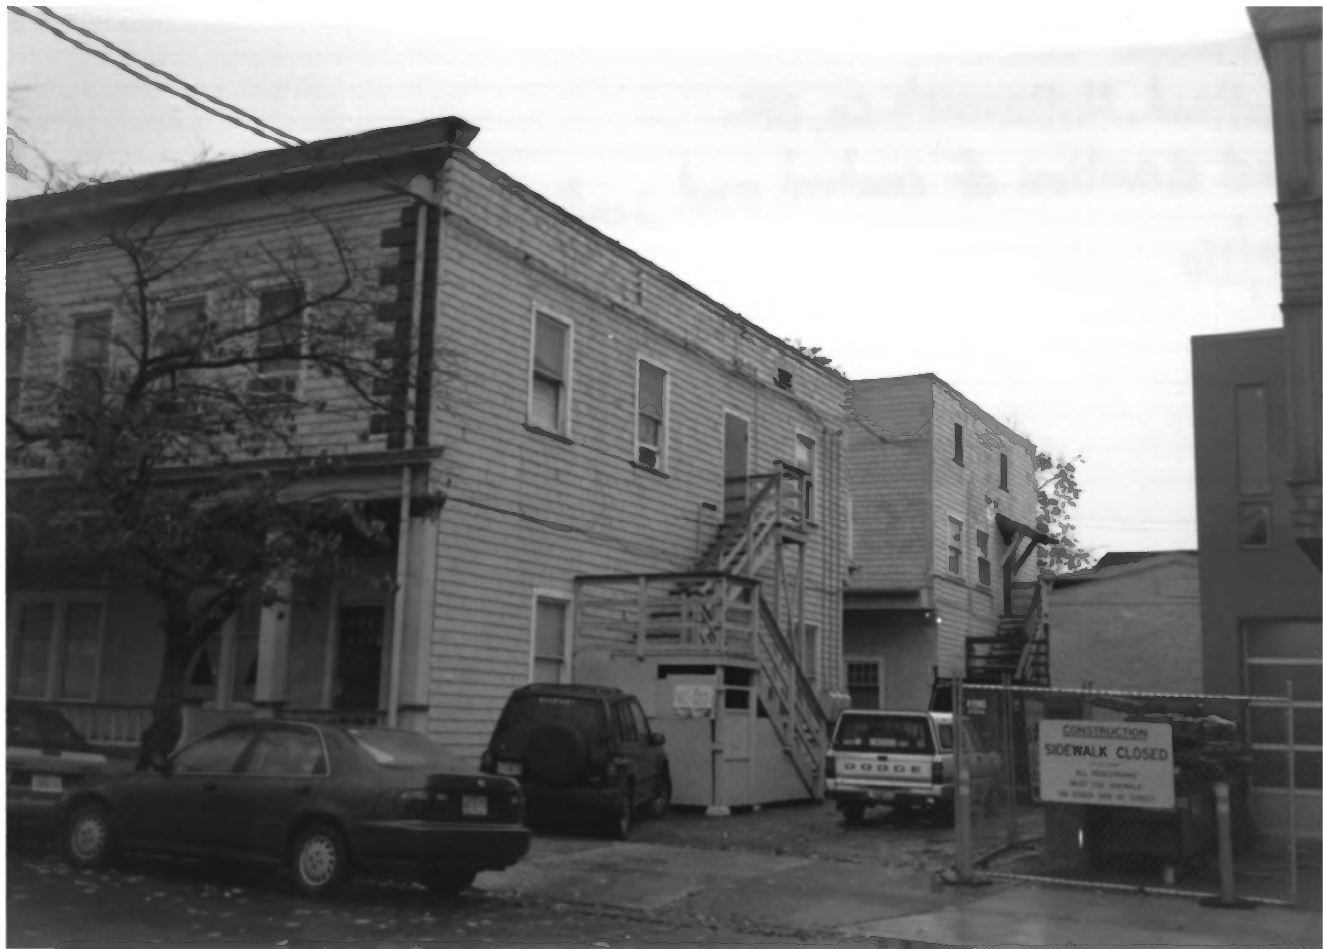
6/16

East elevation of central and south wings facing NW

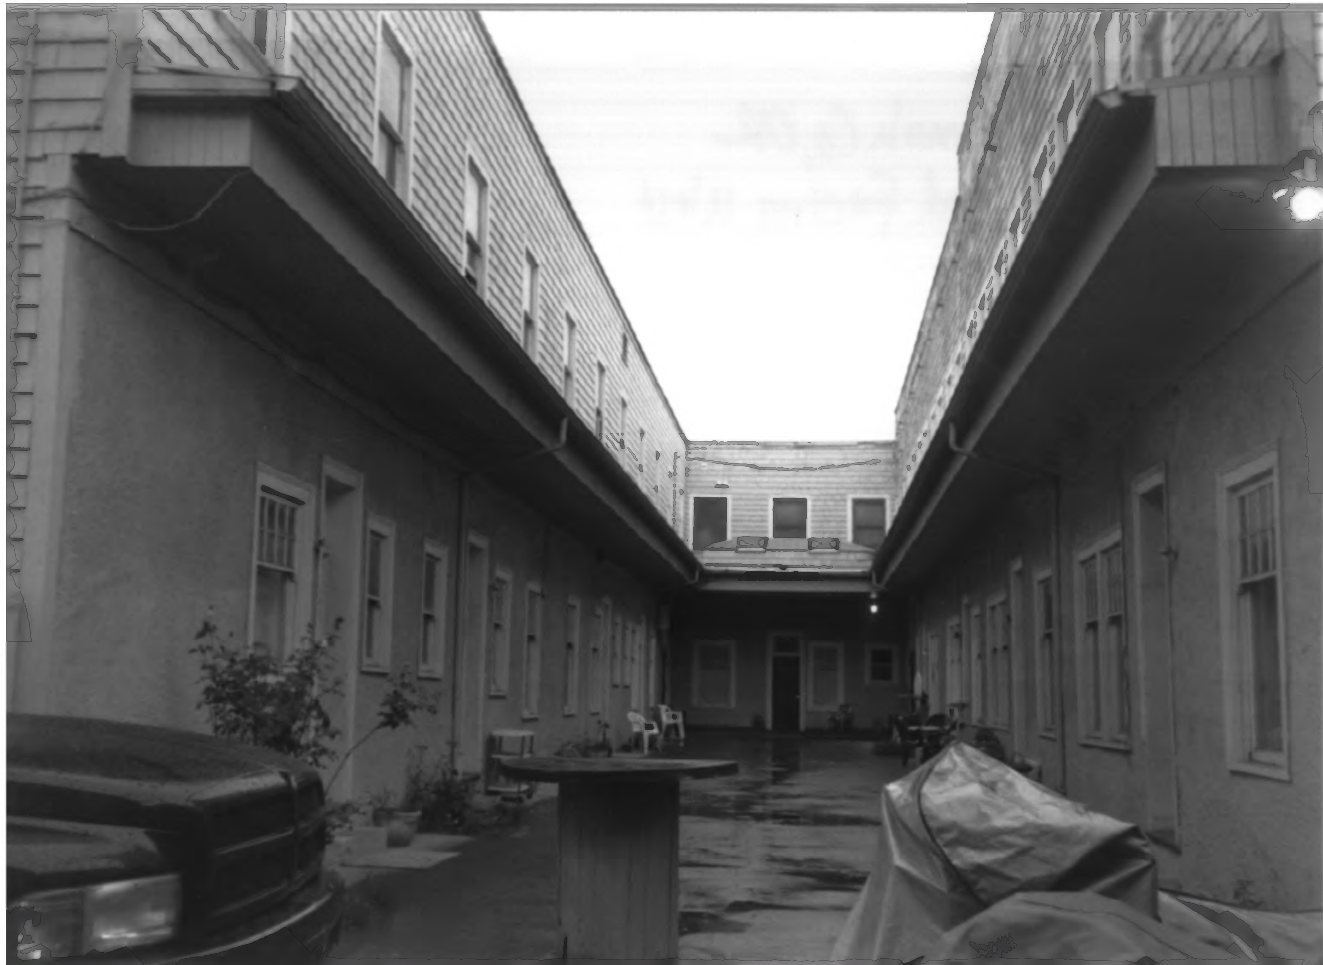
7/16

South Courtyard Facing West

and continuous pent roofs on the north and south walls. Access to the interior halls can be gained through double doors on the porches. The south courtyard is paved in concrete. The north courtyard is unpaved, with small porches leading to each apartment that exit to the courtyard.

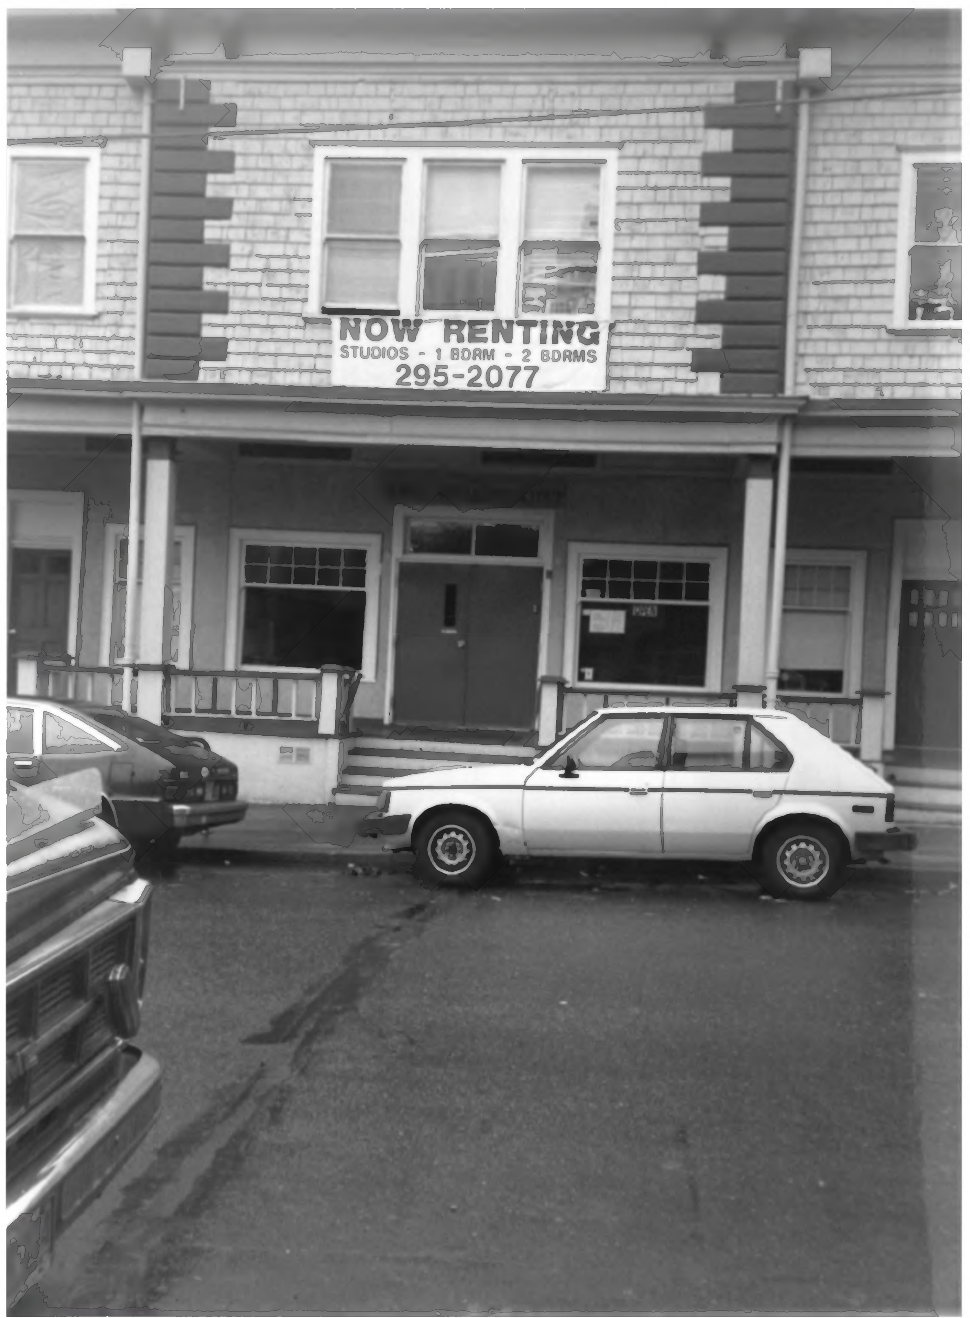
9/16

detail of main entrance portico facing East

The primary entrance, on the west elevation, and the secondary entrance, on the south elevation, are both centered under slightly projecting porticos, which are set off by quoins on the second story and paired brackets at the eaves. Originally, these porticos were further defined by decorative wood arches over the entrances, and parapets that extended above the roofline.

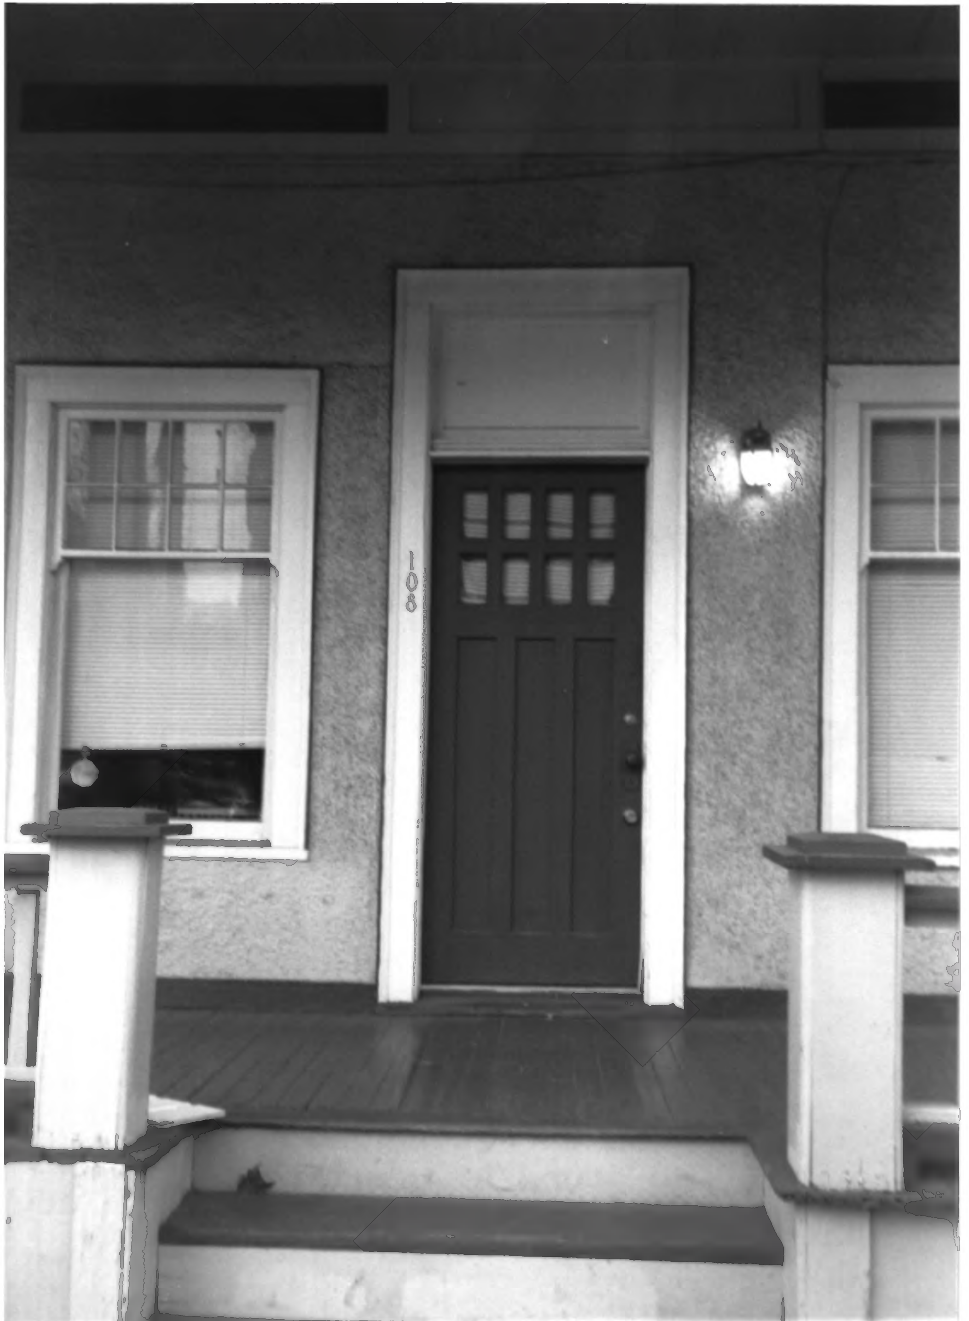
10/16

detail of single apartment door and window

The original doors are in the Craftsman style. They have three flat, vertical panels on the lower 3/4, and eight small lights in the top 1/4. Doors are paired at the main entrances to the building and courtyards. Each door was originally topped by a transom, most of which have been covered over. Some of the exterior doors have been replaced with various incompatible style doors. The building owner intends to reproduce the original doors for the entire building.

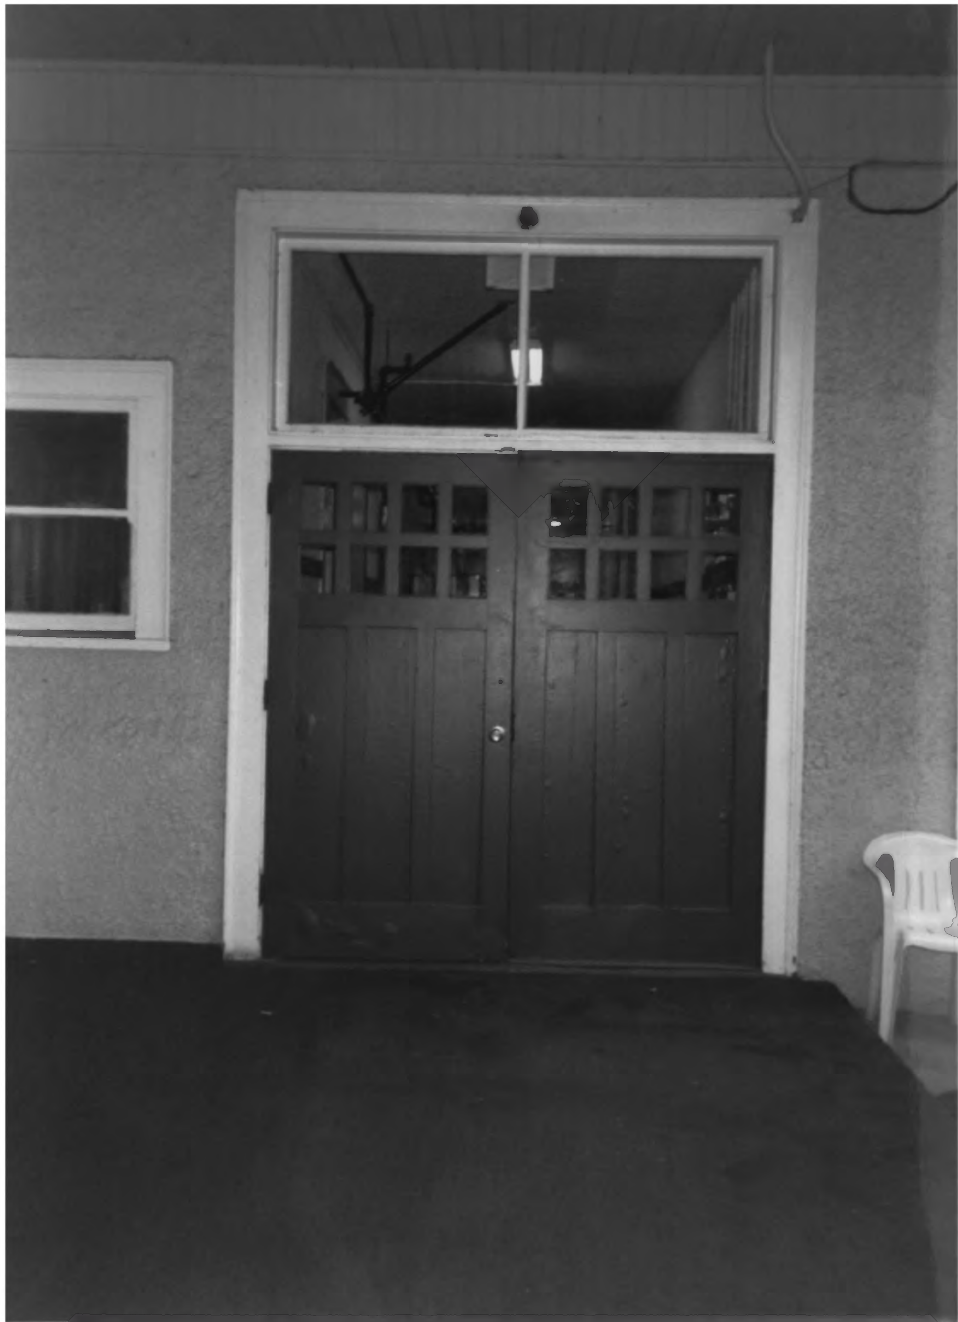
11/16

detail of double door entrance

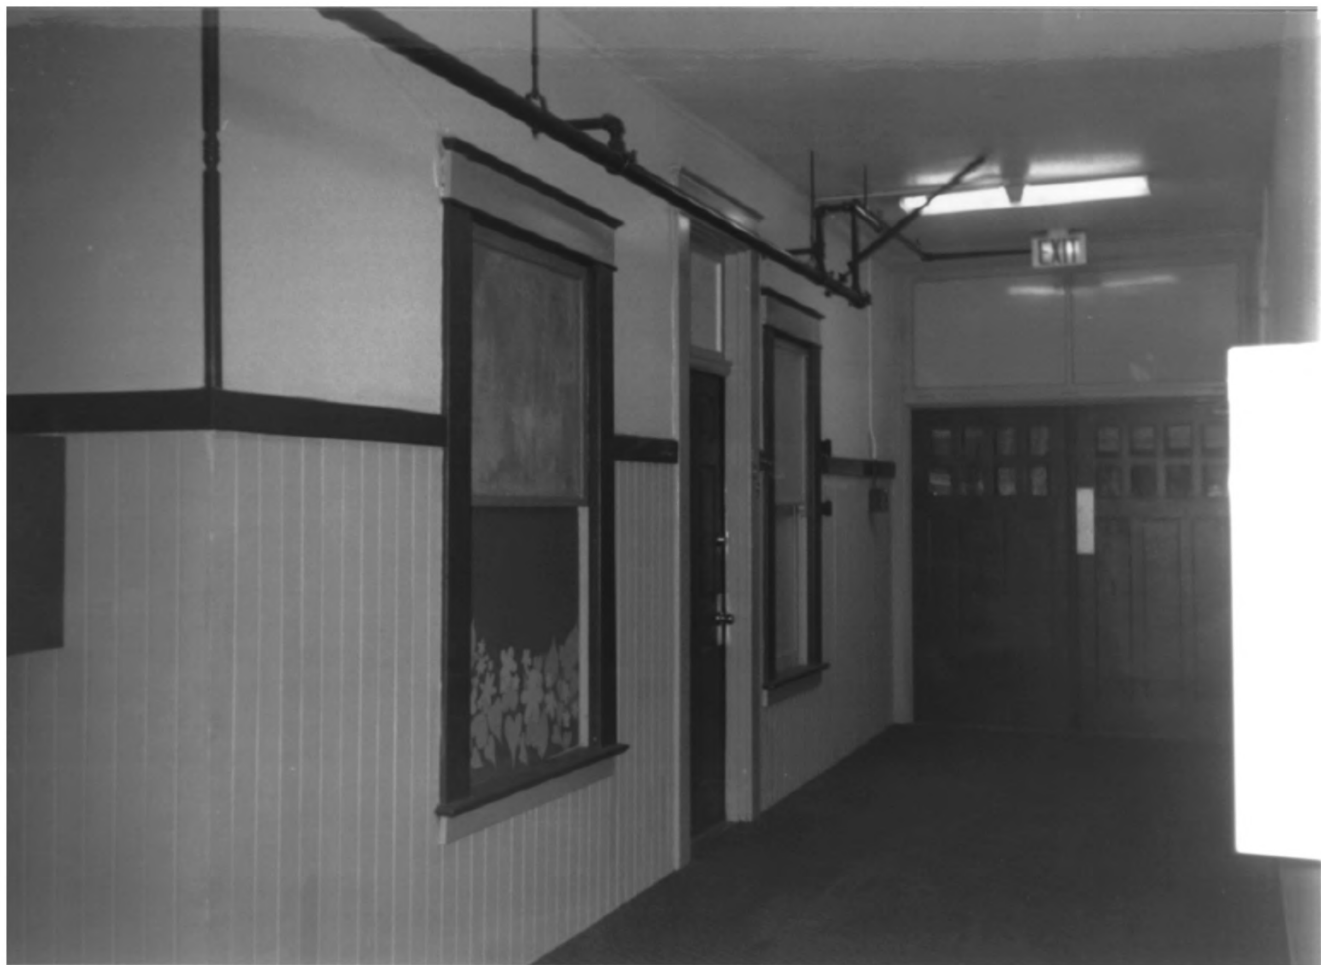
12/16

first floor hallway

The interior finishes of the common areas of the Fairmount Hotel were simple. The walls in the common areas of the building have painted beadboard wainscoting. The staircase rails have square balusters and newel posts with simple caps. Door and window frames are plain, lintels have simple molded caps. Some of the original five-panel interior doors remain. Interior doors had transoms, which have been blocked or painted over. The hallways are punctuated with window openings to some apartments which allowed additional light and ventilation into the units. These have been blocked, but their frames remain, and some still hold the original 1/1 sash, which have been painted over.

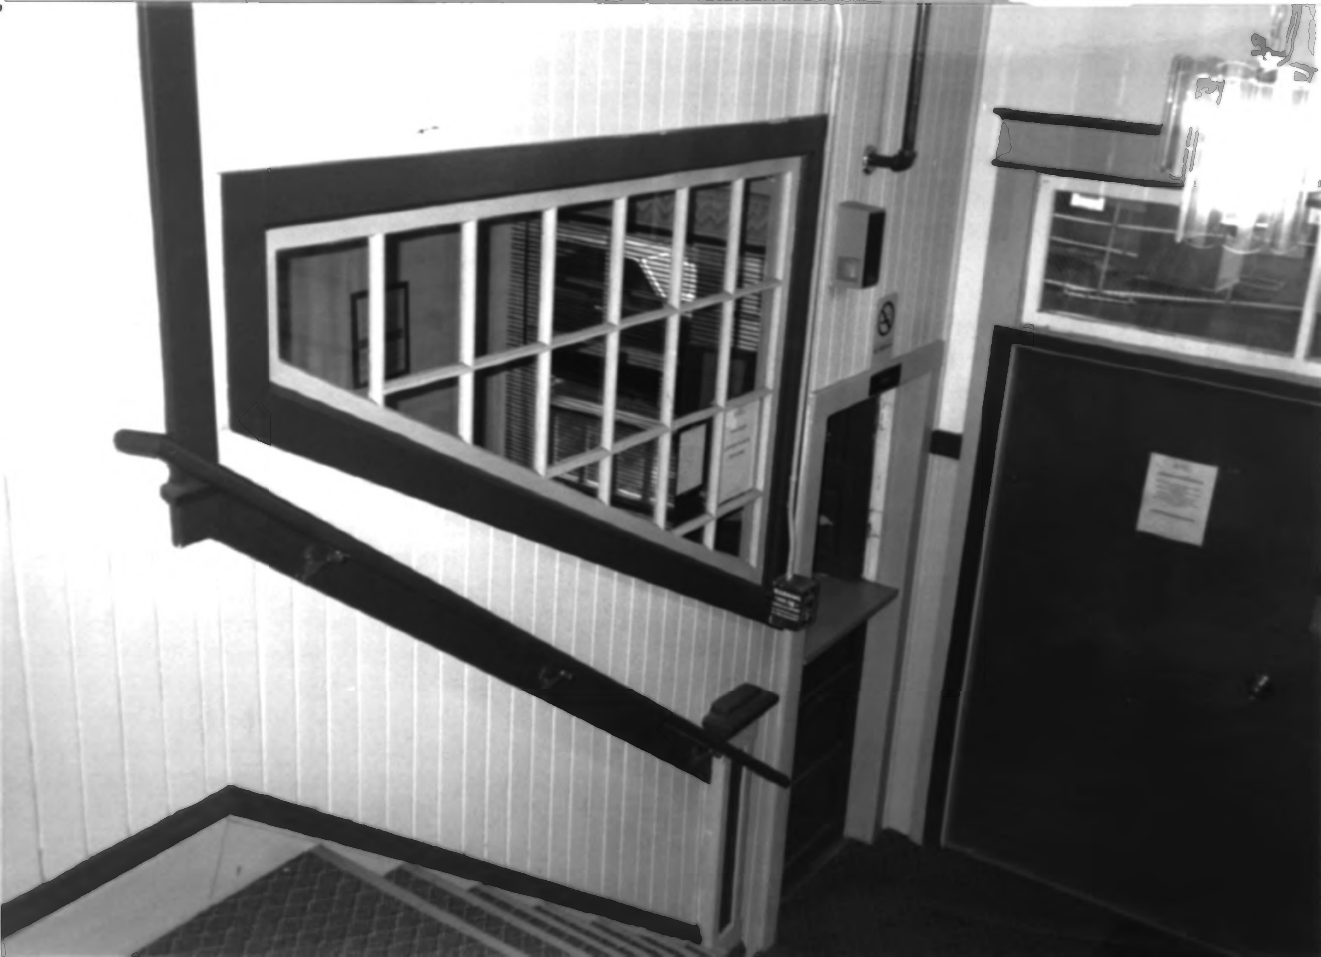
13/16

Staircase office and main entrance

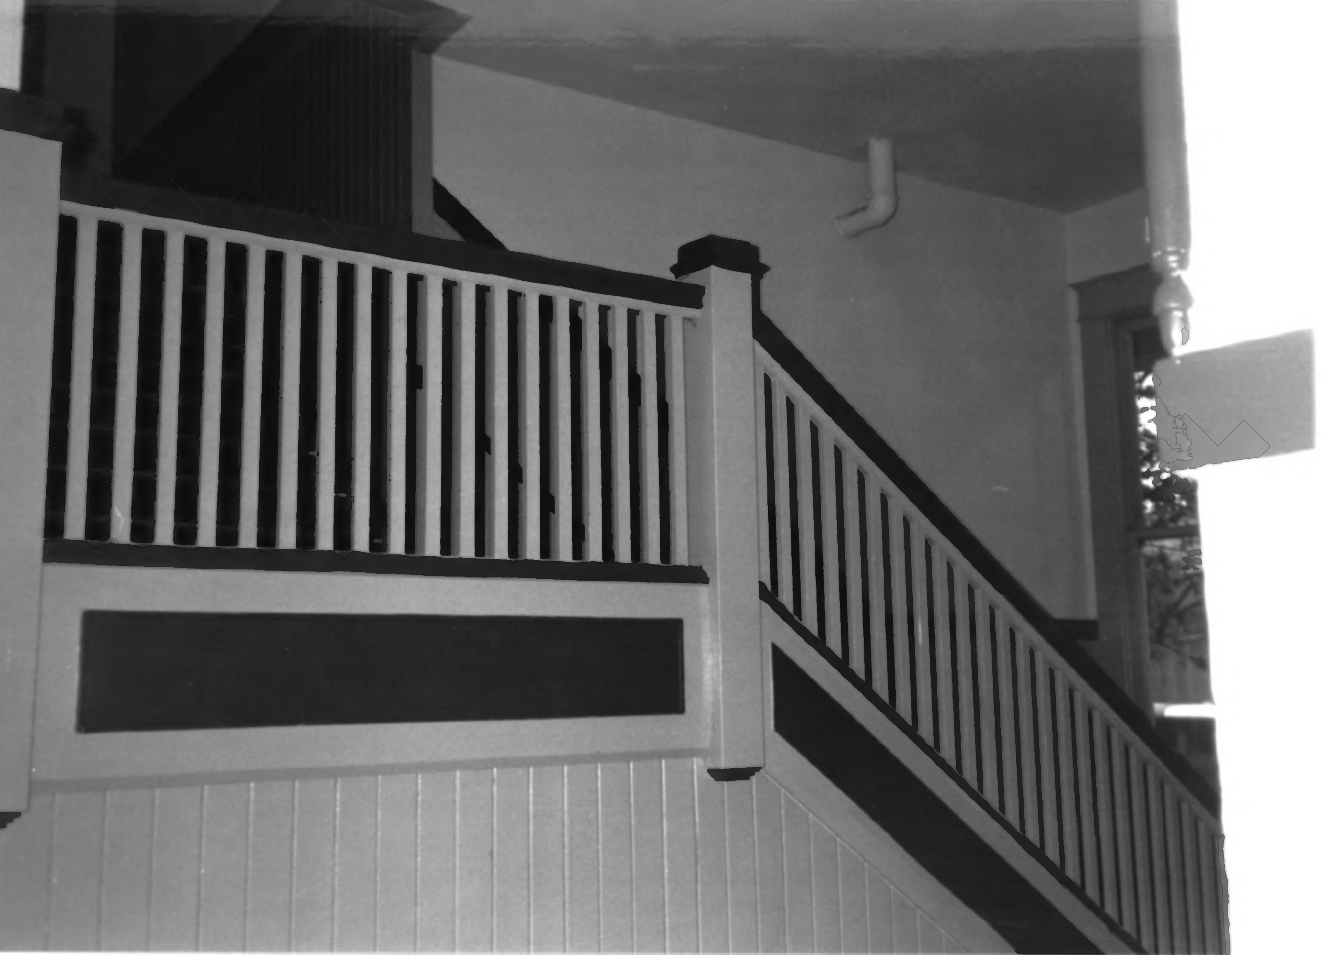
14/16

Staircase detail

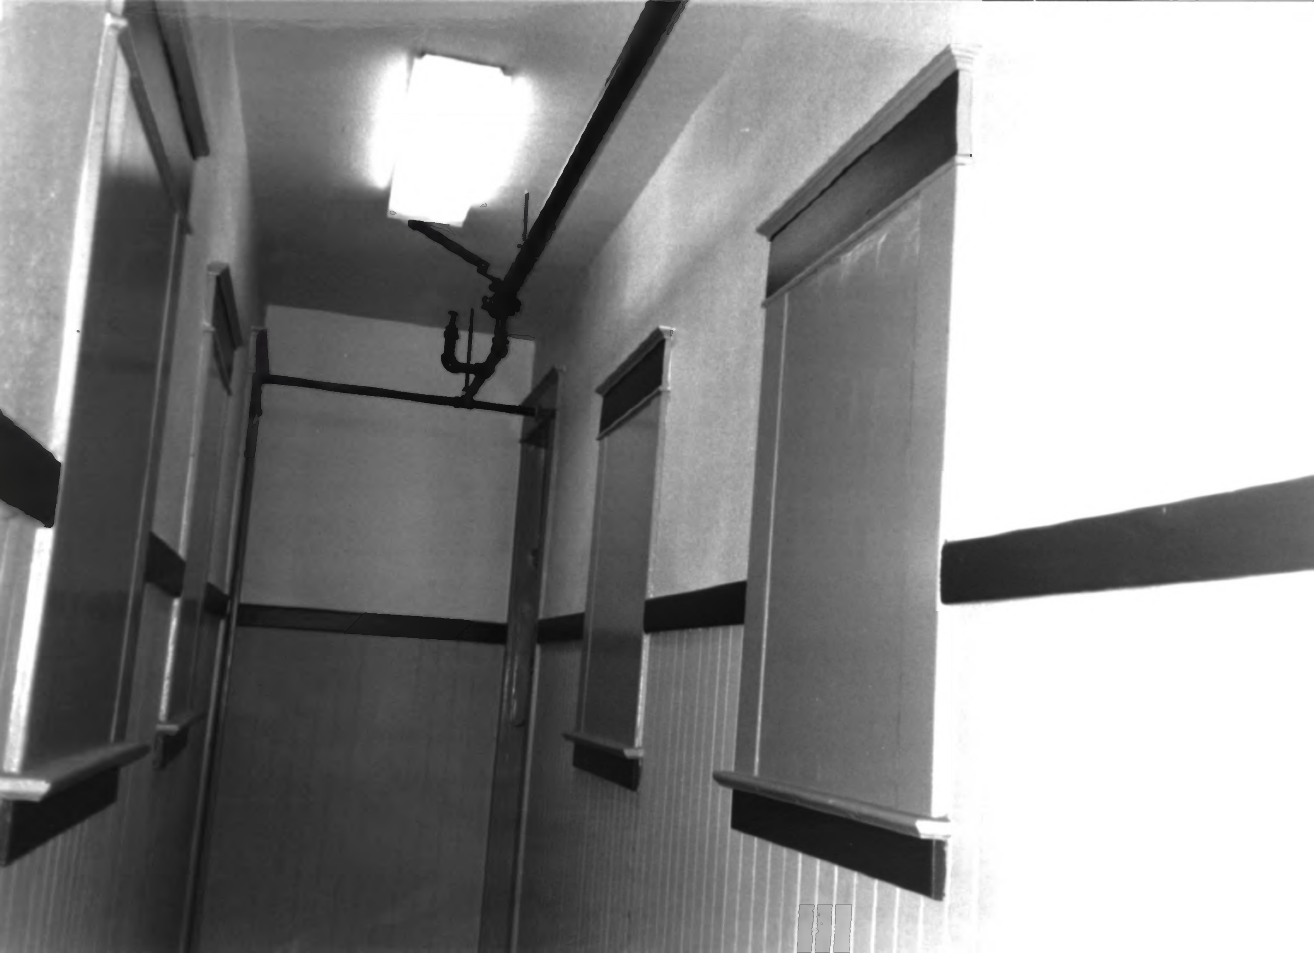
15/16

Second floor hall detail

On the second floor, the halls were originally lit by large steel and glass pyramidal skylights, which remain intact but have been painted over. The large, central hall on the second floor originally had a light well opening to the first floor hallway below. The well was encircled with a plain balustrade. It was removed in the 1980s to meet fire codes, leaving the wide upstairs hallway strangely out of proportion with the rest of the common spaces.
