National Register of Historic Places Registration Form

historic name Adams, Louis J., House
other names/site number N/A

street & number 423 W. Main Street not for publication
city or town Silverton vicinity
state Oregon code OR county Marion code 047 zip code 97381

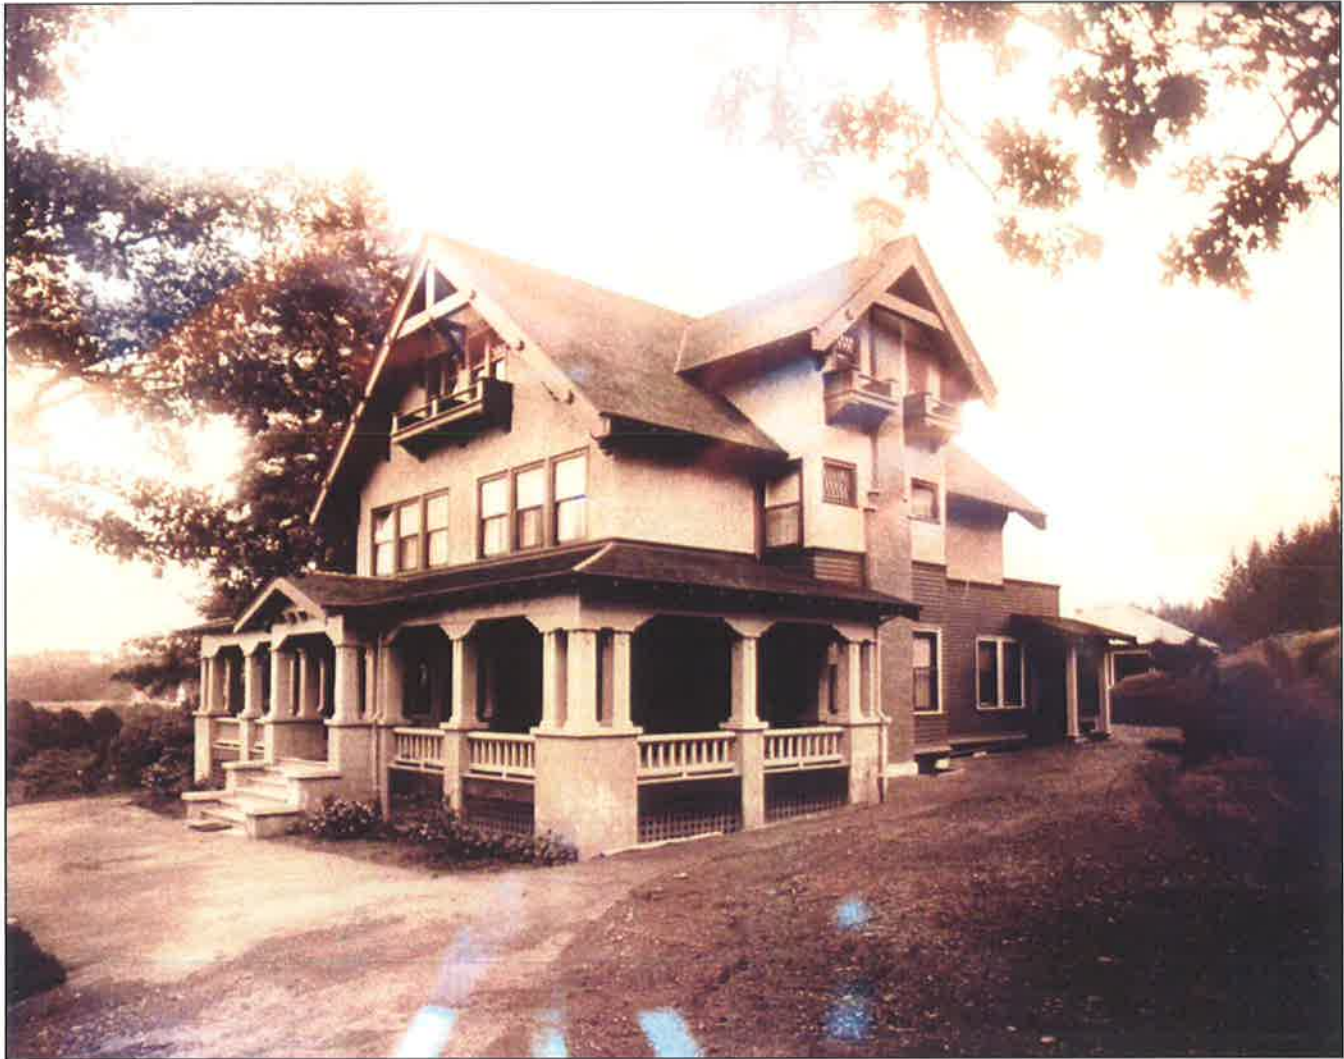
Figure 4: Historic photograph of the Louis J. Adams House, taken ca. 1920 facing east-southeast. The photo is in the collection of Ron and Jane Jones, current owners of the Louis J. Adams House.

The garage, located to the southeast of the house, and facing the west, is a three-car garage that matches very closely the original, visible in a photo in the collection of the current owners, taken ca. 1920. That garage appears to be a three-bay, pyramidal or hipped roofed structure with corner boards and simple trim around the bay doors. The present garage appears to be either a slightly altered original (the building now has a vented pyramidal roof peak), or a very closely-matched modern replacement. The current garage has coved-shiplap (drop) siding, and the same trim pattern seen in the historic photo. It is possible that the roof has been replaced on the original. Because the garage is a secondary structure to the principal building (the house), is designed and appears very similar to the original garage and with compatible materials, and because it is located behind the house, its alteration, or even replacement do not seriously affect the eligibility of the house.
