**NATIONAL REGISTER OF HISTORIC PLACES
INVENTORY -- NOMINATION FORM**

Clackamas Lake Ranger Station. *Historic District*

The Clackamas Lake Ranger Station Historic District is located on a high plateau in the High Cascades physiographic province of Oregon near Mt. Hood, approximately 22 miles south of Government Camp. The site is entirely within Clackamas County, on the Bear Springs Ranger District of the Mt. Hood National Forest. The Historic District encompasses portions of sections 25, 26, 35, and 36, Township 5 South, Range 8 1/2 East, Willamette Meridian, in the U.S.G.S. Mt. Wilson and Highrock quadrangles.

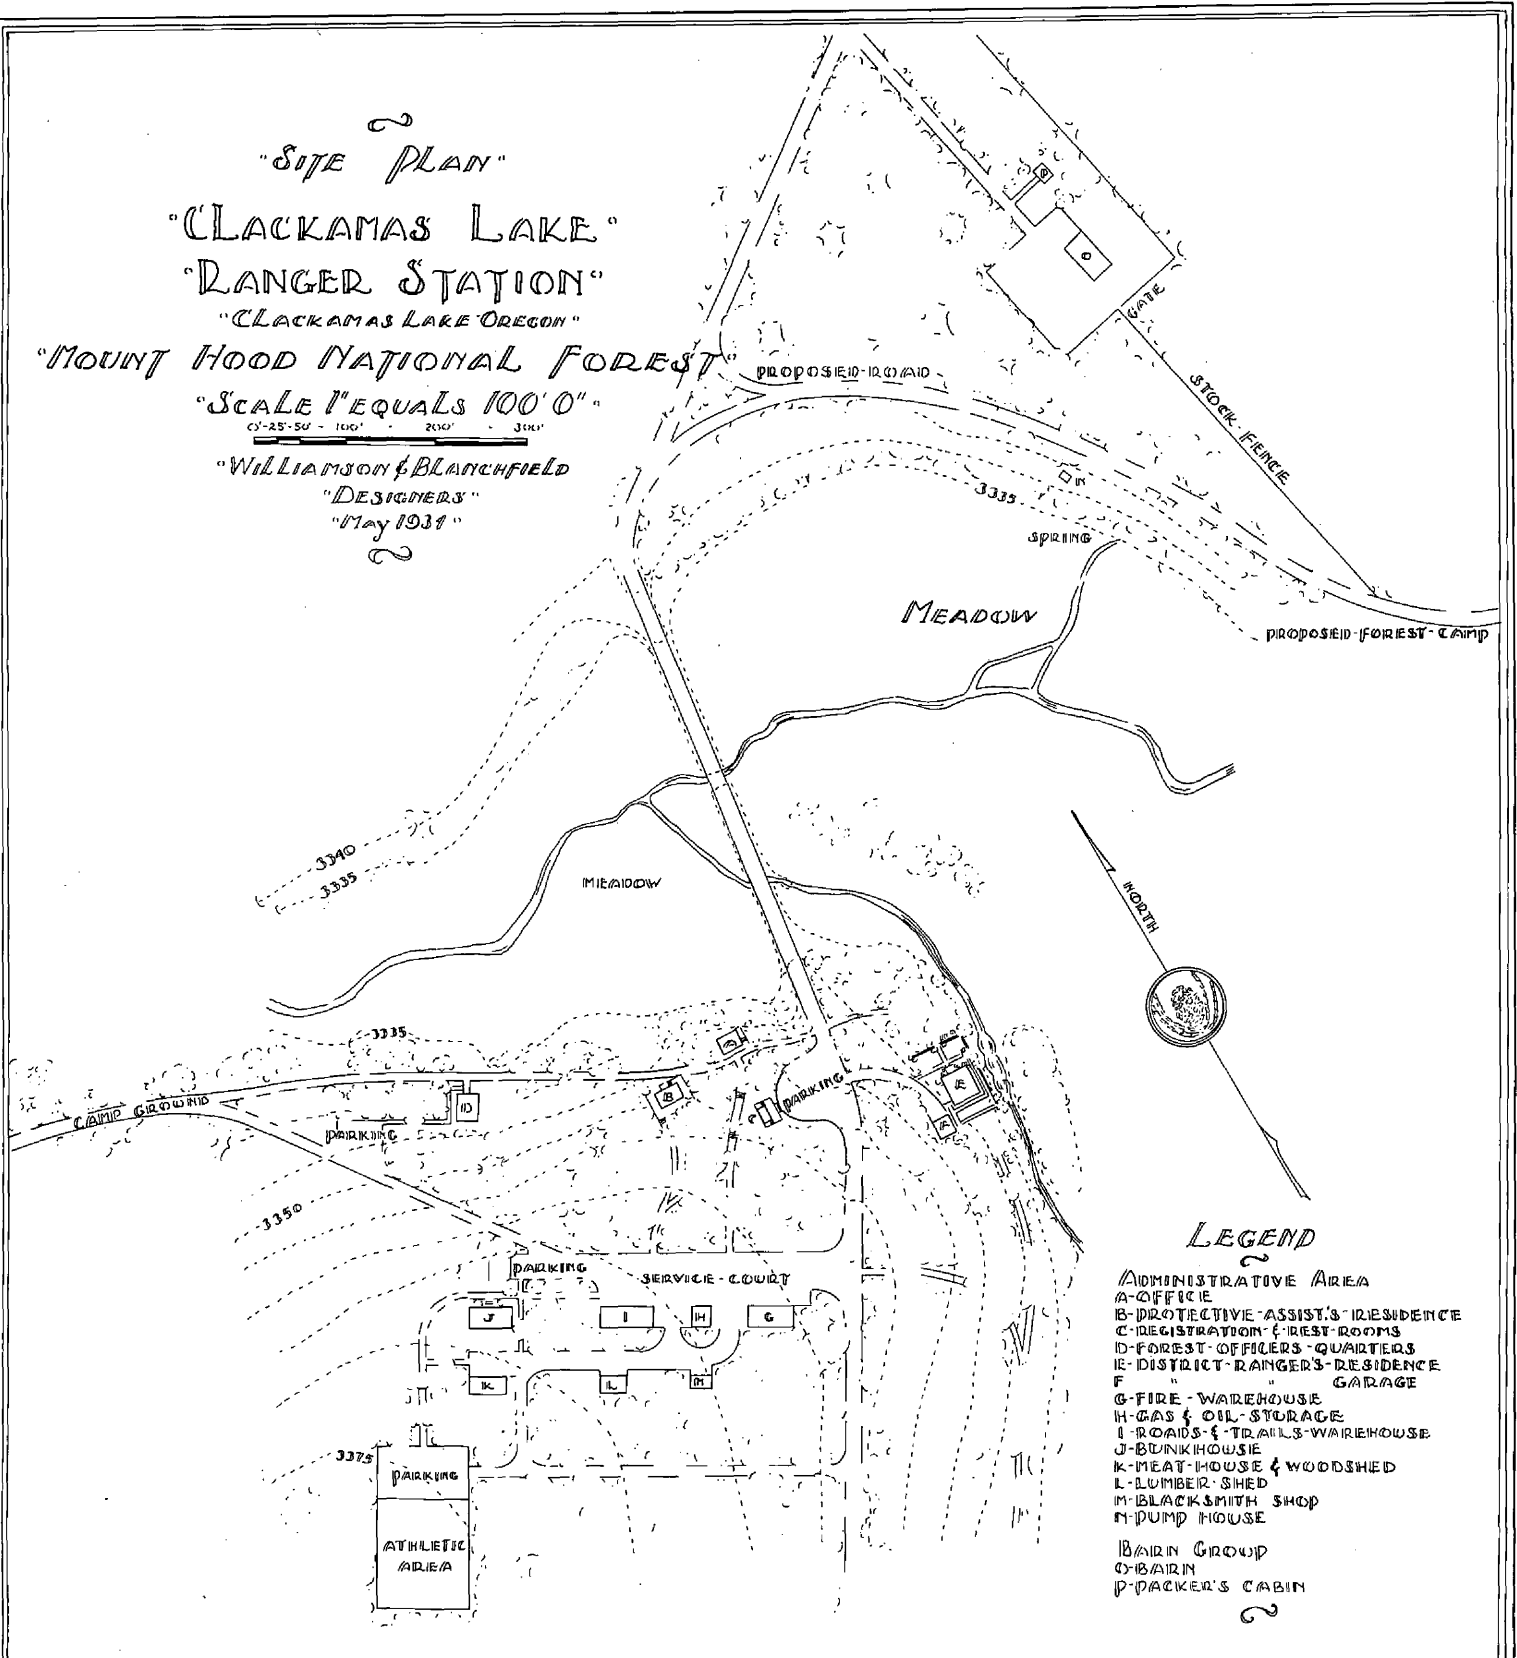
- ADMINISTRATIVE AREA
- A-OFFICE
- B-PROTECTIVE ASSIST.'S RESIDENCE
- C-REGISTRATION & REST ROOMS
- D-FOREST OFFICERS' QUARTERS
- E-DISTRICT RANGERS' RESIDENCE
- F " GARAGE
- G-FIRE WAREHOUSE
- H-GAS & OIL STORAGE
- I-ROADS & TRAILS WAREHOUSE
- J-BUNKHOUSE
- K-MEAT HOUSE & WOODSHED
- L-LUMBER SHED
- M-BLACKSMITH SHOP
- N-PUMP HOUSE
- O-BARN GROUP
- P-PACKER'S CABIN

An extensive landscaping plan was included in the original design of the Ranger Station. Paths and roads within the building complex were graded and graveled. Tightly fitted, without mortar, native rocks edge all paths, roads and parking areas. All of this rock work is in place and in good condition. Great care was taken to save trees wherever possible during construction. Native shrubs were collected and replanted after grading was completed. Some domesticated spirea was purchased and incorporated in the landscape design. The majority of shrubs have either died or become vastly overgrown. Several large trees have died and others have been removed for safety reasons. The original planting designs are readily apparent and could easily be replicated today.

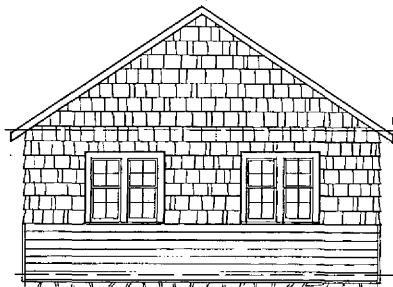
WEST ELEVATION

FIRE WAREHOUSE	
CLACKAMAS LAKE RANGER STATION	
BLDG #2201	
AS-BUILT DRAWING	SHEET 1
SCALE: 1/4" = 1'-0"	OF 1

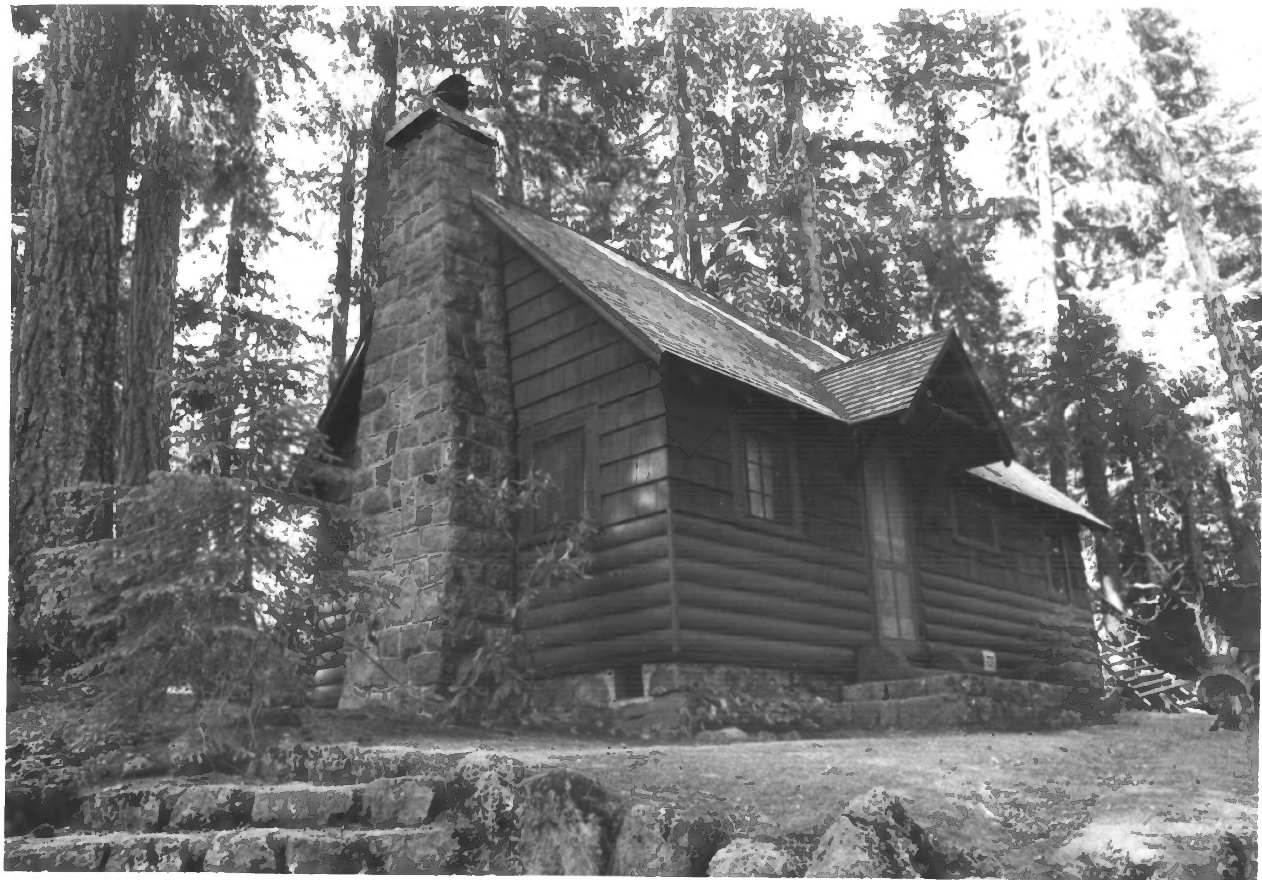
#B-1 PROTECTIVE ASSISTANT'S RESIDENCE

Camera Direction: West toward east and north
elevations.

- B. Protective Assist's Residence: 1934, Rectangular, 3 room, 1 story, wood frame, poured concrete foundation, coursed squared rubble veneer, wood-

shingled high gable roof, gabled hood, center north (main) facade, supported by peeled pole brackets. Exterior end chimney, coursed squared rubble masonry, center east gable end; stretcher-bond brick interior chimney, center north slope or roof. Horizontal slab wood or cants to four-foot level above water table on all elevations, remaining exterior wall surfaces covered with wall shakes. Six and nine-light single sash windows, singly and in combinations with mullions, plain molded trim and flat surrounds. Main entry, center north facade, a single-leaf wood panel door, accessed by two straight stone side steps, open flagstone platform. Doorstep is hewn from peeled log section, ends chamfered. Rear entry, center west gable end. Interior walls, vertical fir boards, stained and varnished, varnished board floors, stone fireplace, center east wall of living room; kitchen and bath, painted walls, linoleum floor covering. No significant structural or material alteration to interior or exterior.

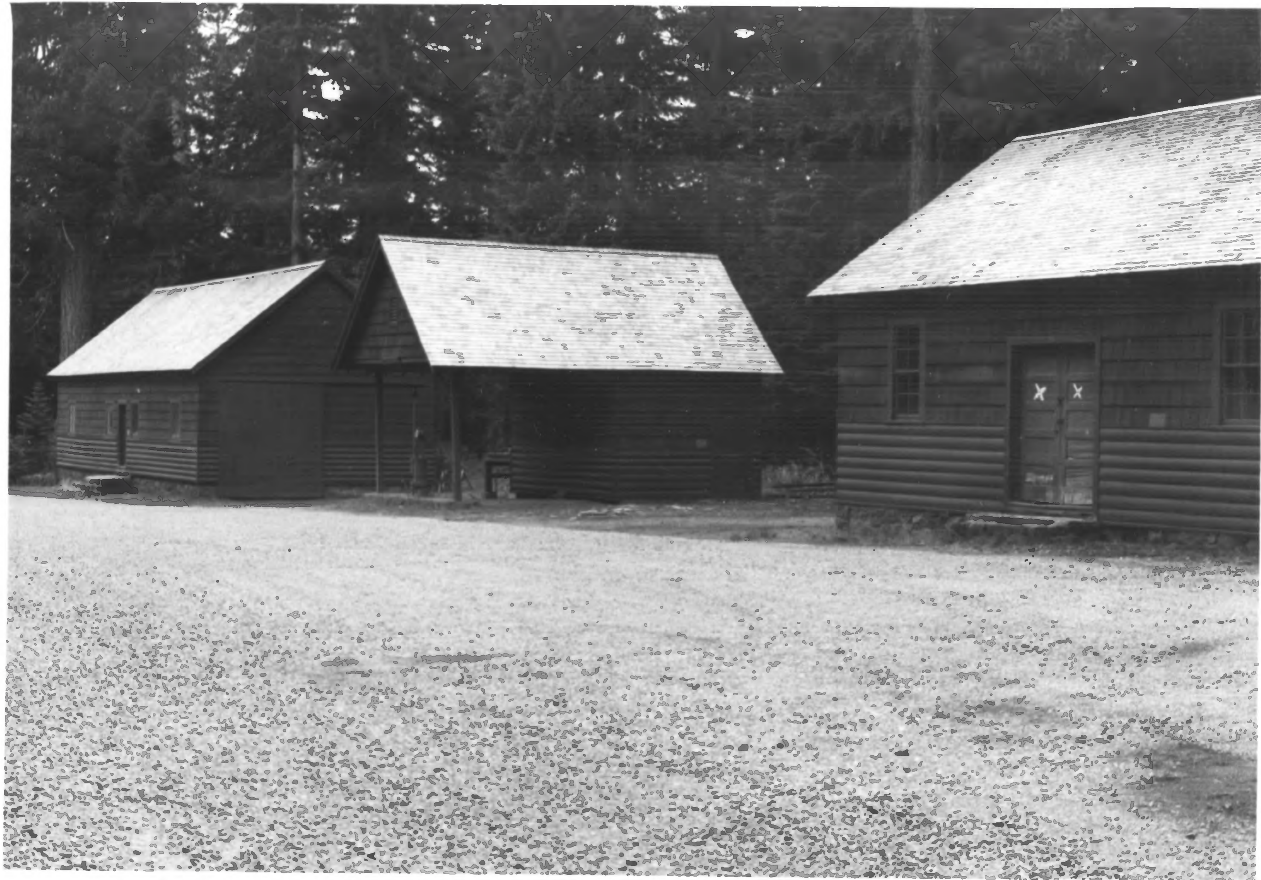
#X-1 VIEW OF SERVICE COURT

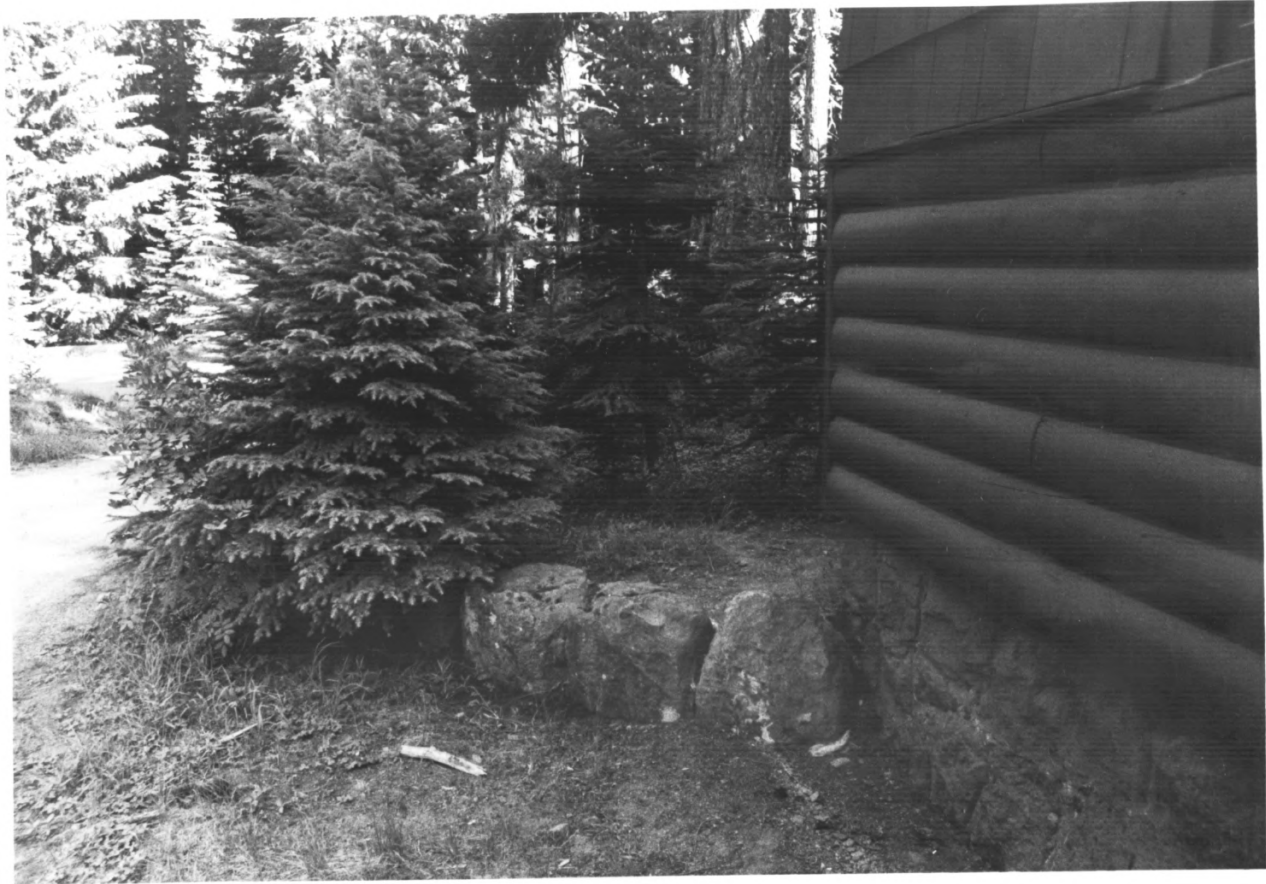
#X-2 EXAMPLE OF TYPICAL SQUARE RUBBLE ROCK BUILDING
FOUNDATION AND ROCK EDGING FOUND ALONG PATHS
AND DRIVEWAYS.
