**NATIONAL REGISTER OF HISTORIC PLACES
INVENTORY -- NOMINATION FORM**

HISTORIC Double-0 Ranch Historic District
AND/OR COMMON Double-0 Ranch Historic District

MALHEUR NATIONAL WILDLIFE REFUGE
 DOUBLE O RANCH HISTORIC SITE

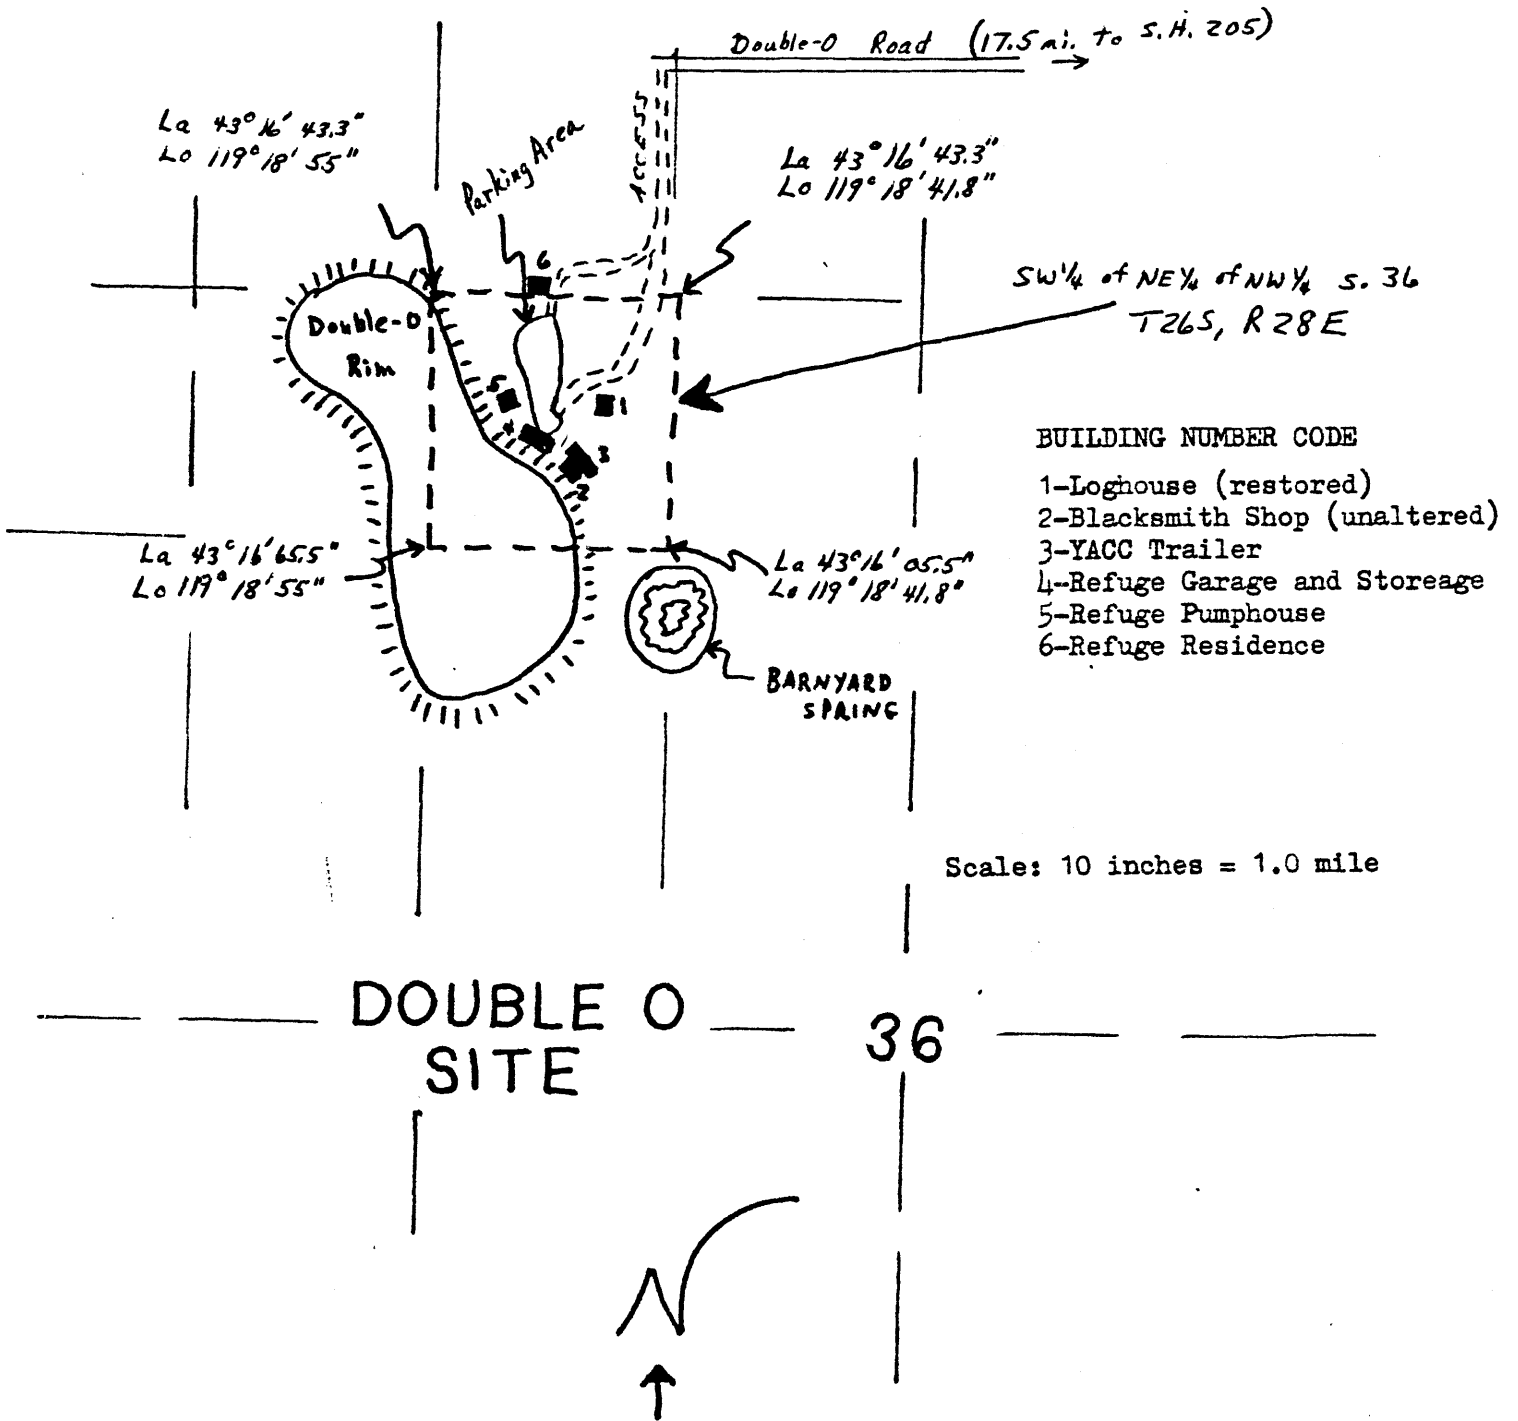
SW¹/₄ of NE¹/₄ of NW¹/₄ S. 36
 T26S, R28E

- BUILDING NUMBER CODE**
- 1-Loghouse (restored)
 - 2-Blacksmith Shop (unaltered)
 - 3-YACC Trailer
 - 4-Refuge Garage and Storage
 - 5-Refuge Pumphouse
 - 6-Refuge Residence

The boundary of this site is shown on the accompanying map. The area is ten acres in size and the northwest corner of the site lies at the base of the rim, approximately ten feet south of a line directly west of the southwest corner of the refuge residence. The tract is legally described as the SW-1/4 of the NE-1/4 of the NW-1/4 of Section 36, Township 26S, Range 28 East, Willamette Meridian. The longitude and latitude of the four corners of the tract are further described on the enclosed sketch.

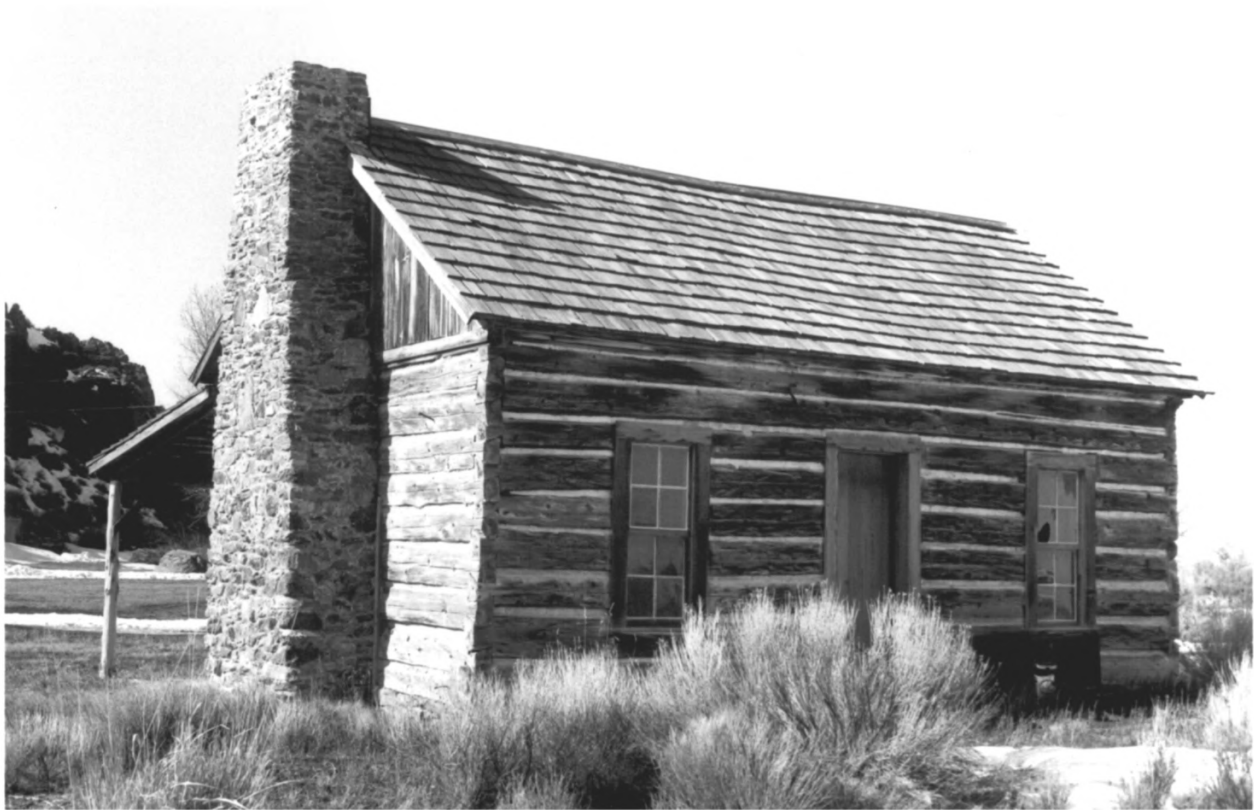
00-04

Looking west, Loghouse

The Loghouse is also a log walled building. Like the Blacksmith Shop, the structure is made of hand-hewn logs that were squared. Ends of the logs are dove-tailed to make the logs interlocking. The Loghouse has a cedar shingled roof and a wooden floor. The 1-1/2 story building has an upper room where the cook used to sleep during the Riley & Hardin ownership of the ranch. There are two windows on the north side of the building, a door on the south side, and another door on the north side. The Loghouse is 24' long, 16' wide, and 15' high. An old anvilstand and brand marks in the woodwork may be found inside. This building was restored in 1979. A new roof was added, windows and doors were straightened and repaired, the porch and fireplace were reconstructed using alkali mortar and native rocks from the site (see photos). A concealed concrete foundation, capped with native stone, was also added. The construction was accomplished to restore the building as near as possible to its original condition per Wayne R. Hill's research.

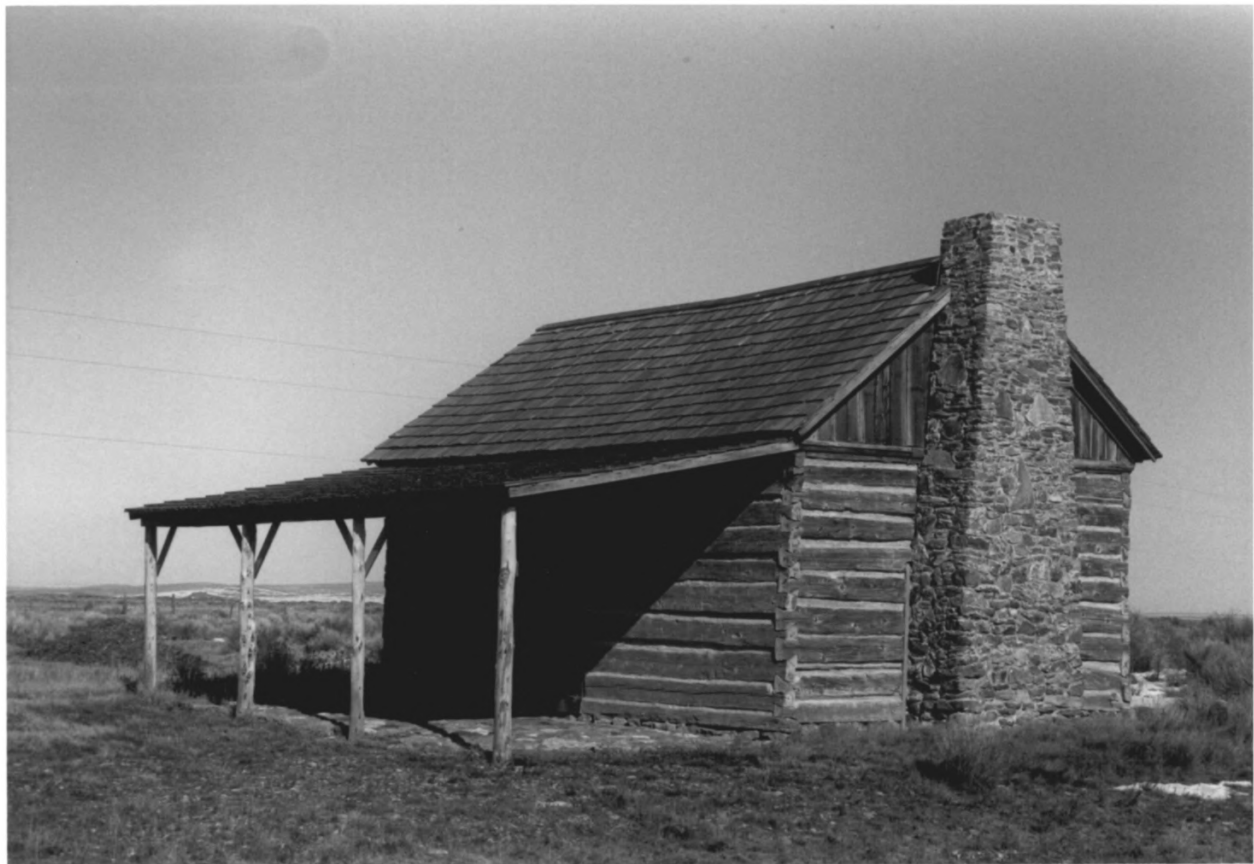
00-05

Looking northeast, Loghouse

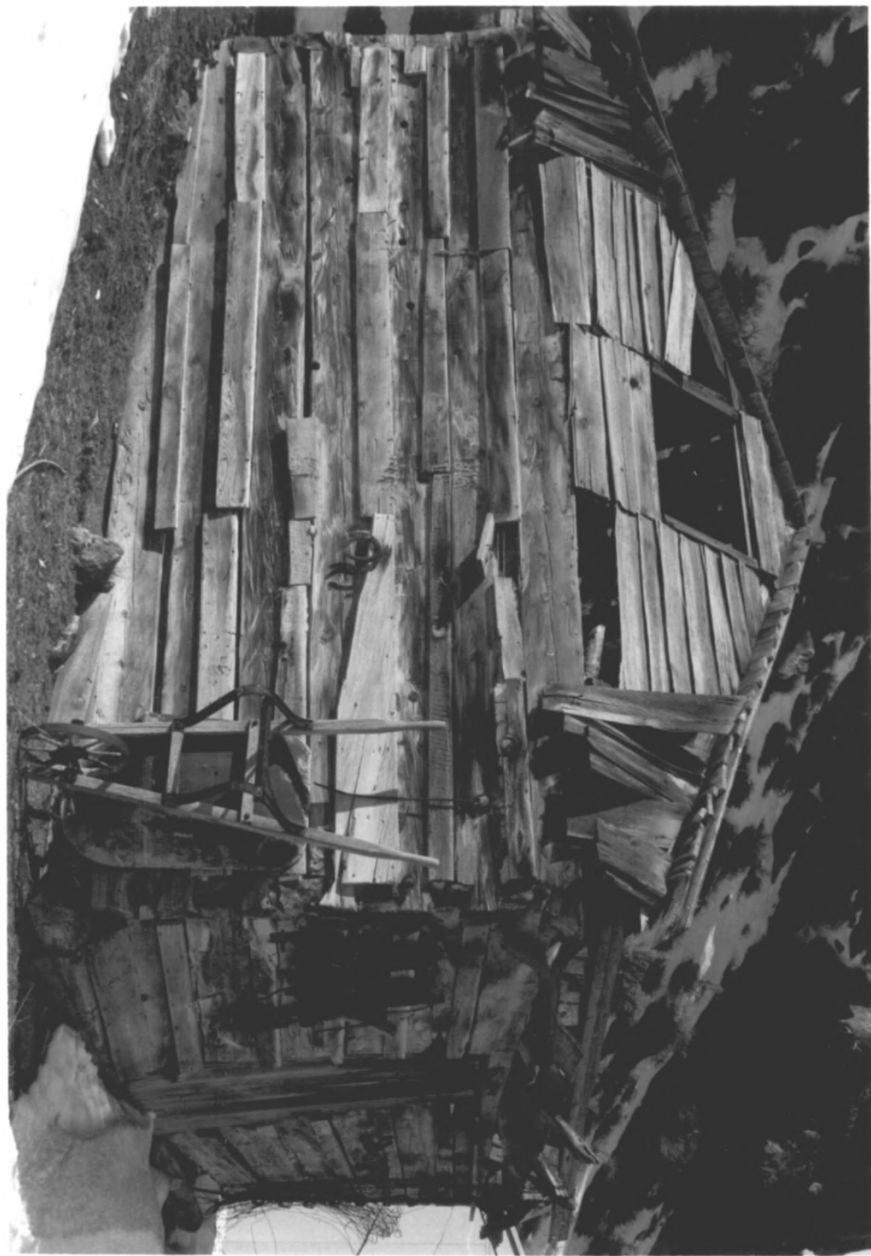
00-06

Looking west, Blacksmith Shop

The Blacksmith Shop is a log walled, single story building with no foundation. A board roof and floor were added to the structure around 1903. Original floor was probably dirt and the roof was wood shingled. A door is on the north side and there is one window on both the east and west sides of the building. The building is approximately 19' long, 15' wide, and 13' high. This building is presently in poor shape (see photos). The roof is falling in, but the logs are all intact and plans have been drawn up and submitted to restore this structure in the same manner as the Cookhouse-Blacksmith shop.

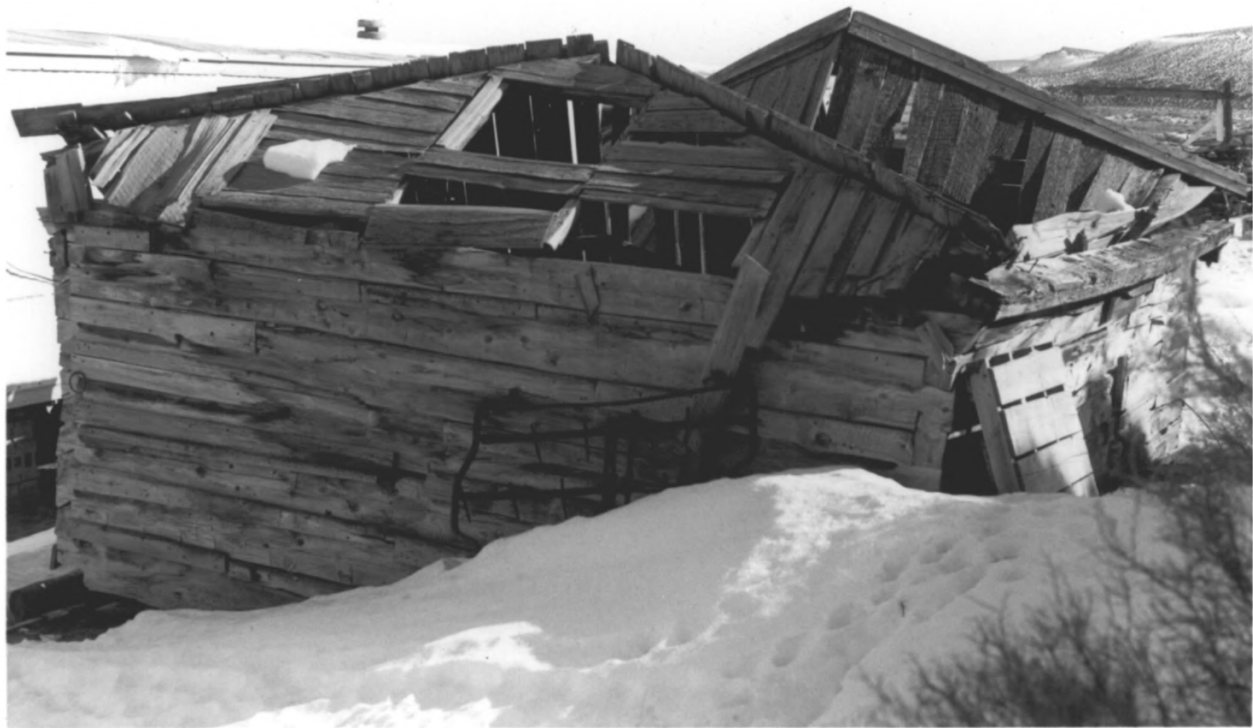
00-07

Looking east, Blacksmith Shop

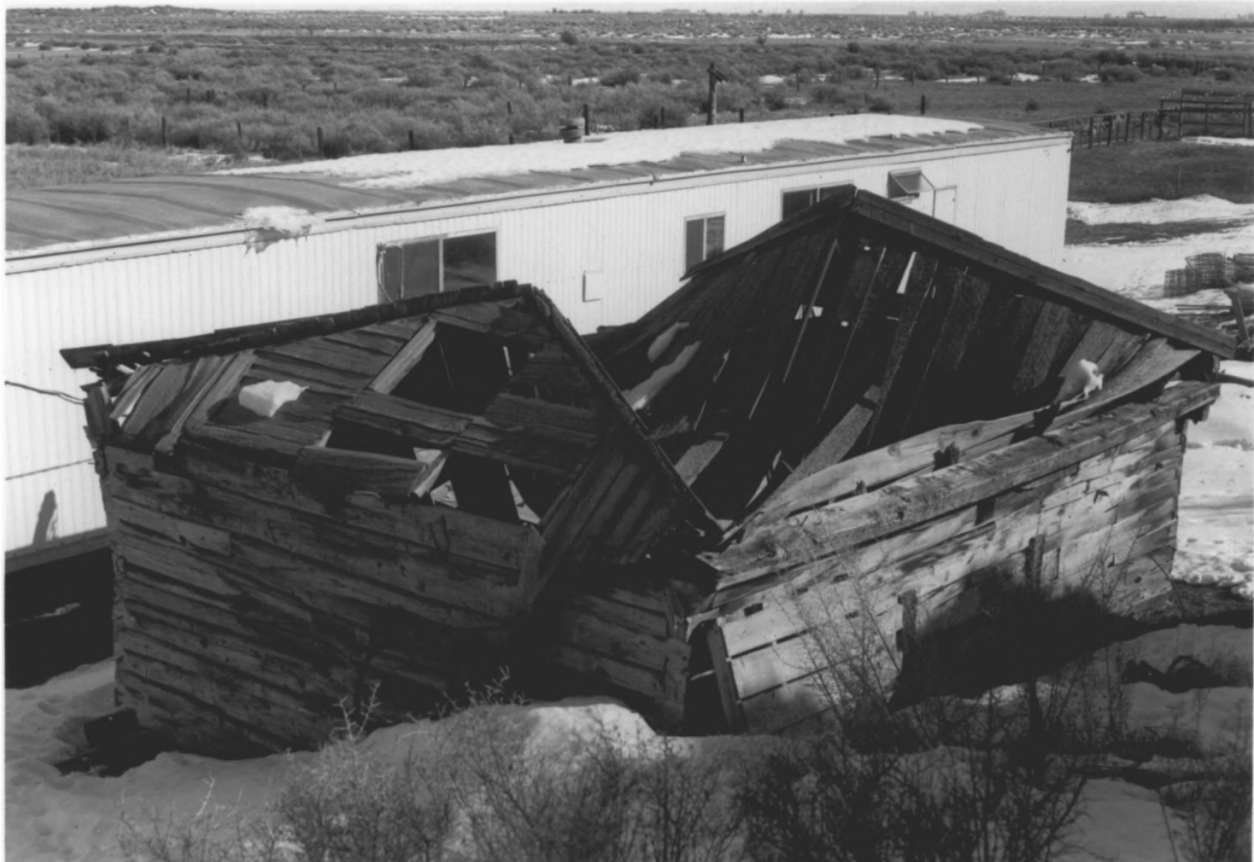
00-08

Looking east, Blacksmith Shop
