**National Register of Historic Places
Inventory—Nomination Form**

historic Macksburg Lutheran Church

street & number 10210 So. Macksburg Road N/A not for publication

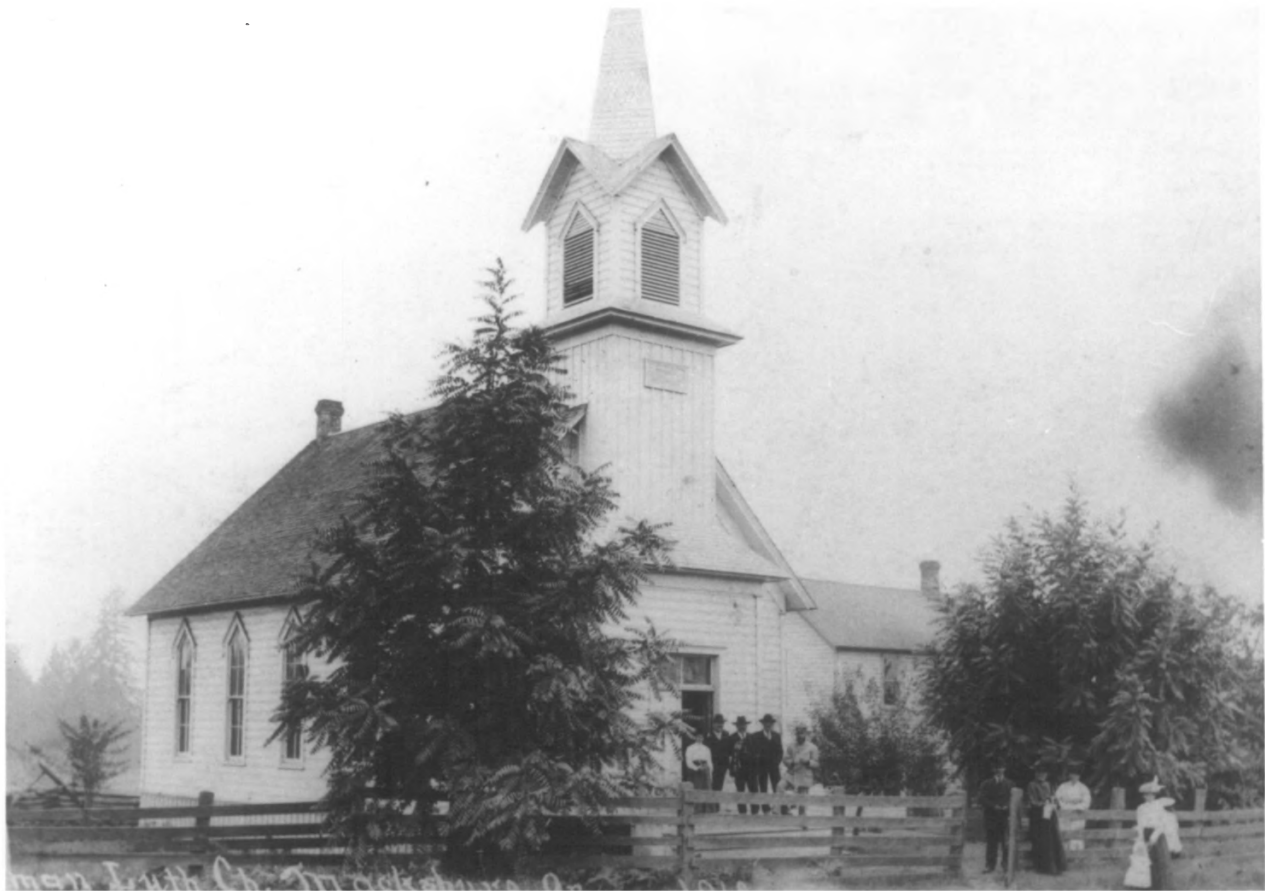
Picture #1 of 10

Macksburg Lutheran Church
10210 S. Macksburg Rd.
Canby, Oregon Clackamas Cty.
Front (North) and East side of
Church with parsonage to the
right.

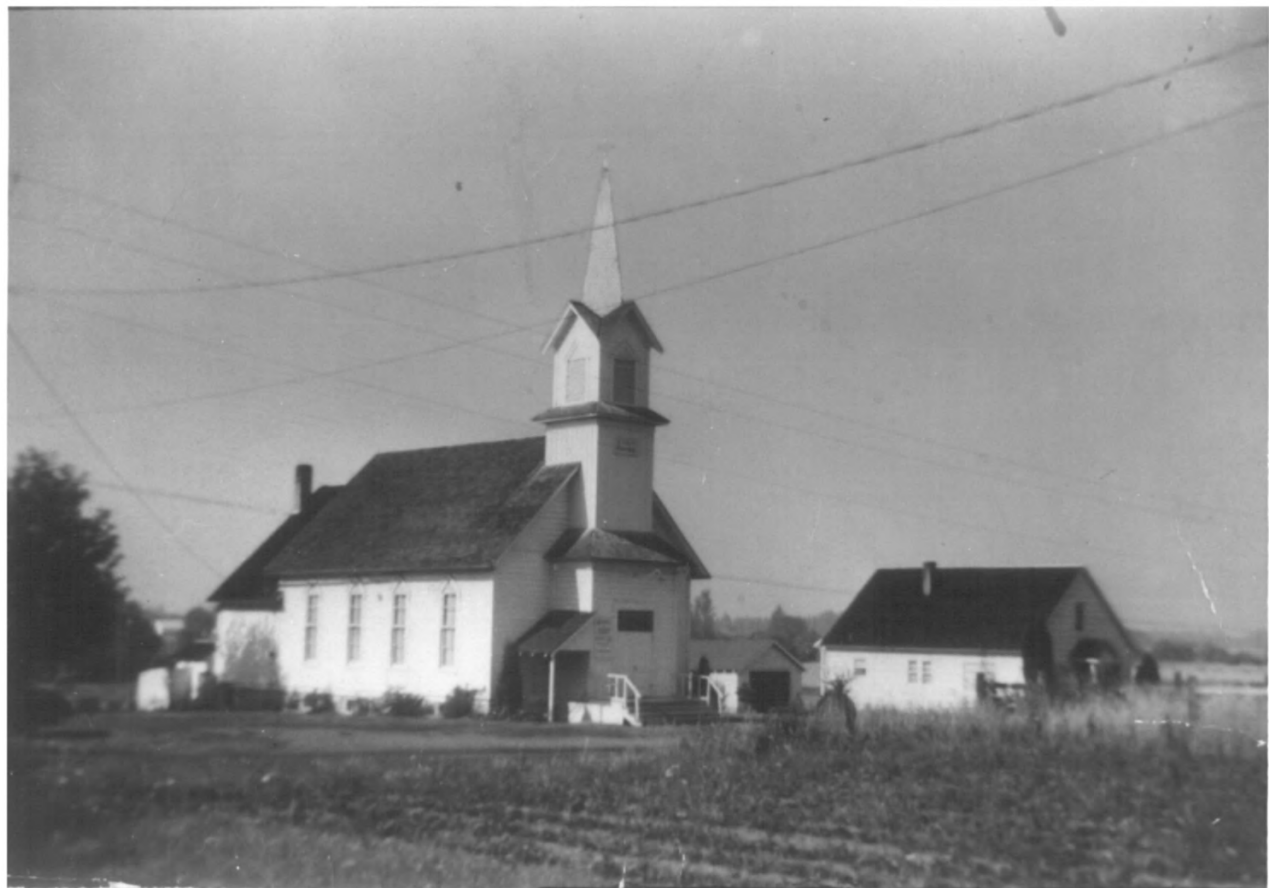
Picture #2 of 10

Front (North) and East side of
Church. New parsonage to right.
At left, rear, addition to the
back of Church (1929) of a Sun-
day school room, sacristy, and
altar.

An equally sensitive addition was made to the south end in 1929, when the concrete foundation was added. The south addition, housing an altar alcove, sacristy and Sunday school room, was finished to match the original volume. Its gable roof, like that of the later narthex, is lower in height than the main volume roof, but its pitch corresponds to that of the main roof. The side walls of the sacristy-Sunday school addition are blind. A single, double-hung window with plain, straight-topped trim is at either side of the end wall to light the respective interior spaces. A brick outside end chimney breaks through the eave to the east of center.

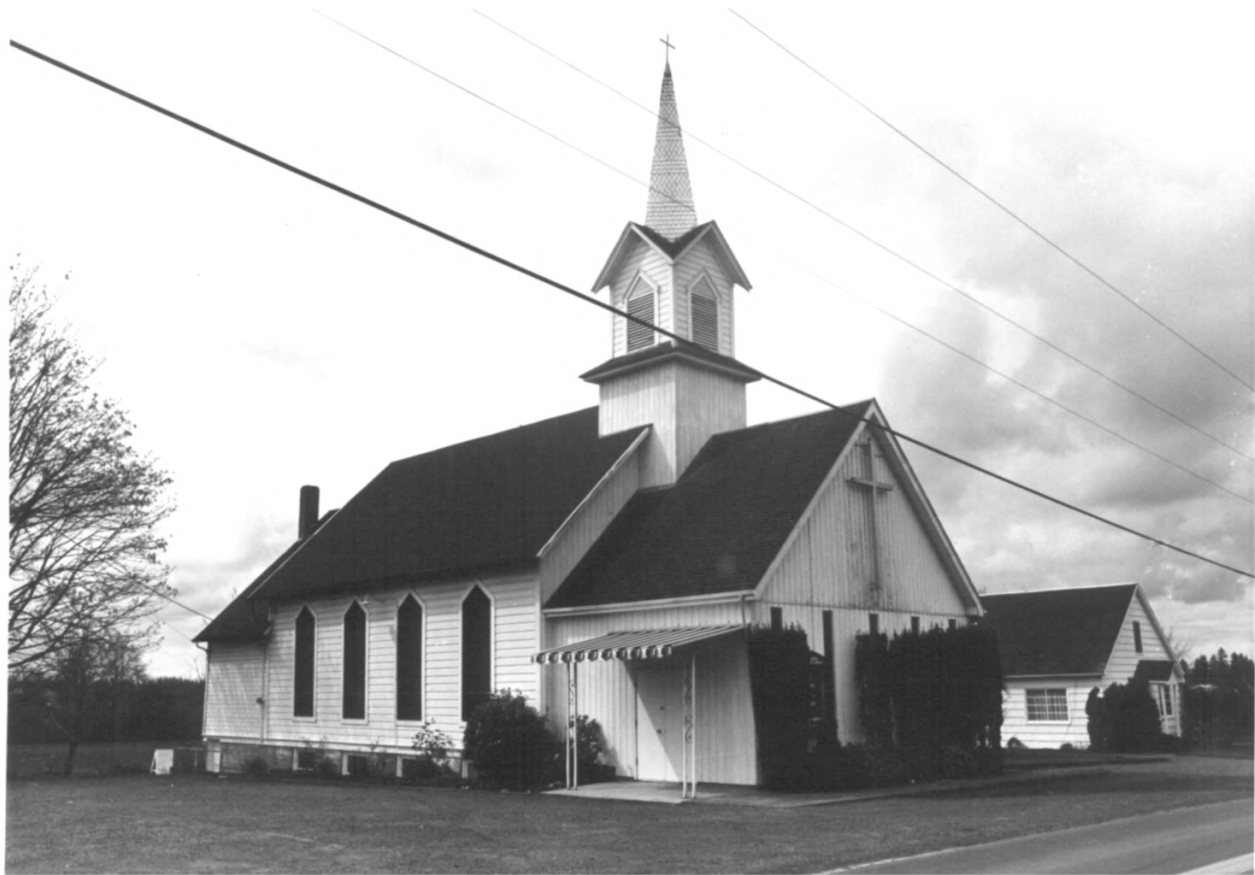
Picture #3 of 10

Macksburg Lutheran Church
10210 S. Macksburg Rd.
Canby, Oregon Clackamas Cty.
Front (North) and East side,
showing Church as it appears to-
day. Entrance changed in 1965 when
Narthex was added and stairs to
basement changed to make more
efficient use of area.
Photographer--Diane Gonthier,
Canby Herald 1981
Negative--Mrs. F. O. Kraxberger,
10286 S. Macksburg Rd., Canby,
Oregon 97013
Camera facing southwest

In 1944 a full basement was excavated under the building to house a furnace room, with its oil furnace, a kitchen and parish hall. In 1965, the narthex was constructed to improve access to the sanctuary and parish hall, which was increasingly used for general community gatherings.

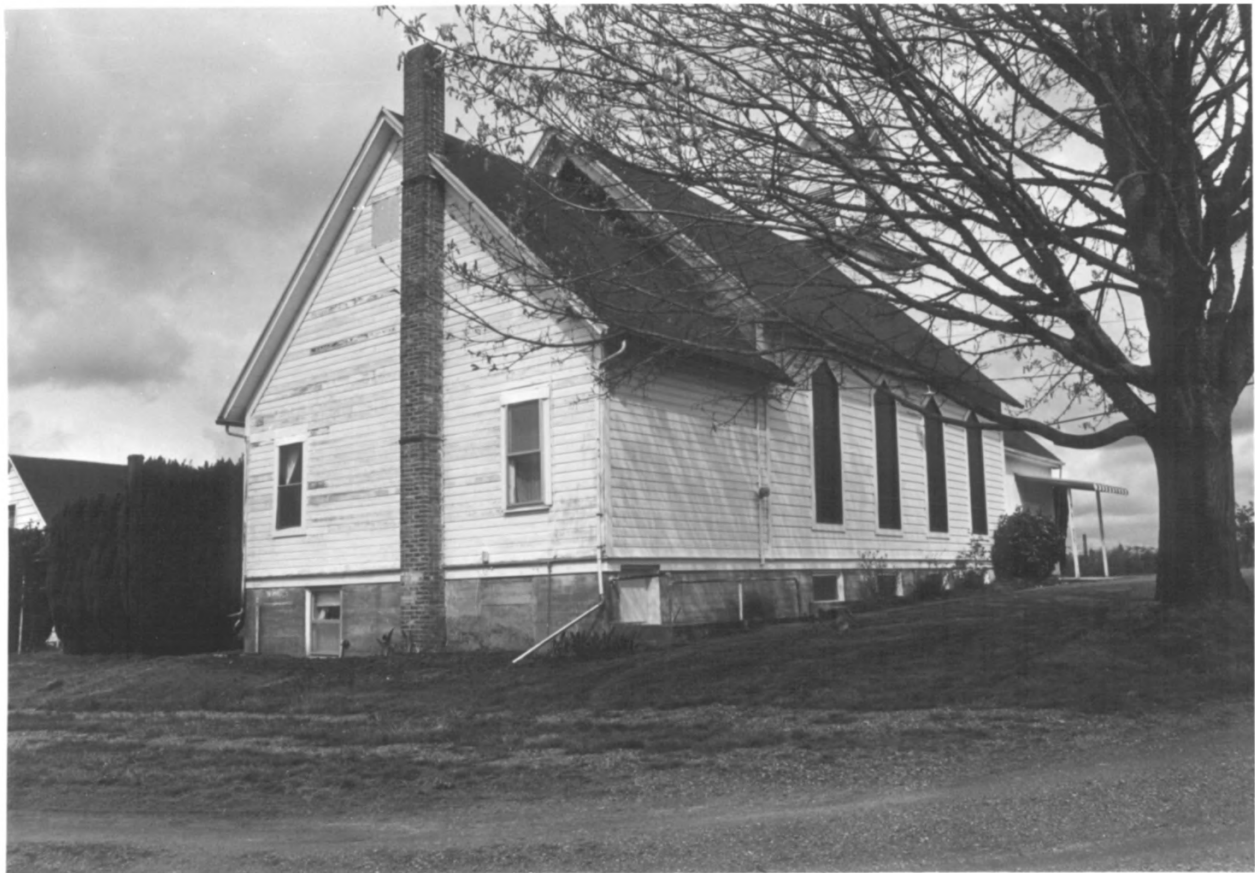
Picture #4 of 10

Macksburg Lutheran Church
10210 S. Macksburg Rd.
Canby, Oregon Clackamas Cty.
Addition at rear of Church,
made in 1929, with no other
change to date except cement
foundation.

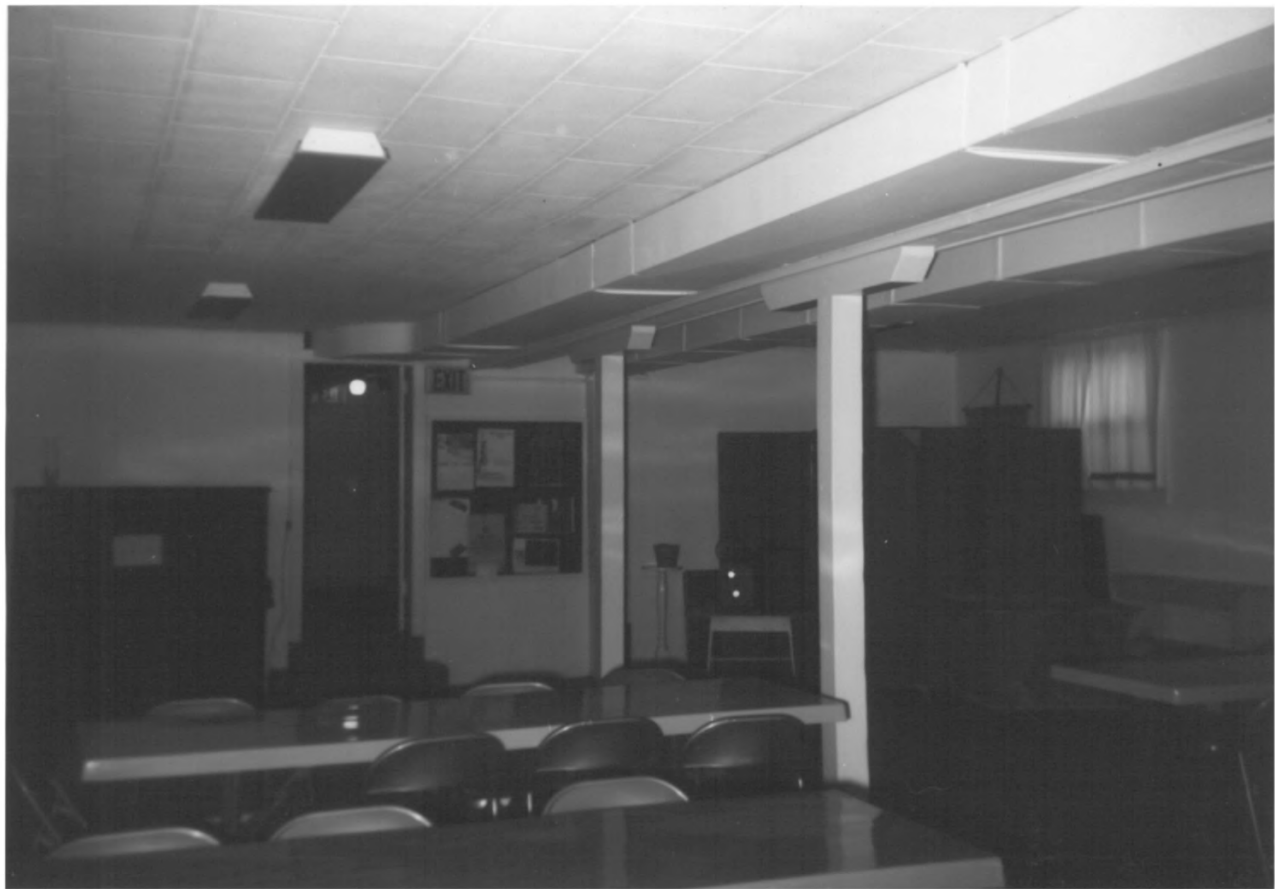
Picture # 8 of 10

Macksburg Lutheran Church
10210 S. Macksburg Rd.
Canby, Oregon Clackamas Cty.
Basement fellowship room, used
for Sunday School, club meetings,
flower shows, elections, wedding
receptions.

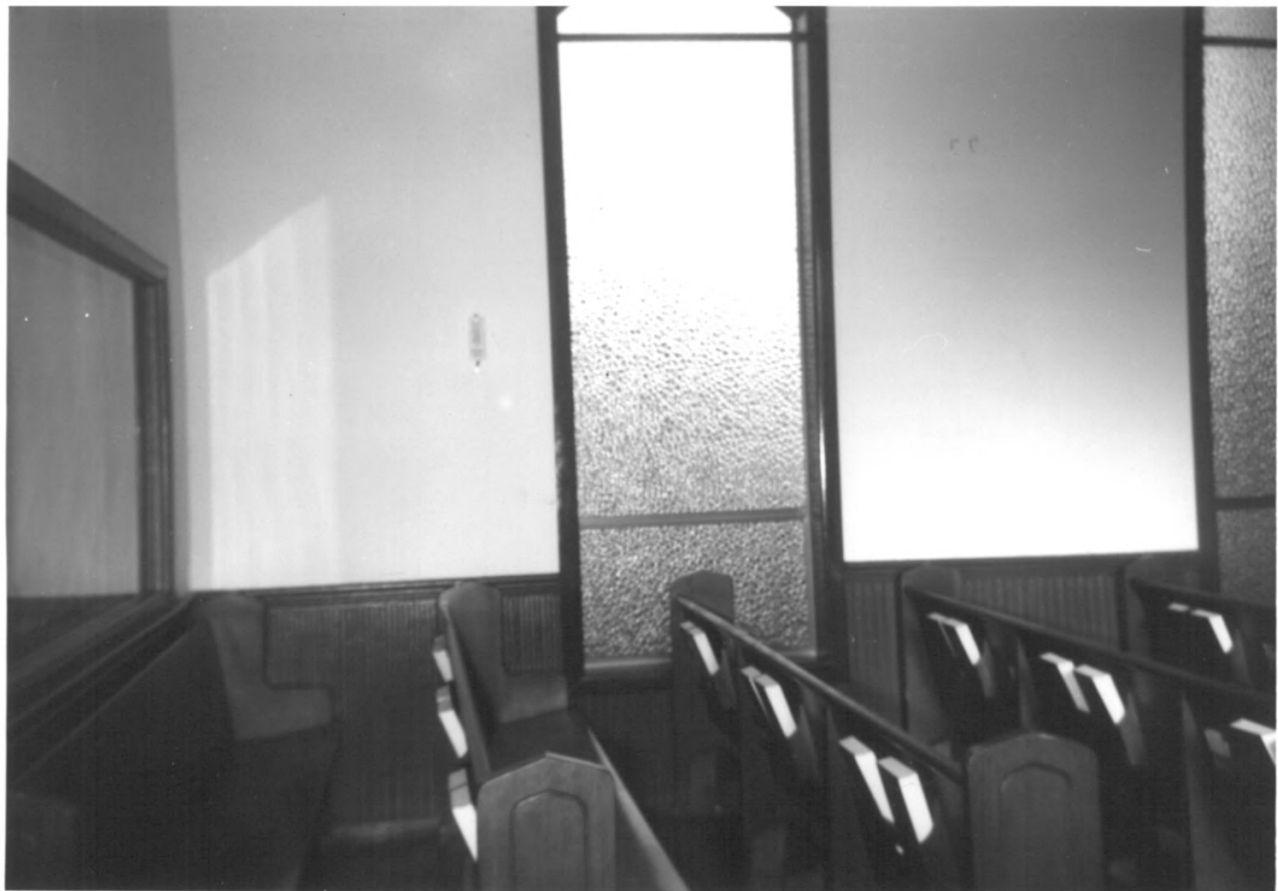
Picture #9 of 10

Macksburg Lutheran Church
10210 S. Macksburg Rd.
Canby, Oregon Clackamas Cty.
Pews installed, 1944. Windows
replaced at same time with orig-
inal casings. Plasterboard added
in 1944 when original wainscoating
painstakingly removed and reused.
Cry Room extreme left.
Photographer--Mrs. Dave Brown,
15526 S. E. Francis Ave.,
Milwaukie, Oregon 97222 1981
Negative--Mrs. F. O. Kraxberger,
10286 S. Macksburg Rd., Canby,
Oregon 97013
Camera facing east

The interior of the main volume is a single space traditionally organized with wood pews on either side of a center aisle. The only natural lighting is provided by windows in either side wall. As noted above, these windows were enlarged in 1965 to admit more light. While the window trim is new, the proportion of the windows remains distinctly vertical, and triangular arch heads remain a part of the scheme. The altar end of the room is formally arranged with a pointed-arched altar alcove in the center and doors leading to the sacristy and Sunday school rooms, respectively, to either side. The church was originally heated by a wood stove which stood in the center of the room surrounded by benches made of one-by-twos. This arrangement was first modified, apparently, in 1929 by the addition to the south end.

In 1944, reportedly, when the basement was excavated, or very likely during the construction of 1965, original interior wall cover of heavy painted paper was replaced with sheetrock. The original wainscoting was retained on the side walls, however. The roof framing system is enclosed. Original wood flooring of the sanctuary is overlaid with tile and carpeting. The narthex addition of 1965 added space for a cry room, choir room and storage at the north end of the sanctuary. In the basement, the same addition added toilet rooms to the furnace room, kitchen and parish hall of 1944.

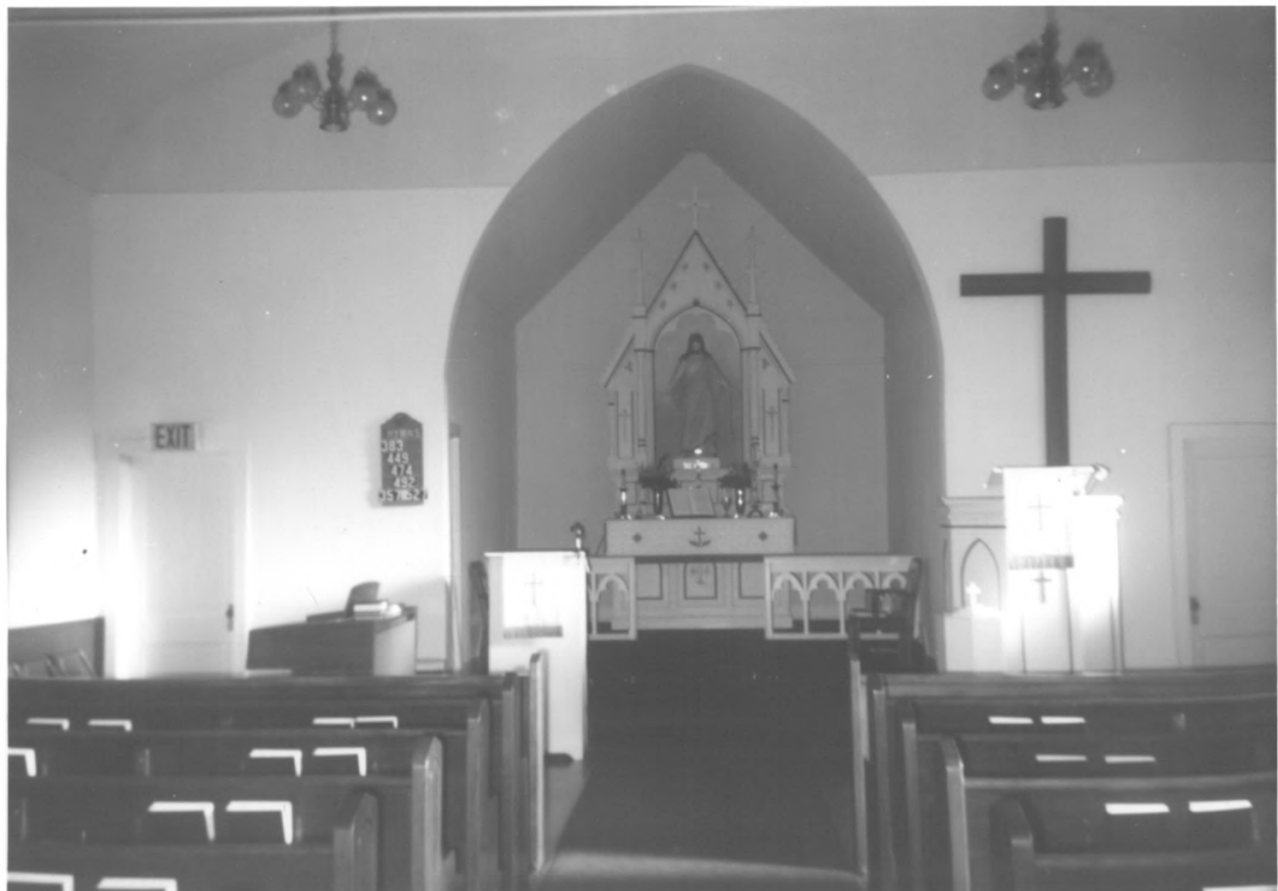
Picture #10 of 10

Macksburg Lutheran Church
10210 S. Macksburg Rd.
Canby, Oregon Clackamas Cty.
Chapel and altar. Door to
Sunday School room on right,
Sacristy on left.
Photographer--Mrs. Dave Brown,
15526 S. E. Francis Ave.,
Milwaukie, Oregon 97222 1981
Negative--Mrs. F. O. Kraxberger,
10286 S. Macksburg Rd., Canby,
Oregon 97013
Camera facing south
