National Register of Historic Places Inventory—Nomination Form

historic Sutherlin Bank Building

street & number 101 West Central Avenue N/A not for publication

city, town Sutherlin N/A vicinity of Fourth Congressional District

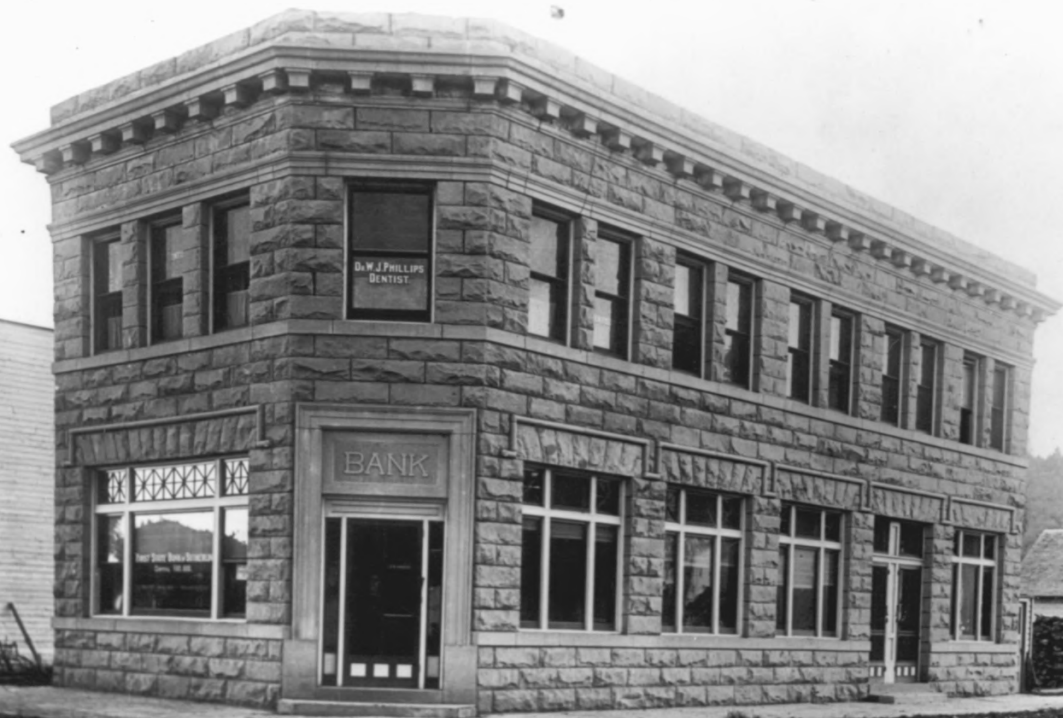
1. Sutherlin Bank Building
2. Sutherlin, Oregon, Douglas Co.
3. unknown
4. c. 1910
5. Douglas County Museum,
Roseburg, Or 97470
6. Southeast elev.
7. #1

The heavy rock-cut stone of the south and east walls is emphasized by three horizontal bands of smooth stone. North and west walls are constructed of brick. The building was originally topped by a handsome stone cornice which was removed in 1949 due to deterioration and its attractiveness to nesting swallows. A stucco covered extension now forms a cap on the South and East elevations. Vertically-set stone lintels top the street-level windows and are outlined by a decorative stone modling. The original street-level three-part windows with a decorative grillwork on the top are one of the feates of the building recalling the American Renaissance style; other features are the stone lintels, the decorative cornice, the flat roof, upper rectangular windows and the horizontal emphasis of the smooth stone bands.

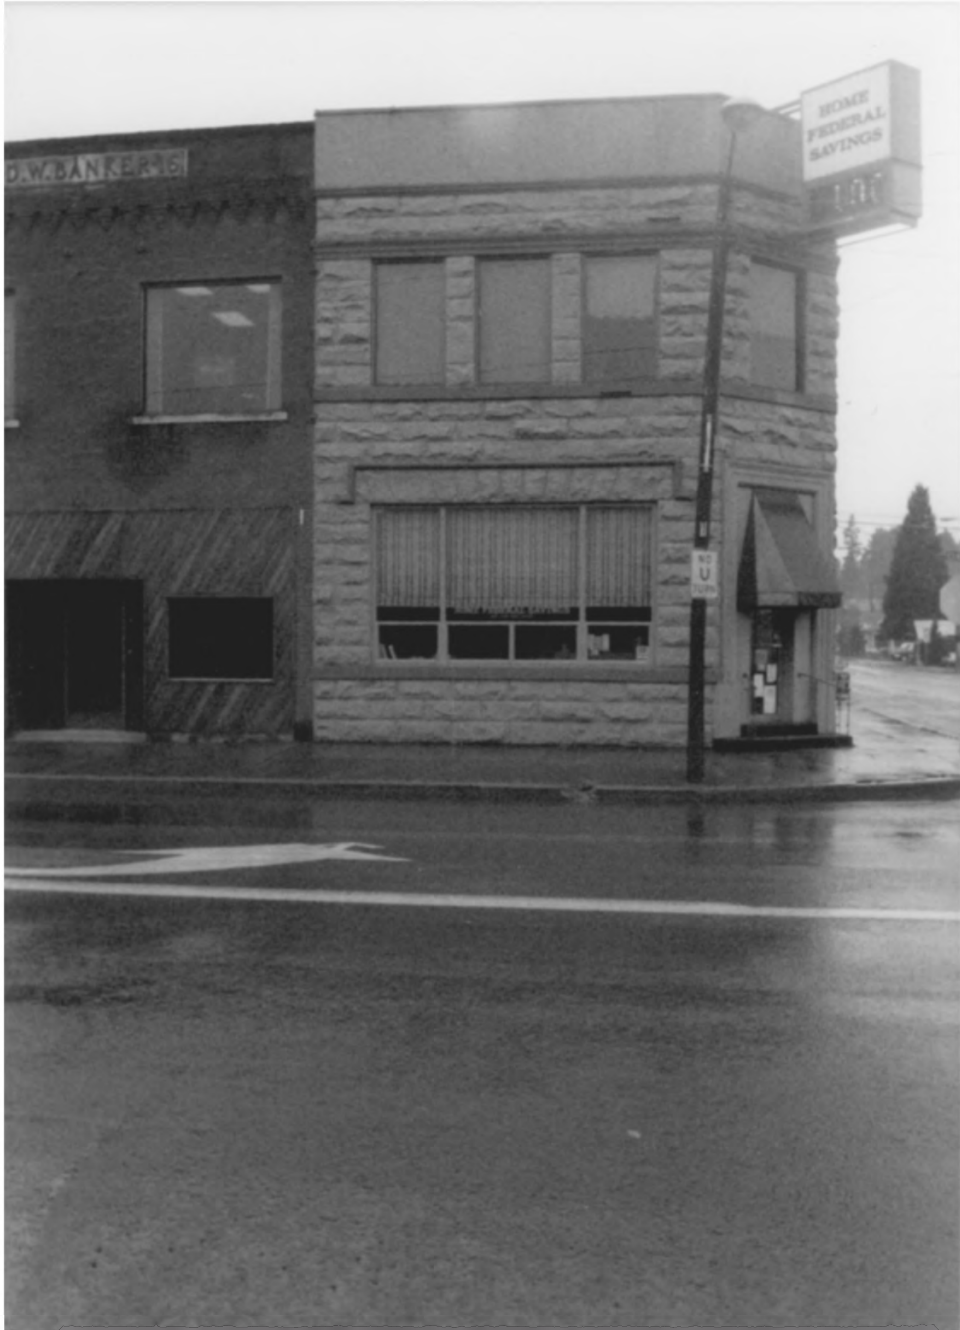
1. Sutherlin Bank Building
2. Sutherlin, Oregon, Douglas Co.
3. Marianne Kadas 4. 1983
5. Marianne Kadas, 690 Laurel
6. South elevation 7. Sutherlin, OR 97479 #2

Windows on the north brick wall have a heavy slab-type stone lintel. Four large evenly spaced windows and matching doorway are features at the street level on the east elevation, and one large window occupies a major portion of the south elevation. Second floor windows correspond with the lower level with five pairs of rectangular windows on the east elevation, a large window over the corner entryway and three windows on the south elevation. The upper windows are deeply recessed and have a strong vertical emphasis. All the windows have been somewhat modified with larger panes; the upper level windows are single-pane with anodized aluminum frames.

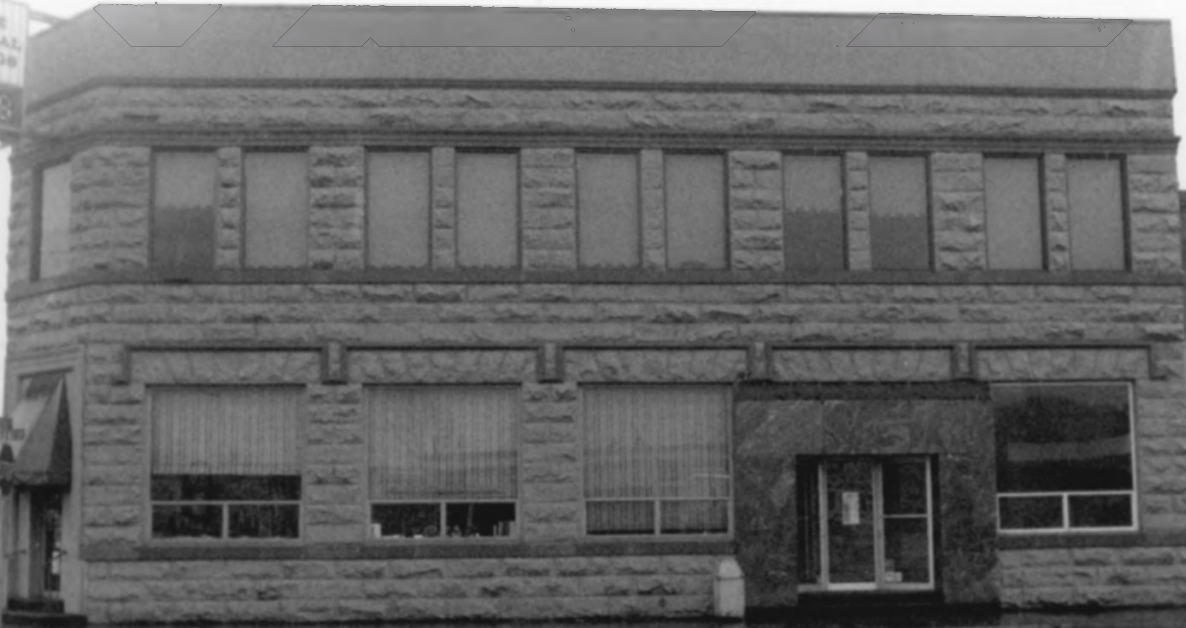
1. Sutherlin Bank Building
2. Sutherlin, Oregon, Douglas Co.
3. Marianne Kadas 4. 1983
5. Marianne Kadas, 690 Laurel
Sutherlin, OR 97479
6. East elevation 7. #3

The smooth-stone corner entryway has been slightly modified, and the side windows have been removed along with the lettering "BANK" above the door. When the building was remodeled in 1949 the entrance on the east elevation was used for the main entrance and at that time the surrounding area was faced with slabs of gray and pink marble measuring 3 x 8 feet.

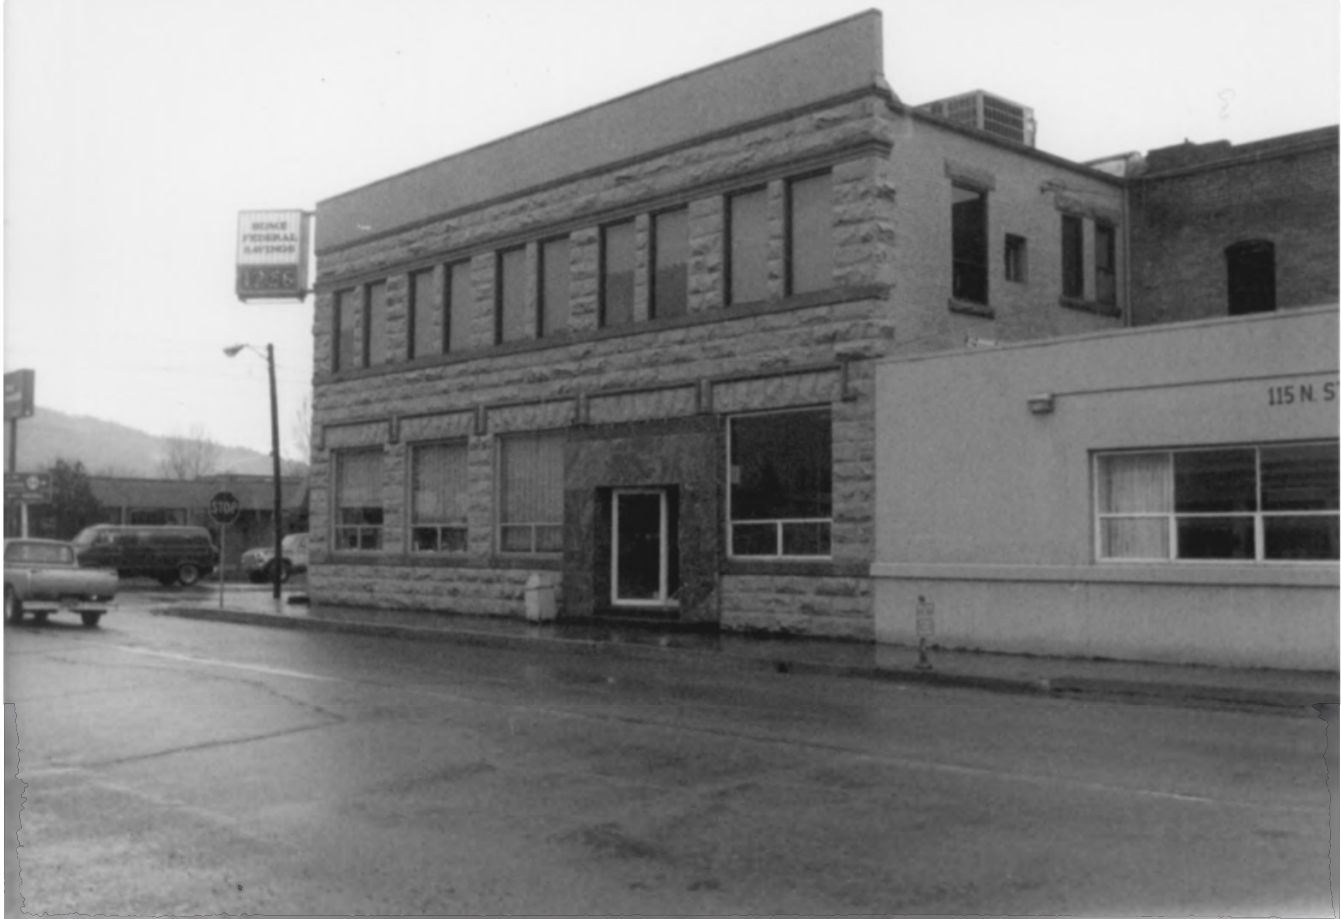
1. Sutherlin Bank Building
2. Sutherlin, Oregon, Douglas Co.
3. Marianne Kadas 4. 1983
4. Marianne Kadas, 690 Laurel
Sutherlin, OR 97479
6. Northeast Elevation 7. #4

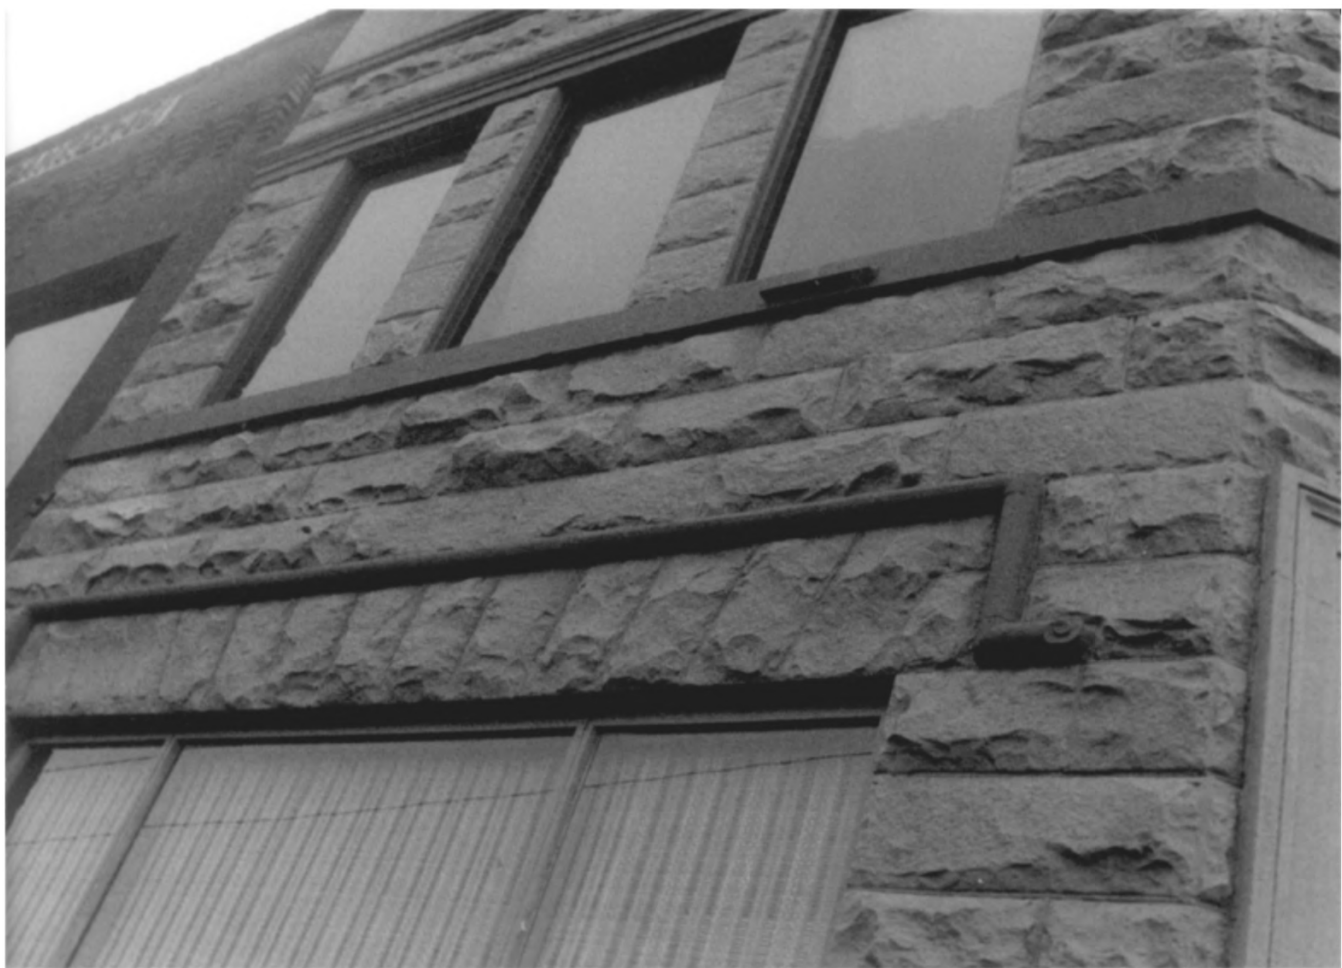
1. Sutherlin Bank Building
2. Sutherlin, Oregon, Douglas Co.
3. Marianne Kadas 4. 1983
5. Marianne Kadas, 690 Laurel
Sutherlin, OR 97479
6. Lintel, s. elev. 7. #5

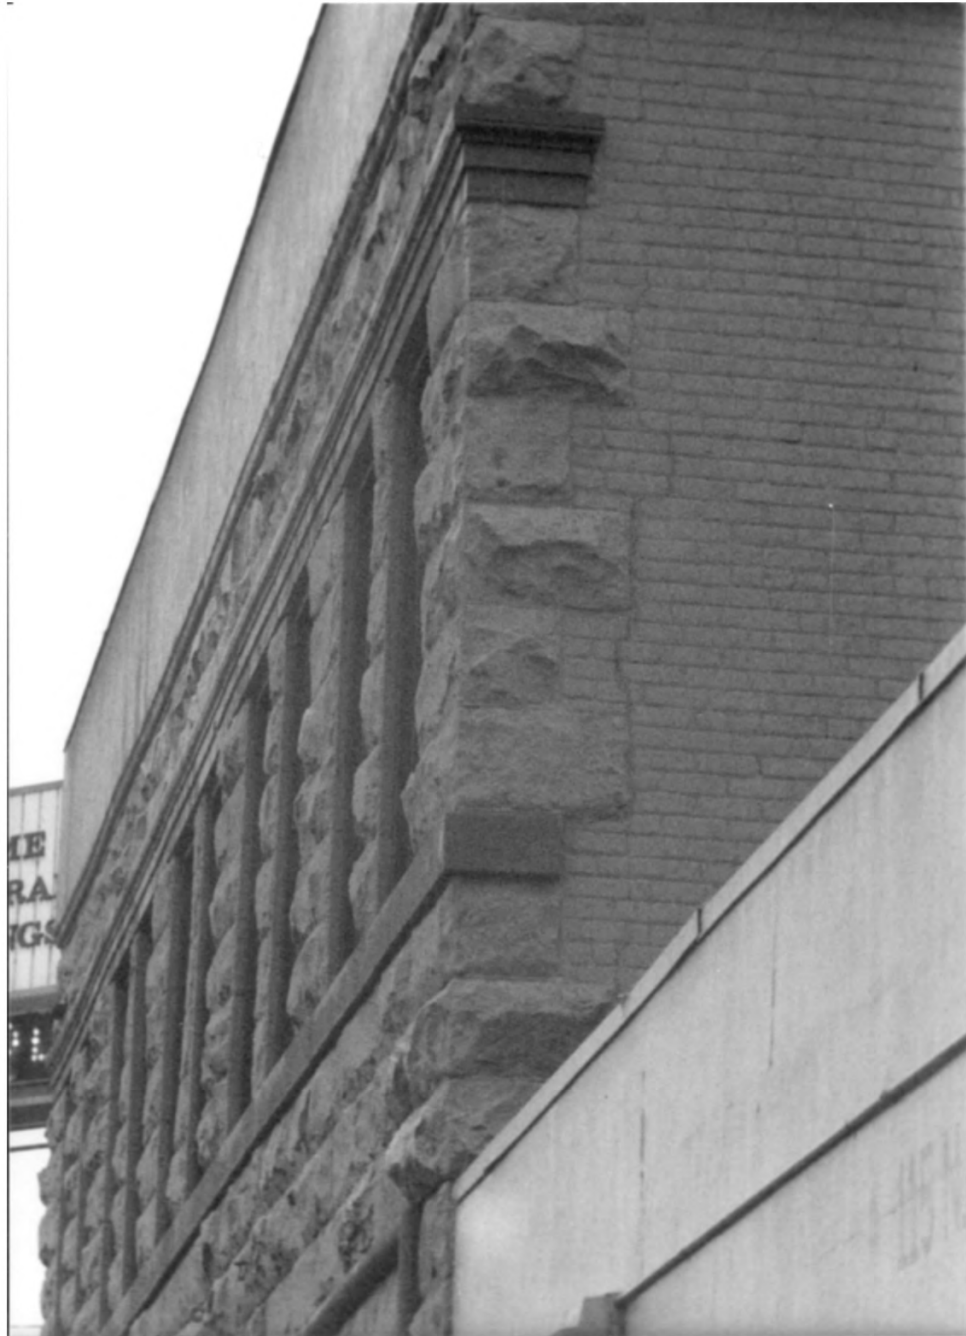
1. Sutherlin Bank Building
2. Sutherlin, Oregon, Douglas Co.
3. Marianne Kadas 4. 1983
5. Marianne Kadas, 690 Laurel
6. 2nd floor, NE elev. ^{Sutherlin, OR 97479} 7. #6

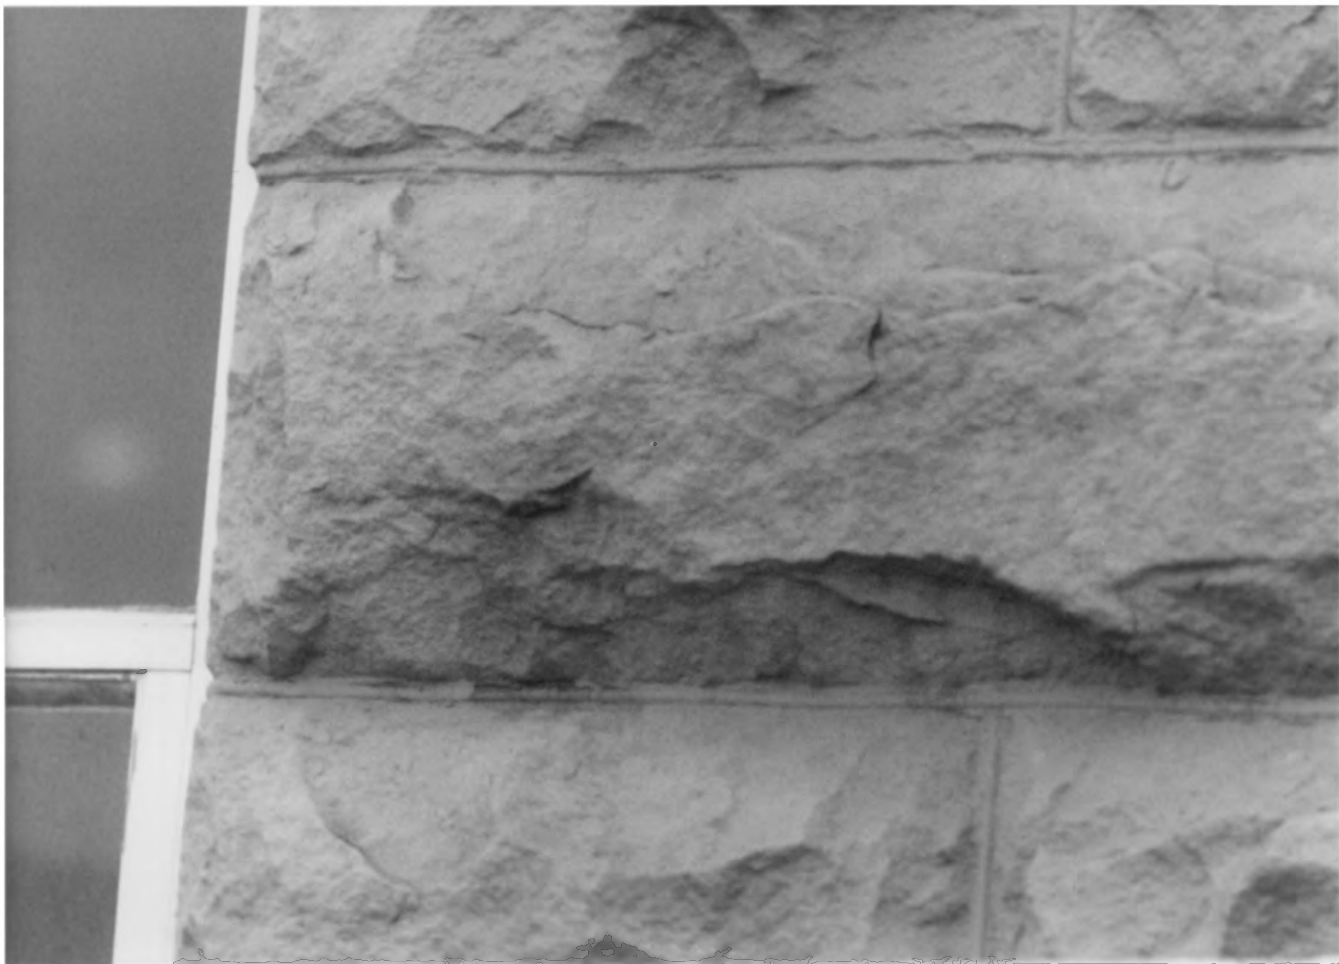
1. Sutherland Bank Building
2. Sutherland, Oregon, Douglas Co.
3. Marianne Kadas 4. 1983
5. Marianne Kadas, 690 Laurel,
Sutherland, OR 97479
6. S. Elev. close-up 7. #7
