**NATIONAL REGISTER OF HISTORIC PLACES
INVENTORY -- NOMINATION FORM**

DEPRESSION-ERA BUILDINGS

NAME: Cabin Lake Guard Station

LOCATION: Deschutes National Forest, Fort Rock Ranger District; Congressional District 2; Vicinity of Bend, Oregon (41); Lake County (037)

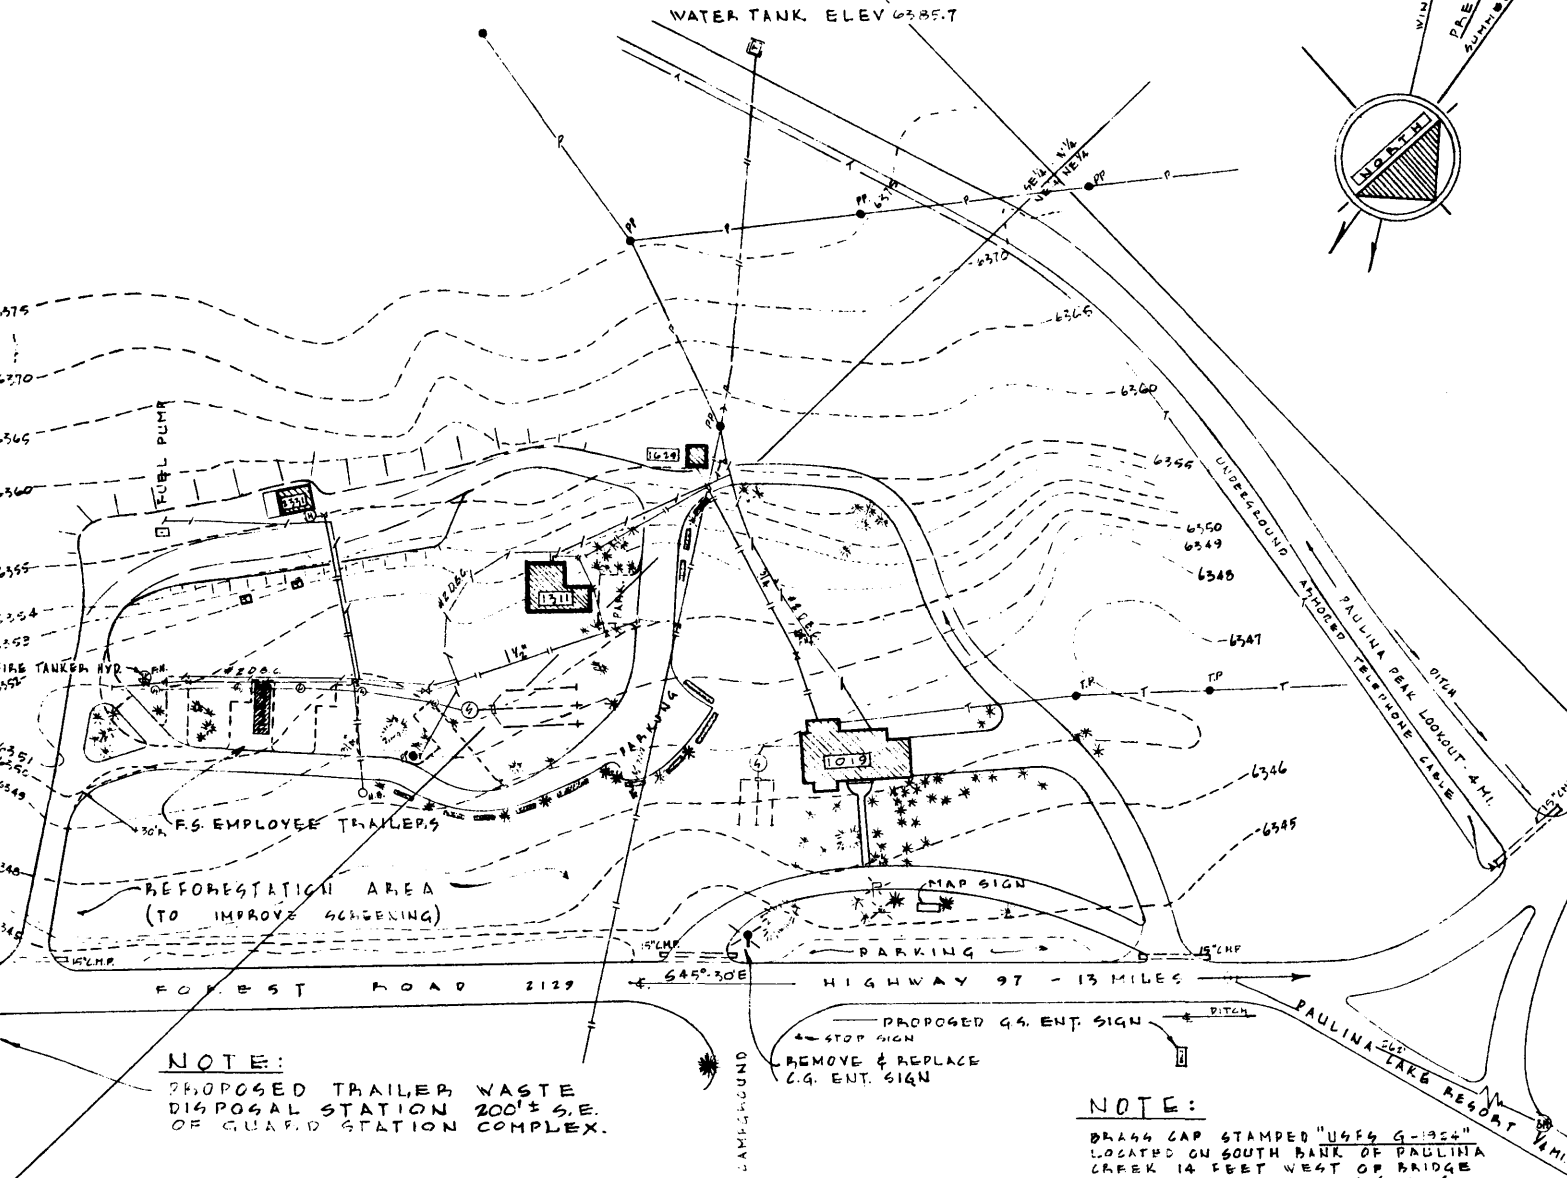
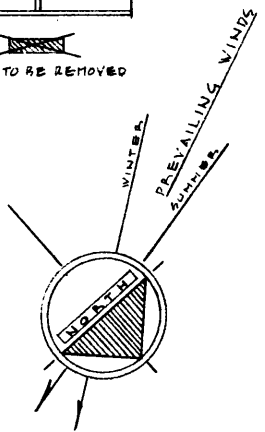
Paulina Lake Guard Station

NOTE:
 PROPOSED TRAILER WASTE DISPOSAL STATION 200'± S.E. OF GUARD STATION COMPLEX.

SOIL TYPE: PUMICE WITH SANDY SILT

APPROVED: PHILIP L. HEATON, ASST. REGIONAL FORESTER BY ASHLEY A. ROUSH, FOREST SUPERVISOR 1-12-66		U. S. DEPARTMENT OF AGRICULTURE FOREST SERVICE DESCHUTES NATIONAL FOREST THE PACIFIC NORTHWEST REGION		SITE PLAN PAULINA LAKE GUARD STATION SCALE 1" = 50'	
REGIONAL ENGINEER ASST. REGIONAL FORESTER ASST. REGIONAL FORESTER	DRAWN: _____ DESIGNED: _____ CHECKED: _____ SUBMITTED: _____	REVISOR: D.P.G. " " " " E.J. Parker	DATE: 1-11-66 DATE: _____ DATE: _____ DATE: 2-18-66	GEL. 34, T216, R12E, W.M. DIST. D-3	SHT 1 of 1

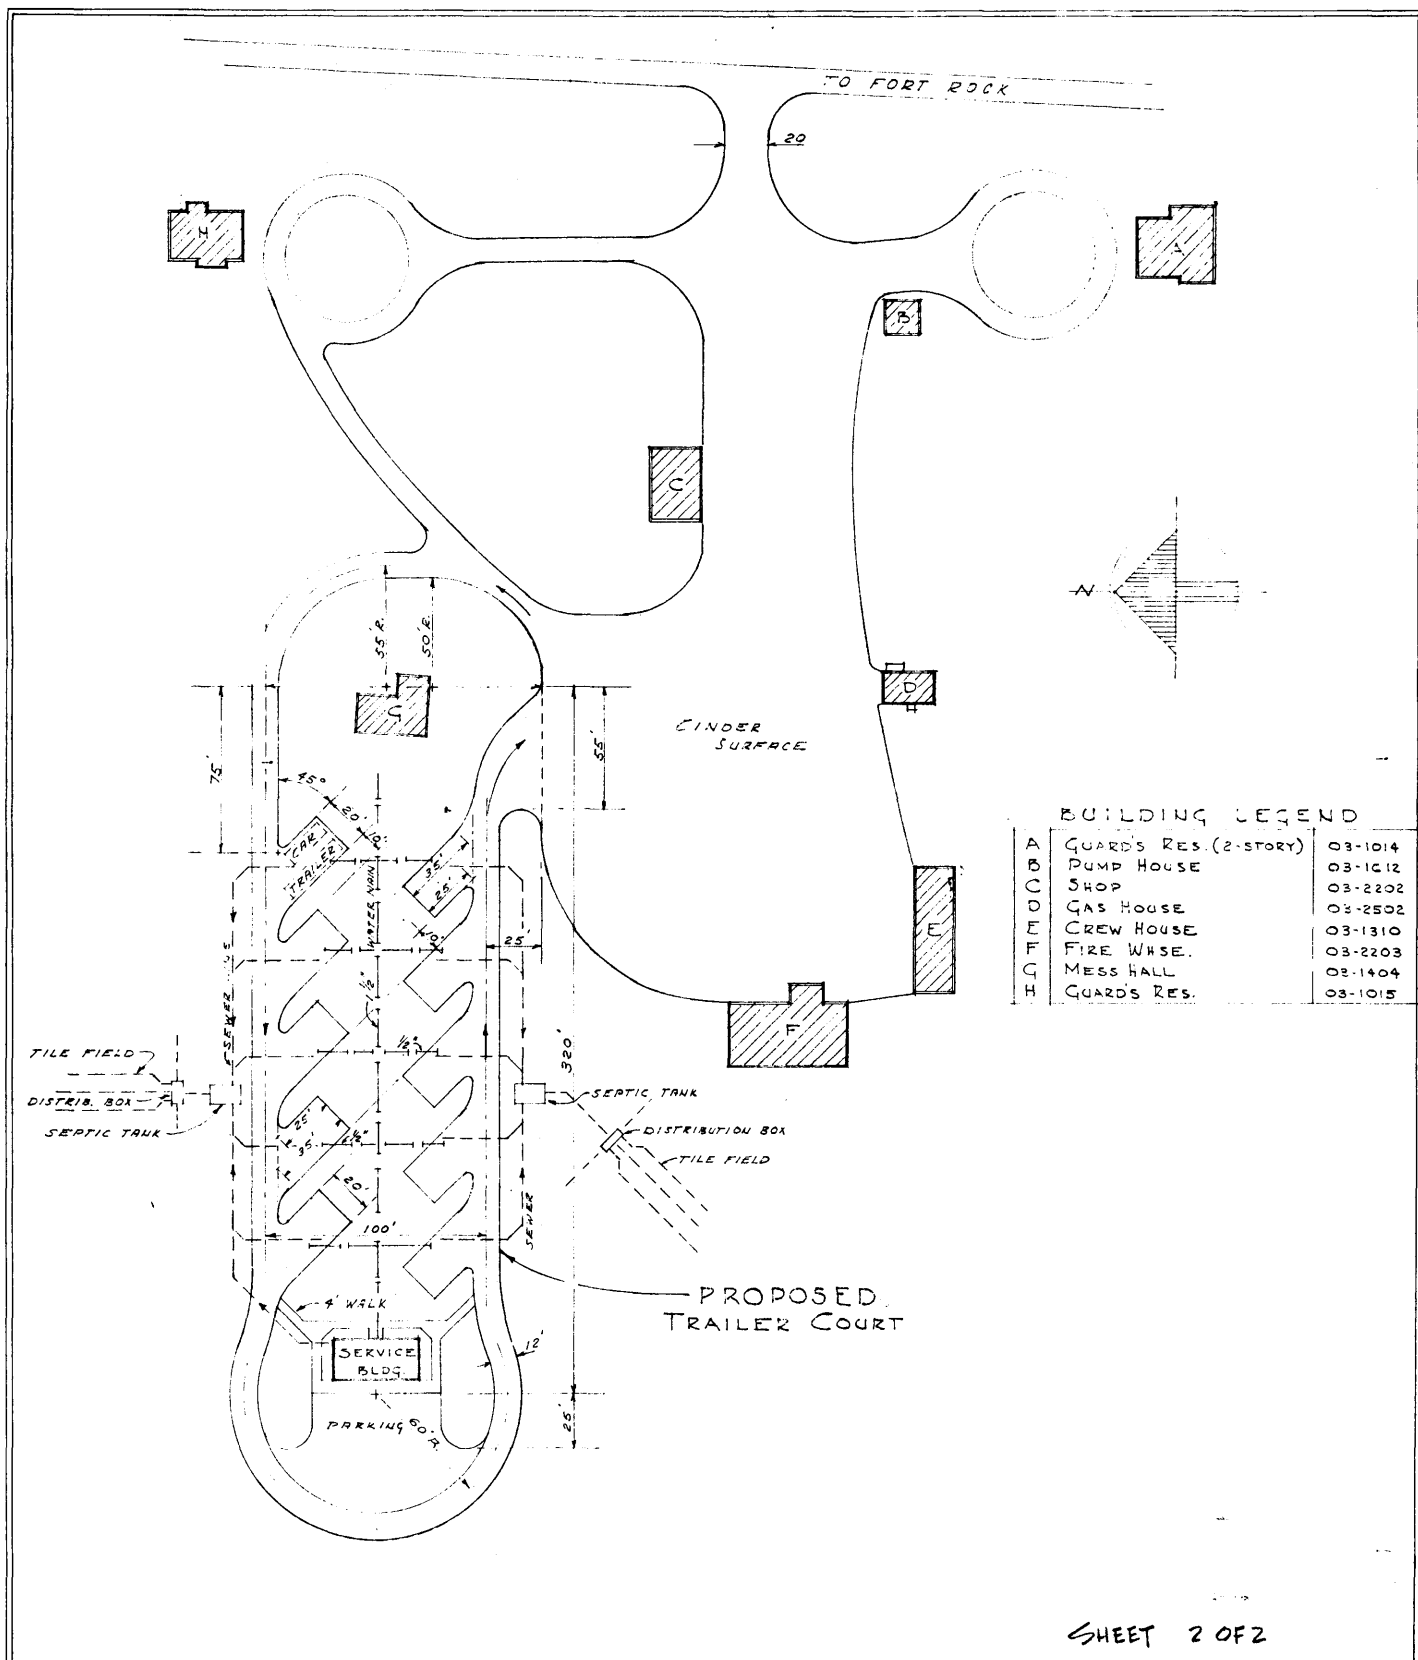
Cabin Lake Guard Station

A	GUARDS RES. (2-STORY)	03-1014
B	PUMP HOUSE	03-1012
C	SHOP	03-2202
O	CAS HOUSE	03-2502
F	CREW HOUSE	03-1310
F	FIRE WHSE.	03-2203
C	MESS HALL	03-1404
H	GUARDS RES.	03-1015

SITE PLAN
 PROPOSED TRAILER COURT
 CABIN LAKE GUARD STATION
 SEC. 17, T. 24 S. R. 14 E., W.M.
 SCALE - 1" = 40'

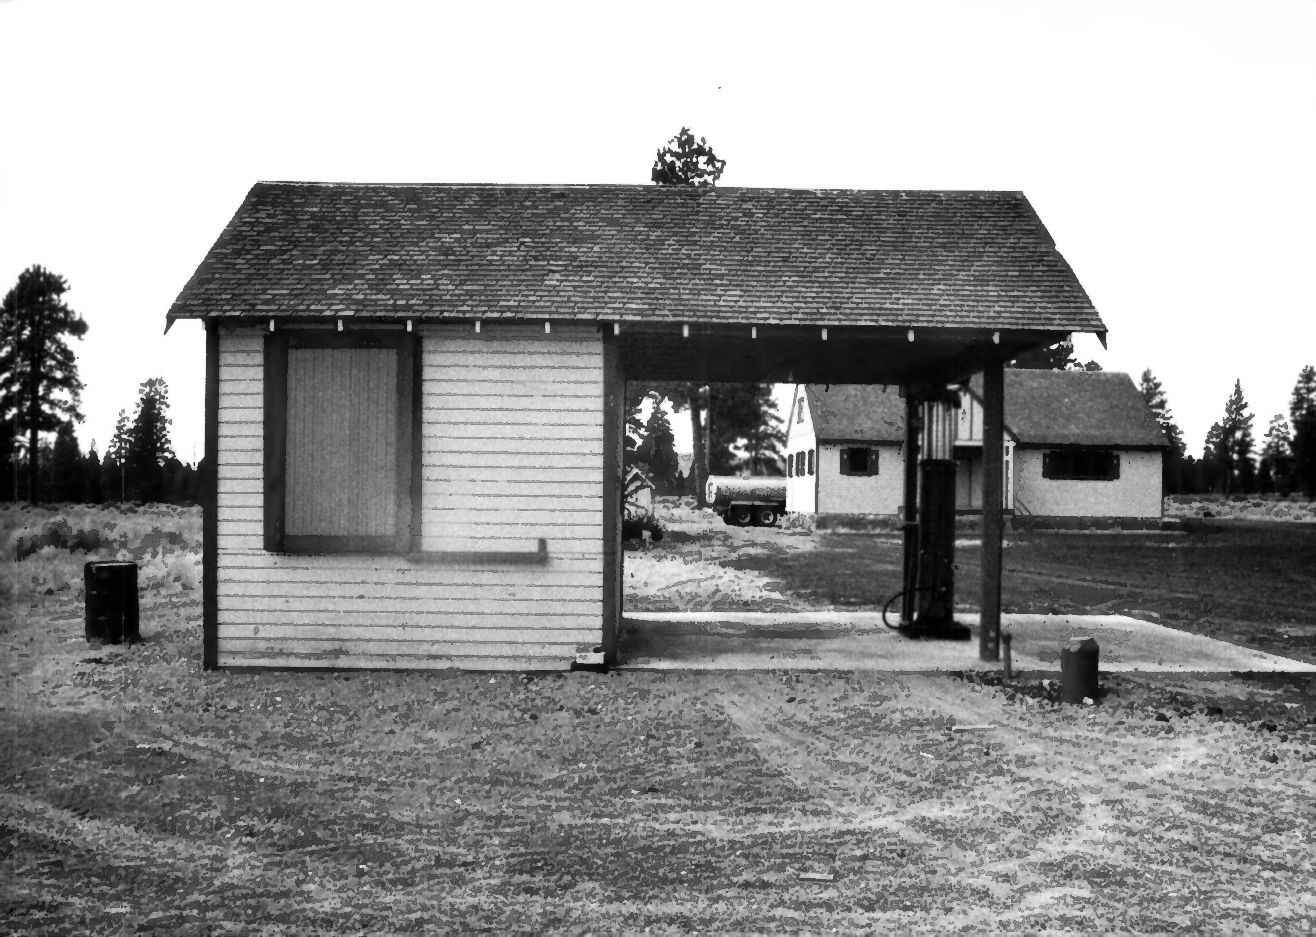
- 1) Name of Property: Cabin Lake Guard Station--
Gas House #2502
- 2) City and State: Vicinity of Bend, OR
- 3) Photographer: Carl M. Davis
- 4) Date: August 1984
- 5) Negative Location: USDA Forest Service, Regional Office, Recreation Unit, CRM files.
- 6) Description: Looking west at east (left) elevation
- 7) Photograph Number: 01-03-2502

Cabin Lake Guard Station, Gas House #2502: 1934; Rectangular, 1 story, wood frame, poured concrete foundation, wood-shingled medium gable roof, roof extending beyond anterior wall of structure to form cover for service area, gas pump, supported by two 4x4 posts. Narrow shiplap, horizontally placed, all exterior walls, gable pediment, end boards. Six-light casement window, vertical placement, center, gable pediment. Single-leaf slide-opening door, off-set on west elevation. No decoration. No obvious structural or material alterations to exterior.

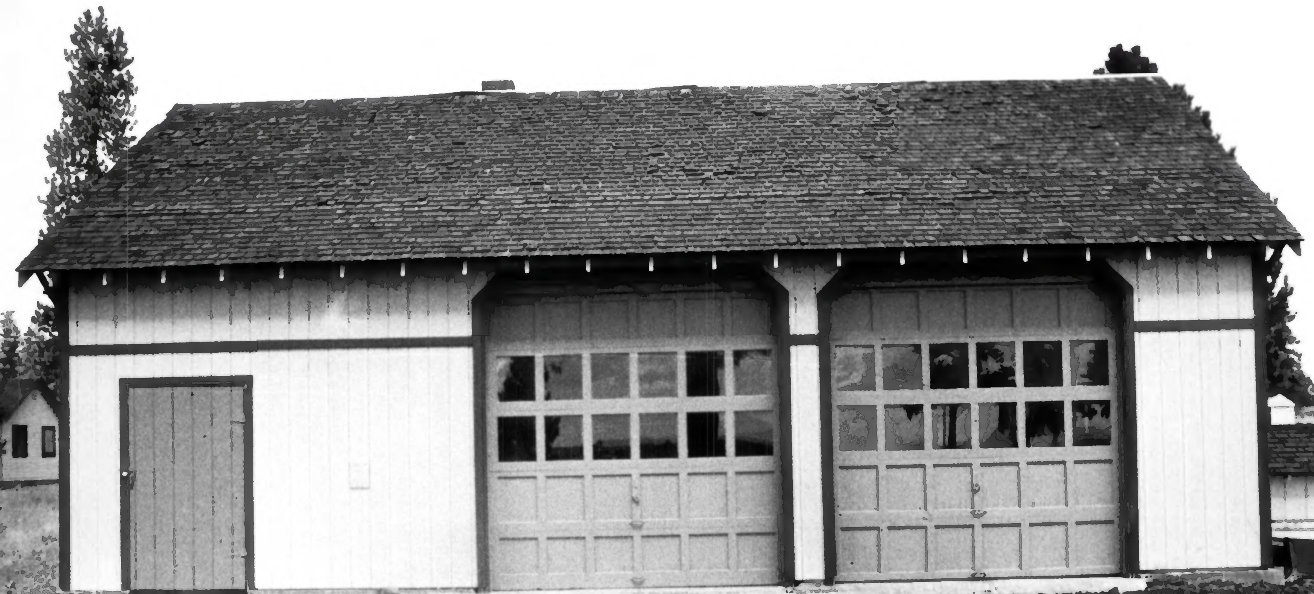
- 1) Name of Property: Cabin Lake Guard Station -
Automotive Shop #2202
- 2) City and State: Vicinity of Bend, OR
- 3) Photographer: Carl M. Davis
- 4) Date: August 1984
- 5) Negative Location: USDA Forest Service, Regional Office, Recreation Unit, CRM files.
- 6) Description: Looking north, at main south-facing elevation
- 7) Photograph Number: #01-03-2202

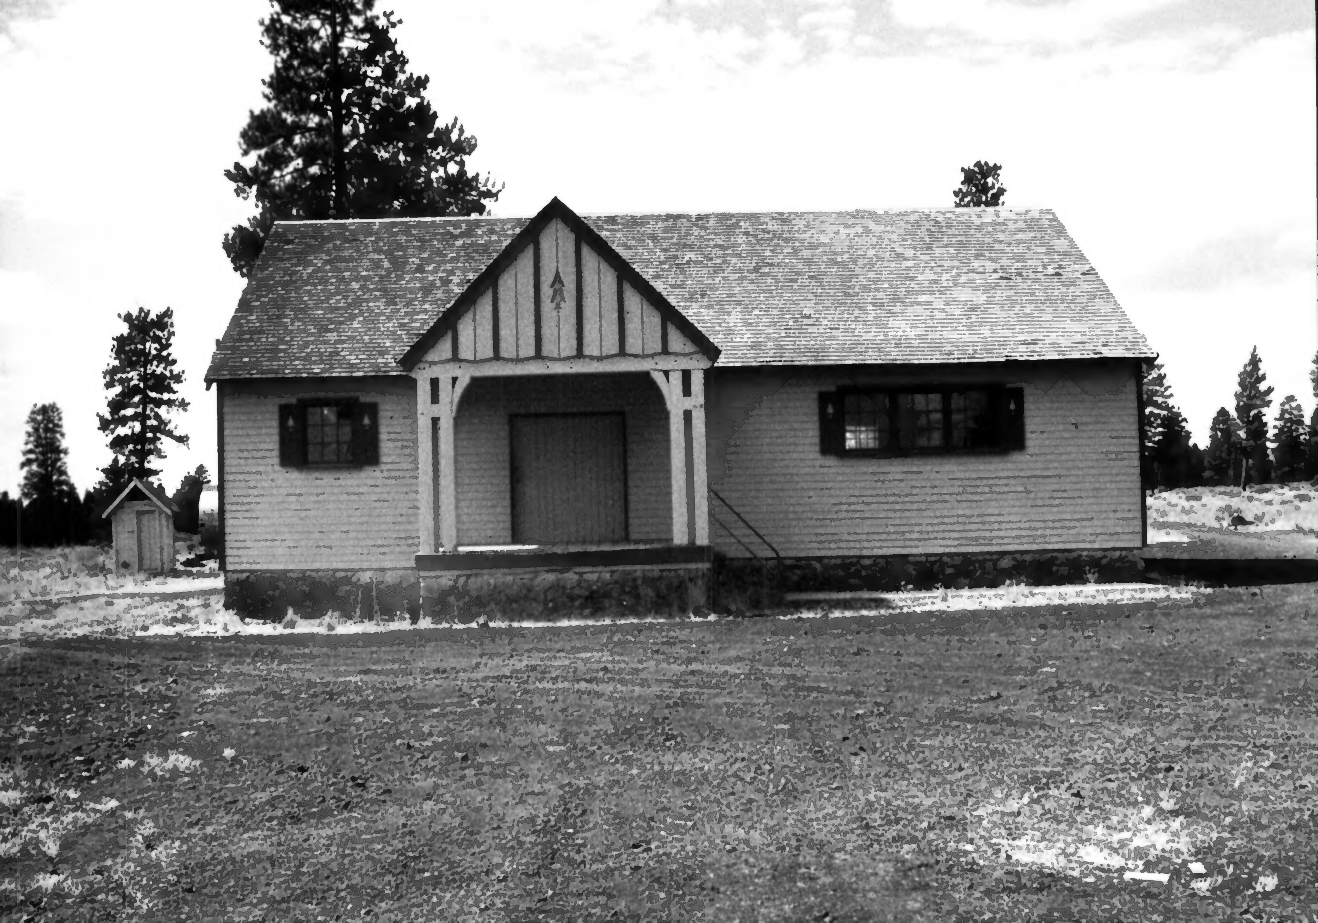
- 1) Name of Property: Cabin Lake Guard Station--
Fire Warehouse #2203
- 2) City and State: Fort Rock, Oregon
- 3) Photographer: Carl M. Davis
- 4) Date: August 1984
- 5) Negative Location: USDA Forest Service, Regional Office, Recreation Unit, CRM files.
- 6) Description: Looking west, at main east-facing facade
- 7) Photograph Number: 01-03-2203

Cabin Lake Guard Station, Fire Warehouse #2203: 1938; Rectangular, 1 story, wood frame, poured concrete foundation with uncoursed rubble veneer, wood-shingled medium gable roof, center porch gable on main facade. Narrow, rounded shiplap exterior, end boards, vertical boards, angular cut, plain battens every other board on gable ends and porch gable pediment. Four-light casement windows, singly and in combination with mullions, each window flanked by narrow vertical board shutters. Main entry, a vertical board slide-opening door, centered beneath gabled porch roof; roof is supported by heavy squared-timber posts reinforced with short, curving inset brackets. Stone veneered open porch platform, accessed by straight side steps, serves as loading dock. A single well-formed tree symbol is centered on the porch pediment; a single simpler formulation of the tree symbol appears on each window shutter. No obvious structural or material alterations to exterior.

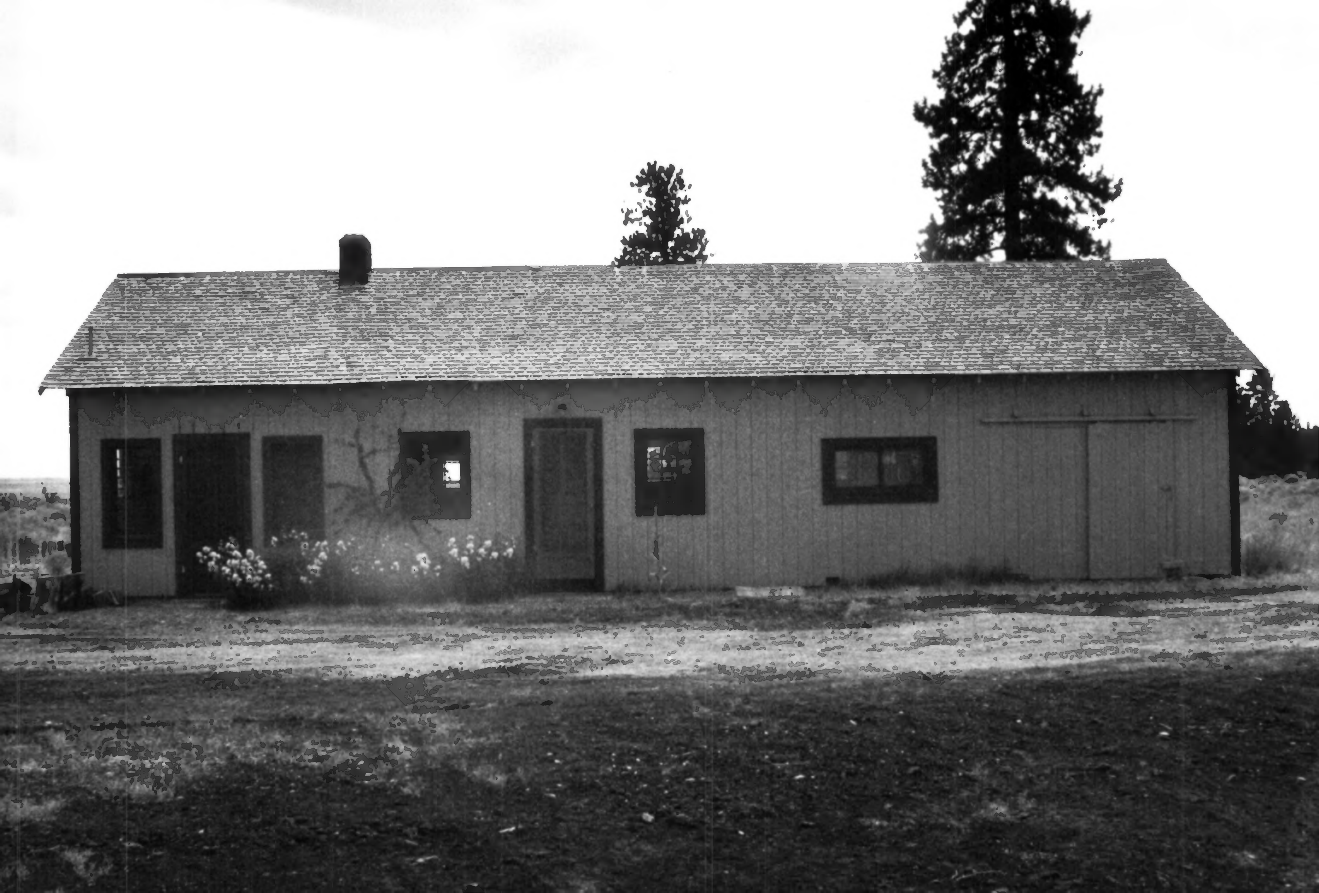
- 1) Name of Property: Cabin Lake Guard Station--
Bunk House #1310
- 2) City and State: Vicinity of Bend, OR
- 3) Photographer: Carl M. Davis
- 4) Date: August 1984
- 5) Negative Location: USDA Forest Service, Regional Office, Recreation Unit, CRM files.
- 6) Description: Looking south at main elevation of bunkhouse
- 7) Photograph Number: 01-03-1310

Cabin Lake Guard Station, Bunkhouse #1310: 1923; Rectangular, 1 story, wood frame, poured concrete foundation, wood-shingled medium gable roof, brick interior chimney straddles ridgeline, off center. Vertical board siding, all exterior walls. Eight-and-nine light casement windows. Two uncovered wood-panel doors, each with window in upper panel, one horizontal slide-opening door, interspersed on main facade. No decoration. No obvious structural alterations; exterior wall materials have appearance of modern channel-grooved siding, which would indicate replacment of original exterior fabric.

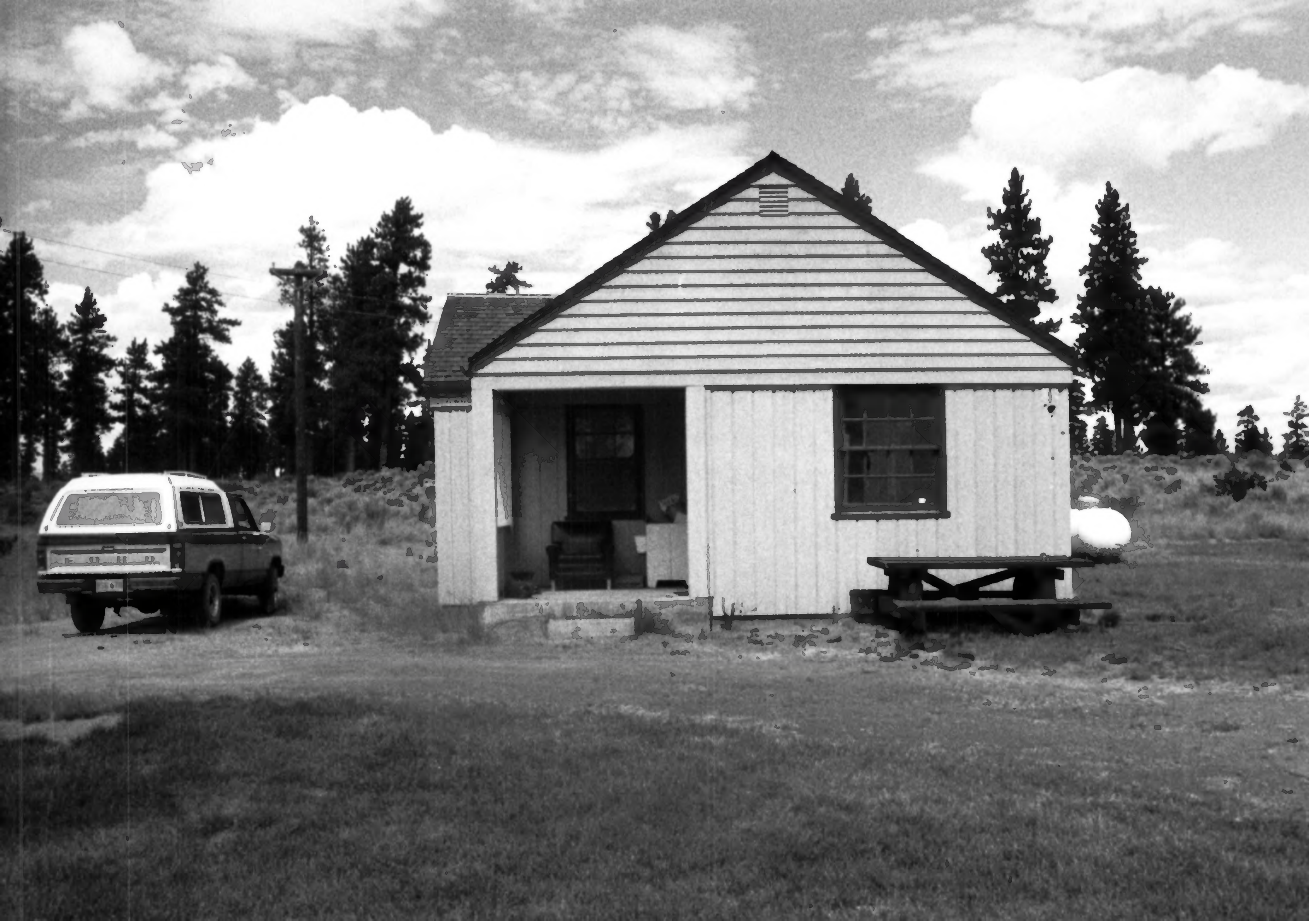
- 1) Name of Property: Cabin Lake Guard Station Guard Residence #1015-2
- 2) City and State: Vicinity of Bend, OR
- 3) Photographer: Carl M. Davis
- 4) Date: August 1984
- 5) Negative Location: USDA Forest Service, Regional Office, Recreation Unit, CRM files.
- 6) Description: Looking east, at west elevation of guard's residence
- 7) Photograph Number: 01-03-1015-2

Cabin Lake Guard Station, Residence #1015: 1938; T-shaped 1 story, wood frame, poured concrete foundation, wood-shingled medium gable roof, projecting center gable, east facade, projecting bay, off center, west elevation, interior chimney, center, rear slope of roof. Vertical board siding to eaves, horizontal clapboard on gable ends. Eight over eight double-hung sash windows. Main entry, two-panel wood door with nine-light window, off center on east facade, recessed, sweep of roof, supported by two 8x8 posts, provides cover for porch, partially enclosed on one side by low vertical board railing, accessed by two straight cement side steps. No decoration. No obvious structural alterations to exterior.

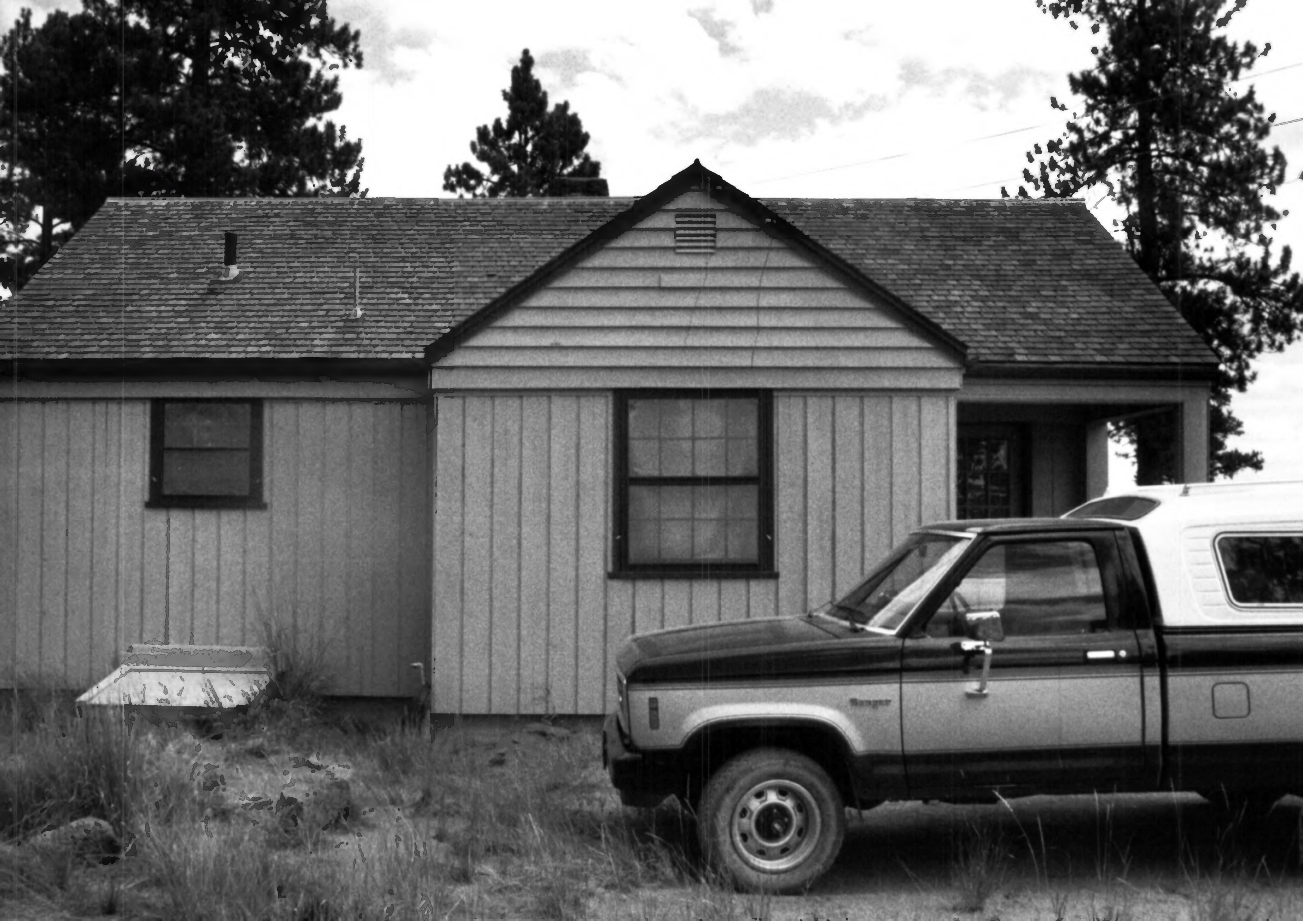
- 1) Name of Property: Cabin Lake Guard Station--
Residence #1015
- 2) City and State: Bend, OR
- 3) Photographer: Carl M. Davis
- 4) Date: August 1984
- 5) Negative Location: USDA Forest Service, Regional Office, Recreation Unit, CRM files.
- 6) Description: Looking north, at south gable end, main entry
- 7) Photograph Number: 01-03-1015-1

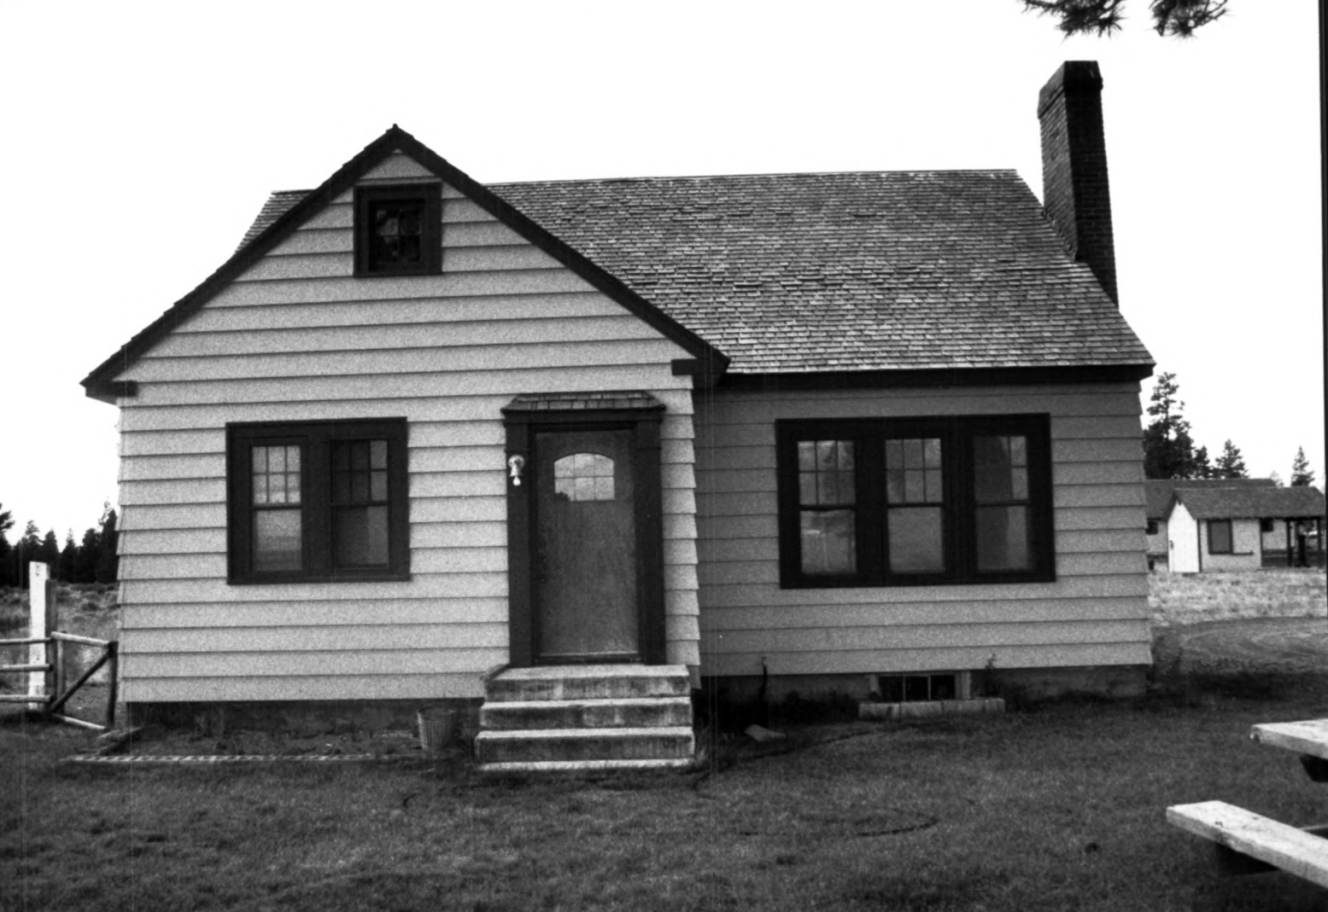
- 1) Name of Property: Cabin Lake Guard Station--
Residence #1014
- 2) City and State: Vicinity of Bend, OR
- 3) Photographer: Carl M. Davis
- 4) Date of Photograph: August 1984
- 5) Negative Location: USDA Forest Service, Regional Office, Recreation Unit, CRM files.
- 6) Description: Looking west, at main east-facing facade of Ranger's Residence
- 7) Photograph Number: 01-03-1014

Cabin Lake Guard Station, Rangers' Residence #1014: 1934; L-shaped, 1-1/2 story, wood frame, poured concrete foundation, wood shingle medium gable roof, projecting offset gable, west facade, brick exterior end chimney, inset patterns (horizontal diamond and angular hourglass shapes) in contrasting light-colored brick, off center on south gable end. Horizontal clapboard (1x12) exterior wall materials. Double-hung sash windows, singly and in combinations of two and three with mullions. Main entry, off center in offset gable end, west facade, shingled shed pent roof above wood panel door, accessed by three straight cement steps, open cement platform; side entry, slightly off center on south gable end, covered by gabled hood with semi-elliptical arch, straight wood brackets, accessed by two straight cement steps, open cement platform. No decoration. No obvious exterior alterations.

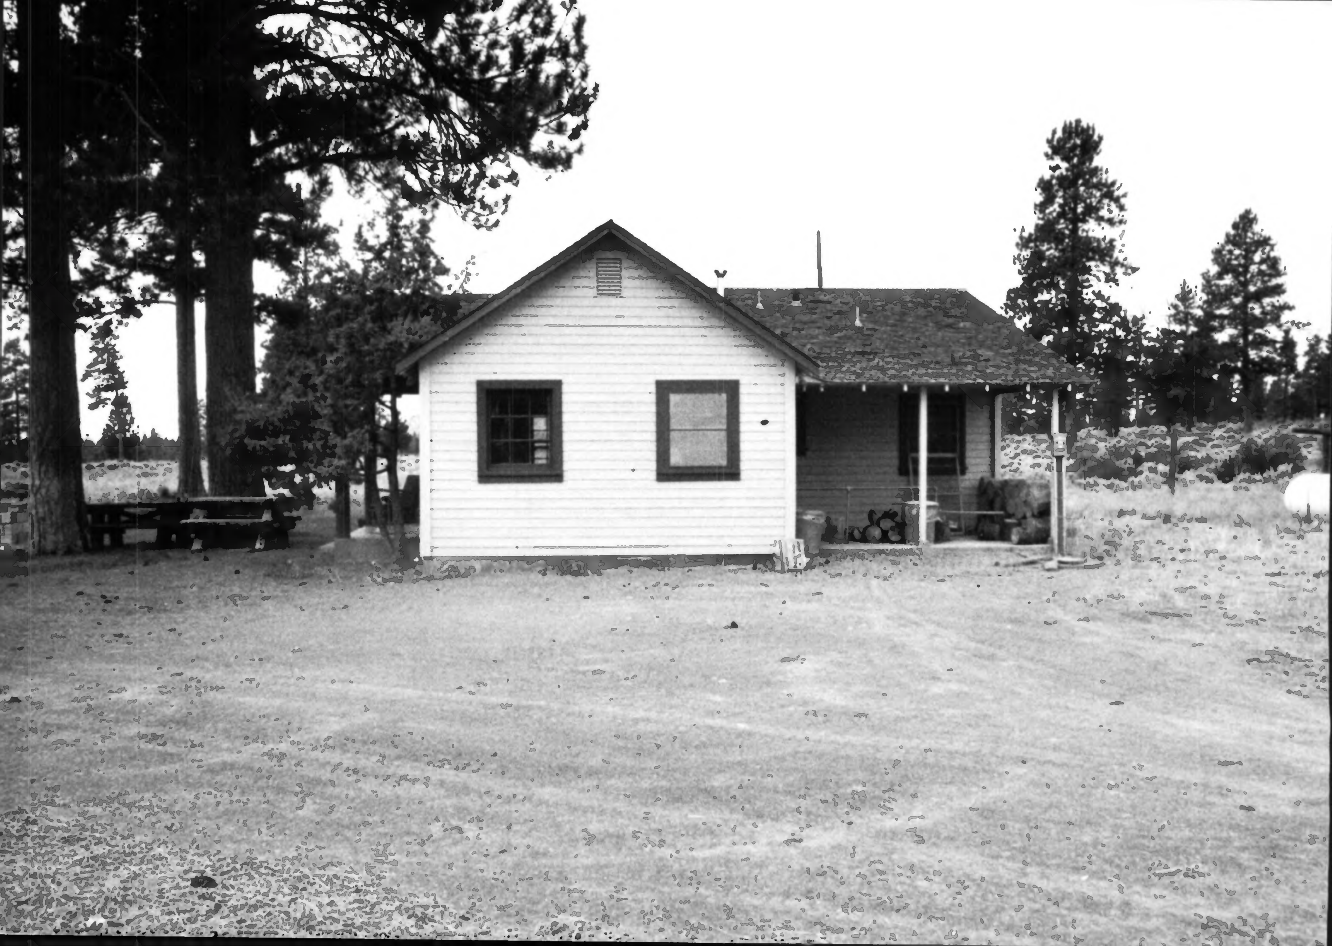
- 1) Name of Property: Cabin Lake Guard Station
Cookhouse #1404
- 2) City and State: Vicinity of Bend, OR
- 3) Photographer: Carl M. Davis
- 4) Date: August 1984
- 5) Negative Location: USDA Forest Service, Regional Office, Recreation Unit, CRM files.
- 6) Description: Looking west at east (right) elevation)
- 7) Photograph Number: 01-03-1404-2

Cabin Lake Guard Station, Cookhouse #1404: 1934; Rectangular, 1 story, wood frame, poured concrete foundation, wood-shingled medium gable roof, center porch gable, main facade, brick interior chimney, center, rear slope of roof. Narrow rounded shiplap exterior walls. Eight-over-eight double hung sash windows. Main entry, two-panel wood door with window in upper panel, center, north facade, covered by gabled porch roof, supported by two peeled-pole posts, accessed by open concrete platform. Porch gable pediment enclosed only by three peeled pole support members in spoke-like arrangement. No decoration. No obvious structural or material alteration to exterior.

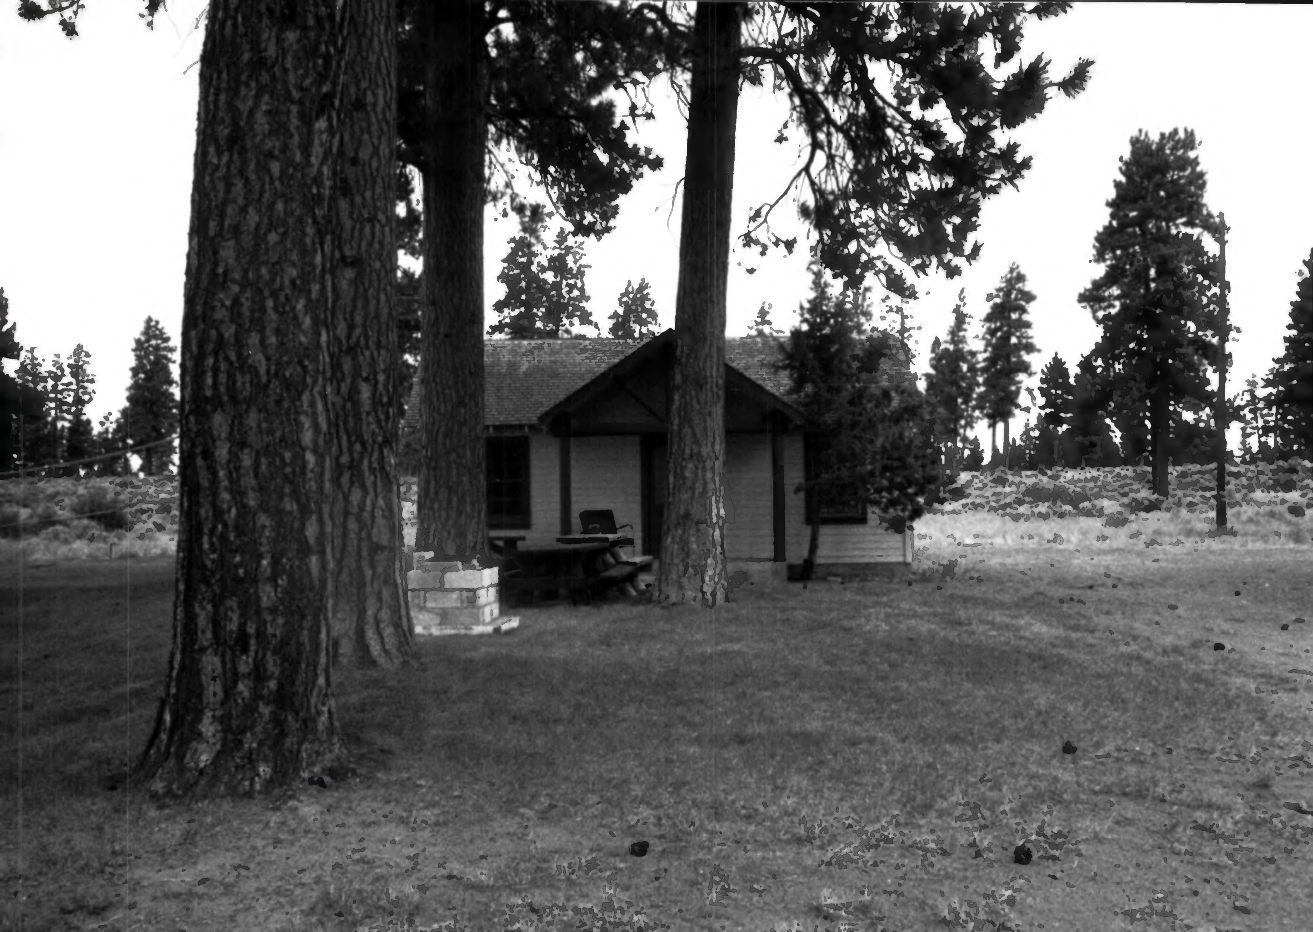
- 1) Name of Property: Cabin Lake Guard Station--
Cookhouse #1404
- 2) City and State: Fort Rock, Oregon
- 3) Photographer: Carl M. Davis
- 4) Date: August 1984
- 5) Negative Location: USDA Forest Service, Regional Office, Recreation Unit, CRM files.
- 6) Description: Looking north at main facade.
Building formerly Ranger Station office
- 7) Photograph Number: 01-03-1404

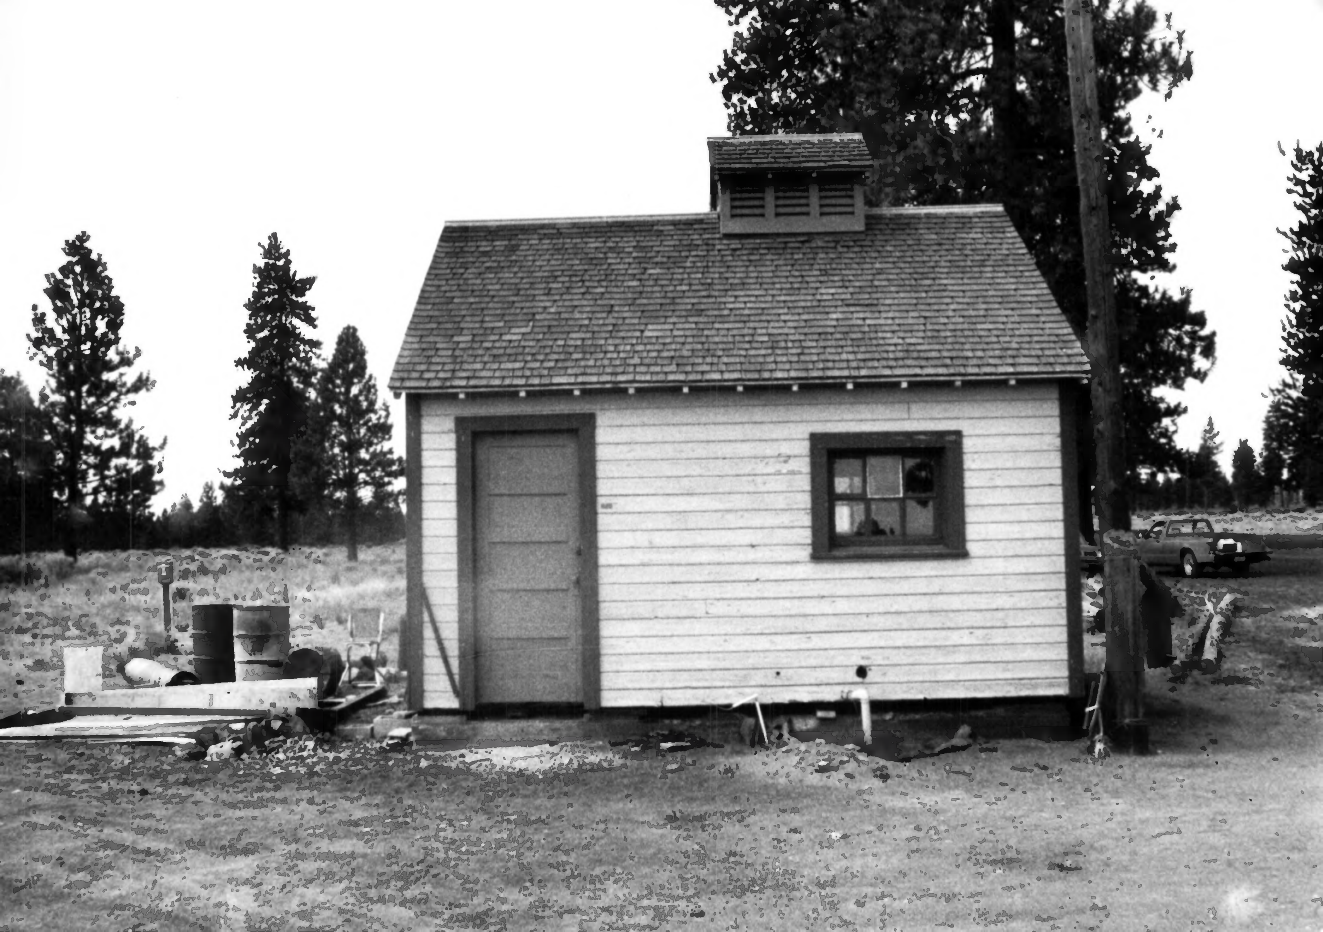
- 1) Name of Property: Cabin Lake Guard Station--
Generator House #1612
- 2) City and State: Vicinity of Bend, OR
- 3) Photographer: Carl M. Davis
- 4) Date: August 1984
- 5) Negative Location: USDA Forest Service, Regional Office, Recreation Unit, CRM files.
- 6) Description: Looking west, at east (right) elevation
- 7) Photograph Number: 01-03-1612

Cabin Lake Guard Station, Generator House #1612: 1923; Rectangular, 1 story, wood frame, poured concrete foundation, wood shingled medium gable roof with gabled cupola, louvered for ventilation, slightly off center astride ridgeline. Narrow rounded shiplap exterior to eaves, end boards, vertical board and batten on gable ends. Six-light casement windows. Single-leaf five-panel wood door off-center on west elevation, slide-opening door, center, north gable end. No decoration. No obvious structural or material alterations.
