**NATIONAL REGISTER OF HISTORIC PLACES  
INVENTORY -- NOMINATION FORM**

DEPRESSION-ERA BUILDINGS

NAME: Cascade Locks Work Center

LOCATION: Mt. Hood National Forest, Columbia Gorge Ranger District;  
Congressional District 2; Cascade Locks, Oregon (41); Hood River  
County (027)

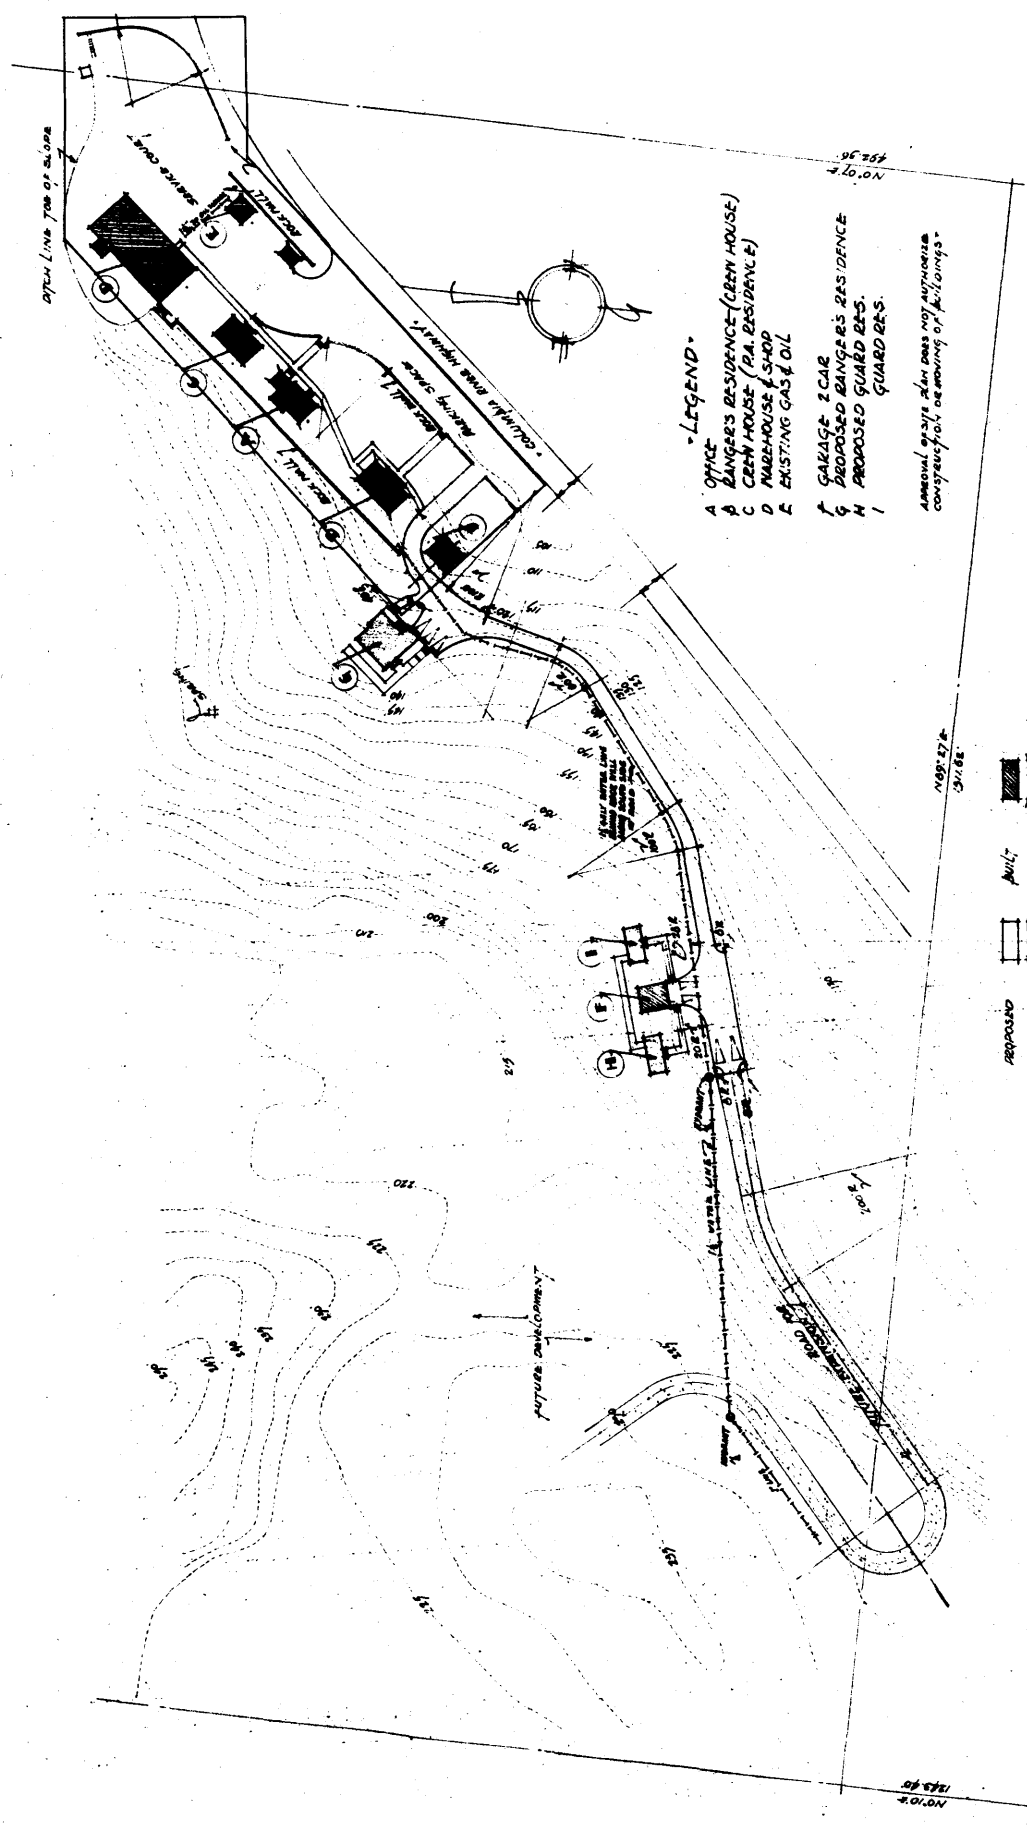
DATE PLAN  
 COLUMBIA GEORGE H. G.  
 SEC. 2, T. 17N., R. 6E.  
 SCALE 1/2" = 100'

- LEGEND**
- A OFFICE
  - B BANGOR'S RESIDENCE (CREW HOUSE)
  - C CREW HOUSE (RA. RESIDENCE)
  - D MARSH HOUSE & SHOP
  - E EXISTING GAS & OIL
  - F GARAGE & CAR
  - G PROPOSED BANGOR'S RESIDENCE
  - H PROPOSED GUARD BRS.
  - I

U.S. DEPARTMENT OF AGRICULTURE  
 FOREST SERVICE  
 MT. HOOD NATIONAL FOREST  
 NORTH PACIFIC REGION  
 (REV) JAN 20 1939

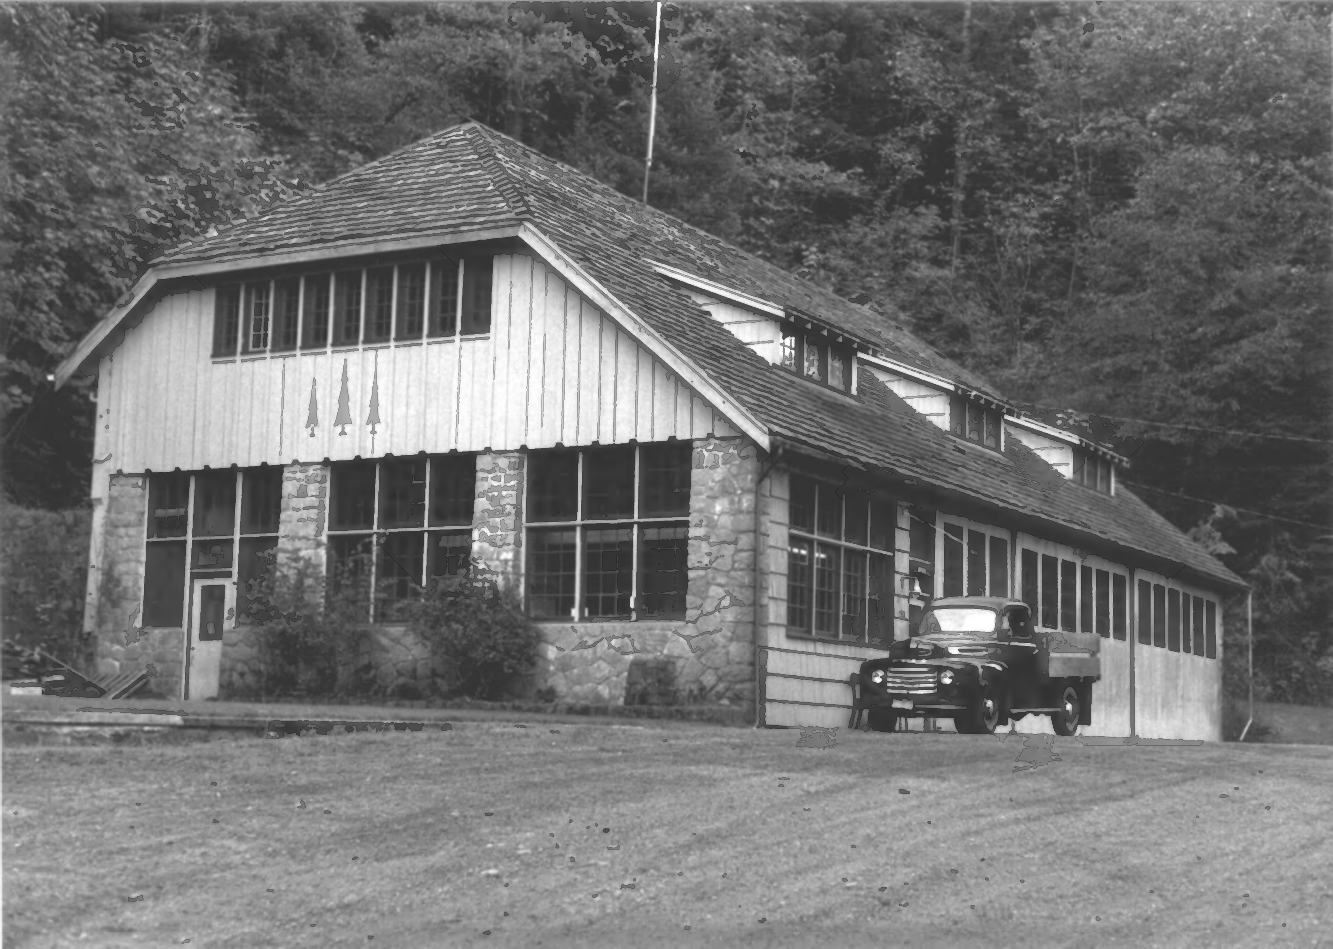
- 1) Name of Property: Cascade Locks (WC)--Warehouse
- 2) City and State: Cascade Locks, Oregon
- 3) Photographer: Susan Marvin
- 4) Date: 10/05/83
- 5) Negative Location: USDA Forest Service, Regional Office, Recreation Unit, CRM Files
- 6) Description: Looking southwest at left and main north-facing elevations
- 7) Photograph Number: 06-04-MHCGD-1

Columbia Gorge Work Center: Warehouse: 1936-38 Rectangular, 1 1/2 story, wood frame, poured concrete foundation, wood shingled medium hipped gable roof, eaves project, rafters exposed, three shed-roof dormers on north slope of roof. Six bays in length. Exterior walls on main facade and rear elevation, and dormer cheeks are wall shakes, ground level on east and west gable ends are broken-coursed rubble masonry, gable ends are vertical boards, battens every other board. Mullion windows, with two, three, and four divisions, single sash, of six, nine, and twelve lights on ground level; mullion windows with nine divisions of eight lights in vertical arrangements on each gable end. Single leaf two-panel doors with window panels are located to the right of the easterly most bay on the main facade, and offset to the left on the east gable end: five horizontal slide-opening vertical board vehicle doors, each with three 12-light windows, enclose the remaining five bays on the north (main) facade. Three well-shaped tree-logo cutouts in horizontal arrangement, are centered on each gable end. No apparent structural additions or alterations; no obvious material modifications.

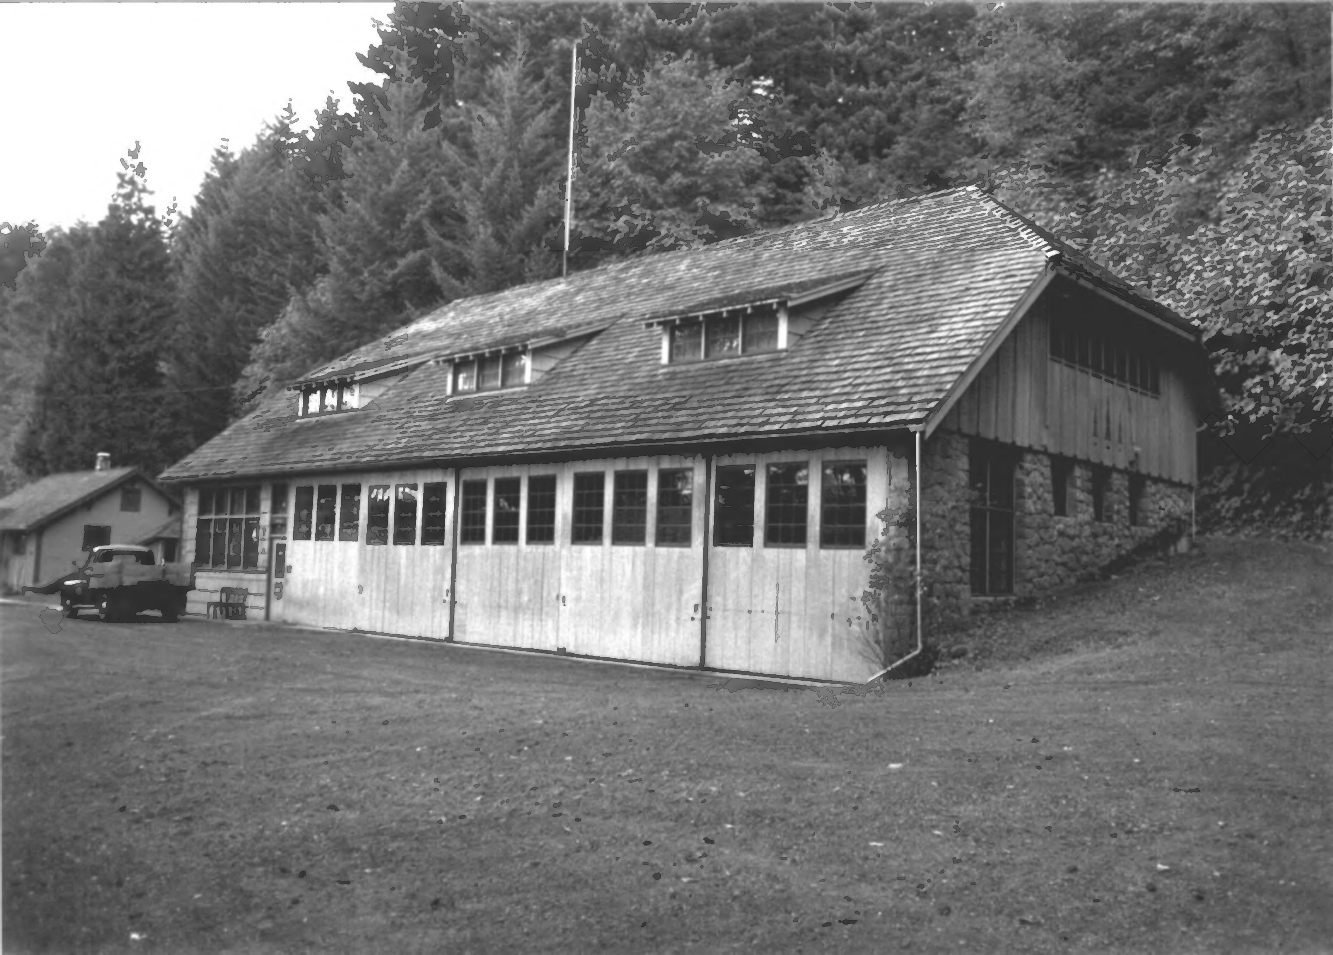
- 1) Name of Property: Cascade Locks (WC)--Warehouse
- 2) City and State: Cascade Locks, Oregon
- 3) Photographer: Susan Marvin
- 4) Date: 10/05/83
- 5) Negative Location: USDA Forest Service, Regional Office, Recreation Unit, CRM Files
- 6) Description: Looking east at main north-facing and right elevations
- 7) Photograph Number: 06-04-MHCGD-2

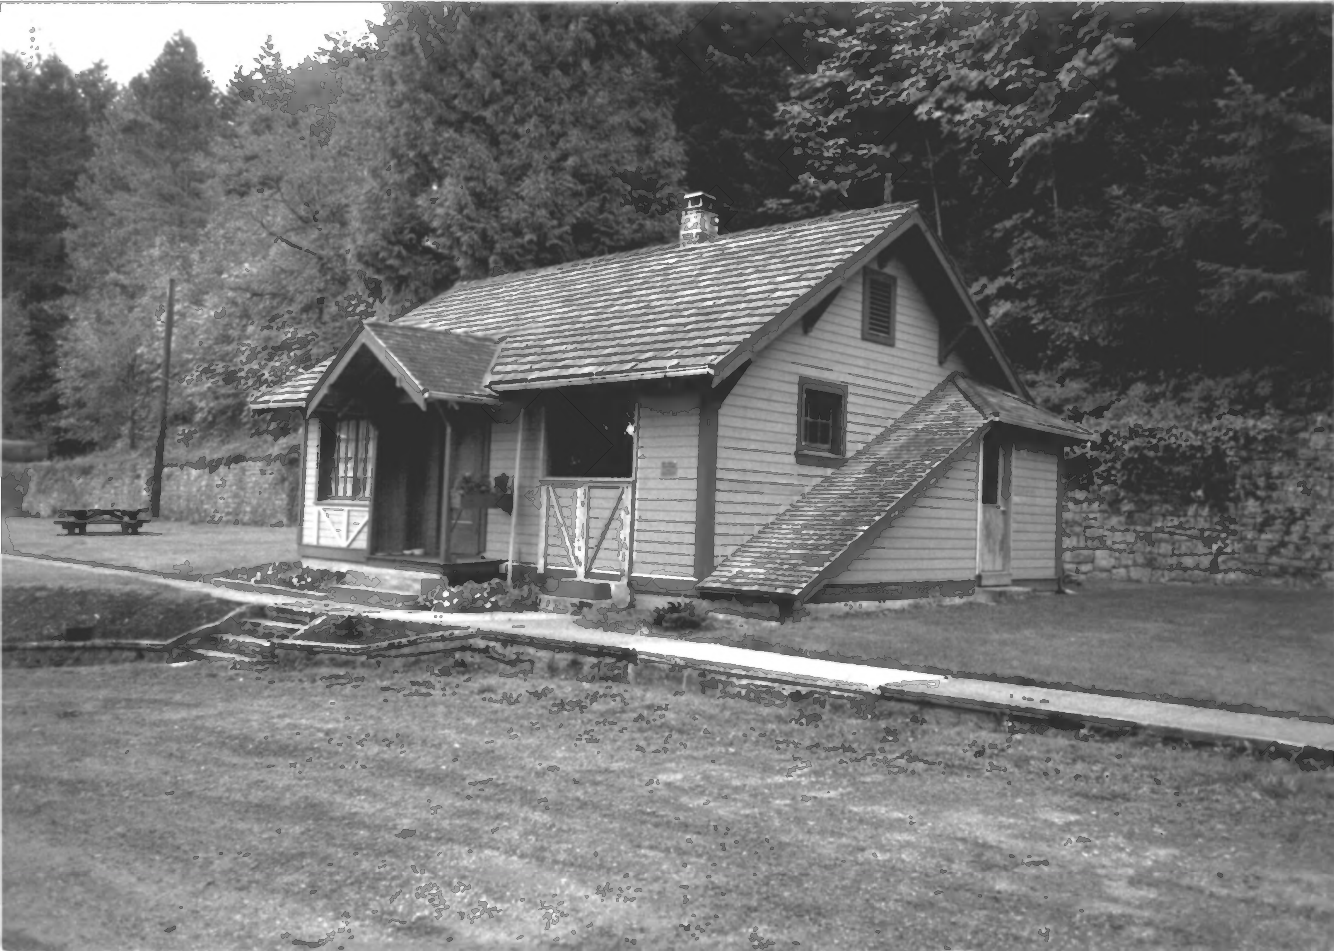
- 1) Name of Property: Cascade Locks (WC)--Protective Assistant's Residence
- 2) City and State: Cascade Locks, Oregon
- 3) Photographer: Susan Marvin
- 4) Date: 10/05/83
- 5) Negative Location: USDA Forest Service, Regional Office, Recreation Unit, CRM Files
- 6) Description: Looking east at main and right elevations.
- 7) Photograph Number: 06-04-MHCGC

Prevention Assistant's Residence: Rectangular, 1 1/2 story, wood frame, poured concrete foundation, split shake medium gable roof, eaves project, rafters exposed, verges project, fascia alone, supported by plain brackets, stretcher bond brick interior chimney, center of ridgeline, center gable porch on north (main) facade. Exterior walls are flush siding with end boards. Windows are

twenty-four light single sash on the main facade, and six light sash on gable ends and rear. Main entry is a single-leaf door, accessed by two straight steps and an open plank platform, at the center of the main facade. A hip roofed structural addition, clad with similar flush siding, abuts the west gable end. The large multi-light window to the right of the main door has been replaced with a single pane sash of smaller dimension. No decoration.

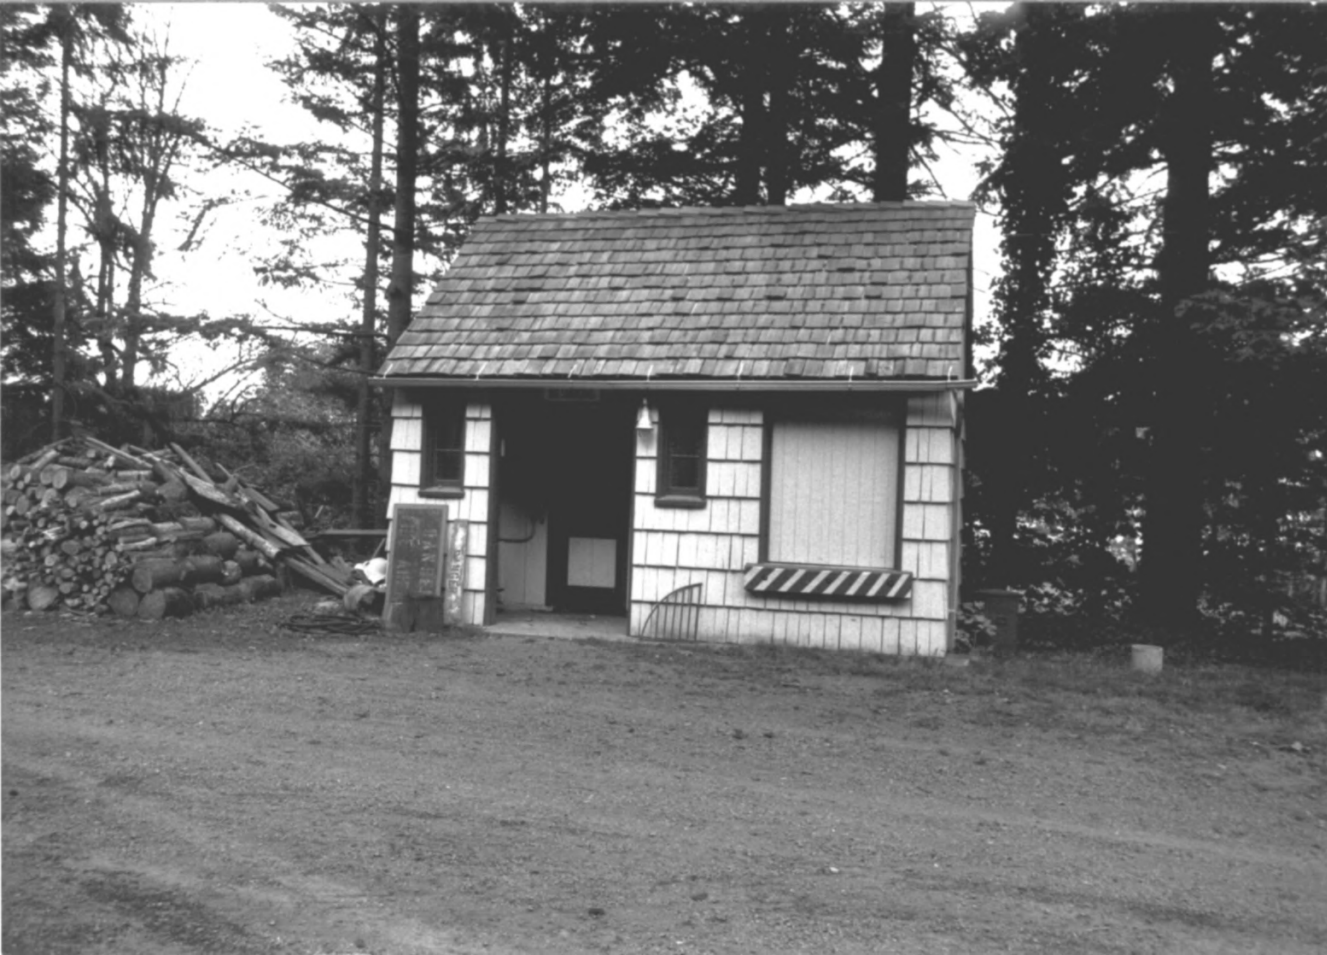
- 1) Name of Property: Cascade Locks (WC)--Gas and Oil House
- 2) City and State: Cascade Locks, Oregon
- 3) Photographer: Susan Marvin
- 4) Date: 10/05/83
- 5) Negative Location: USDA Forest Service, Regional Office, Recreation Unit, CRM Files
- 6) Description: Looking northwest at main elevation.
- 7) Photograph Number: 06-04-MHCGE

Gas House: Rectangular, 1 story, wood frame, poured concrete foundation, wood shingled medium gable roof. Exterior walls are covered with wood shingles. Windows are single sash with three lights in vertical placement. Main entry is slightly off-set to left on south (main) facade. Single leaf two-panel door with 12-light window is recessed in anterior wall: enclosure also protects gas pump. A horizontal slide opening vertical board door, centered in wall, is off-set to the right on the main facade: opening is elevated to facilitate loading. No apparent structural addition or alteration; no obvious material modification. No decoration.
