National Register of Historic Places Registration Form

Arminius Hotel

Morrison Hotel

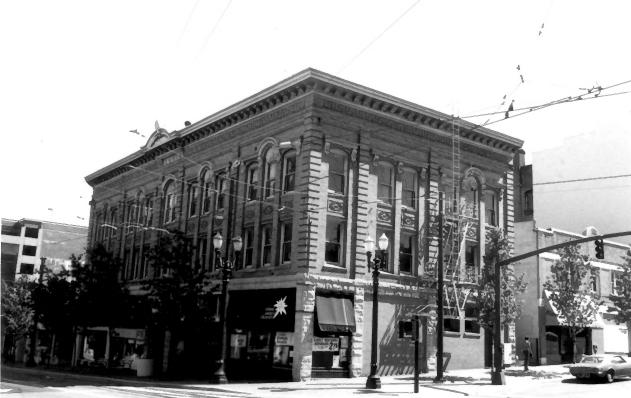
1 of **8** Looking east across Eleventh Street.

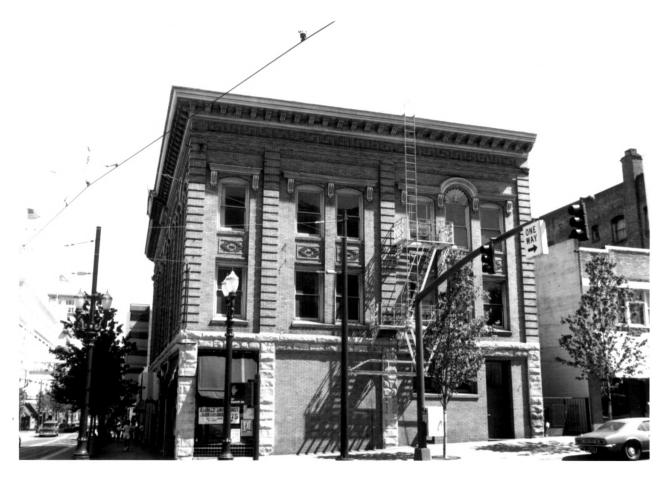
2 of 28 West elevation (side).

The west side of the Morrison Hotel is the second major street elevation which faces Eleventh Avenue. Directly across Eleventh Avenue is the Light Rail Transit terminus. The west facade is divided into three bays of one, two and three, one-over-one wood sash windows each. The classical entablature on the north facade is continued on the west facade.

The two bays (north and center) of third-story windows are topped by cast stone label moldings and consoles, and have segmental arched brick openings and wood sash. The three windows in the southernmost bay are decorated identical to the third floor window bays on the north facade. Brick pilasters separate each of the three bays on the two upper floors. Lozenge patterns of burnt brick are located in the spandrel panels between the first and second story windows. The exterior of the upper two stories on the west facade are unaltered in appearance, and are in excellent condition.

The ground floor of the west facade is defined by a belt course and four piers of rock-faced ashlar, and is largely intact. An awning covers the transom windows of the northwest bay, which has a large storefront window below, and black and yellow

ceramic tile bulkheads. The center bay on the first floor is filled in with brick, as per the original sketch. The third bay is brick pierced with two small, deep-set single pane windows and a door opening on the southernmost corner. The placement of the windows and door appear to be original according to the original sketch of the building. A decorative wrought-iron fire escape, painted buff to match the window trim, is situated on the west facade.

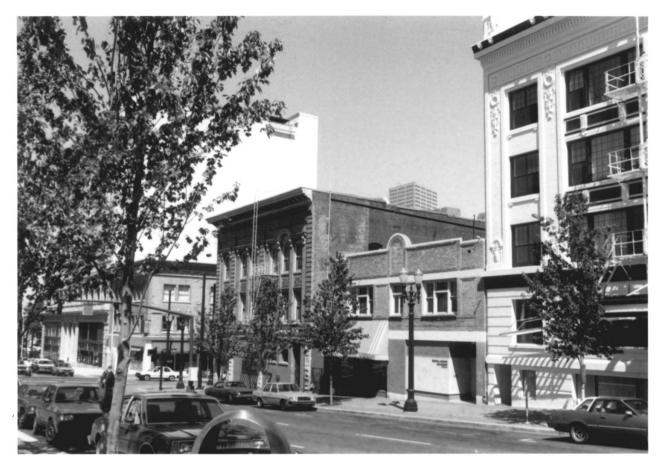
$3 ext{ of } 28^\circ$ West and south elevations.

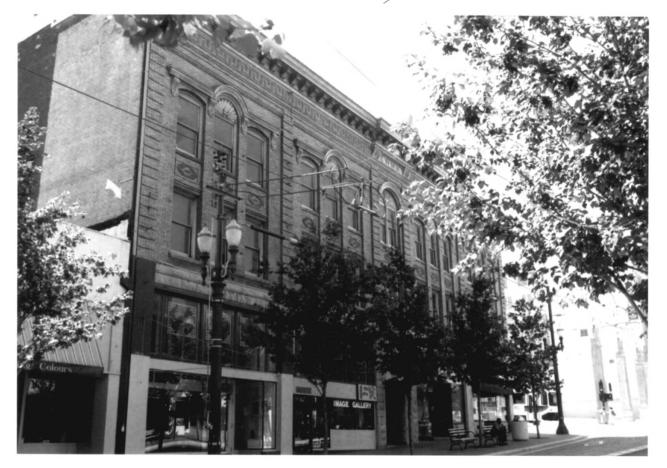
4 of 8 North and east elevations.

The primary facade faces north and is divided into 5 bays. A deep entablature caps the building on the north and west facades, which is comprised of classical elements such as scrolled cast stone brackets and a frieze of burnt brick fretwork. The cornice in the central bay is topped by a cast stone carved pediment and antefix. Directly below the cornice within the frieze panel are the cast stone letters "A.D.U.G." (translated Allegemeine Deutsche Unterstuetungs Gesellschaft; or General German Aid Society). The paired one-over-one third story wood windows in the central bay are topped by an arched cast stone label supported by scrolled consoles. Below the label is a panel containing a medallion bearing the date "1904."

The east facade of the building is brick painted brown and silver. The roof line on this facade is topped by a plain metal cap. There are no door or window openings on this facade. The one-story stucco building directly east of the Morrison Hotel shares a party wall with the hotel.

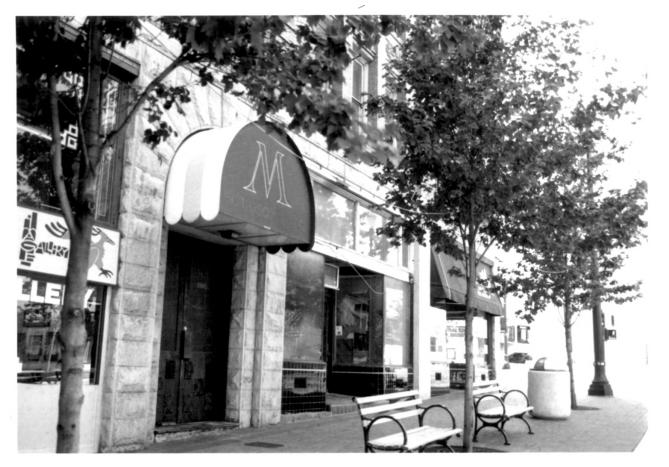
5 of 8 Main entrance on north elevation.

The ground floor was altered in 1929 by the removal of the original storefronts, which were replaced by four newer storefronts, and a set of wooden double doors in the central entrance. A hooded awning of green canvas conceals the original beveled glass fan light over this central entrance. This window was probably designed by the Povey Brothers of Portland, Oregon, as a copy of their advertisement appears in the specifications for the building. The wooden storefront located at the corner of 11th and Morrison Streets has a recessed central entry flanked by single fixed windows. Transom windows are covered by a green canvas awning. The recessed entrance contains a glass door with a wood frame, and a tile threshold. The bulkheads are made up of black and yellow ceramic tile. The next storefront to the east has a central recessed entry, exposed transom windows which appear to have been altered, and a brick threshold. Two wooden, double doors open into the storefront. Bulkheads are yellow and black tile.

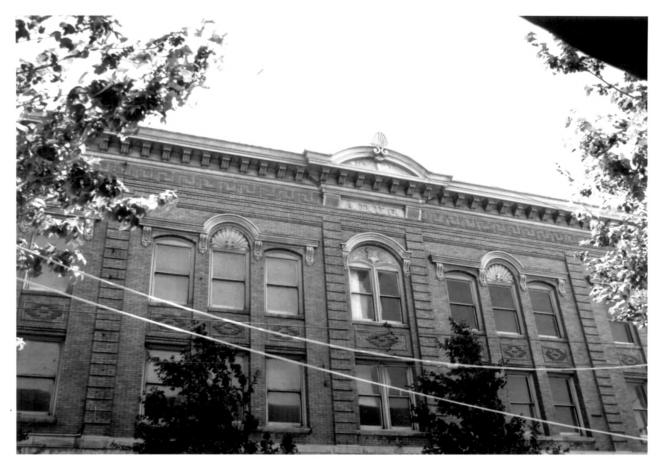
6 of ∴8 West elevation, upper two stories.

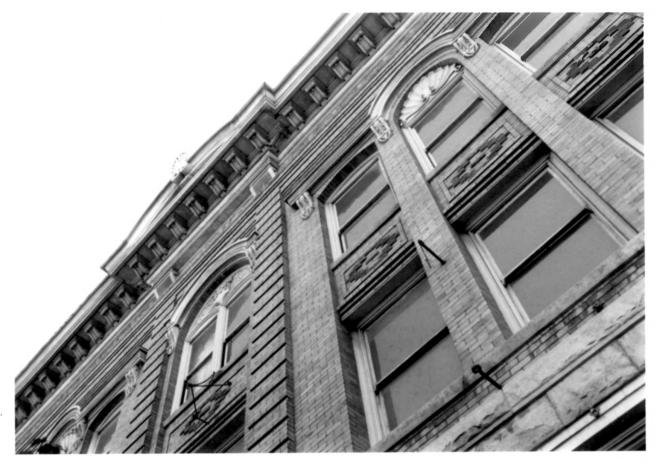
7 of 28 West elevation detail of entablature.

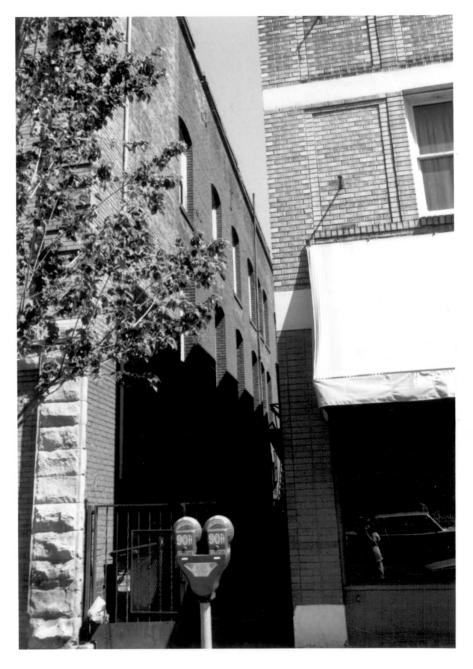
8 of 28 South elevation.

The south facade (rear) faces onto an alleyway. This facade is comprised of a dark red brick which has been painted black at the base and bears the remains of painted signage on the upper stories. Six evenly spaced brick window openings are located on each of the two upper stories. The windows are one-over-one, double-hung wood sash. Two of the first story openings and three arched, brick door openings have been filled in with stucco. A central door opening, partially filled in, is still in use. An iron staircase leads to a door on the second floor.
