National Register of Historic Places
Registration Form

historic name Mohle, Wilhelmina, House
other names/site number N/A

street & number 734 S.E. 34th not for publication
city, town Portland vicinity
state Oregon code OR county Multnomah code 051 zip code 97214

Name of related multiple property listing:
Historic and Architectural Resources of Eastside Portland

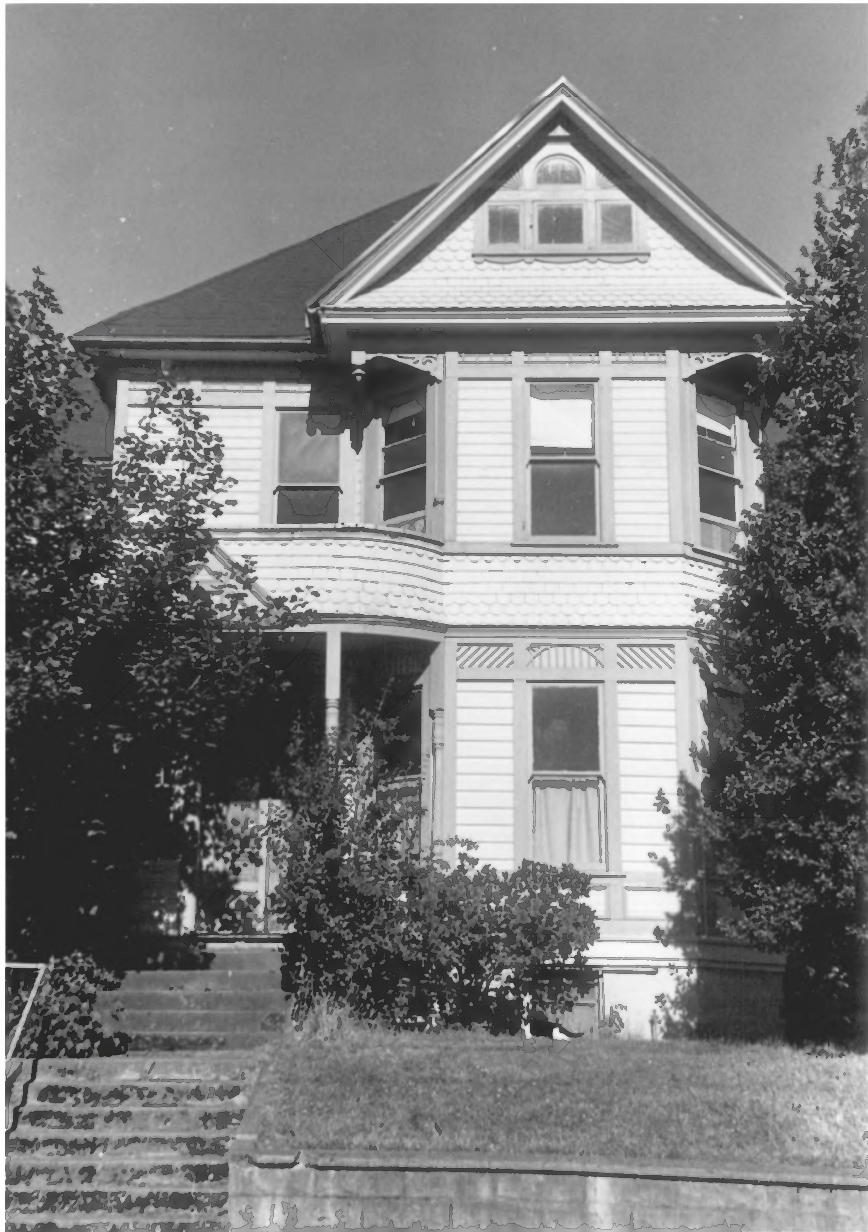
- 1 734 S.E. 34th MOHLER, WILHELMINA, HOUSE
- 2 Portland, Oregon, Multnomah County
- 3 Smith, Patrick
- 4 August 1988
- 5 Roll S-24 # 6
- 6 Looking east at west elevation
- 7 # 1 OF 4

This corner lot is surrounded by a concrete retaining wall three-feet high and has no original outbuildings associated with it. Asymmetrical in plan, this two-and-one-half story house is built on a brick foundation with a full basement. The roof line, presently of composition shingles, has many sections to it. Primarily a hip roof, three cross intersecting gables project out over two-story polygonal window bays which have bracketed hoods of jigsawn tracery and pendants ornamenting them. A partial wrap-around front porch on the northwestern corner has a flat roof which is lined by an enclosed, shingled balustrade. Another attached porch to the rear of the northeastern corner has a shed roof supported by slender turned columns. Two chimneys rise from the roof; one in the center of the structure, the other at the eastern end. One shed dormer projects from the eastern hipped end.

The exterior is covered with a variety of siding types which give a multi-textured appearance to the structure. At the bottom of the first floor, below the windows, are recessed panels of wide, tongue-and-groove. The first floor and ground floor siding is bevel-channelled shiplap. At the top of the first floor is a fascia board of recessed panels with a diagonal raised pattern and semi-circle patterns over the window openings.

The semi-circle patterns are bordered by sunburst-like spandrels. A two-foot wide band of imbricated shingles separates the first floor from the second. Employed in this shingled course are hexagonal, rectangular and fishscale patterns. At the top of the second floor, another band of ornamental panelled frieze with wooden lattice work provides embellishment below the cornice. In the gabled ends, small palladian windows pierce the wall and have sunburst ornamentation on either side of the central arch. Patterned shingles fill the rest of the gable ends. The windows on the first two levels are predominantly narrow one-over-one double-hung sash, as well as some large single panes bounded by small squares of multi-colored glass.

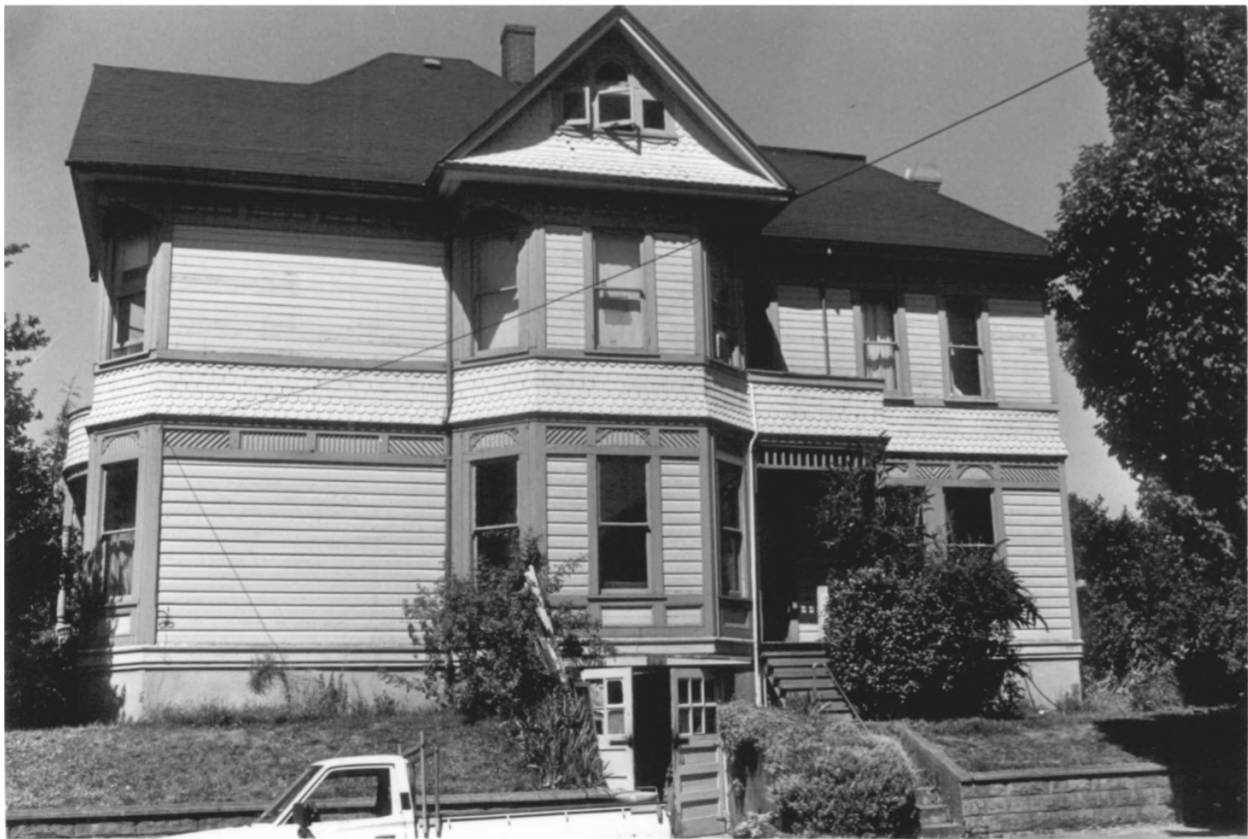
7 # 2074

6 Looking north at south elevation

The building is almost completely intact except for two new windows which were installed on the dining room in 1929. A 1923 integrated basement-level garage in the south side of the house was added in 1923.

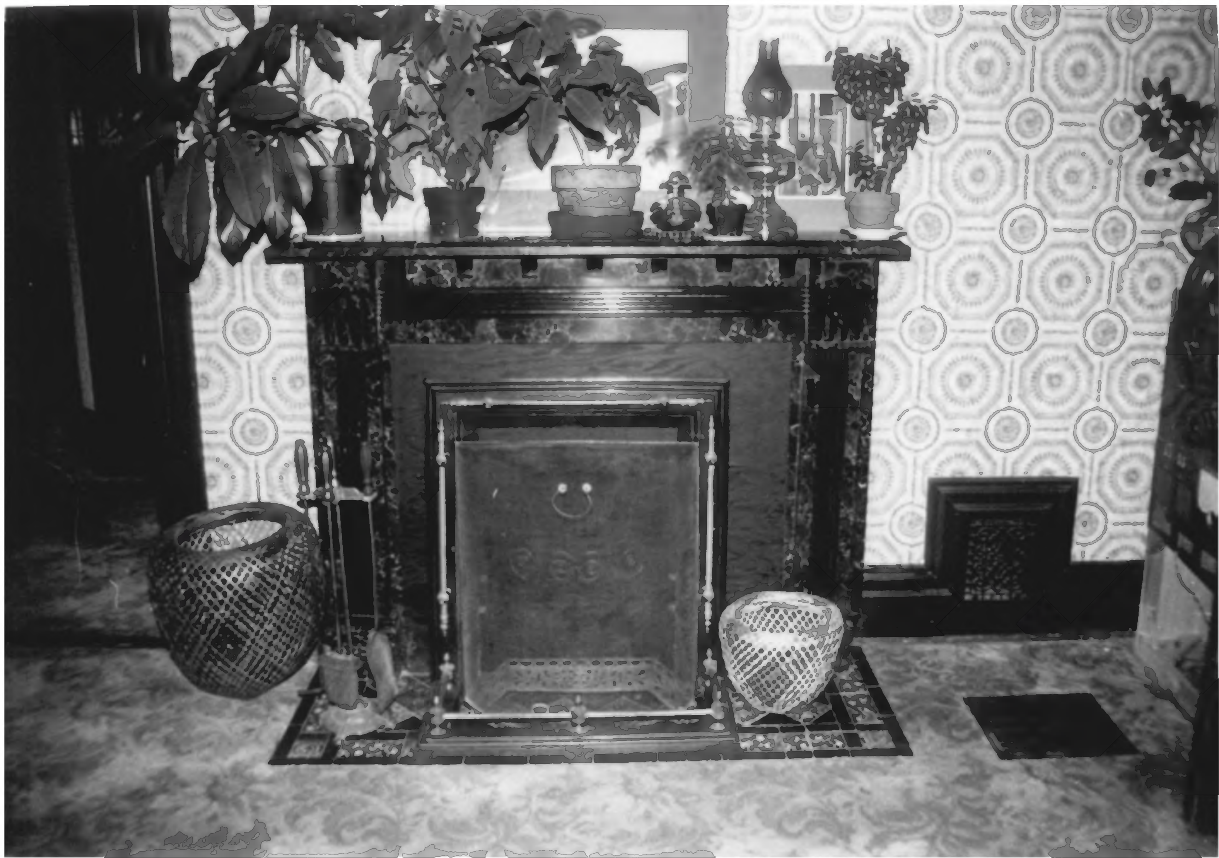
7 # 3 OF 4

6 Interior of living room fireplace

The same panelled treatment has been used on the bay windows in the sitting room. This room has a handsome green marble fireplace. The ceramic hearth is composed of two types of tiles: cordovan-red rectangular and triangular tiles, and raised floral motif tiles. There is a large, circular ceiling flange and light fixture in the sitting room, as well as in the parlor. A set of pocket doors separate the sitting room and the parlor.

The interior is richly decorated throughout; however, the most distinctive element is the handsome green marble fireplace in the sitting room.

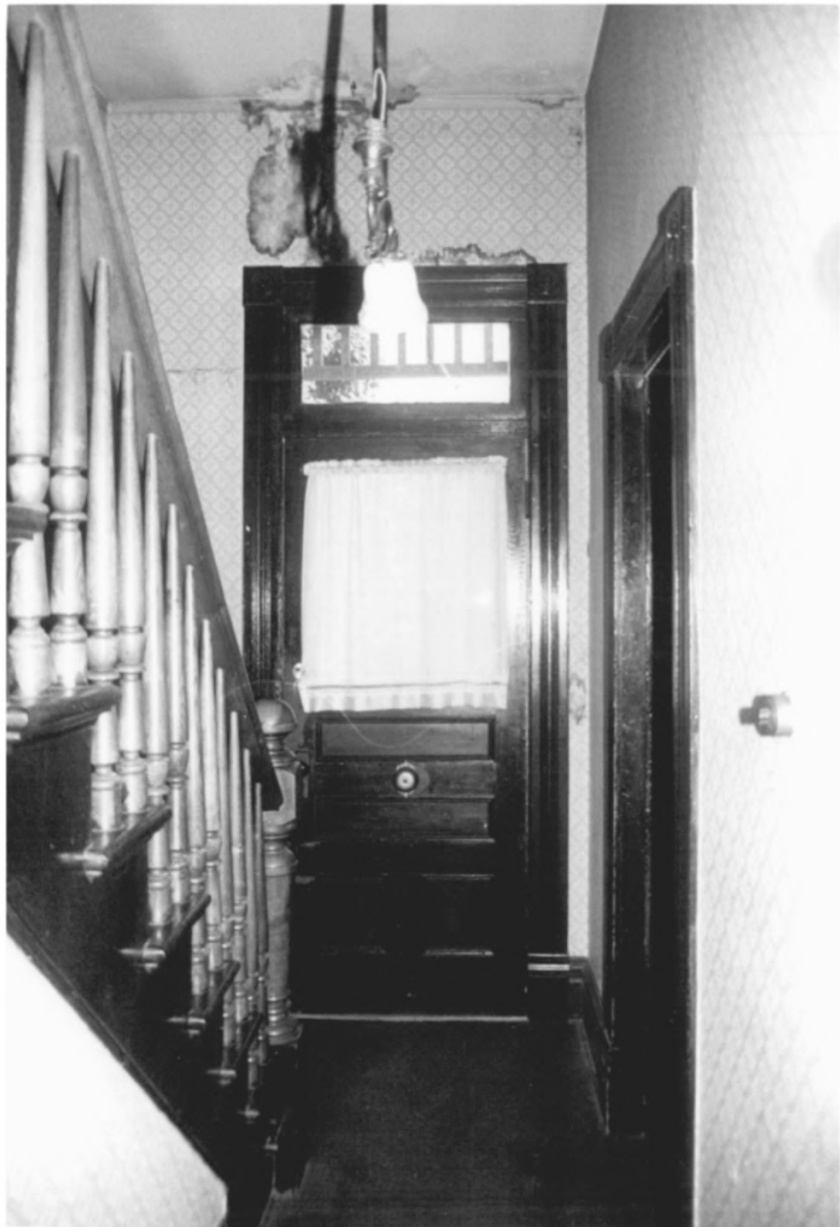
- 1 734 S.E. 34th MOHLER, WILHELMINA HOUSE
- 2 Portland, Oregon, Multnomah County
- 3 Zisman, Karen
- 4 July 1988
- 5 Roll K-3 # 13
- 6 Interior: Back hallway and stairs
- 7 # 4 OF 4

A back hall, stairs and bath divide the front from the back of the house. The stairs have a newel post with a large turned shaft, square base and half-sphere cap. The balusters are also turned. The bath has bevelled tongue-and-groove wainscoting, a built-in tub, wall-hung sink, toilet and ceiling light fixture.
