National Register of Historic Places Registration Form

historic name Jones, Clarence H., House
other names/site number N/A

street & number 1834 S.E. Ankeny
city, town Portland
state Oregon code OR county Multnomah code 051 zip code 97214

Name of related multiple property listing: Historic and Architectural Resources of Eastside Portland

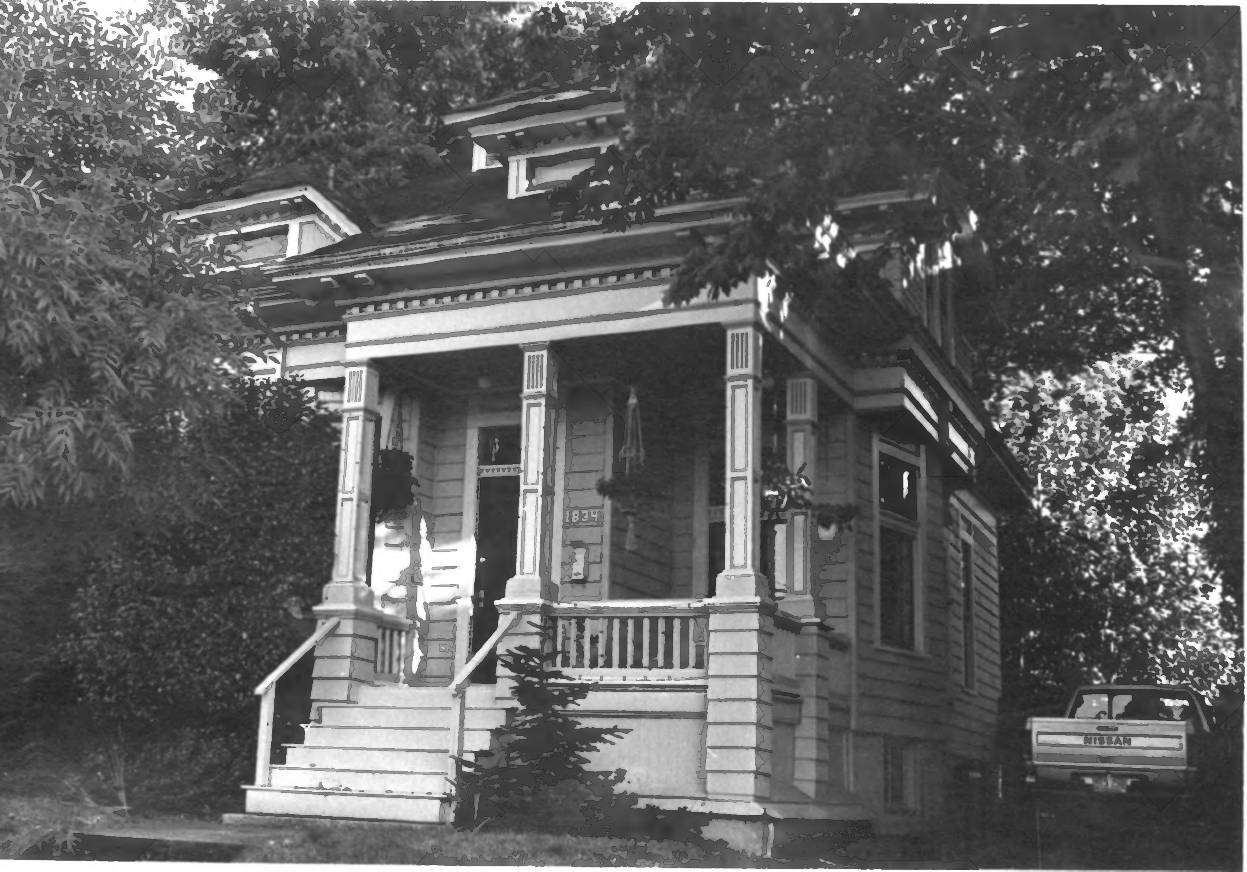
7 # 1 of 4

6 Looking southeast at north and  
west elevations

One-and-one-half stories, this house rests on a concrete foundation and has a full basement. The general form of the plan is asymmetrical and is covered by a main hip roof cross intersected by jerkinhead dormers on the east-west axis. These jerkinhead dormers have partial returned eaves and have a pair of windows set into them surrounded by hexagonal shingles. A dentilated frieze runs below the eave, and pairs of small brackets are found on either edge. The bottom of the jerkinhead on the east elevation tapers into the wall on the first floor. A shed dormer with similar decorative treatment sits on the back side. Off of the front, or north, face of the roof a hip which covers the front porch merges with the main roof and at the apex of both of these hips are little hip dormers pierced by single pane casements. Another jerkinhead dormer projects from the east side of the main roof over a polygonal bay, but unlike the others, its exterior surface around the casement window is clad with diagonal tongue-and-groove. Two red brick chimneys and a stovepipe protrude from the roof.

The exterior surface on the first level is covered with rectangular shingles. Narrow one-over-one double-hung sash is the primary window type, but many closed windows in the polygonal bays are surmounted by leaded glass transom lights. A row of dentils separates the upper transom from the lower pane. On the north elevation, an attached front porch has a balustrade composed of

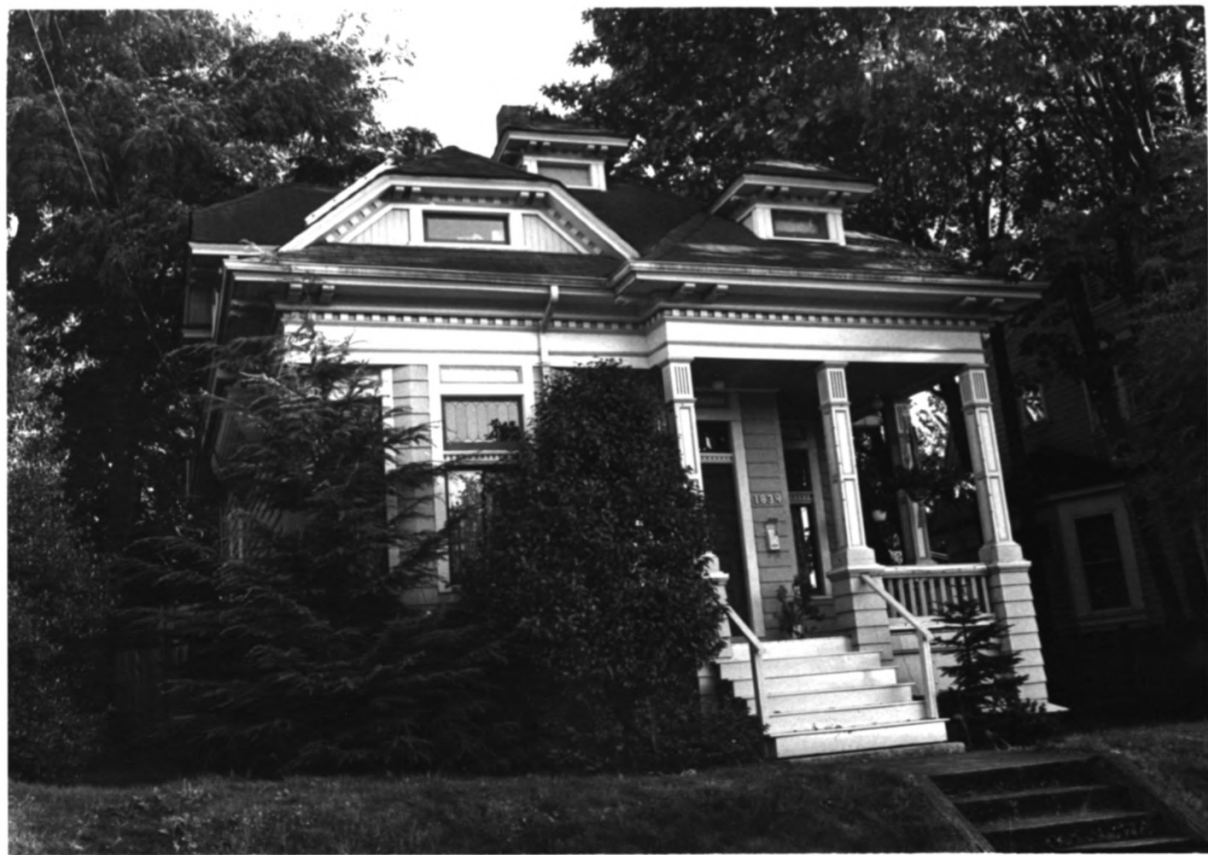
7 # 2 of 4

6 Looking south at north elevation

square balusters. Porch columns have square panelled shafts and elongated scored capitals which rest on wood piers. The front door is on the east end of the porch and consists of four recessed panels with a leaded glass transom. A polygonal bay below the jerkinhead dormer occupies the rest of the north facade. The main feature on the east elevation is the tapered bottom of the projecting jerkinhead dormer. Below the projecting jerkinhead on the west elevation a triangular bay extends from the flat wall and has a one-over-one double-hung sash window on each side. Further to the rear, an old door is located some three feet from the ground. The original stairway was removed.

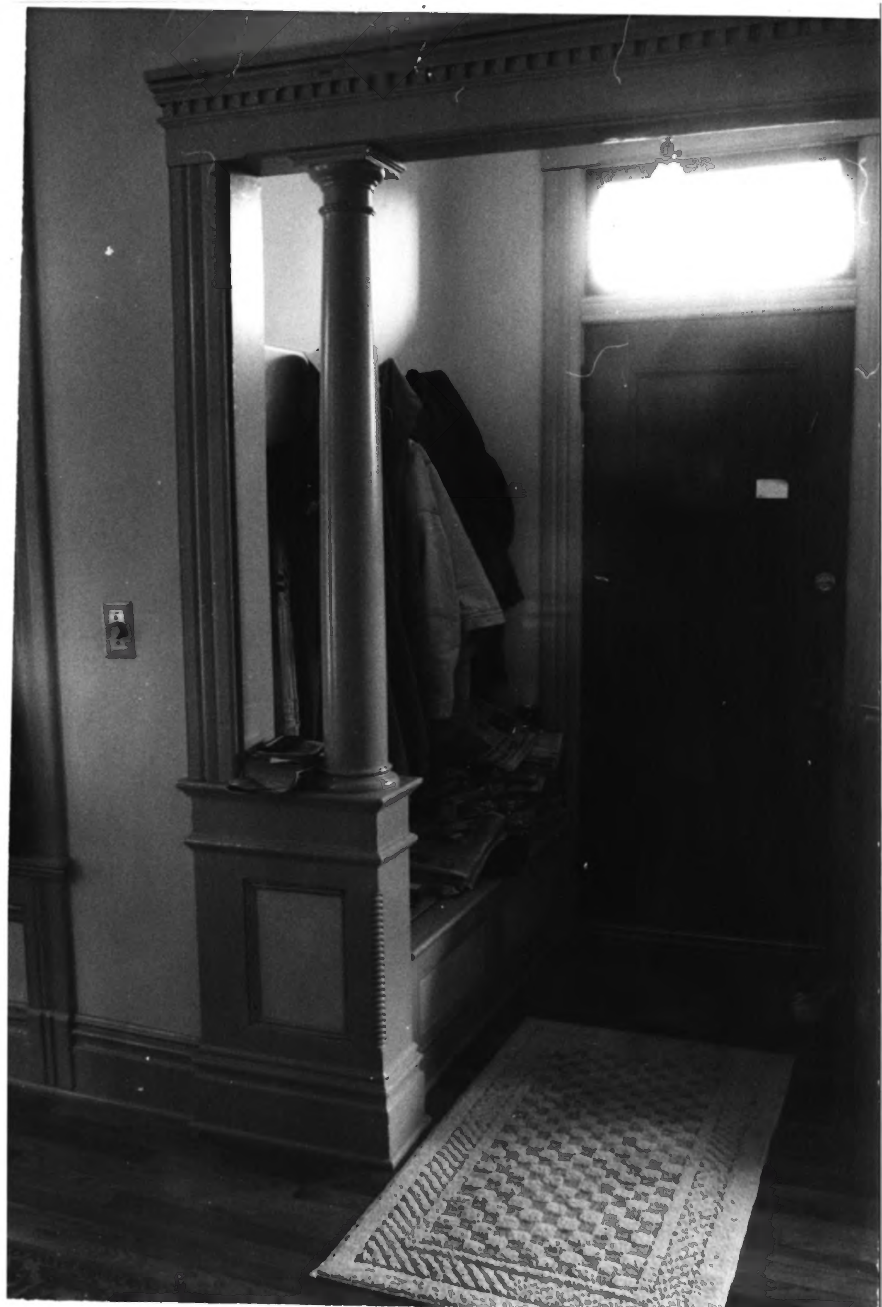
- 1 1934 S.E. Anteny Jones, Clarence H., House
- 2 Portland, Oregon, Multnomah County
- 3 Jane Morrison
- 4 July 1988
- 5 Roll J-5 #20
- 6 Interior's Detail of entry vestibule
- 7 #3 of 4

The interior of the house is characterized by the profuse use of molding and other millwork. Mopboards with caps and molded window surrounds are used throughout the first floor. The small foyer is separated from the living/dining room by a flat arch supported by a classically inspired support and panelled base. A panel built-in bench is located between the arch and front door. The dining room is polygonal, the shape determined by the bay window on the west wall. An arch or doorway has been removed between the living and dining room (n.d.). The stairs have been altered as well, presumably in conjunction with the conversion of the house into a duplex. This change was later reversed.

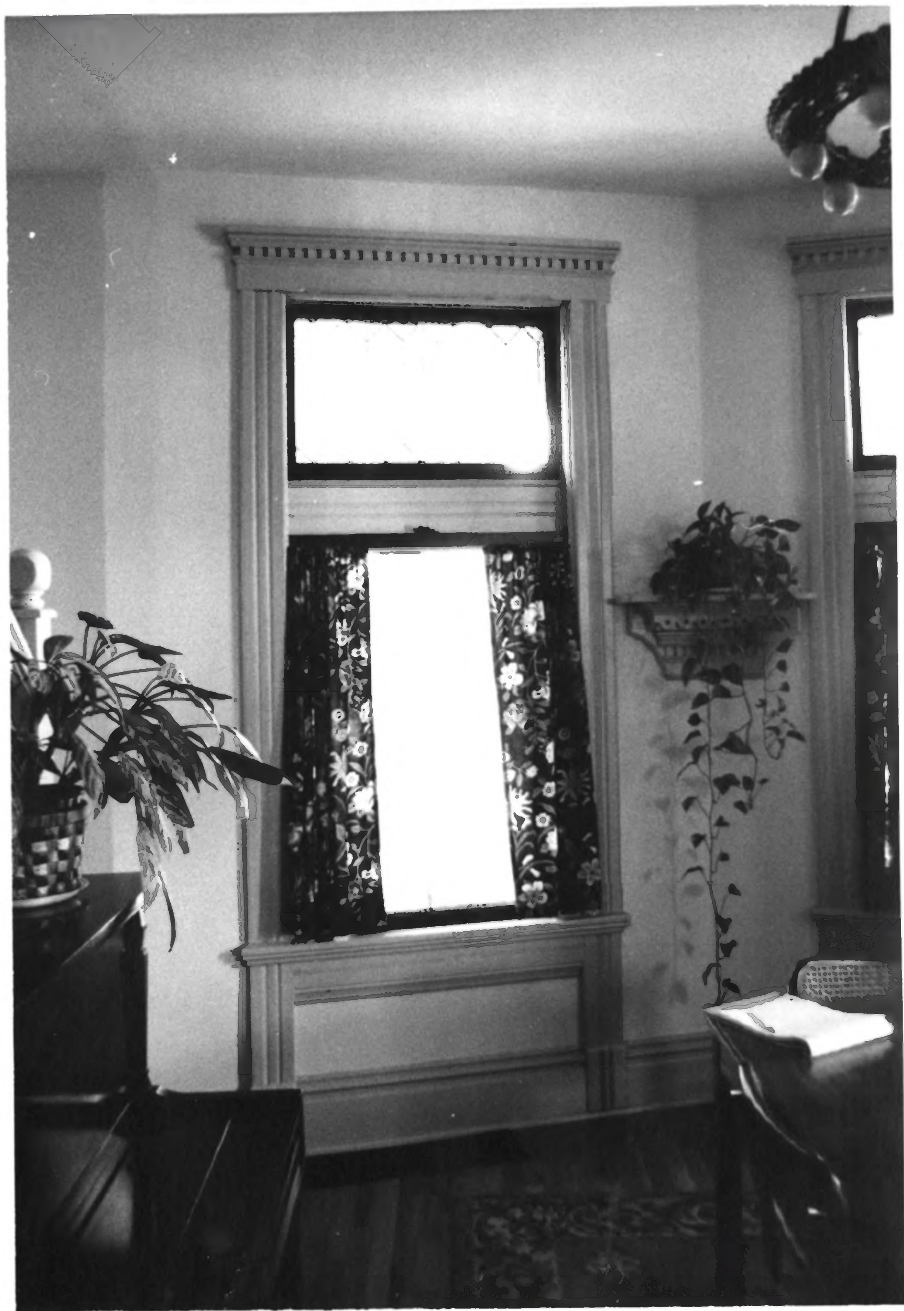
- 1 1834 S. E. Antkeny Jones, Clarence H., House
- 2 Portland, Oregon, Multnomah County
- 3 Jane Morrison
- 4 July 1988
- 5 Roll J-5 # 21
- 6 Interior view of living room window.
- 7 # 4 of 4
