National Register of Historic Places Registration Form

historic name Jacobberger, Josef, House
other names/site number N/A

street & number 1502 SW Upper Hall Street
city, town Portland
state Oregon code OR county Multnomah code 051 zip code 97201

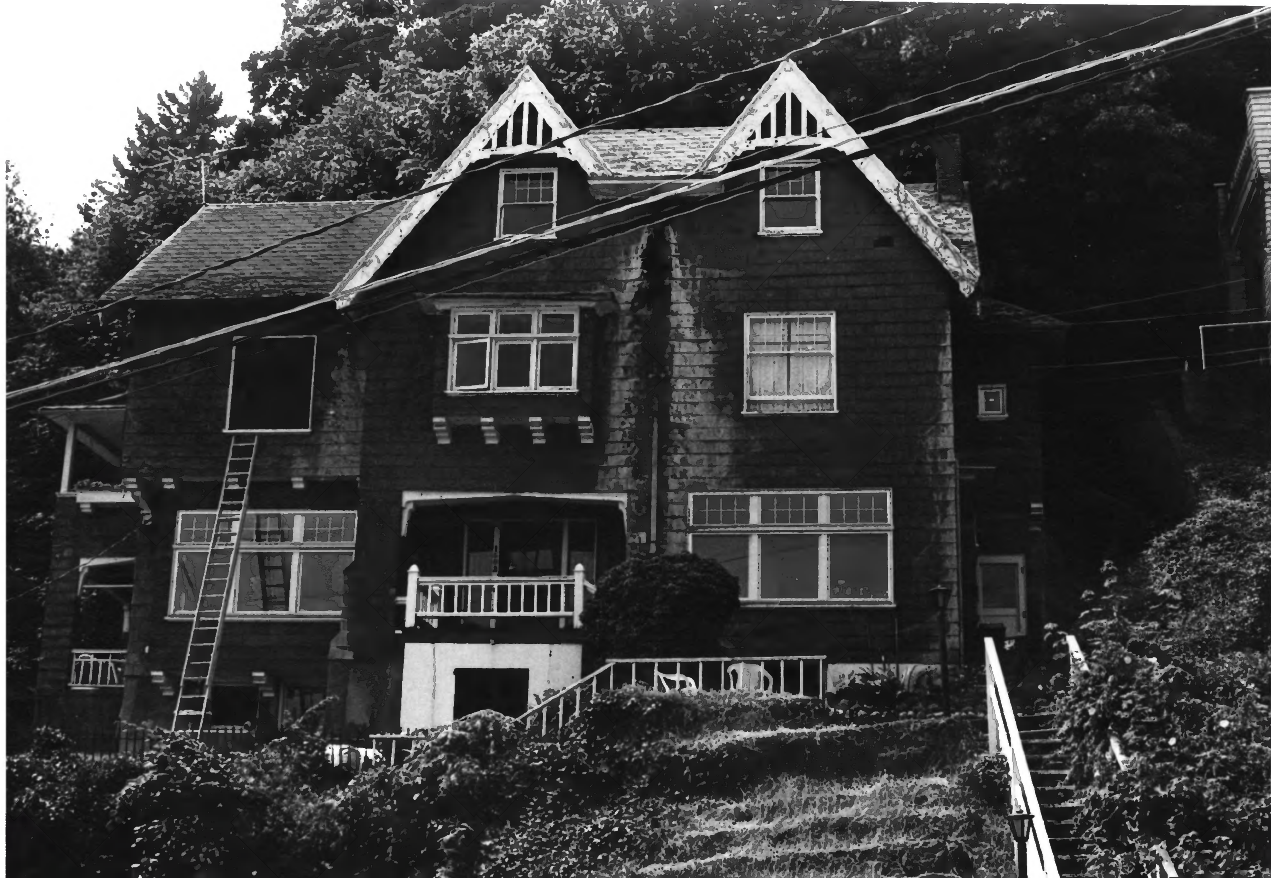
Number 1 of 29.

North (front) elevation.

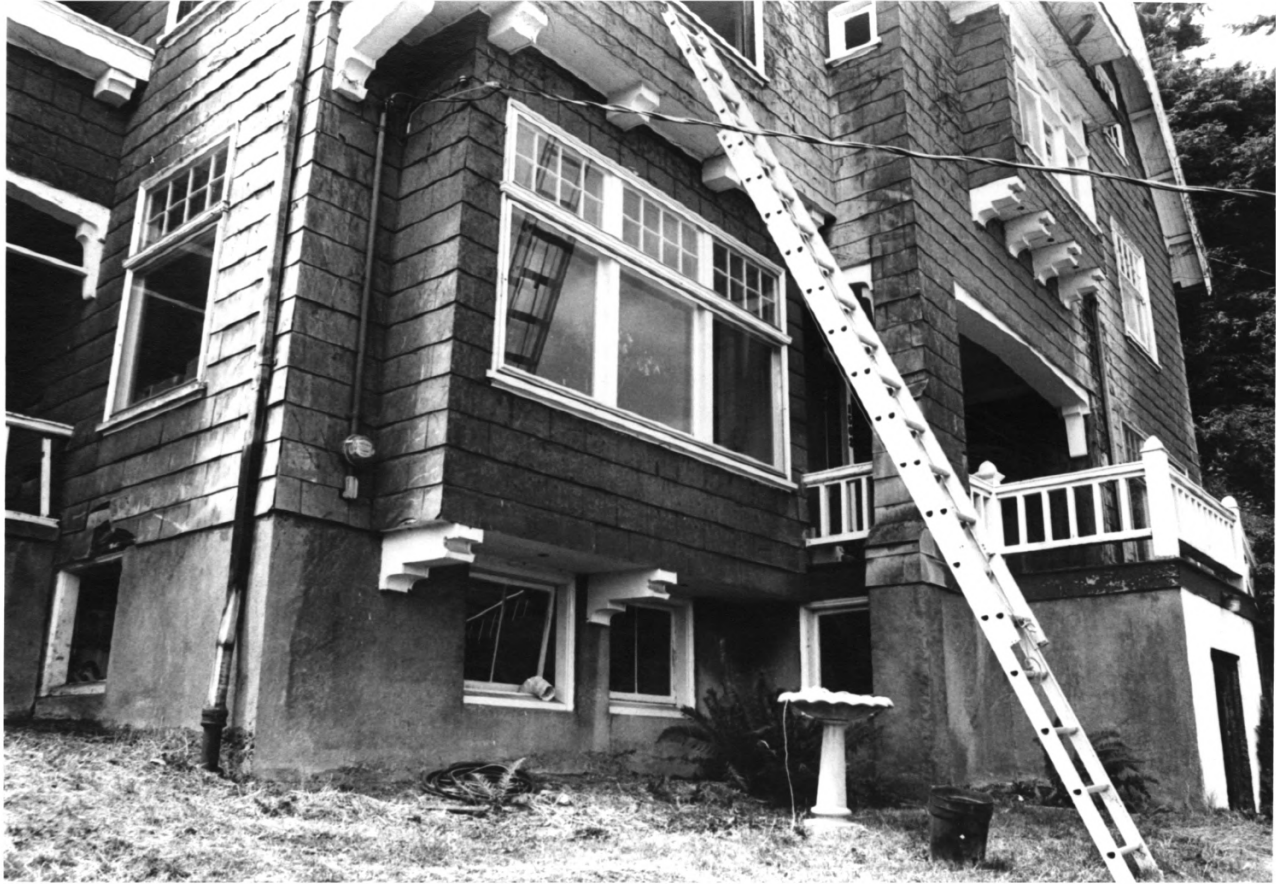
Number 3 of 29.

North (front) elevation, showing details of the bays,  
and of the brackets under the overhangs.

salient that holds on the second story - at the center of the building - a rectangular, cantilevered bay supported by carved wooden brackets. Beneath this is a large recessed entry porch, serviced by a smaller, balustraded, landing and stairs. East of the main salient, the second floor is cantilevered over the first, which itself carries a salient projecting outward over a high foundation wall. The overhangs at both levels are supported by heavy, well crafted, wooden brackets. A two story salient to the east holds a first floor porch and a second floor covered balcony. The home is clad with gray cement-asbestos (a.k.a., mineral-fiber) singles. A steeply pitched double gable rises above the main salient, and then intersects the main cross gabled roof, which is also steeply pitched. The roof shingles are asphalt. The combined use of a steeply pitched gabled roof, having intersecting double gables, with projecting bays and porches, all on a rectangular, asymmetrical, plan is characteristic of the Arts and Crafts Style. The shingle cladding, the mixing of sash and casement windows, and the high craftsmanship shown throughout the home, are also characteristics of the style. [4]

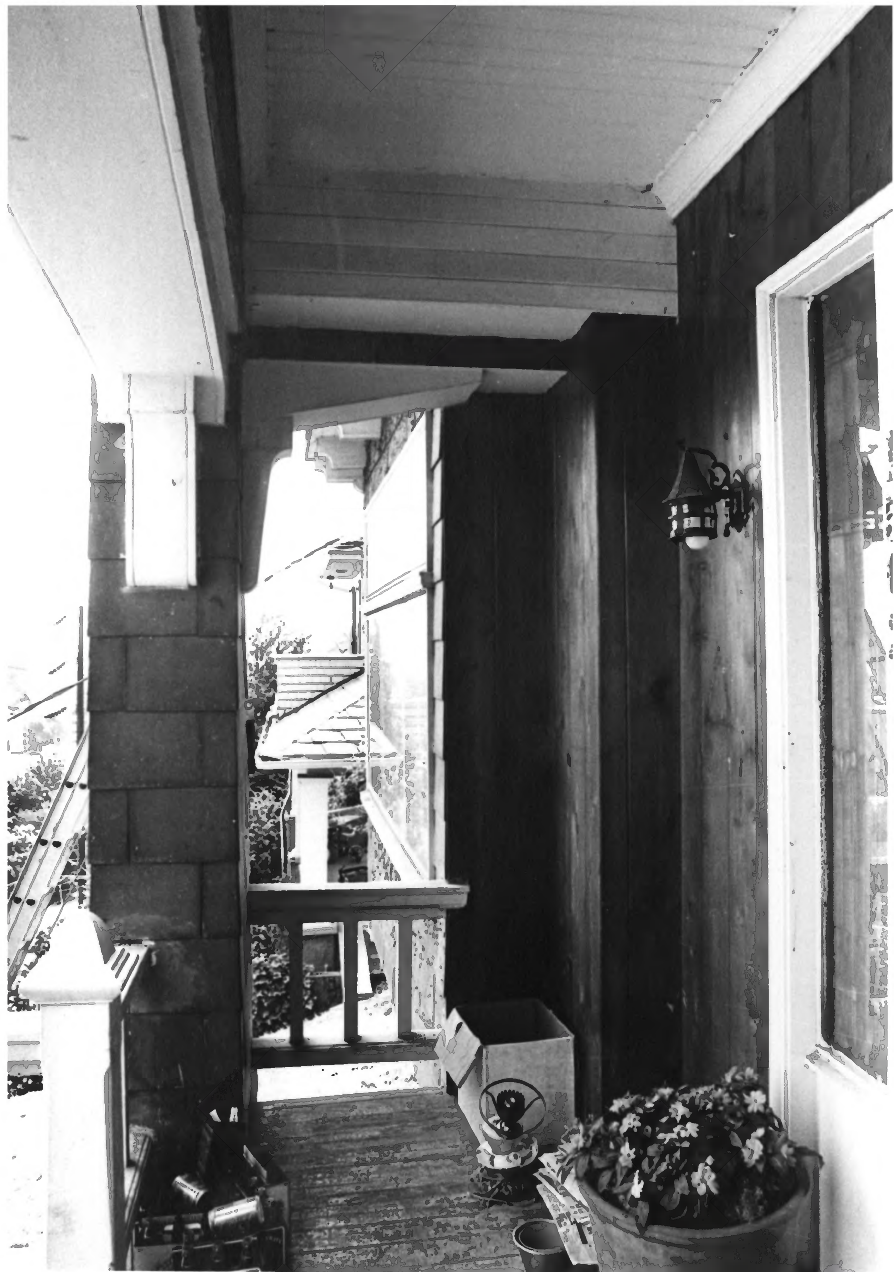
Number 4 of 29.

North (front) elevation, the entry porch looking east,  
showing original cladding on the end wall and ceiling,  
and the newer siding on the main wall.

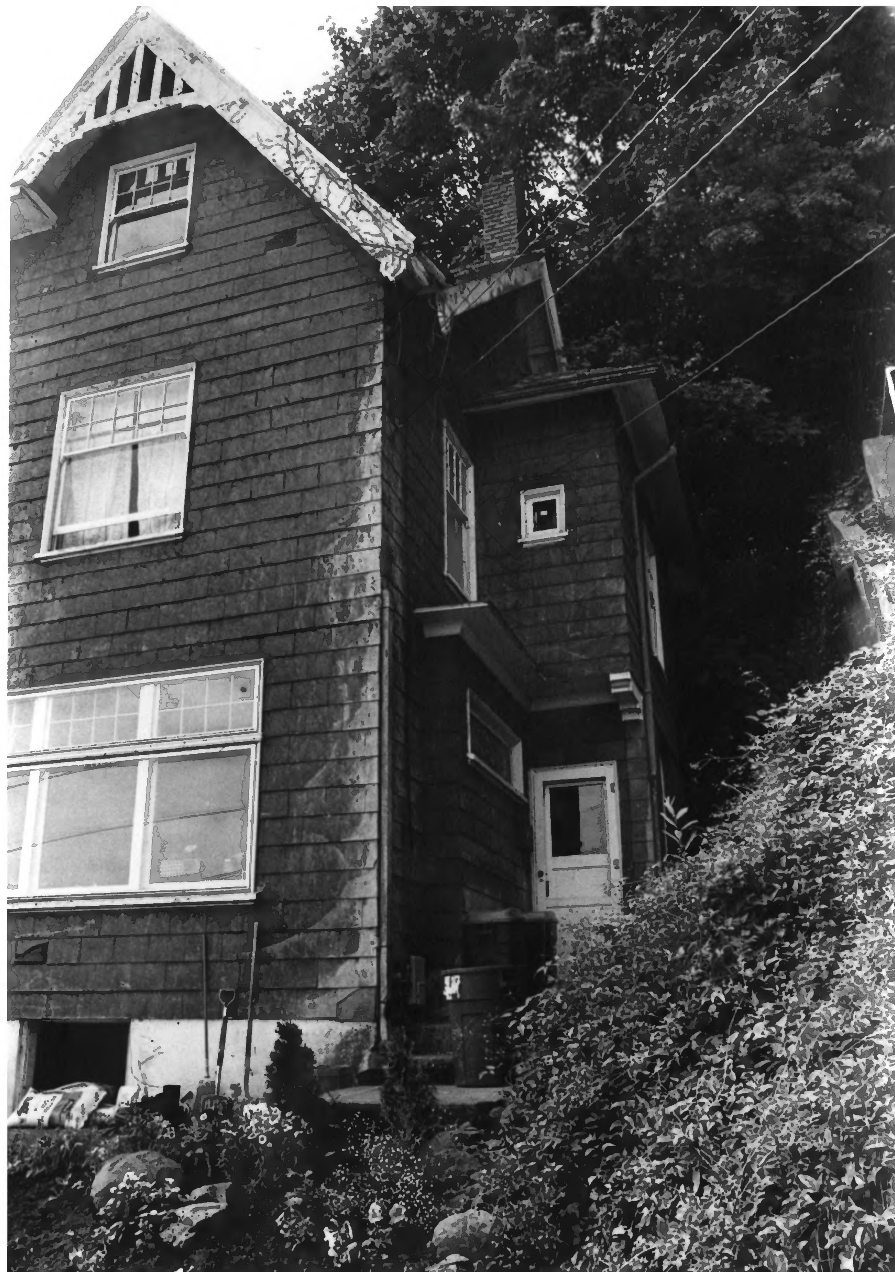
Number 5 of 29.

North (front) and west elevations, showing the  
northwest corner, placement of the west entrance, and  
the first floor stained glass window.

The west facade of the Jacobberger House is comparatively simple. At the rear of the facade, a two story salient with a hipped roof rises under the main east-west gable of the house. The first floor of this projection is formed by a concrete wall, while the second floor is clad in asbestos shingles. Both levels hold double-hung windows. Forward of the salient the walls are clad with shingles. On the first floor, a small salient holds a stained glass window, placed high on the wall. This window originally lit the dining room prior to its conversion into a kitchen. (See below.) It is largely clear glass, with an intricate vine and leaf pattern formed by stained glass and leading. The glass of the leaves is a light, opalescent, pink.

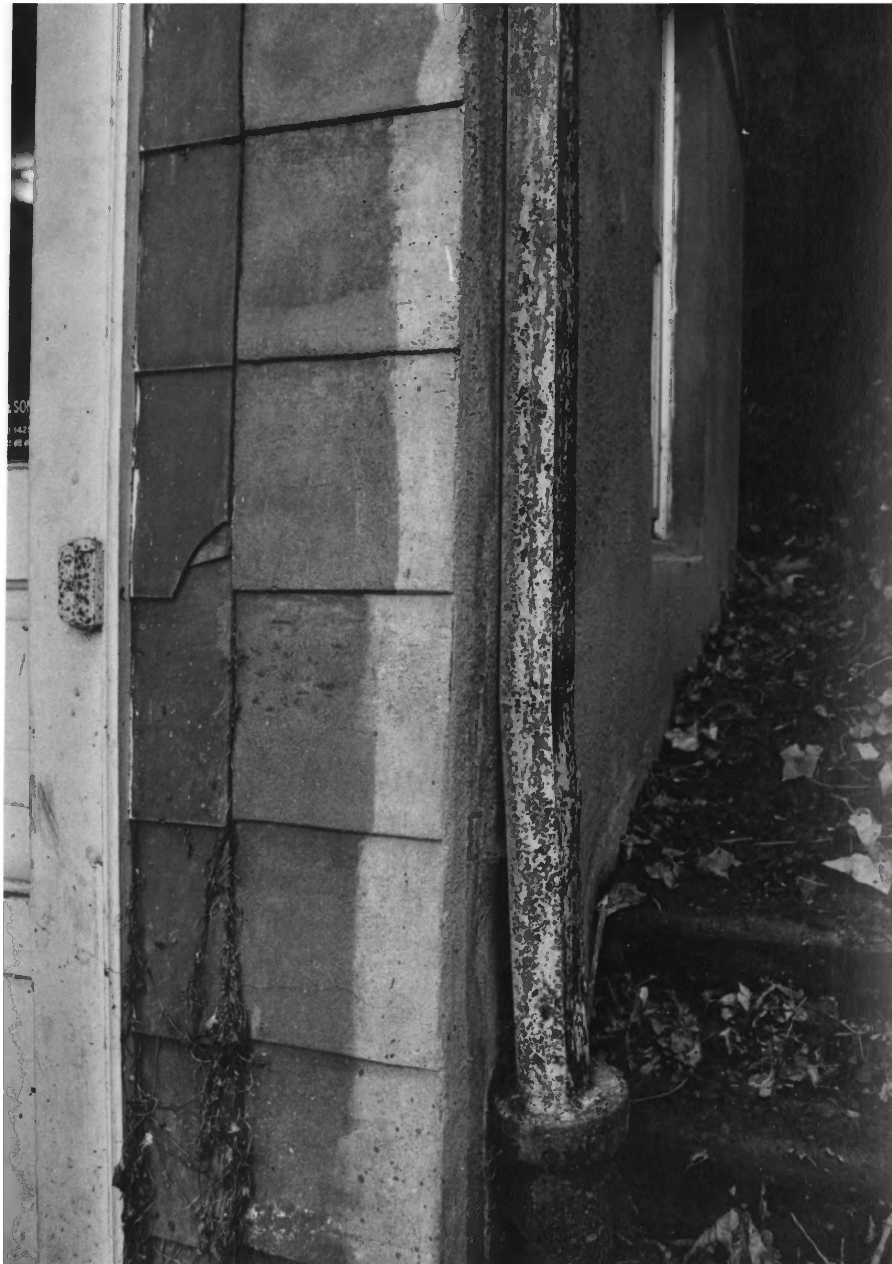
Number 7 of 29.

West elevation, showing details of the concrete  
foundation wall impressed to match the cement-asbestos  
shingles.

A walkway beneath the stained glass window and leads to steps to a service door in the side of the two story salient. This walkway is sheltered by an overhanging projection on the salient - holding a small casement window, and by a narrow roof at the second floor level. Above this small roof is a double-hung sash window, eight over one. An interesting feature of this facade is displayed on the corner of the salient, next to the entrance. The end of the concrete side/foundation wall is impressed to resemble the shingles covering the main walls. The false concrete shingles on this end of the side wall match in size and alignment the concrete-asbestos shingles on the remainder of the wall.

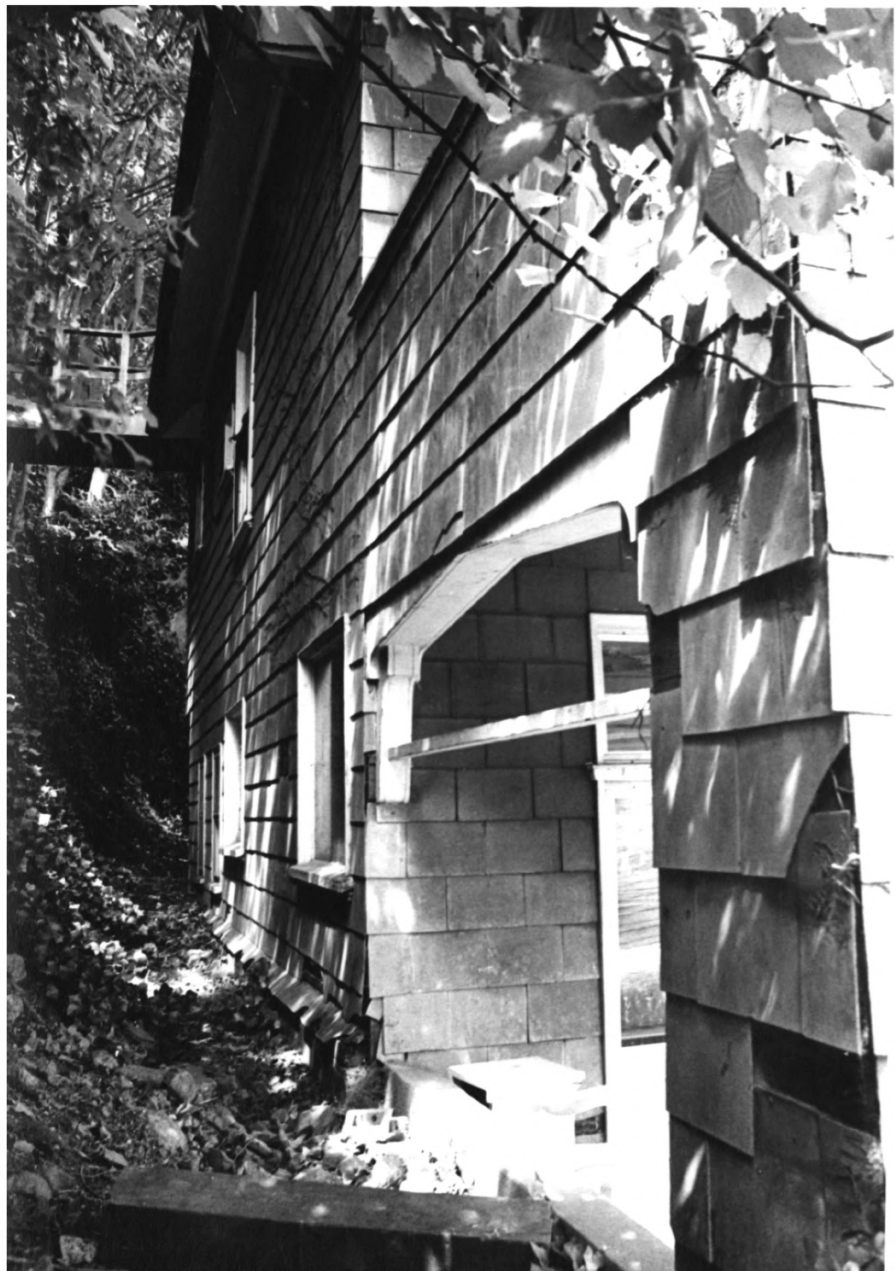
Number 8 of 29.

South (rear) elevation, from the southeast corner,  
showing porch opening and details of shingles. The  
fire escape ramp is visible in the background.

The south facade of the Jacobberger House is close to the steep hillside, so that at the third floor level a centrally located fire escape (added in 1977) extends directly from a small solarium to the bank. The rear of the house is shingled above the high foundation wall. A third of the way along the building from the southwest corner, the wall projects in a large salient that reaches to the third

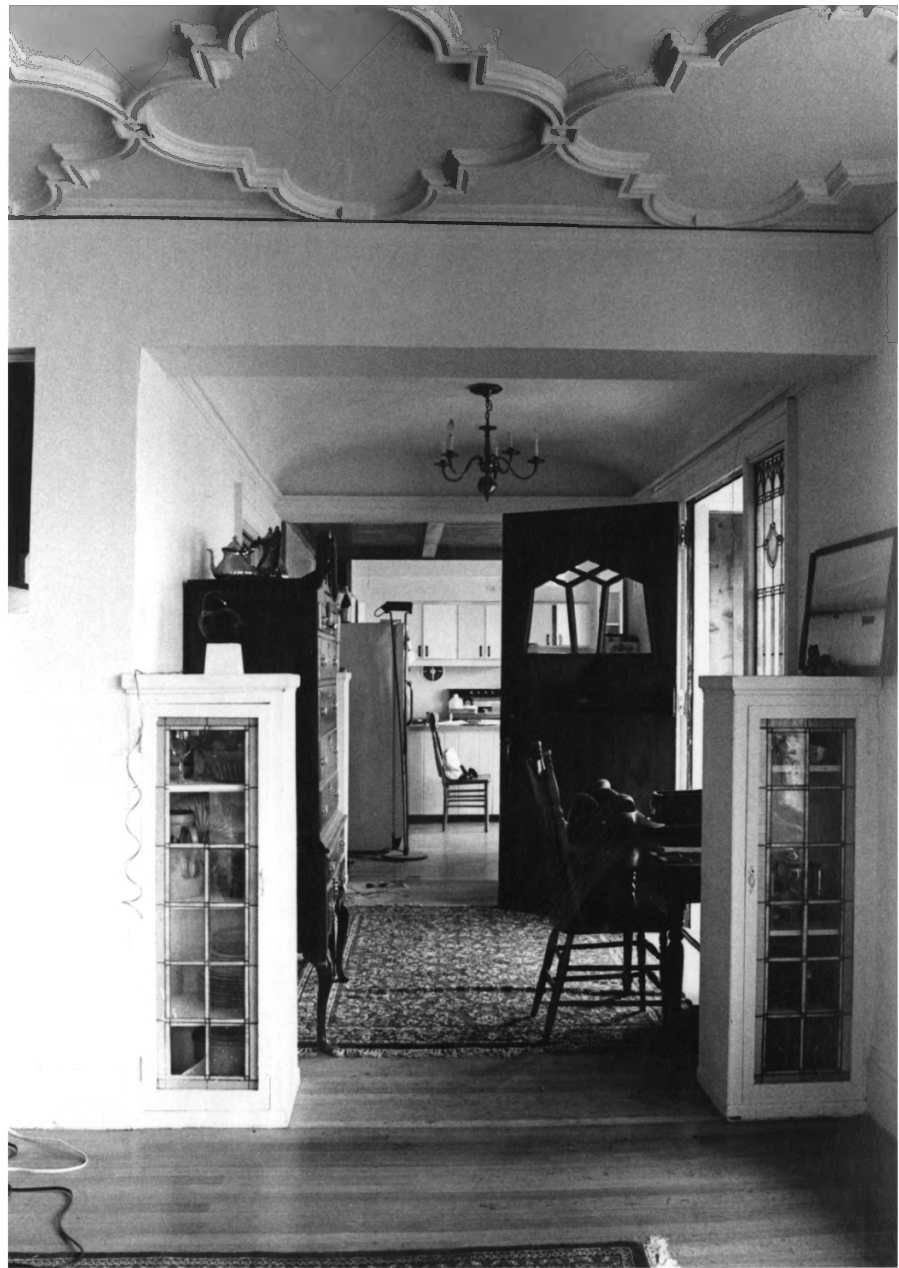
Number 10 of 29.

Living room, looking west through the entry hall into the original dining room, now the kitchen, and showing details of the stained glass doors on the shelves flanking the living room entrance.

East of the wide entrance hall the living room, spans the house from north to south. The room's wide portal is flanked by a pair of curio cases, some 54 inches high, with stained glass doors. The doors have twelve clear panes in two columns, divided and bordered by a light tan, opalescent, stained glass. Three large double-hung windows, eight over one, are mounted in a window seat projecting outward from the room. The seat lifts to reveal a storage cabinet. A single window of similar design is set in the east wall, near the its north end. On the south end of the same wall is a double French door, topped by a fixed eight pane window, opening onto the side porch. Opposite, on the west wall, is a wide opening, set 5 feet above the floor, that looks onto the main staircase. It is believed by Edward Pederson, a Portland architect and former owner of the Jacobberger House, that a decorative screen set with stained glass originally graced this opening. [11] It had been removed prior to his purchase of the building in 1974. [12] There is a high baseboard on the east and west walls.

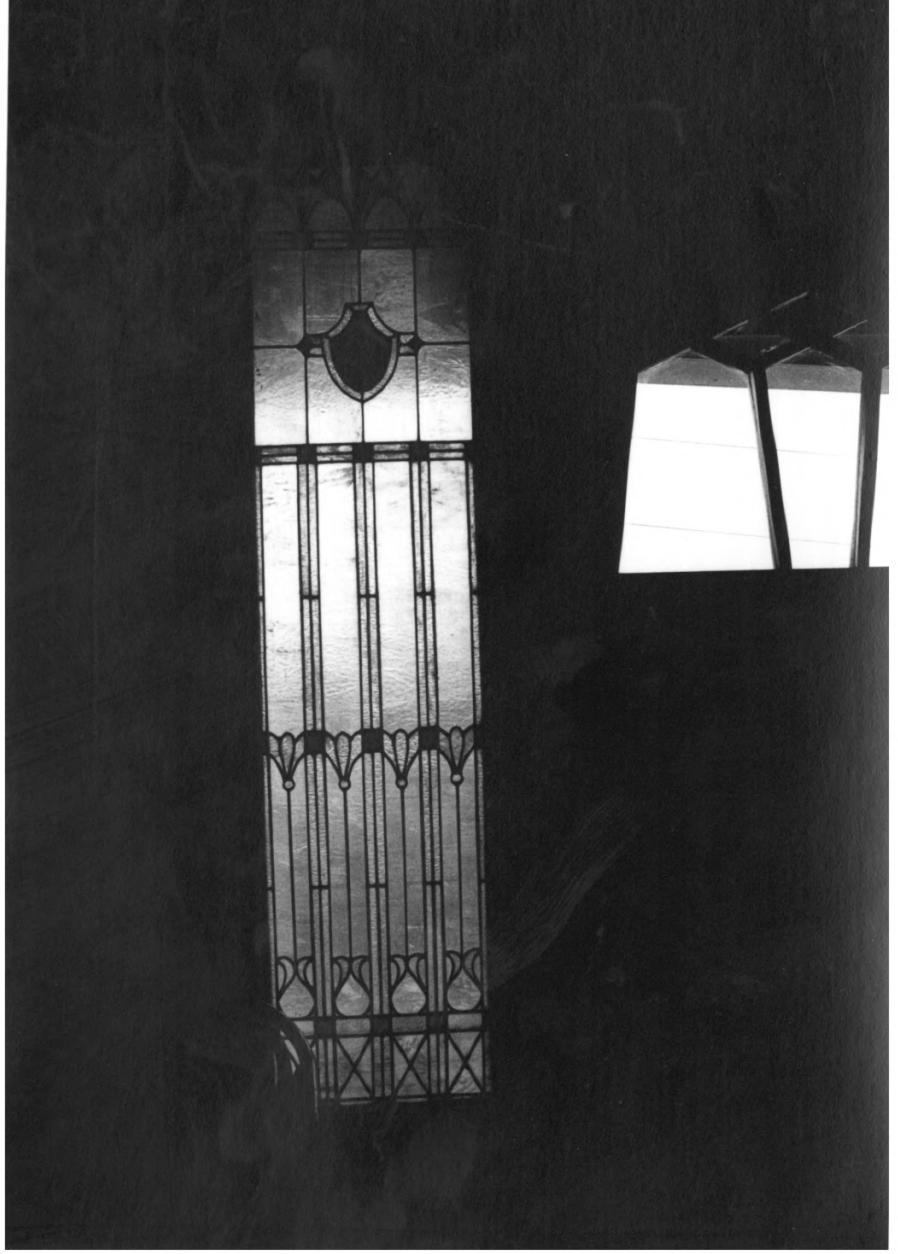
Number 11 of 29.

Entrance hall, looking north, showing details of one of the stained glass windows flanking the main entrance, and a detail of the door.

The Jacobberger House is entered through its heavy, brass-bound, door with its small tri-partate window, flanked by a pair of tall stained glass windows. These large windows

(69 inches high by 17 inches wide), and the other stained glass in the home, are believed by Polly Povey Thompson to have been made by the well known Portland firm run by David Povey and his brothers. [10] The door opens into a large entrance hall that looks directly through a wide sliding door to the main staircase, and a smaller hall leading to the rear of the home. The entry hall has a high, rounded vault ceiling, running east to west. Picture frame molding circles the top of the walls, while a small molding borders the floor. The floors of the first floor are oak.

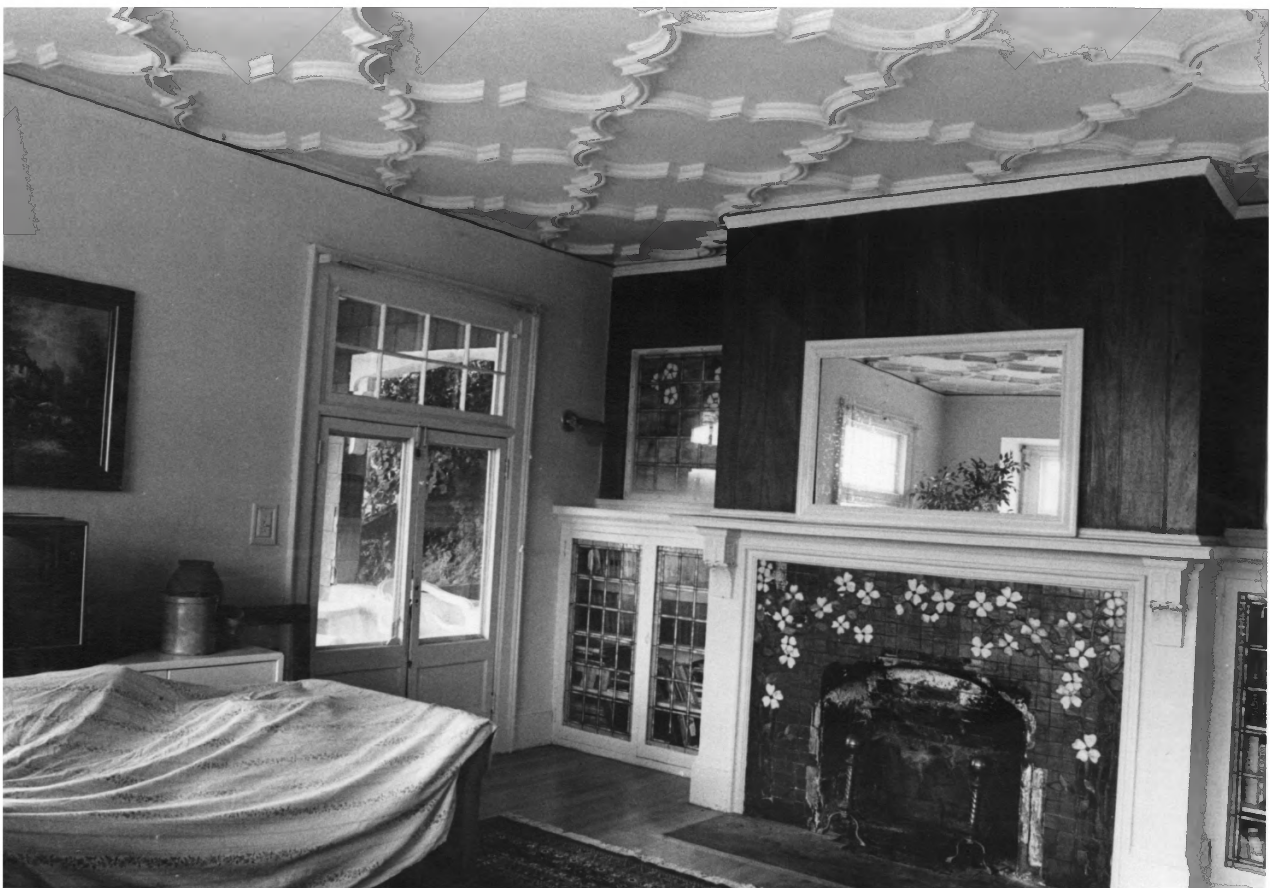
Number 13 of 29.

Living room, looking southeast, showing the fireplace,  
bookcases with stained glass doors, stained glass  
window, French doors, and ceiling.

Centered on the south wall of the living room is a large fireplace, surrounded by gold colored tile decorated with an intricate white dogwood design. The daughter of a former owner, Lucy Elden Dickinson, has reported that the dogwood design on the tiles, and on windows flanking the fireplace, were designed to match a dogwood tree that originally grew in the yard. [13] A small tree that may well have been this dogwood is visible in historic photographs of the home. Some of the tiles surrounding the fireplace have been damaged. The hearth consists of dark brown 2 inch tiles, that may represent a change from the original. The fireplace is bordered by a heavy wooden mantle and side posts. Flanking the fireplace are a pair of built-in

bookcases. They are protected by clear and stained glass double doors, similar in design to those of the entrance cases. The wall above the fireplace and bookcases is currently covered with modern, dark wood, paneling - an alteration from the original. It is understood by the owner that the golden fireplace tiles, with their dogwood design, extend from the mantle to the ceiling. [14] A large mirror is set above the mantle. The mirror is flanked on the walls above the bookcases by a pair of stained glass windows.

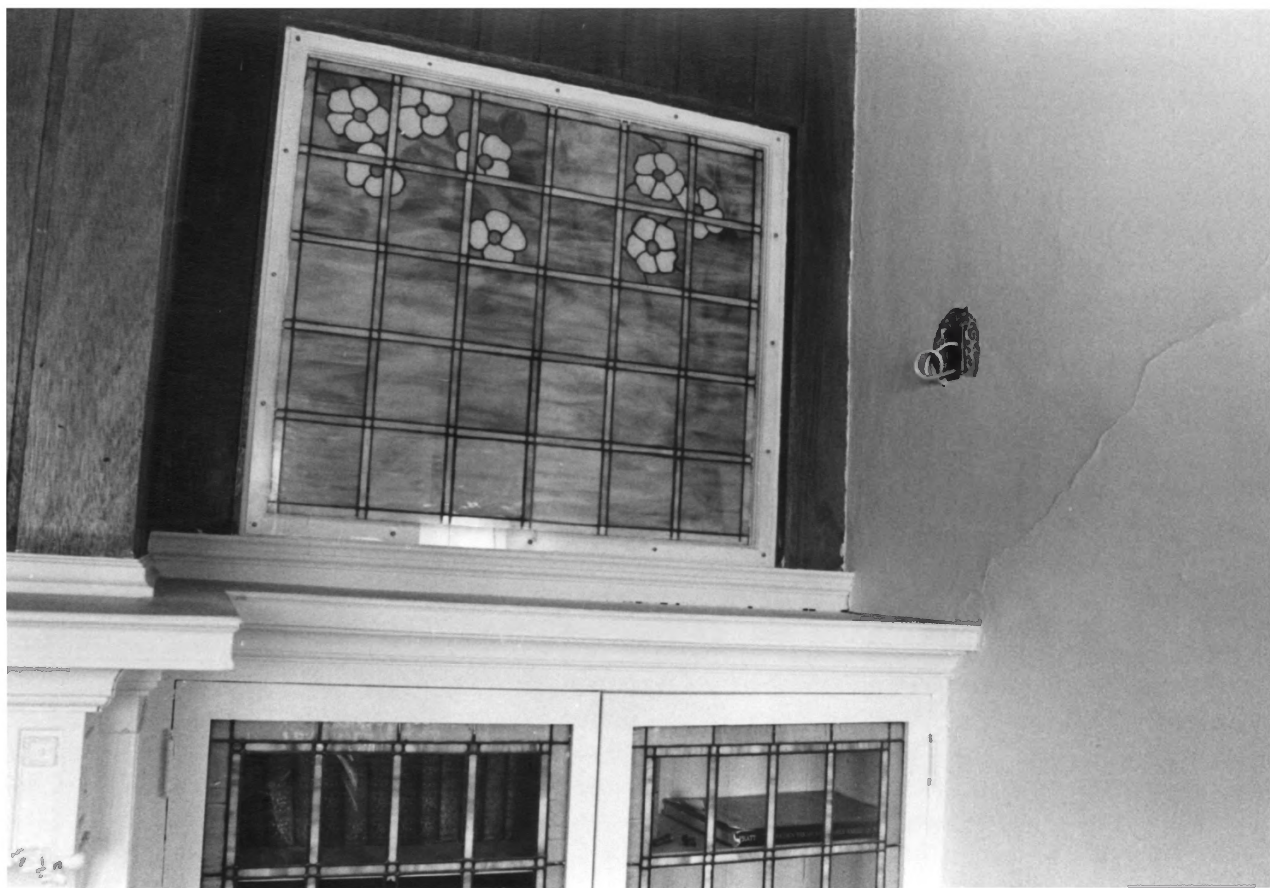
Number 14 of 29.

Living room, looking southwest, showing stained glass window the flanking fireplace, and the top of the built-in bookcase and its stained glass.

The stained glass windows on the south wall of the living room are extremely intricate in design, and represent a sophisticated technical and artistic achievement. The windows are composed of square, cream colored panes, divided by strips of beige glass - both are opalescent. The windows repeat the dogwood design of the fireplace tiles, using two layers of glass. The outer glass carries the branches of the dogwood tree, while the inner carries the white flowers. The technique adds a startling three-dimensional effect to the windows. As noted, all of the stained glass windows in the home are believed to have been made by Portland's best stained glass company of the era, the Povey Brothers' studio. The firm was active in Portland from 1888 until 1928, and the refined design, fine lines, and opalescence of the glass in the home are characteristic of Povey Studio's work. [15]

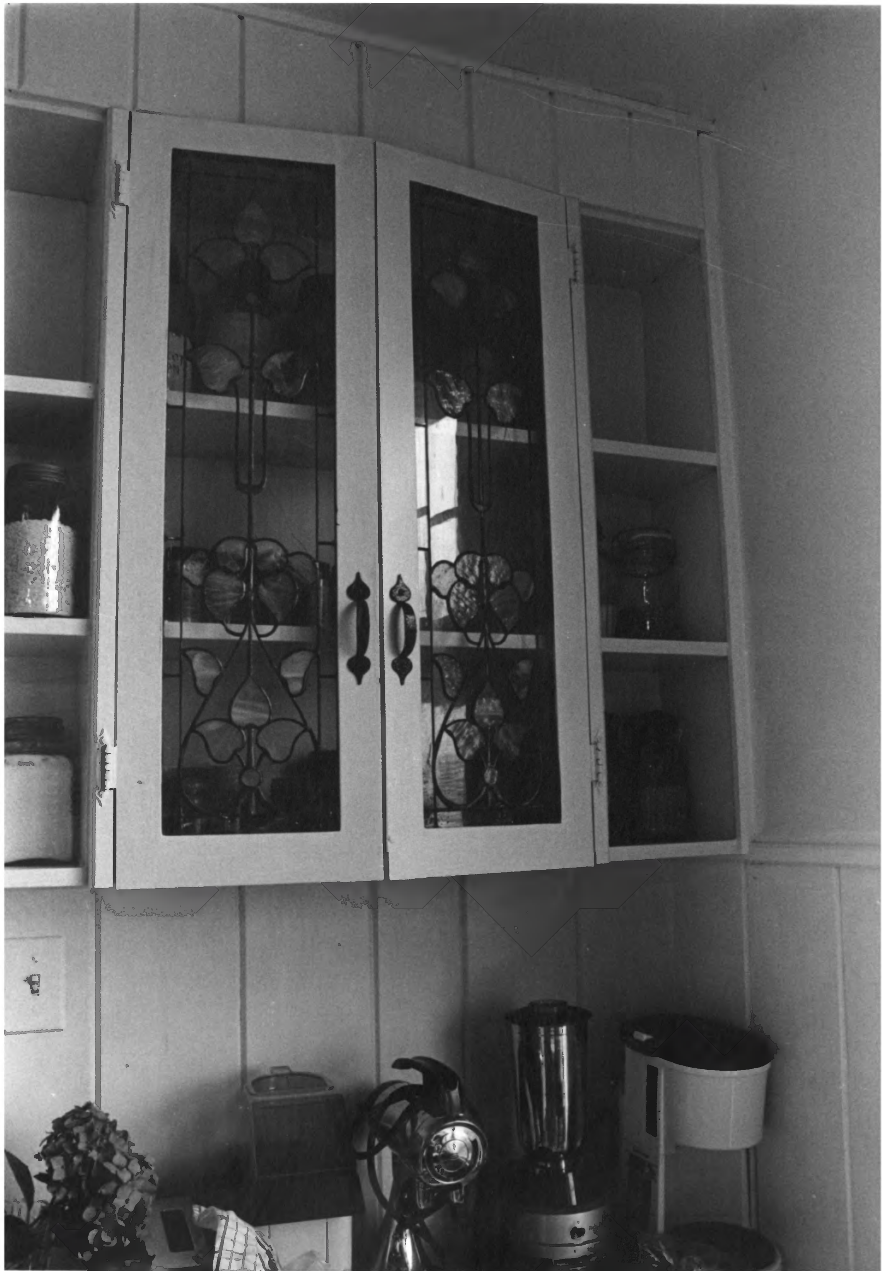
Number 16 of 29.

Original dining room, now the kitchen, looking west and showing the cabinet doors now holding the stained glass windows that originally protected the built-in cases flanking the entrance of the room.

The most significant alteration to the Jacobberger House occurs on the first floor where the original dining room was converted into the kitchen, while the original kitchen was converted into a general purpose room. The conversion of the dining room was, however, carried out with considerable care. The false ceiling protects the original ornate ceiling, allowing for easy restoration. The wooden floor has been partially covered by linoleum. The stained glass window in the west wall is intact, and is only covered by cabinets on the inside. Further, the stained glass doors of the built-in bookcases have been preserved as kitchen cabinet doors.

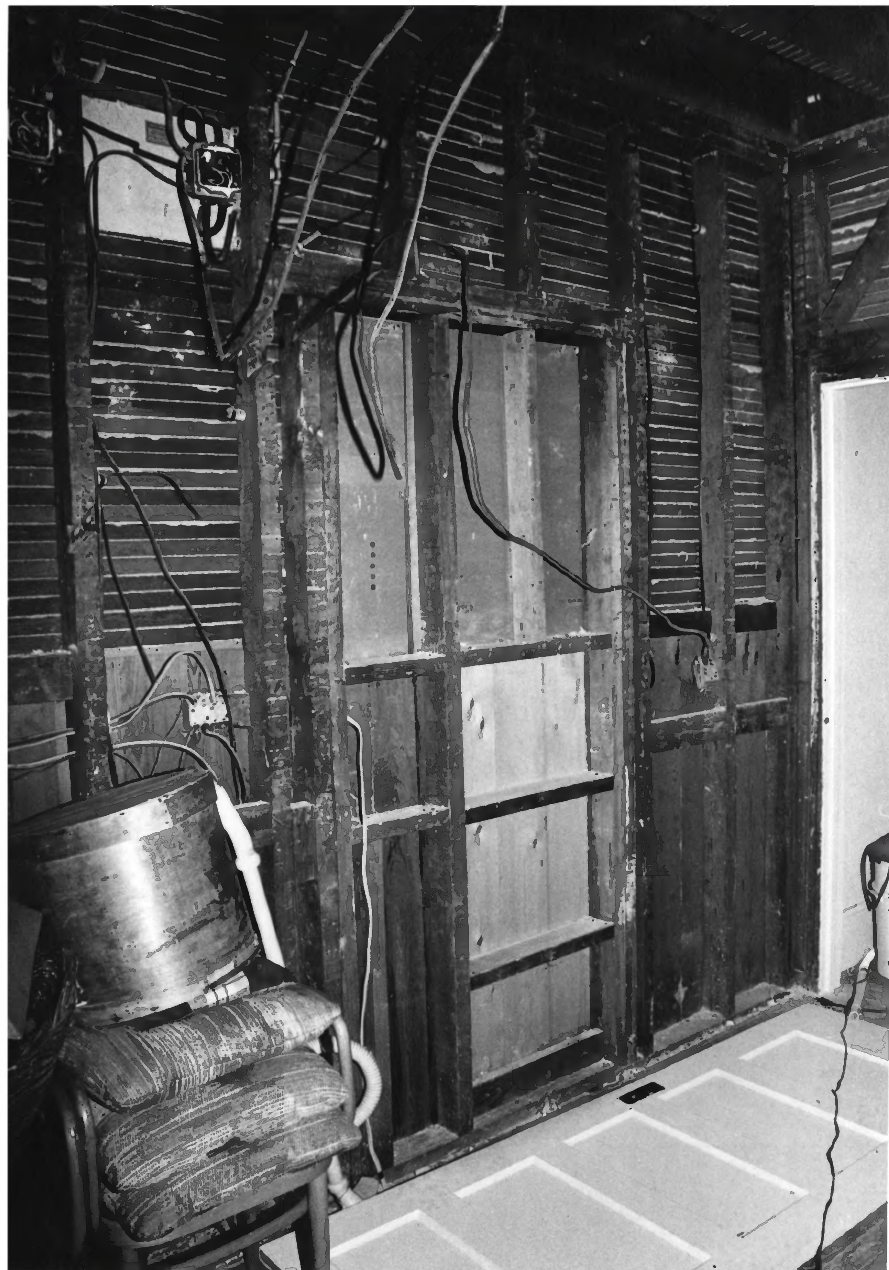
Number 19 of 29.

Original kitchen, looking northeast and showing the framing of the door into the dining room.

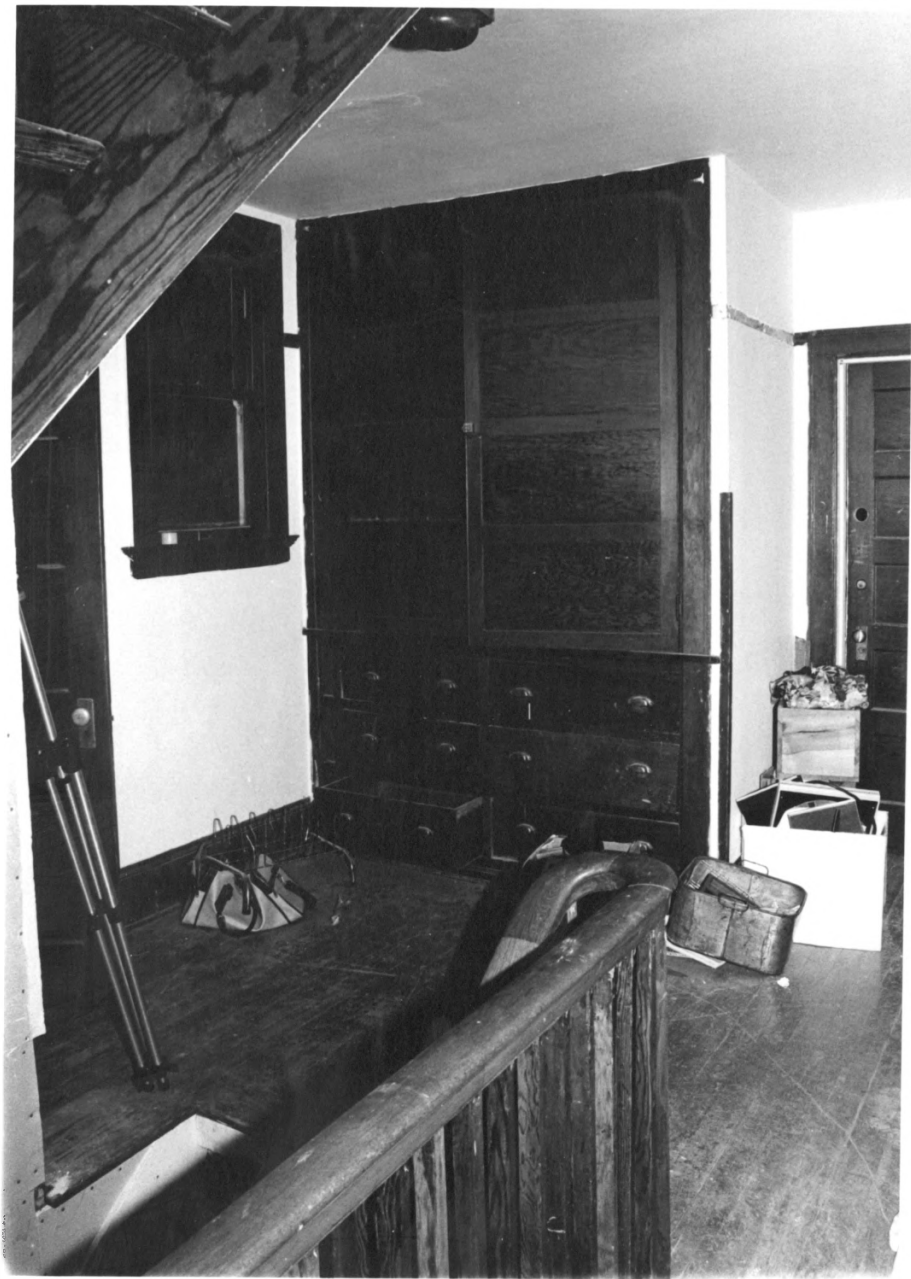
Number 21 of 29.

Second floor hallway and landing, looking west, showing  
the built-in cabinets and drawers of the linen closet.

The second floor landing west of the stairs holds a large, built-in, set of cabinets and drawers serving as a linen closet. To the south of the stairs are a small window, and next to it, the door to the separate toilet. A door to the bath opens next to the toilet. The original alignment of the bath and toilet is not clear. Both rooms have been remodeled with linoleum floors and modern fixtures. The toilet is clearly more modern than the house, while the bathtub was removed and replaced with two shower stalls when the building was used by the fraternity. It is likely that the space currently taken by the toilet and bathroom was the original bathroom. The rooms are, however, very small.

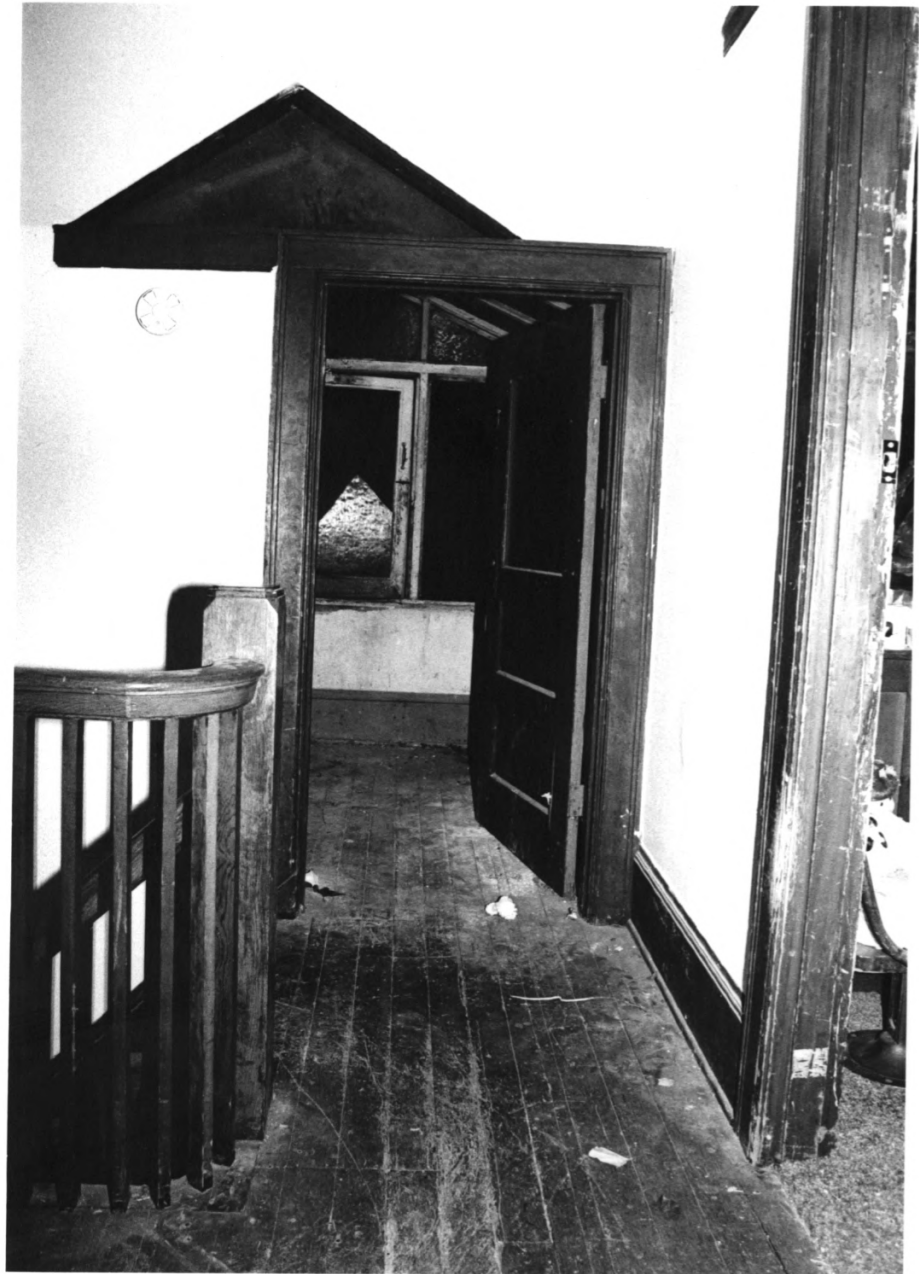
Number 27 of 29.

Third floor landing, showing the door to the solarium,  
and the triangular window over the door.
