National Register of Historic Places
Registration Form

historic name Imperial Stock Ranch Headquarters Complex

other names/site number Hinton - Ward Ranch

IMPERIAL STOCK RANCH

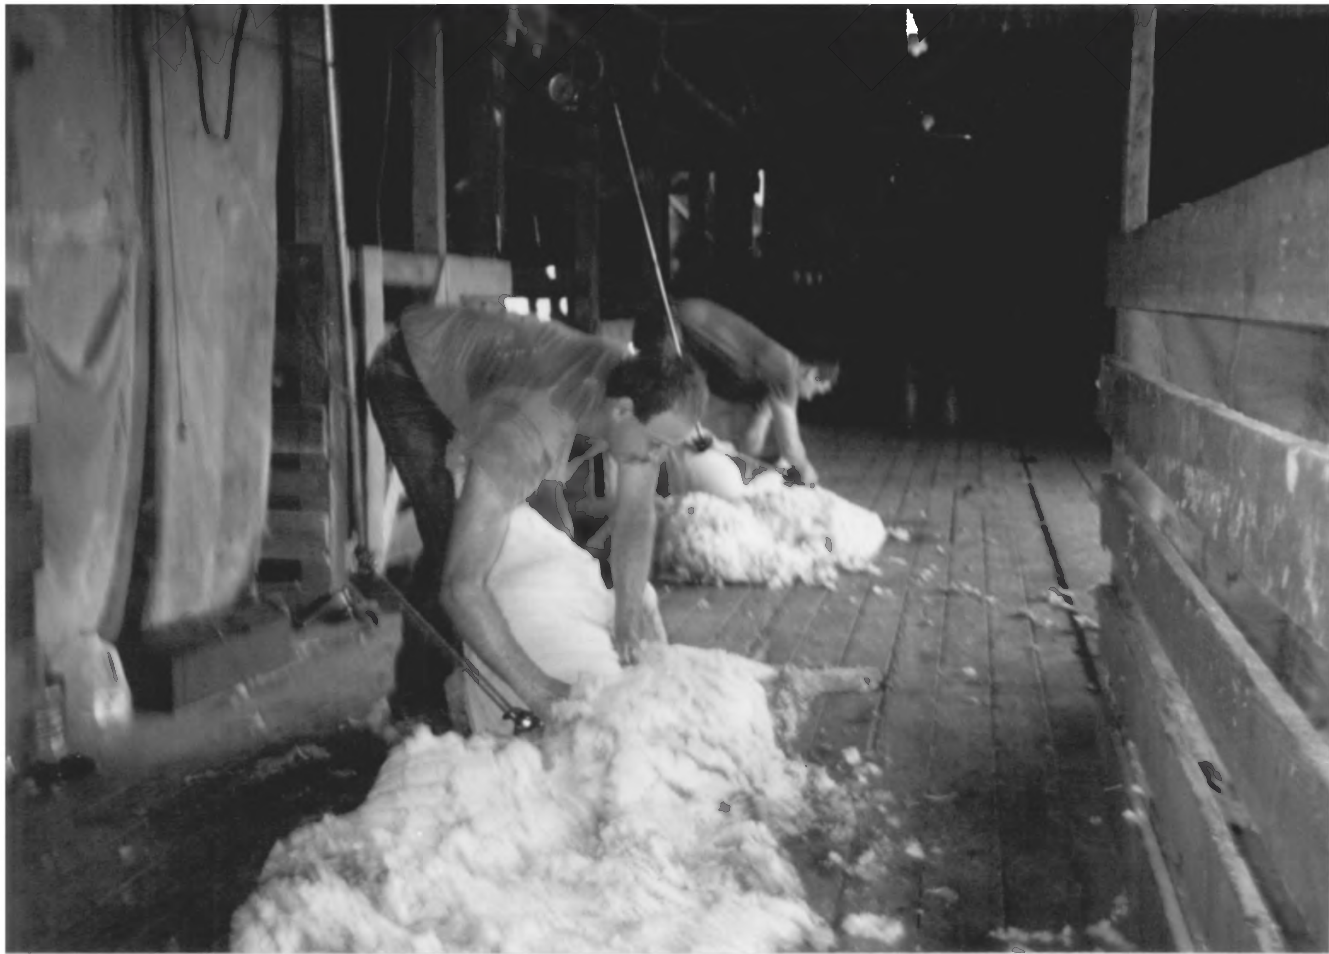
(41 of 42)

1. Name of Resource: Shearing Plant
4. Date: May, 1993
6. View: Looking North, at two shearers at work, on the shearing floor. (Andy Zettle in the foreground.)
7. Photograph Number: Resource 11
41 of 42

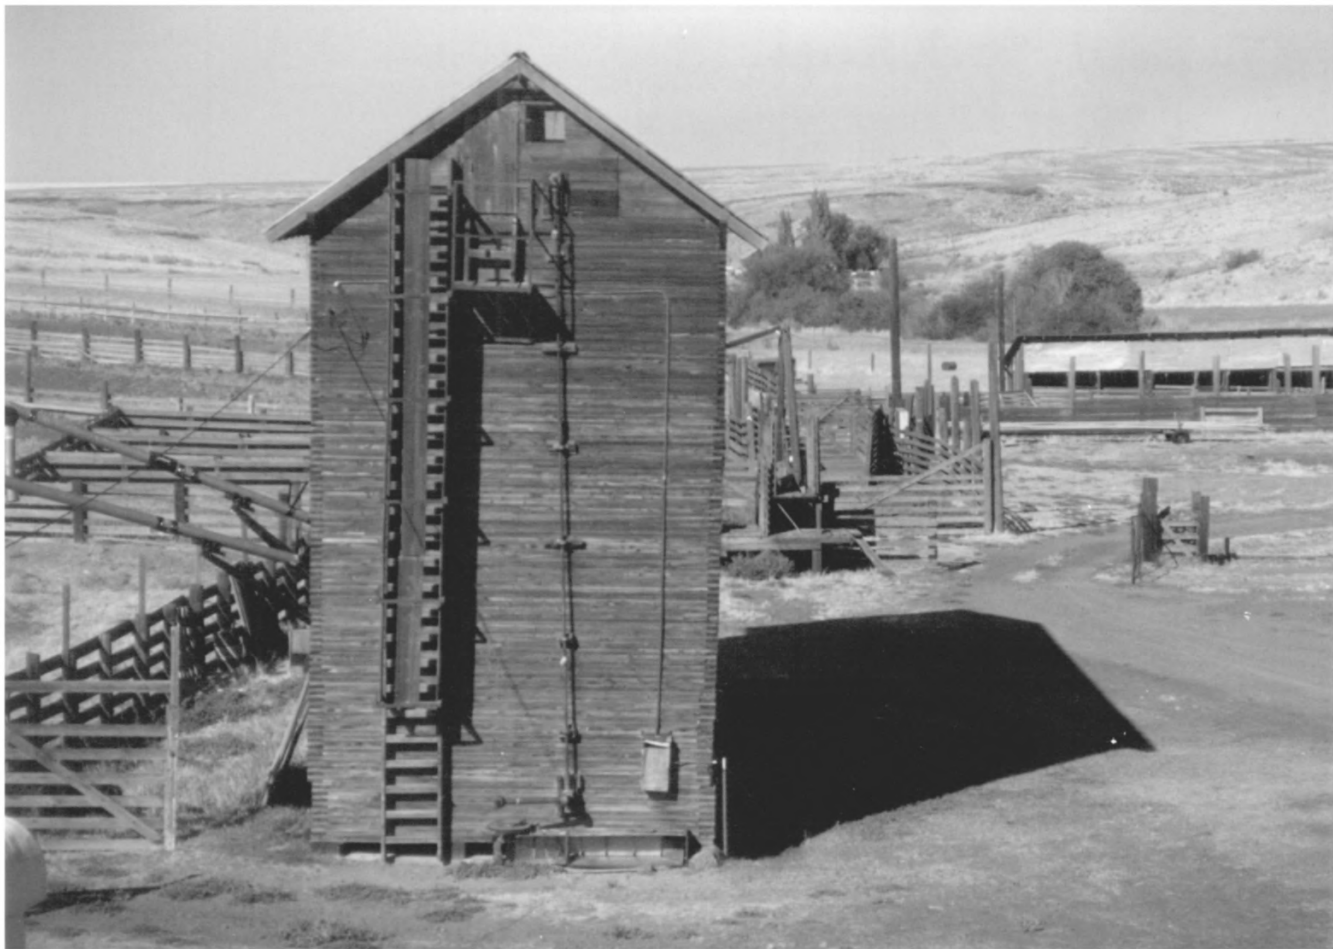
(42 of 42)

1. Name of resource: Grain Elevator
6. View: South elevation of the Grain Elevator. Feedlot and Scales visible to the rear; Lambing Barn to the right.
7. Photograph Number: Resource 16; 17
42 of 42
