National Register of Historic Places
Registration Form

historic name United Presbyterian Church of Shedd

other names/site number Valley Rose Chapel

UNITED PRESBYTERIAN CHURCH OF SHEDD (1892)

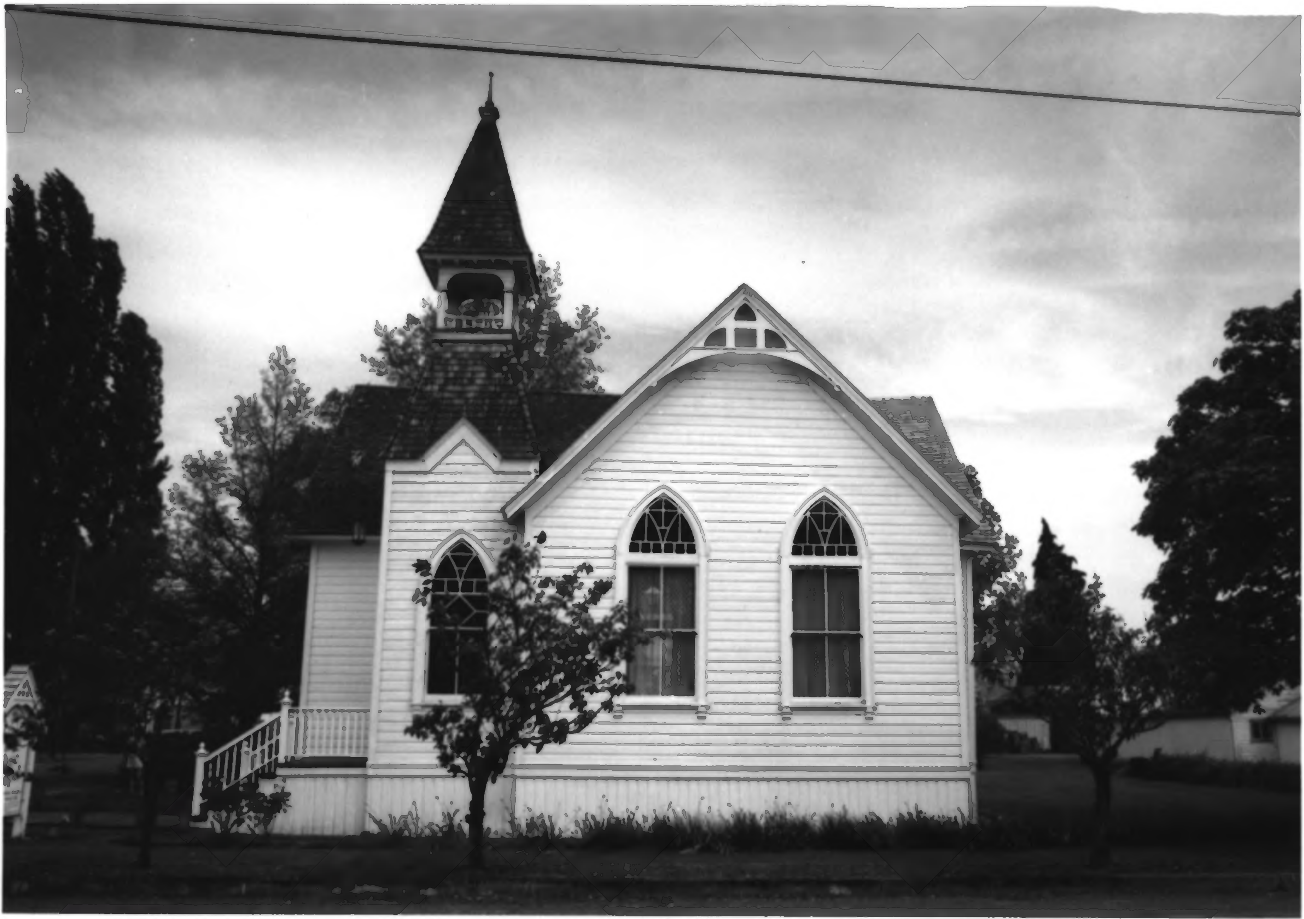
1 of 13

WAST EVALUATION

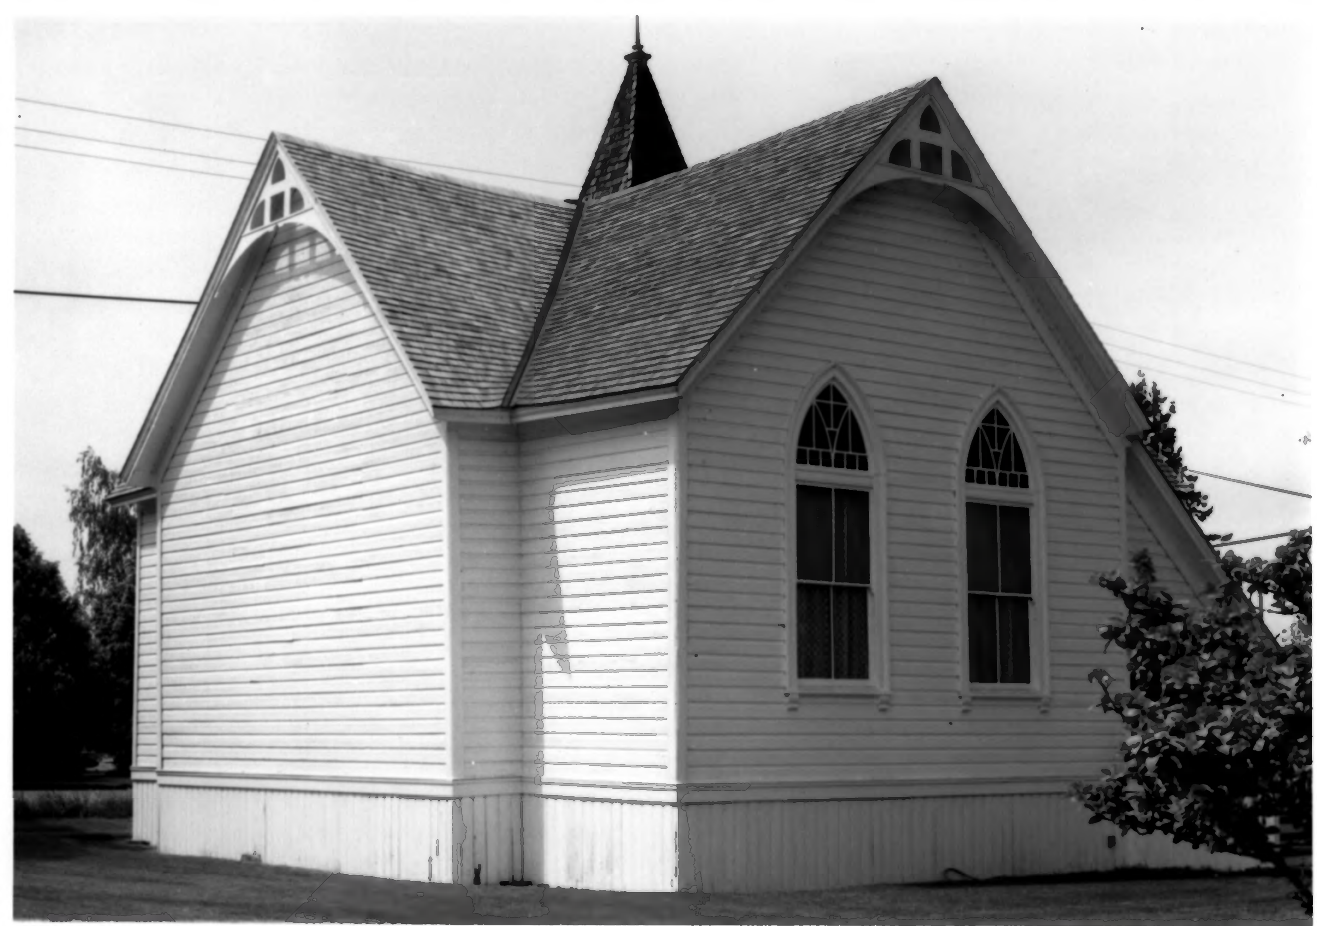
2 of 13

SOUTH AND EAST EVALUATIONS

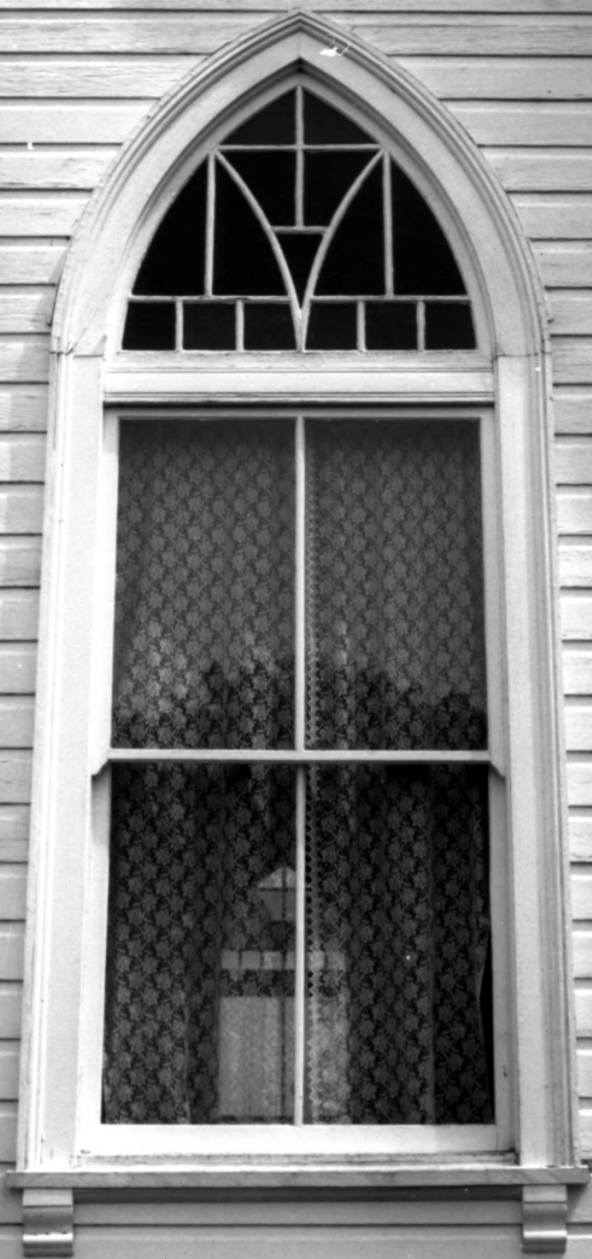
6 of 13

WINDOW, EAST WALL

There are 7 windows, all in lancet shaped openings. The windows are 2 over 2 double-hung sash clear glass with wood muntins, with a lancet shaped stained glass in the stationary upper portion. The stained glass is of relatively simple design with several colors represented, and a cross motif portrayed in the tracery. The windows on the principal facade are coupled in a double lancet style. Beneath the outside window sills lie the decorative console brackets. The outer window trim is 1" x 6", topped on the outer edges with a fluted 1" x 3" moulding. The upper sash stiles have a ogee curve on the bottom outer edges. Three single windows face west, with one in the steeple, two single windows face east, and the south elevation is blind. The two windows facing west, located in the nave, were rebuilt in 1991, at the time the entry was moved from that side. The Eugene Planing Mill provided the windows, moulding was custom milled

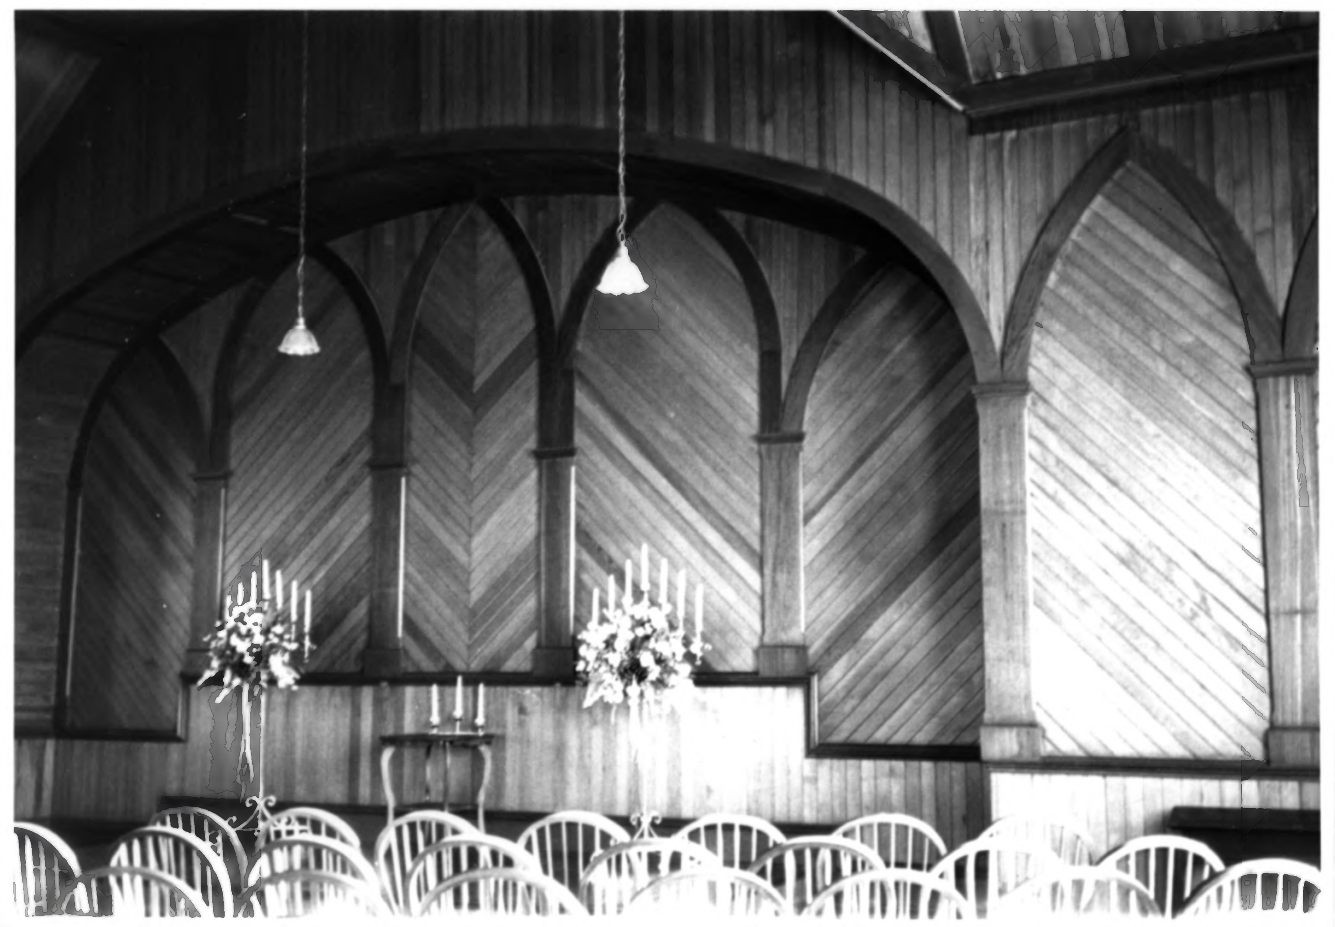
8 of 13

SANCTUARY, SOUTH WALL

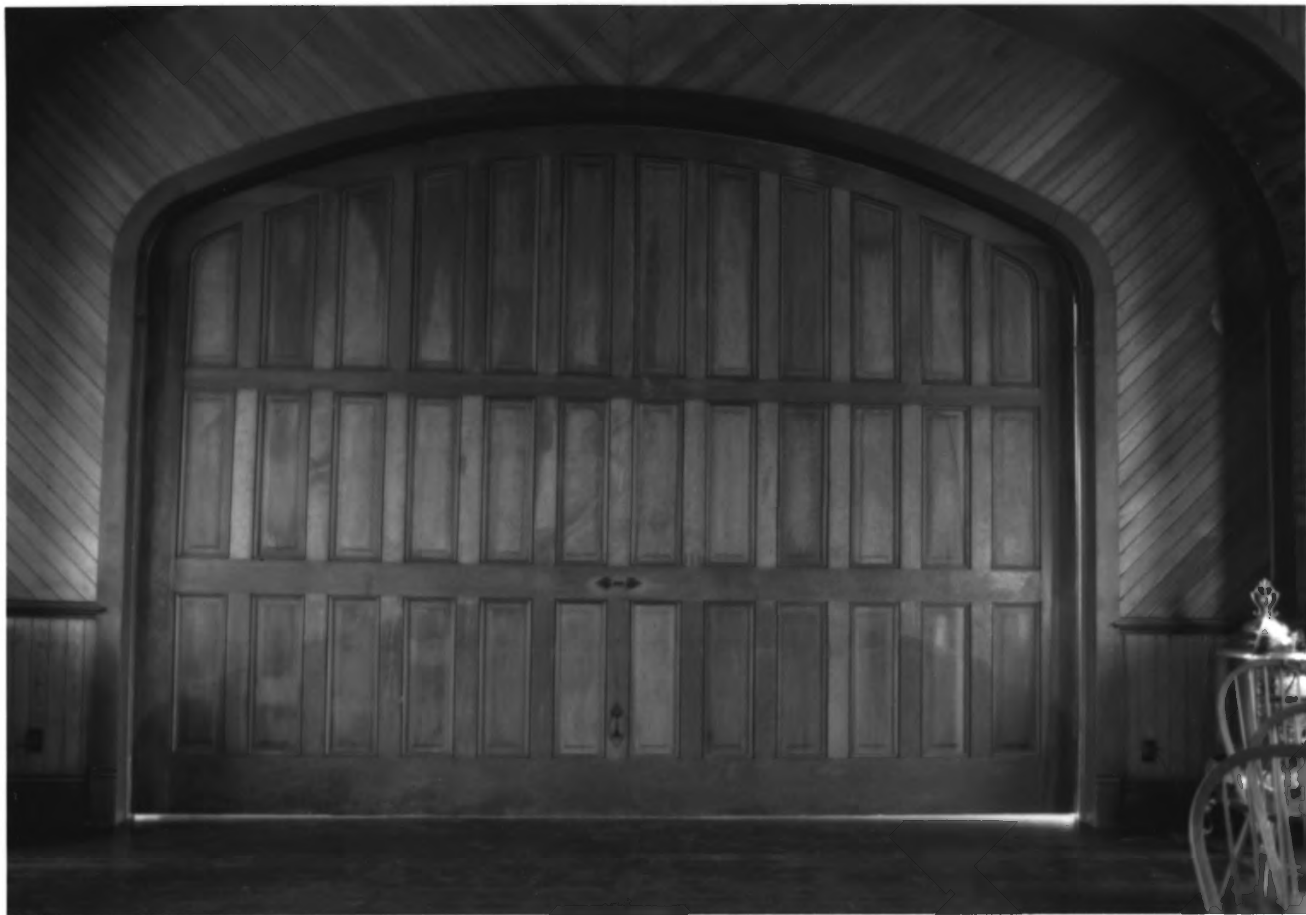
9 of 13

SANCTUARY, PARTITION DOOR, NORTH WALL

There are four interior doors, three of which are original. The most significant is a 16 foot wide raised panel (36 panels) partition door located in an alcove between the nave and the anteroom. It is elliptically arched, and raises up vertically, counterbalanced with sections of railroad rails. This massive door is stained on the nave side and painted white on the anteroom side. The hardware on this door is nonhistoric, antique replacement, purchased in 1991 at Rejuvenation House Parts in Portland. The original interior door leading from the vestibule entry to the anteroom has moulded raised panels and original hardware. The round knob and escutcheon are of a flat, ornamental bronze, and has been identified as a circa 1885 match to a style manufactured by P & F Corbin, of New Britain, CT. The door leading from the sanctuary to the back entry is an oversized original raised panel door, complete with the original ornamental bar handle hardware. It has a self-closing exposed torsion spring mechanism in the jamb, with heavy iron hinges. The door from the back entry vestibule to the bathroom is not original, and matches the back entry door.

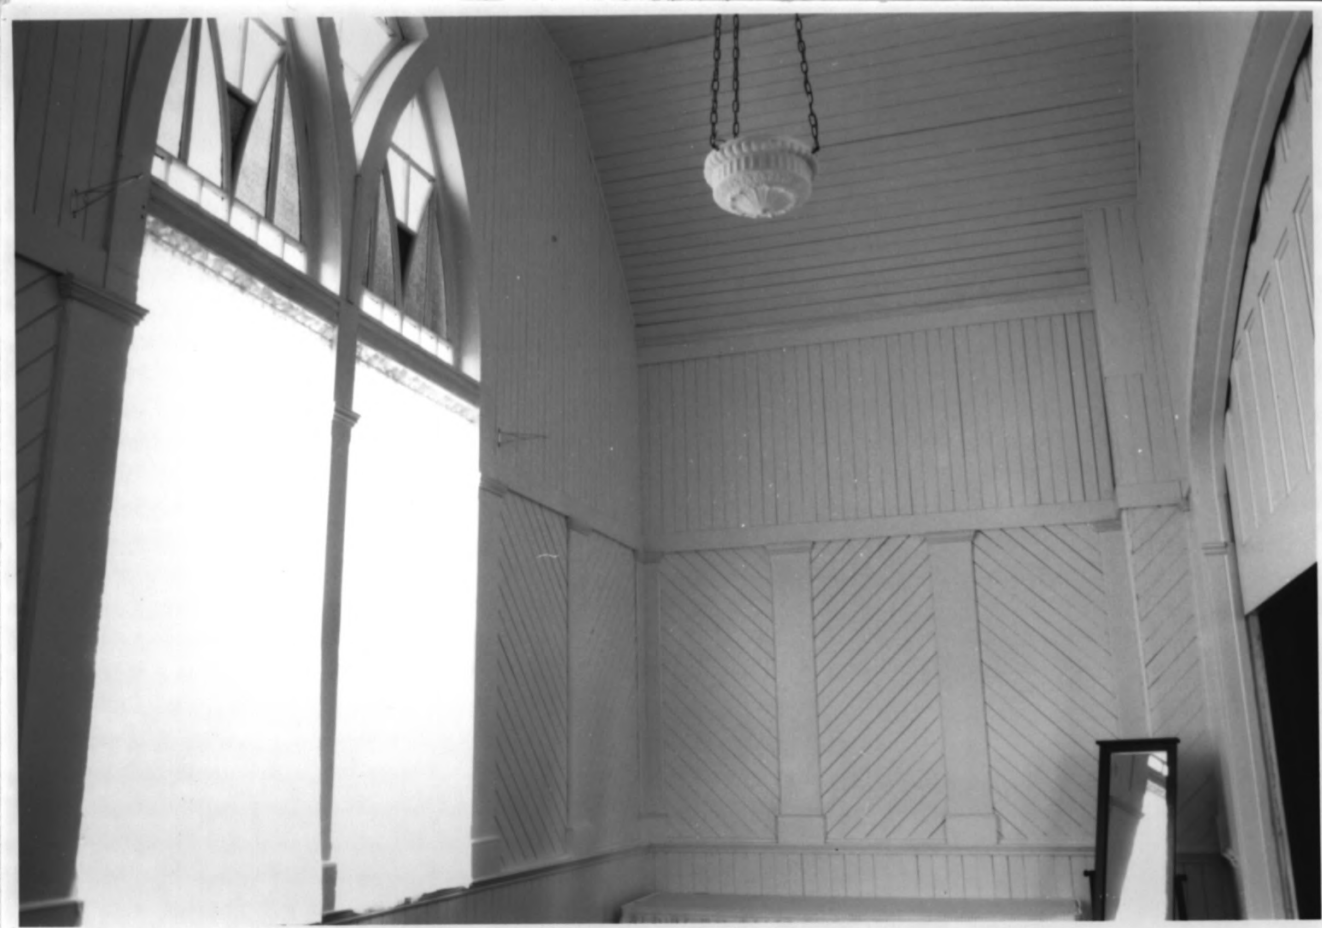
10 of 13

ANTEROOM, NORTH AND EAST WALLS

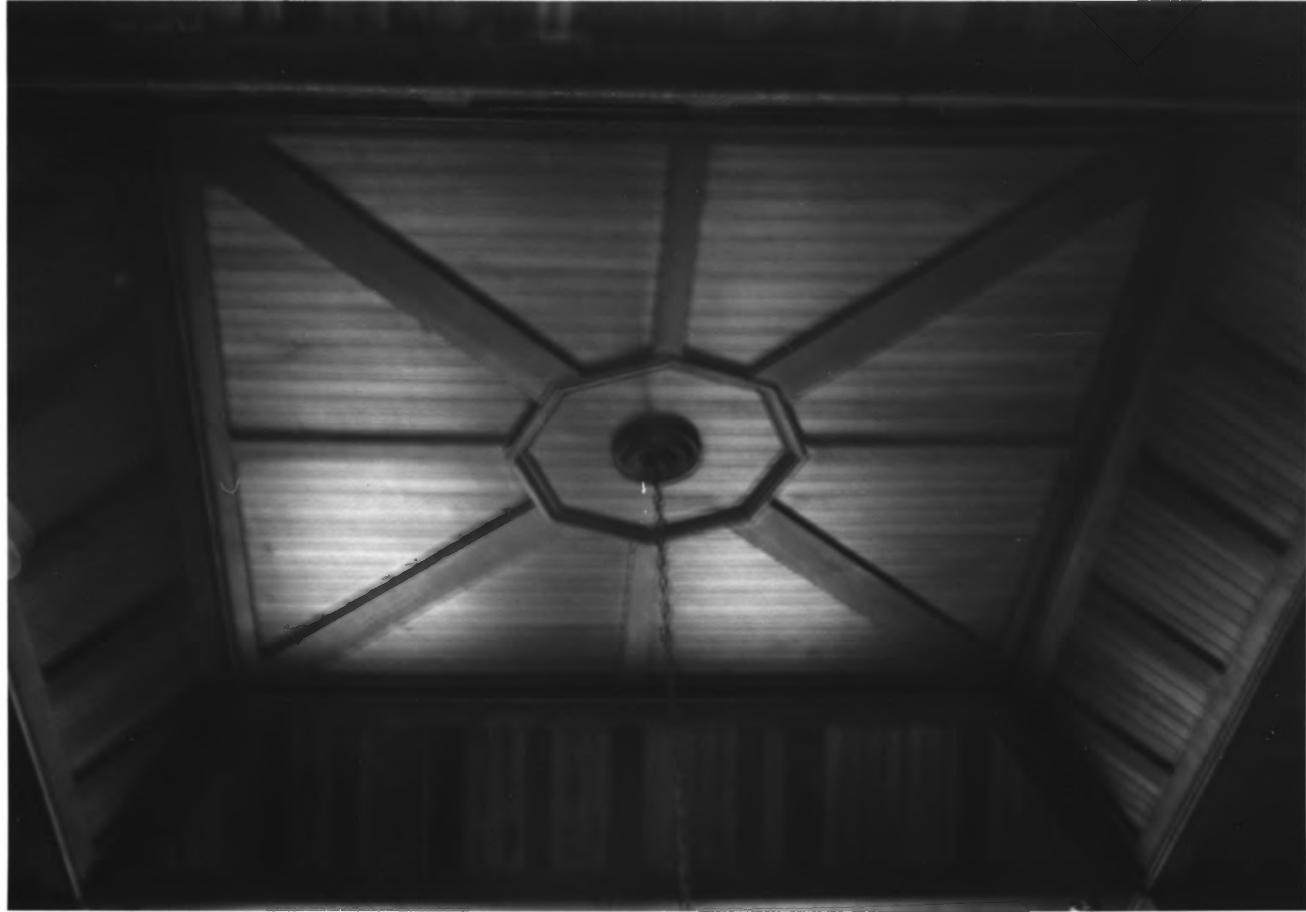
11 of 13

SANCTUARY CEILING

The ceiling is comprised of the pinewood paneling, trimmed with the darker redwood boards. Approximately a 10' by 10' area in the center of the ceiling is coffered. This detail features trim pieces arranged octagonally around the center ceiling plate for the lighting fixture, with 8 dark trim boards radiating to the interior hip portion of the coffer. These hip panels are interspersed with dark trim boards approximately every 2 feet. The east and west portions of the ceiling, contain less trim detail, and are paneled with the white pine. The south and north portions of the nave ceiling have a barrel vaulted appearance, three feet deep, and are trimmed with both the light and dark woods. Interior hips in the front upper corners above the chancel, caused by the roof valleys, add to the visual interest.

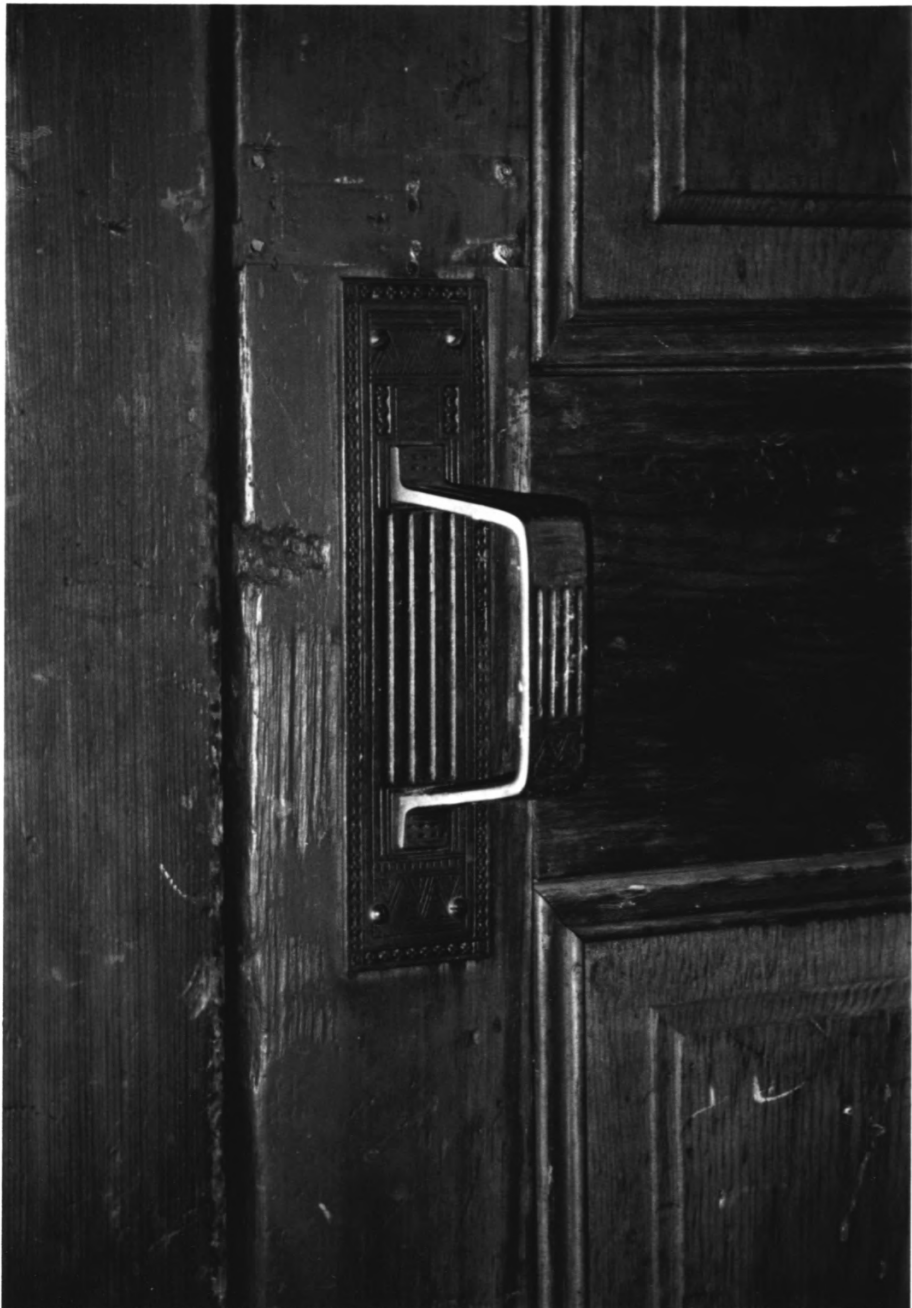
DOOR HANDWASH

SECONDARY ENTRANCE VESTIBULE
