National Register of Historic Places
Registration Form

historic name Roosevelt Hotel

street & number 1005 SW Park Avenue N/A not for publication

ROOSEVELT HOTEL (1924)
1005 SW Park Avenue
Portland, Multnomah County, Oregon

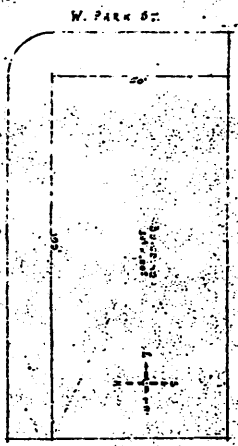
①
 HOTEL BUILDING
 101-103 West Park St.
 6' Granite base
 FOR THE ARCHITECT
 CLAYTON BARRON
 508 S. ROCKY MOUNTAIN AVENUE

WEST PARK ST. ELEVATION
 SCALE 1/4" = 1'-0"

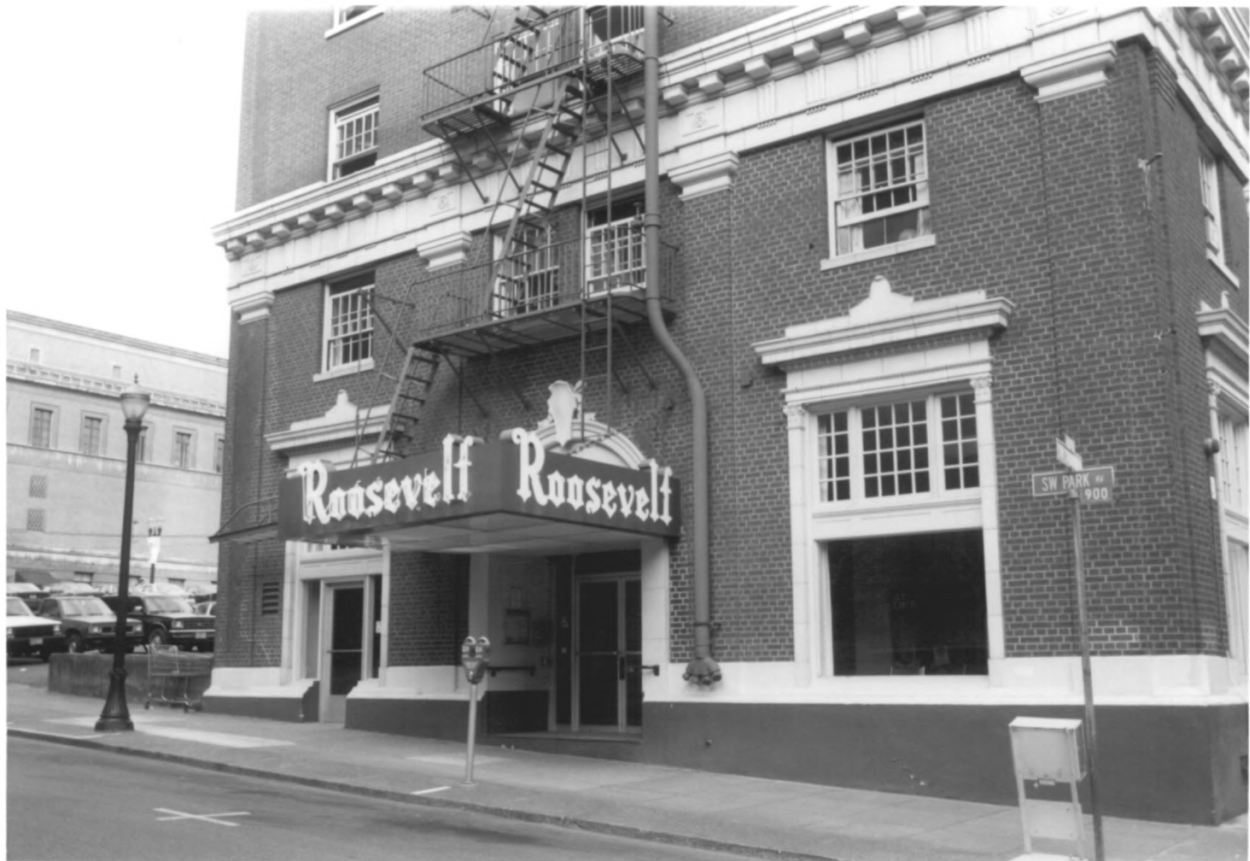
Photo 2 of 16

E elevation main entrance detail

The ground floor treatment is particularly elaborate. On the east, windows flank the center entry. These are divided into two halves, with the lower half a single fixed pane in wood frame. The upper half is divided into tripartite multilights. These windows have a dramatic terra cotta surround with a classical terra cotta hood. Second floor windows are eight over eight, double hung wood sash. At the center is a classically styled double wood doors with sidelights and semicircular fan light; a steel and glass canopy provides shelter to the entry. Adding to the east facade are recessed brick panels at the eighth floor level between each bay.

In 1974, the Salmon Street entries were modified to the present form for the Zen Restaurant. In 1976, the marquee was removed and the present metal tongue canopy installed. A commercial glass and aluminum butterfly door was also installed.

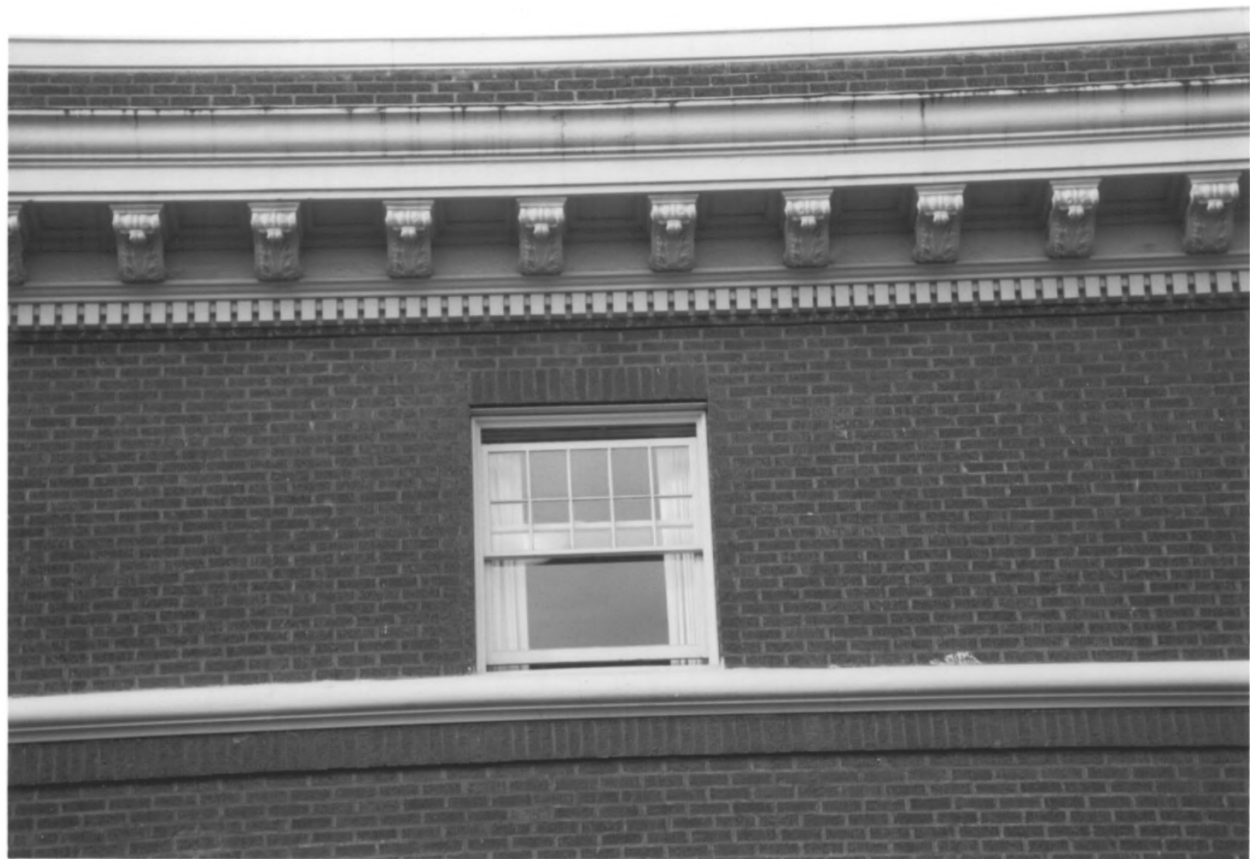
Photo 8 of 16

Exterior detail

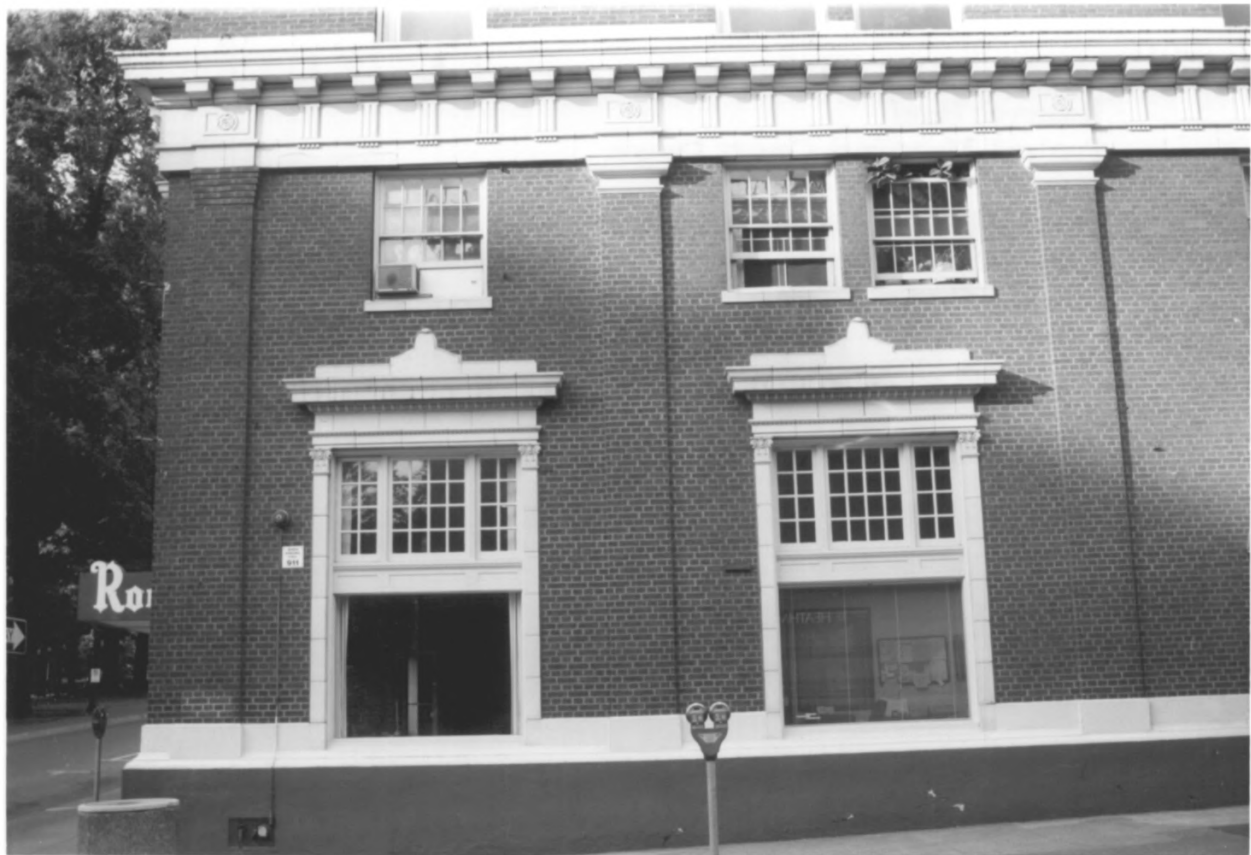
Photo 9 of 16

Exterior detail

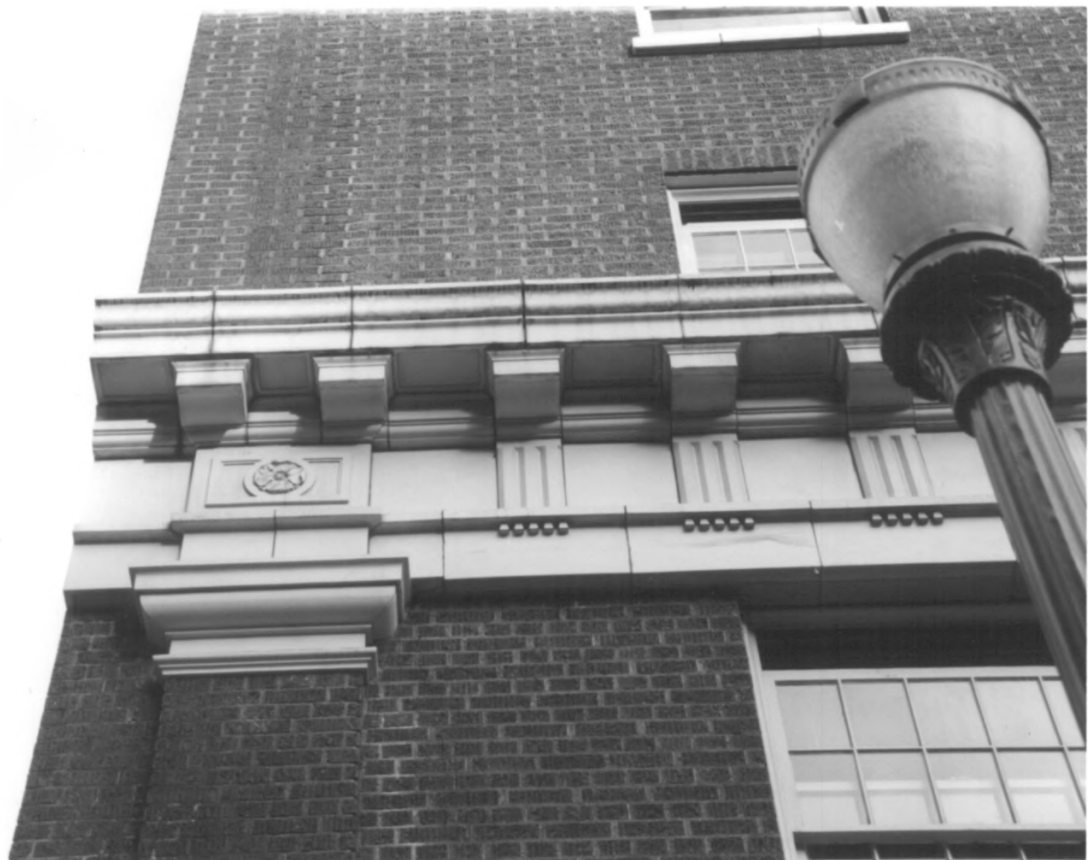
Photo 10 of 16

Exterior detail

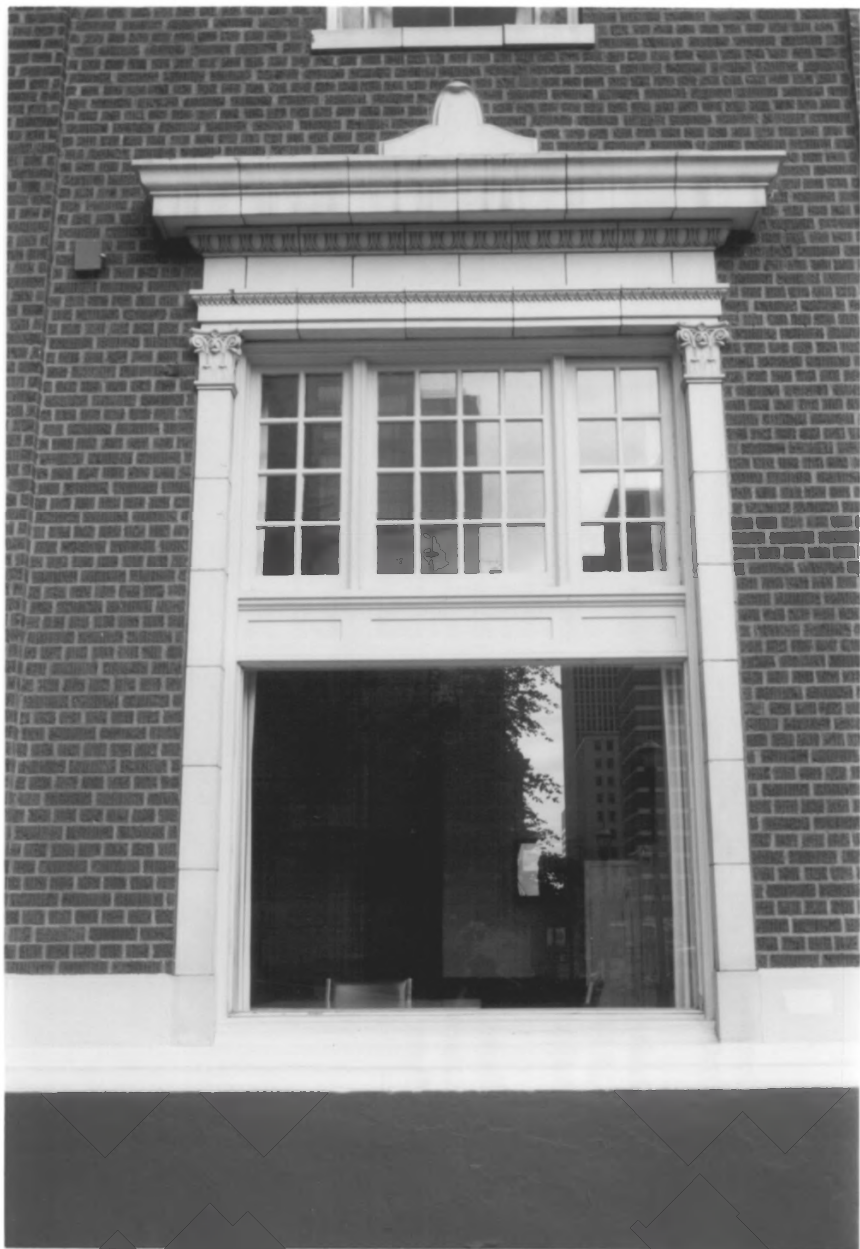
Photo 11 of 16

Exterior detail
