National Register of Historic Places  
Registration Form

historic name The Emerson Apartments

street & number 5310 N Williams Avenue  not for publication

## 7. GENERAL DESCRIPTION

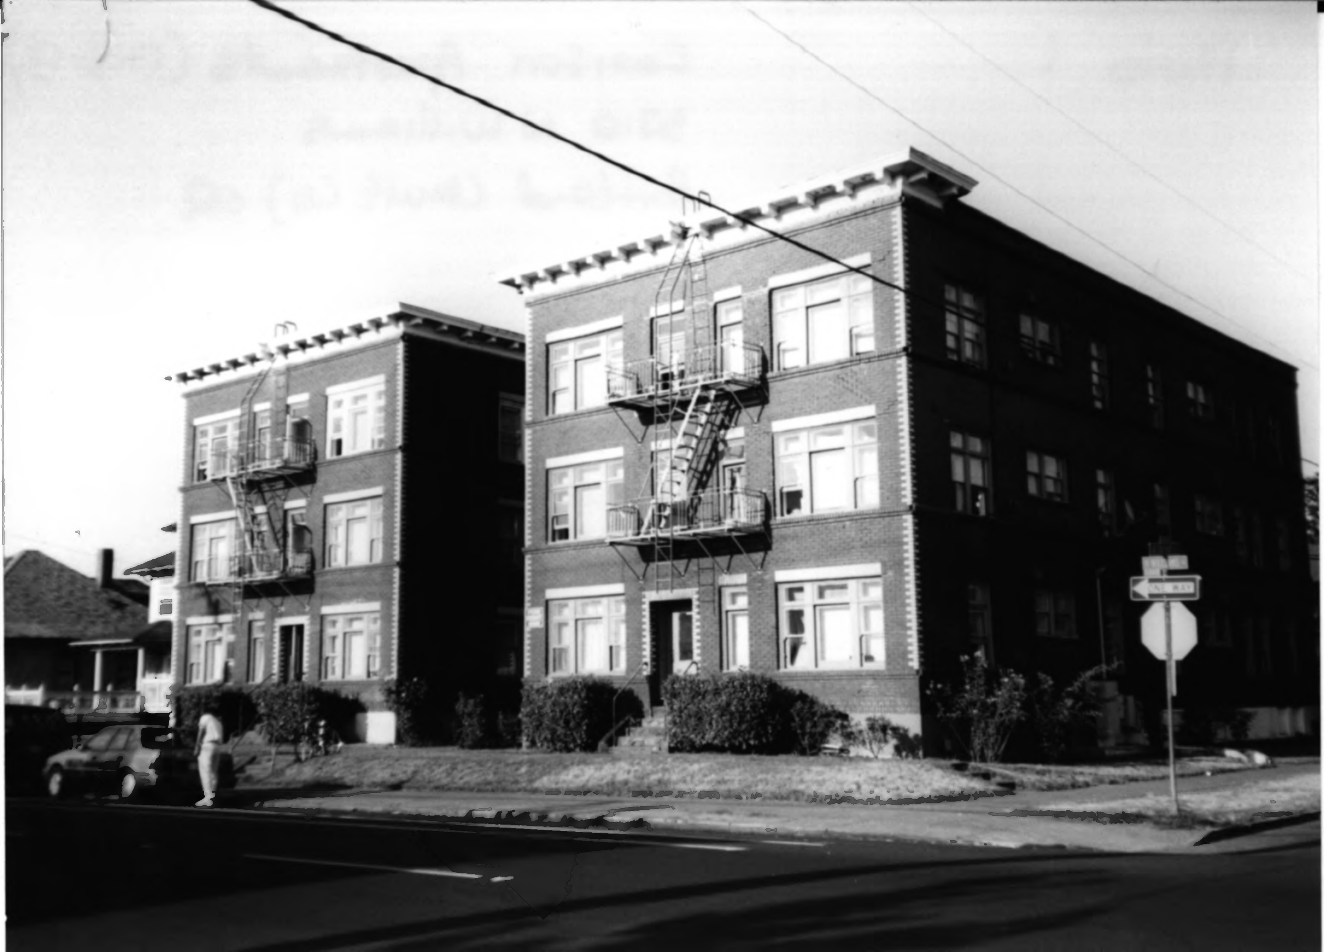
Photo 1 of 15

West & South Elevations  
(from SW)

The Emerson Apartments of 1912-13 is a brick walled 3 storey structure with a symmetrical layout as a perfect example of the Streetcar Commercial design.(Photo 1) This building slightly differs from others typical of this era due to envelopes in the center in the front and rear allowing for more windows and light to the many units inside.(Photo 4) All the windows are of the one over one double-hung type and the wooden originals. The glass in many of the windows is broken, especially on the third floor and at the end of the hallways. The flat roof is of asphalt slightly pitched in areas in order to funnel water to

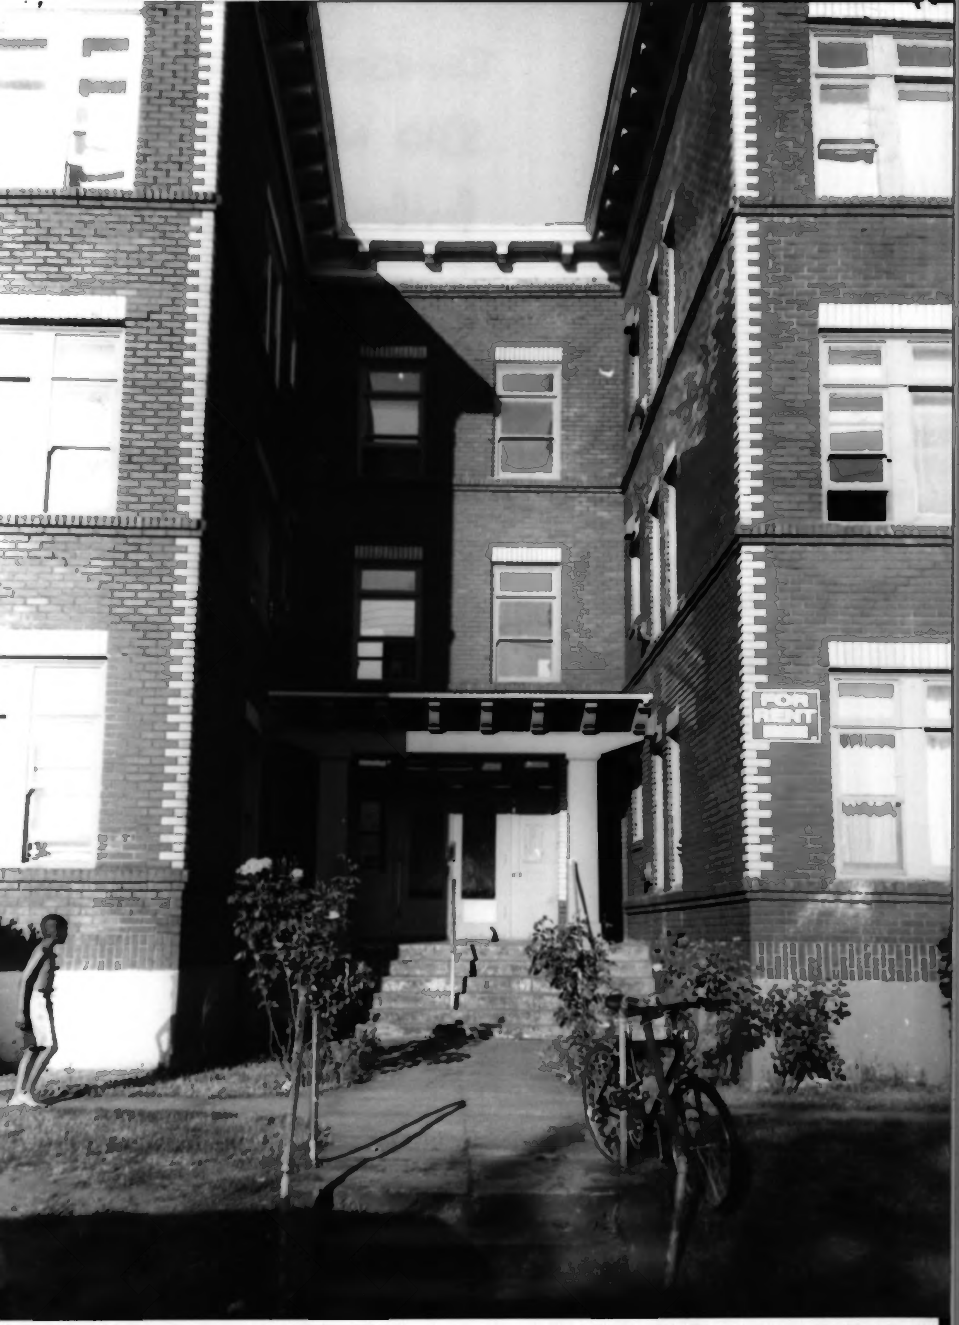
Photo 4 OF 15

Front entrance  
(from w)

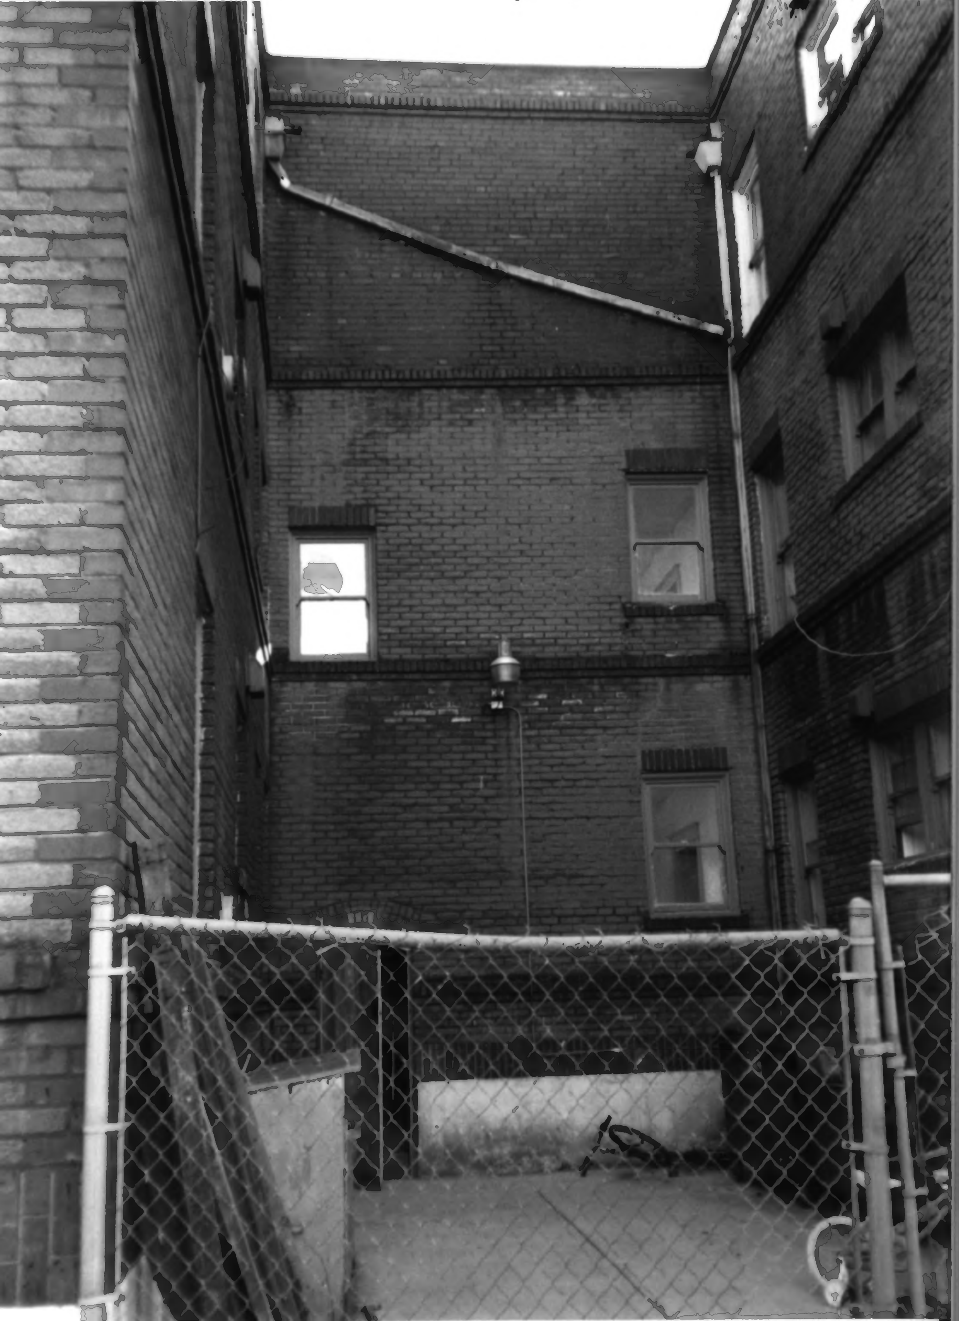
Photo 6 of 15

Rear courtyard or service area  
(from E)

The east (rear) elevation faces the alley and has an envelope in the center over 32' deep used as a servicing area with a locked gate and fence.(Photo 6) At the south end of the inside wall is a single door at ground level. At the northeast corner of this paved area is a sunken grade basement access area with a double set of large doors. The facade of this elevation differs from the others by domination on the first and second level by bricks cast

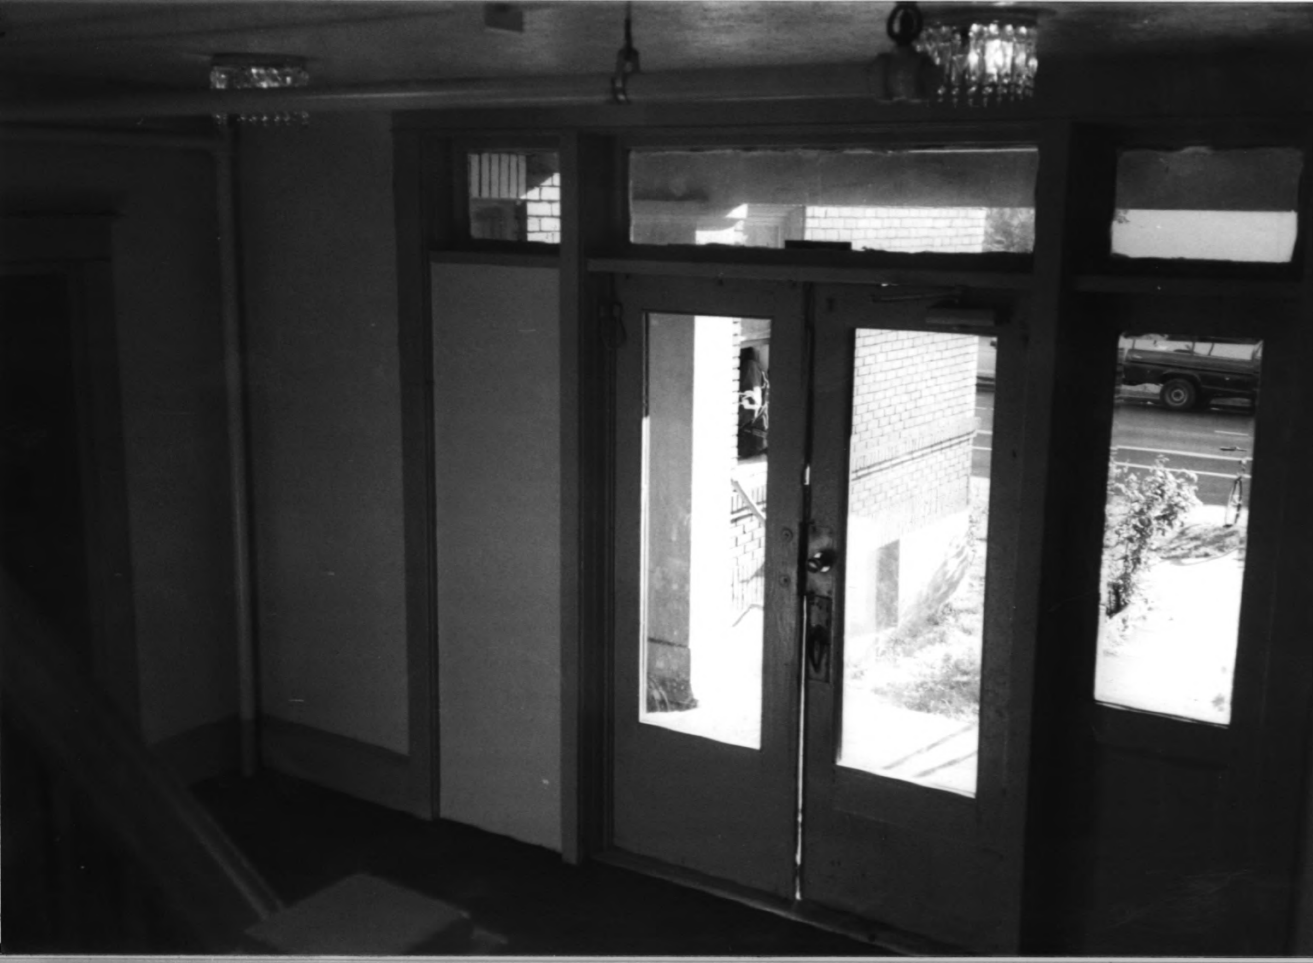
Photo 8 of 15

Inside main foyer  
(view from NE)

The main foyer is immediately inside the ground level entrance with the double front doors.(Photo 8) Straight ahead is a bench that sets between the staircase openings. There is a pipeline along the length of this with a fire sprinkling system added in 1975 for updated fire code requirements. To the immediate left at the north wall is a metal door that accesses the north wing that may have been added for fire code requirements in 1975. To the right just before this opening is the staircase upward to the second and third floors. The balustrade is the original of Douglas-fir construction throughout the entire staircase. In the foyer to the immediate right (south) is a framed opening to a short hallway (5' long) where another metal fire door is met. To the left just before this opening

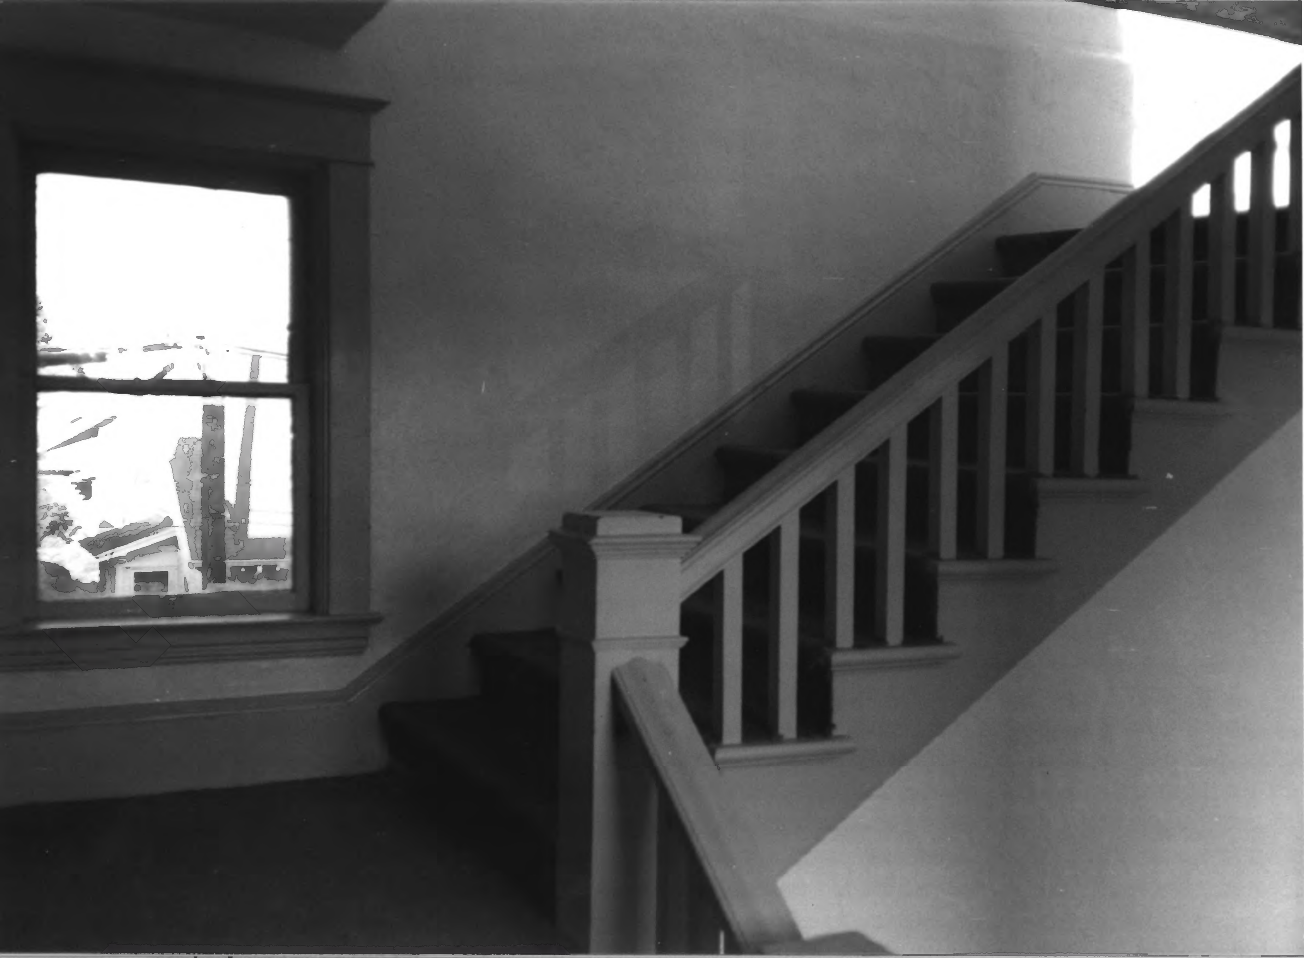
Photo 9 OF 15

Stairwell between 2<sup>nd</sup> & 3<sup>rd</sup> floors  
(view from W)

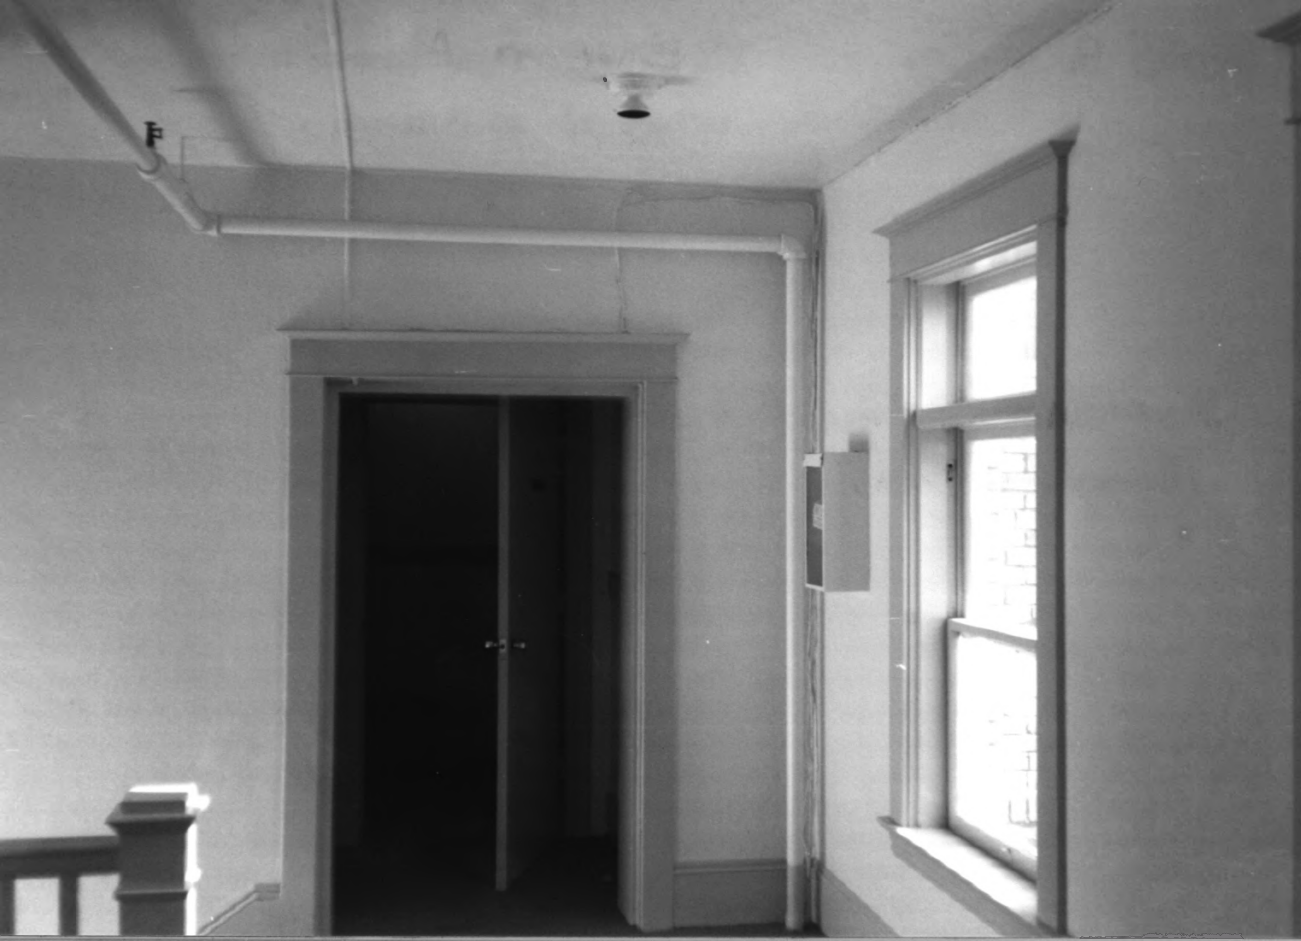
Photo 10 of 15

Swing entrance, 3<sup>rd</sup> floor landing  
(view from N)

Going back to the main foyer, the upward staircase at the left runs east to a landing lit by a single window and turns south upward to another landing also with a window, then west to the second floor. At the second floor foyer, sets of windows light from the west and the staircase continues in the same fashion to the third floor.(Photo 9) The fire sprinklers run the entire course of the staircase. The third floor foyer is the same as the second except for the presence of a door for roof access at the northeast corner instead of an open staircase.(Photo 10) There is no attic in the building.

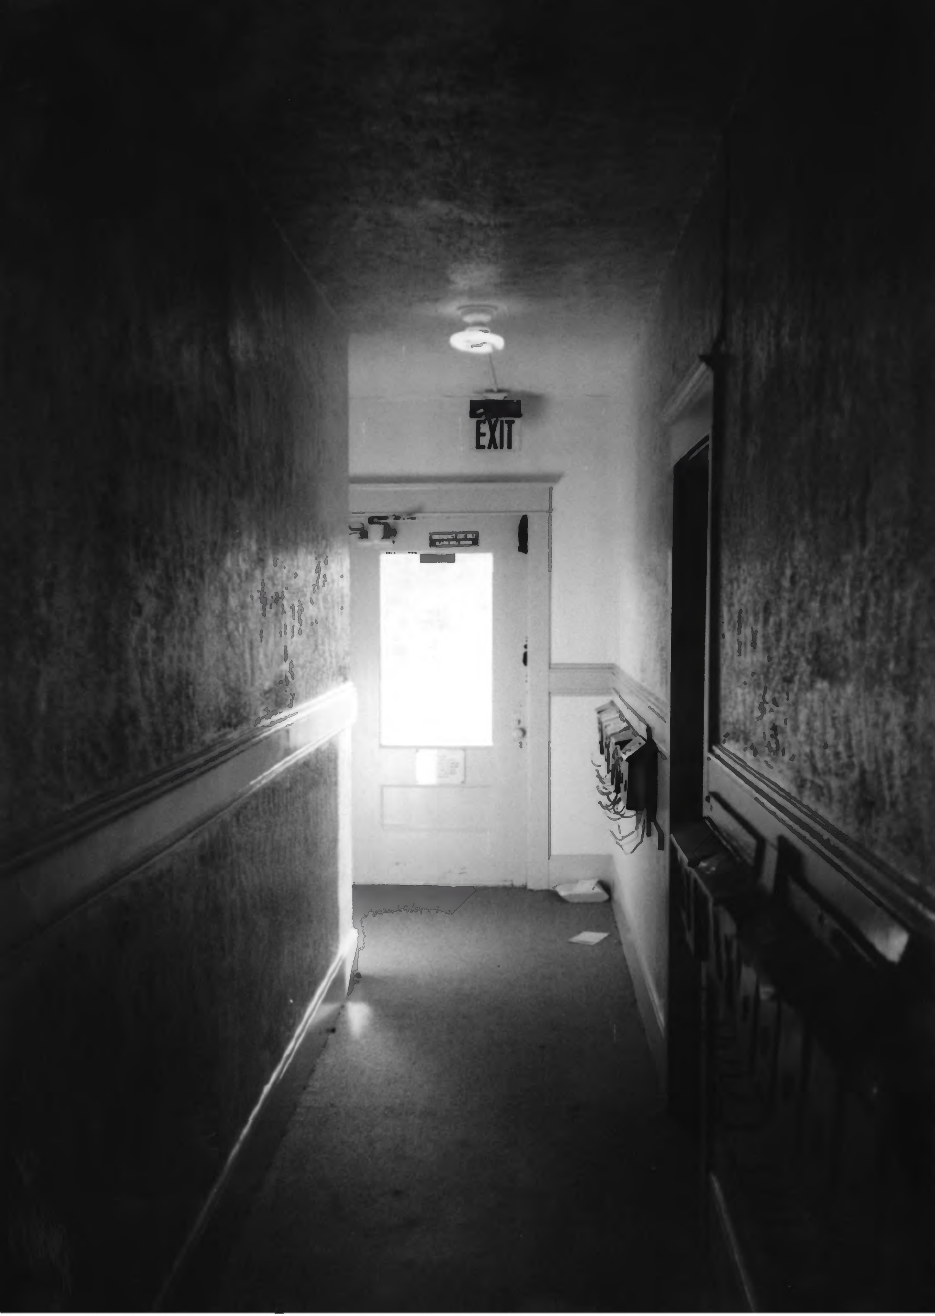
1<sup>st</sup> floor hallway on S wing to  
fire exit door (view from E)

Back in the south wing hall, the west end has the same layout as the north wing with unit doors on each side and a fire exit door straight ahead.(Photo 11) The second and third floors differ with a window to the fire escape.(Photo 13) On the south side past the similar jog is the door to Unit 7, a one bedroom apartment. This door opens into a shallow foyer with the living area ahead with windows on the south and west walls. North of this area is a dining area with a shaped plaster opening like inside the other units. In the east wall is a doorway to the kitchen. At the northeast corner of the kitchen is an angled hall space with a door to the left for the bathroom and one to the right for the bedroom. On the north side of the bedroom is a small walk-in closet. Units 27 & 37 have the same floor plan.

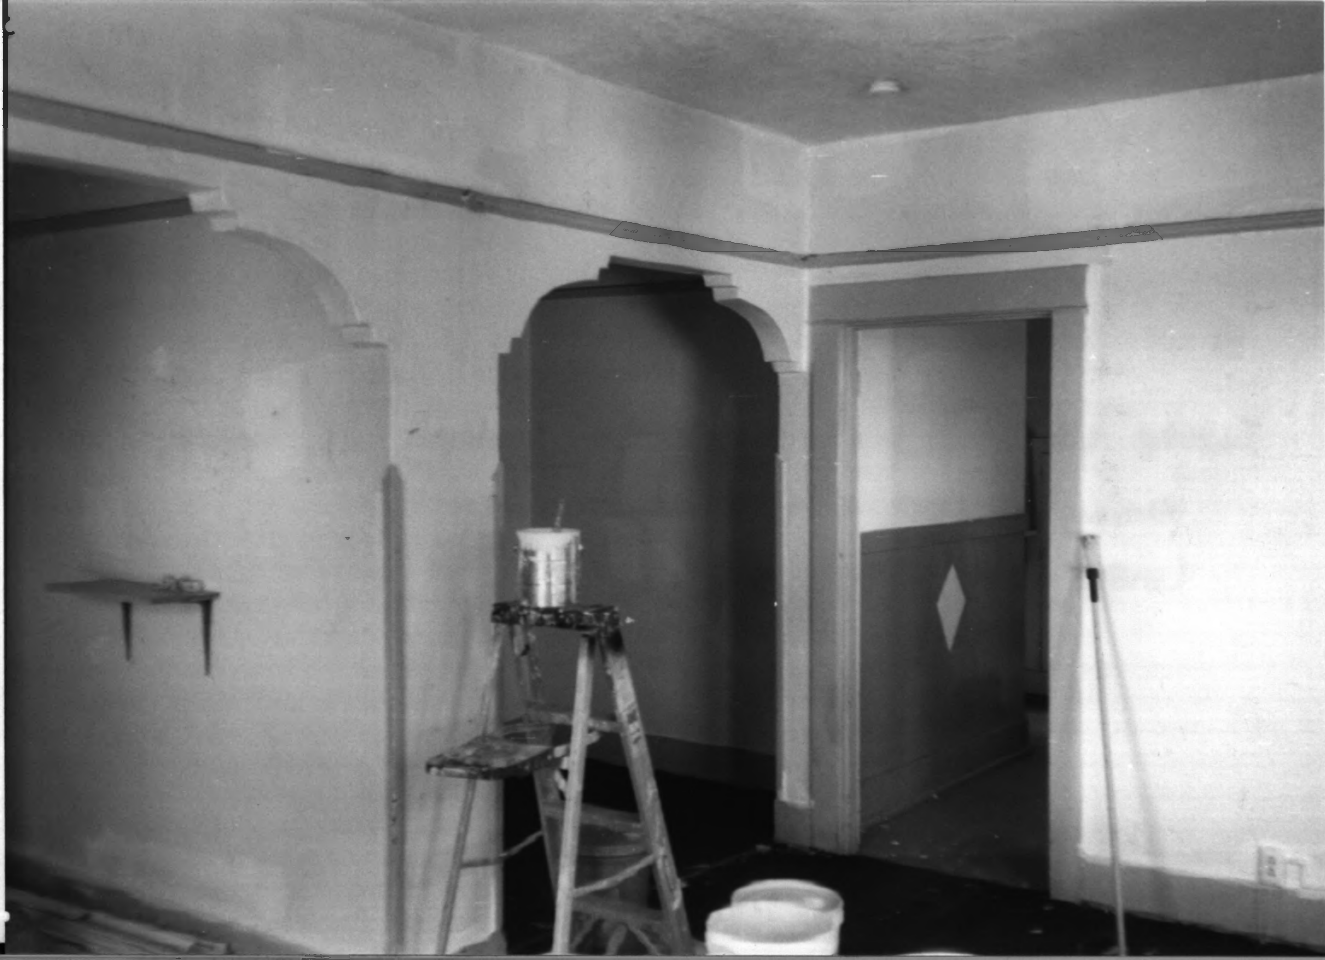
Photo 14 OF 15

Inside Unit 33 - living area looking at foyer,  
dining alcove, a kitchen doorway  
(view from NE)

patterned key shaped arched opening to a more spacious living area.(Photo 14) At the southwest corner on the south wall is a dining area alcove separated by the same arched openings. At the south end of the west wall is the opening into the kitchen. Going past the kitchen is a short angled hall space with the bathroom door to the left and the bedroom door to the right. Inside this more spacious bedroom is a double set of windows to the north and a walk-in alcove to the south. This space substitutes the closet and has the same shaped plaster cast opening. The floor plans to Units 23 & 33 above are identical.
