# National Register of Historic Places Registration Form

Union Station (Additional Documentation)  
Name of Property

Multnomah County, Oregon  
County and State

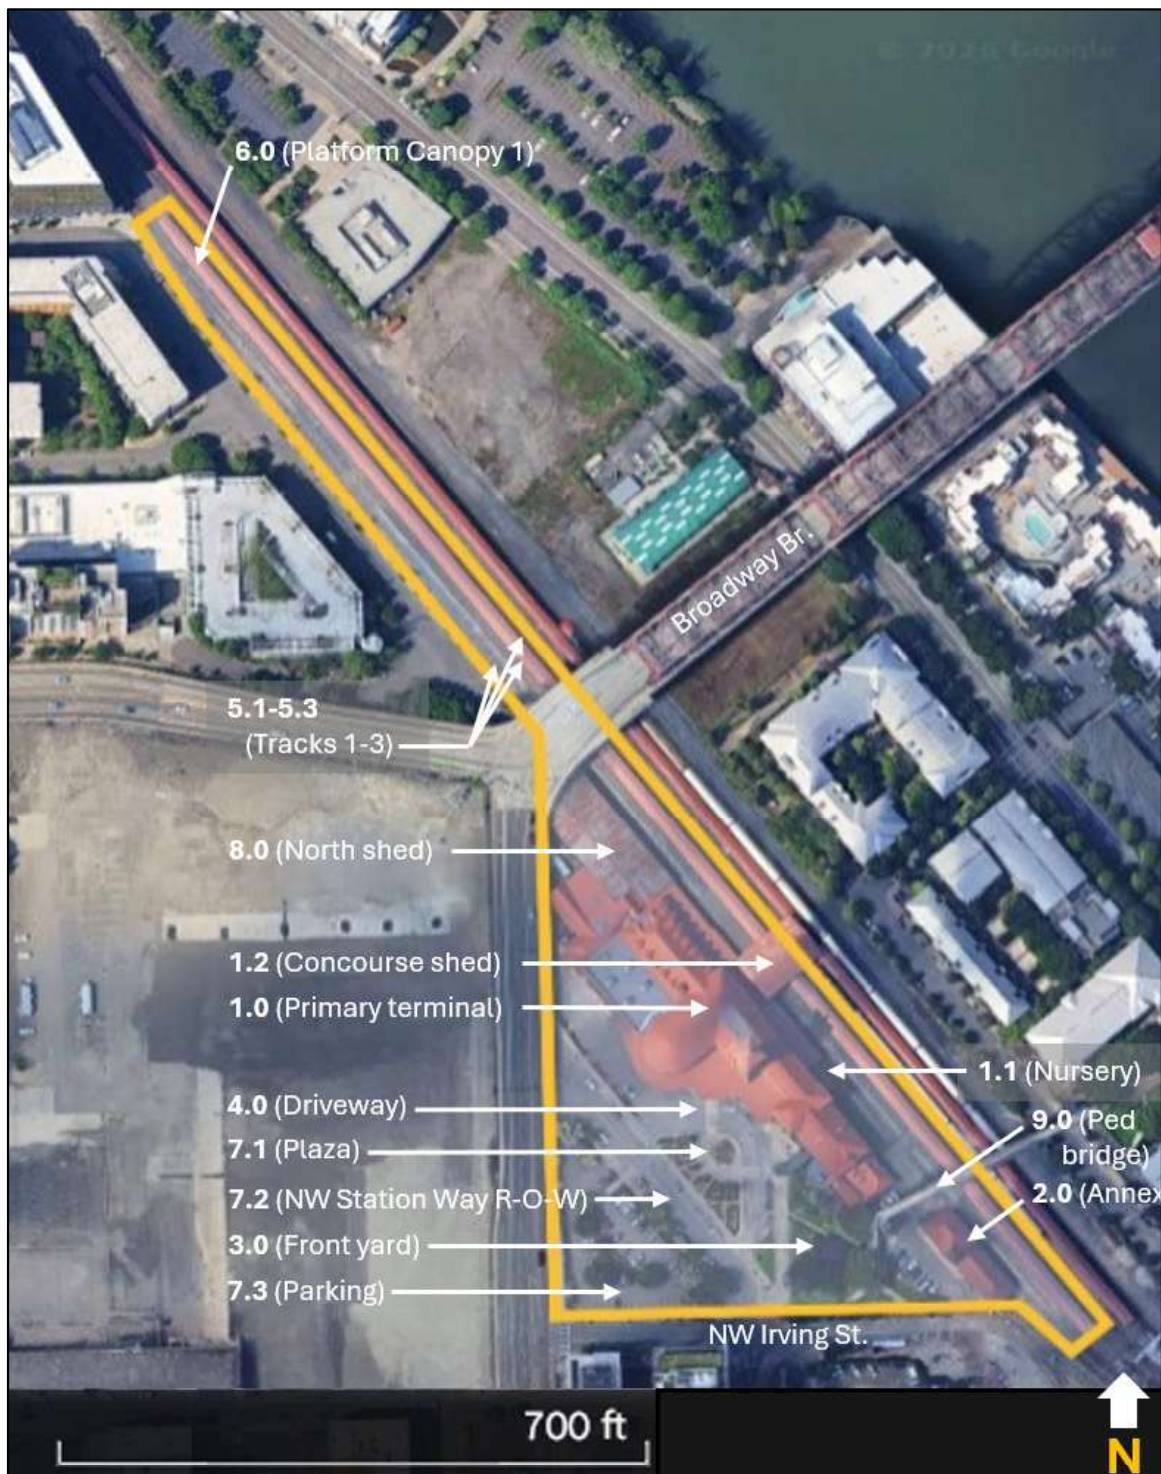
**Figure 4.** Site Plan (Keyed to Table 1, Section 7).

Nominated boundary (unchanged from 1989 Boundary Clarification) is shown in gold.

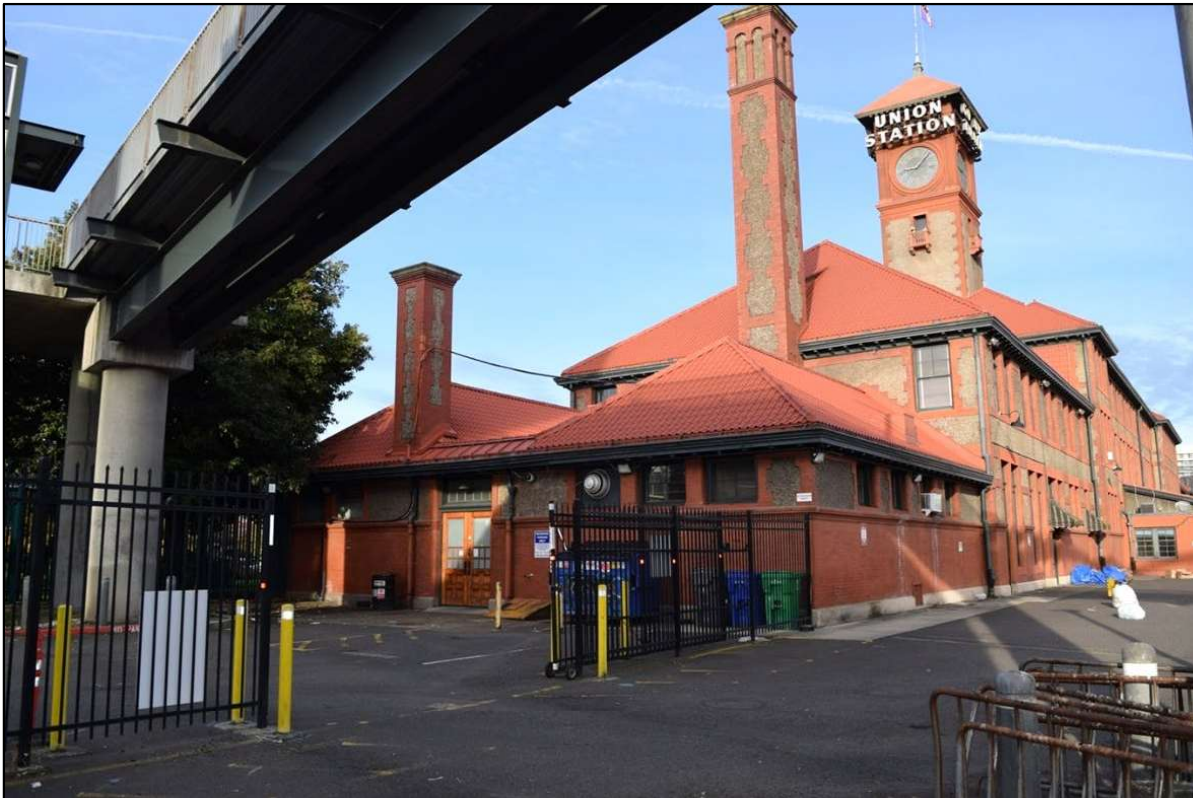
**Photograph 4 of 18:** OR\_MultnomahCounty\_UnionStationAmendment\_0004 ]  
Southeast end of Primary Terminal; looking north.

The single-story façade at the southeast end (**Photograph 4**) continues the tall brick base of the building with five high windows above it, interspersed with panels of pebbled stucco trimmed with brick "quoining." A pair of wood and glass doors (likely not original) with a multipane transom is centered on the elevation. Only two of the five windows are the original four-pane configuration; two on the left have been replaced and the center one infilled with a round duct and panel. Tall black vertical metal fencing extends the planes of the

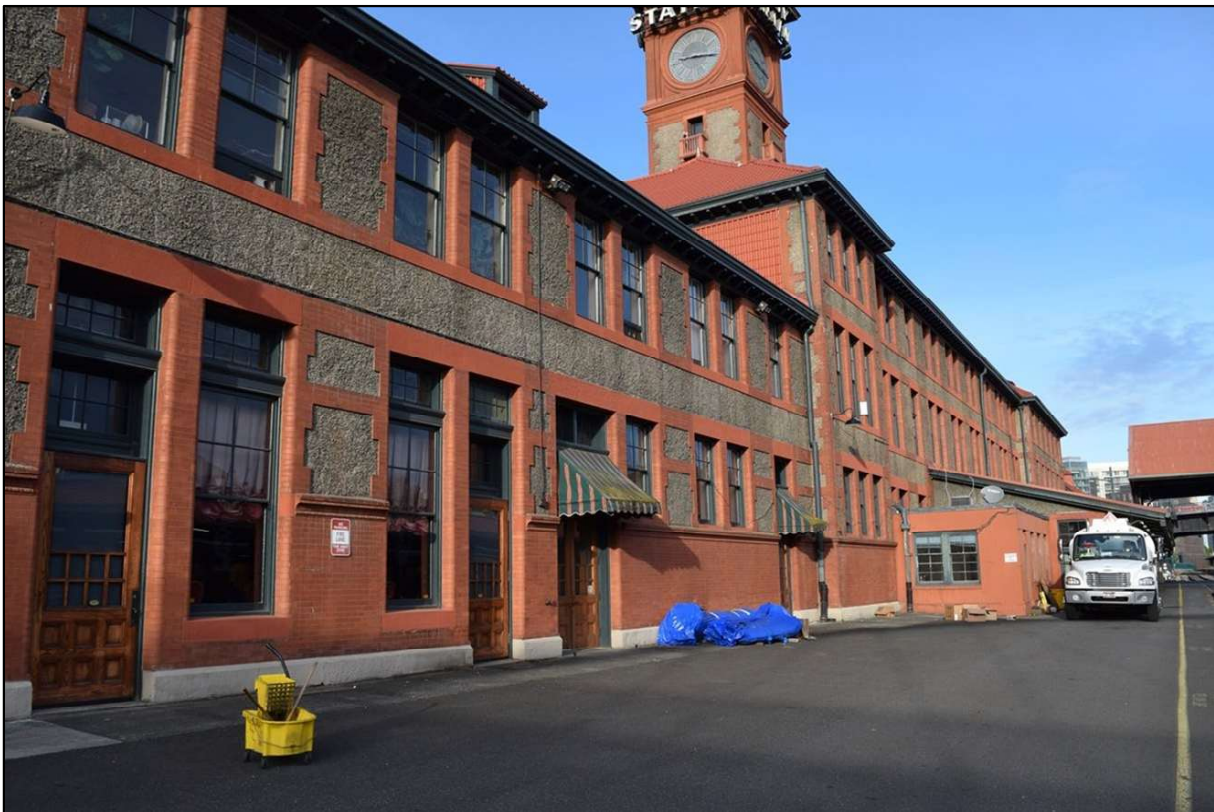
**Photograph 6 of 18:** OR\_MultnomahCounty\_UnionStationAmendment\_0006  
Northeast façade and Nursery addition, looking north.

Continuing around the building to the northeast façade, starting from the single-story volume, there are four high four-pane windows above the base, one of which has been infilled with a projecting air conditioning unit. The northeast roof here has a single modified dormer with no window and a flat roof. At the two-story volume, the wall steps slightly out towards the northeast. Ground-level openings are mostly vertically aligned with uppers, but four of these lower openings are doorways; one a pair of double doors, all with transoms above them, two of which are fitted with individual fabric canopies. Two are taller windows, extending down into the brick base, and three windows stop at the top of the brick base. The upper level has four pairs plus a single window, all four-over-one. A small shed-roofed dormer in the roof of the two-story volume has a four-pane window.

Openings in the nursery, constructed in 1944, include a pair of wood double-hung four-over-six windows facing southeast, with horizontally-oriented panes, a single plain wood door with (covered) transom and three four-over-six windows facing northeast. The door has a small concrete step. There are several noticeable cracks in the walls. Some mechanical equipment is located on the roof of the nursery addition, and a large black pipe extends from the wall just above the nursery down into the concrete sidewalk.

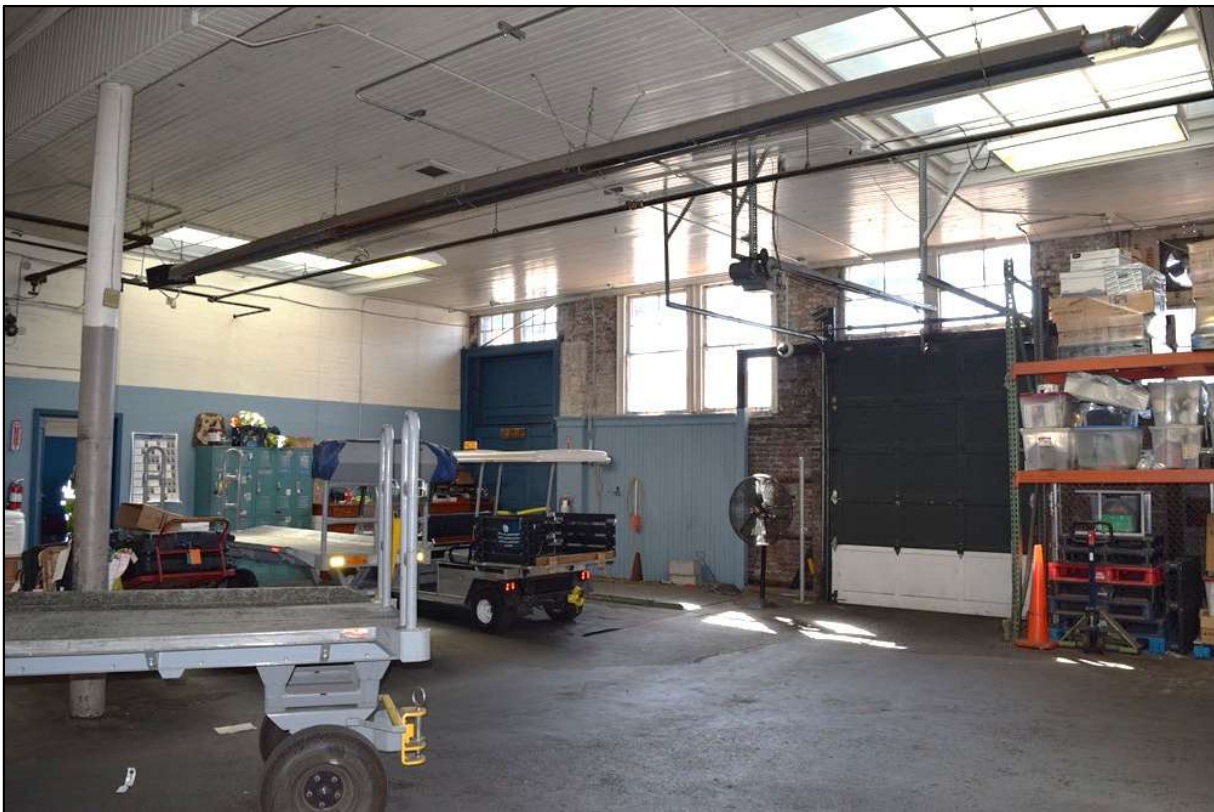
**Photograph 14 of 18:** OR\_MultnomahCounty\_UnionStationAmendment\_0014  
Interior of baggage handling room, looking south.

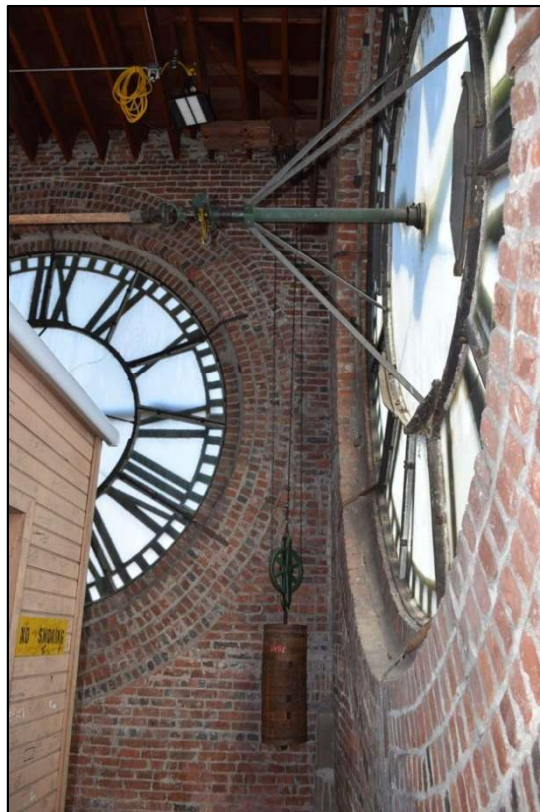
**Photograph 18 of 18:** OR\_MultnomahCounty\_UnionStationAmendment\_0018  
Interior clock tower at top, looking southwest.
