National Register of Historic Places Registration Form

historic name Cumberland Presbyterian Church

street & number 1400 Santiam Road SE not for publication

city or town Albany vicinity

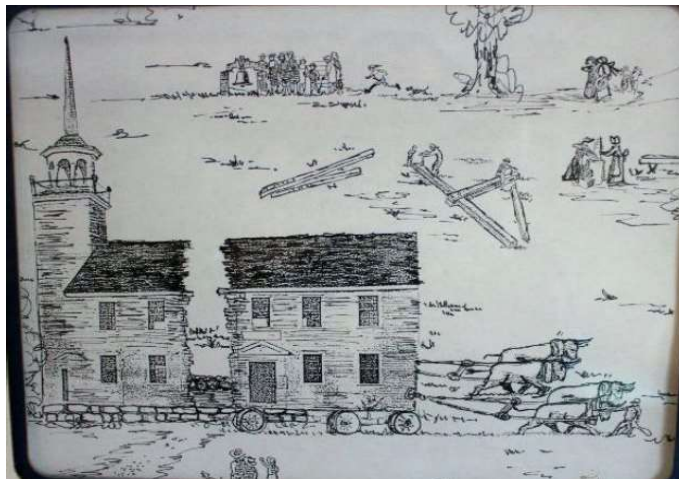
First Parish Church in East Derry, NH

A description and depiction (below) of this type of enlargement is included in the history of First Parish Church in East Derry, New Hampshire. The church's history states "In 1824 this church building was enlarged to its present size by cutting it down the middle and building between the two halves. Twenty-four feet were added to the center..."

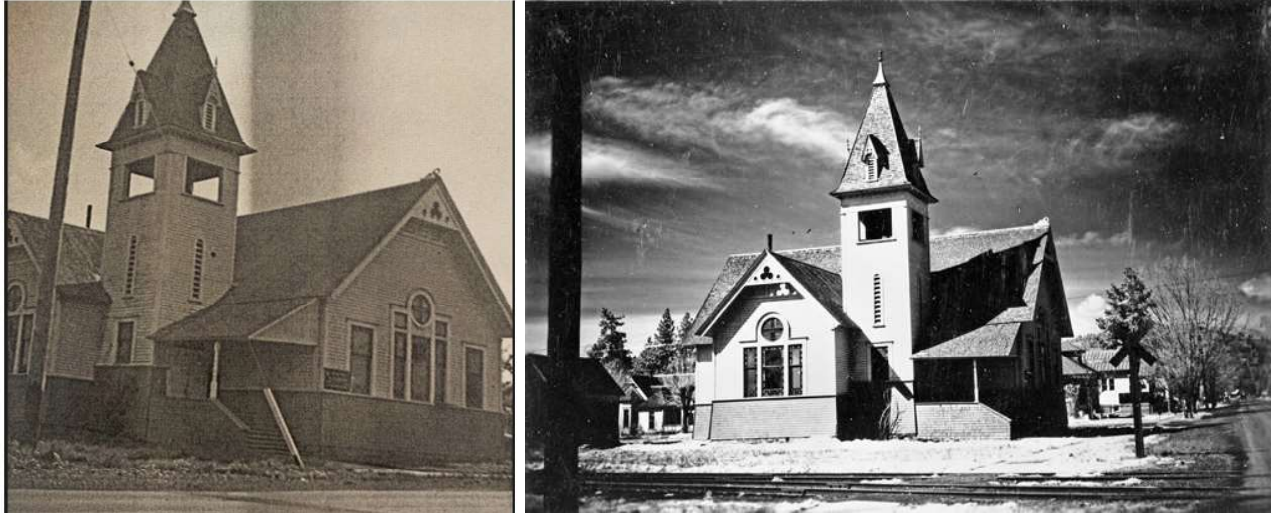
Elgin Presbyterian Church ca. 1898

gabled peaks in Elgin was also a decorative element used in several places on the Albany church. The majority of Elgin church's siding is horizontal lap siding, but a small amount of imbricated shingling is found at the gable peak.

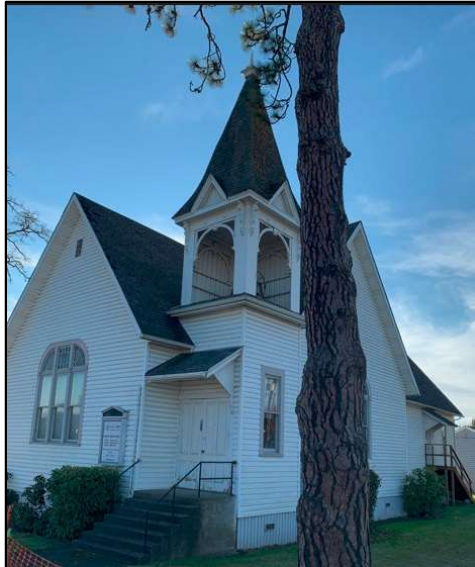
First Christian Church, Halsey, Oregon ca. 1892

Architecturally, the First Christian Church is similar to Albany's Cumberland Presbyterian Church in that it is a cross gable side steeple church with elements of Queen Anne ornamentation. The façade and window ornamentation differ from the Albany church in the extent of ornamentation is limited to a few basic windows and the side steeple. For the place and period, the Albany Cumberland Presbyterian Church retains far superior integrity and is more greatly enhanced by Queen Ann ornamentation.

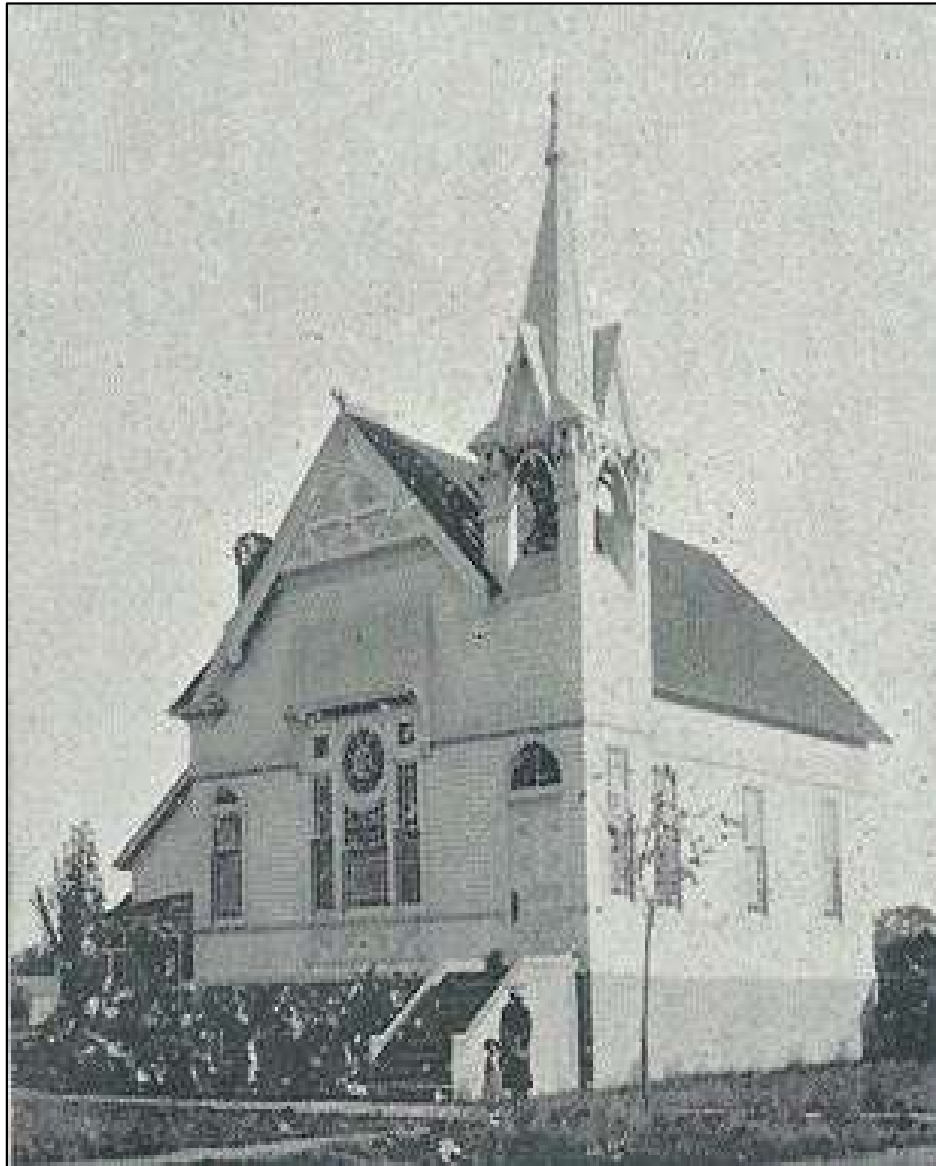
Figure 10: Photo of Cumberland Presbyterian Church ca. 1892
Rectory (inextant) slightly visible on left

Constructed in 1892, Albany's Cumberland Presbyterian Church displays elaborate Queen Anne architectural adornment on a simple rural meetinghouse style church.¹ (See Figure 10 and Photo 1) Extensive Queen Anne ornamentation covers the one-story church façade from foundation to peak, twenty feet above. The northwest entry to the church sits below a bell tower adorned by octagonal butt shingles, a Gothic arch belfry, and four gabled peaks. The church's north facing façade features elaborate asymmetrical Queen Anne ornamentation of shiplap siding, decorative imbricated shingling, ornate mouldings, colored glass divided lite windows, and a multipaneled single entry door. The central ganged ten-foot-wide window unit is anchored by a colored glass wheel window, covered by a diamond shingled window hood. The front gable end is adorned by quarter and half fans, sunbursts, rosettes, striated and decorative frieze boards situated below a peak corbel. Originally built as a one-room church with side steeple adjacent to pastureland beyond the eastern boundary of Albany, Oregon, the congregation enlarged the building in 1917 by bisection and adding a cross gabled center section. Alterations to the building outside of the period of significance include excavation work for a basement in 1931, the addition of meeting and storage rooms, and walling over the apse in the main floor worship hall to create a small meeting room or storage area. The most significant change occurred on October 17, 2021, when the church was moved one thousand feet to its current location. Despite the alterations and the move, the church retains its integrity to convey its Queen Anne architectural significance. Today the church is the only Queen Anne style church within the Albany historic inventory, the second oldest church on Albany's east side, and one of four pre-WWII wooden churches in Albany.² The building is considered one of the five most significant historic church buildings in Albany.³

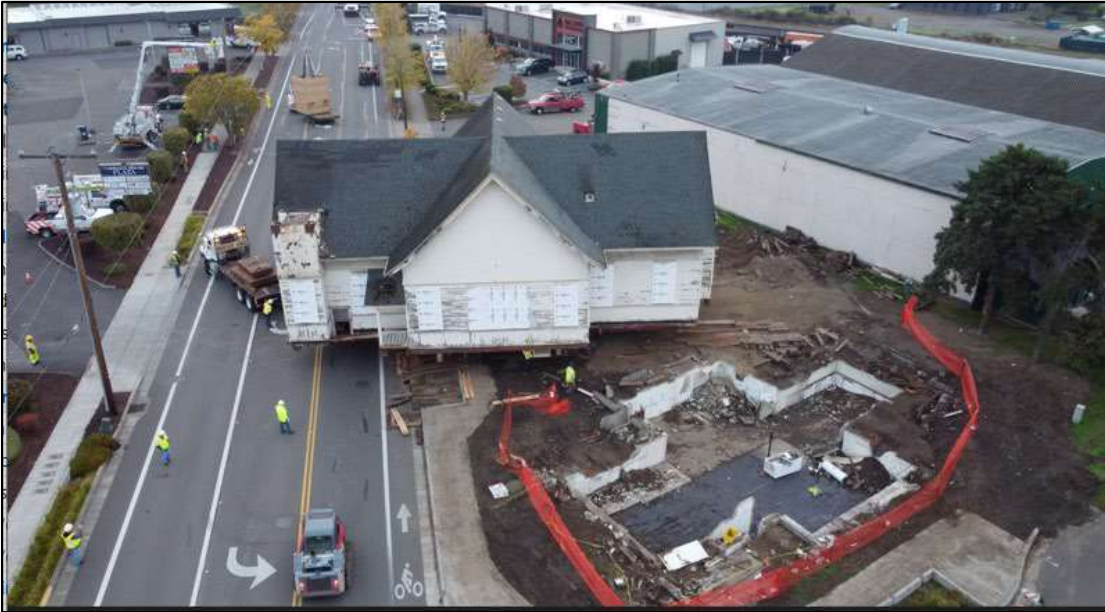
Figure 20: Image of Cumberland Presbyterian Church being moved off foundation and onto Santiam Road

The church move took place the morning of Sunday, October 17, 2021, when a semi cab/tractor slowly pulled the church from the lot onto Santiam Road and headed three blocks east to the new location. The 1,000' move took approximately three hours. (See Figures 20-22.) Once at the new site the building which had been turned ninety degrees for the move was pivoted back to return the north façade to the same orientation as it had been when built at the corner of Fourth and Main. The building was supported on cribbing while the concrete foundation was laid and cured at the new location. Once the foundation was cured the church was lowered onto the new foundation. This foundation gives the church a floor elevation of approximately 32", the same approximate elevation as the 1917 remodel. Photographs of the church before 1917 show eight risers leading to the entrance on the original church. The floor height

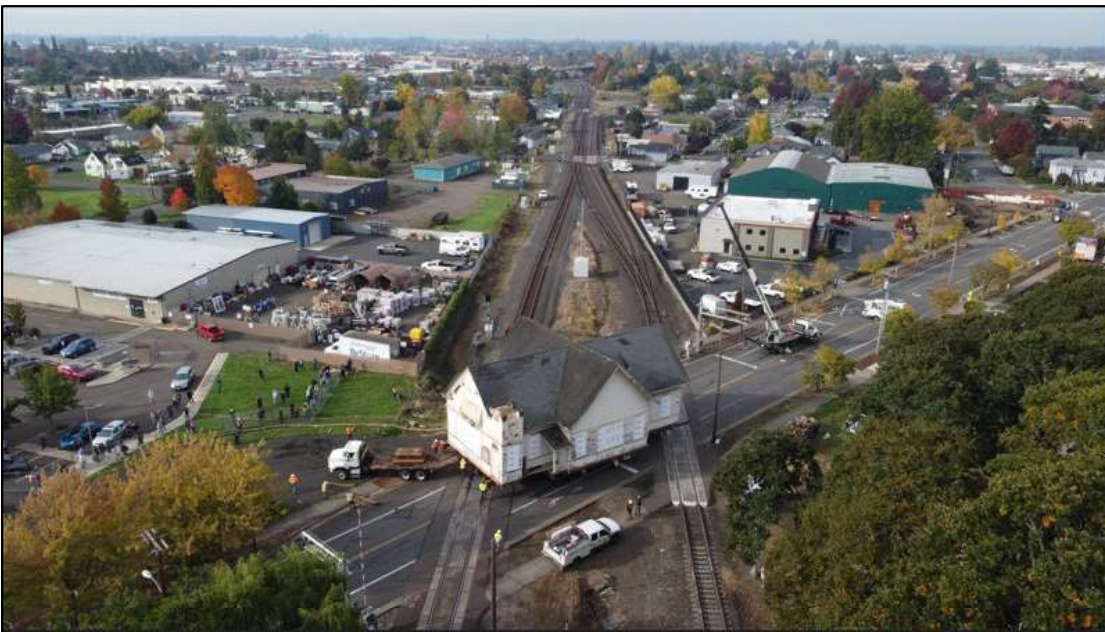
Figure 21: Image of Cumberland Presbyterian Church being moved across Union Pacific and Albany and Eastern railroad tracks

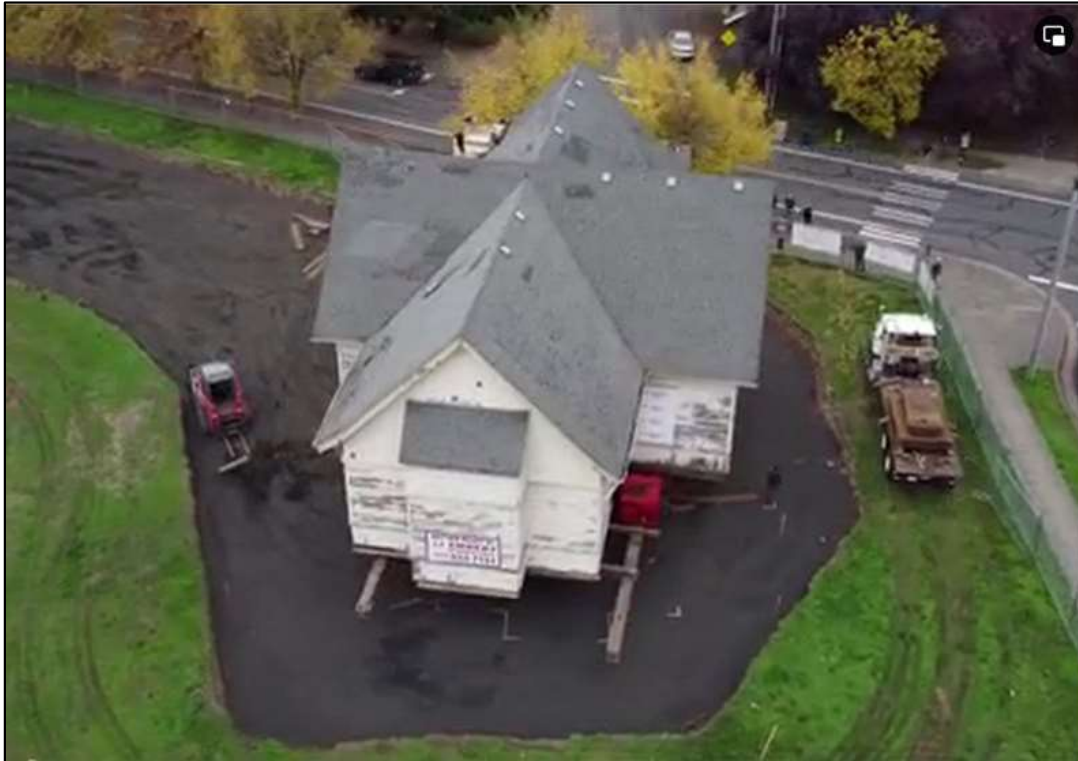
Figure 22: Image of Cumberland Presbyterian Church being rotated into place facing Santiam Road at new location.

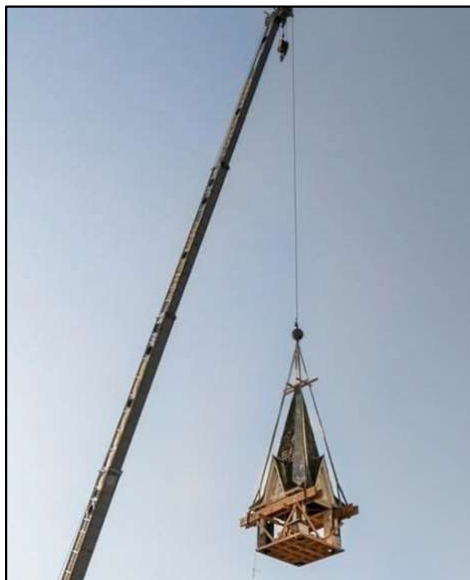
Figure 23: Image of Cumberland Presbyterian Church steeple move.

A new composition roof was installed in December 2022. After the move, while the weathervane and the bell tower were at ground level the decorative shingles and mouldings were cleaned, replaced/repainted, and painted in keeping with the original design. Wood shingles and siding which had been taken off to accommodate the bell tower removal were cleaned, painted, and reinstalled when possible. Unfortunately, most of the removed shingles were not salvageable. These were replaced with hand cut custom wood shingles to match the existing pattern. The bell tower was returned to its location on the northwest corner of the building on 24 April 2023. The bell has not yet been lifted to the bell tower. Damaged and deteriorating exterior horizontal and vertical wood siding were replaced with hand cut custom wood siding to match the existing pattern. The church exterior was fully repainted in the fall of 2023.

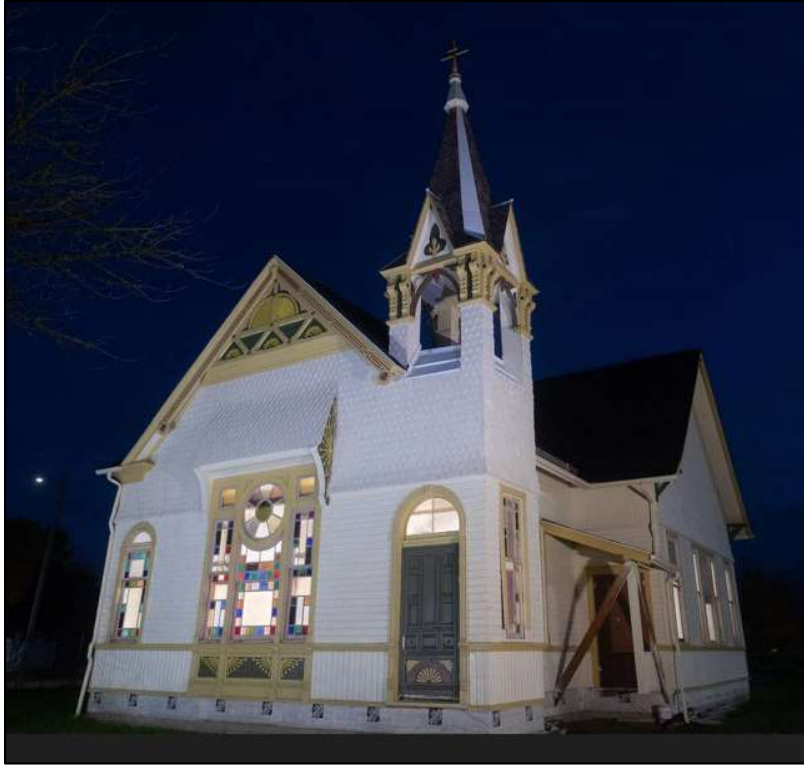
Photo 1 of 18: North façade(left) and west elevation (right), camera facing southeast

- Photo 1 of 18:** OR_Linn_CumberlandPresbyterianChurch_001
North façade(left) and west elevation (right), camera facing southeast
- Photo 2 of 18:** OR_Linn_CumberlandPresbyterianChurch_002
North façade(left) and west elevation (right), camera facing southeast and downward (aerial view)

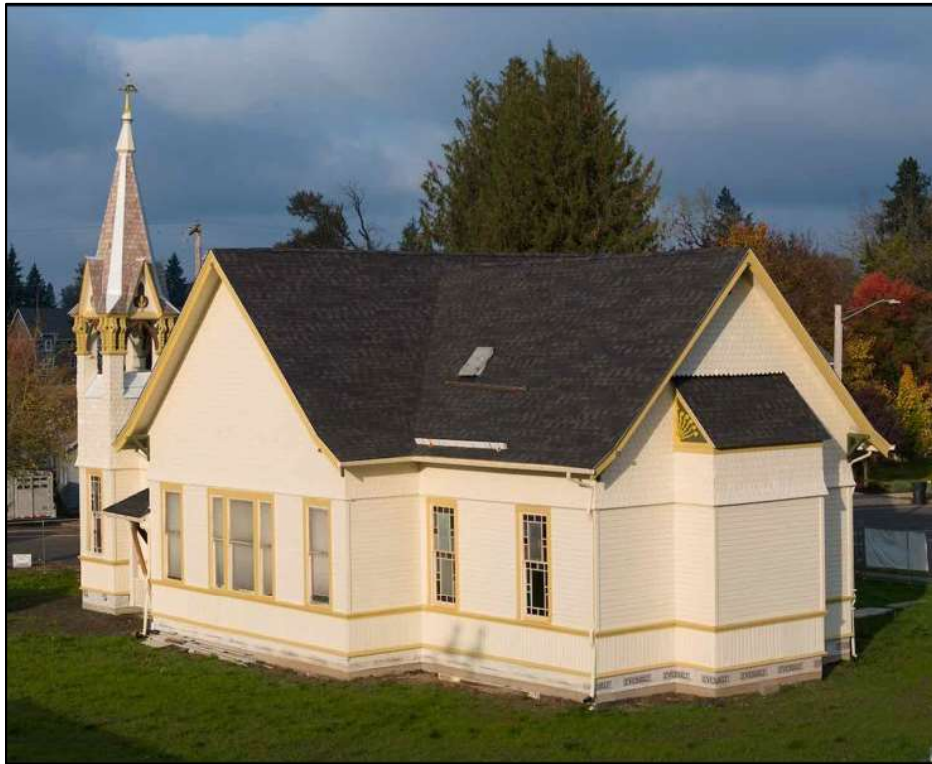
Photo 2 of 18: North façade(left) and west elevation (right), camera facing southeast and downward (aerial view)

The front/north end of the church's east side extends past the rectangular structure of the church to house a wood stove which is no longer in place. The chimney wall extension with gable end continues the pattern at the lower portion of all church walls where the foundation is capped by a frieze board with bed moulding above which sits 30" vertical double bevel lap siding. Above the siding a band board starts the transition to the gable peak, adorned with diamond imbricated shingles below a full sunburst, centered between triangular rosettes with details that mimic the trefoil of the bell tower. South of the chimney wall the church's east side housed four equally spaced 4' x 8' true divided lite colored glass double hung windows with eleven over fifteen light configurations. (See Photo 2 for an image of the double hung windows.)

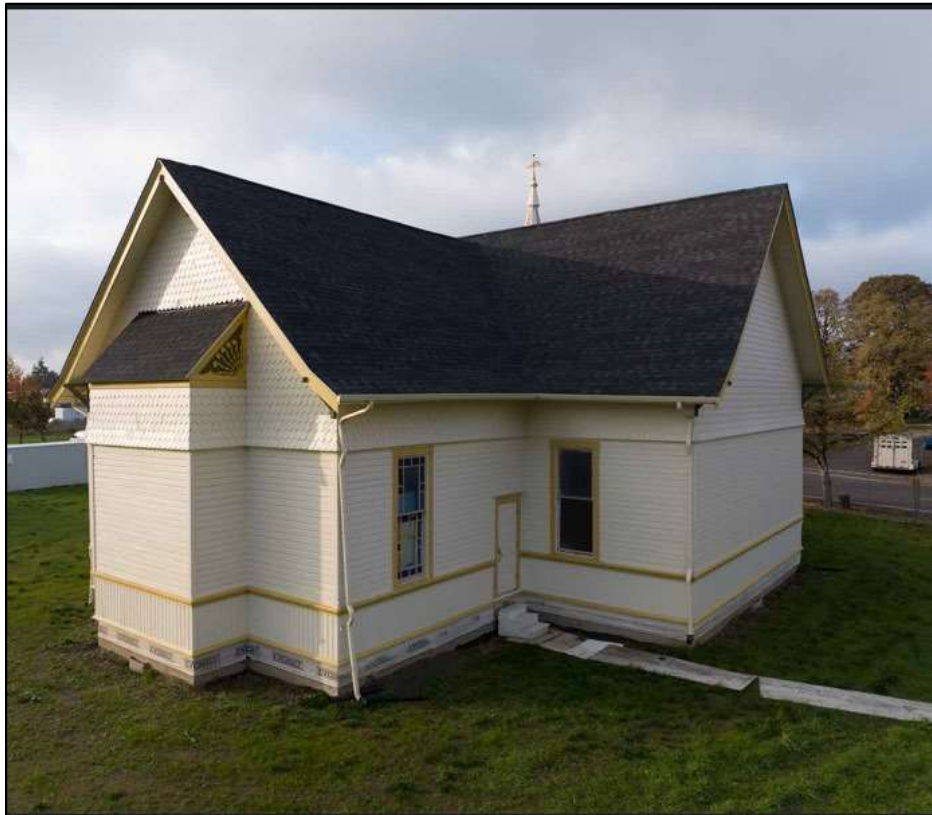
Photo 3 of 18: West elevation (left) and south elevation (right), camera facing northeast

The church's footprint measured 33' wide by 42' deep when built in 1892. The single-story gable end side steeple church is balloon framed with steep 20' peaks running north to south. Wood used in frame construction has been identified as Douglas Fir and Western Larch. Octagonal and diamond butt imbricated shingling sit above horizontal and vertical lap siding displaying textural changes along each side of the building. Queen Anne ornamentation including sunbursts, inset panels, and decorative corbels adorn the gable ends and north facing façade. (See Photo 1 for image.) Albany's Sanborn Fire Insurance Map of 1895 identifies a wood shingle roof, brick foundation, and a brick chimney on the three-year-old building. The foundation is capped by a frieze board with bed moulding above which sits 30" vertical double bevel lap siding. A band board transitions from the vertical siding to a strip 8½' high of horizontal siding terminating at a 4½" wide band board. Rising from the top band board to the gable peaks and the side frieze boards are 35" of octagonal imbricated shingles. (See Photos 3 and 4.)

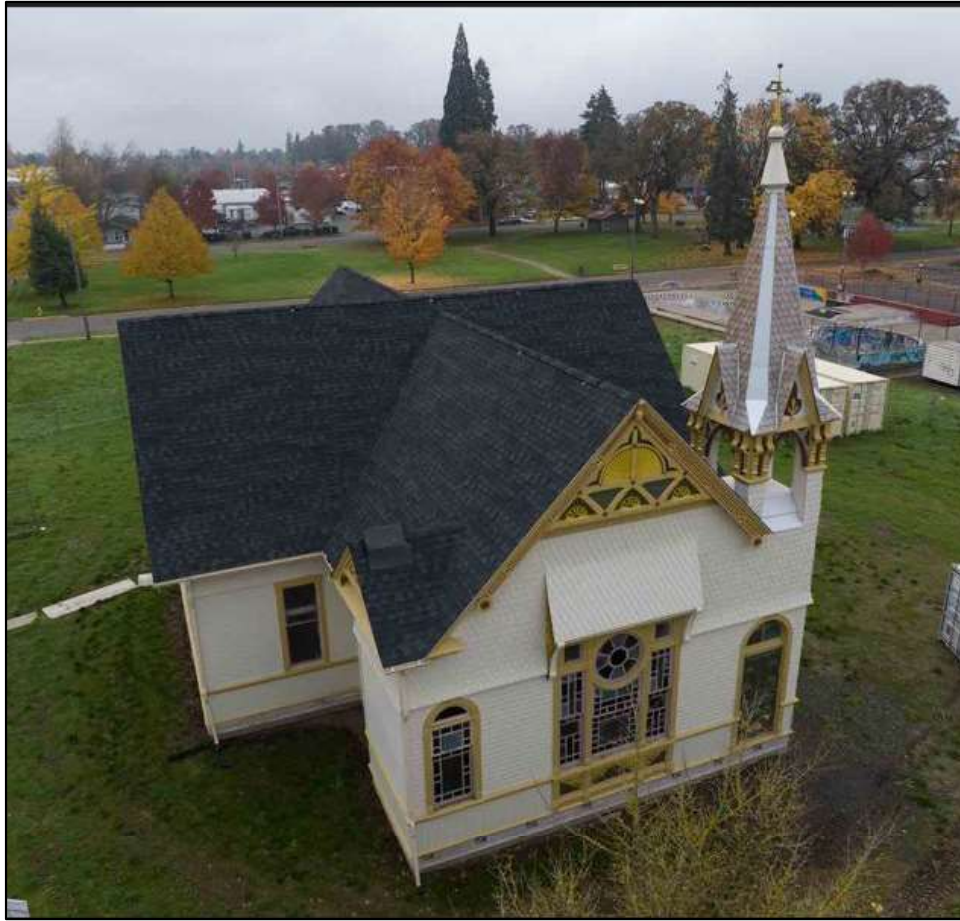
Photo 4 of 18: South elevation (left) and east elevation (right), camera facing northwest

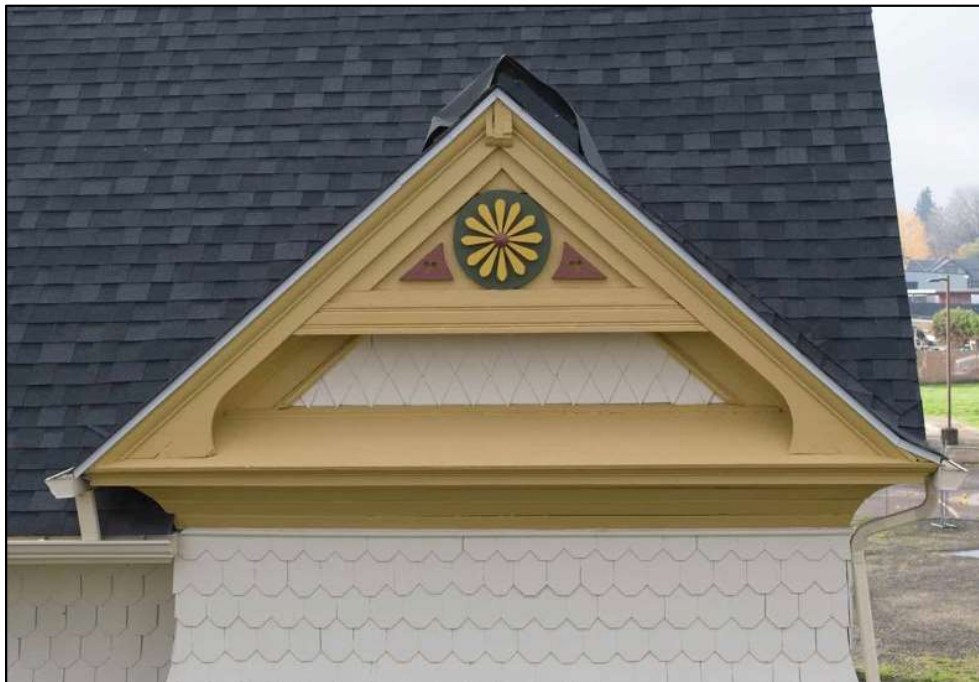
Photo 5 of 18: North façade (front) and bell tower (right), camera facing south southwest (aerial view)

To the west/right on the front is the church's entry, an elaborate 4' x 7'9" eleven panel door; two lower panels feature rosettes while the lowest panel includes quarter sunbursts on each side highlighting a larger, centered half sunburst. Three irregularly spaced hinges hint that perhaps the bottom of the door was cut down at an unknown point in its history. Surrounding the entry door is 5½" wide double fluted casing anchored at the base by 5½" wide plinth blocks. On both sides of the door's top outer edges 5½" rosettes embellish corner blocks and mark the transition to casing for a half round two lite compass window with centered keystone. (See Photos 1, 5, 8 to view entry door and associated transom.)

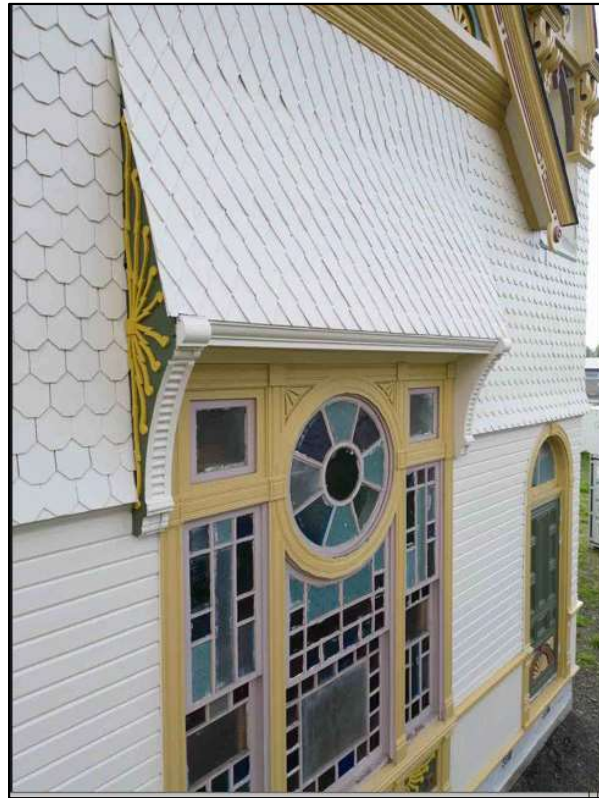
Photo 6 of 18: East chimney gable end, camera facing west

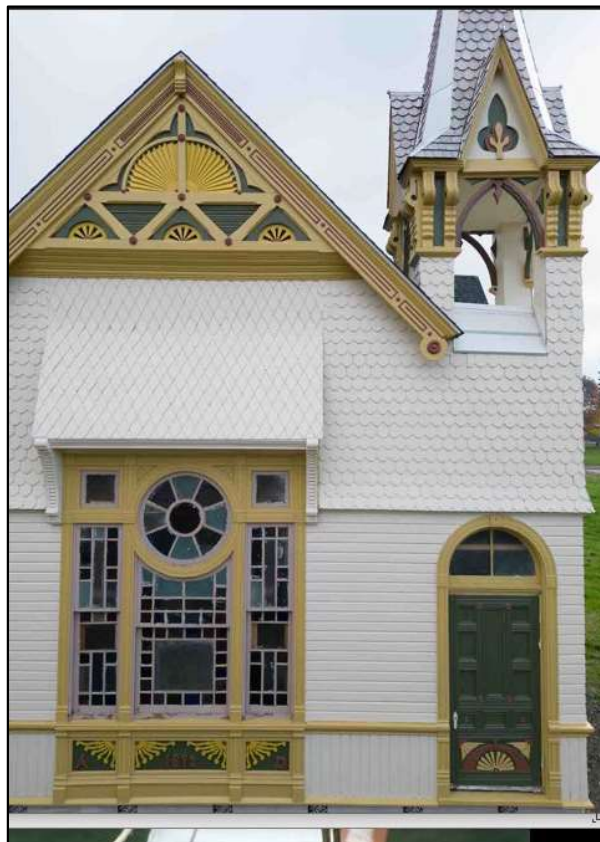
Photo 7 of 18: North façade ganged window unit, window hood, rose window, shingle patterns, camera facing southwest

The colored glass windows are mostly primary colors of green, amber, violet, blue, red. Various textures within the glass include ripple, reed, and hammered. A June 2020 Cumberland Church window survey by Albany's stained-glass expert, Jeff Senders,⁷ identifies twelve different glass types in the windows. Descriptions include Flash Glass, English Muffel, Hammered Tight Glass, Ripple Glass, Antique Granite Back, Chinchilla, Tight Moss, ½" Cross Reed, Korean Glass Clear, Tight Crystal Ice, Clear Etched, and Florentine Glass. (See Photos 1, 7, 8.)

The ornate window unit is sheltered by a diamond shingled wooden hood supported on both sides by dentil edged corbels. Above the corbels on the outsides of the hood are half sunbursts. Eastlake architectural elements are included in the sunburst and fan elements of the north peak gable, frieze boards, and the decorative panels. Above the ganged window hood the 10' wide x 5' high the gable end is ornamented Eastlake style with bands of vertical milled frieze boards. The frieze banding sits five feet below the peak above which are inset panels, fan quarters, half rounds and triangles all enhanced with rosettes. (See Photos 1, 5, 7, 8 for further understanding of the complex suite of features on the building's façade.)

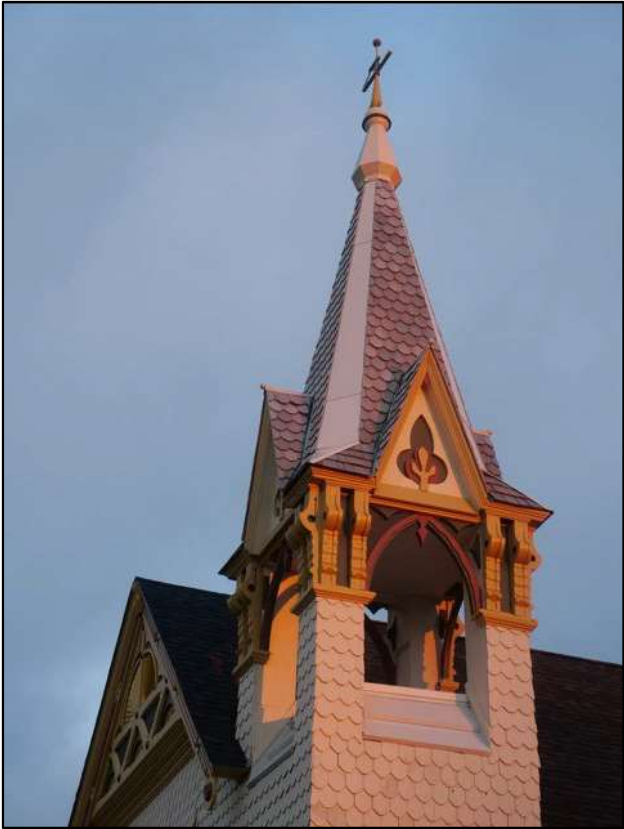
Photo 8 of 18: North façade ganged window unit, gable, bell tower and entry door, camera facing south

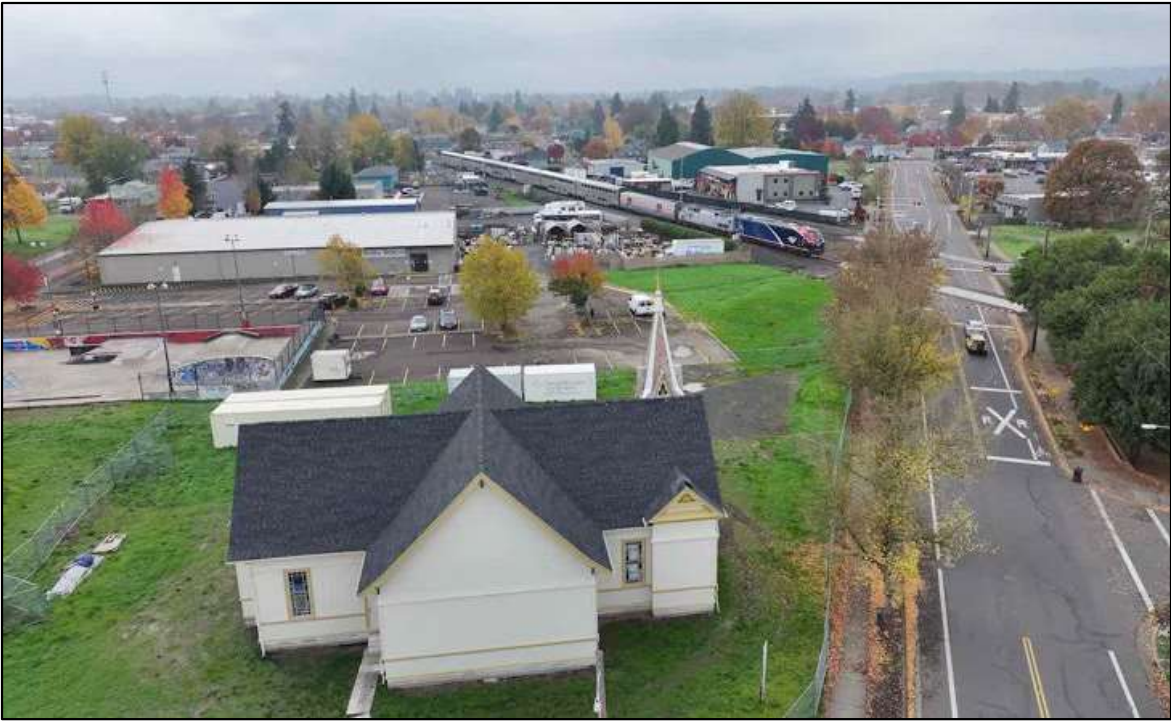
Photo 9 of 18: Bell tower detail camera facing southeast

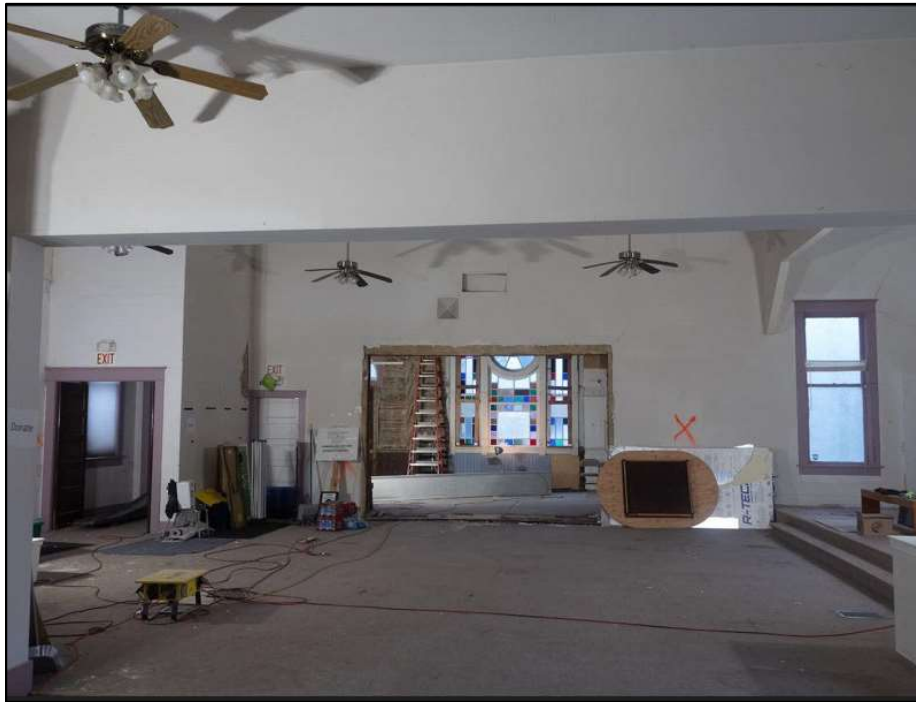
Photo 11 of 18: Interior 1917 nave (foreground) looking to 1892 north half of nave interior, camera facing north

- Photo 11 of 18:** OR_Linn_CumberlandPresbyterianChurch_0011
Interior 1917 nave (foreground) looking to 1892 north half of nave interior, camera facing north

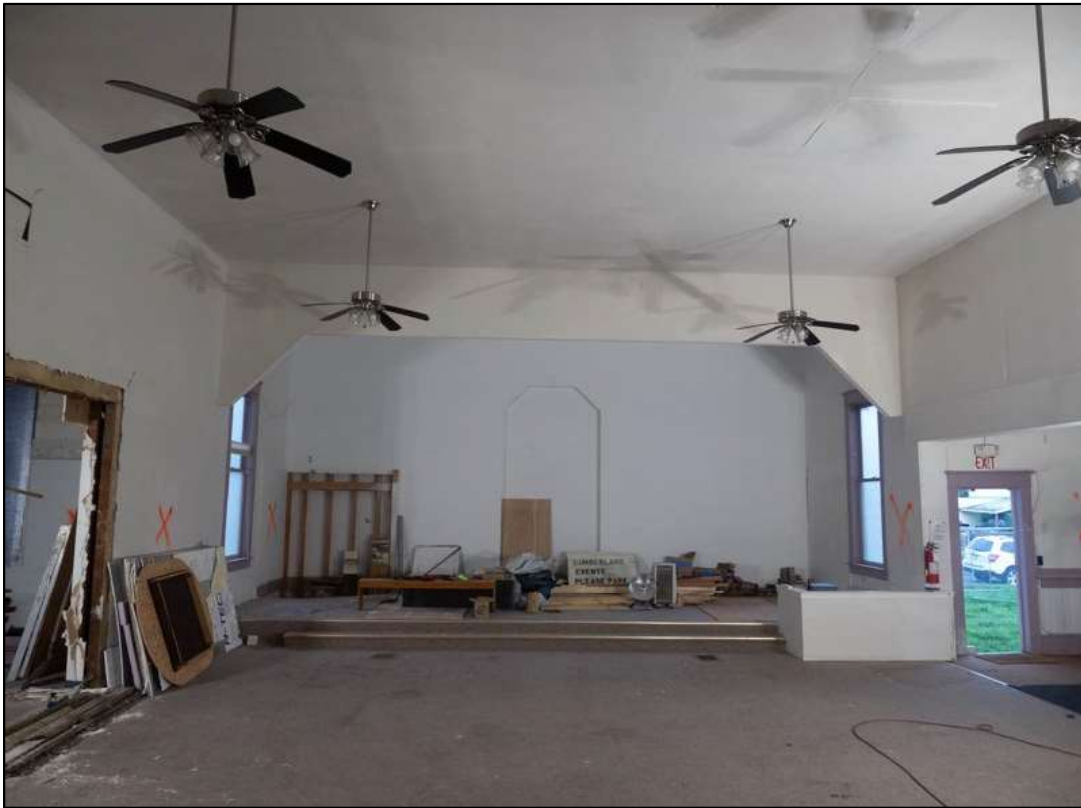
Photo 12 of 18: Interior of 1892 ganged window unit and moulding, camera facing north

Millwork in the window units include 1½" muntin bars separating the colored glass. Mullions separating each panel are 5½" wide double fluted casing as found on all exterior single unit double hung windows. The window sections are anchored by 5½" wide plinth blocks below, and 5½" rosette embellished corner blocks above. The interior of the ganged window on the north façade is topped by a crown of triple peaked ornate wooden rosette style head blocks. Fourteen feet above the floor copper colored stenciling circumvents the north portion of the church. It is evident that the moulding ornamentation preceded the stenciling as seen in areas where the exact stencil pattern was adjusted to avoid conflict spatially with the wood head blocks. (See Photo 12 for an image of the stenciling, the triple peaked rosette style head blocks, the ornate windows and the colored glass.)

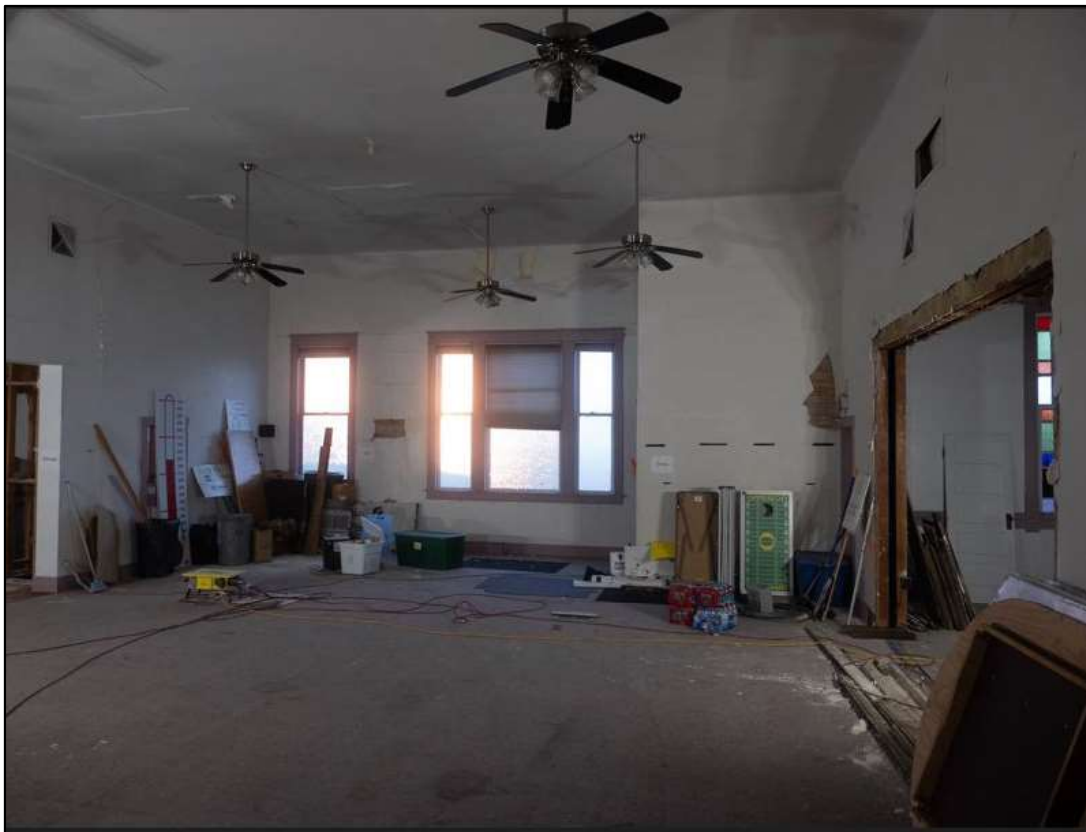
Photo 13 of 18: Interior of 1917 nave and pulpit platform, camera facing east

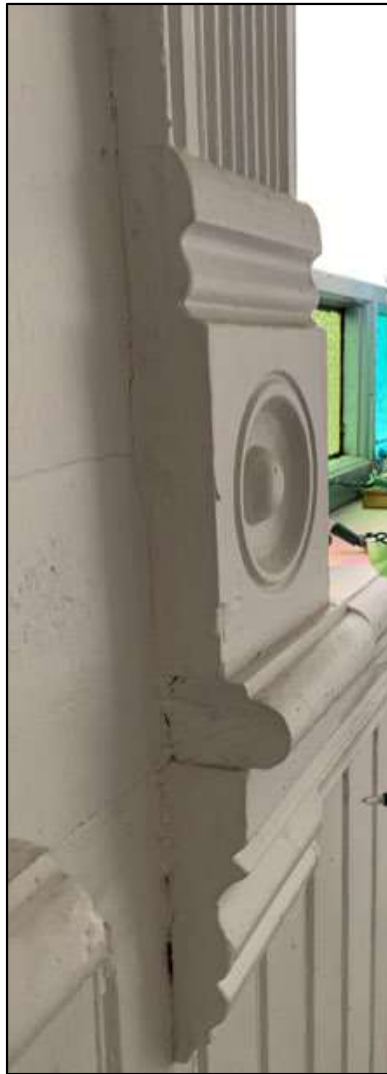
Photo 16 of 18: Interior 1892 moulding detail

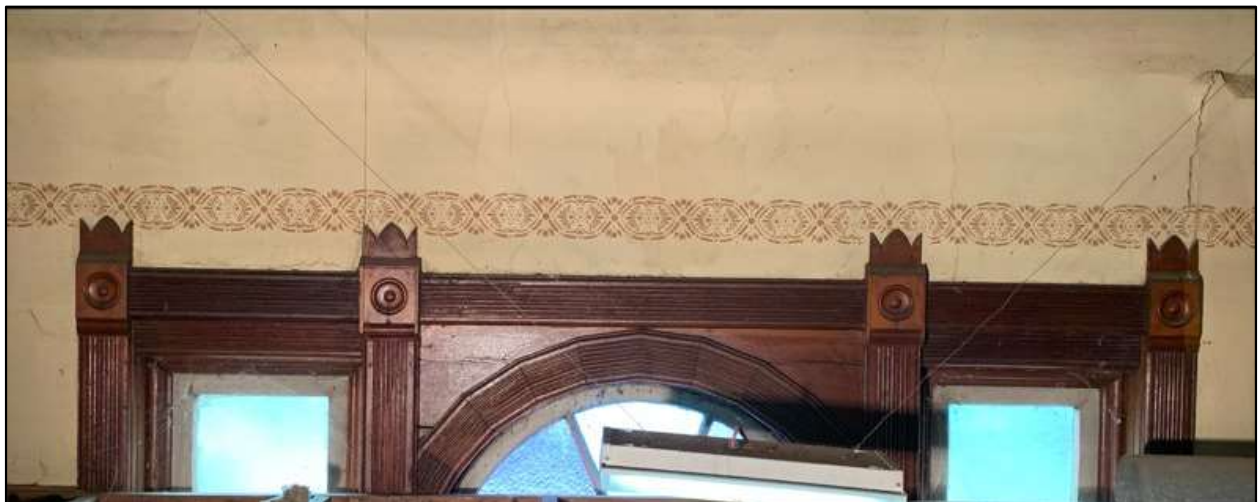
Photo 17 of 18: Additional 1892 moulding detail showing fluted casing, rosettes, bullnosed window stool, corner blocks, chair rail and wainscotting.
