## National Register of Historic Places Registration Form

historic name Pass Creek Covered Bridge

Douglas Co., Oregon  
County and State

OTHER: Bridge, Covered Bridge (Howe Truss)

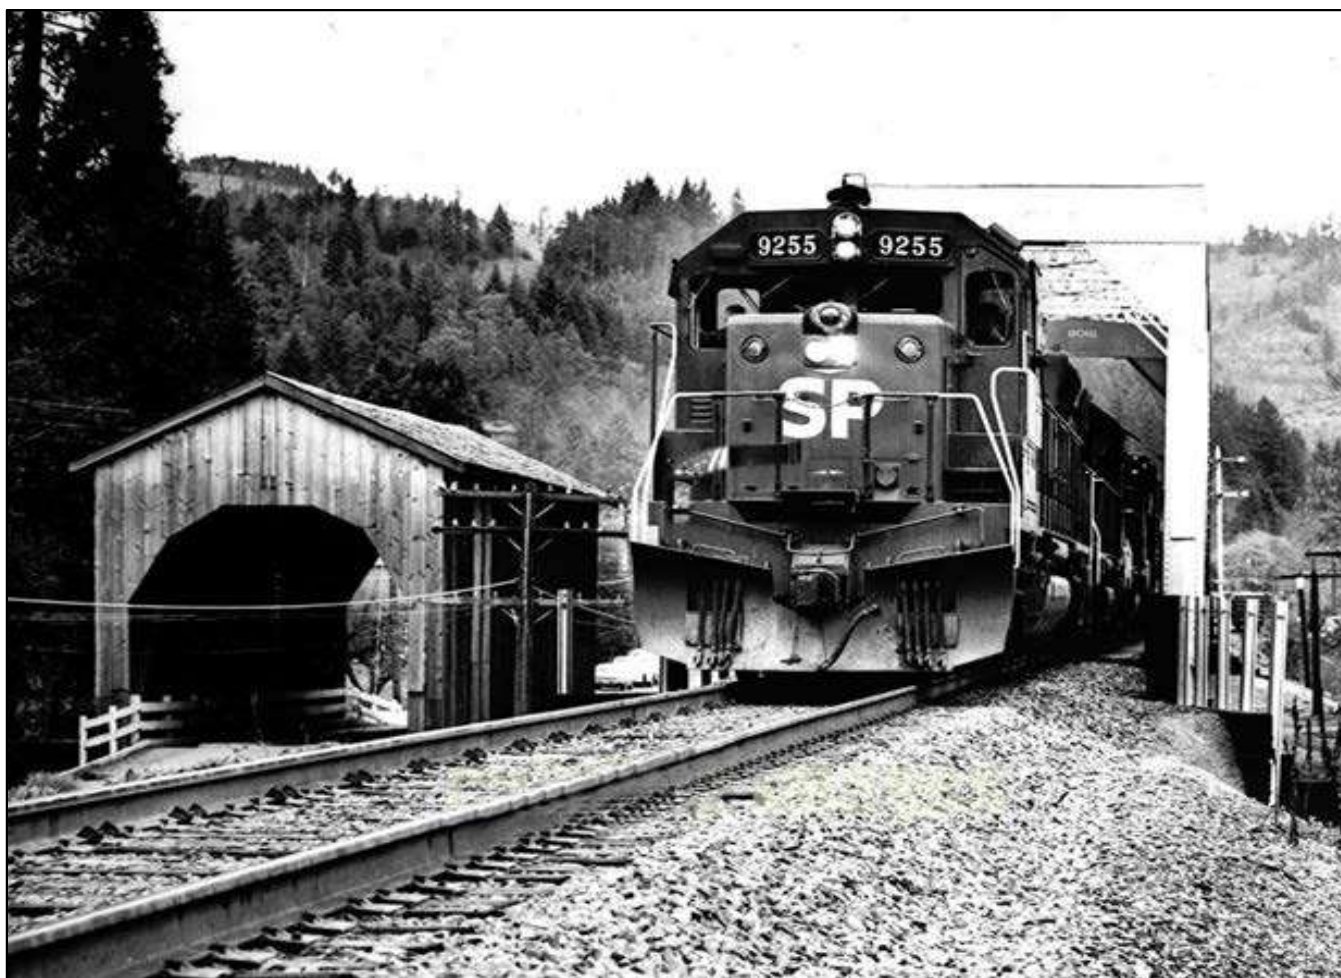
**Figure 8. View of the Pass Creek Covered Bridge in its original location on North First Street beside the steel railroad bridge over Pass Creek (circa 1972).**

The bridge's character-defining Howe-truss configuration, segmented portals, vertical board siding without battens, and gabled housing remain clearly legible (Figures 7 and 8, Photograph 1). Available documentation indicates that the bridge was relocated and reassembled rather than reconstructed, preserving the historic truss form and overall massing of the structure. While roofing has been replaced over time and the existing siding may include repaired or replacement material, the underlying truss configuration, portal design, and structural expression remain intact. The surviving Howe-truss components, including substantial timber framing members and hand-hewn timbers incorporated into the structure, continue to convey the bridge's historic design and construction methods and remain the features most critical to its significance under Criterion C.

Despite its relocation, the reconstruction of piers and approaches, and targeted replacement or reinforcement of materials, the bridge retains substantial historic fabric. This includes the hand-hewn bottom chords and the timber Howe truss superstructure. Traditional timber truss joinery remains visible beneath the gabled housing and continues to convey early twentieth-century timber truss construction methods (Photographs 8 and 9). The bridge therefore retains integrity of materials and workmanship.

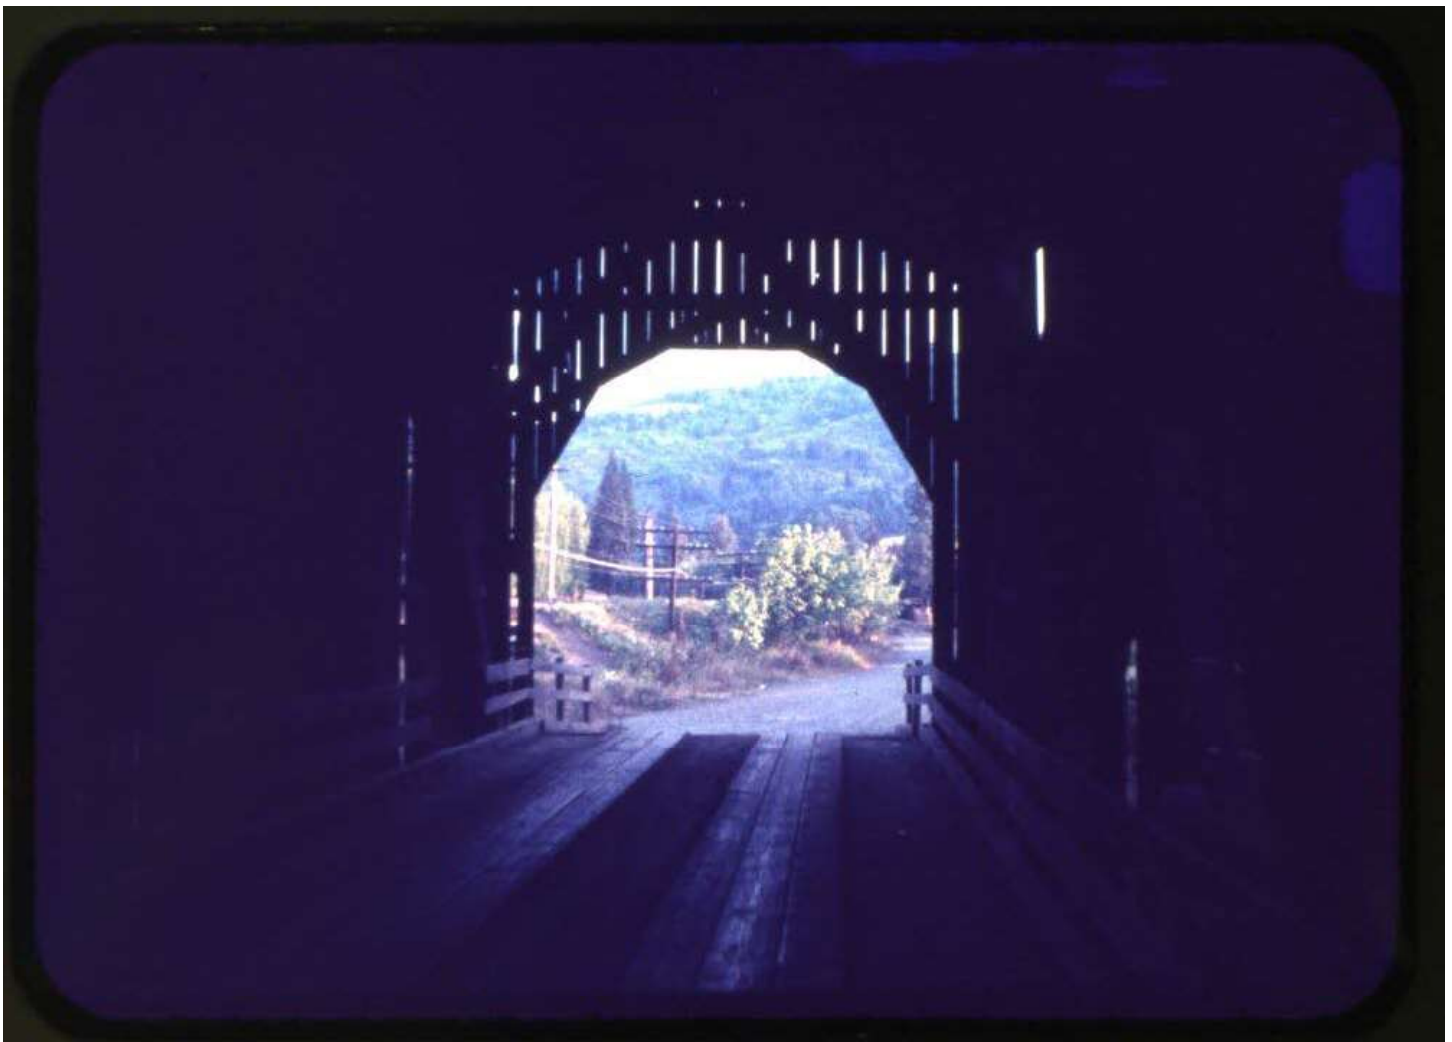
**Figure 9. Interior view looking out through the portal of the Pass Creek Covered Bridge in its original location, showing the plank deck, slatted timber siding, and portal framing typical of Oregon covered bridge construction, facing south (circa 1970s).**

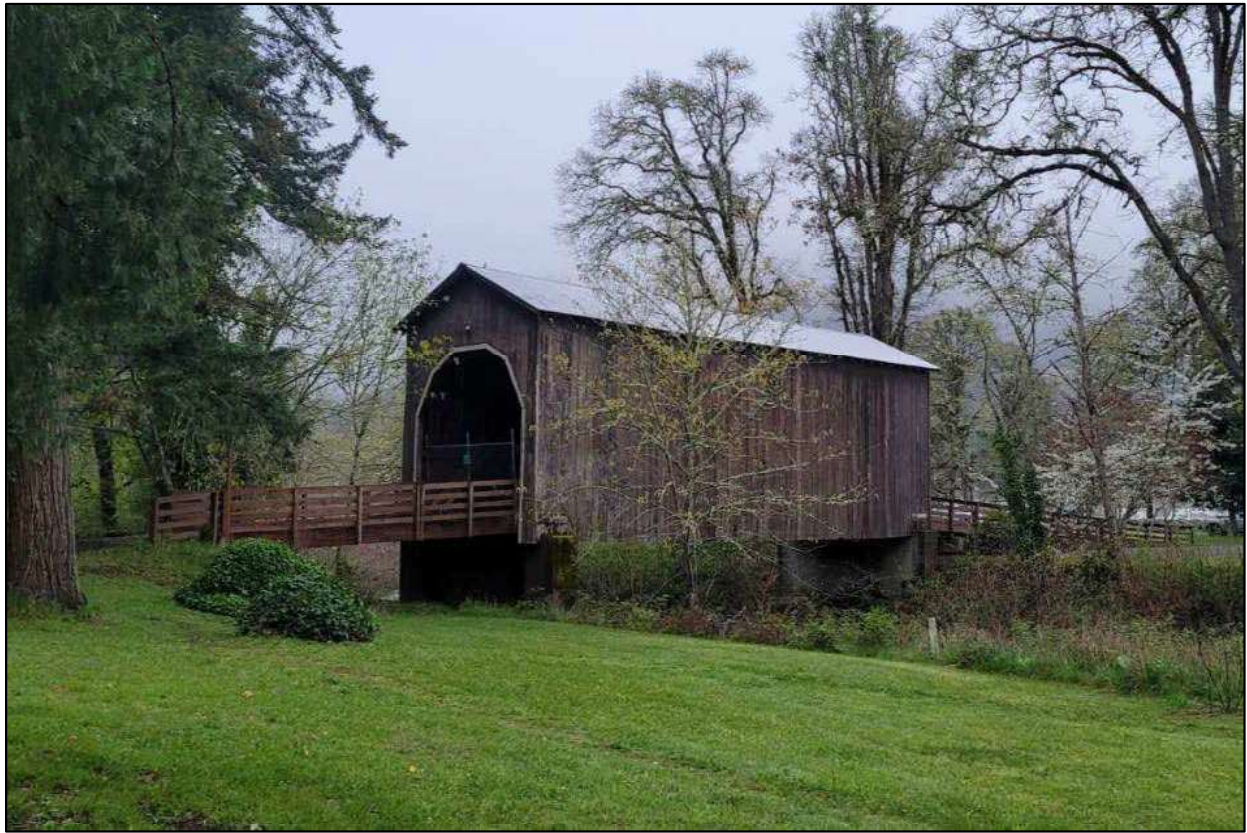
**Photograph 1 of 9:** OR\_DouglasCounty\_PassCreekCoveredBridge\_0001  
Overview of Pass Creek Covered Bridge, camera facing northwest.

The housing is clad in vertical 1-inch by 12-inch cedar boards without battens, painted brown (Photograph 1). Although some siding was installed new during the 1988 reassembly, it is consistent with historic photographs that show the bridge's traditionally unadorned and utilitarian appearance (Figure 8). The housing has segmented portal openings characteristic of Oregon covered bridges but, somewhat unusual for this resource type, lacks any portal "wraparound" (a feature where the siding wraps around the end of the truss and into the bridge interior for a short distance, to provide additional weather protection to the truss). This absence is thought to be an original design characteristic (Figure 9, Photographs 5 and 7) The decking, floor beams, and roof rafters are wood, and the roof is clad in galvanized sheet metal installed in 2014.<sup>5</sup>

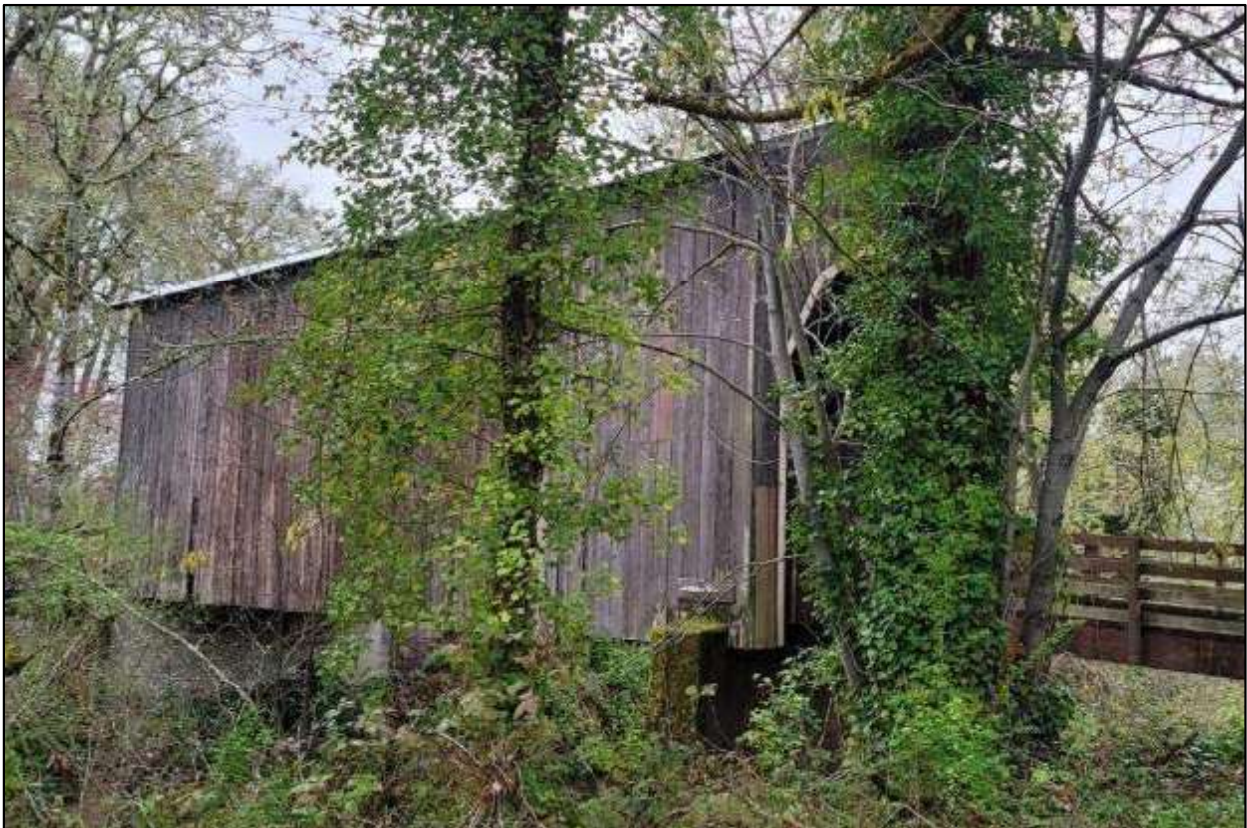
**Photograph 2 of 9:** OR\_DouglasCounty\_PassCreekCoveredBridge\_0002  
West wall and south portal of Pass Creek Covered Bridge, camera facing northeast.

The concrete piers supporting the structure date to the 1988 reassembly (Photographs 2 and 5). The approach spans, constructed during the relocation and rebuilt intermittently since, utilize untreated timber stringers, decking, and railings consistent with their functional purpose and modern construction period. One intermediate bent on the north approach incorporates salvaged rail material from another local bridge reconstructed in 2005 (Photograph 6).<sup>6</sup> Bridge historians have noted that the craftsmanship and existing holes in the hand-hewn bottom chords suggest they may be original components of a ca. 1870 bridge associated with the Overland Stagecoach Route that was replaced first in 1906 and then again in 1925 by the Pass Creek Covered Bridge.<sup>7</sup> These chords were retained and reinforced with 6-inch by 14-inch helper timbers during the 1988 reassembly.<sup>8</sup>

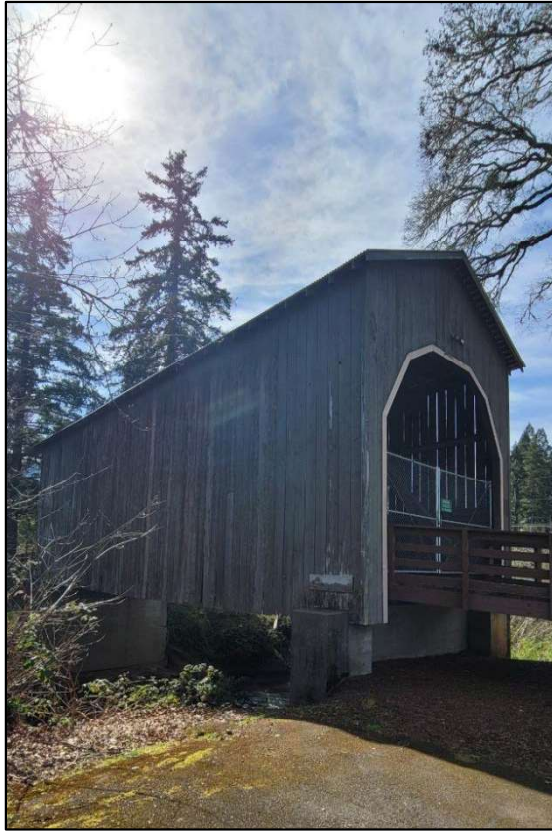
**Photograph 5 of 9:** OR\_DouglasCounty\_PassCreekCoveredBridge\_0005  
East wall and north portal of Pass Creek Covered Bridge, camera facing southwest.

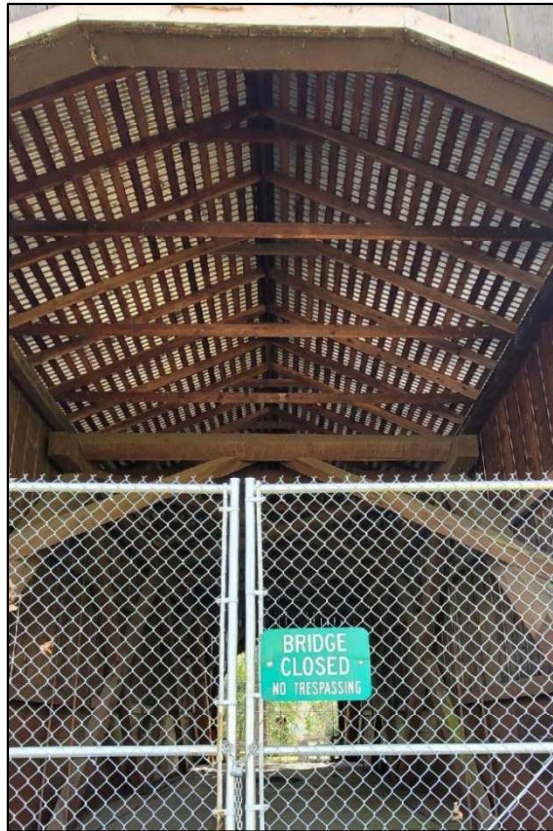
**Photograph 8 of 9:** OR\_DouglasCounty\_PassCreekCoveredBridge\_0008  
Top of wood Howe truss and roof framing inside Pass Creek Covered Bridge, camera facing south, the bridge's exposed interior trusswork clearly conveys its historic Howe-truss design, with diagonal timber members readily visible.
