Hershberger Mountain Lookout

National Register of Historic Places Registration Form

historic name Hershberger Mountain Lookout

Built in 1925, Hershberger Mountain Lookout is a standard "D-6" cupola-style lookout structure with a wood frame and a wood-shingled, hipped roof, a kind commonly built by the Forest Service during the 1920s in Oregon and Washington in District [now Region]

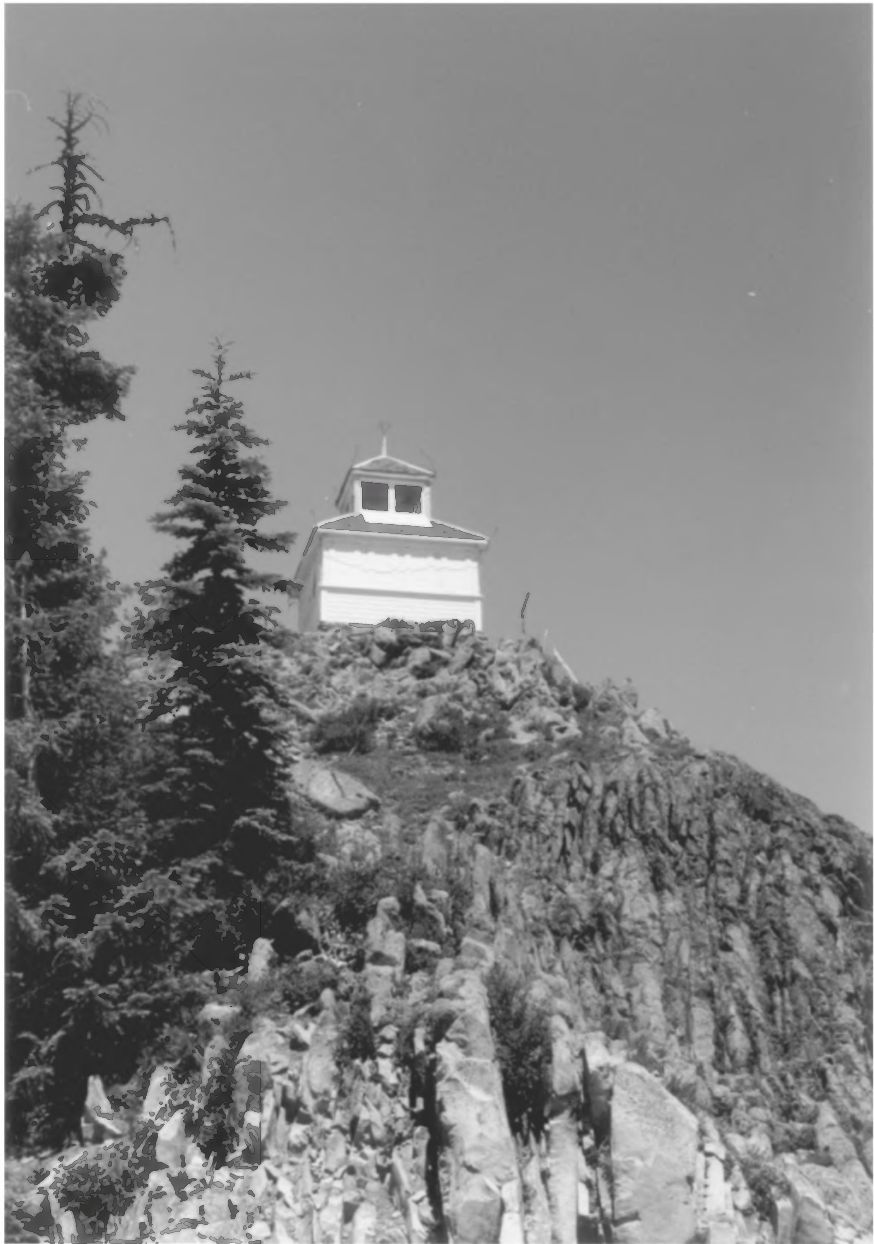
143

- 1) Hershberger Mountain Lookout
- 2) NW ¼ Section 22, T 29 South, Range 3 East, W.M., Douglas County Oregon
- 3) Photographer: Katherine Atwood
- 4) Date of Photograph August 1999
- 5) Negative holder: Rogue River National Forest
P.O. Box 520
Medford, Oregon 97501
- 6) View of south elevation
- 7) Photograph number 1 of 3

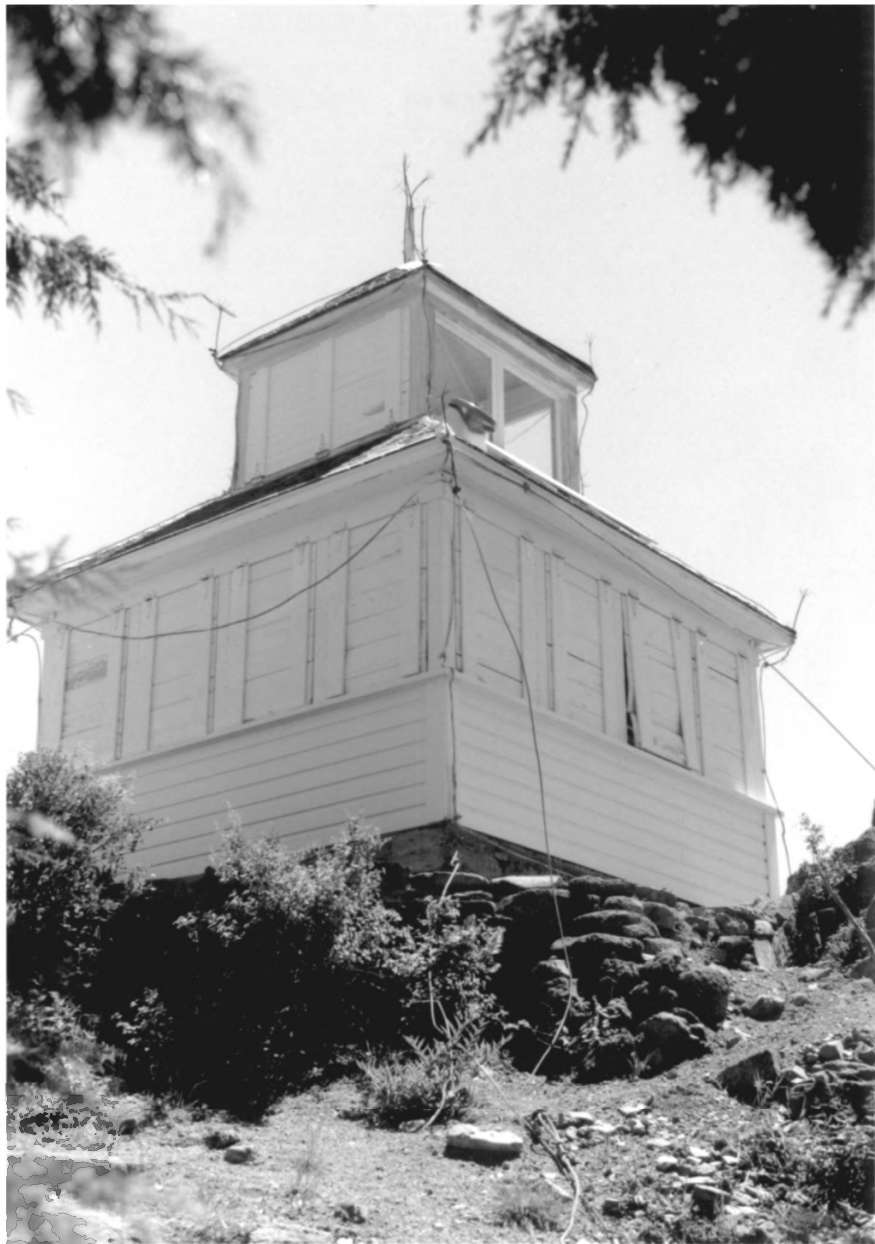
243

- 1) Hershberger Mountain Lookout
- 2) NW ¼ Section 22, T 29 South, Range 3 East, W.M., Douglas County Oregon
- 3) Photographer: Katherine Atwood
- 4) Date of Photograph August 1999
- 5) Negative holder: Rogue River National Forest
P.O. Box 520
Medford, Oregon 97501
- 6) View of the north and west elevations
- 7) Photograph number 2 of 3

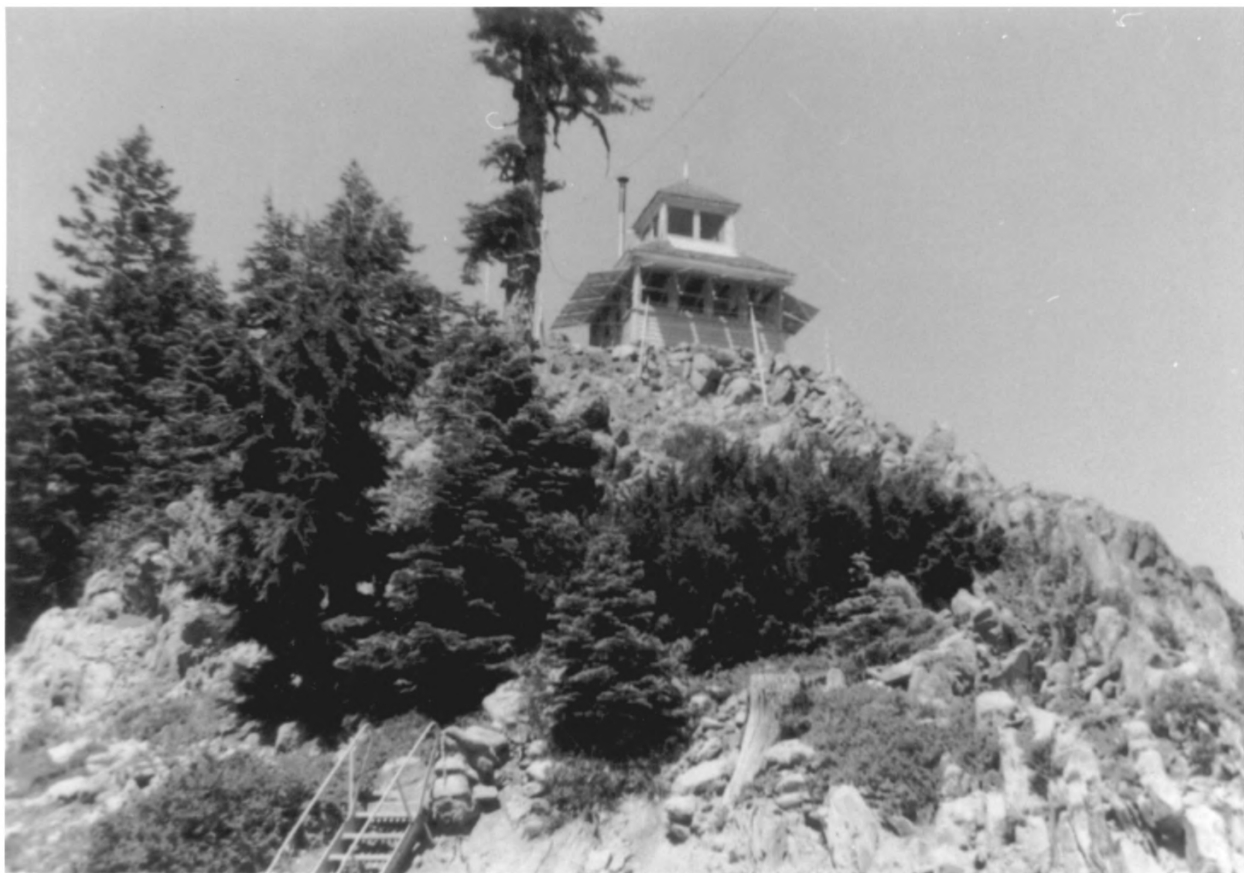
- 1) Hershberger Mountain Lookout
- 2) NW ¼ Section 22, T 29 South, Range 3 East, W.M., Douglas County Oregon
- 3) Photographer: Unknown
- 4) Date of Photograph: 1961
- 5) Negative holder: Rogue River National Forest
P.O. Box 520
Medford, Oregon 97501
- 6) Historic View
- 7) Photograph number 3 of 3
