IATIONAL REGISTER OF HISTORIC PLACES INVENTORY -- NOMINATION FORM

SEE INSTRUCTIONS IN <i>HOW</i> TYPE ALL ENTRIES	TO COMPLETE NATIONA COMPLETE APPLICABL	A <i>L REGISTER FORM</i> .E SECTIONS	S
NAME			
HISTORIC			
CRATER LAKE LODGE			
AND/OR COMMON			· · · · · · · · · · · · · · · · · · ·
SAME		, , ,	—. — . — . — . — . — . — . — . — . — .
LOCATION (Crater Lake	e National Park		
STREET & NUMBER	and the second of the second o		
RIM DR IVE /		NOT FOR PUBLICATION	
CITY, TOWN Klamath Falls Vic.		CONGRESSIONAL DIST	RICT
CRATER LAKE NATIONAL PARK	VICINITY OF	SECOND	CODE
STATE OREGON	041	COUNTY KLAMATH	035
CLASSIFICATION			
CATEGORY OWNERSHIP	STATUS	DDEC	ENT USE
DISTRICT X-PUBLIC	X_OCCUPIED		
X_BUILDING(S)PRIVATE		agriculture X_commercial	museum X_park
STRUCTUREBOTH	_UNOCCUPIED		
	WORK IN PROGRESS	EDUCATIONAL	PRIVATE RESIDEN
	ACCESSIBLE	ENTERTAINMENT	
OBJECTIN PROCESSBEING CONSIDERED	YES: RESTRICTED _XYES: UNRESTRICTED	XGOVERNMENT LINDUSTRIAL	SCIENTIFICTRANSPORTATION
REGIONAL HEADQUARTERS: (If applicable) NATIONAL PARK SERVICE/PACIFIC	NORTHWEST REGIONA

CRATER LAKE LODGE (BUILDING NO. 565)

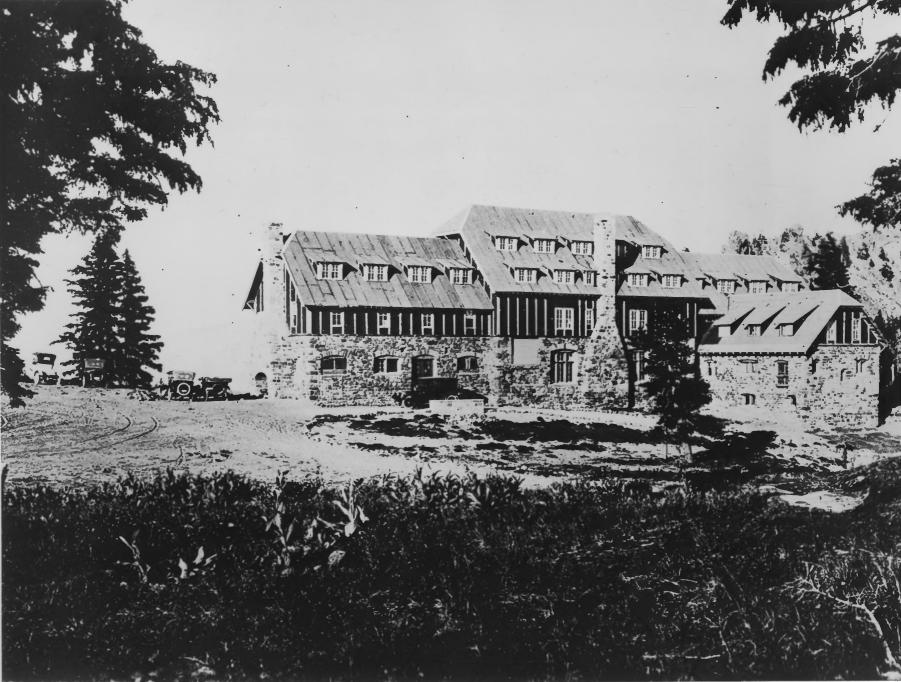
SOHS NEG. NO. 2639

CRATER LAKE LODGE, VIEWED FROM THE, SOUTH -SOUTHWEST, NOTE UNFINISHED APPEARANCE OF EXTERIOR PROBABLY TAKEN CIRCA 1915

Crater Lake Lodge, Crater Lake NP
View from the south/southwest
Klamath County, Oregon
Southern Oregon Historical Society Neg
2639
Circa 1915

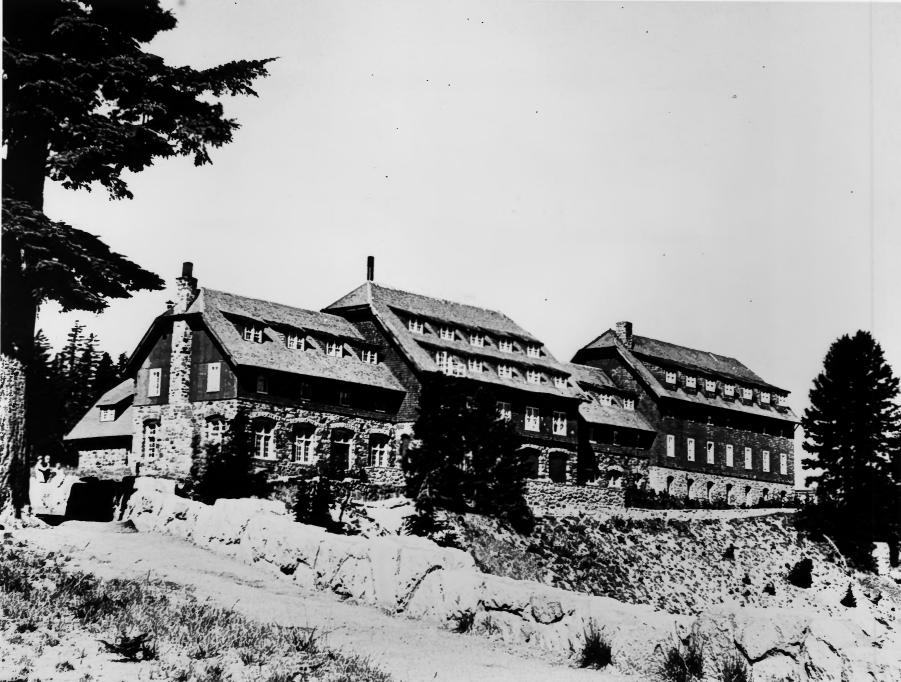
NPS PHOTO FROM THE PARK NEG. NO. 569

GRATER LAKE LODGE LODKING FROM NORTHEAST

AS THE LODGE APPEARS PODAY
PROBABLY TAKEN 1950-60'S
NOTE PLYWOOD ON EAST WALL

Crater Lake Lodge, Crater Lake NP
"As the lodge appears today"
Klaqmath Gounty, Oregon
NPS photo from the park's neg. no. 569
Circa 1950-60

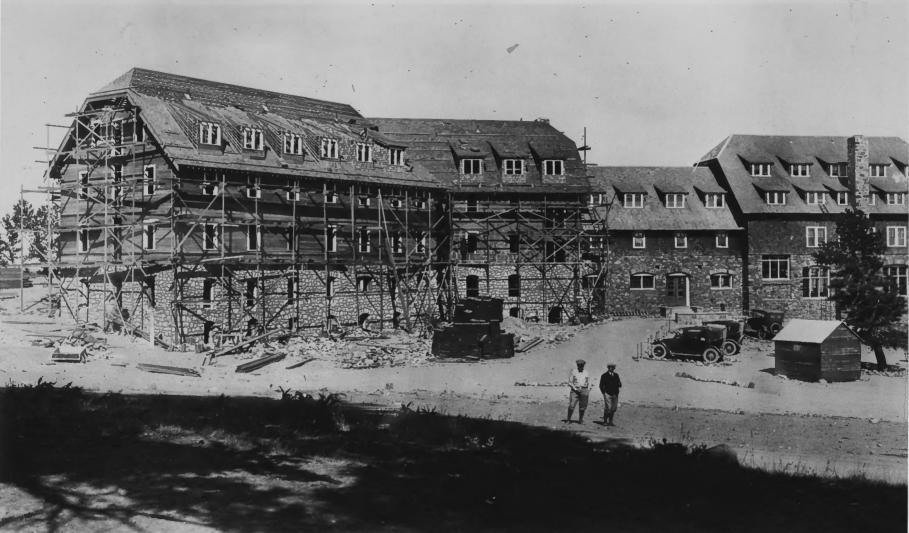
11PS PHOTO FROM PARK SCRAPBOOK

CRATER LAKE LODGE ANNEX ADDITIONS UNDER CONSTRUCTION, LOOKING FROM THE SOUTHWEST CIRCA 1923

Crater Lake Lodge, Crater Lake NP
The lodge annex additions under
construction, looking from the
southwest
NPS photo from park scrapbook
Girca 1923

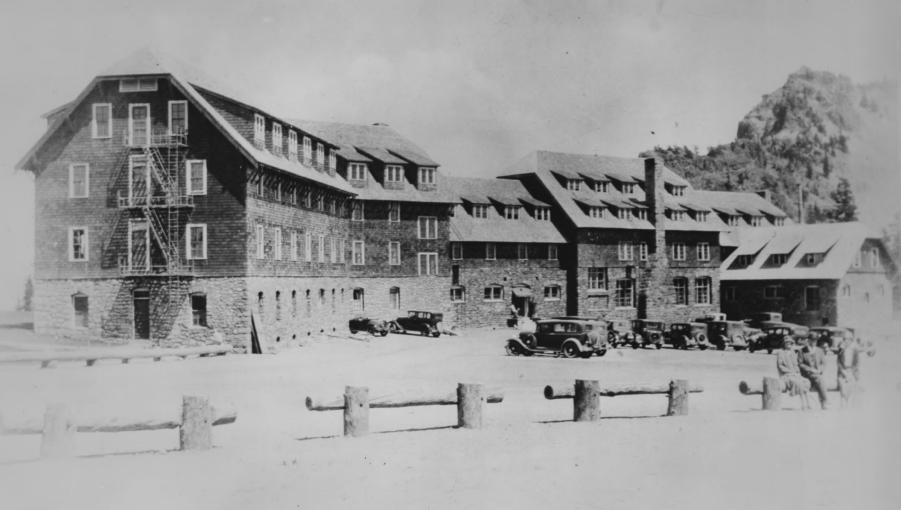
SOLTS NEG. NO. 2651

CRATER LAKE LODGE LOOKING FROM THE SOUTHWEST CIRCA 1925

Crater Lake Lodge, Crater Lake NP
Looking from the southwest
Southern Oregon Higher 2cal 98 ociety Neg.
2651
Circa 1925
MAY 5 1981

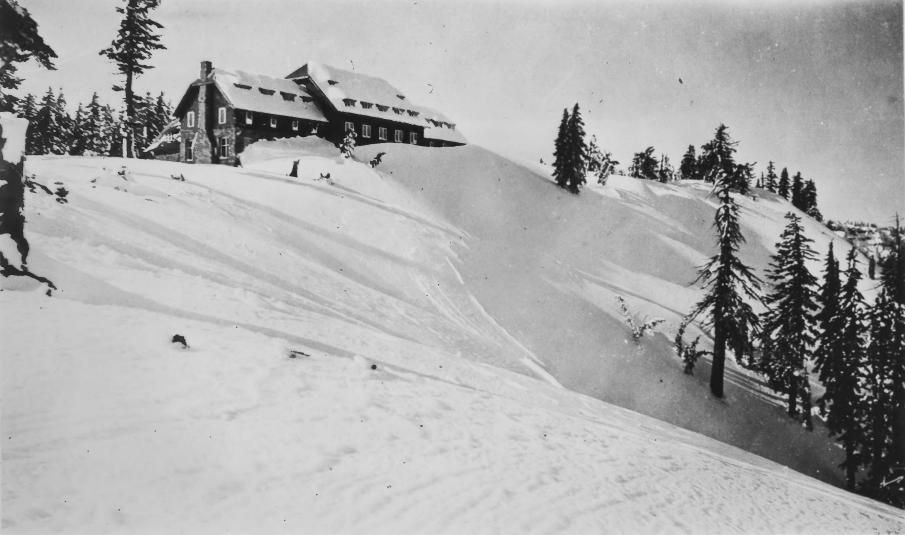
NPS. PHOTO FROM PARK SCRAPBOOK

CRATER LAKE LODGE LODKING FROM NORTHBAST, PALOR TO ANNEX ADDITIONS, BUT AFTER SHINGLE SIDING, PROBABLY CIRCA 1921

Crater Lake Lodge, Crater Lake NP
Klamath County, Oregon
Looking from northeast prior to annex
additions
NPS photo from park scrapbook
Circa 1921

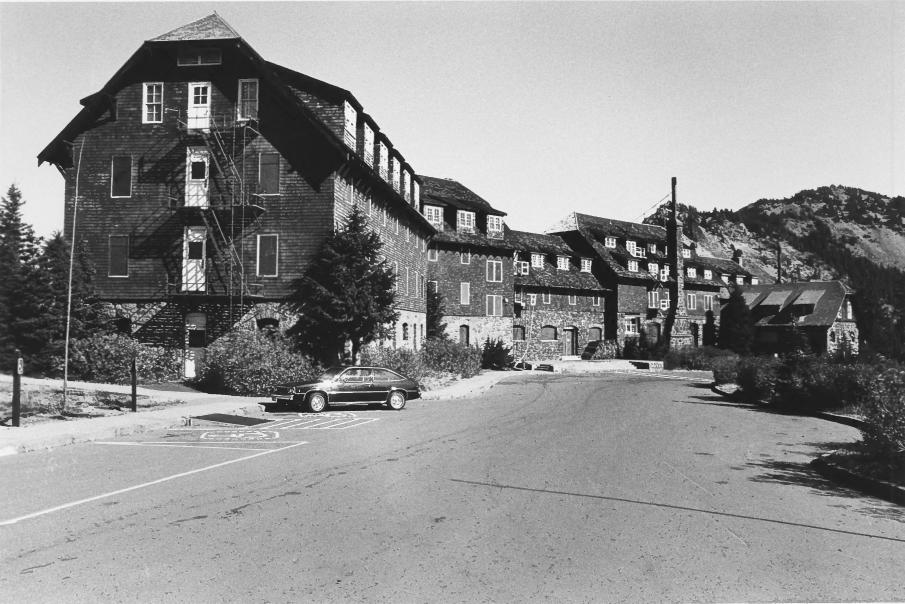
FROM THE SOUTH WEST 10/80 CRATER LAKE NATIONAL PARK, OREGON

Crater Lake Lodge from the southwest Crater Lake National Park Klamath County, Oregon By Henry Law of the Denver Service Center(NPS), October 1980

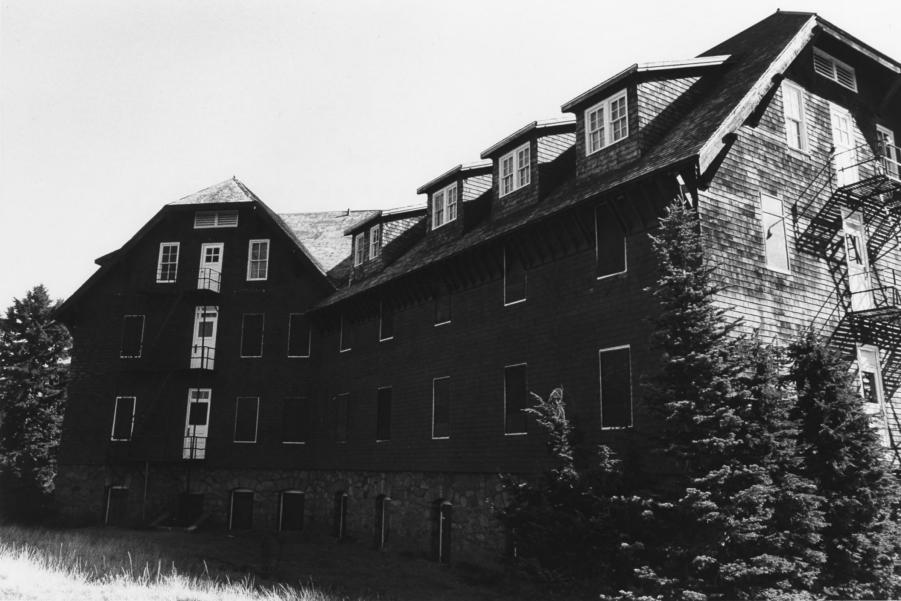
Crater Lake Lodge, Crater Lake NP
West end of annex and annex wing
Klamath County, Oregon
By Henry Law of the Denver Service
Center(NPS), Octaber 1980 APR 2

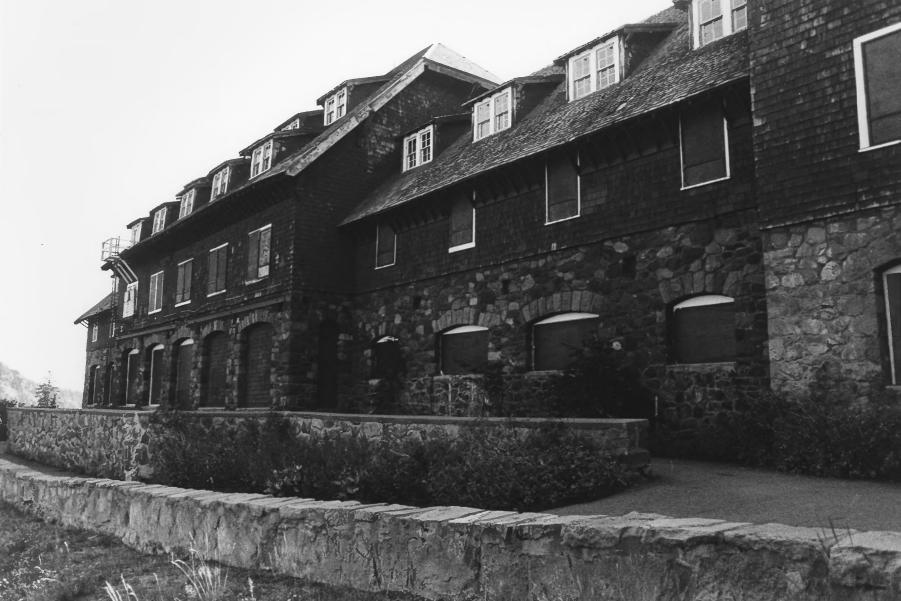
CRATER LAKE LODGE 10/80 NORTH SIDE OF MAIN BUILDING CRATER LAKE NATIONAL PARK, OREGON

Crater Lake Lodge, Crater Lake NP North side of main building Klamath County, Oregon By Henry Law of the Denver Service Center(NPS), October 1980

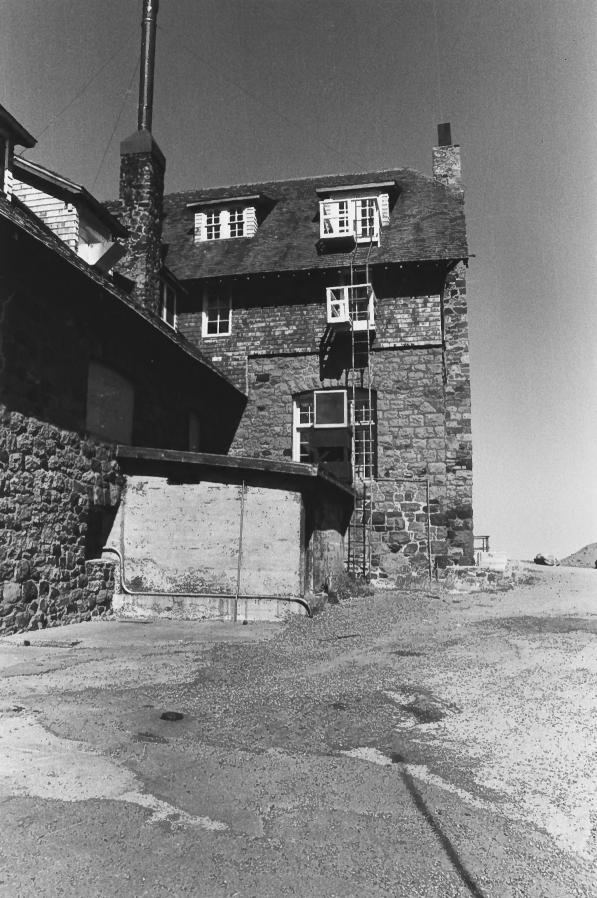
SOUTH ELEVATION, EAST END CRATER WATER NATIONAL PARK, OREGON

South elevation, east end
Klamath County, Oregon
By Henry Law of the Denver Service
Center(NPS), October 1980

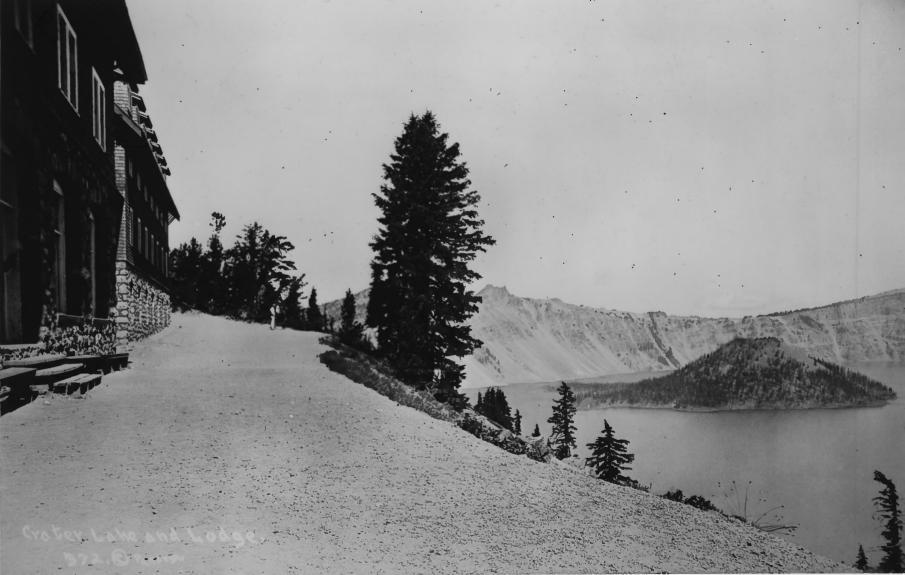
CRATER LAKE LODGE LOOKING WEST ALONG NORTH FACAD OF THE LODGE, NOTE THIS WAS PRIOR TO CONSTRUCTION OF PATIO AND RIM WALK WALL PRES NEW DEAL ERA

Crater Lake Lodge, Crater Lake NP Looking west along north facade of the lodge, prior to construction of patio and rim walk wall NPS photo from park scrapbook 2 1981

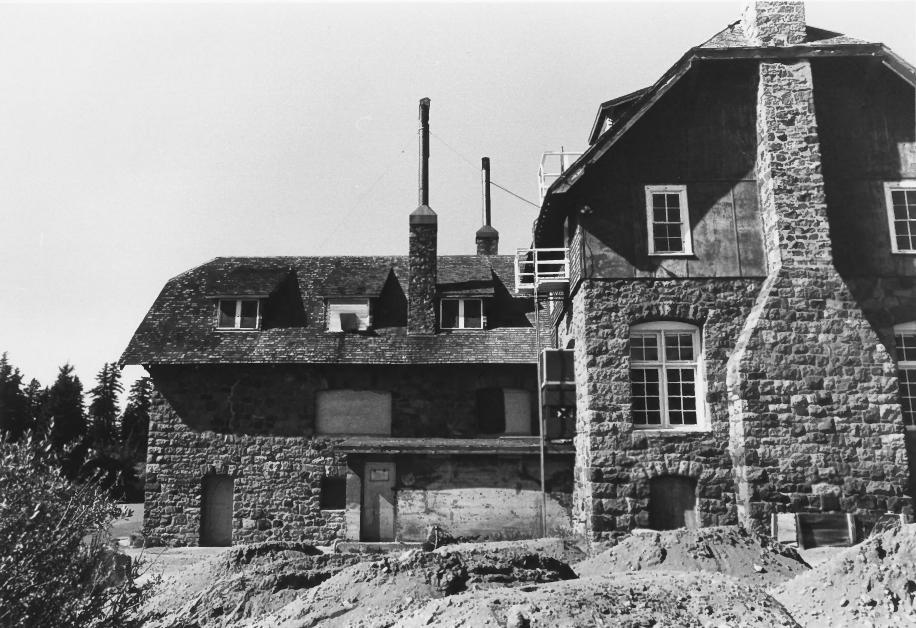
CRATER LAKE LODGE 1980 EAST ELEVATION CRATER LAKE NATIONAL PARK, OREGON NPS PHOTO BY

Crater Lake Lodge, Crater Lake NP East Elevation
Klamath County, Oregon
By Henry Law of the Denver Service Center (NPS), October 1980
APR 2 1981

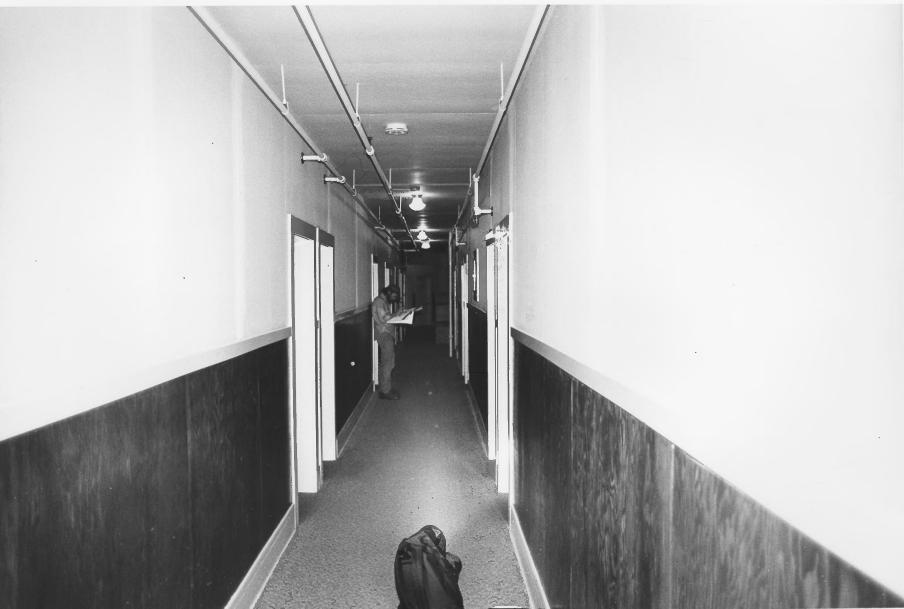
CRATER LAKE LODGE INTERIOR HALL, ANNEX WING 10/80 CRATER LAKE NATIONAL PARK, OREGON

Crater Lake Lodge, Crater Lake NP Klamath County, Oregon APR 2 1981 Interior Hall, Annex Wing By Henry Law of the Denver Service Center (NPS), October 1980 MAY 5 1981

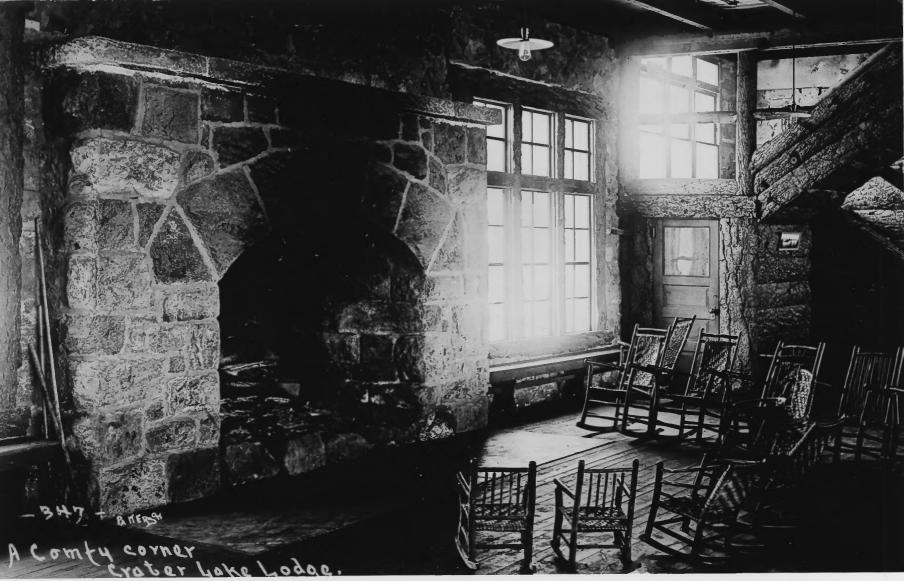
CRATER LAKE LODGE, INTERIOR VIEW OF LOUNGE FIREPLACE, LODGEING FROM NORTHEAST, NOTE LIGHTING FUTURES. PROBABLY EARLY, AT LEAST 1940'S OR EARLIER

Crater Lake Lodge, Crater Lake NP
Interior view of lounge fireplace
Klamath County, Oregon APR 2
NPS photo from park scrapbook
MAY 5 1981

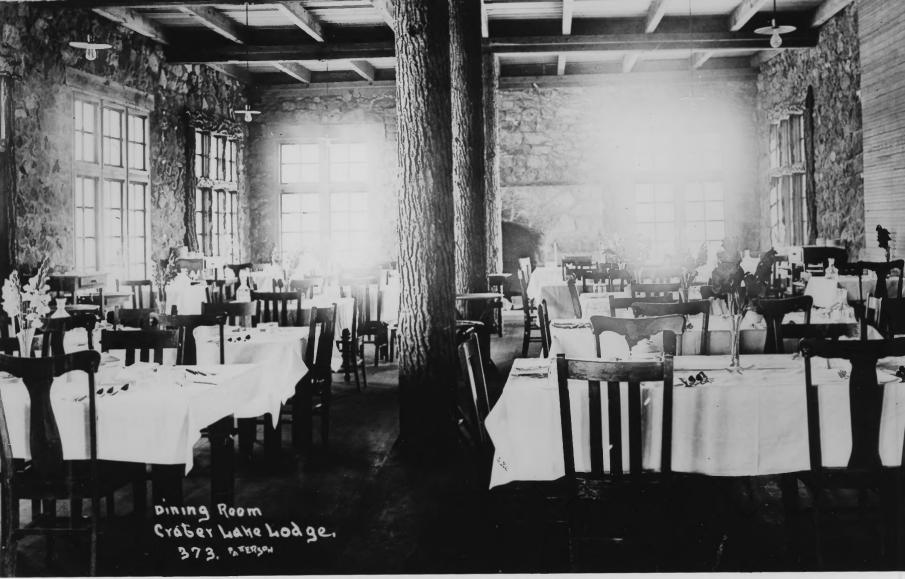
CRATERLANE LODGE FARLY VIEW OF DINING HALL LOOKING FAST NOTE EARLY LIGHT FIXTURES

Crater Lake Lodge, Crater Lake NP Early view of dining hall looking east Klamath County NPS photo from the park scrapbook MAY 5 1981 APR 2 1981

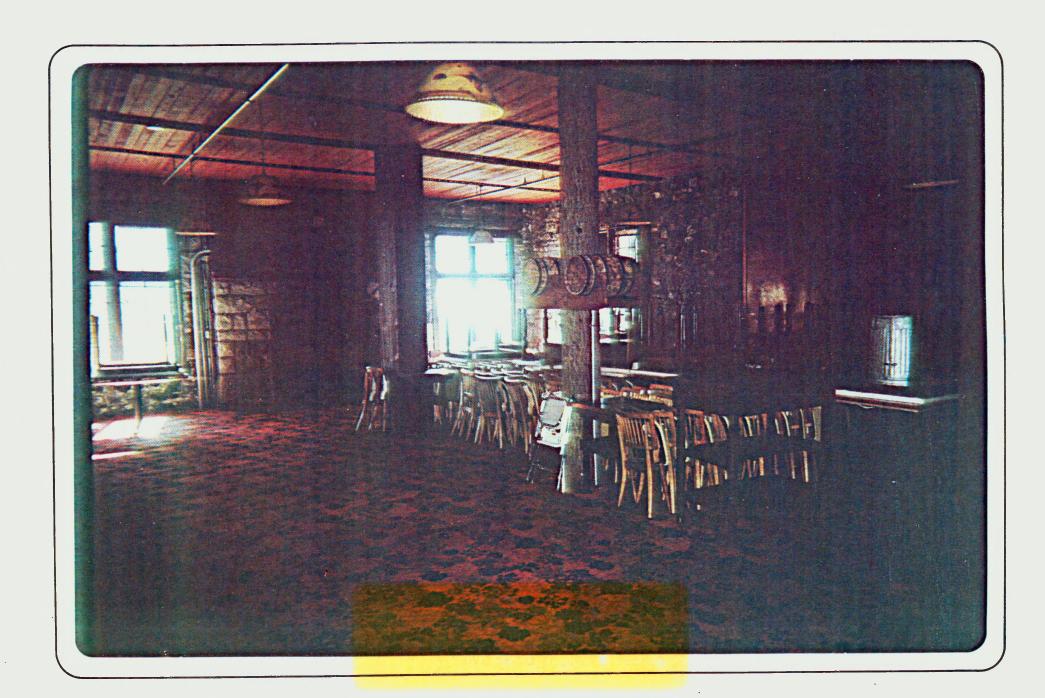
CRATER LAKE LODGE, DINING HALL LOOKING SOUTHEAST, 10/81

Crater Lake Lodge, Crater Lake NP
Klamath County, Oregon
Dining Hall, looking southeast
By Henry Law of the Denver Service
Center (NPS), October 1980

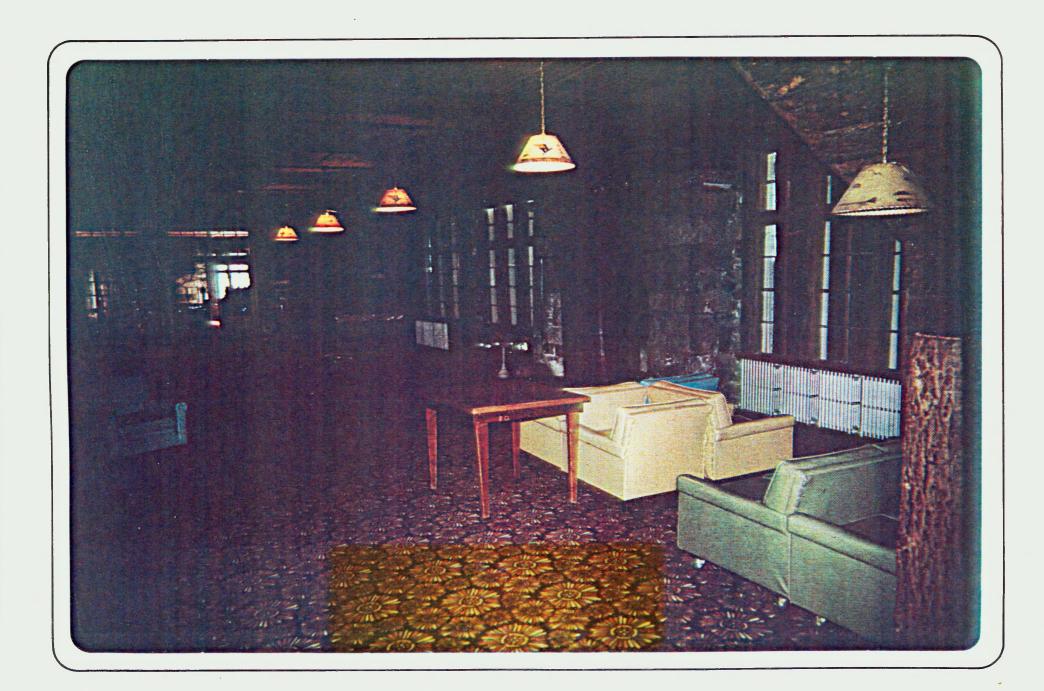
FROM LOUNGE STAIRWAY

Crater Lake Lodge, Crater Lake NP
Klamath County, Oregon APR 2
Lounge, looking east from lounge
stairway
By Henry Law of the Denver Service
Center (NPS), October 1980

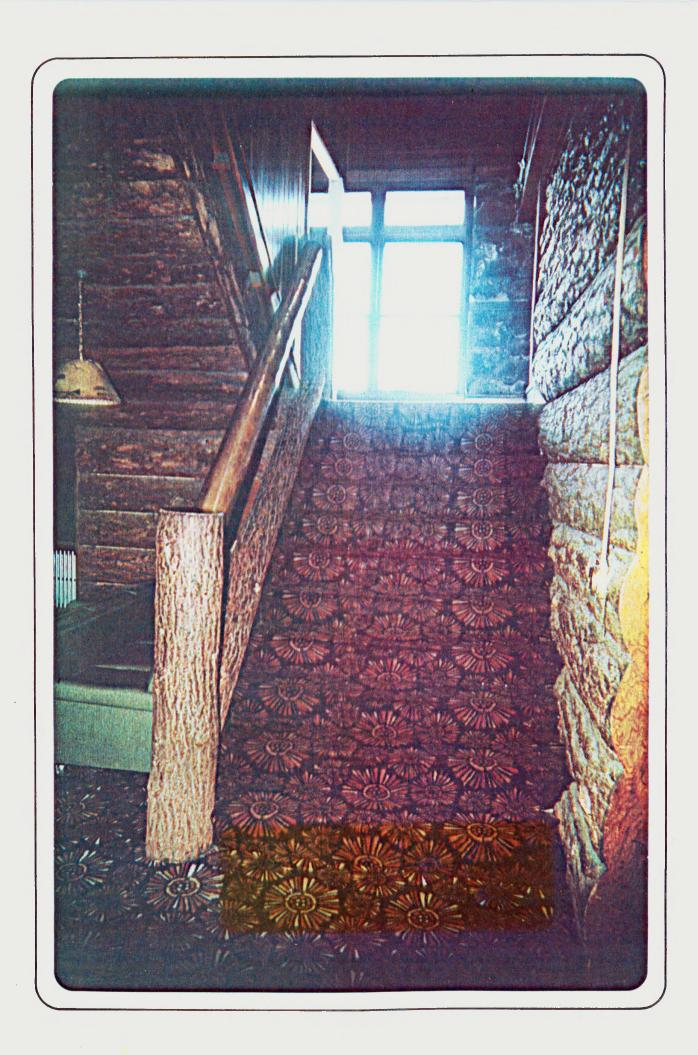
FROM GROUND FLOOR, 10/80

Crater Lake Lodge, Crater Lake NP Klamath County, Oregon Lounge stairway from ground floor By Henry Law of the Denver Service Center(NPS), October 1980 MAY 5

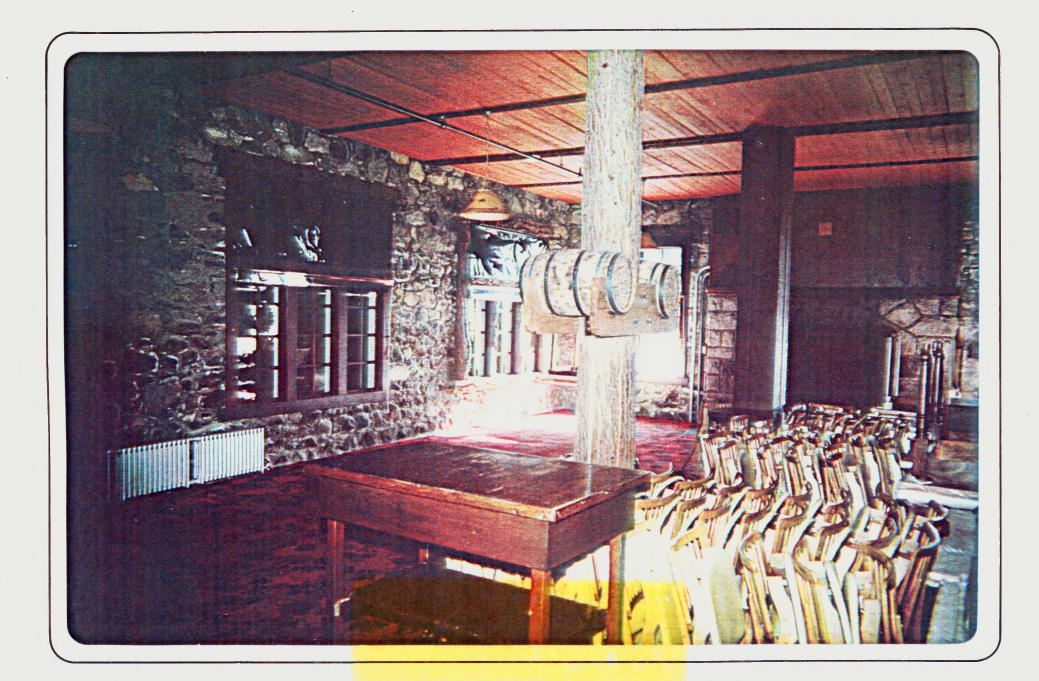
CRATER LAKE LODGE, DINING HALL LOOKING NORTHEAST, 1980 Note enclosed log poet and largeting

Crater Lake Lodge, Crater Lake NP
Klamath County, Oregon
Dining Hall looking northeaster 2
By Henry Law of the Denver Service
Center (NPS), October 1980
MAY 5 198

The interior public spaces appear much as they did in early photographs, but columns have been added to mitigate structural deficiencies which are a result of the failure of the onsite construction to follow the original construction plans by R. L. Hockenberry and Co., Architects. A dropped ceiling of rough sawn boards has been added to cover the addition of plumbing into the guest rooms, and all of the flooring has been carpeted. Finishes in the corridors and guest rooms have been significantly altered over the course of the lodge's operation.
