CRATER LAKE

PNRO INVENTORY

National Park Service
Pacific Northwest Region
Cultural Resources Division

1. SITE I.D. NO.		5. ORIGINAL USE Administrative Offices		7. CLASSIFICATION		9. RATING	
2. NAME(S) OF STRUCTURE ADMINISTRATION BUILDING #1 (LCS# 12011)		6. PRESENT USE Administrative Offices				10. DATE Completed 1935	
3. SITE ADDRESS (STREET & NO) Park Headquarters Munson Valley North Side Administration Circle				8. UTM ZONE EASTING NORTHING		11. REGION 10	
4. CITY/VICINITY COUNTY STATE Crater Lake National Park, Klamath, Oregon				SCALE 1:24 1:62.5 OTHER		QUAD NAME	
12. OWNER/ADMIN ADDRESS U.S. Department of Interior, National Park Service, Seattle, Washington

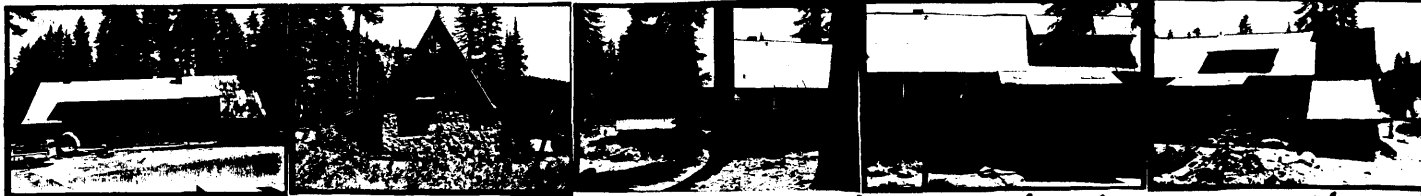
SOUTH ELEV.
8-25-84
M. COPLIN

A rustic style stone and wood bunkhouse and mess hall; 7,631 s.f. (orig. 4,438 s.f.), 2-1/2 stories. Rectangular ground floor constructed of massive stone masonry with second and attic floors within steeply pitched wood roof. Sheet metal roof applied over original shake roof, with board and batten siding at gable ends and sidewalls of shed-roofed dormers which penetrate the roof on the north and south sides. An additional "dormer on a dormer" at the north side provides windows into attic floor. The roof pitches from the top of the first floor stone walls to the ridge at either side of building, which narrows the second and attic floor plans. A major addition to the building on the east end was completed in 1934, and generally matches the design of the original section. The only access to the second floor is provided by an exterior stair on the north side of the building, which is a poorly constructed replacement for an original log design stair; the stair is roofed over and enclosed within a pole and board structure. A small shed addition over original kitchen porch on NW corner was added sometime in the 1940s. A stone and concrete porch on the south side, added in 1935, provides entry into the main dining space on the ground floor. Windows are original wood sash with wire snow screens added. Doors are badly deteriorated flush panel type, not original. The stone work is in good condition but the roof and siding are deteriorated. Much of the original charm of the building has been lost through deterioration and replacement of exterior parts without regard for original design.

Interior construction is a conglomeration of changes over the years. Floor and wall construction are wood frame. What little original wood paneling remains is badly deteriorated with many coats of paint. Most interior doors, hardware

The Mess Hall was the most deteriorated of the three structures that have been rehabilitated since 1985. The interior was largely unusable as years of deferred maintenance and incompatible alterations had taken its toll on the structure and imminent collapse seemed possible.

The exterior rehabilitation included a new shake roof, repainting according to the original color scheme, repointing as required of the masonry base, addition of a snow entrance to the front elevation, and replacement-in-kind of the wood sash and doors. The interior was largely gutted and rebuilt, with new wall, floor and ceiling surfaces (wall board, lightly stained trim, carpet) and a new spatial layout (offices and laboratories for the Resource Management and Ranger Divisions).

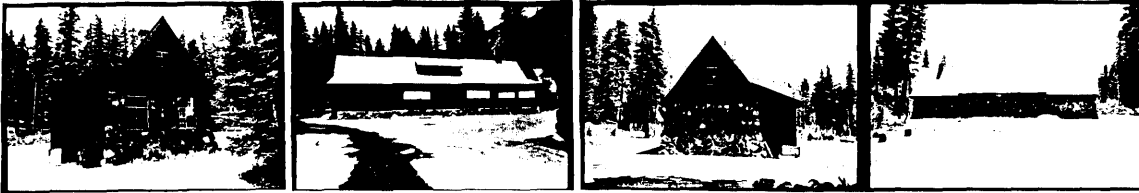
ELEV. - EAST
8-25-84
M. COPLIN

A rustic style stone and wood warehouse; 1,900 s.f. (original 900 s.f.); 1-1/2 stories. Ground floor constructed of stone masonry; second floor within steeply pitched roof structure. The plan is rectangular with a covered loading dock extending the length of the south side. Sheet metal roof applied over 24" sugar pine shakes, 12" exposed; 14/12 pitch roof. Bevel siding stained brown on gable ends; one 6-window shed dormer penetrates roof on south side. Windows are steel casements with heavy timber lintels. First and second floors are wood joist construction with 2" plank floor. Interior open stair to second floor storage. The center portion houses warehousing with office and restroom on the east end and cold storage on the west. Deterioration of the north stone wall, which has been pushed in by excessive snowdrift, is evident; permanent bracing has been installed on north wall and cut into floor.

Warehouse was designed and built by NPS in 1926. An extensive remodeling of the building took place in 1934-35: additions extended both ends of the building; the original dormer was replaced by a larger dormer; the original stone chimney on the west end was replaced by a new stone chimney on the east; and a covered porch was built over the extended loading platform. The original and addition sections are clearly demarcated by the difference in the size of the stones used; the original section is small rubble stones, the 1934 masonry used much larger boulders. The 1934 additions were funded as a P.W.A. project (F.P.34) supervised by NPS landscape architect Francis G. Lange and P.W.A. appointee E.E.

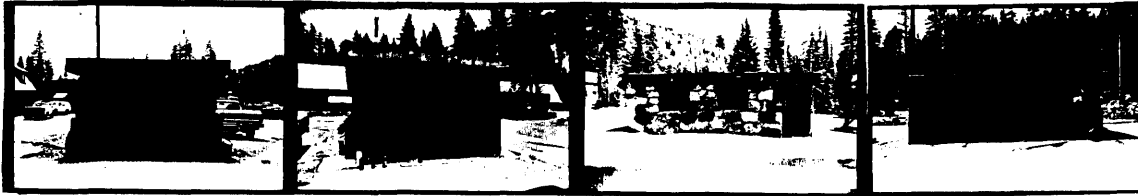
NORTH ELEV.
8-25-84
M. COPLIN

Rustic style stone and wood oil and gas house; 12'x20' originally with added enclosed 6x12 south porch, 308 sq. ft., one story. Walls constructed of large rustic stones with concrete backup. Plan is rectangular. South end has enclosed space housing fuel pumps. Doors on north and south are original paneled wood. Heavy timber lintels over doors and original steel windows. Flat roof replaces original steeply pitched shake roof. Original north end porch with stone columns is missing. Not much left of original building except some stone work (doors) and steel sash windows in east and west walls. Building has structural roof problems and poses a fire hazard.

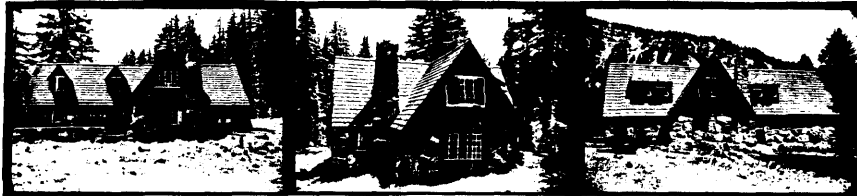
EAST ELEV.
8-25-84
M. COPLIN

A rustic style stone and wood residence; 2,795 s.f.; 1-1/2 stories with garage and partial basement underneath. Ground floor is constructed of massive stone masonry with the second floor within a steeply pitched roof. The plan is cruciform with long axis north-south; garage entry on the basement south side. A large flagstone terrace of native park stone is located on southeast corner of the house. Shake roof is 16/12 pitch with gable ends at the four ends of the cruciform and dormers on the east and west sides of the roof. Massive stone chimney rises to ridge line on the north side of living room. Upper gable ends are board and batten siding over wood frame construction. Windows are steel sash. Main entry doors are heavy plank construction with special design hardware. Exterior appearance matches the original design.

Interior construction is standard stud walls, wood joist floors. Massive stone fireplace in living room has excellent cut native stone (rough burnt lava rock) and handmade wrought iron fixtures. First floor houses living room, dining, kitchen, entry hall, one bedroom with bath; open stair to one large bedroom with bath and three medium-size bedrooms with bath off central upper hall. Interior finishes: painted plaster with standard cut wood moldings--some painted, some natural S&V. Cabinets are painted wood. Interior hardware is original and of excellent quality with some repair and replacement needed. Hardwood floors on main level and upper level are VG fir. Finishes have generally

declined and some water stain and plaster cracking have occurred. Good collection of original furniture, needs refurbishing. Original wrought iron light fixtures need refurbishing. Oil furnace replaced original gravity air wood-fired furnace in 1964.

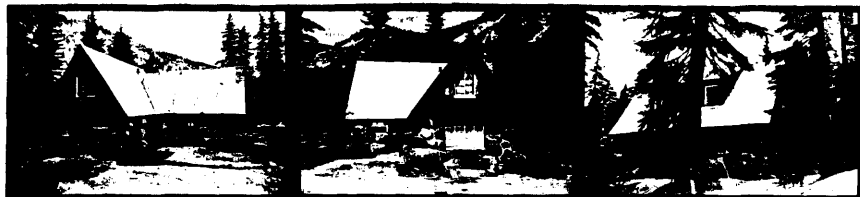
NORTH ELEV.
8-25-84
M. COPLIN

A rustic style stone and wood residence; 1,530 s.f.; 1-1/2 stories. Ground floor is constructed of massive stone masonry with second floor within steeply pitched wood roof structure. The plan is L-shaped with entry porch on the north side of the house away from existing road. Sheet metal roof applied over original shake roof is 16/12 pitch with wood board and batten siding at gable ends. A shed roof dormer with three windows penetrates the roof on the north side. Massive stone fireplace; stone chimney rises to above ridge line on the east side of the living room. There is evidence of chimney deterioration above the roof and problems with the roof. Windows are steel sash with heavy timber lintels. In addition to original north entry into living room, an exterior door into kitchen and another into downstairs bedroom now serve as entries into house. Doors are heavy plank construction with some original wrought iron hardware. Exterior appearance has been altered with change in roof material and grade changes around the house.

Interior construction is standard wood joist floors, stud walls with plaster. Fireplace has nice stone work but is in bad repair and very dirty. Ground floor plan includes kitchen, dining room, living room, and one bedroom with adjacent bath. Oil burning stove added in living room. Partial open stair from living room to upper hall. Two bedrooms and a single bath open off hall. A third long attic bedroom is reached through the east side bedroom. The interior finishes are badly deteriorated. Much of the exterior elegance shown in early photos is gone due to deterioration and site changes.

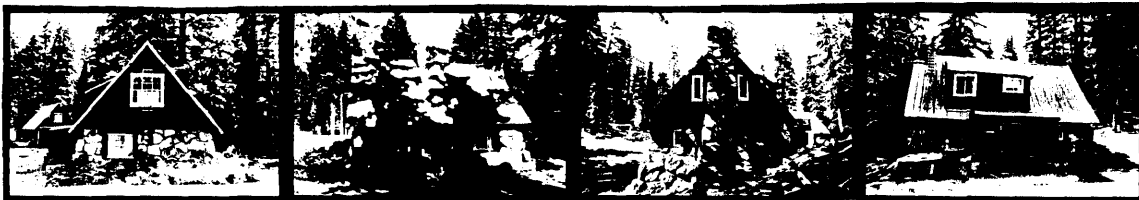
NORTH ELEV.
8-25-84
M. COPLIN

A rustic style stone and wood residence; 946 s.f.; 1-1/2 stories; rectangular space 18'x28'. Ground floor constructed of massive stone masonry with second floor within steeply pitched (14/12) wood roof structure. Sheet metal roof applied (1962) over original shake roof, with board and batten siding at gable ends. A shed roof dormer penetrates the roof on the east side with two windows into upper story rooms. Massive stone fireplace and chimney is exposed on the south end of house and rises above ridge line. Windows are original steel casements with heavy timber lintels. A snow tunnel shed at the main entry was built on top of the original flagstone porch on the east side in 1954. A rear entry on west side enters into rear porch area within house.

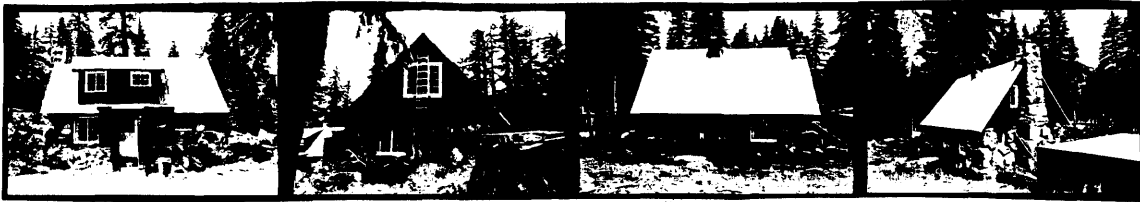
SOUTH ELEV.
8-24-84
M. COPPIN

A rustic style stone and wood residence; 916 s.f.; -1-1/2 stories, rectangular space 18'x28'. Ground floor constructed of massive stone masonry with second floor within steeply pitched 14/12 wood roof structure. Sheet metal roof applied (1962) over original shake roof, with board and batten siding at gable ends. A shed roof dormer penetrates the roof on the south side with two windows into upper story rooms. Massive stone fireplace and chimney is exposed on the west end of house and rises above ridge line. Windows are original steel casements with heavy timber lintels. Main entry door into living room is now reached through snow tunnel shed entry added to south side of building in 1954. This was built over stone entry porch of the original design. There is some evidence of deterioration around the chimney and roof junction. A rear entry on north side enters into rear porch area within the house. A wood flat roof garage was added to the west during the 1950s; it is of poor design and appears structurally unsound.
