# National Register of Historic Places Registration Form

historic name Barker, S. B., Building  
other names/site number Dunn Brothers Inc. Building

street & number 333 South Main Street  not for publication  
city, town Condon  vicinity  
state Oregon code OR county Gilliam code 021 zip code 97823

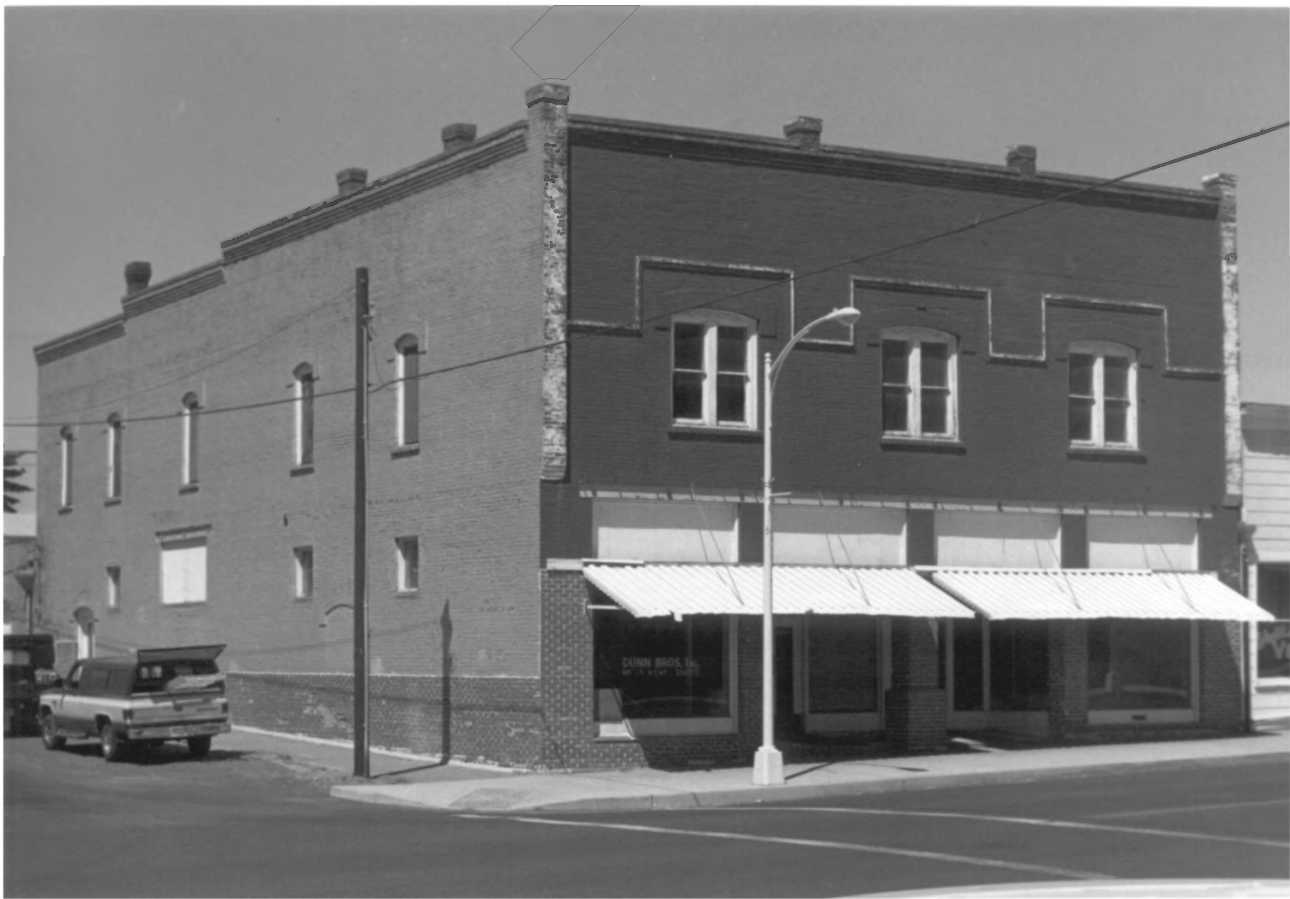
Photo #12 OF 30

SOUTH AND EAST ELEVATIONS

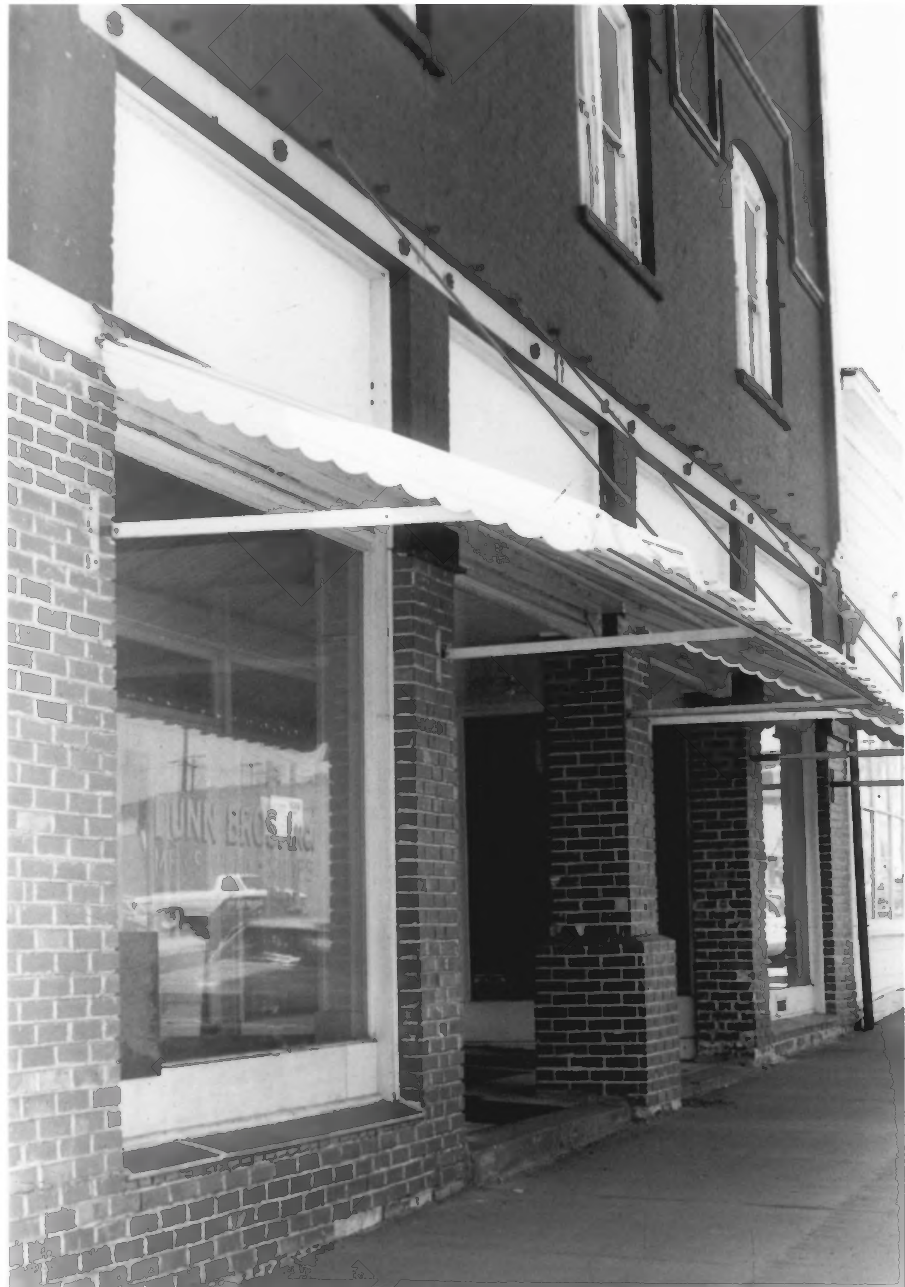
Photo #14 OF 30

EAST FRONT, LOOKING NORTH

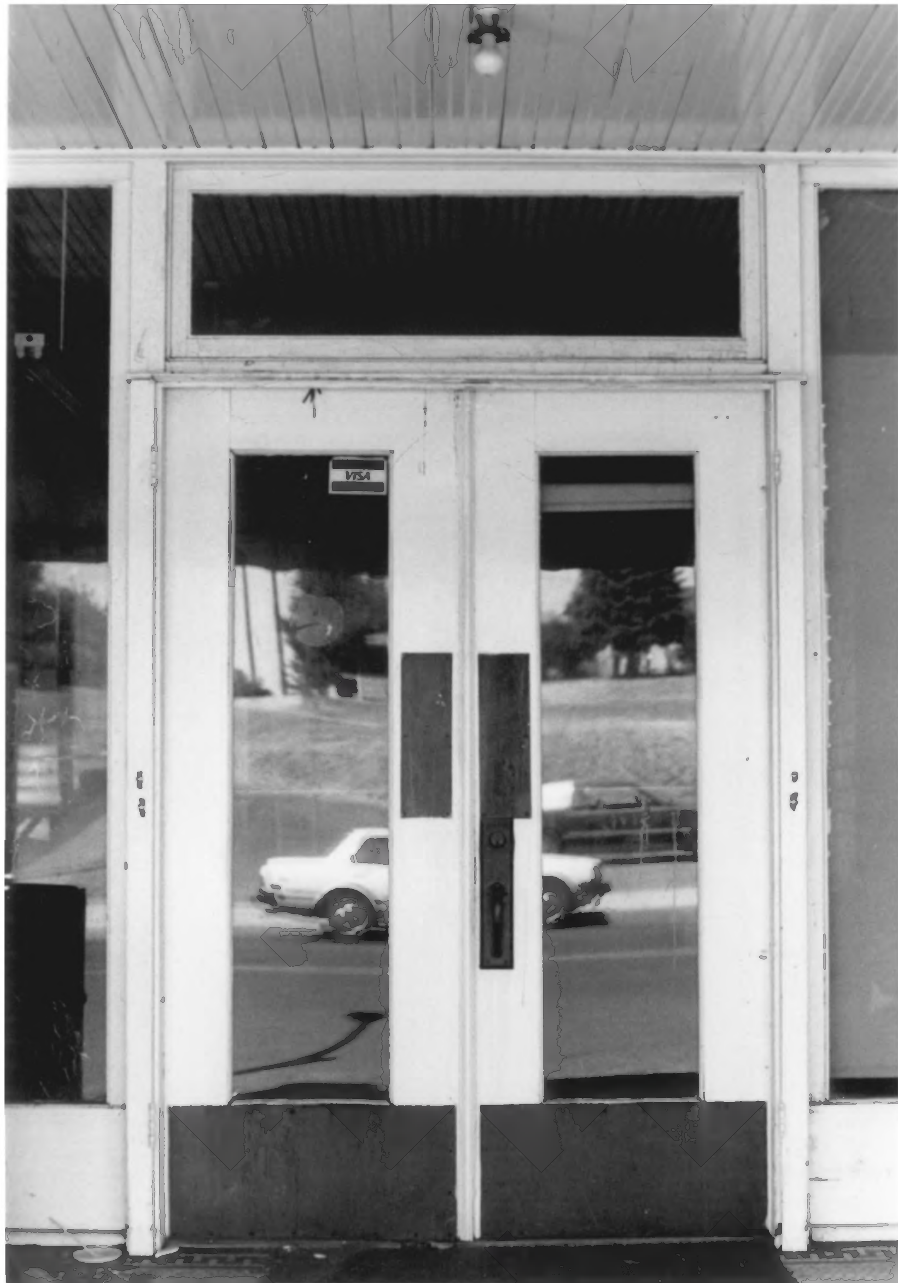
Photo #15 OF 30

FRONT ENTRANCE, EAST FACIA

The storefront window system, including the recessed porch, are all wood framed and painted. The one pair of remaining original entry doors (photo no. 15) have not been painted on the interior and display the beautifully grained oak of the entire storefront. A second pair of doors were removed in the recent past, stored on the premises and replaced with a modern hollow metal door for security reasons. The current owner plans to return this second pair of doors to their original location. The entry porch, recessed within the two center bays of the facade, measures approximately eight feet deep by 22 feet wide. The ceiling is wood panelled in a bead and groove pattern. The stoop slopes approx. 1" to the foot, to meet the sidewalk level at it's northern extreme, and is surfaced primarily with white, hexagonal ceramic mosaic tile. Green and white square tiles are used for the border pattern as well as for a center panel reading "BARKER'S" (photos no. 16 and 17).

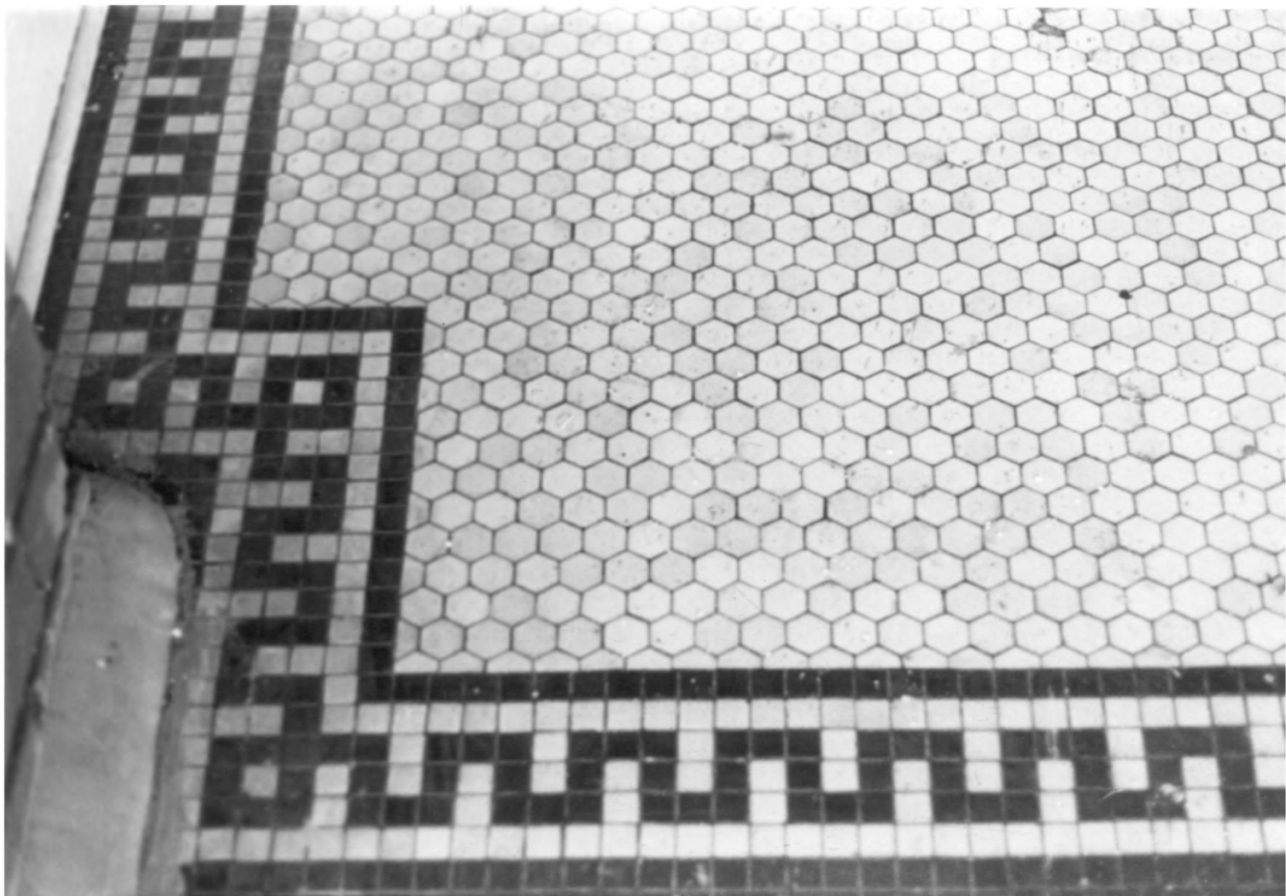
Photo # 16 OF 30

ENTRANCE PAVING TILE

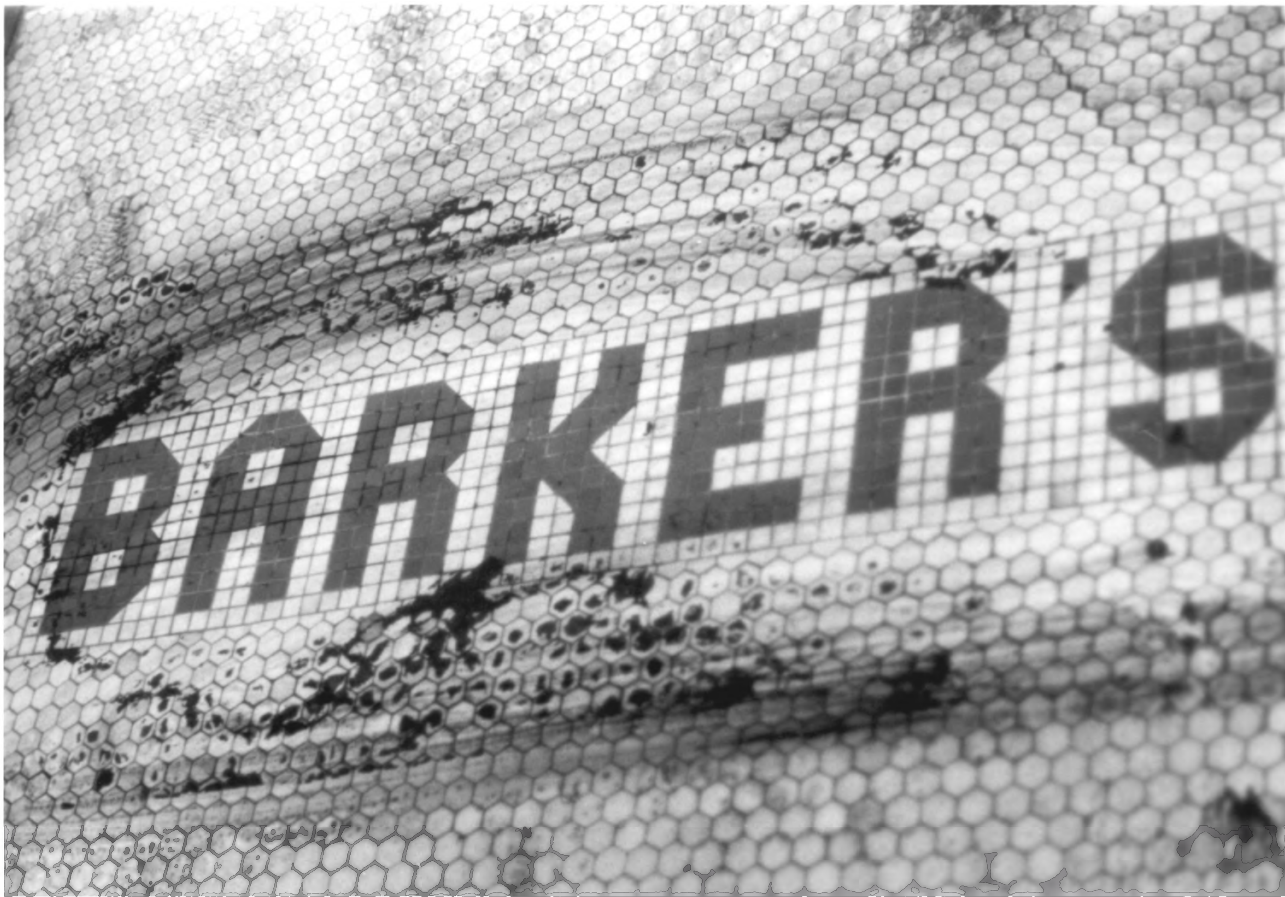
Photo #17 OF 30

ENTRANCE PAVING TILE

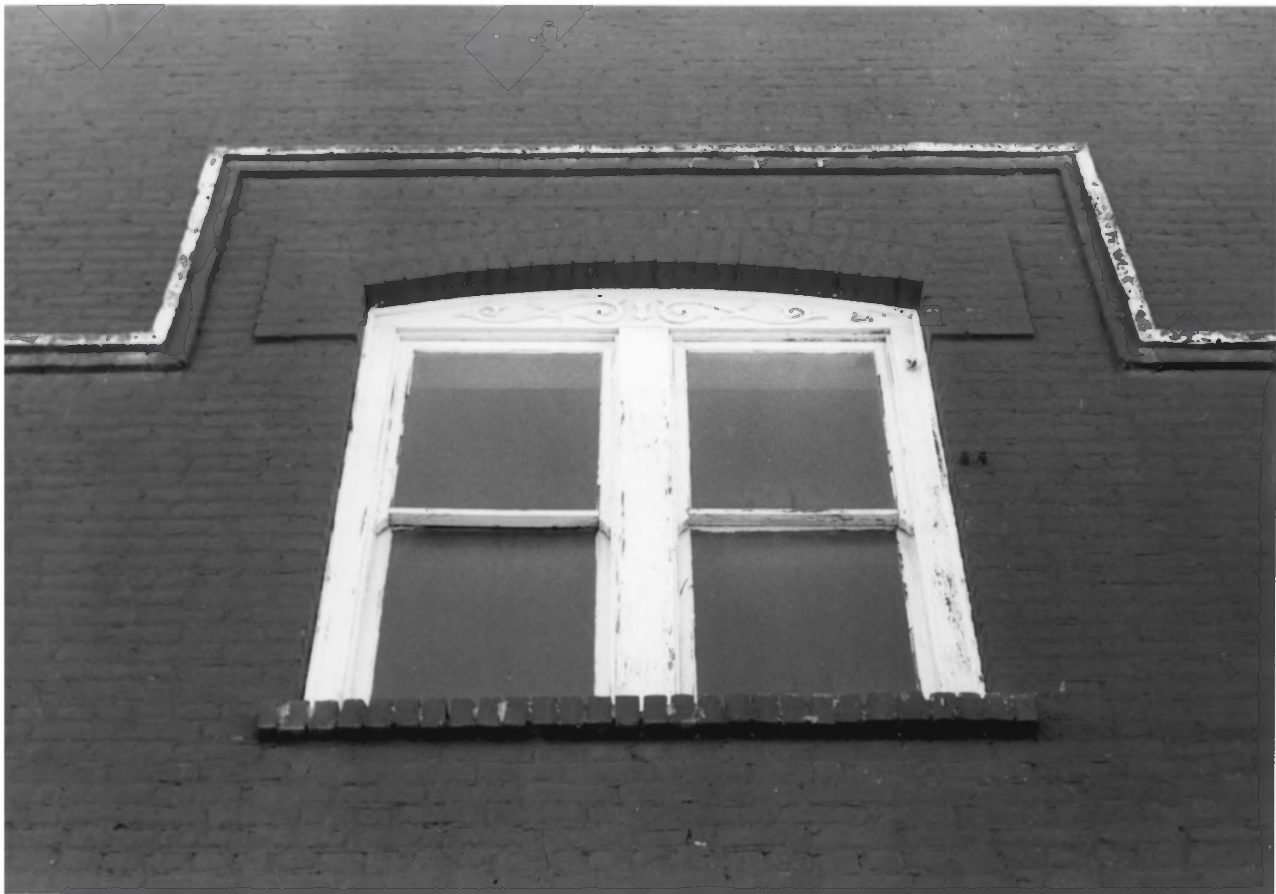
Photo # 18 of 30  
S.B. Barker Building (1903)

SECOND STORY BRACING, FRONT (EAST) ELEVATION

with only their function changing. The second story facade is divided into three bays, each with a pair of double-hung windows (photo no. 18).

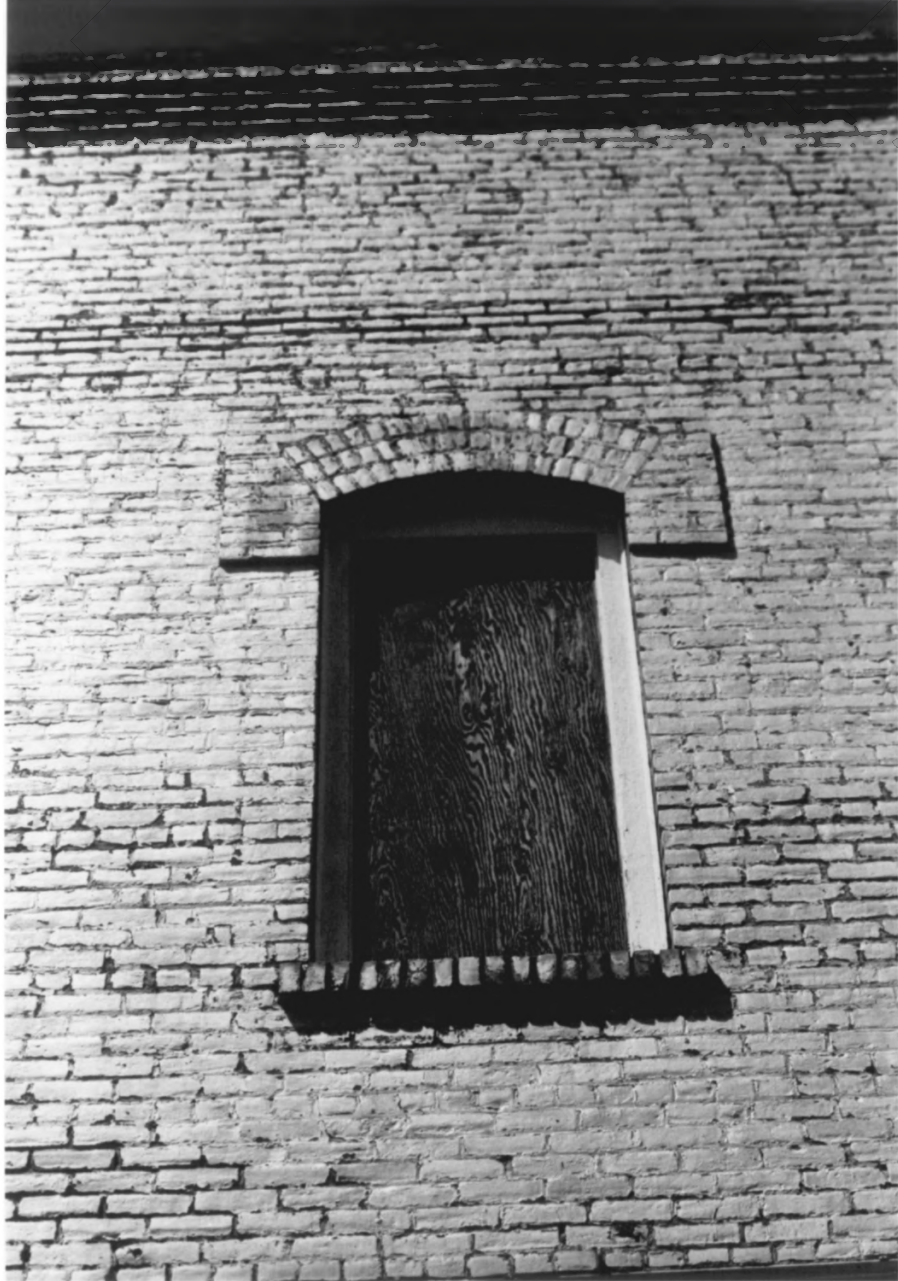
Photo # 19 OF 30

SECOND STORY OPENING, SOUTH REAR WALL

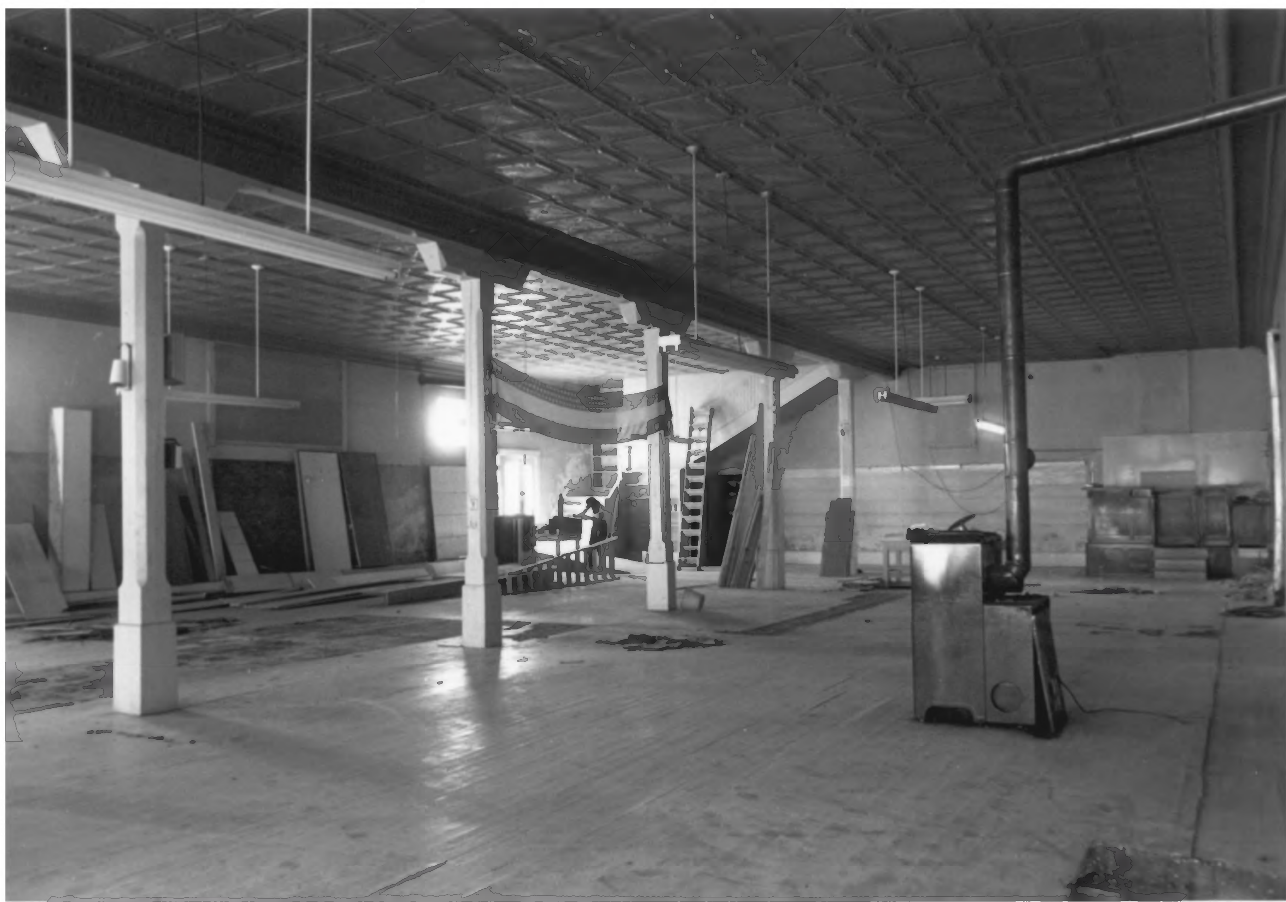
Photo # 23 OF 30  
S.B. Barker Building (1903)

FIRST FLOOR ENTRANCE, LOOKING WEST

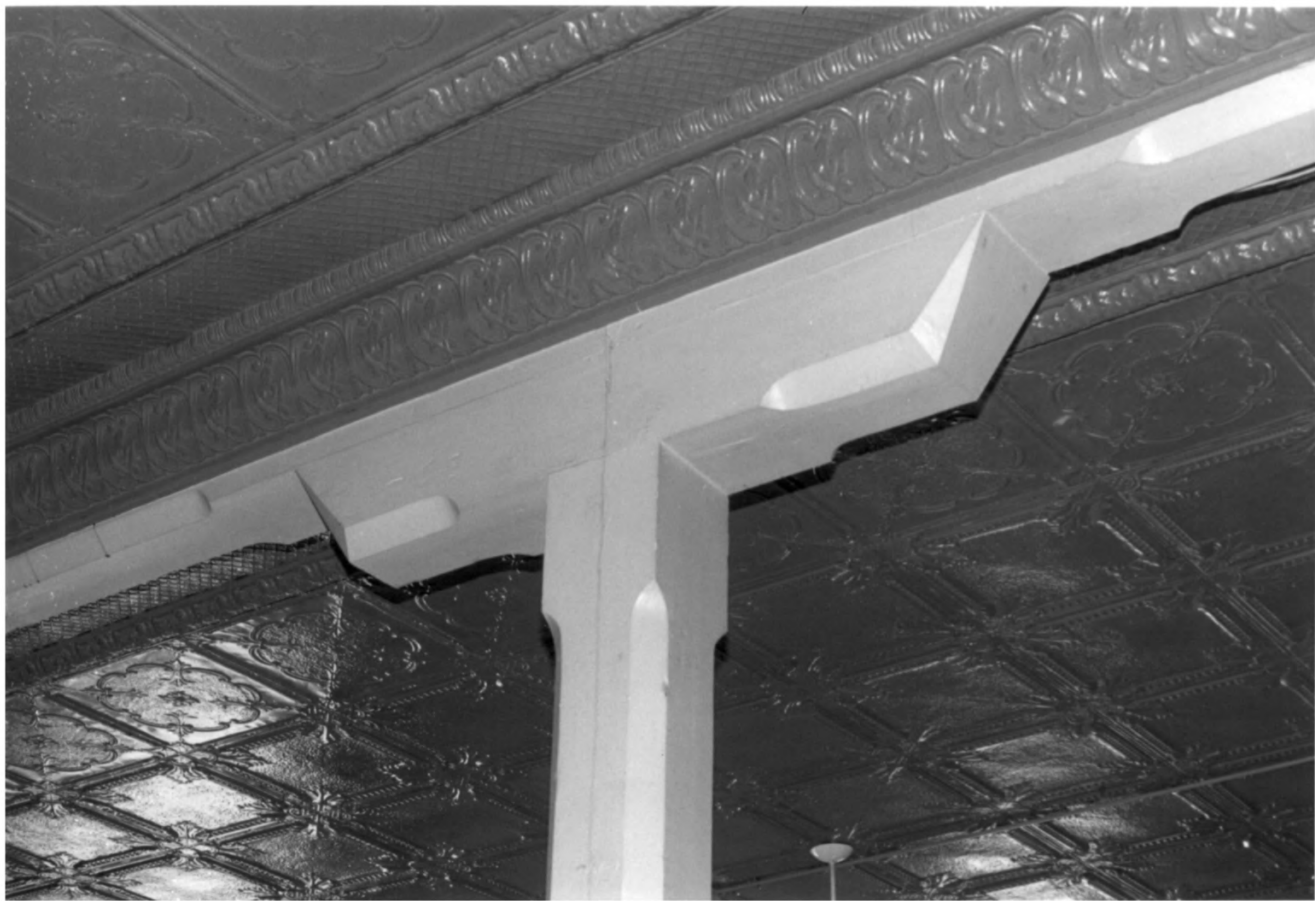
Photo # 24 OF 30

VIEW OF FIRST FLOOR  
CHAMFER DETAILS,

COLUMN AND BEAM, WITH  
AND EMBOSSED TIN CEILING

The most dramatic interior feature of the building is the first story pressed metal ceiling (photos no. 24 through 27). The ceiling is in excellent condition with virtually

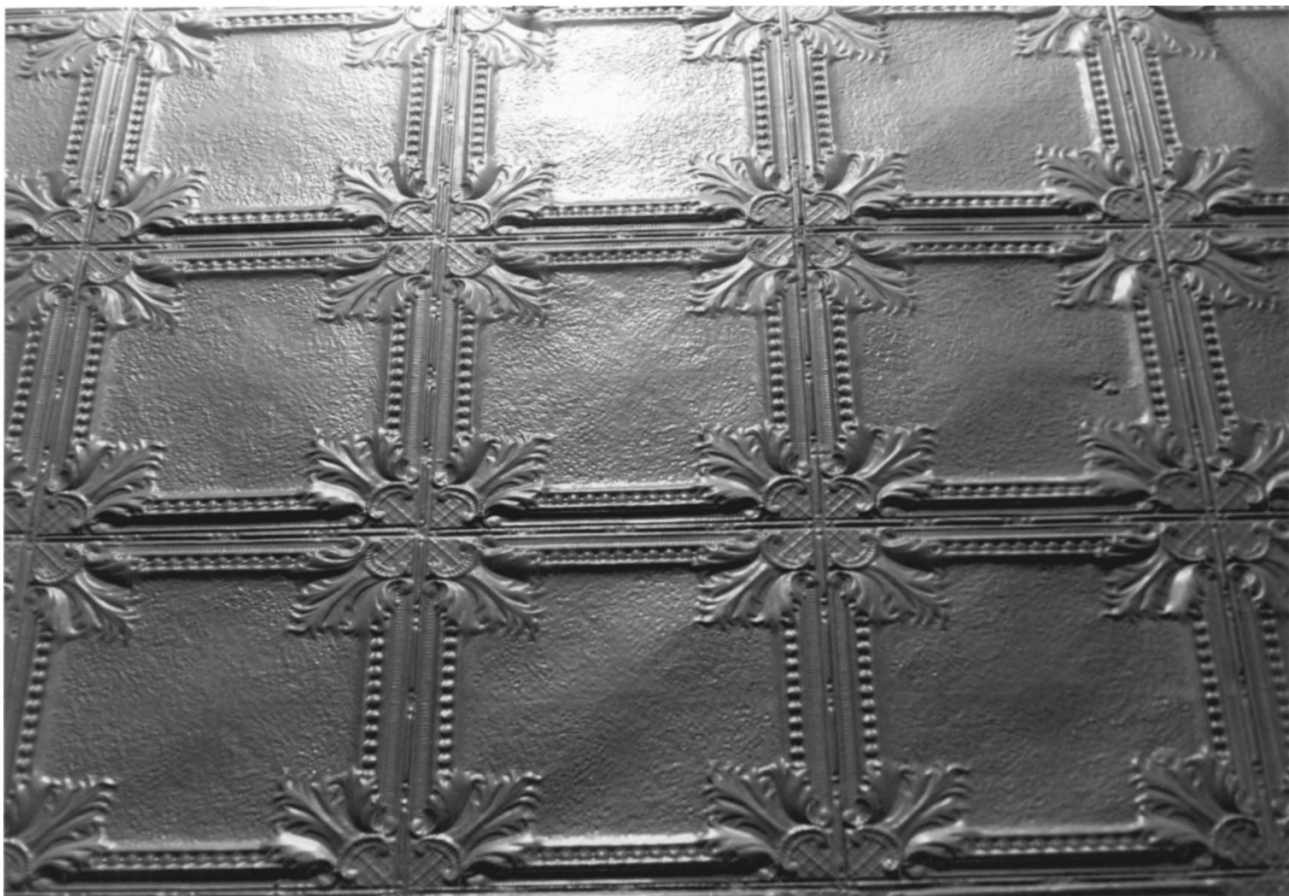
Photo # 25 OF 30

DETAIL OF AMBASSADOR TIN CEILING

no damage or alteration. Suspended fluorescent light fixtures have been added requiring a small surface conduit to be installed at the ceiling, but no disruption to the ceiling is apparent. Several different patterns of ceiling tiles and border strips were used to create the highly decorative ceiling. The center beam running east/west through the building divides the ceiling in two identical sections. Each section is bordered on all sides, except at the rear wall and stairwell where the ceiling has been terminated without a border. The border is composed of four separate strip mouldings, the outer most being an 8" deep coved strip with a leaf pattern, next a narrow bead molding about 2 inches wide with an egg and dart type pattern, then a flat strip about 8 inches wide with a low relief pattern of intersecting lines and finally another bead molding about 4 inches wide in a leaf pattern. Within the border just described, the main ceiling is composed of simple square tiles in a geometric pattern with floral patterned border tiles.

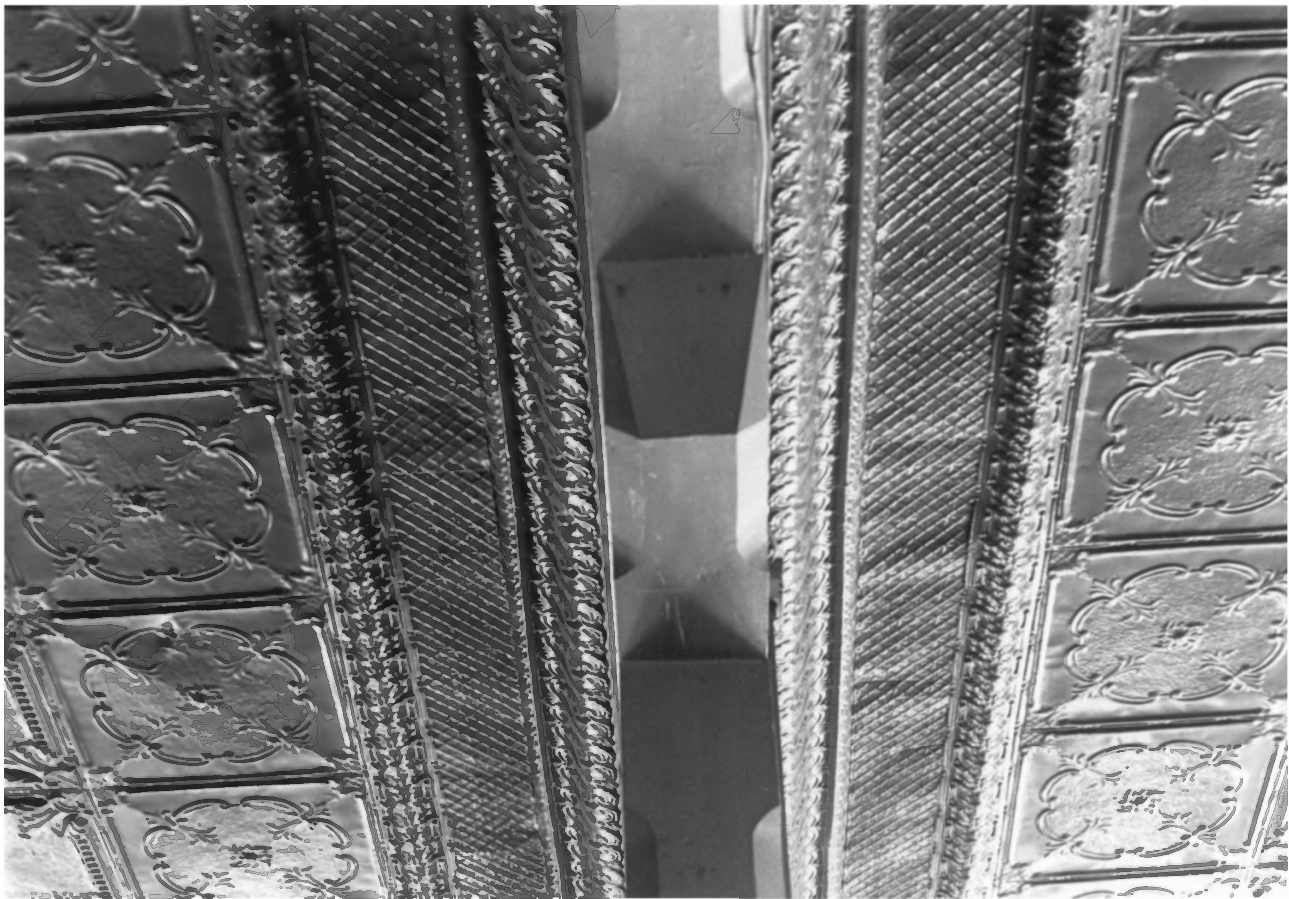
Photo # 26 OF 1930

DETAIL OF EMBROIDERED TIN CEILING

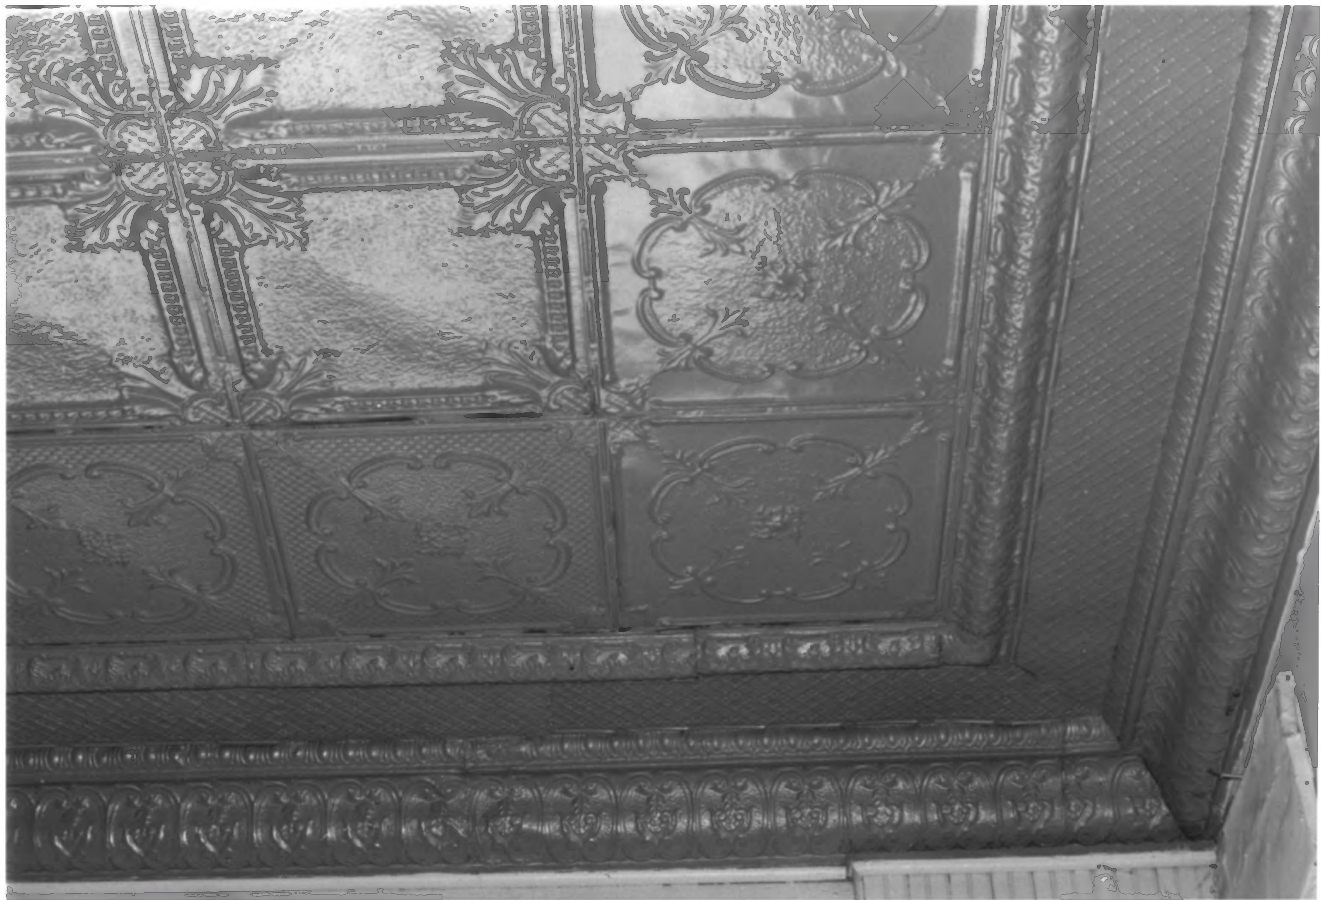
Photo # 27 of 30

DETAIL OF EMBOSSED TIN CEILING

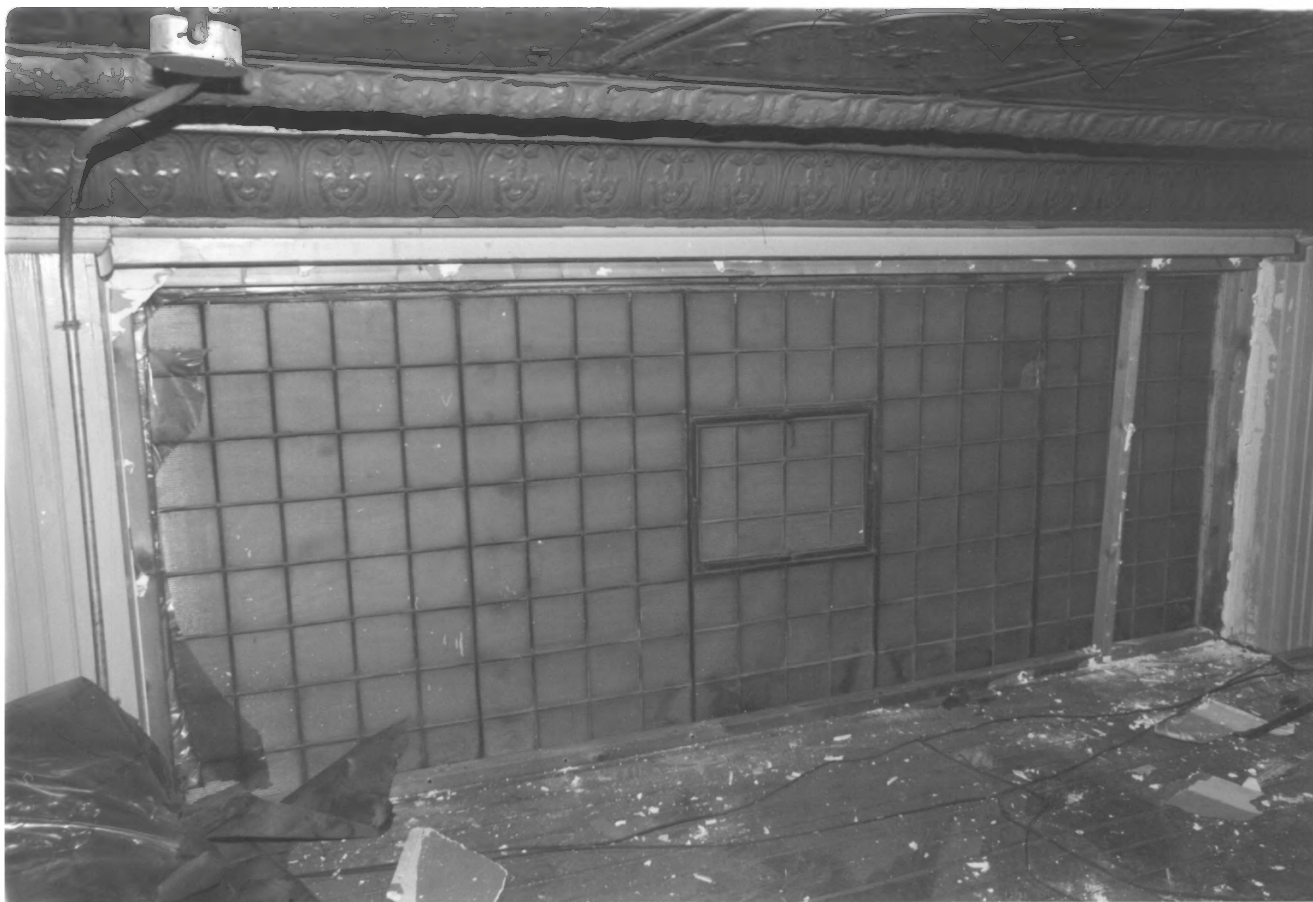
Photo # 28 OF 30

TRANSOM PANEL FILLED WITH PRISM GLASS,  
STORM FRONT ENTRANCE, LOOKING EAST

Transom panels above the storefront windows and recessed porch contain 4" by 4" by 1/2" thick, leaded, textured glass units in four panels approx. 8 feet wide by 4 feet high. Each panel of glazing has a center section of twelve glass units, 4 units wide by 3 units high, which open for ventilation (photo no. 28). The panels are currently covered with plywood on the exterior and gypsum board on the interior, installed in recent years to block sunlight.

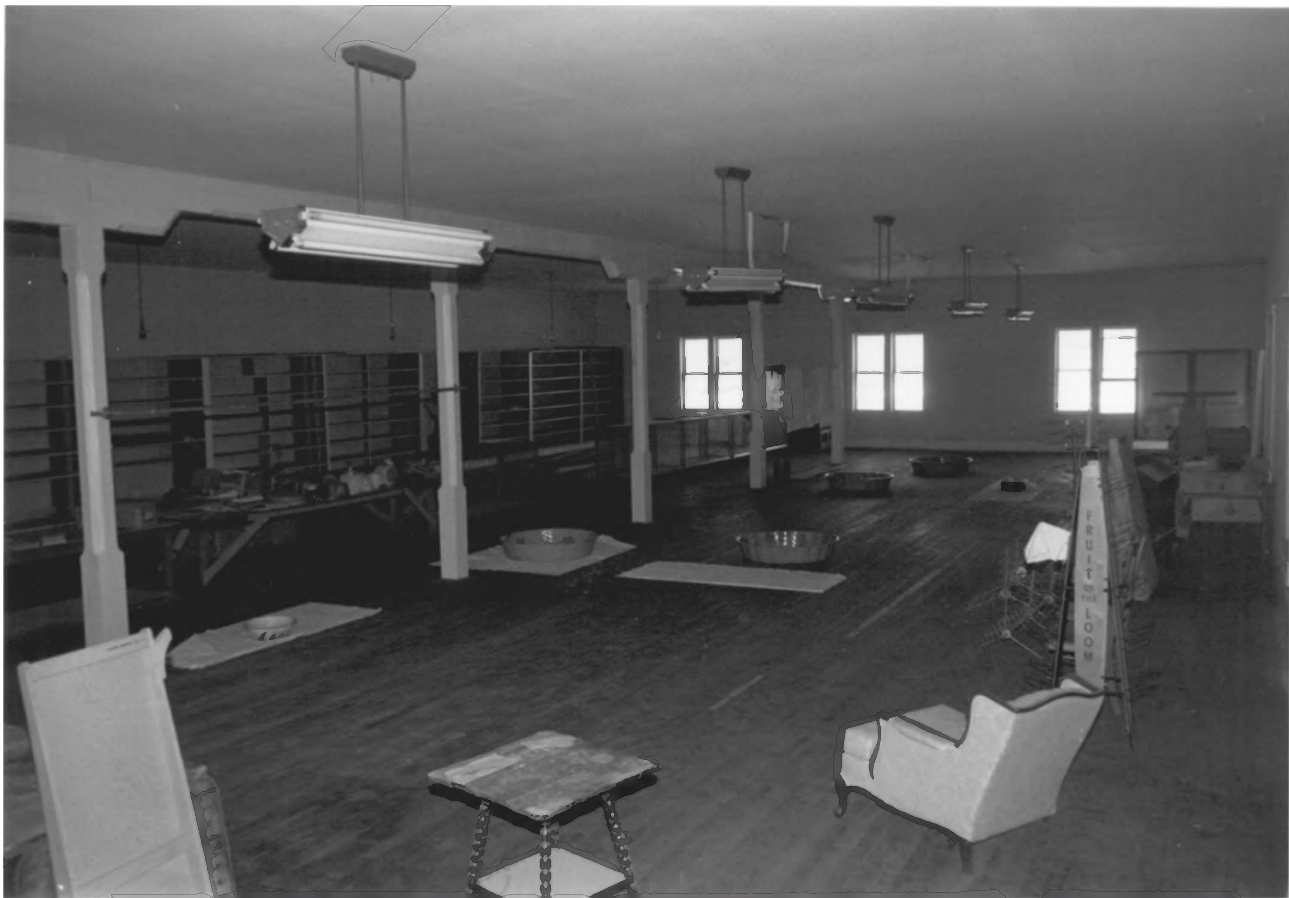
Photo # 29 OF 30

SECOND STORY INTIMATION, LOOKING EAST TO FRONT OF  
BUILDING.

Sometime after J. D. Burns moved Dunn Brothers Inc. into the building, he gutted the second story for additional retail space leaving the toilet rooms intact, as they are today (photo no. 29). Possibly at this time the stair vestibule was removed as the stair now serves to connect the first and second floor activities. Evidence of patched plaster on the second floor walls and discolorations on the original wood flooring make it possible to trace the locations of several of the original partitions.
