National Register of Historic Places
Registration Form

historic name Crook County Bank Building
other names/site number Bowman, A. R., Memorial Museum

The Crook County Bank, now the A. R. Bowman Memorial Museum, is a detached, two-story, stone building situated on the southeast corner of Highway 26 (West 3rd) and North Main Streets, the central intersection for downtown Prineville. Built in 1911 for the Crook County Bank, the building is one of several in Prineville constructed out of basalt quarried from west of Prineville. After the Crook County Bank discontinued operations in 1923, the Bank of Prineville, and then the Prineville National Bank, occupied the building until 1934.

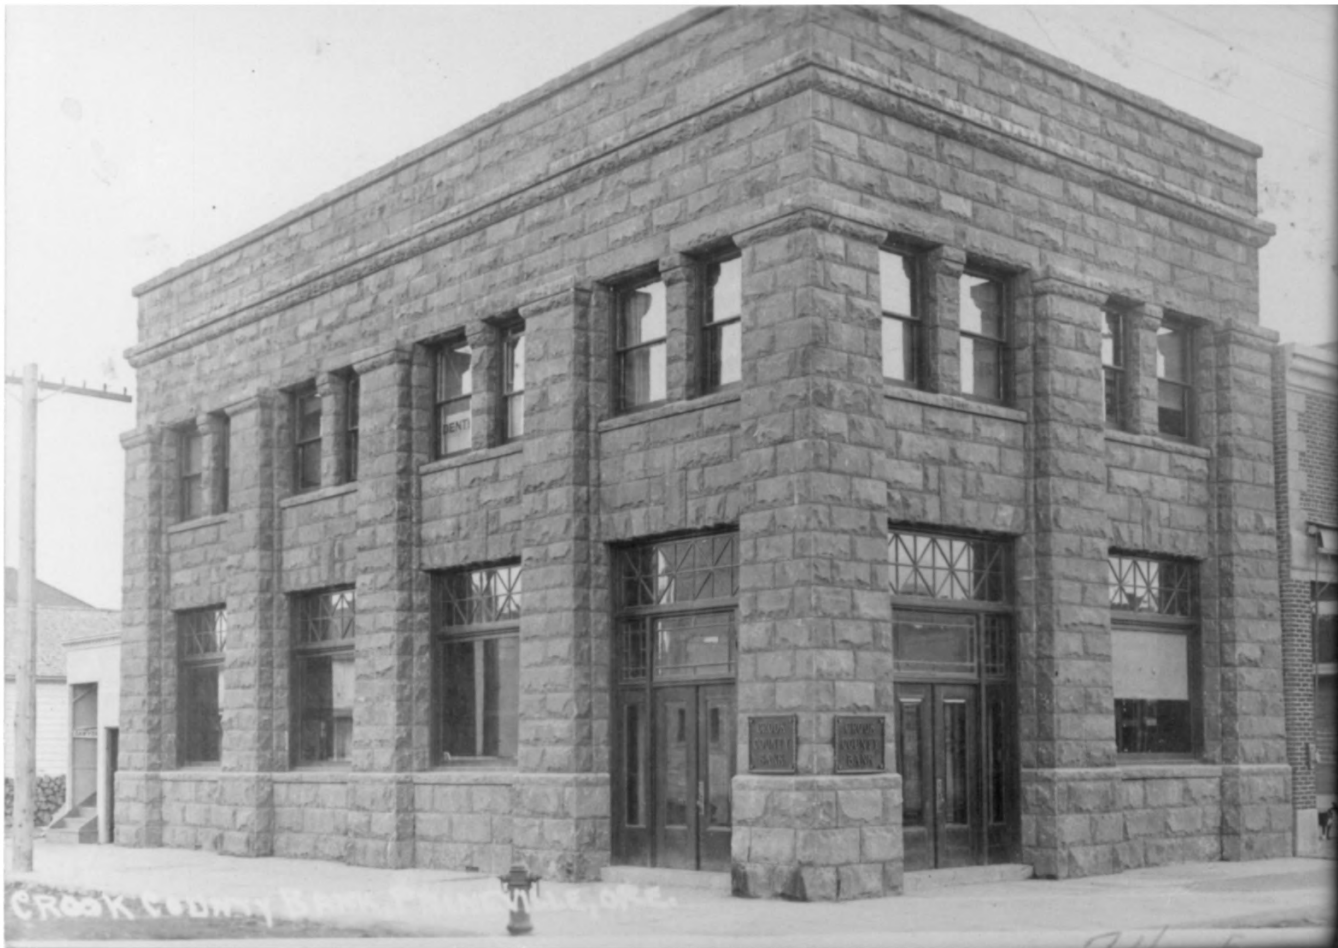
2 of 22

CROOK COUNTY BANK BUILDING
A.R. BOWMAN MEMORIAL MUSEUM
Exterior: Completed stone building as the
Crook County Bank. Entrance to
the upstairs offices was gained
by stairway on left of photo

The nominated property includes a 12 x 15-foot wood-frame storeroom/covered stair on the east end of the building that, before a renovation of 1971, provided the only access to the second story office space.

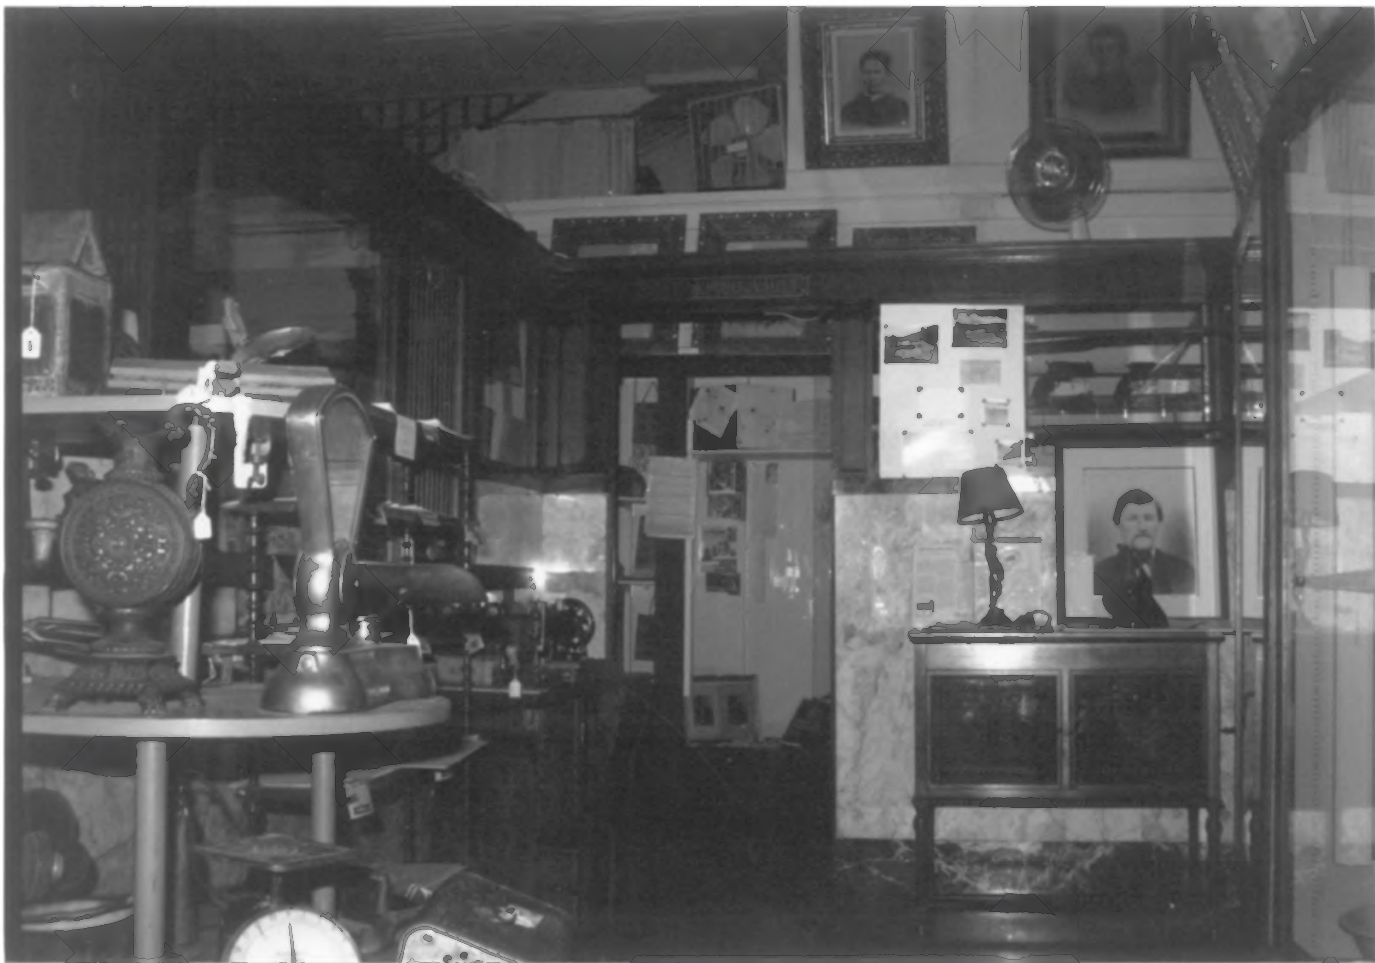
7 of 22 Interior: Public side of the teller cages. Shows
verd antique marble, surmounted by a
solid mahogany top screen with
bronzé panels

entire front of the counter is of verd antique marble (from Vermont) and Toheen and Alaska marble, surmounted by a solid mahogany top screen with bronze panels, while the partitions forming the director's office are of mahogany, with beautiful panels of etched, art-glass. The mahogany screens and partitions are finished in scroll detail.

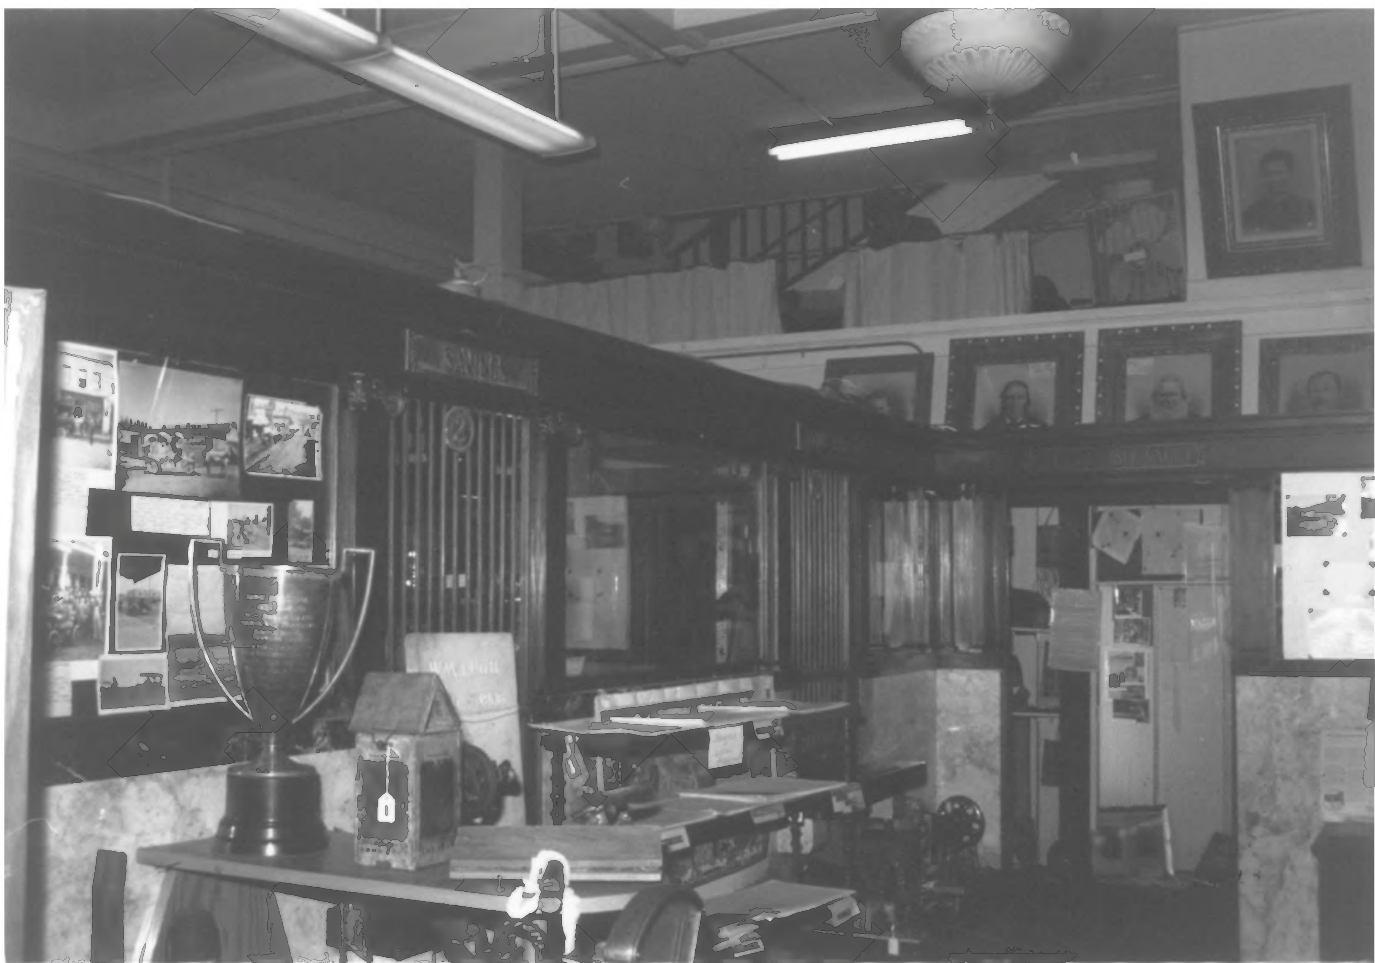
* 8 of 22

Interior: South side of Museum showing public side of two of the three teller cages.

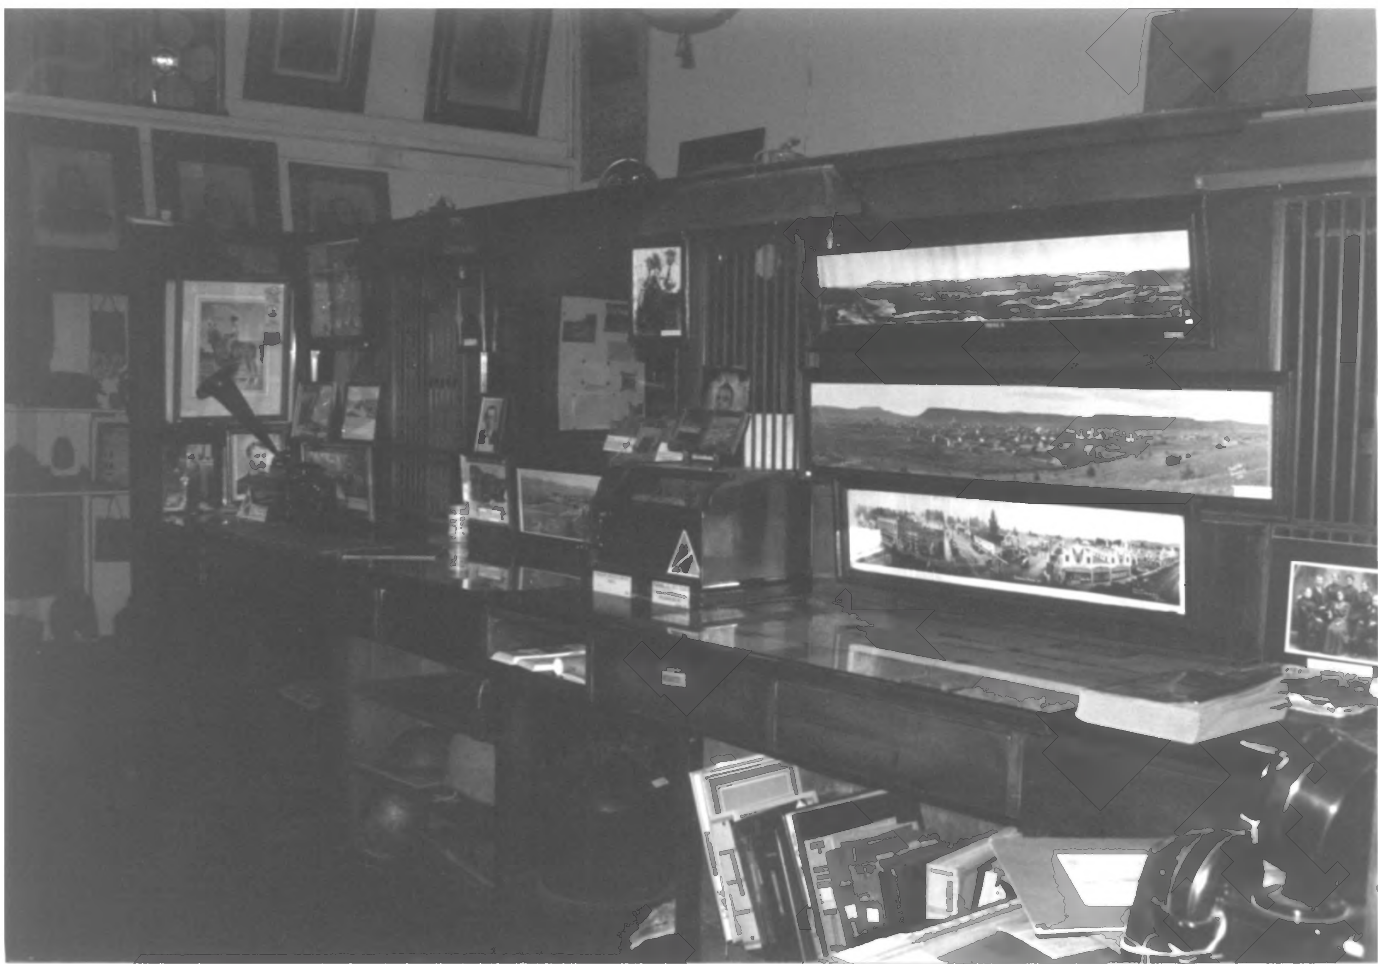
*9482

Interior: Worker's side of teller cage with
hardwood drawers below counter.

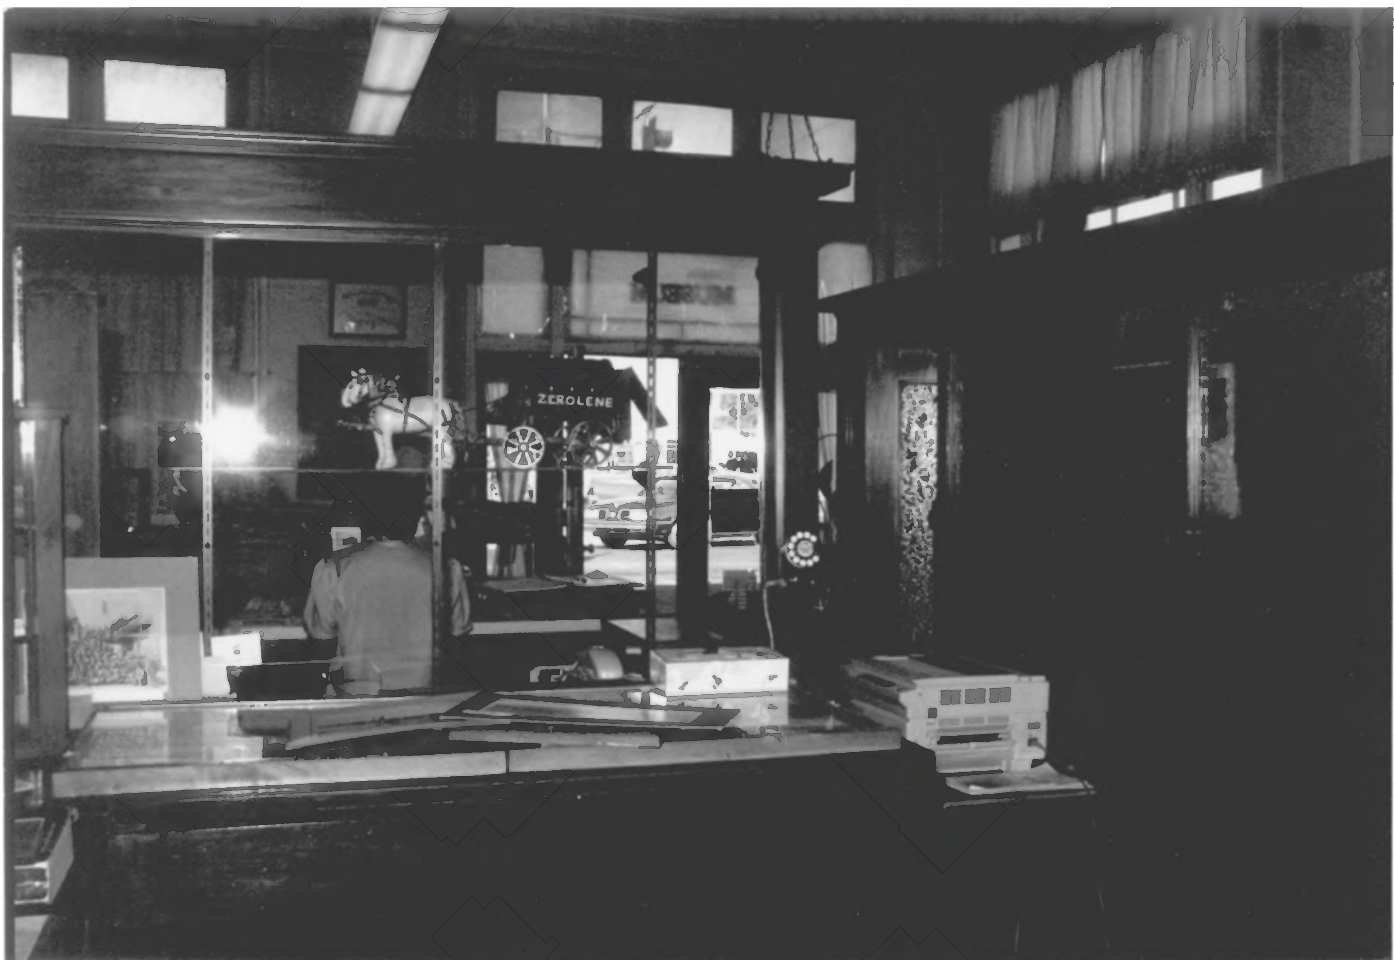
#10 of 22

Interior: Etched art glass and mahogany
enclosed private office space on left.
Clear glass divider separated front
open office from teller cages

The entrance to the area behind the front counter is now used by the Director/Hostess and is protected from public use by a swinging half-door. The former Bank President's office has become the Library. The bank's main floor space was used as: vestibules, lobby, safe deposit area, accounting, and for the Bank President. The vestibules (entries), lobby, and accounting spaces now contain tall built-in display cases with glass fronts and interior lighting.

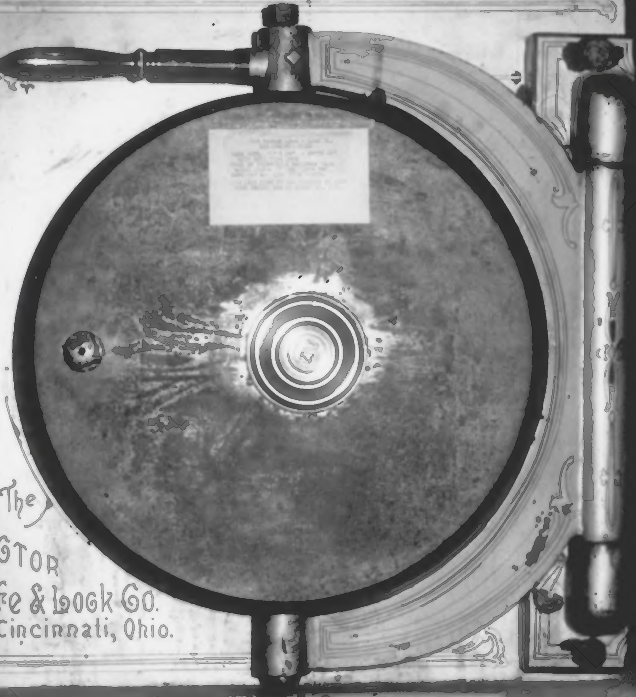
10 of 10 Interior: Original safe inside vault.
Time-lock dismantled

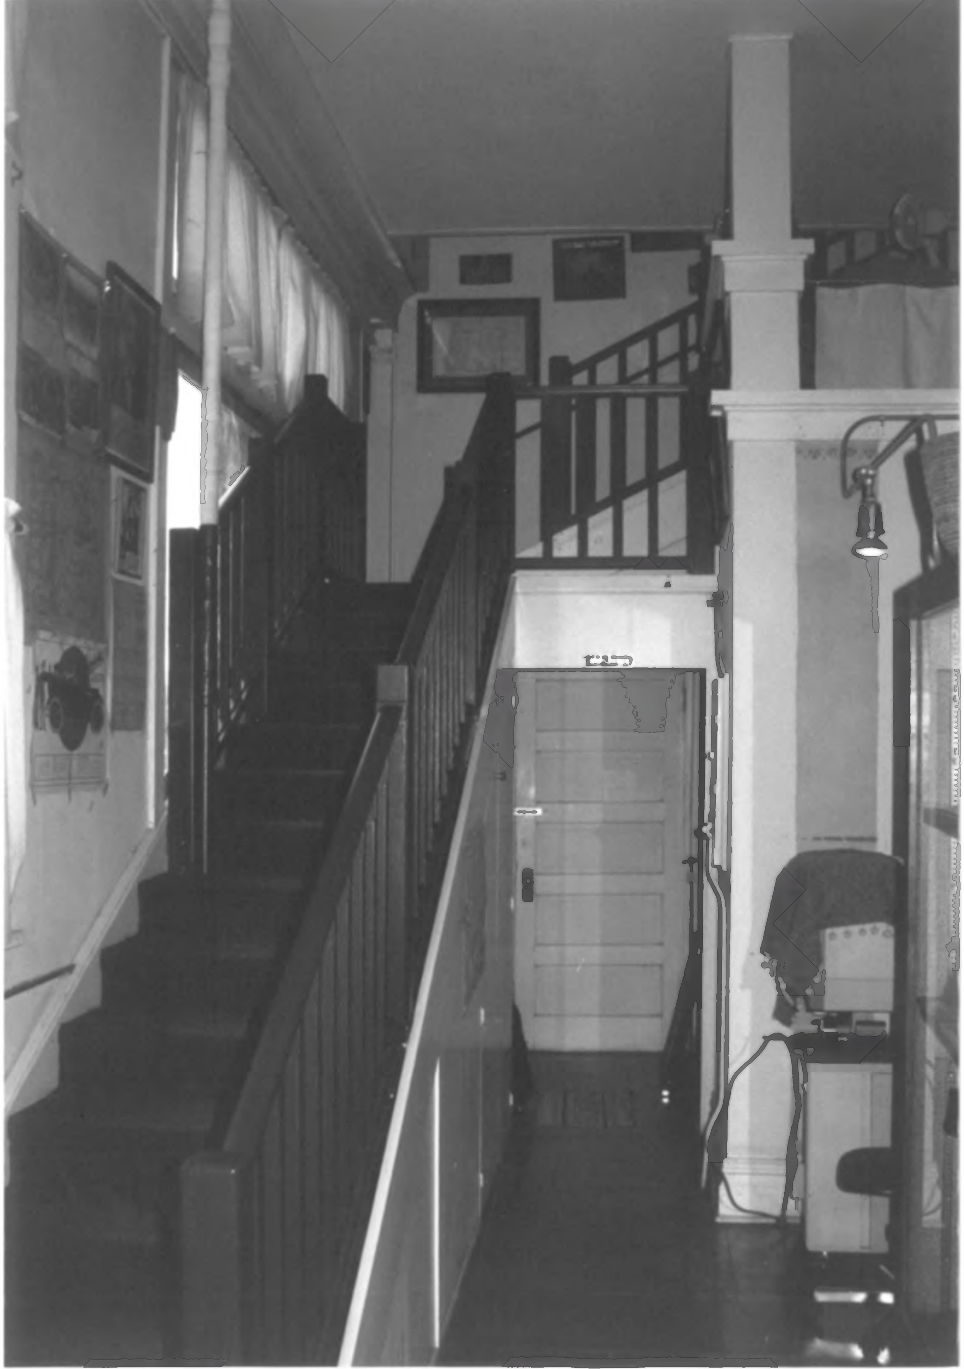
* 12922 Interior: Stairway now leads to
balcony and display rooms
upstairs. Doorway is to
the furnace room.

In March 1972, bids were put out for an interior stairway to the second floor to be located at the east end of the north wall, giving entry off its landing to a balcony over the corridor, vaults and lavatory; also for new wiring to be installed downstairs and on the balcony. This remodeling was begun in October, after the museum closed for the winter, and completed before the museum reopened for the 1973 season. The rooms upstairs required only some plaster repairs and paint. The roof and chimney were repaired and the costs were partially covered by the county. Most of the lumber and time was donated. The total disbursements for March 1, 1973, to December 1, 1973, were \$1,688.52.

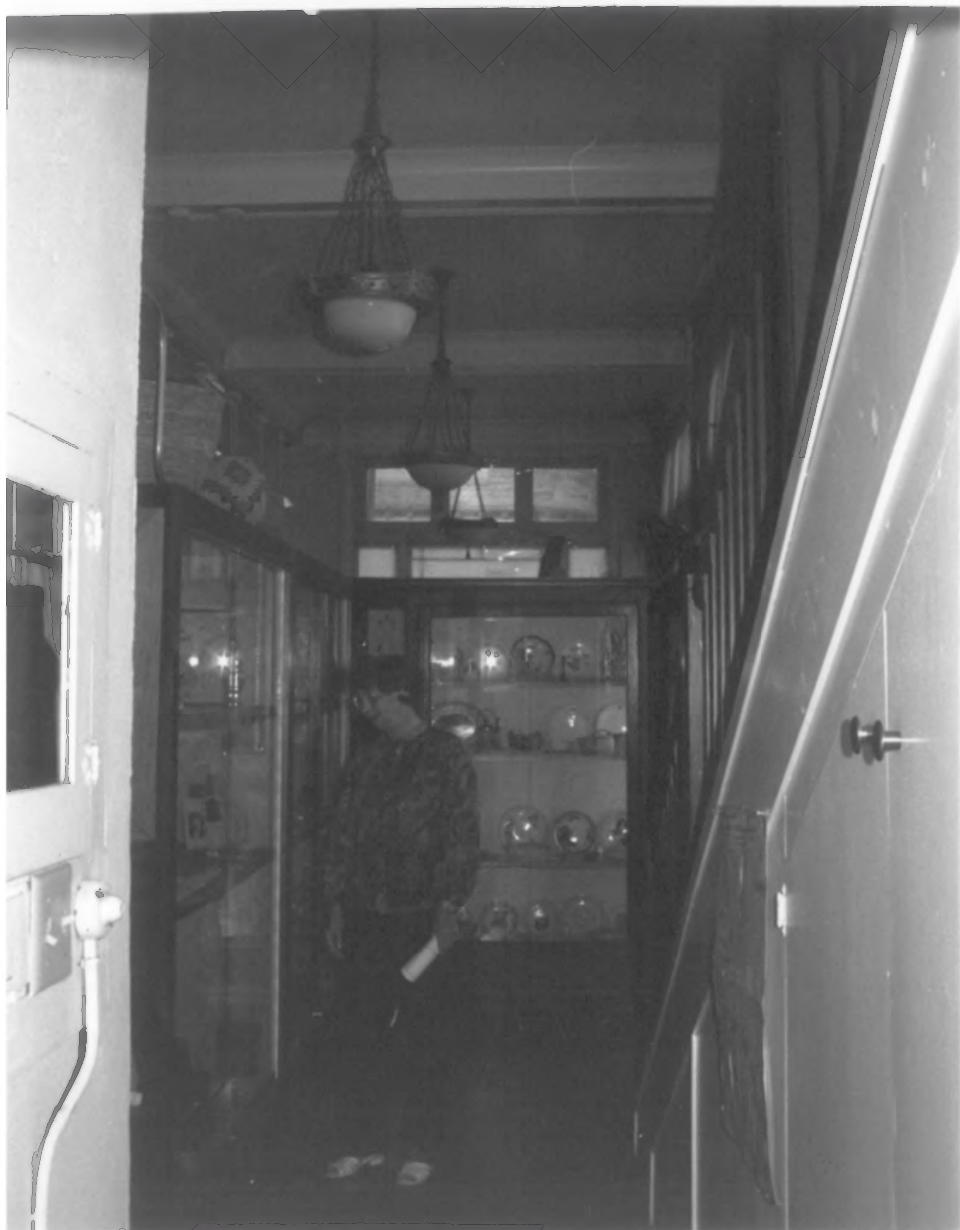
22 of 22

Interior: Shows alignment
of 3 of the 6 lights
hanging downstairs

Inside, the walls and ceiling are covered with plaster and are painted. From floor to ceiling measures fourteen feet. There are three cross-beams running north and south across the ceiling, and a center-carry-beam bears east and west, forming seven divisions on the ceiling. There is detailed crown molding running around the perimeter of the ceiling. There are six, tasseled chandeliers hanging from the ceiling, featuring gilt and alabaster.
