**NATIONAL REGISTER OF HISTORIC PLACES
INVENTORY -- NOMINATION FORM**

DEPRESSION-ERA BUILDINGS

Lick Creek Guard Station

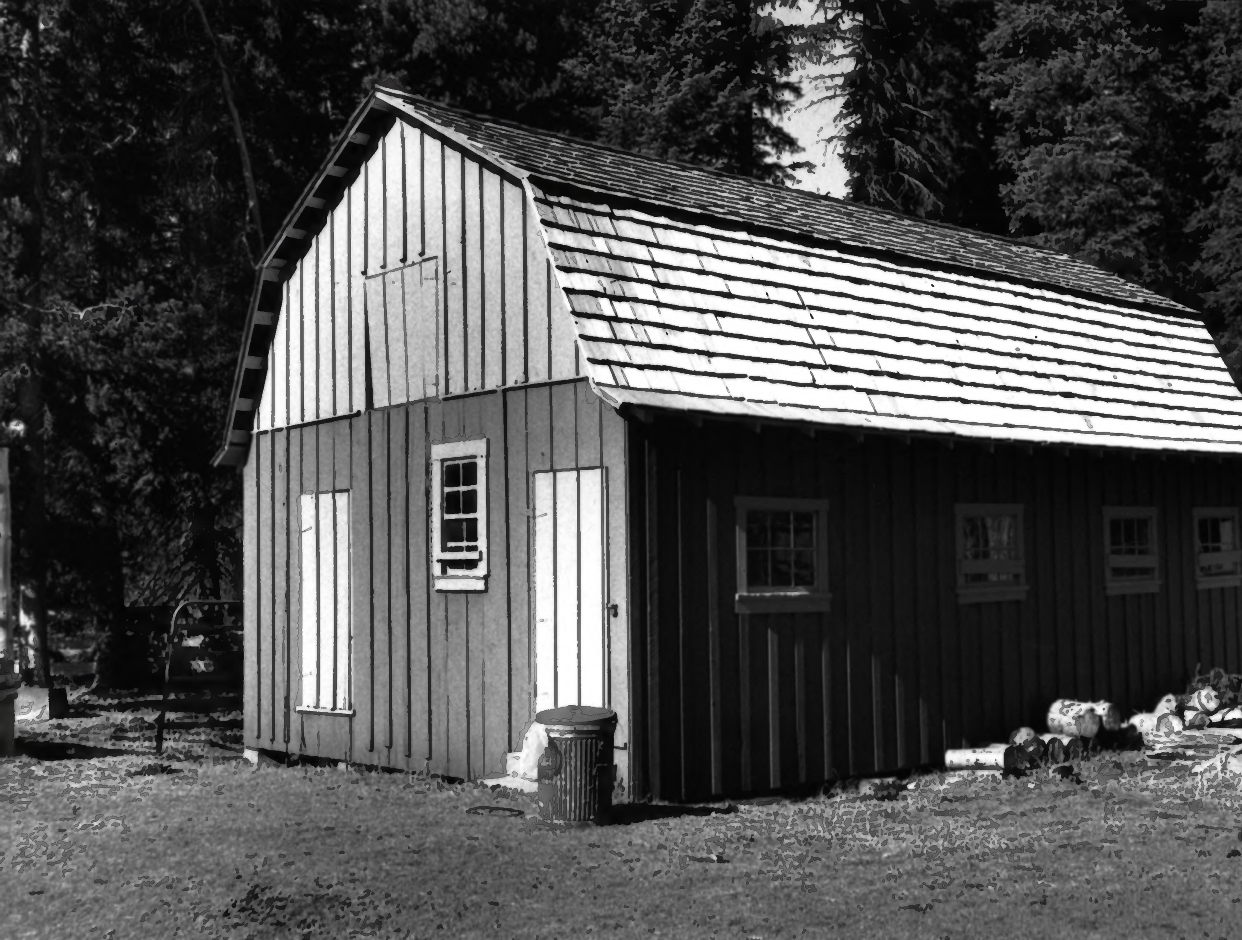
- 1) Name of Property: Lick Creek Guard Station--
Barn #2405
- 2) City and State: Enterprise, Oregon
- 3) Photographer: Bruce Womack
- 4) Date: 10/13/83
- 5) Negative Location: USDA Forest Service, Regional Office, Recreation Unit, CRM files.
- 6) Description: Looking northwest at south gable end, east elevation
- 7) Photograph Number: 16-04-2405

Barn #2405: Rectangular; 1 1/2 story; wood frame; concrete pier foundation; wood-shingled bellcast gambrel roof, eaves project, rafters exposed, verges project, plain. Exterior walls are vertical board and batten. Windows are six-light single sash, in horizontal placement. A single-leaf vertical board door offset to right on south gable end; single-leaf vertical board door offset to left and slightly elevated on south gable end; hay door centered, left level on south gable end; slide-opening vertical board stock door on north gable end. No apparent structural additions or alterations; no obvious material modification. No decoration.

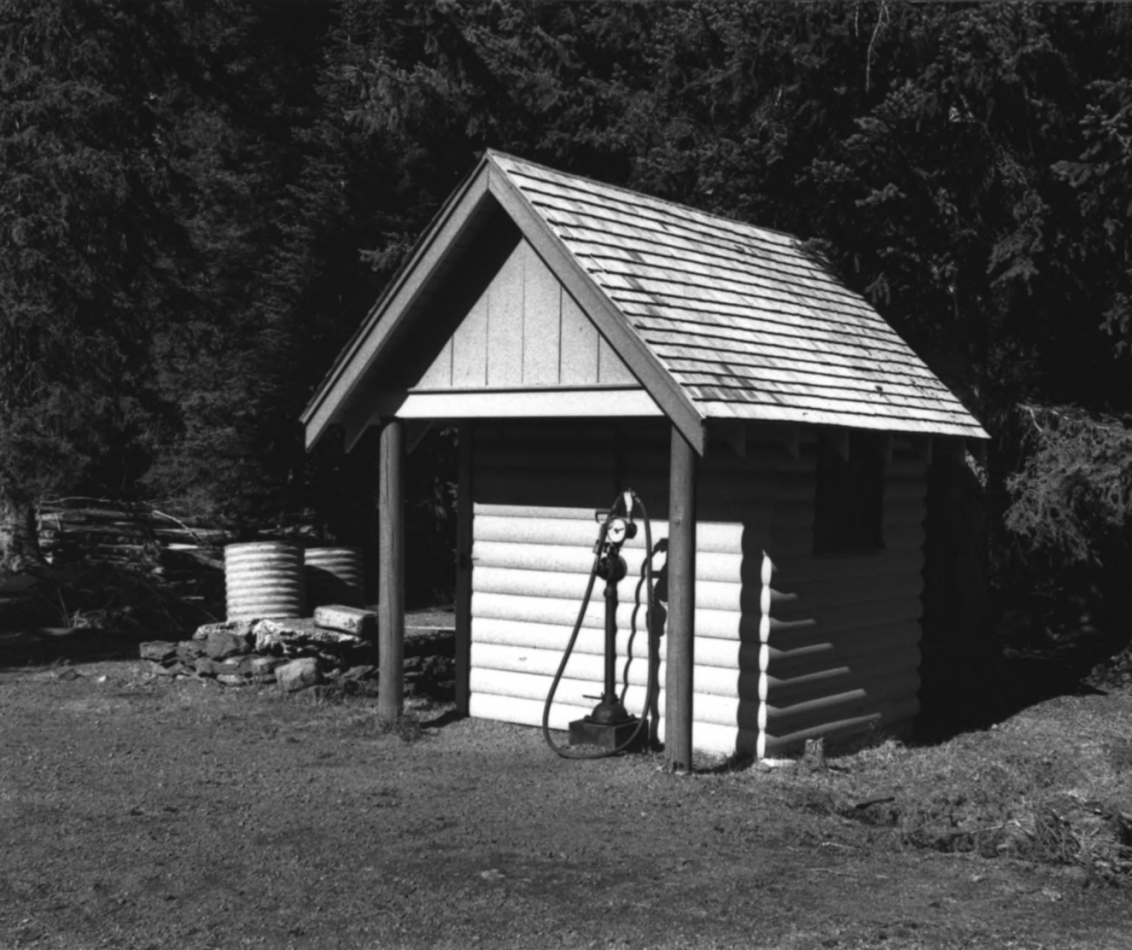
- 1) Name of Property: Lick Creek Guard Station--
Gas House #2505
- 2) City and State: Enterprise, Oregon
- 3) Photographer: Bruce Womack
- 4) Date: 10/13/83
- 5) Negative Location: USDA Forest Service, Region-
al Office, Recreation Unit, CRM files.
- 6) Description: Looking northwest at main
south-facing facade, east elevation
- 7) Photograph Number: 16-04-2505

Gas House #2505: Rectangular, 1 story, wood frame; poured concrete foundation; wood-shingled medium gable roof, eaves project, rafters exposed, verges project, fascia alone, roof extends beyond plane of anterior wall to form porch, supported by peeled log posts. Exterior walls are semilunate shiplap to eaves level, vertical boards on gable ends. Windows are nine-light sashes on east and west elevations. Slide-opening single-leaf door, surfaced with horizontal semilunate shiplap, offset to left on south (main) facade. No apparent structural additions or alterations; no obvious material modifications. No decoration.

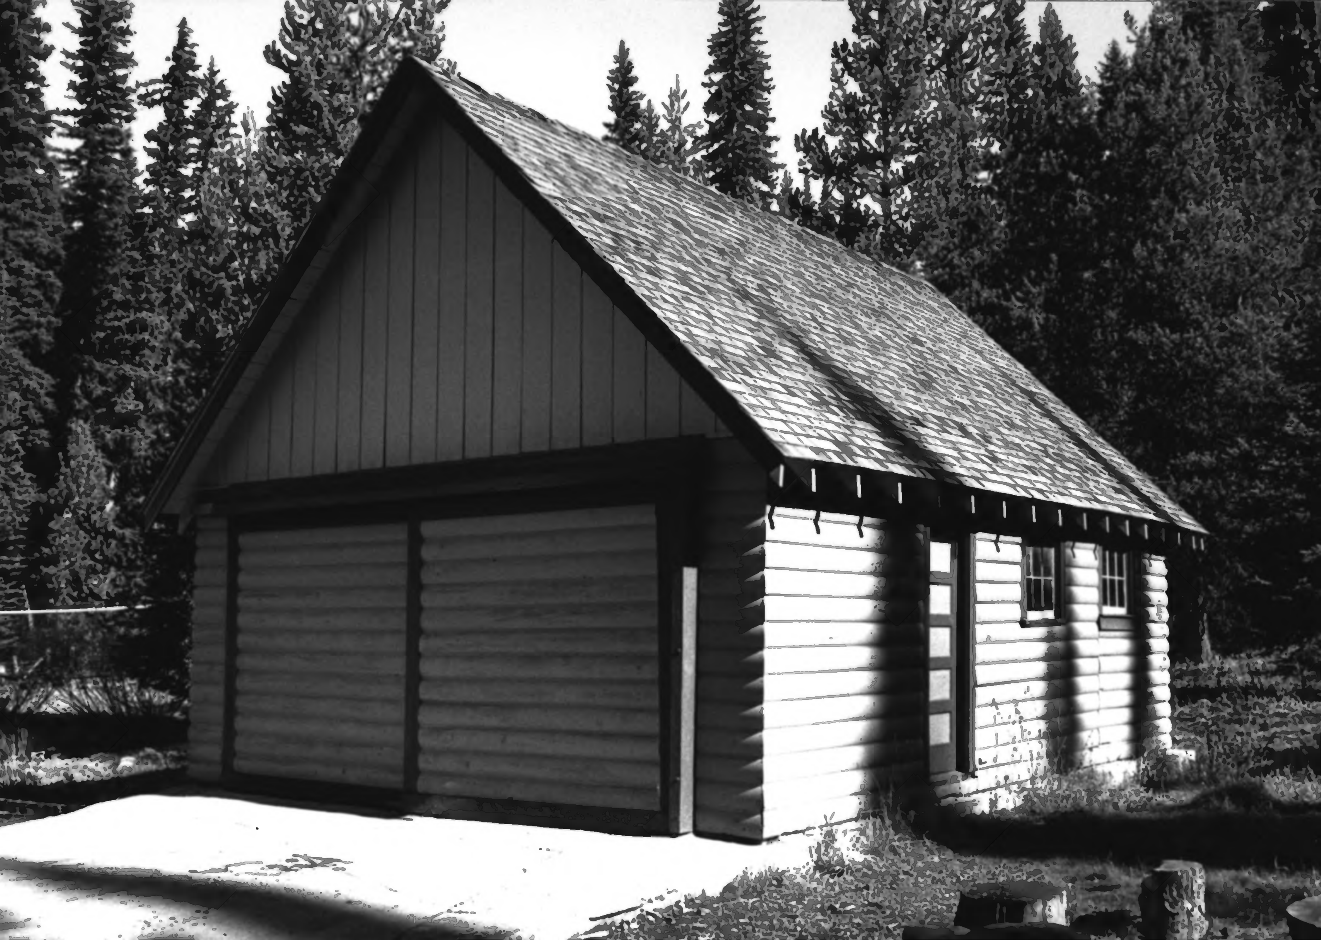
- 1) Name of Property: Lick Creek Guard Station--
Garage/Storage #1515
- 2) City and State: Enterprise, Oregon
- 3) Photographer: Bruce Womack
- 4) Date: 10/13/83
- 5) Negative Location: USDA Forest Service, Regional Office, Recreation Unit, CRM files.
- 6) Description: Looking northeast at west gable end, south elevation
- 7) Photograph Number: 16-04-1515

Garage/Storage #1515: Rectangular, 1 story, wood frame, wood-shingled medium gable roof, eaves project, rafters exposed, verges project, fascia alone. Exterior walls are semilunate shiplap to eaves level, vertical boards on gable ends. Windows are six-light single sash, in horizontal arrangement. Two horizontal slide-opening vehicular doors, surfaced with semilunate shiplap, extend across west gable end. Single-leaf five-panel door offset to left on south elevation. A poured concrete foundation, floor and driveway have been placed under the garage since the period of construction. No structural additions or alterations. No decoration.

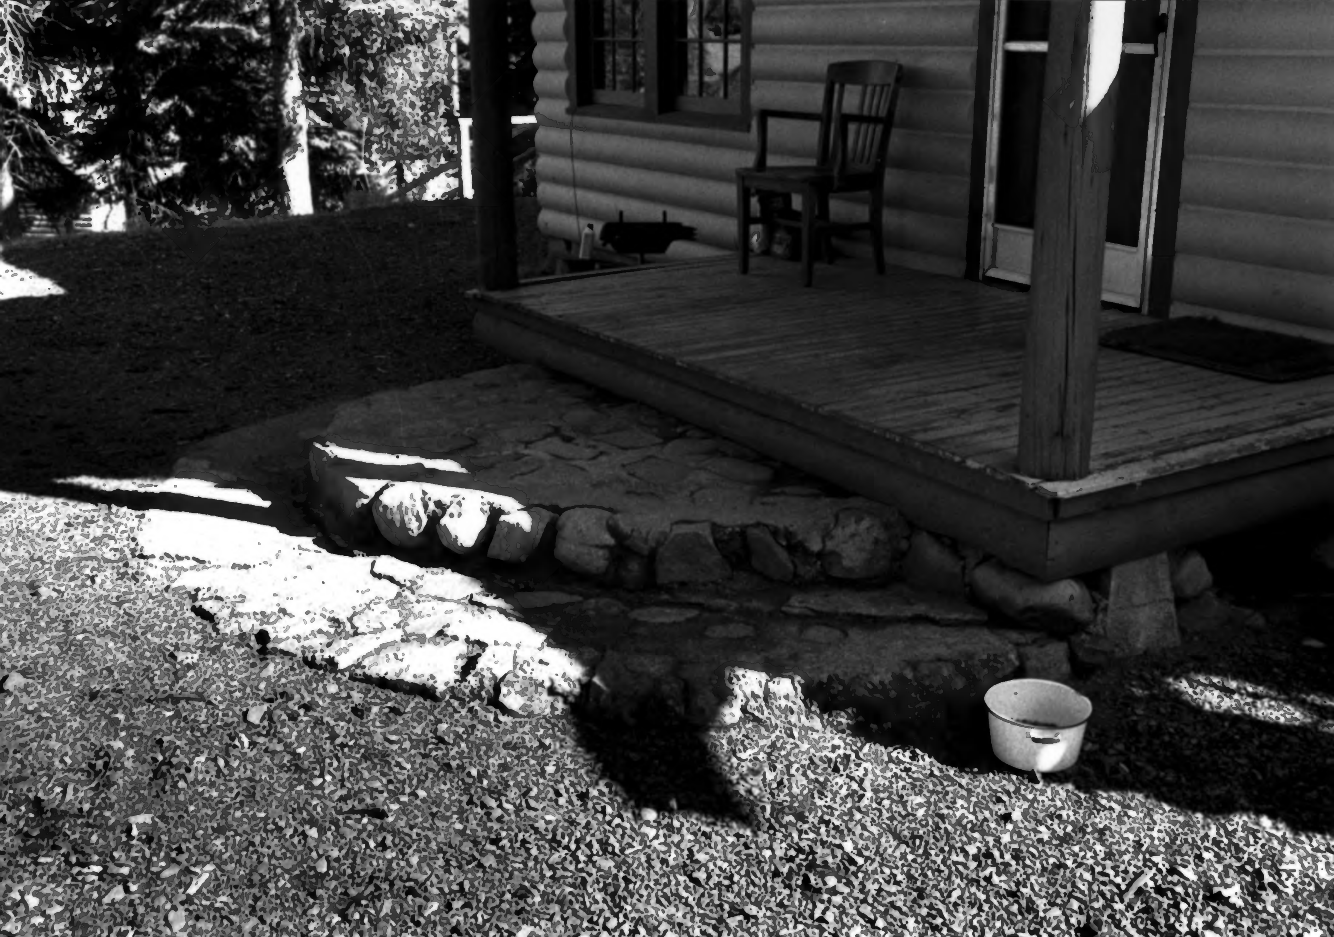
- 1) Name of Property: Lick Creek Guard Station--
Residence #1030
- 2) City and State: Enterprise, Oregon
- 3) Photographer: Bruce Womack
- 4) Date: 10/13/83
- 5) Negative Location: USDA Forest Service, Regional Office, Recreation Unit, CRM files.
- 6) Description: Detail--Semi-circular field stone step
- 7) Photograph Number: 16-04-1030-2

double-hung sash, singly and in combinations of two with mullions. Main entry is single-leaf vertical plank door, centered, west (main) facade. Entrance is covered by center gable porch, supported by two peeled log posts, and accessed by two semicircular field stone steps, open plank porch platform. No apparent structural additions or alterations; no obvious material modification. No decoration.

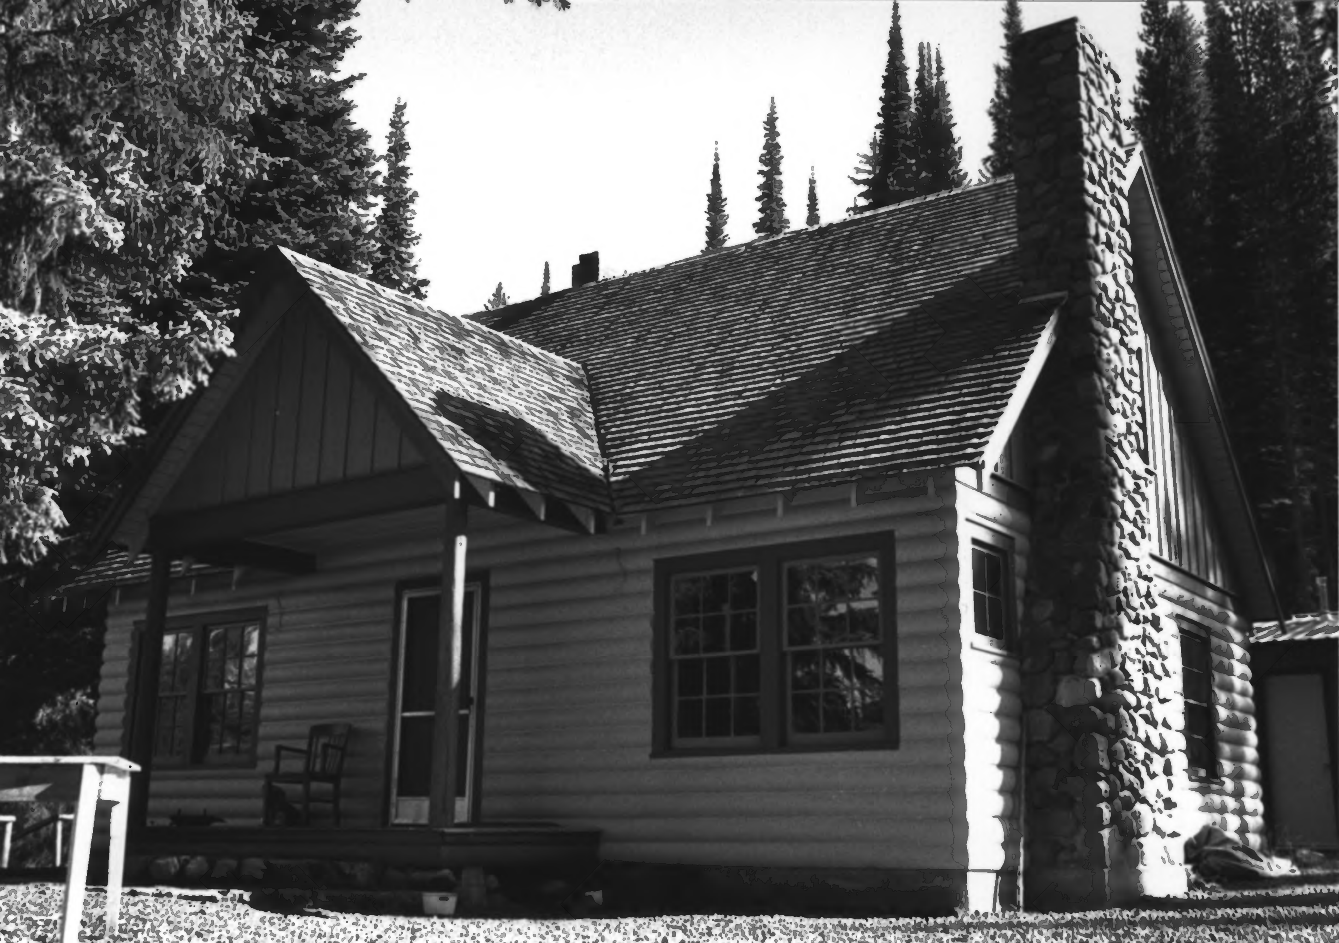
- 1) Name of Property: Lick Creek Guard Station--
Residence #1030
- 2) City and State: Enterprise, Oregon
- 3) Photographer: Bruce Womack
- 4) Date: 10/13/83
- 5) Negative Location: USDA Forest Service, Regional Office, Recreation Unit, CRM files.
- 6) Description: Looking east at south gable end, main west-facing facade
- 7) Photograph Number: 16-04-1030

Residence #1030: Rectangular; 1 1/2 story; wood frame; poured concrete foundation; wood shingled medium gable roof, eaves project, rafters exposed, verges project, fascia alone; field stone masonry exterior end chimney offset to left on south gable end, brick interior chimney offset to left below ridgeline on rear slope of roof. Exterior walls are semilunate shiplap to eaves level, vertical board and batten on gable ends and center porch gable. Windows are six-over-six

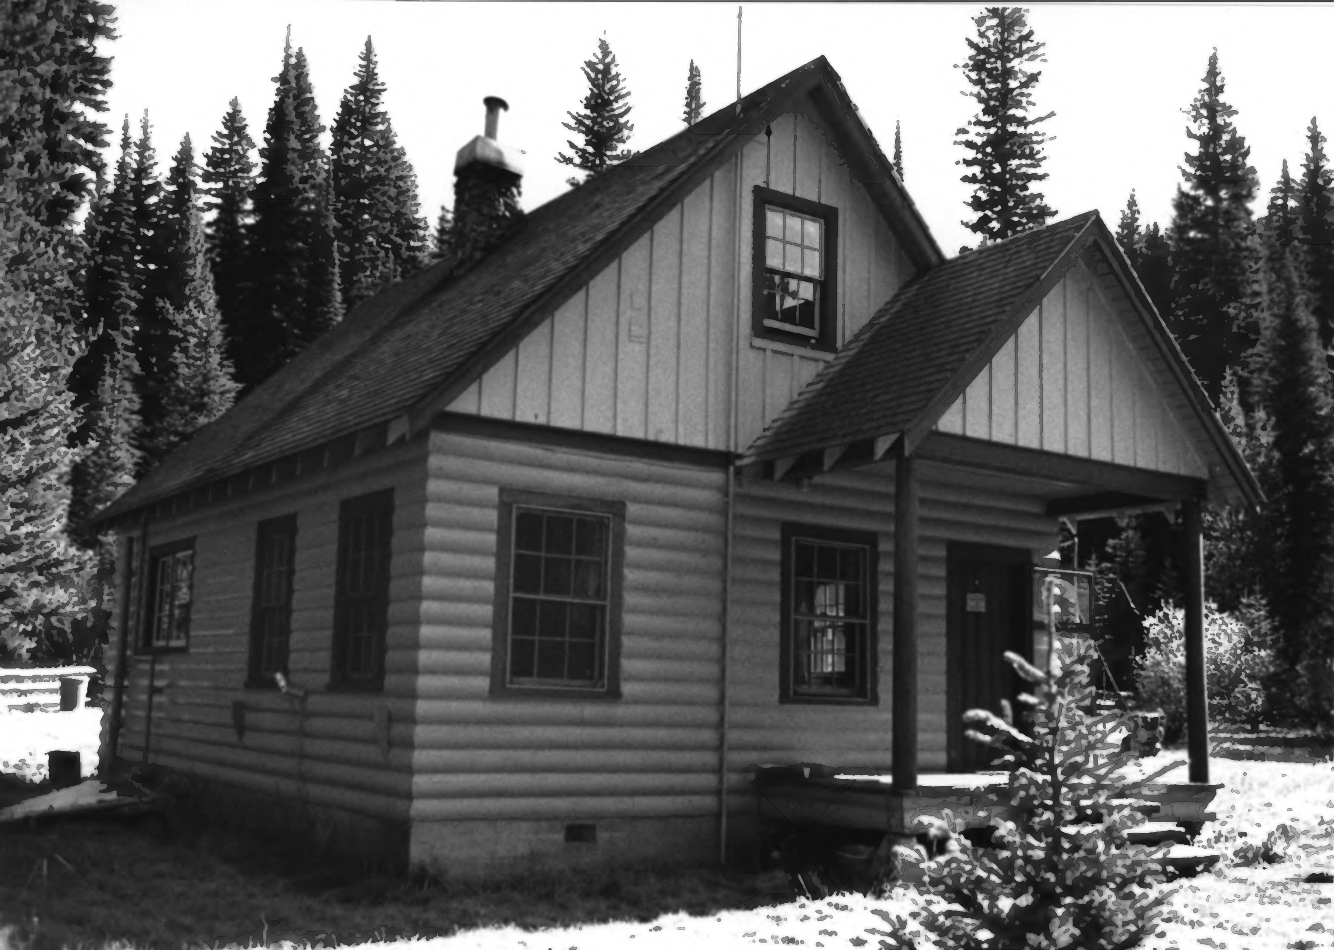
-
- 1) Name of Property: Lick Creek Guard Station--
Office #1031
 - 2) City and State: Enterprise, Oregon
 - 3) Photographer: Bruce Womack
 - 4) Date: 10/13/83
 - 5) Negative Location: USDA Forest Service, Regional Office, Recreation Unit, CRM files.
 - 6) Description: Looking southeast at north elevation, main west-facing gable
 - 7) Photograph Number: 16-04-1031

Lick Creek Guard Station #1031: Rectangular; 1 1/2 story; wood frame; poured concrete foundation; wood-shingled medium gable roof, eaves project, rafters exposed, verges project, fascia alone; field stone interior chimney, centered north slope of roof below ridgeline. Exterior walls are semilunate shiplap to the eaves, vertical board and batten on gable ends and porch gable pediment. Windows are six-over-six double-hung sash. Main entry is covered by gable porch, supported by two peeled log posts, offset on west gable end (main facade). Single-leaf door with vertical semilunate shiplap surface, offset to right beneath gable porch, accessed by three straight plank steps, open plank platform. Rear entry, single-leaf four-panel door, offset to right on south elevation. No apparent structural addition or alteration; no obvious material modification. No decoration.
