### Exterior Masonry Assessment:

#### **Fenton Hall University of Oregon**

### **Condition Assessment**

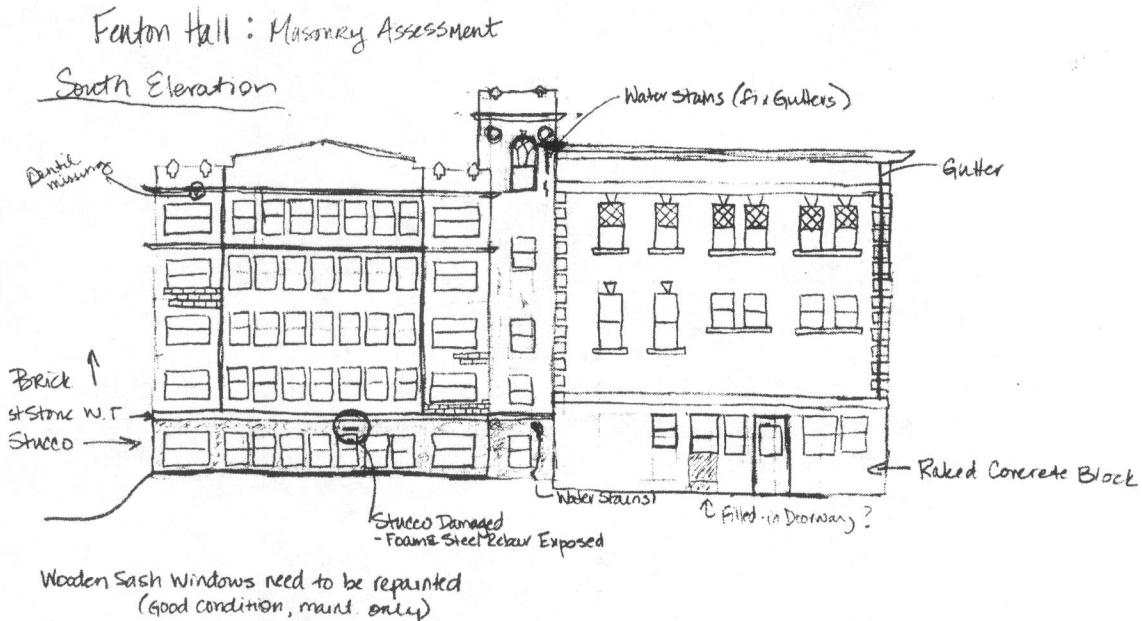
The south elevation can be considered as three distinct structures: the original building to the east; the tower in the center; and the five-story stacks annex to the west. Field Notes from the condition assessment illustrate the tripartite nature of the south elevation.
