BENTON COUNTY CULTURAL AND HISTORIC RESOURCE SURVEY 1983

STATE OF OREGON INVENTORY HISTORIC SITES AND BUILDINGS State Historic Preservation Office Oregon State Parks, Salem, 97310

County	Benton
Theme	6-A
Name (Common)	Hayden Covered Bridge
(Historic)	(same)
Address	Hayden Road at Highway 34, 1½ m. west of Alsea, Ore.
Present Owner	Benton County
(Address)	Corvallis, Ore.
Original Use_	Bridge
Date of Const	ruction 1918

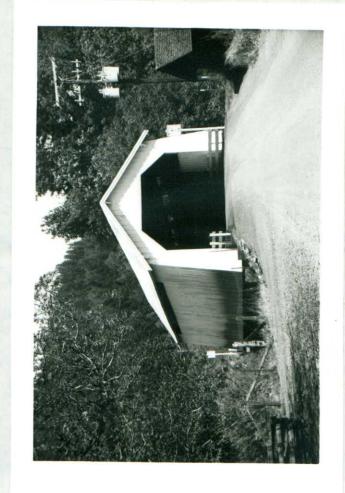
INVENTORY NUMBER 506
AREA: Alsea T 14S R 8W SECTION 2 TAX LOT #
Address: Hayden Road near Hwy. 34 1 1/2 mile west of Alsea
Owner: Benton County
Historic Name: Hayden Covered Bridge
Theme: Transportation/History
Construction Date: ca. 1923
Type/Use: Bridge
Style: Vernacular
Recorded by: R. Clark Date: May 20, 1983 Rating: 1
Condition/ 7 Excel (10), Fair (5), deteriorated (1)

Roll EE # 31 south Story 1	Frame wood	side
Roof gable	Eaves overha	
Basic shape rectangle		Additions
Interior Chimney no		Exterior Chimney no
Dormers no	talker make the	Bays no
Siding board and batten		Cornerboards no
Typical Windows		
Porch Roof	Posts	Placement
Foundation	Other St	ructures
Notable Elements		
Alterations

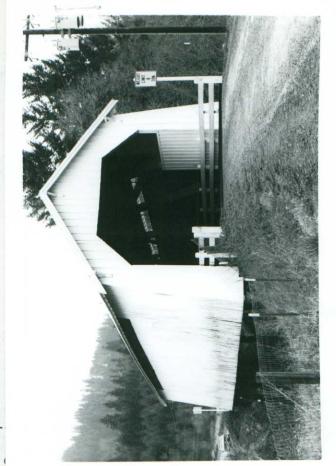
one Hayden Bridge, a covered structure ninety-one feet long, was built in 1918. It spans the Alsea River on Hayden Road about one and one-half miles west of Alsea, Oregon. The bridge has a vertical board and batten exterior which flares at the base. The gable roof is covered with tin. A long, rectangular opening at the eaves on the east and west elevations provides the lighting. The structure is in excellent condition and is in use.

Jamor restoration work was carried out on this bridge in 1946.
